Property Inspection Report

Texas Premium Inspections

16203 Oak Lace Ln
Inspection Prepared For: Marcelo Lopez
Agent: Lawrence Cevallos - Vive Realty

Date of Inspection: 2/26/2025
Year Built: 1997 Size: 1288
Weather: 55° F, Partly Cloudy, Faces East, Vacant

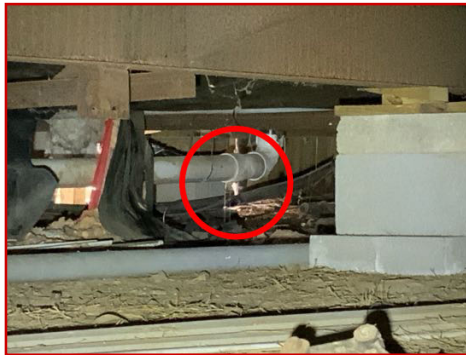
Leaking drain in crawlspace

- Drain, waste and/or vent pipes visibly leaking in the crawl space at the time of the inspection should be repaired to prevent the development of unhealthy conditions.

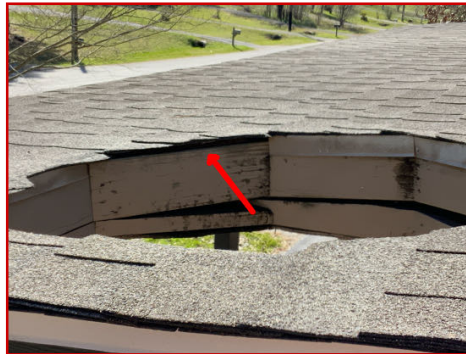
- Exposed nail heads are evident and should be sealed to avoid water penetration.
- Debris should be removed from the roof to avoid moisture damage to the shingles.
- One or more rubber vent boots were concave and will trap and or allow water to penetrate the roof structure.

Example of exposed nail heads

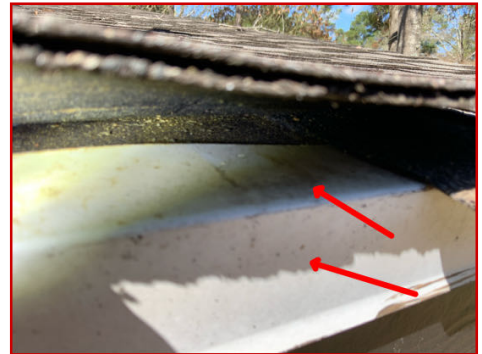
- **Some areas of the roof were missing roof edge flashing. Lack of roof edge flashing leaves the edges of roof sheathing and underlayment exposed to potential moisture damage from wood decay and/or delamination. The inspector recommends replacement of roof edge flashing in areas where it is missing.**

Example of missing drip edge

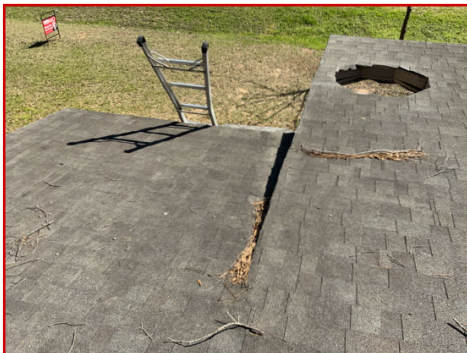
- **Roof edge flashing was improperly installed in places. When asphalt-saturated felt paper underlayment is used, it should overlap roof edge flashing at the eaves, and be overlapped by the flashing at the rakes. This condition may cause moisture damage to roof sheathing in the affected areas from wood decay and/or delamination.**

Example of improper felt overlap at drip edge

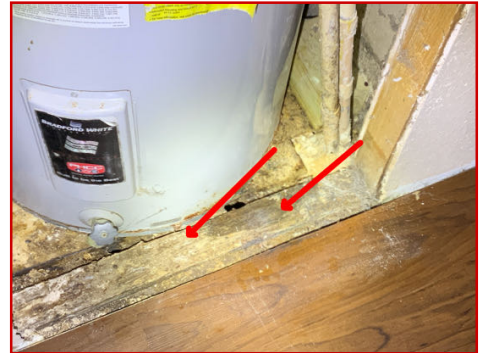
Elevated moisture levels and damage visible in water heater panel

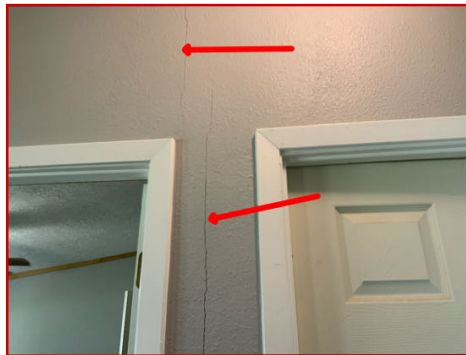
- Larger than typical cracks were noted on interior walls. This condition could indicate greater than normal movement within the structure, recommend further evaluation and correction, as needed, by a qualified professional.

Example of wall cracks

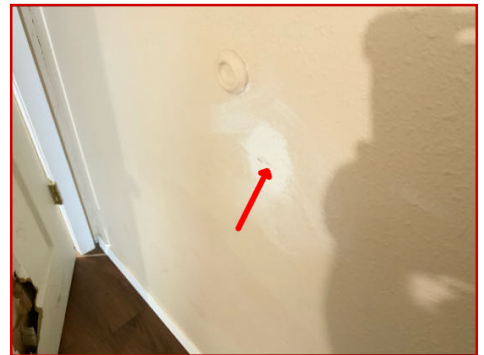
Example of wall cracks

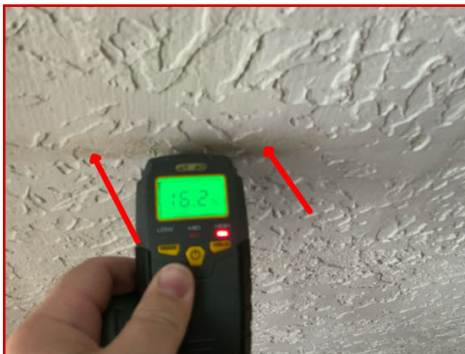
- Stains on the ceiling in the living room, which were visible at the time of the inspection, appeared to be the result of moisture intrusion from roof leakage. The moisture meter showed no elevated levels of moisture present in the stained areas at the time of the inspection, indicating that the source of moisture may have been corrected, or leakage may be intermittent. You should ask the seller about this condition.

Moisture stain in living room ceiling, elevated moisture levels detected at inspection

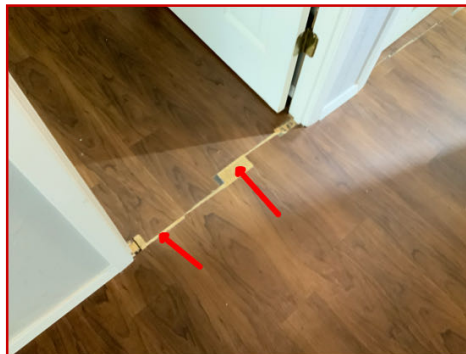
- Installation of vinyl flooring in the home was incomplete, leaving the subfloor exposed in areas.
- The home had minor vinyl floor damage visible at the time of the inspection.

Incomplete flooring installation/exposed subfloor

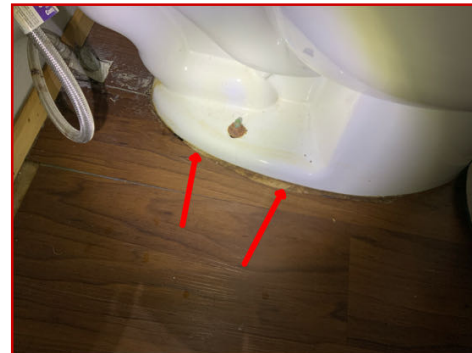
- Sub floor at the base of the toilet, in the hallway bathroom, was deteriorated with elevated moisture levels at the time of inspection. Recommend further evaluation and correction, as needed, by a qualified professional.

Elevated moisture levels in sub floor at toilet

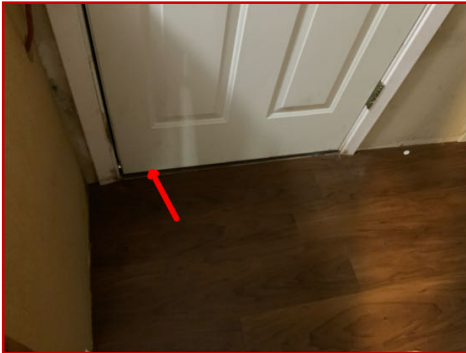
Rear entry binds on threshold

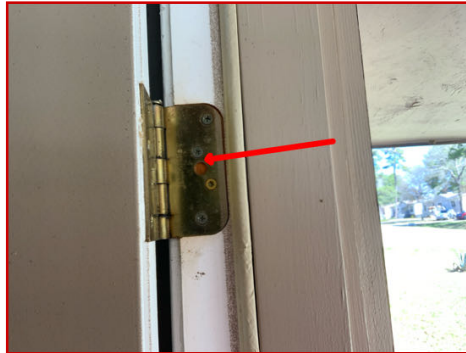
Loose hinge/stripped screws at front door

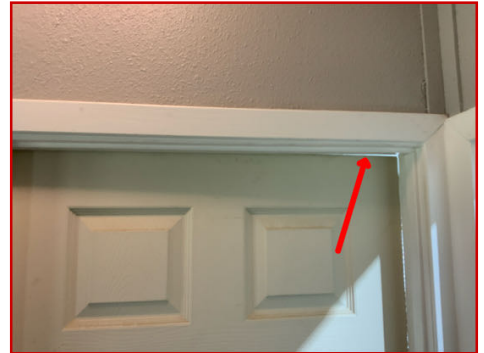
Example of uneven interior door

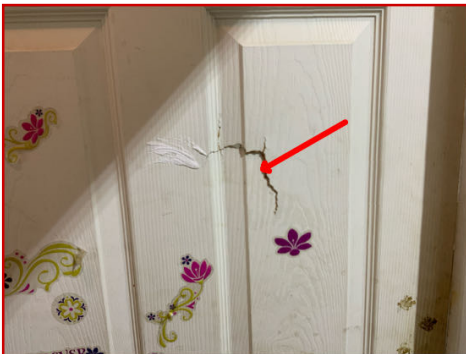
Example of damage to interior door

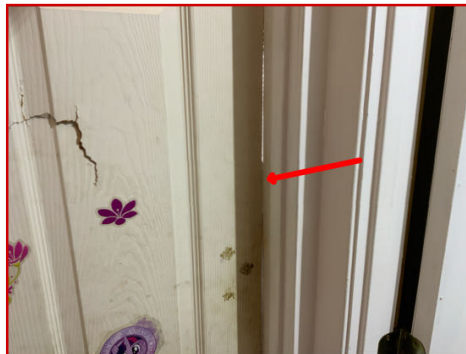
Bedroom door binds on jamb

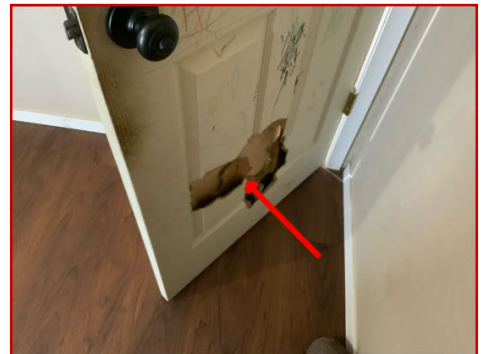
Example of interior door damage

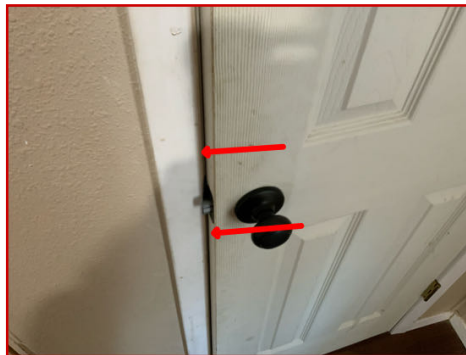
Closet door binds on jamb, will not close

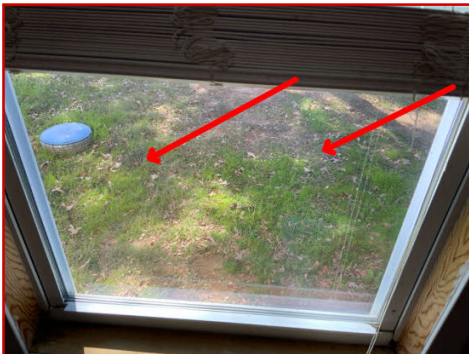
- Windows in the home exhibited moderate deterioration.
- It is desirable to replace window screens that are missing. This present owner should be consulted regarding any screens that may be in storage.

Example of missing screens

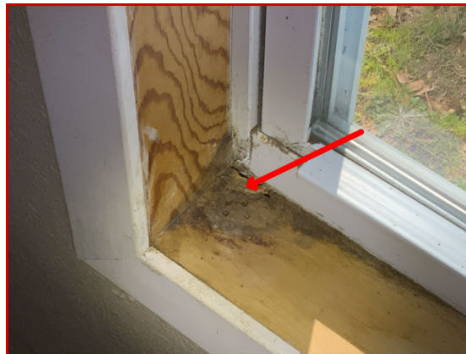
Example of deterioration at interior window sill

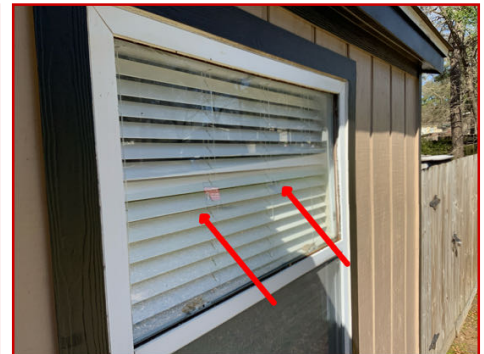
- A exterior window to the front of the home had severe damage visible at the time of the inspection. The window may require replacement.
- One or more Windows sills in the home exhibited moderate damage that appeared to be from moisture intrusion. Sealant around the window exteriors should be re-applied as necessary to avoid continuing damage. Any interior damage should be properly repaired, as needed, by a qualified professional.

Master bedroom, broken window

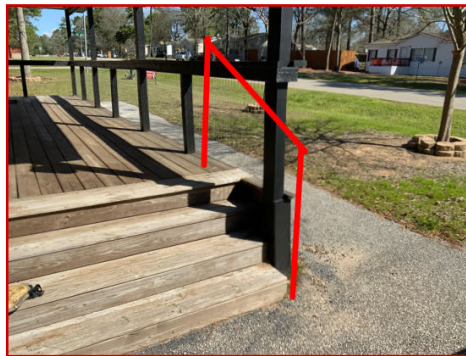
Missing handrail

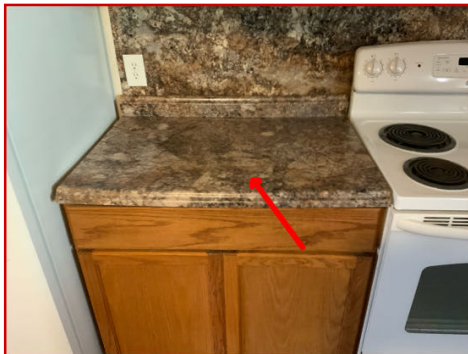
Example of loose counter top

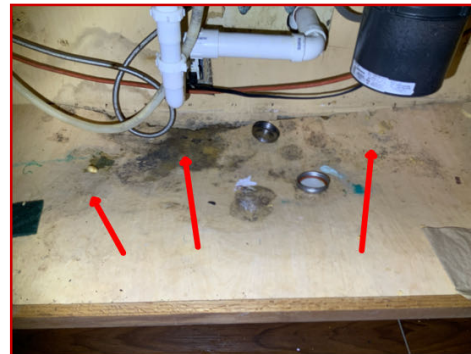
- The floor of the kitchen sink cabinet exhibited damage from current moisture intrusion. The moisture meter showed elevated levels of moisture present in the floor indicating recent leakage. The source of the leak should be located, and the condition corrected to avoid further damage to the cabinets, wall/floor structure and the development of unhealthy conditions like unwanted organic growth.

- The floor of the kitchen sink cabinet was badly damaged and should be replaced.
- The floor of the kitchen sink cabinet has a black, possibly organic, substance on it. The inspectors cannot determine cause, test for or determine the specific substance (soot, possible organic substance, or even stains from prior use). The United States Environmental Protection Association (EPA) states, "If you believe that you may have a hidden mold problem, consider hiring a professional." (Brief Guide to Mold, p.14, EPA). If any area of the residence is suspected of having organic growth, or any member of your family or household is sensitive to mold, we recommend contacting a lab-certified company to conduct a Mold Inspection / Sampling to identify the types of mold (or any other airborne allergens) present.

Elevated moisture levels and damage to kitchen sink cabinet

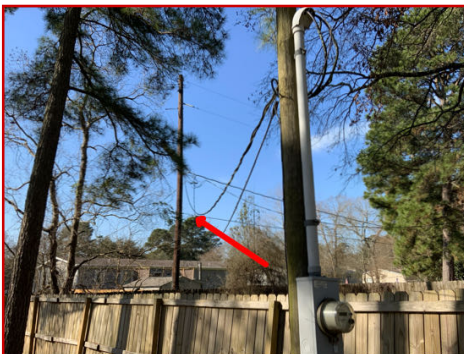
Overhead service proximity to trees, trespasses neighbor's property

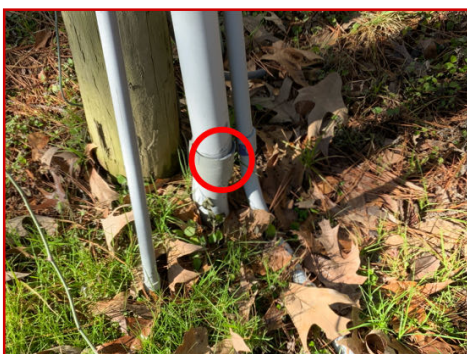
Damaged conduit

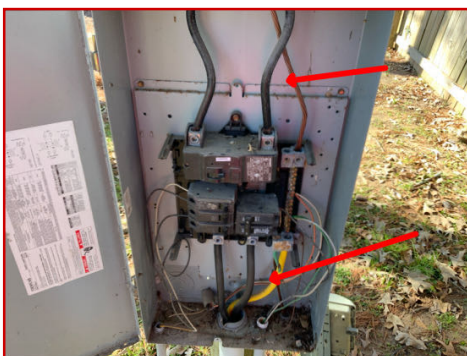
Missing dead front

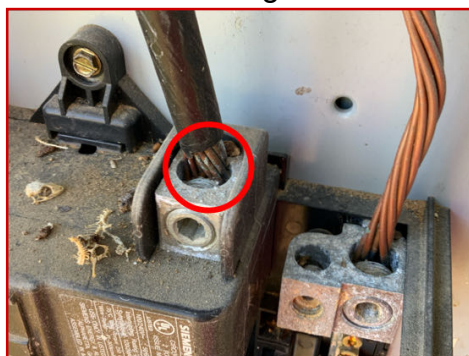
Corrosion visible on copper mains

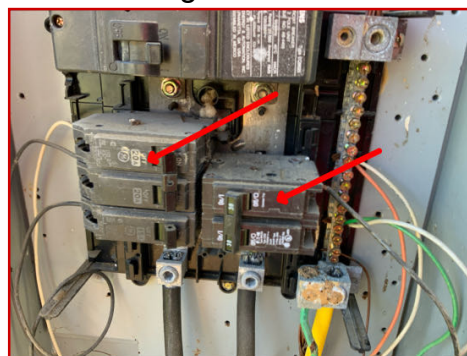
- One or more circuit breaker in this sub-panel were of a brand different from the main panel brand. Because circuit breakers made by different manufacturers vary in design, panel manufacturers typically require that breakers manufactured by their company be used in their panels. Breakers from one manufacturer used in the panel of another manufacturer may result in poor connections which can create a potential fire or shock/electrocution hazard.

Breakers are different brand than panel

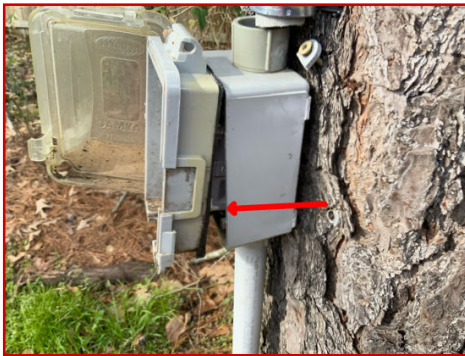
Example of loose exterior receptacle

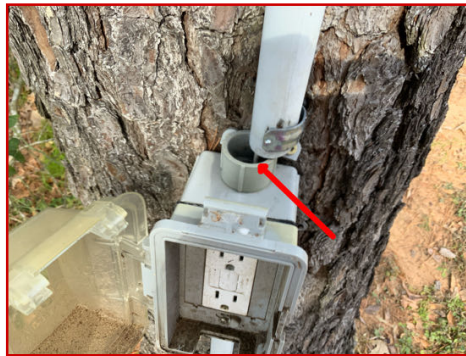
Example of damaged conduit on tree to left of house

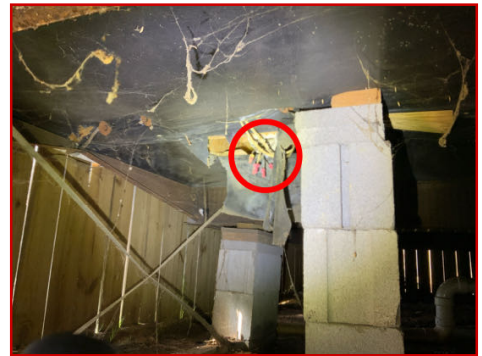
Missing junction box cover in crawlspace

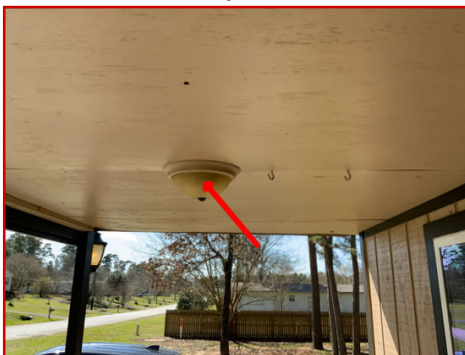
• One or more interior lights did not respond to the controls at the time of inspection. If replacing the bulbs does not remedy this condition, then the circuit should be further investigated by a qualified electrical professional.

Example of inoperative exterior light

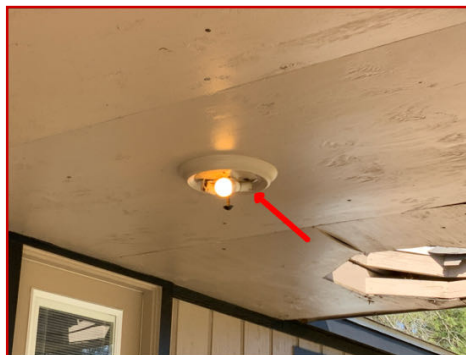
Example of missing diffuser at exterior light

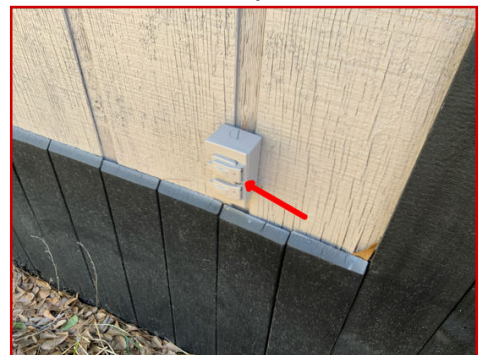
Exterior receptacle, no GFCI

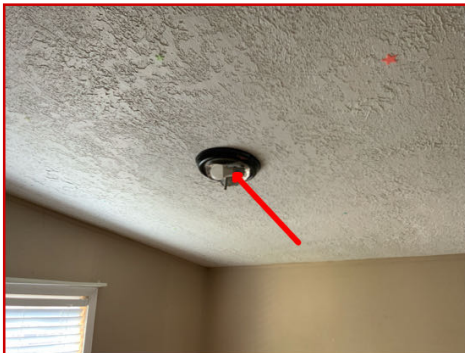
• One or more light fixtures are missing a diffuser and should be replaced.

Example of missing diffuser

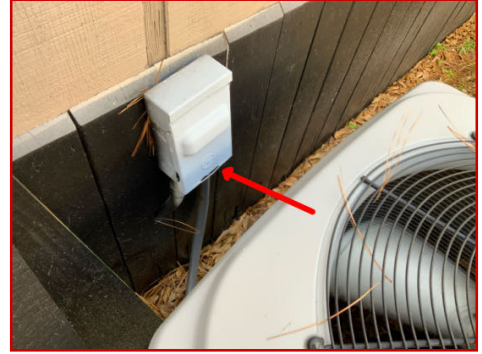
Inadequate workspace at shut off

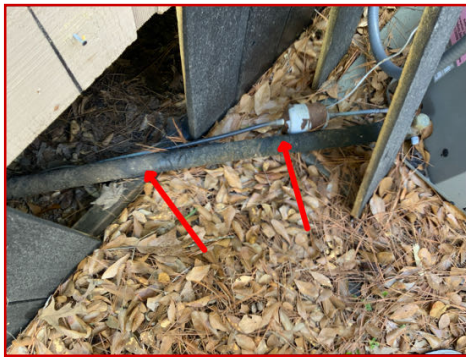
Deteriorated insulation at coolant lines

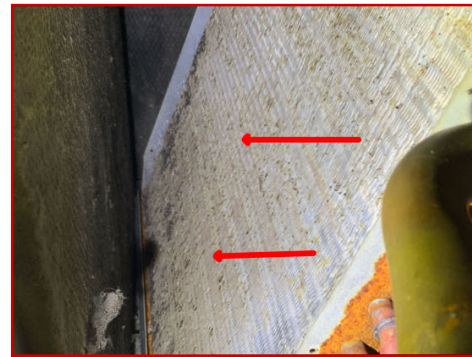
• The interior coils, for this AC system, were very dirty. This can decrease efficiency. Recommend further evaluation and correction, as needed, by a qualified professional.

Interior AC coils are extremely dirty

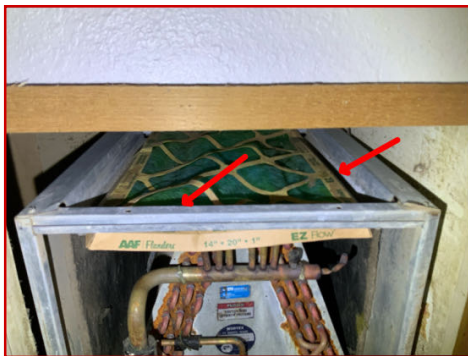
- Filter is torn or damaged and should be replaced.

Example of damaged filter

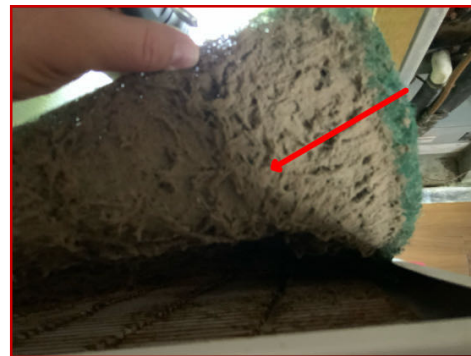
Example of dirty filter

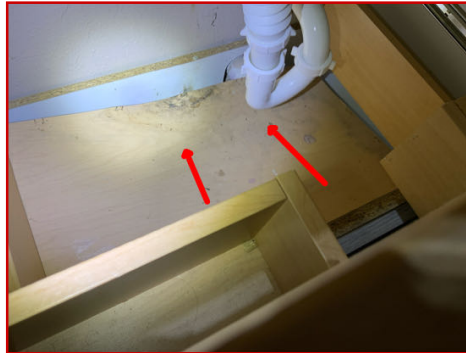
- The floor of the bathroom vanity had damaged visible from previous moisture damage. The area was dry at the time of inspection. Recommend correction, as needed, by qualified professional.

Bathroom vanity cabinet floor, past moisture damage, dry at inspection

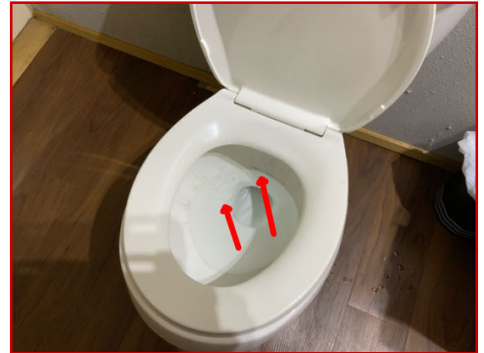
Hallway bathroom, toilet runs continuously

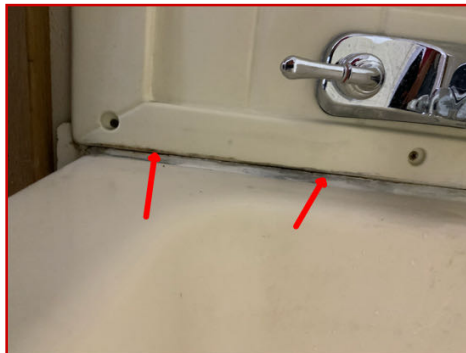
Damaged sealant where tub meets surround

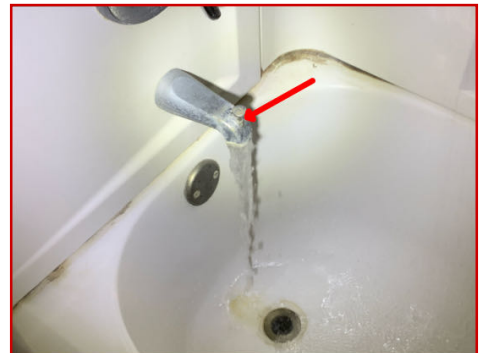
Diverter is inoperable

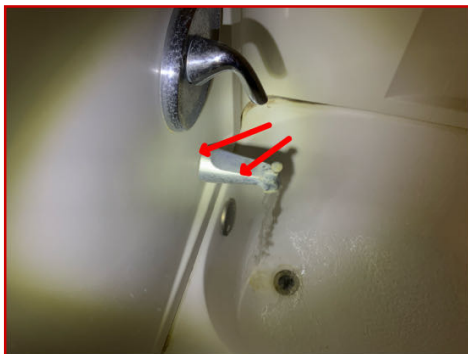
Tub spout is loose/missing sealant

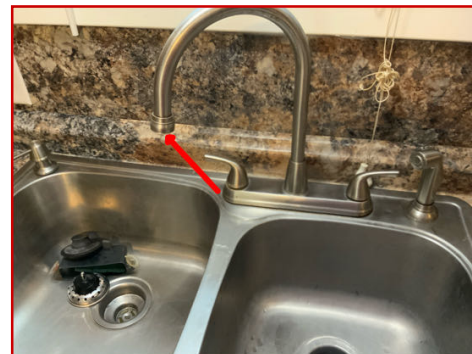
- The faucet in the kitchen leaked while not in use. This typically indicates that a valve seal needs replacement.
- The water pipes servicing the water heater were leaking at the time of inspection. Recommend further evaluation and correction, as needed, by a qualified professional.

Kitchen faucet leaks when not in use

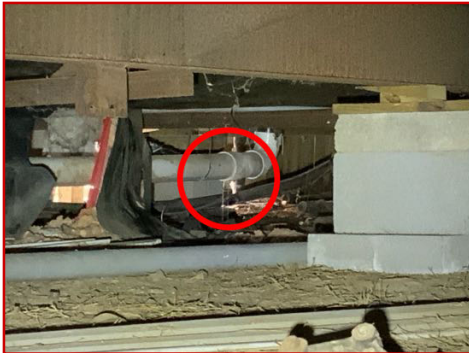
Example of leaking drain in crawlspace

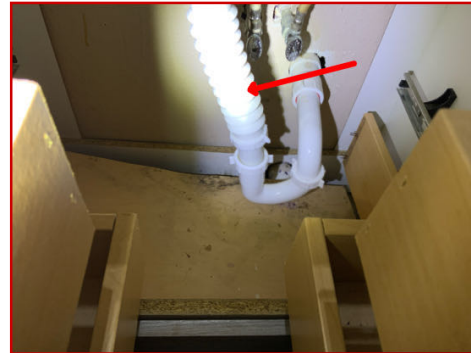
- Flexible (accordion type) tubing was used in one or more locations of the home's visible drainage system. All drain pipe should have a smooth interior, allowing refuse to pass unobstructed through the pipes. Using a flexible or accordion type tubing restricts material flowing through the pipe, potentially causing blockages. This type of pipe is also susceptible to developing leaks along the ridges of the flexible portion of the drain.

Example of accordion style drain line in bathroom

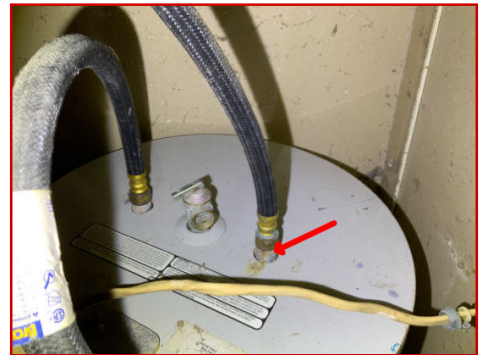
Corrosion visible at water connection

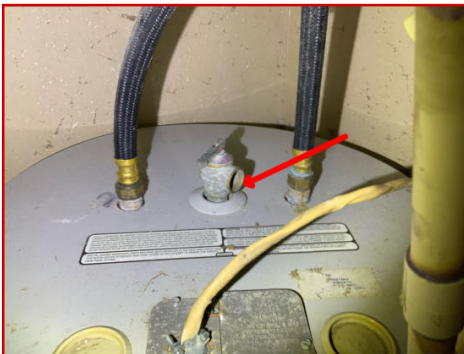
TPR valve improperly terminated

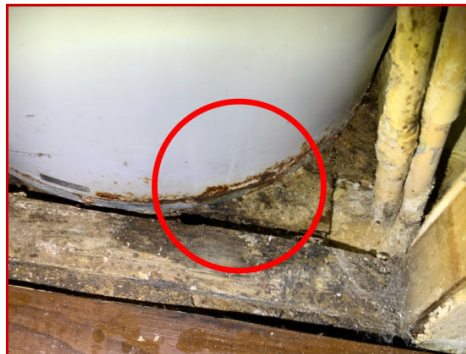
Rust and possible leak visible in water heater casing

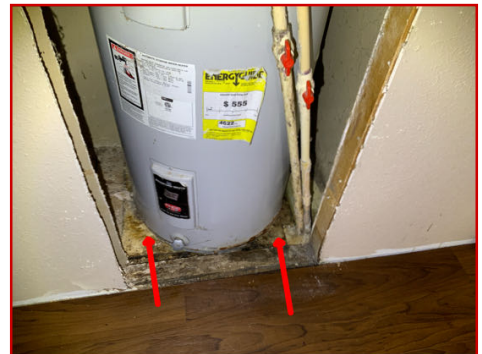
No catch pan
