# 3714 Blackberry Circle

## Missouri City, Texas 77459

Client	--
Reference id	<b>a2ZPd000000IJ0nMAE</b>
Type	<b>Home Inspection and Floor Plan Report - 3714 Blackberry Circle</b>
Inspected by	<b>Rio Bravo - Inspectify Pro - Houston</b>
State license	<b>TREC 22388</b>
InterNACHI	<b>17031522</b>
Scheduled	<b>January 23, 2025, 4:00 PM</b>
Completed	<b>January 23, 2025, 7:01 PM</b>

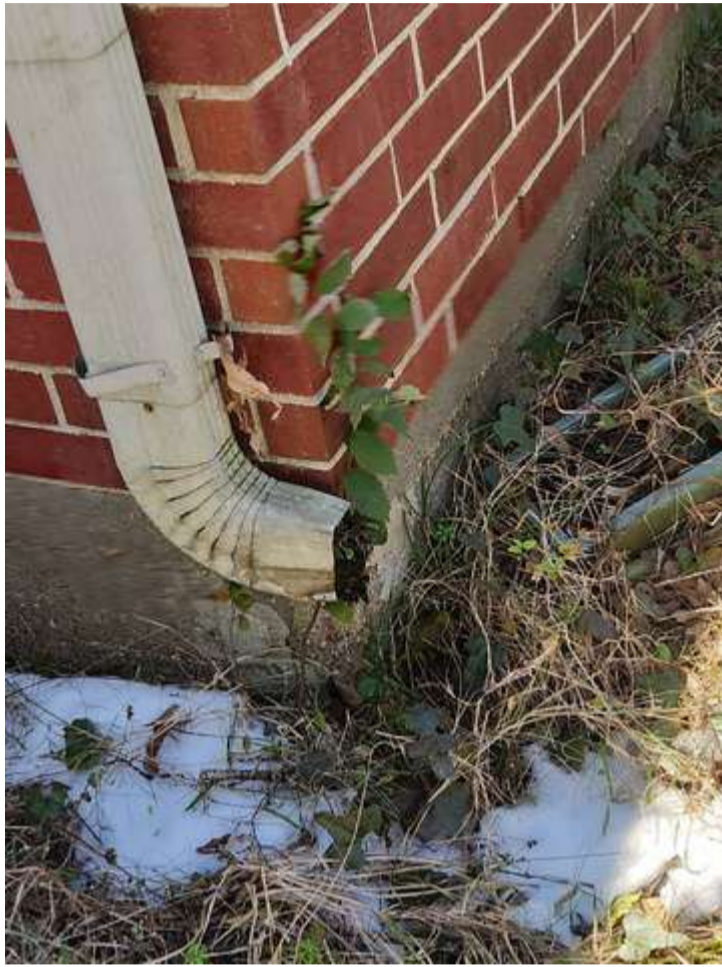
**Back**

### Missing Downspout Splash Blocks

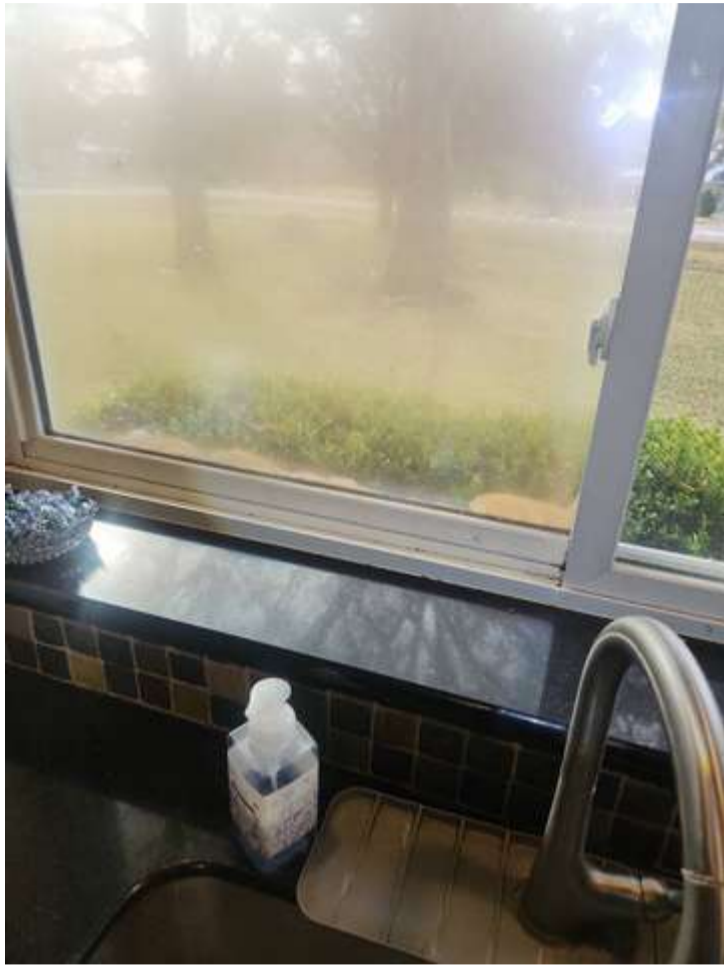
**Kitchen**

### Deteriorated / Failed Window Seal

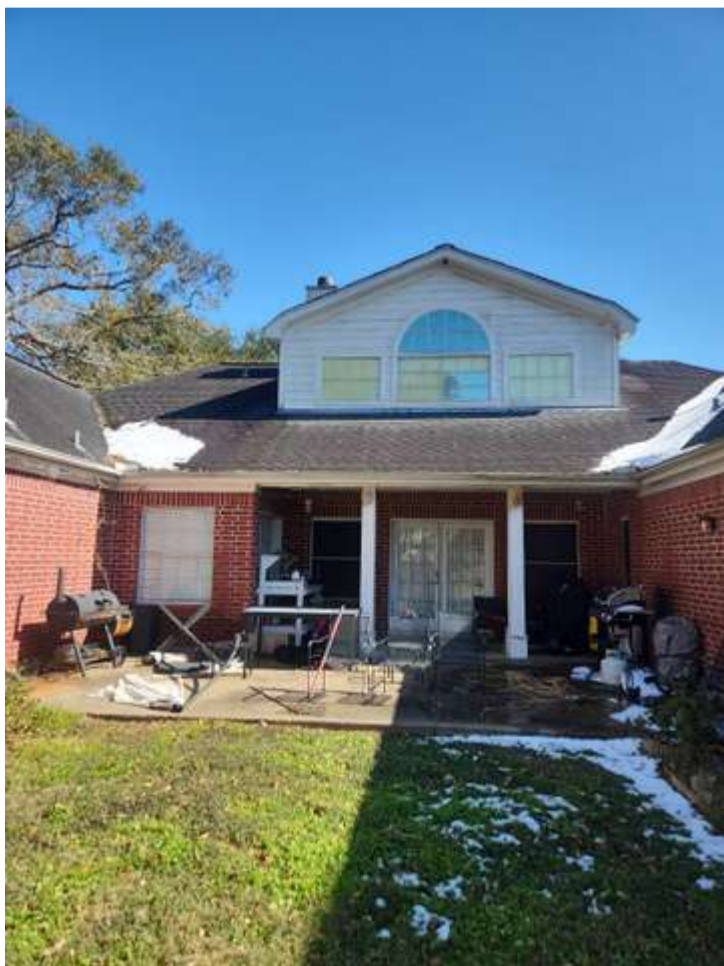
### Missing Window Screen

One or more windows are missing a screen.

**Noted on a few Windows around the home**

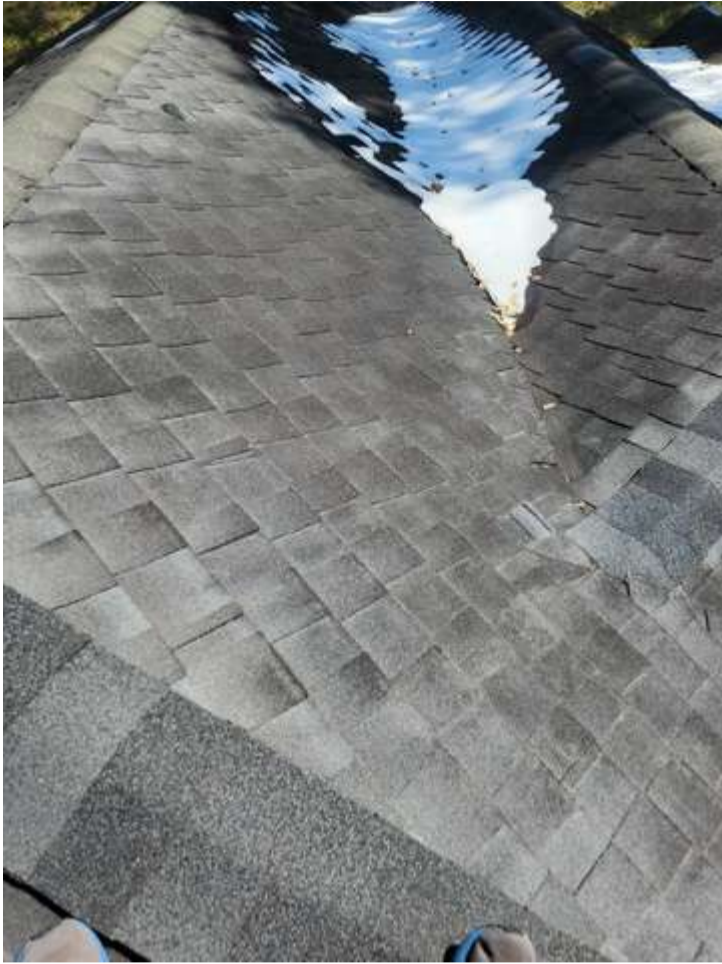
### Damaged Shingles

One or more shingles are cracked or torn.

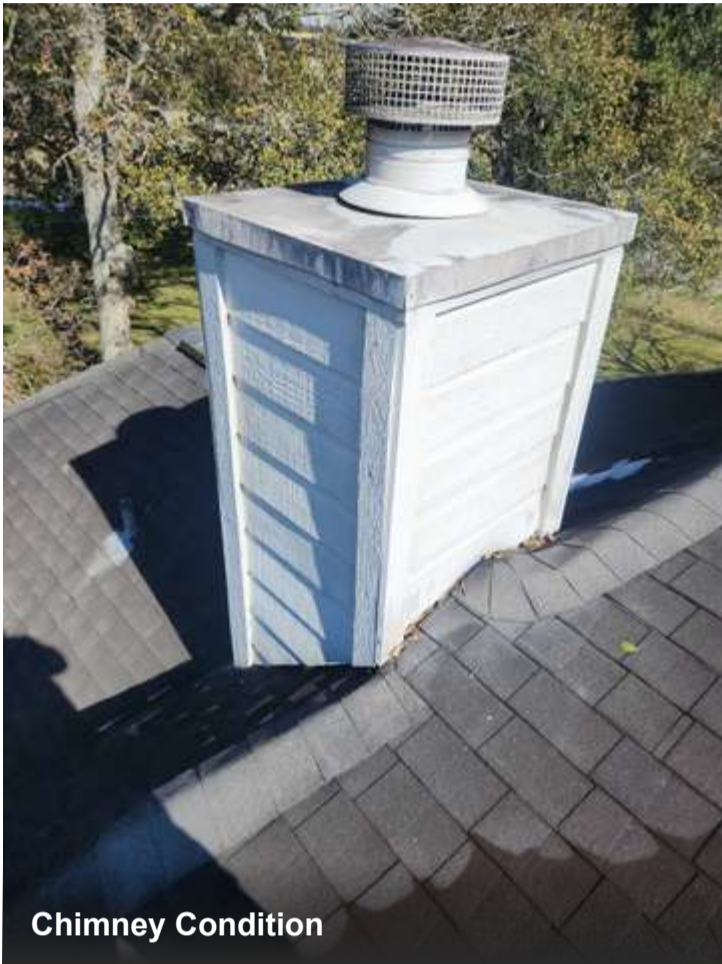
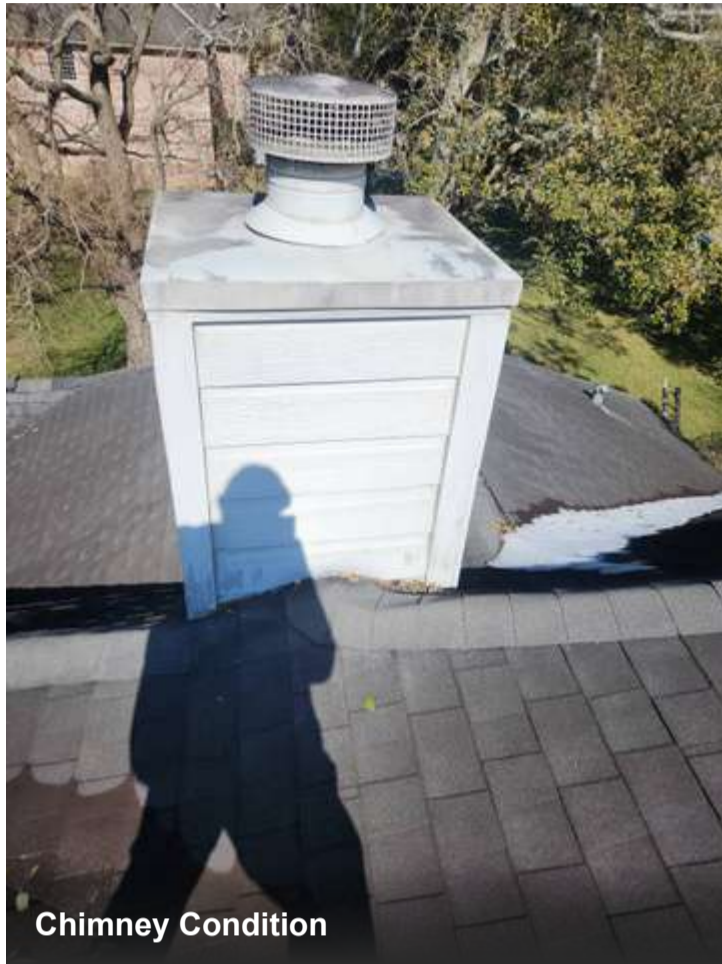
### Deteriorating Exterior

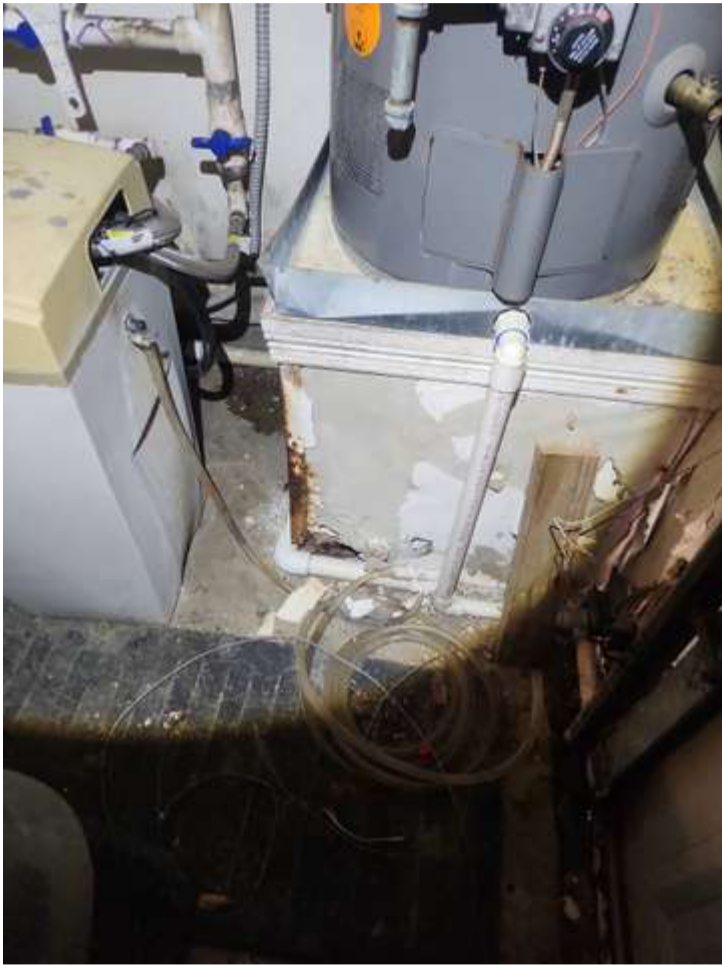
### Damaged Interior Walls or Ceilings

Holes or damage are present on the interior walls / ceilings.

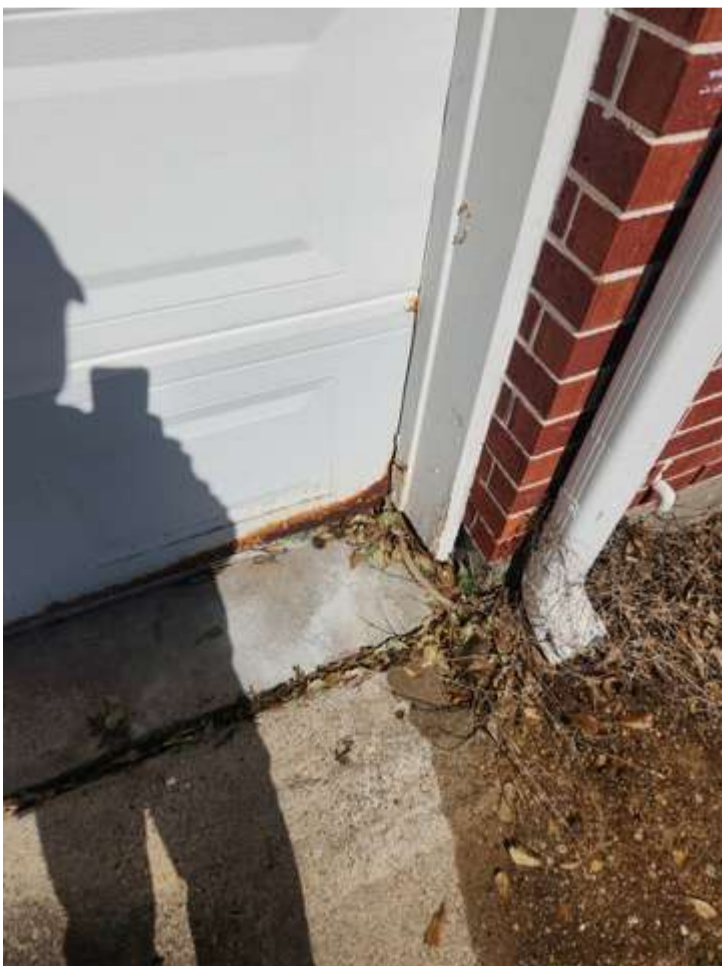
### Damaged Garage Door Panels

One or more garage door panels are damaged.

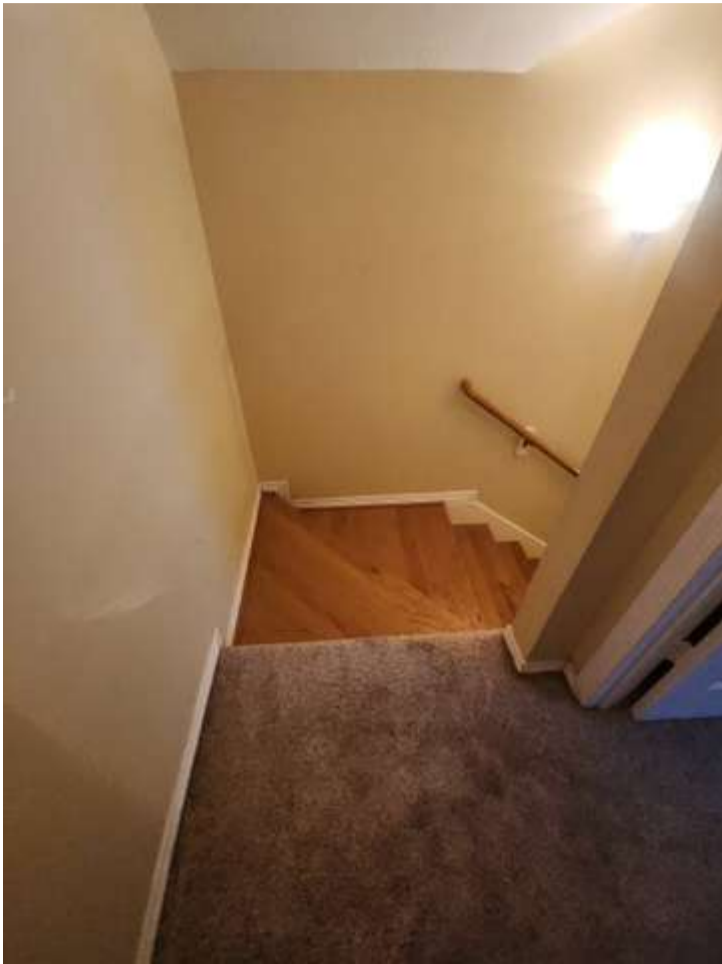
The handrail did not extend the full length of the stairway

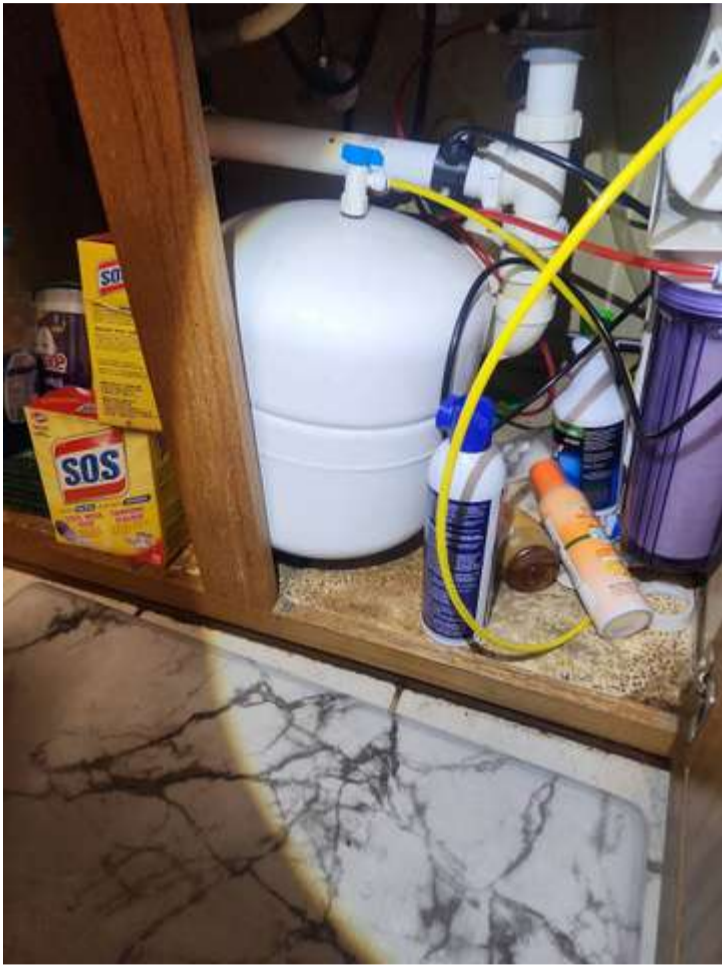
### Water Damage in Cabinet

The cabinet had water damage in one or more areas.

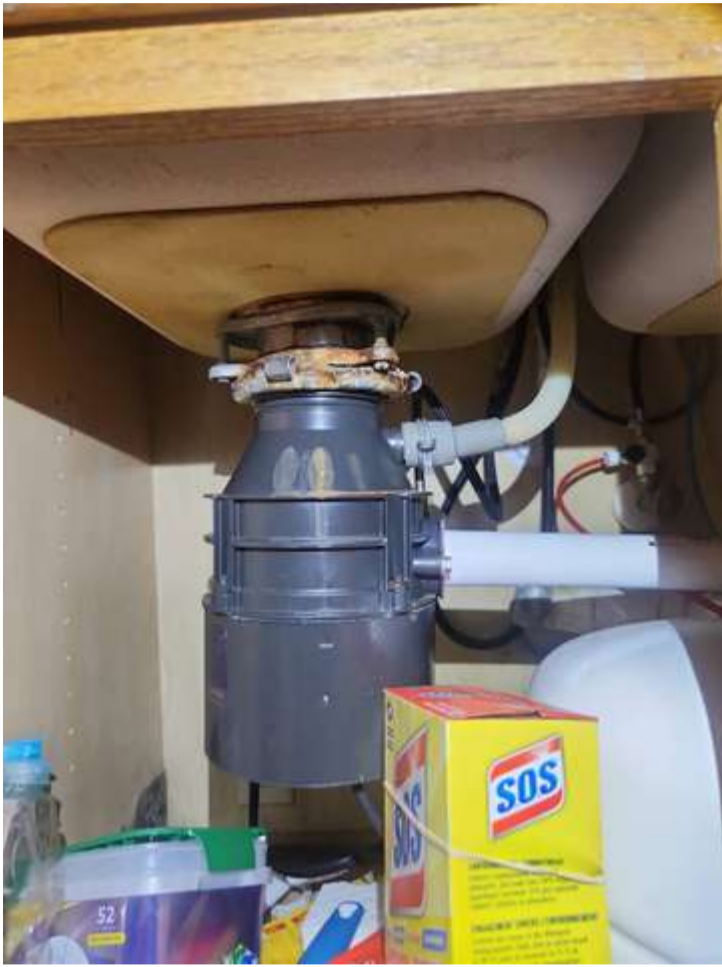
### Garbage Disposal Leaking

The garbage disposal is leaking.

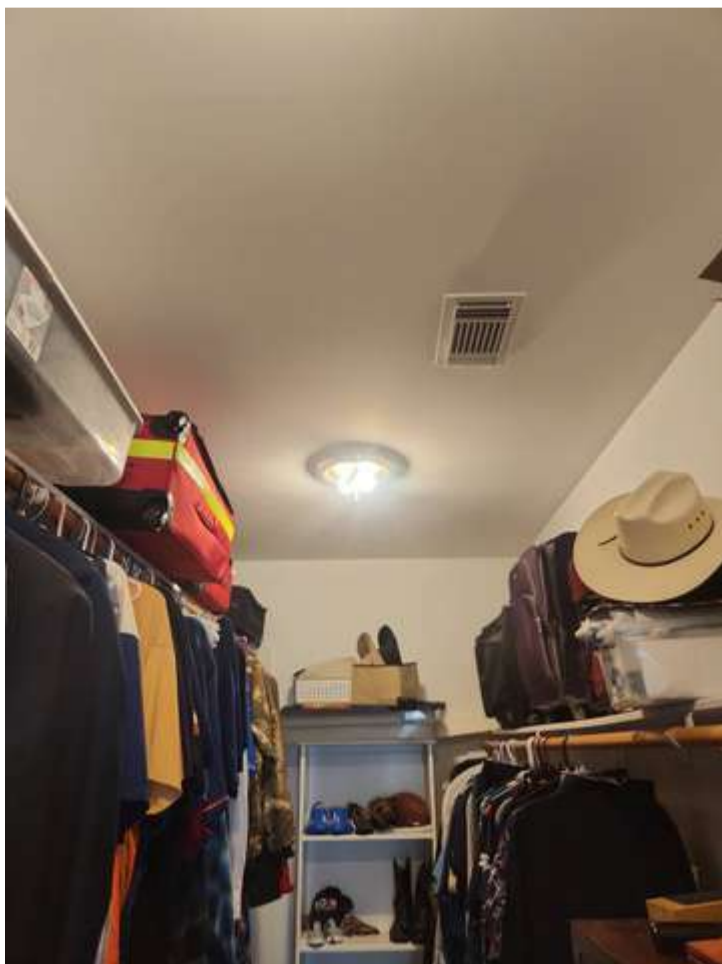
### Bathroom, Master

### Missing Light Cover

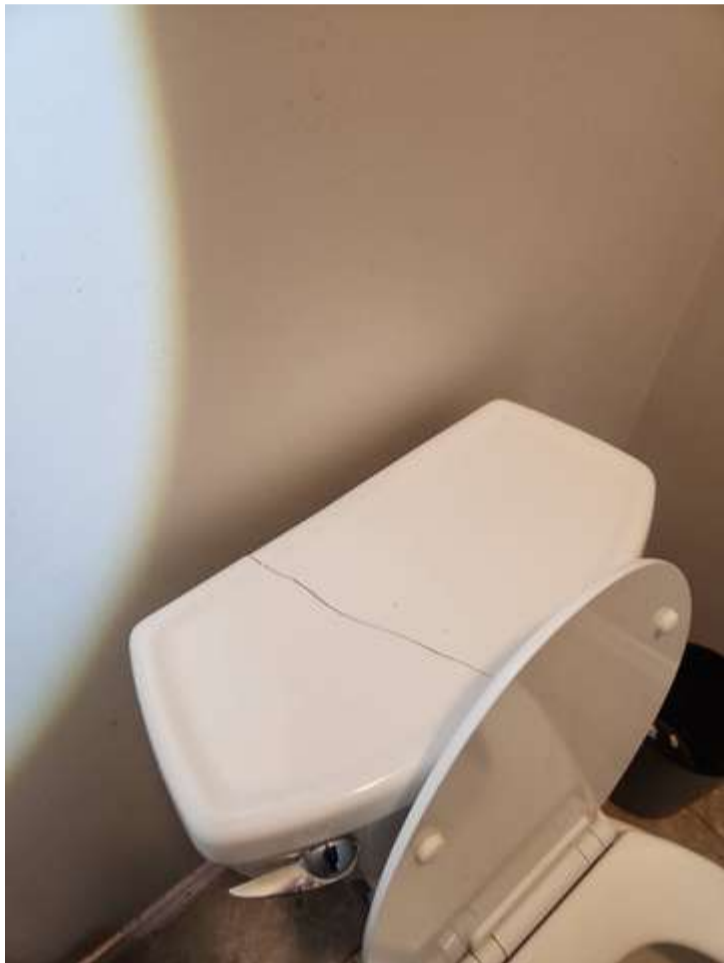
**Master, Bathroom**

### Cracked / Broken Toilet

The toilet is cracked, broken, or otherwise damaged.

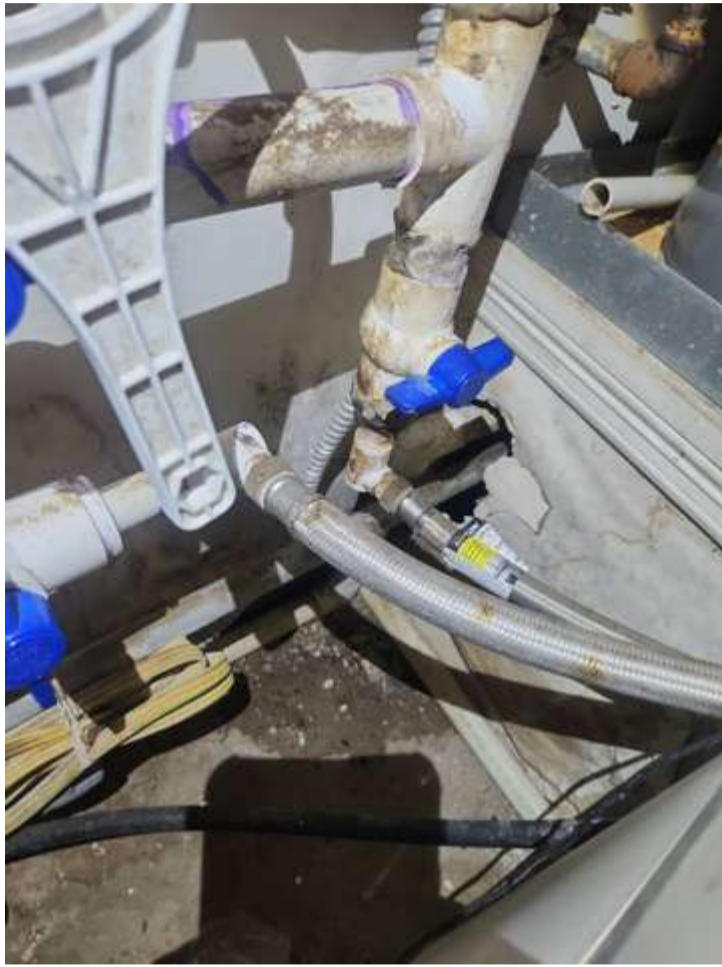
**Garage, Garage**

### Leaking Distribution Pipe

The distribution pipe is leaking.

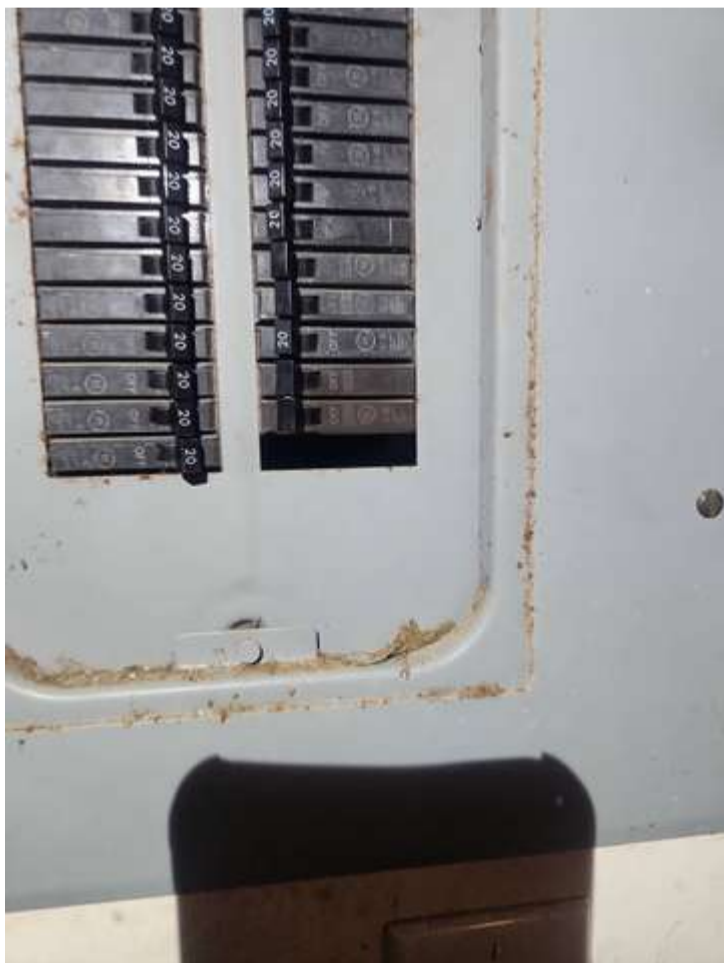
## Missing Electrical Panel Knockouts

The electric panel knockouts are missing.

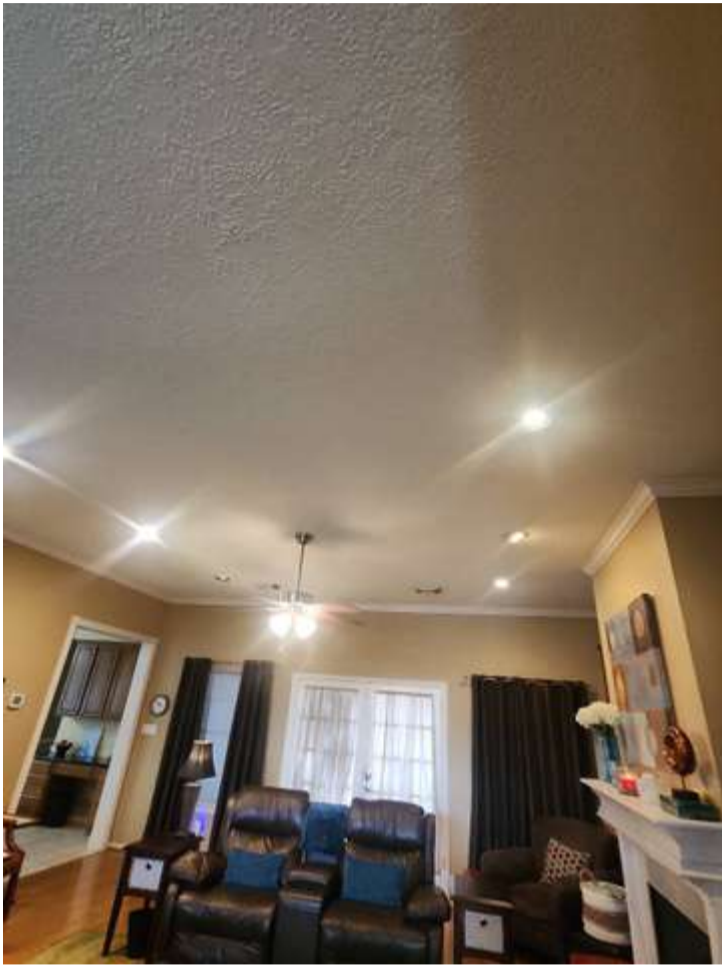
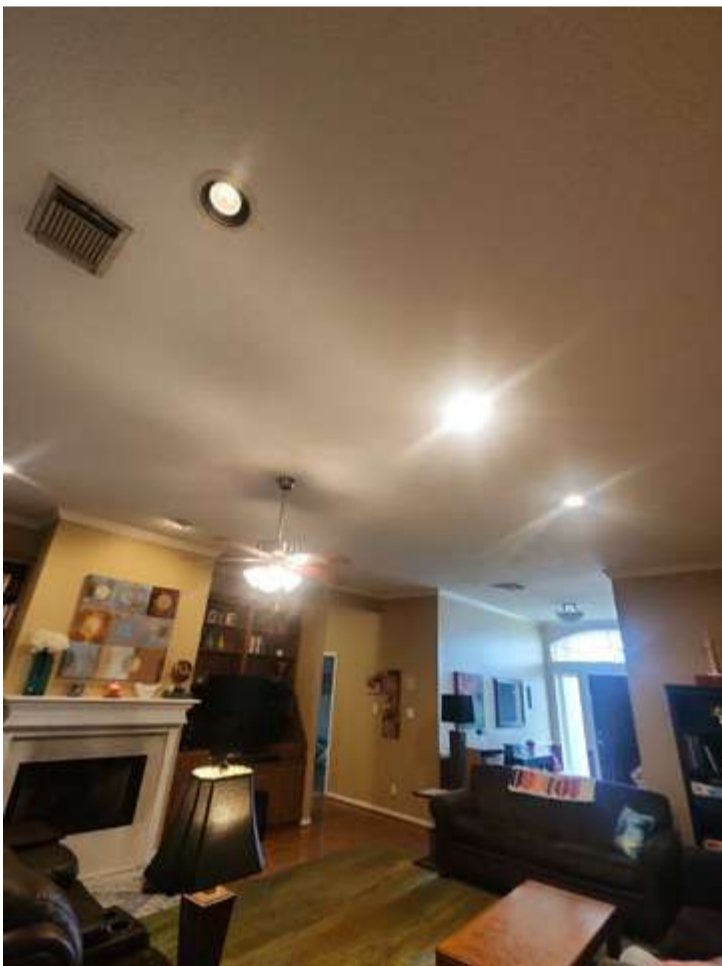
**Living Room**

### Missing Carbon Monoxide Detector(s)

One or more carbon monoxide detector(s) is missing or not installed.

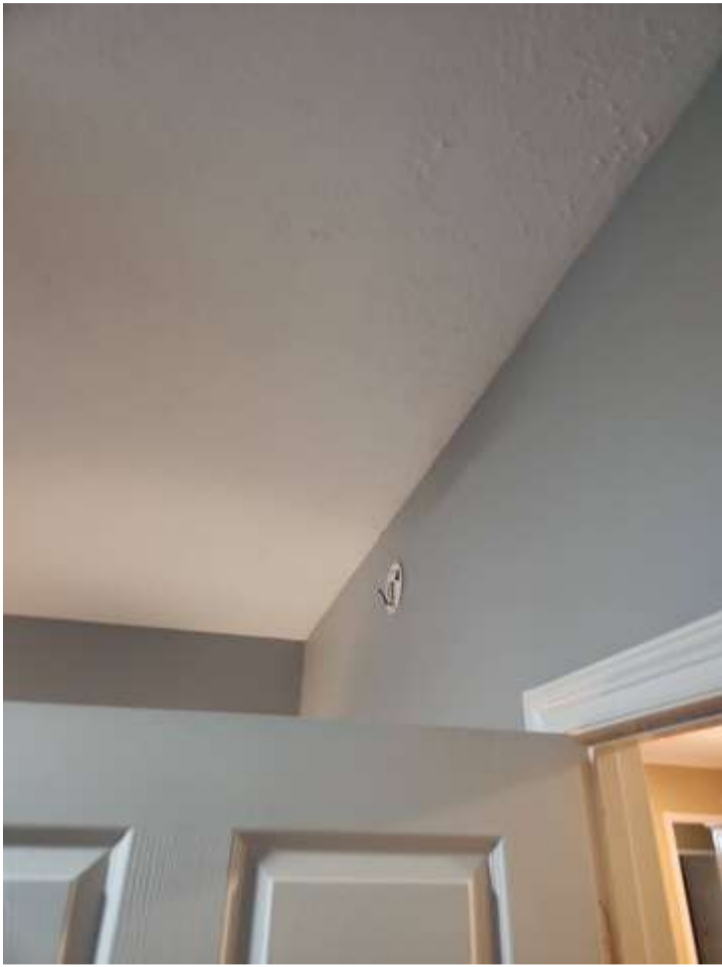
**Northeast, Bedroom**

### Missing Smoke Detector(s)

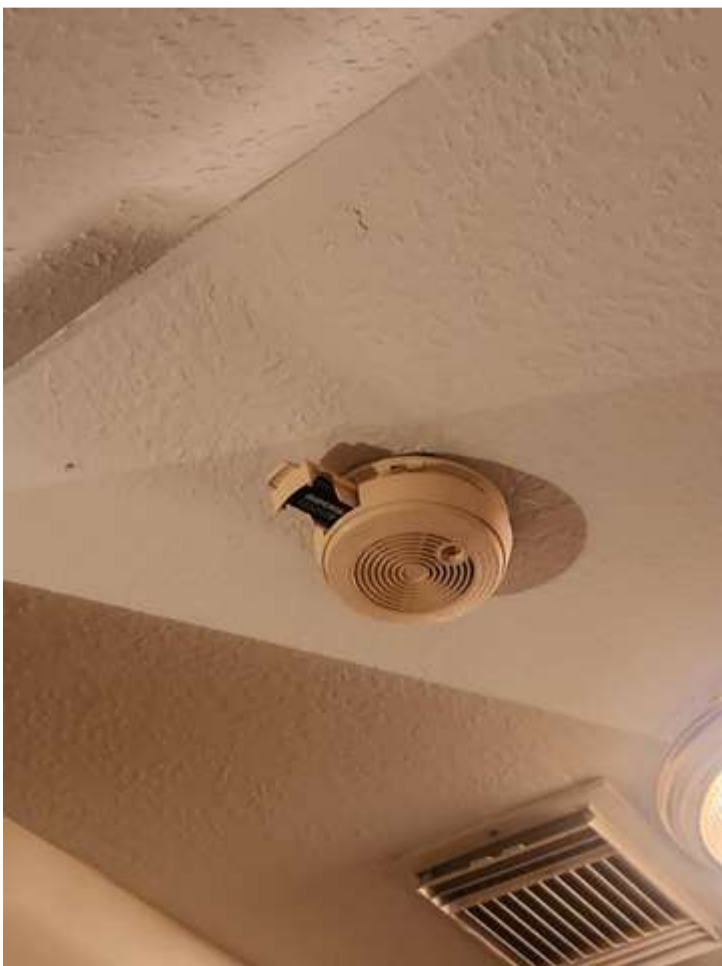
### Smoke Detector Batteries Missing / Needs Replacement

The smoke detector batteries are missing or need replacement.

**Noted at majority of smoke detectors**
