Project: 3707 Jardin St., Houston, TX

Project # 2022-1074 Lab # E177360

LIMITED VISUAL MOLD PROTOCOL

Conducted at:
3707 Jardin St.
Houston, TX 77005

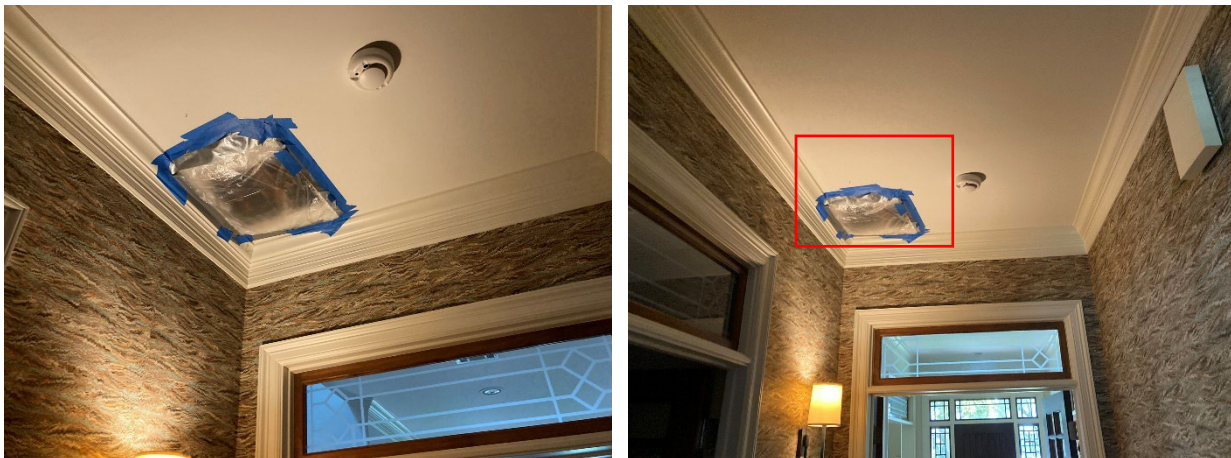
Water intrusion occurred due to roof leak and pipe leak. Microbial growth is present along the drywall and baseboards throughout the basement. Our inspection did not reveal any current water leaks or elevated moisture content at the time of inspection.

- Install limited containment using 6 mil polyethylene.
- Install dehumidifier and HEPA air filtration to capture airborne contaminants and maintain negative pressure inside the containment while remediation is in progress.

- Remove and dispose mold / water damaged ceiling drywall and insulation 2 feet in every direction from last known point of impact.
- Mold damaged materials must be immediately placed in plastic bags for disposal.

- Inspect wall cavity for hidden water / mold damaged materials.
- Clean in-place structurally sound framing, flooring, ceiling joists, metal, and other wood structures by sanding, grinding, or wire brushing. This treatment must remove all fungal growth from the affected materials, or the materials must be removed and replaced whenever structurally feasible.

- HEPA Vacuum all surfaces (floor, walls, ceiling) and damp wipe with antimicrobial solution.
- Upon completion turn HEPA air filtration to **scrub mode** (low setting) for a minimum of 48 hours and leave dehumidifiers on to maintain humidity.
