Texan Inspection Services **Property Inspection Report**

4311 Mustang Crossing Court, Missouri City, TX 77459

Date of Inspection: 1/6/2025 Time: 1:00 PM

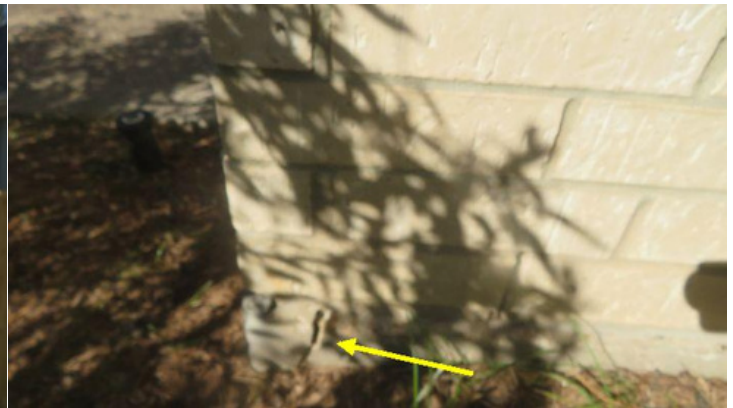
- "Corner pops" were observed on some corners of the foundation. This condition is cosmetic only and does not affect the structural integrity of the foundation. This area should, of course, be monitored for movement, if movement is observed or if bricks/ stones crack recommend further evaluation for possible repairs. Recommend sealing (caulking or slab dressing) the cracks/damage to help stabilize area and monitor for movement.

"Corner Pop"

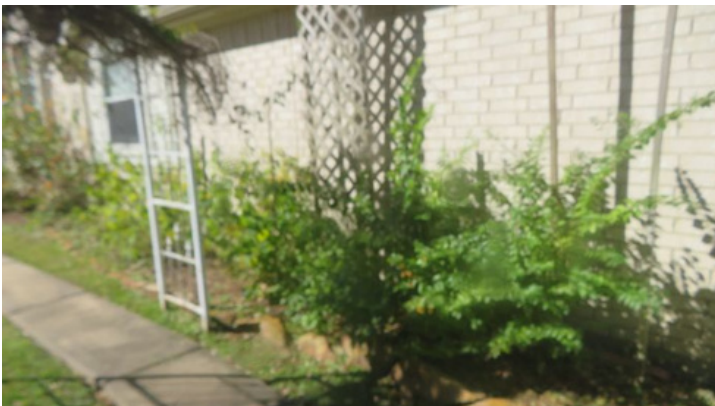
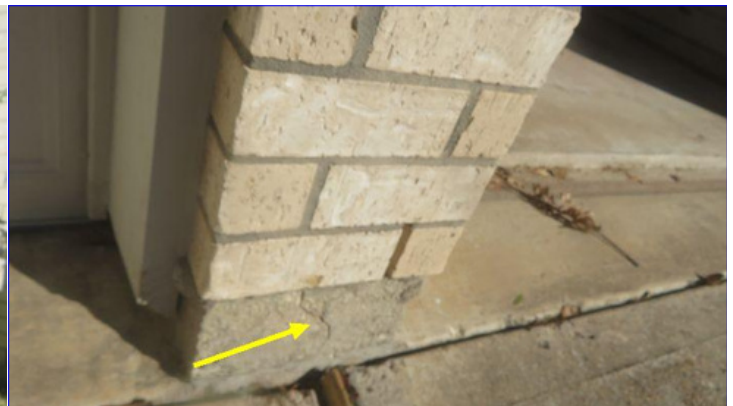
View of the foundation wall was obscured by one or more of the following conditions, but not limited to high soil, high pavers/ flatwork, decking, vegetation, and or slab dressing/ paint. This limits the inspectors ability to inspect areas not visible. Obscured areas should be considered not inspected. Obscured areas may hide deficiencies not visible. All areas of the foundation should be visible. Recommend having foundation/obscured areas further investigated by a qualified foundation /structural specialist for more information about the foundation /structure. Improvements are recommended.

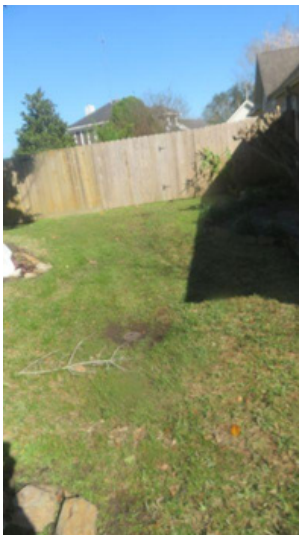
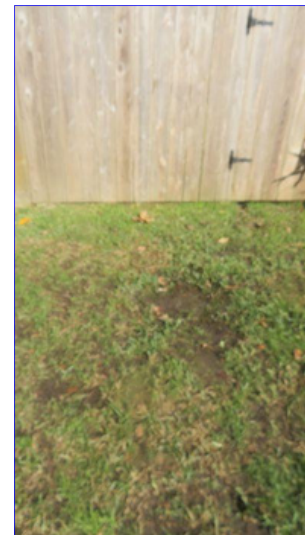
A properly sloped drainage swale (in effect, a wide and shallow ditch) should be created. The grade should slope sufficiently to channel water forward to the storm drainage system, or to the under ground drain system. Improvements are needed for "Proper Drainage."

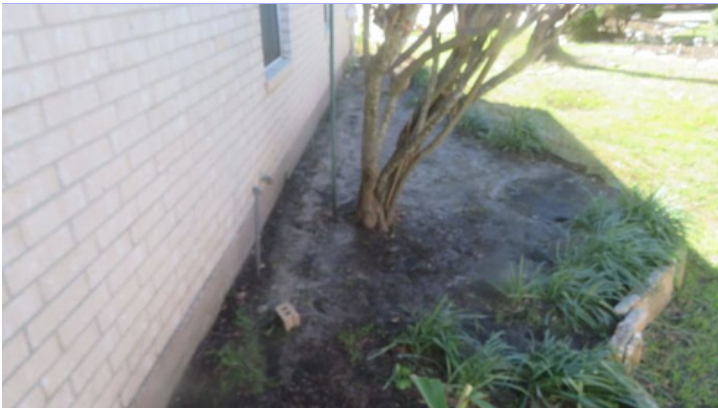
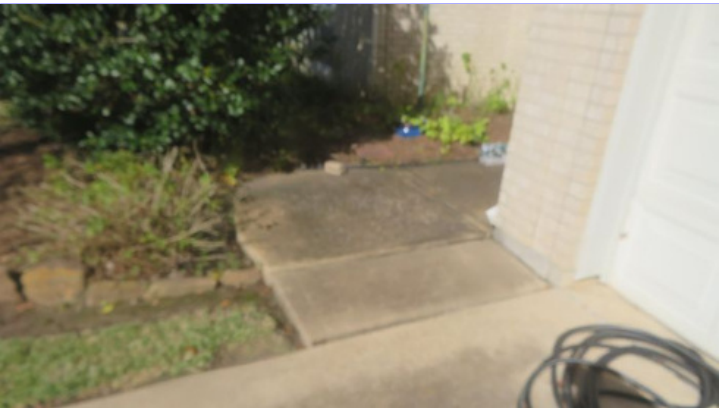
Flower beds are blocking (damming) the flow of water away from the structure. Improvements are needed.

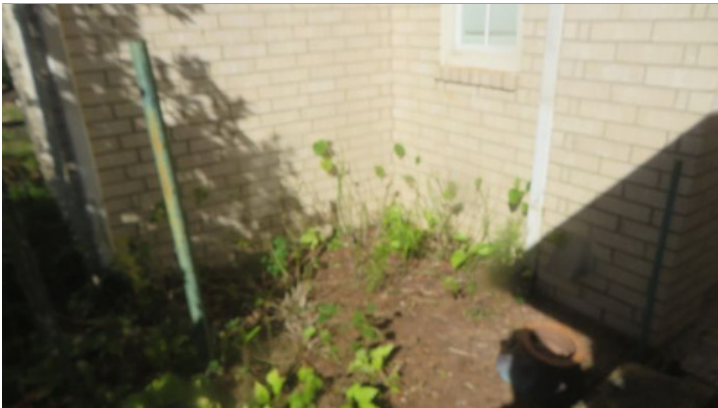
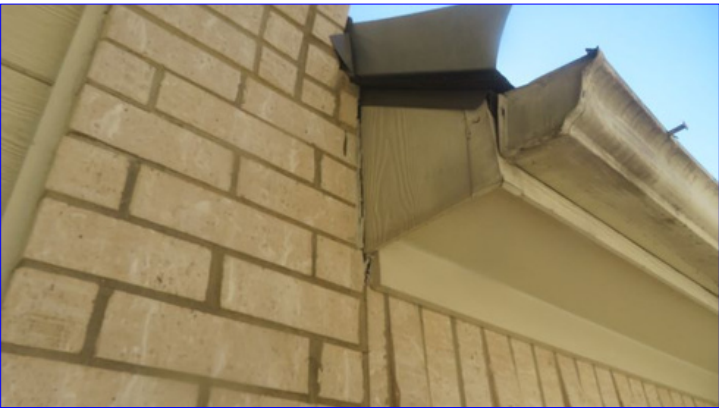
The grading should be improved to promote the flow of storm water away from the structure. This can usually be accomplished by the addition or subtraction of top soil. The ground should slope away from the structure at a rate of six inches of fall within the first ten feet. Ideally, at least 4" to 6" inches of clearance should be maintained between soil level and the top of the foundation walls. Improvements are needed.

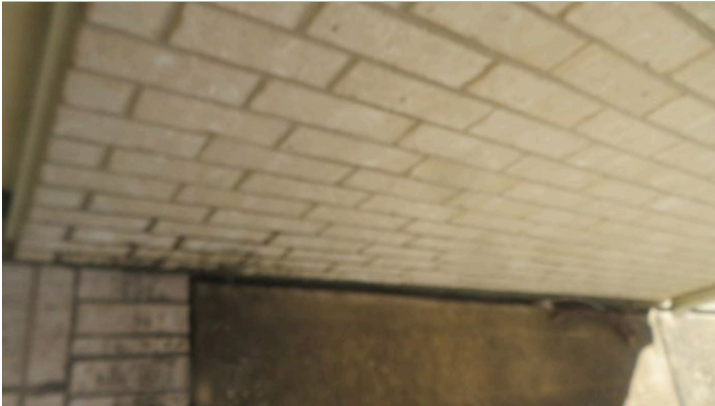
The roof gutters should be cleaned. Observed excessive debris in the gutter system. Debris can clog drains allowing water to back up, causing water intrusion of the structure. Recommend regular cleaning of all drainage systems.

Gutters over spilling. Clogged

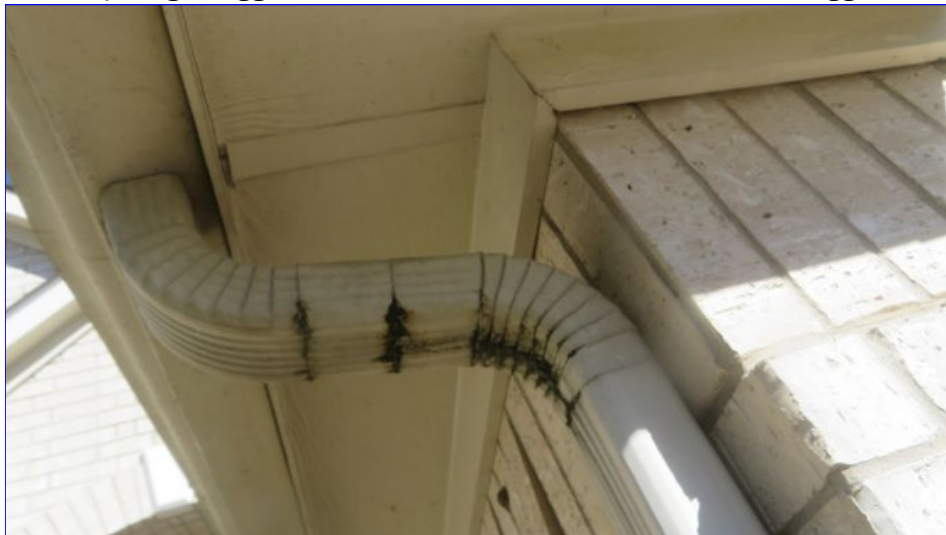
Minor leaks in the gutters should be repaired.

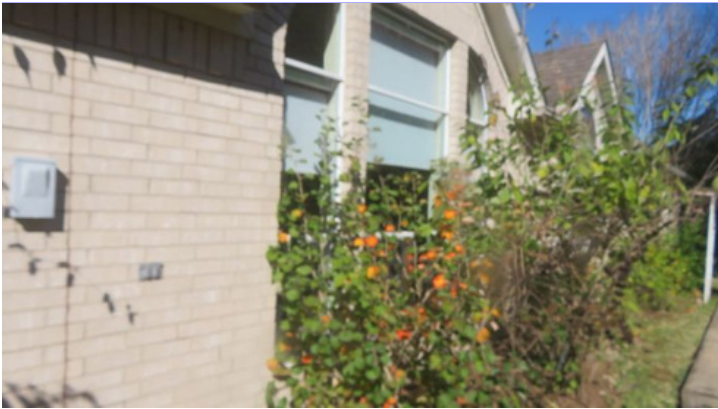
Vegetation is in contact with or has insufficient clearance of exterior walls. It is recommended vegetation be cut back at least 12-18 inches from exterior walls.

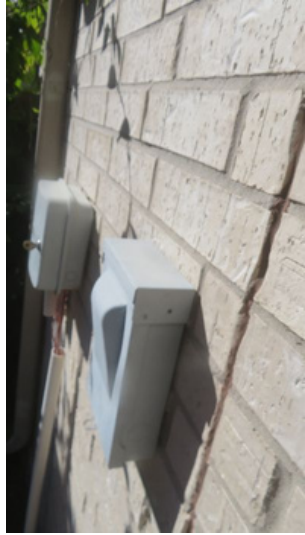
Seals around panel/service boxes/fixtures/access covers/outlets/switch boxes are incomplete/ missing. Panel/service boxes etc, should be properly sealed on top and both sides only.

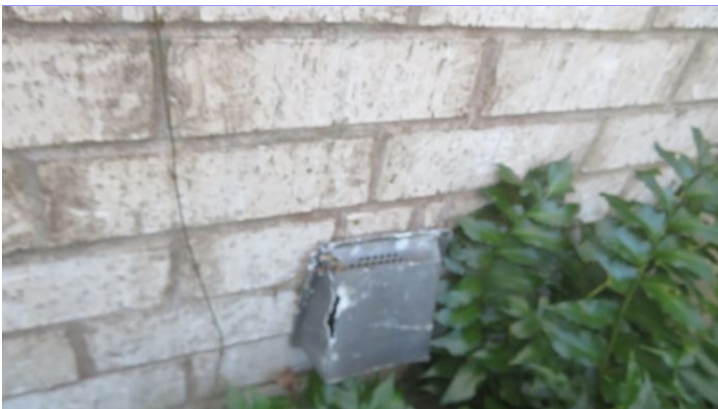
The exterior wall vent(s) appear to be damaged. Recommend repair.

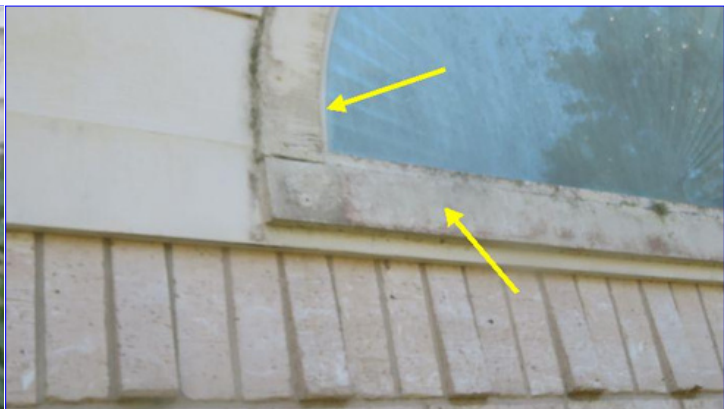
Water damage was observed on the exterior wood siding and trim. Repairs should be undertaken to prevent further damage.

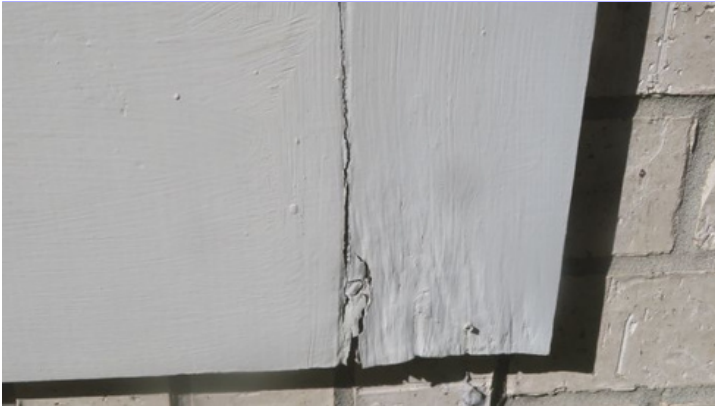
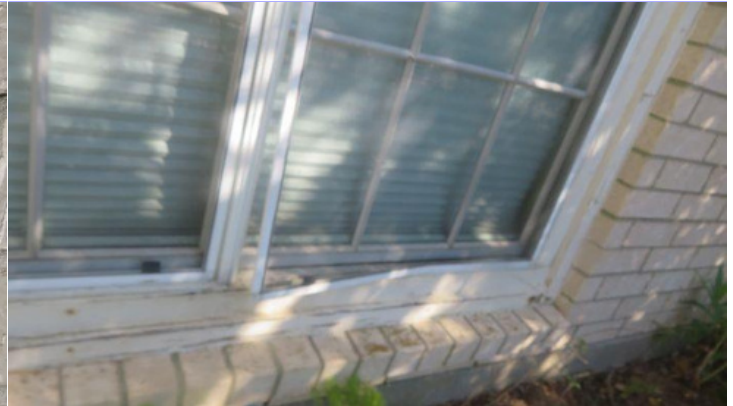
Areas of natural wood appear improperly sealed. Natural wood usually needs more sealing (1 coat primer, 2 coats paint recommended) Recommend sealing/ filing all exterior wood grain (imperfections/cracks/joints) penetrations to prevent potential water entry/penetration of wood, this can cause water damage/deterioration/rot. (trimwork)

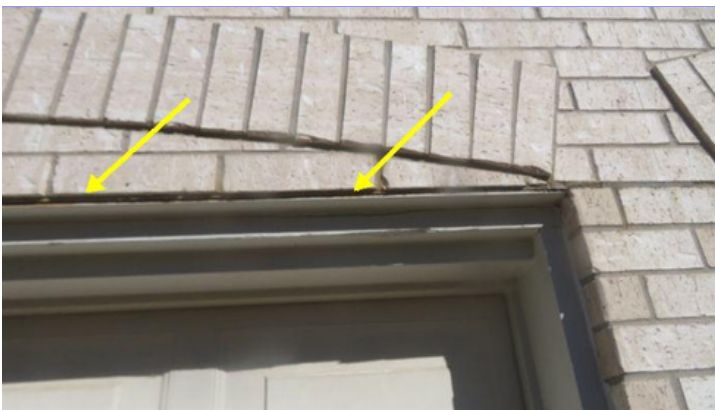
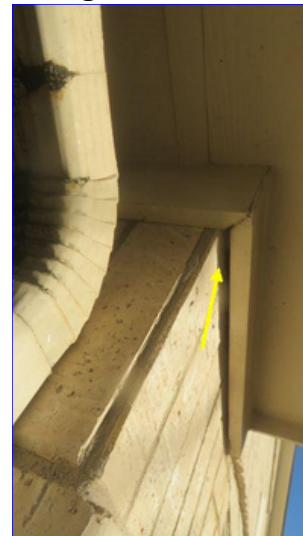
The lintel flashing over the windows and doors appears to be not properly sealed/caulked. If a lintel is not properly sealed it can allow moisture to drain into the interior wall and can also cause the lintels to rust, which may lead to cracks in the brick above the lintels. Repairs are recommended as necessary.

Gaps are present in the trimwork in various locations. Gaps allow intrusion of water, pests and rodents. New Pest Control guidelines "current standards" state that all openings and transition joints, including between the roof, trim and all wall cladding systems should not be gaped over 3/16" inch. Gaps should be caulked, flashed and or be properly screened to reduce intrusion and minimize the use of Pesticides/Poisons.

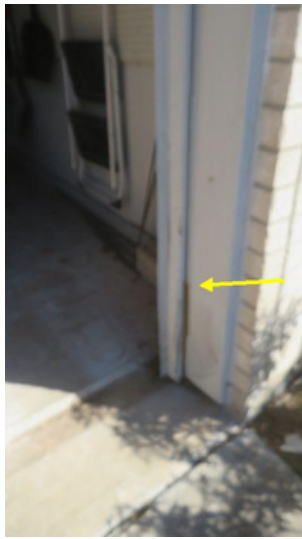
Damage was observed adjacent to the garage door. Recommend repairs.

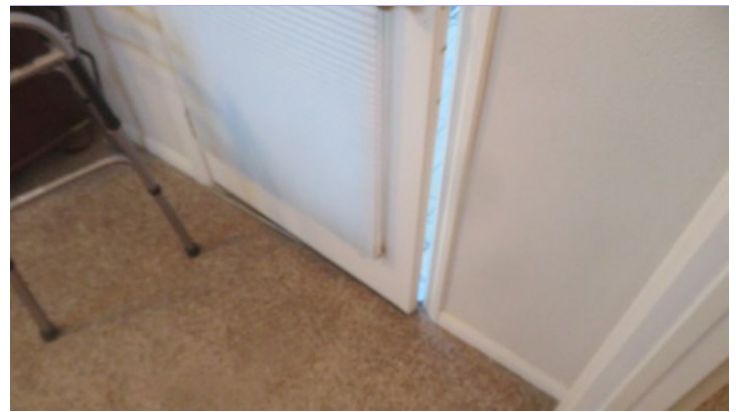
The door drags on the threshold. Adjustments to the door or threshold are recommended for the door to operate properly.

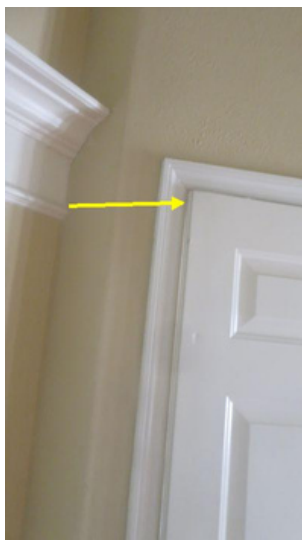
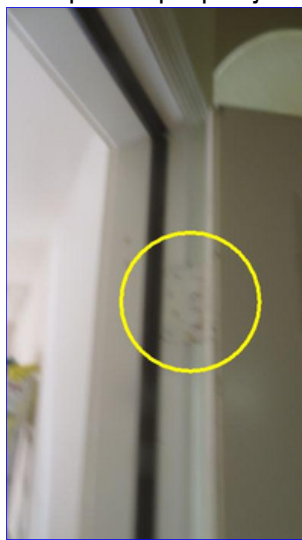
Door is not set square to the jamb. All exterior doors should be properly set (squared to the jamb). All doors known to sag/drag in door jambs, especially over time, should properly align with hardware (bolts, strikes and hinges) and should be weatherstripped. The installation of at least 1 long (2"-3") screw into the wall framing on the jamb side of the hinge can help prevent sag/dragging of the door, stabilize the door frame and increase Security. The installation of a long screw for stabilization usually appears as an odd (non matching) hinge screw. This is not required but is highly recommended.

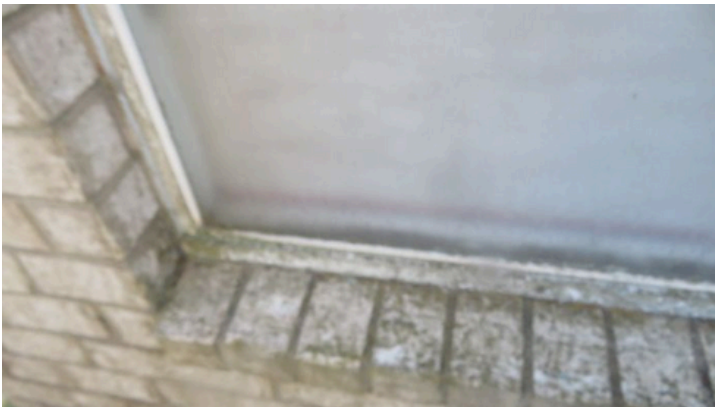
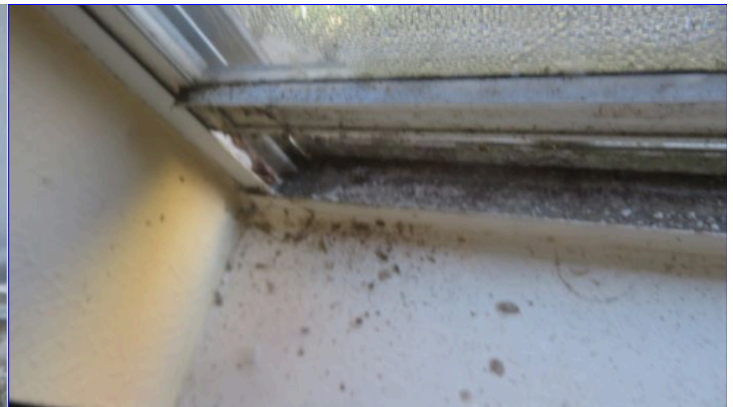
The windows are in mild disrepair. This is a common condition. Trimming and adjustment, hardware improvements, lubrication, repairs are recommended. Repairs are usually made on an as needed basis only. The most important factor is that the window exteriors are well maintained to avoid rot or water infiltration.

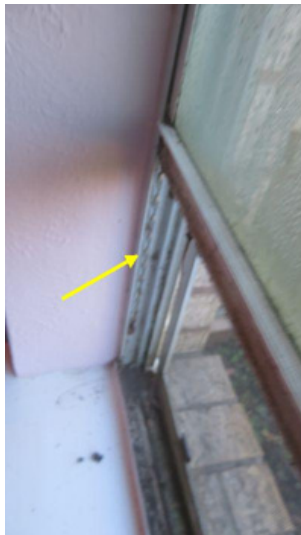
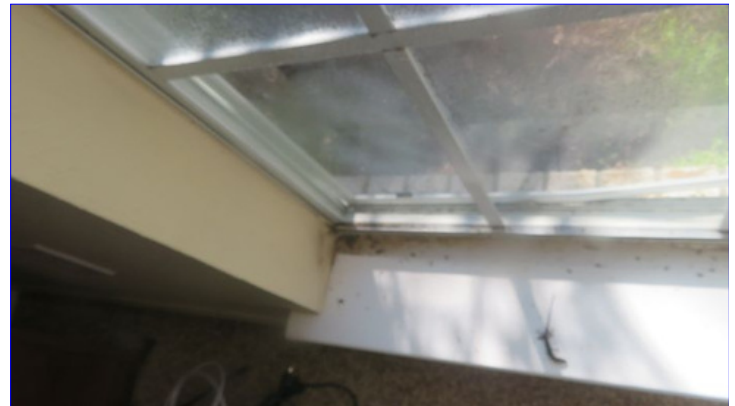
Observed detached tension springs at several windows throughout the home. Tension springs hold the sash in place when the window is open. Repairs are recommended.

Water staining was observed around the window reveals. The cause for the staining should be determined and repairs undertaken, if necessary, to prevent damage.

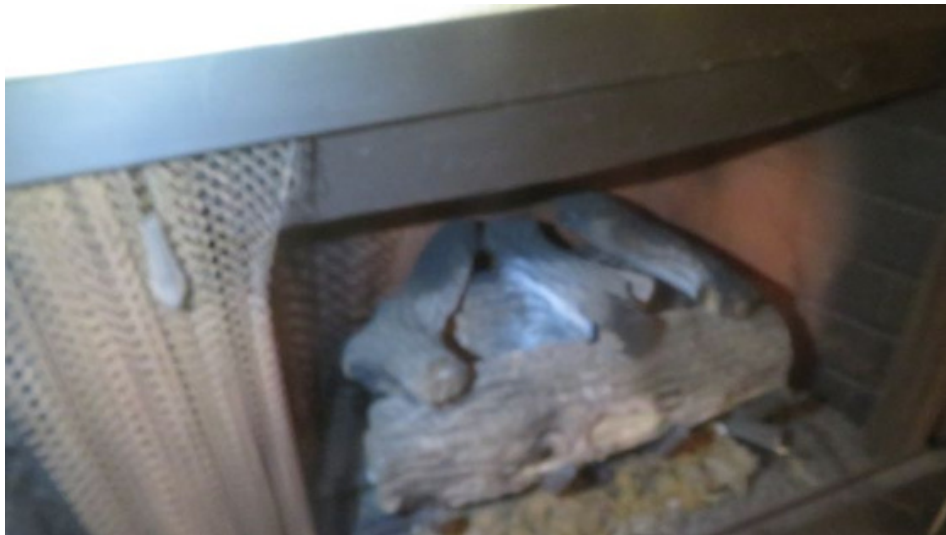
The unit was not operated at the time of the inspection. Recommend further evaluation/ repairs by a qualified fireplace technician.

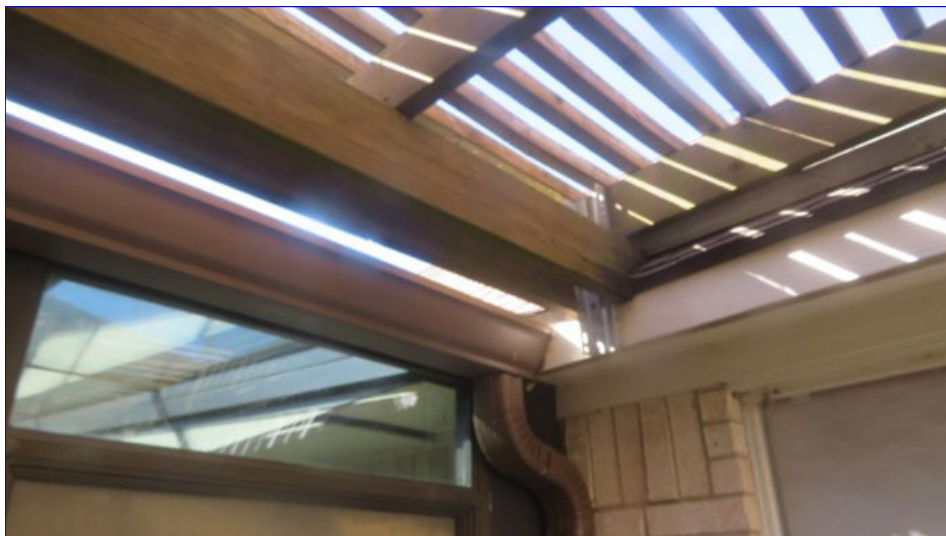
- PATIO
- Awning is improperly attached to cement board. Cement board is an exterior cladding system only, and is "Not Structural" (has No Load bearing capacity). Recommend installation of a support header with proper joist hangers. This is a "Safety Issue".

Awning is improperly attached to cement board. Cement board is an exterior cladding system only, and is "Not Structural" (has No Load bearing capacity). Recommend installation of a support header with proper joist hangers. This is a "Safety Issue".

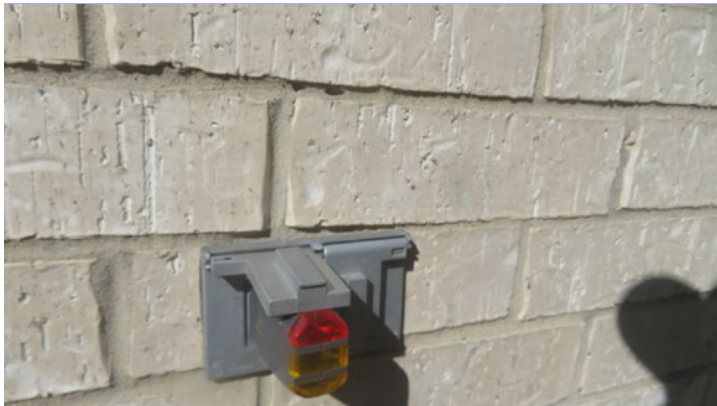
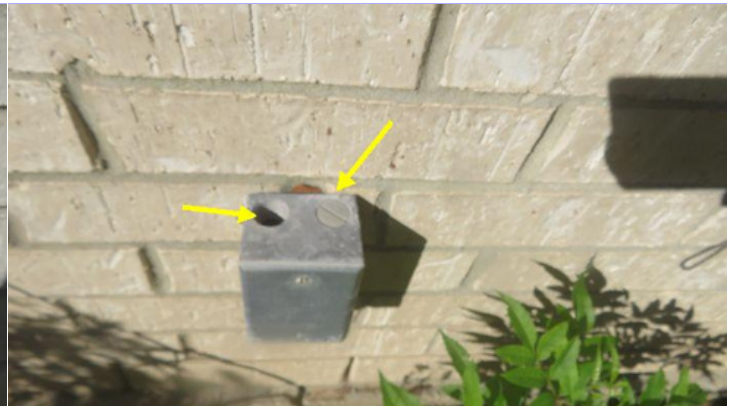
Exterior outlets are required to be weather sealed, and sealed to the surface they are mounted to. Outlets were not sealed in some areas. This is a "Shock Hazard". Repairs, can be done by installing a sealed (bubble type) outlet cover to the original outlet junction box and properly sealing it to the wall. (all)

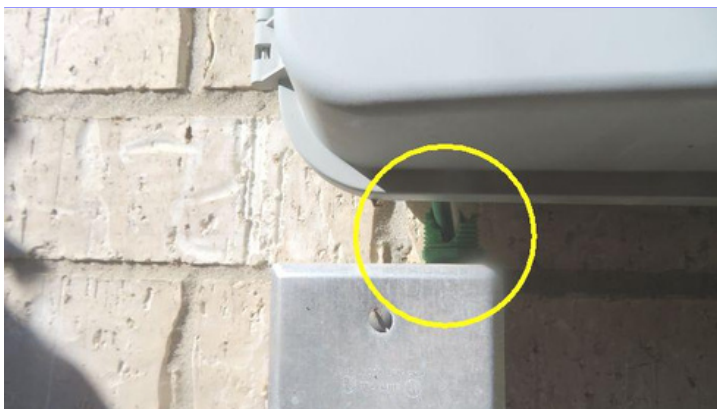
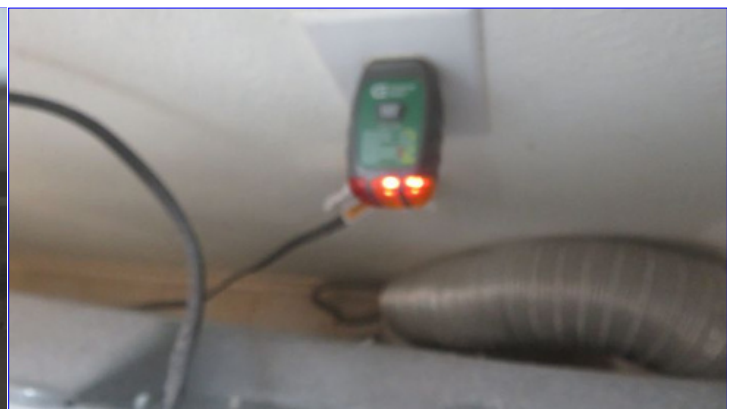
Observed damaged, missing or improper conduit. Exterior grade conduit is required for all exterior circuitry and must be sealed "Water tight" with the proper connections. Recommend repairs. (x1, sprinkler control, see pic)

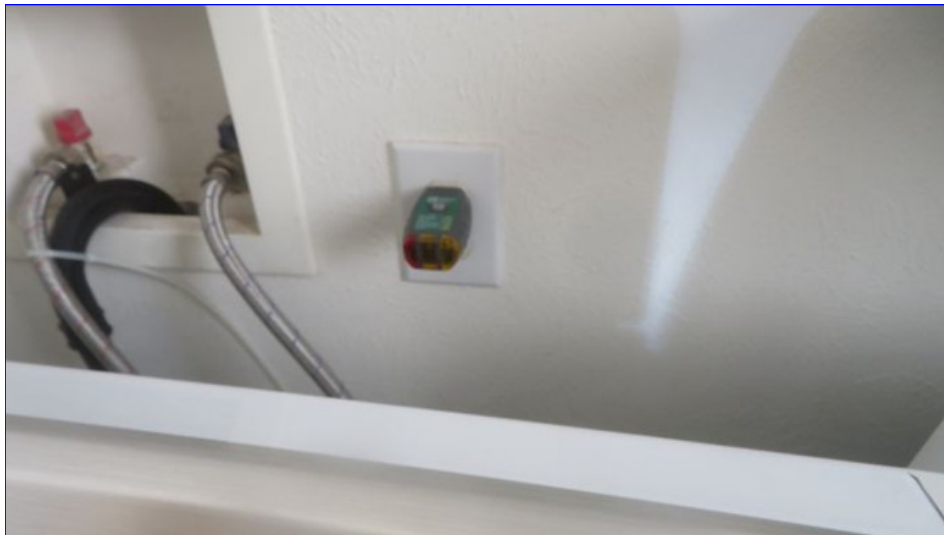
Observed: Outlet(s) inoperative. Outlets and circuits should be investigated and/or repaired. (x1, laundry, see pic))

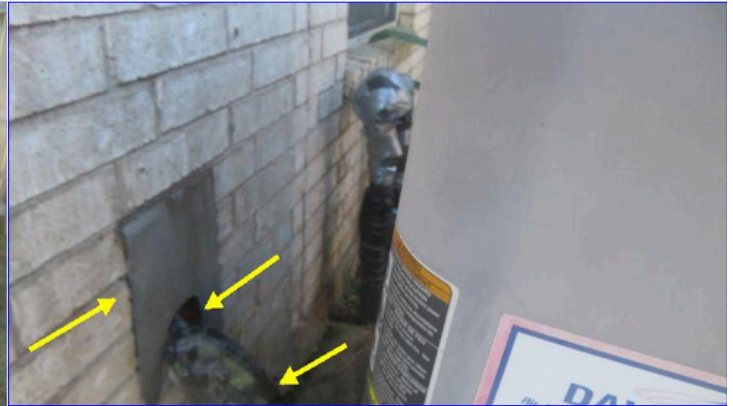
The exterior wall penetration where the A/C power/refrigerant lines enter the structure should be capped with flashing, seal the flashing and seal lines (foam/caulk) where they penetrate the wall. Openings are possible water intrusion and rodent/pest entryway. Recommend properly capping and sealing all openings.

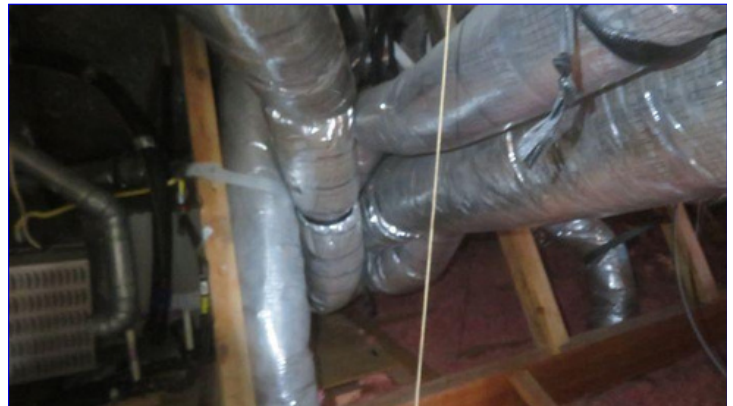
Observed "Contact" of the ductwork between other ducts/surfaces. Separation can be as simple as placing a piece of insulation between the ducts/other surfaces. Further evaluation and improvements are recommended.

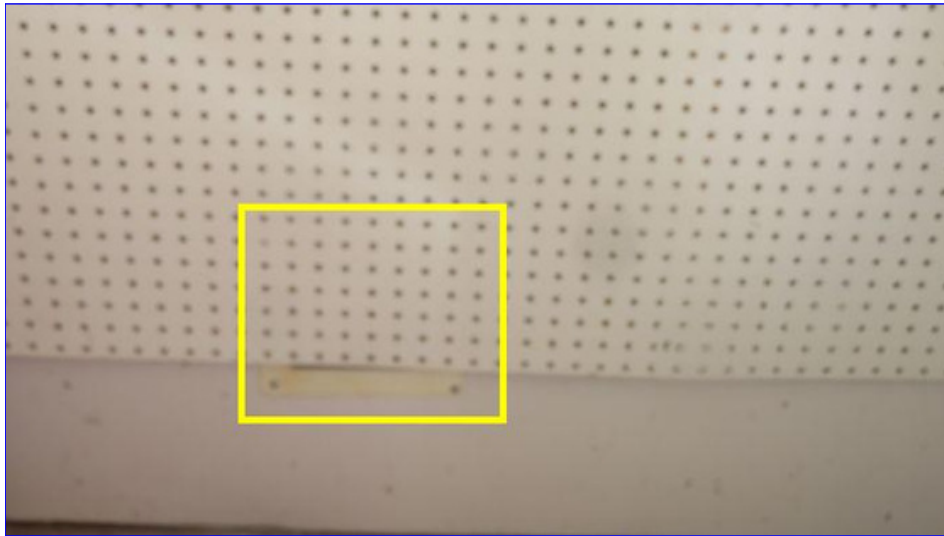
Note: The main water valve (garage) was inaccessible. (behind peg board) Recommend remove board blocking access.

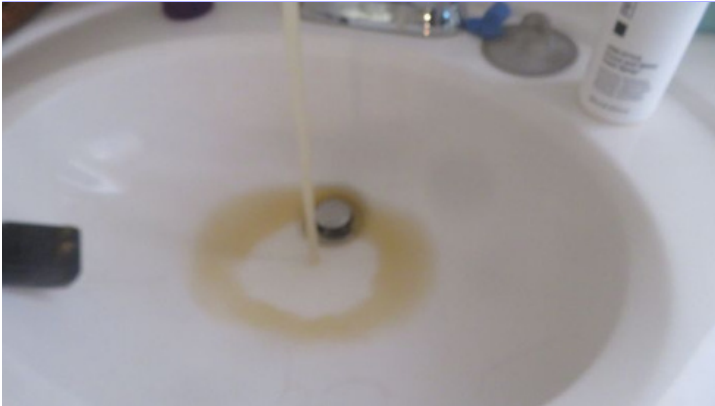
Rust colored water was observed. This is typically caused from sediment in the tank or lines. The tank/lines may need to be flushed. Recommend further evaluation.

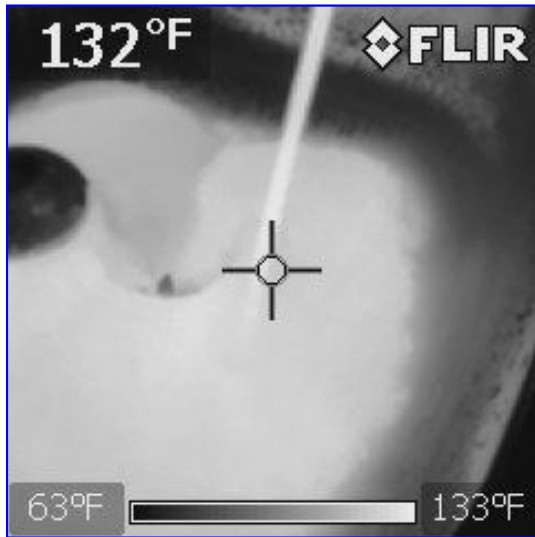
The water temperature was measured at 130+ degrees. The water heater is set to 130 degrees. The potential for scalding of 120 degrees is present. A freshly set the setting is recommended. Further evaluation is recommended.

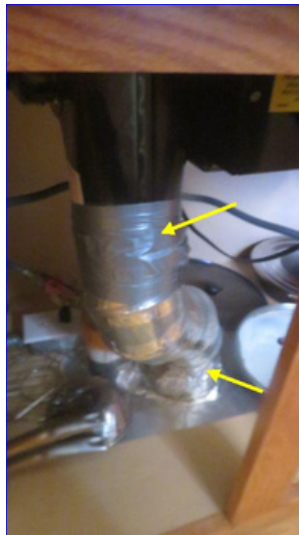
Duct tape was used to seal the unit. Current Standards require Non Combustible sealants. Recommend using the appropriate flanges/mastic/metal tape to seal the unit.

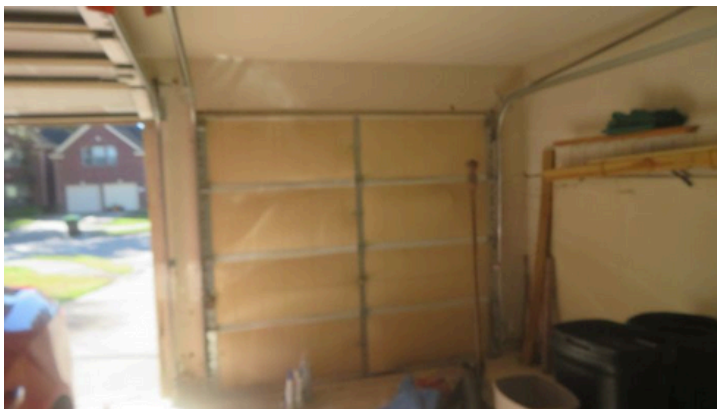
The tension spring cable or mechanism is not adjusted properly or unsprung. Recommend repairs.

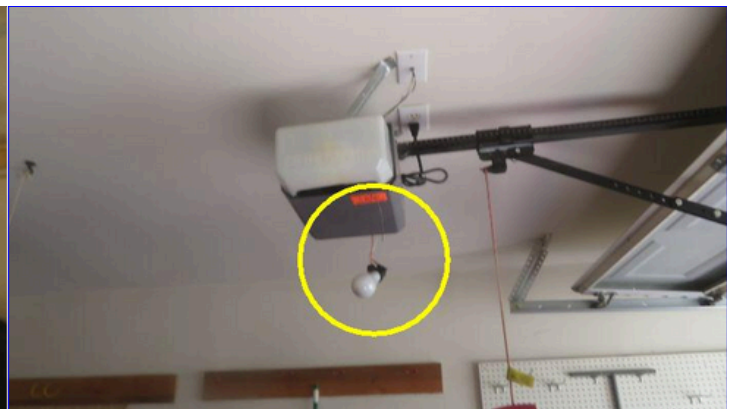
Light bulb on the garage door opener was inoperative at the time of inspection.
