## **INSPECTION REPORT**

**52WB-4YPW  
Ibraheem Malkawi  
4635 Beech St  
Bellaire, TX 77401**

# PROPERTY INSPECTION REPORT FORM

<u>Ibraheem Malkawi</u> Name of Client	<u>06/05/2025</u> Date of Inspection
<u>4635 Beech St, Bellaire, TX 77401</u> Address of Inspected Property	
<u>Zachary Ramage</u> Name of Inspector	<u>#25653</u> TREC License #
<u></u> Name of Sponsor (if applicable)	<u></u> TREC License #

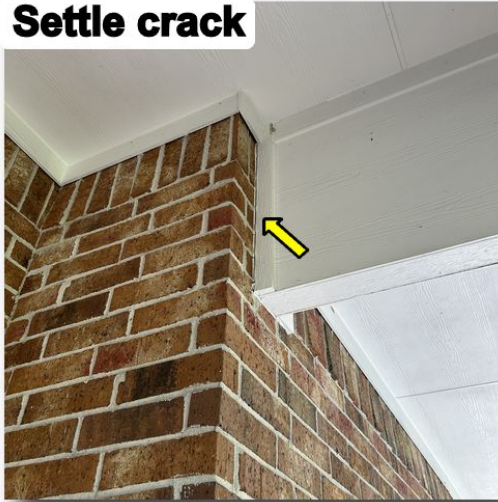
The dwelling appears to have experienced a common degree of settlement for its age and location. The cracking noted at interior and/or exterior areas is not in my opinion currently affecting the serviceability of the structure. If a more detailed evaluation is desired, I recommend further review by a structural engineer.

**Settle crack**

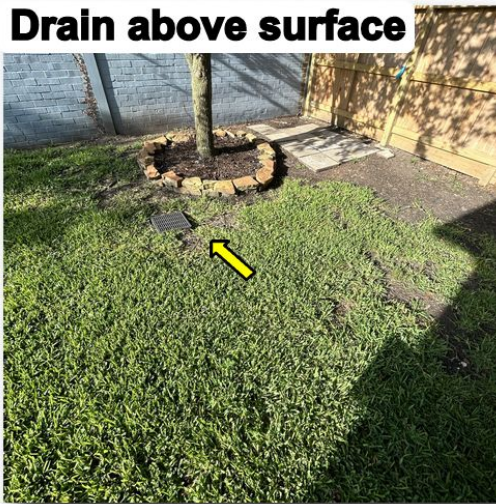
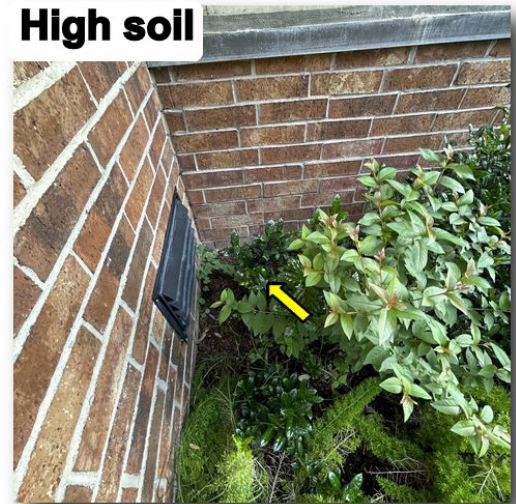
Areas of the surface drains were raised above the surface on South side(s) of the house. We recommend repairs to these areas to allow water to drain into the drain and not pond at the outside.

We recommend that at least two inches of concrete show between the brick or siding and the dirt line. A high soil line was noted at the North, South, East, West side(s). Inadequate clearance can allow water to penetrate into the structure causing moisture damage.

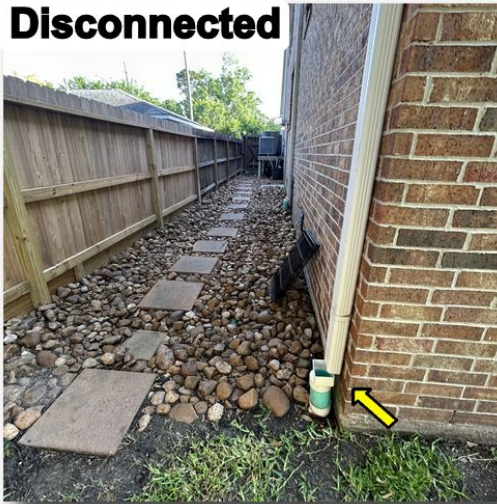
Deficiencies were noted in the installed gutter system including disconnected downspouts. We recommend repairs as necessary to ensure serviceability.

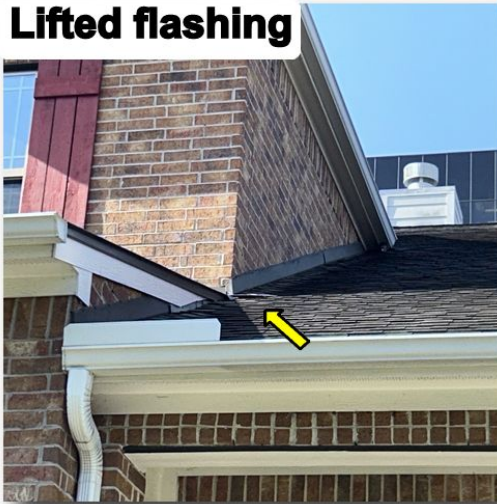
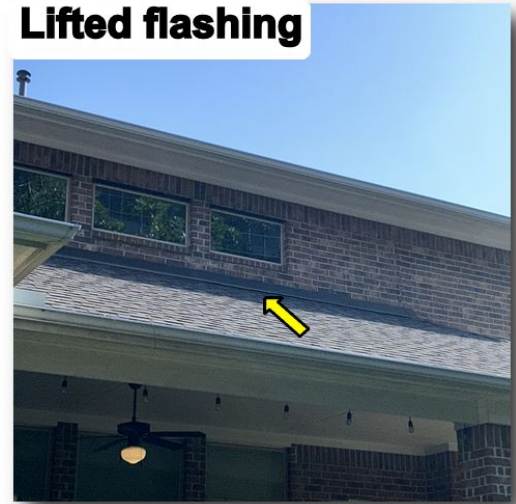
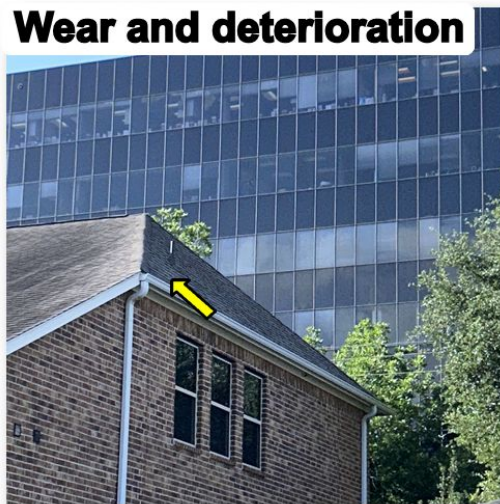
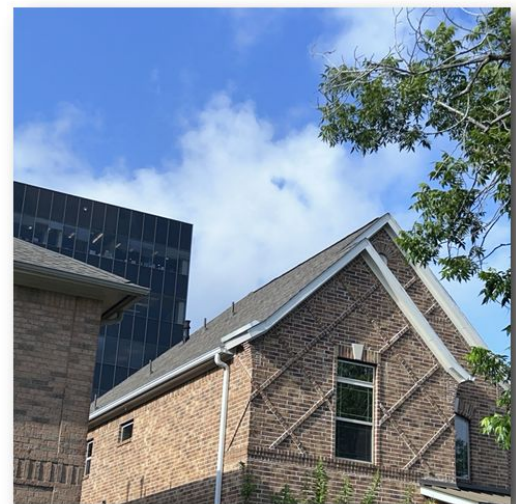
**Loose/lifted flashing was noted at the North, South side. Recommend evaluation and repair as necessary to help ensure serviceability.**

The roof shows a common degree of wear for its age and type, but may be nearing the end of its useful life. We recommend that the insurability of the roof be verified prior to closing.

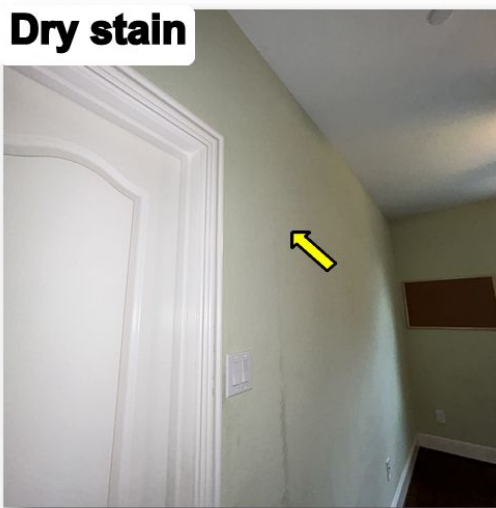
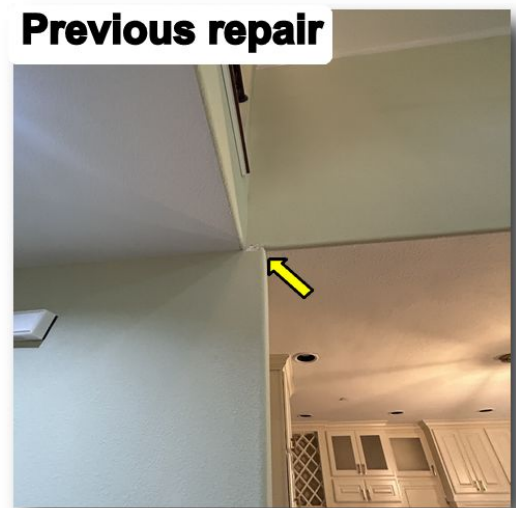
Evidence of repairs/patching observed at some areas. Unable to determine the effectiveness of these repairs or the cause resulting in the repairs.

Apparent water stain(s) were noted on the North bedroom walls. The area(s) were dry at the time of our inspection, we were unable to determine if the stain(s) were still active. If the leaks are still active, we recommend repair as necessary.

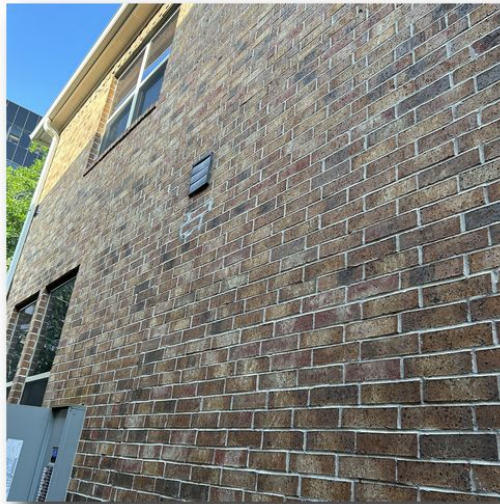
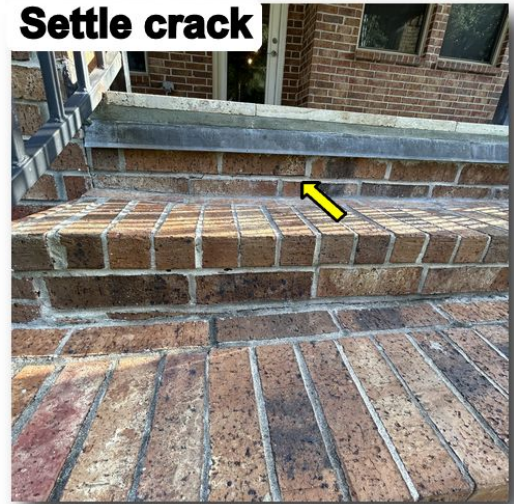
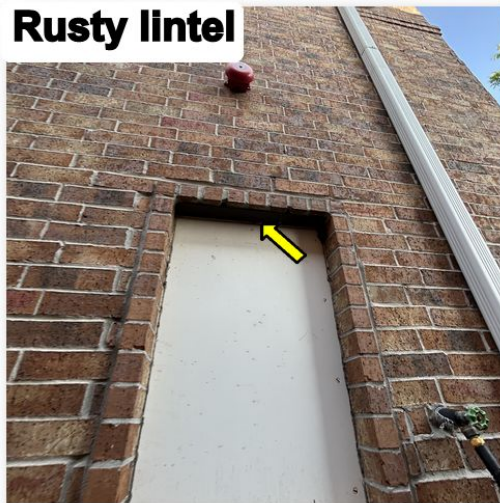
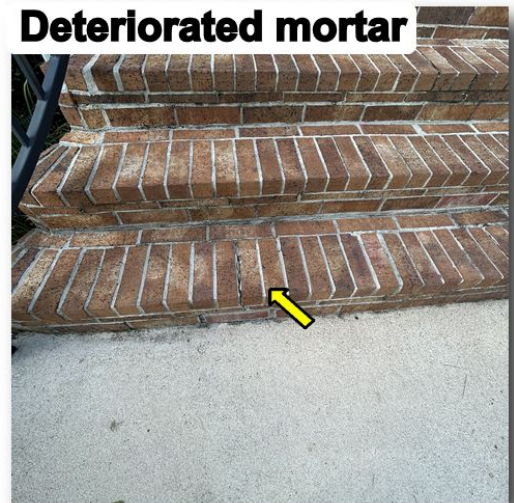
Cracked caulking noted around the structure; we recommend re-sealing to prevent moisture penetration where the caulk is pulling away/separating from adjacent surfaces.

Peeling paint was noted at various locations. We recommend scraping and painting as a matter of normal maintenance.

Settlement cracks were noted at the North, South side(s). Recommend re-sealing the cracks to prevent moisture penetration into the wall structure.

Common cracks observed, primarily a cosmetic concern. Suggest sealing all masonry cracks to prevent water penetration as a routine maintenance effort.

Deteriorated/Missing mortar observed at the brick veneer, recommend evaluation and repairs as necessary.

Rusty brick lintels were noted (metal supports over windows, doors, etc.); recommend repainting to prevent further damage to the metal surfaces.

Evidence of brick and mortar repairs observed in the exterior walls. Unable to determine the effectiveness of these repairs.

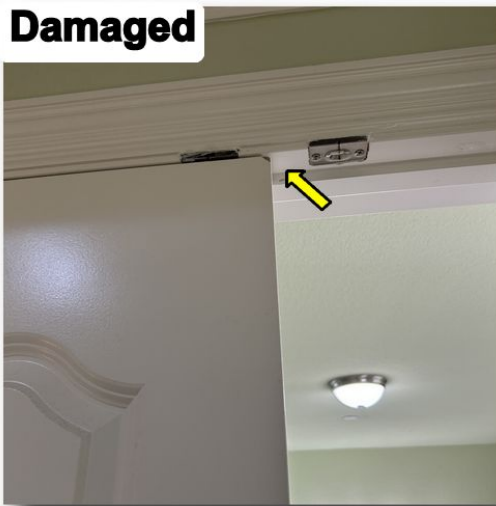
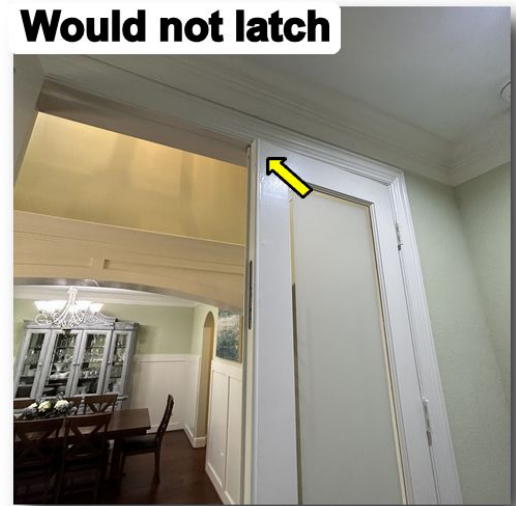
Damage was noted at some doors. repairs and re-sealing may be necessary to prevent further damage to the surface.

The following doors are not properly latching when opening/closing:office.

Some knobs/door hardware were loose at the time of inspection. Repairs may be necessary to restore serviceability.

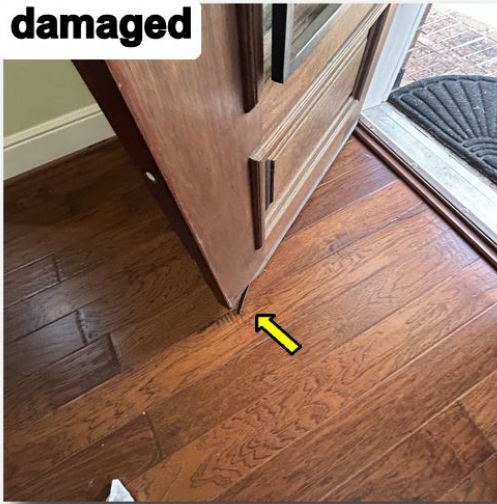
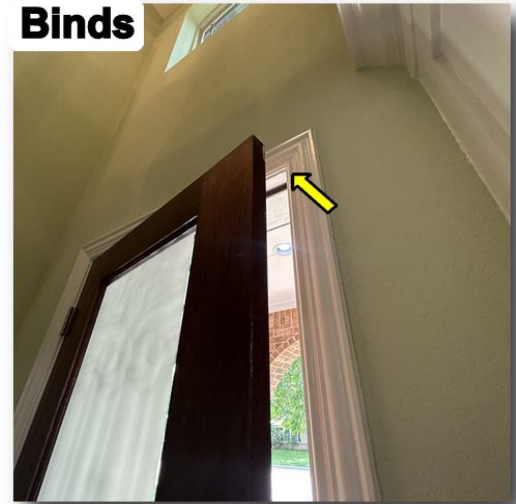
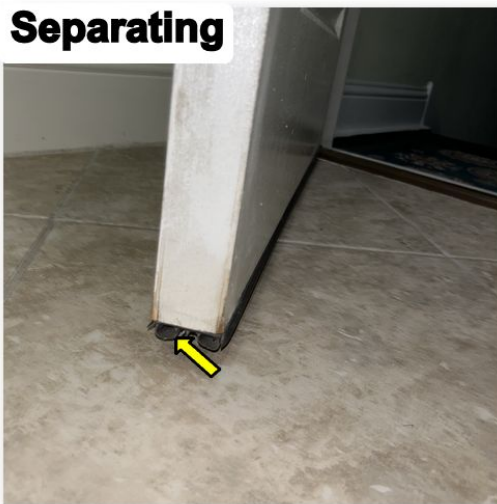
Damage was noted at the Garage entry door(s). repairs and re-sealing may be necessary to prevent further damage to the surface.

The garage entry doors auto-closing device would not fully close the door. The Texas Real Estate Commission recommends auto-closing devices on garage entry doors to help ensure safety.

The front doors door sweep was damaged; Recommend repairs as needed.

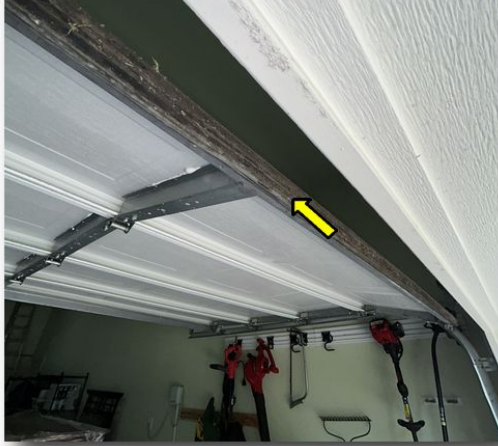
The weather seals at the bottom of the door(s) are damaged.

### Damaged weatherstrip

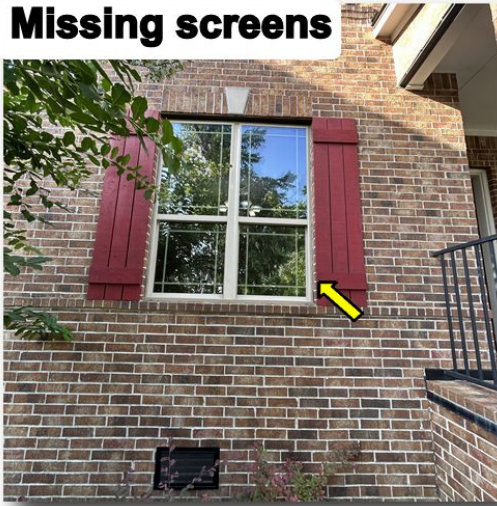
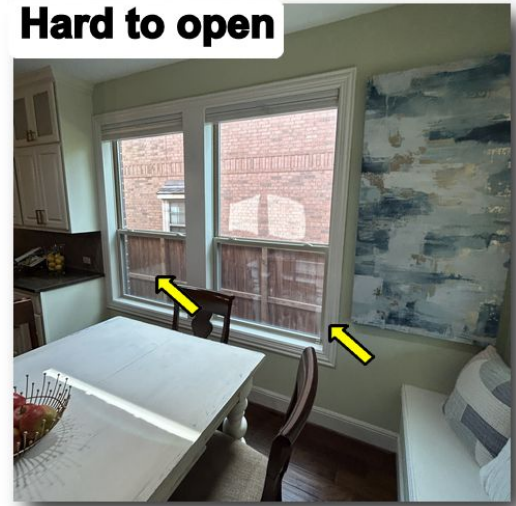
Missing screens were noted, these are not itemized by room.

Some windows would not open easily using normal force. We recommend ensuring that at least one window per room is operable.

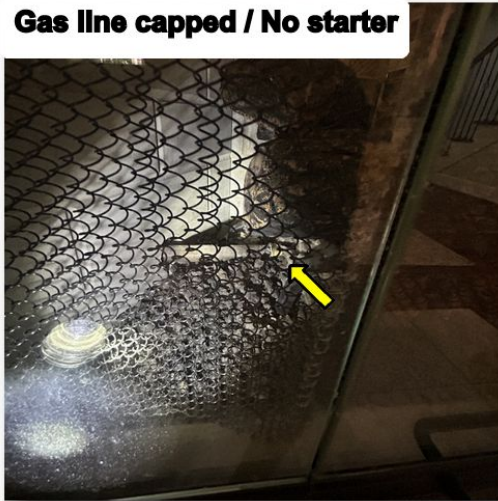
**Gas line capped / No starter**

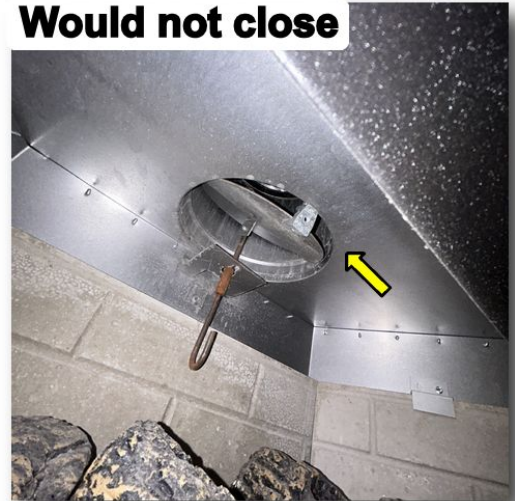
**The damper door will not fully open/close; recommend repair.**

**Would not close**

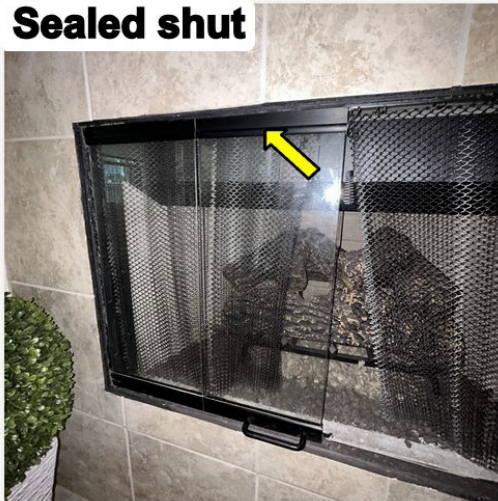
The fireplace door was sealed shut at the time of the inspection.

**Sealed shut**

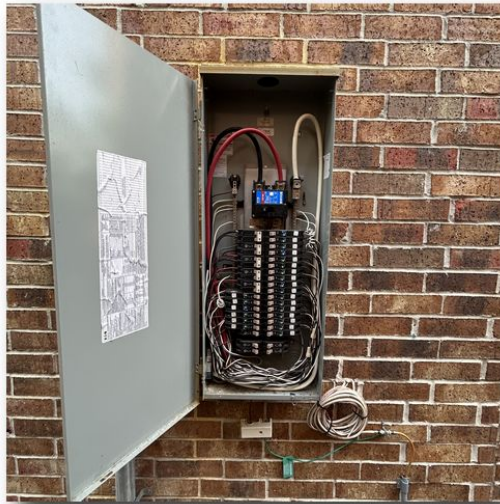
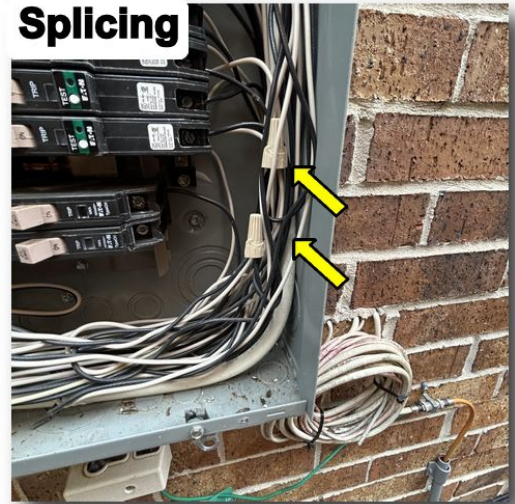
Splicing to supply additional circuits was noted within the panel. We recommend a licensed electrician perform any needed repair.

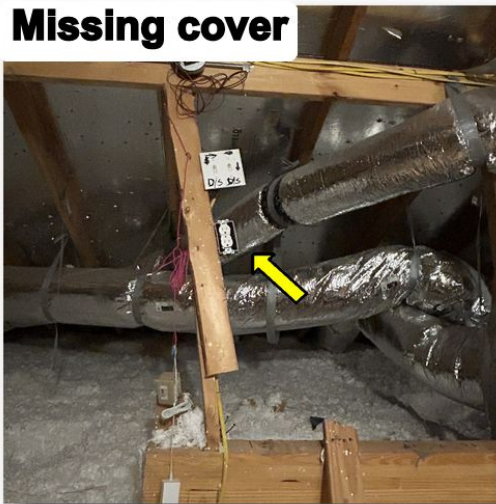
Some loose, missing outlet covers were noted. We recommend replacement to help assure safety. Cost and repair is minimal.

The patio, media room ceiling fan was excessively noisy. We recommend repair to help assure serviceability.

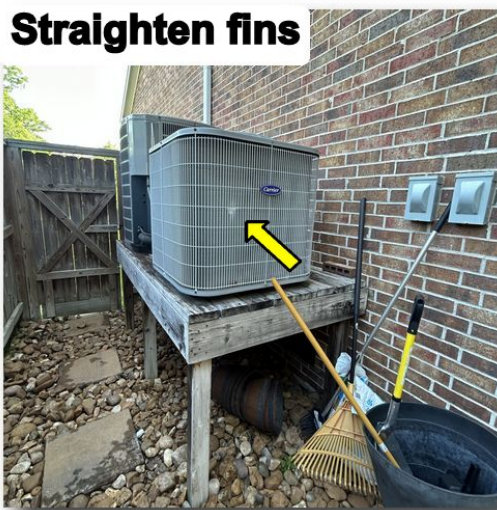
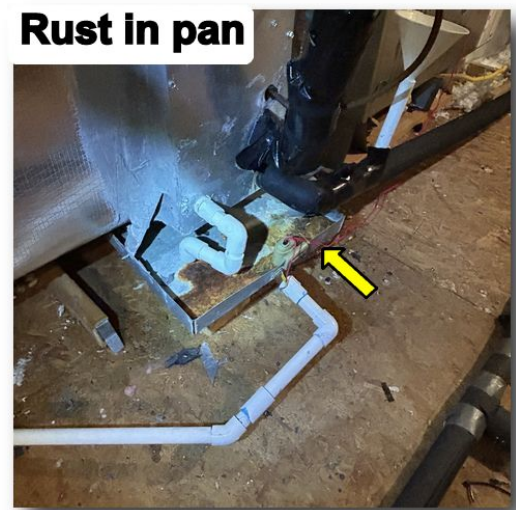
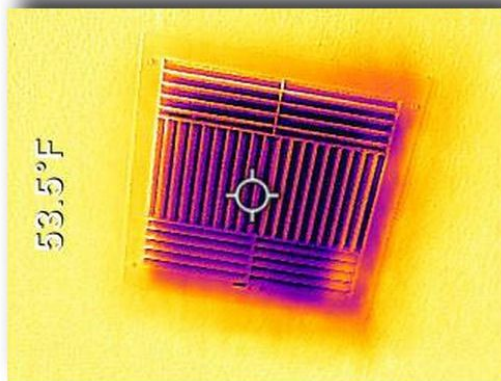
Rust was noted in the pan. At some time in the past, the primary condensate drain line was not properly removing water from the inside portion of the air conditioning system. No visible evidence of ongoing leaking was noted at the time of our inspection. If review is desired, we recommend contacting a licensed heating and air conditioning contractor.

Recommend straightening the cooling fins on the exterior condenser to help assure adequate air flow.

The return air temperature was 69°F and the supply air temperature was 53°F, giving a temperature differential of 16°F, which was within a serviceable range.

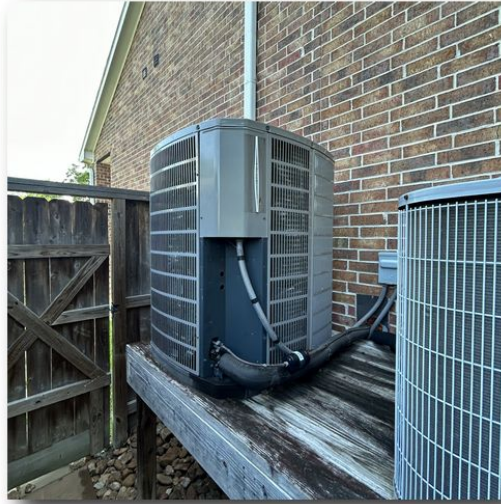
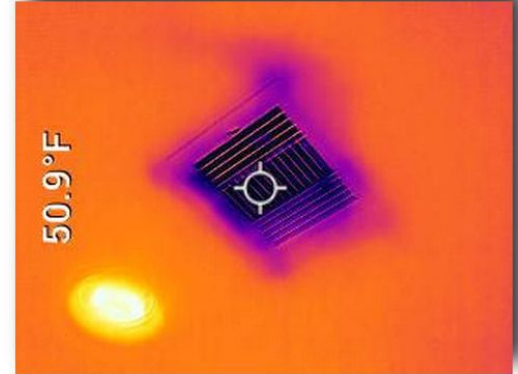
The return air temperature was 70°F and the supply air temperature was 50°F, giving a temperature differential of 20°F, which was within a serviceable range.

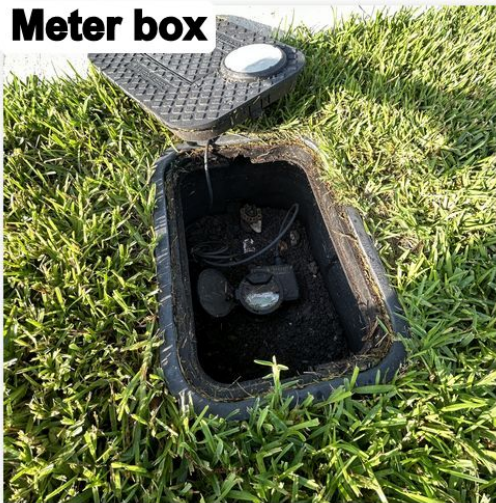
**Meter box**

The water meter drip indicator showed no flow to the structure when no demand was called for at the plumbing supply system.

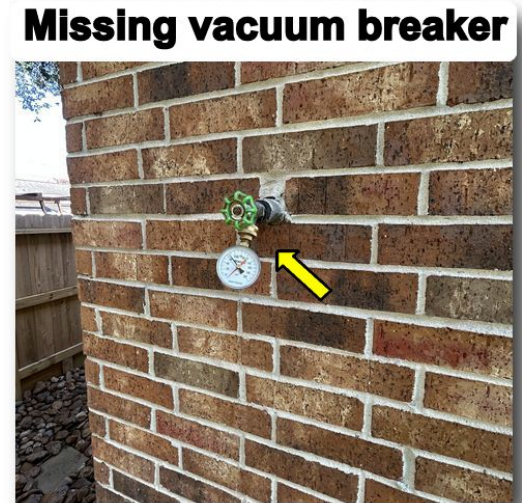
**The hose bibs are missing parts (the vacuum breaker is missing); repairs are needed to restore serviceability.**

**Missing vacuum breaker**

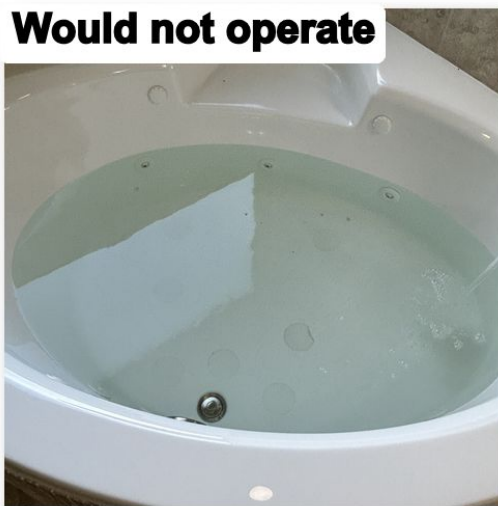
**The hydro therapy tub would not operate. We recommend repair by a qualified contractor.**

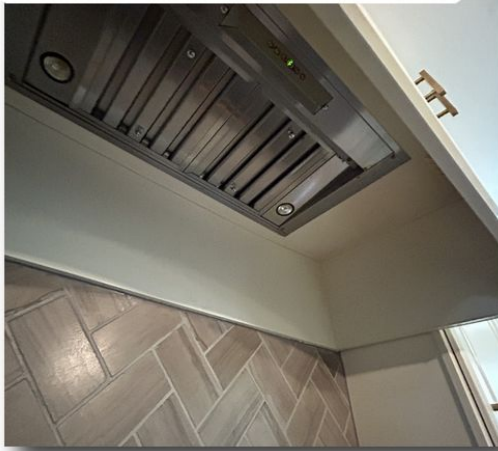
### Fan would not operate

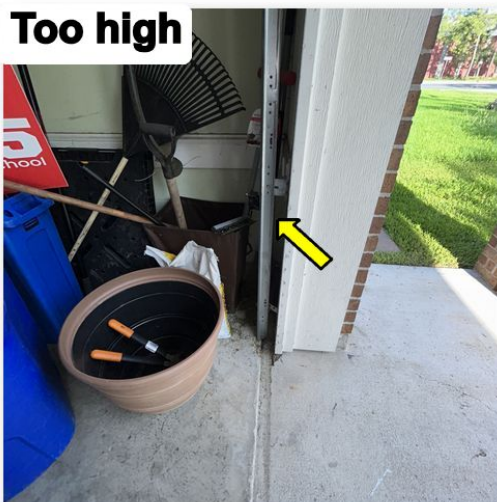
**The electronic eyes were mounted too far above the floor to help ensure safety. We recommend lowering the eyes to within 6 inches of the floor.**

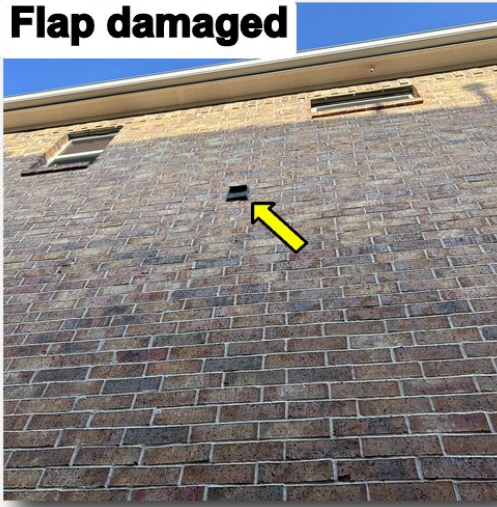
The exterior vent flap was damaged (East side). We recommend replacement to help prevent unwanted animal entry.
