GC Home Inspection

PROPERTY INSPECTION REPORT FORM

John Settlemyre <i>Name of Client</i>	06/30/2025 <i>Date of Inspection</i>
113 Plum Cir, Lake Jackson, TX 77566 <i>Address of Inspected Property</i>	
Chad Gregory Langston Jr. <i>Name of Inspector</i>	25839 <i>TREC License #</i>
Chad Langston <i>Name of Sponsor (if applicable)</i>	7946 <i>TREC License #</i>

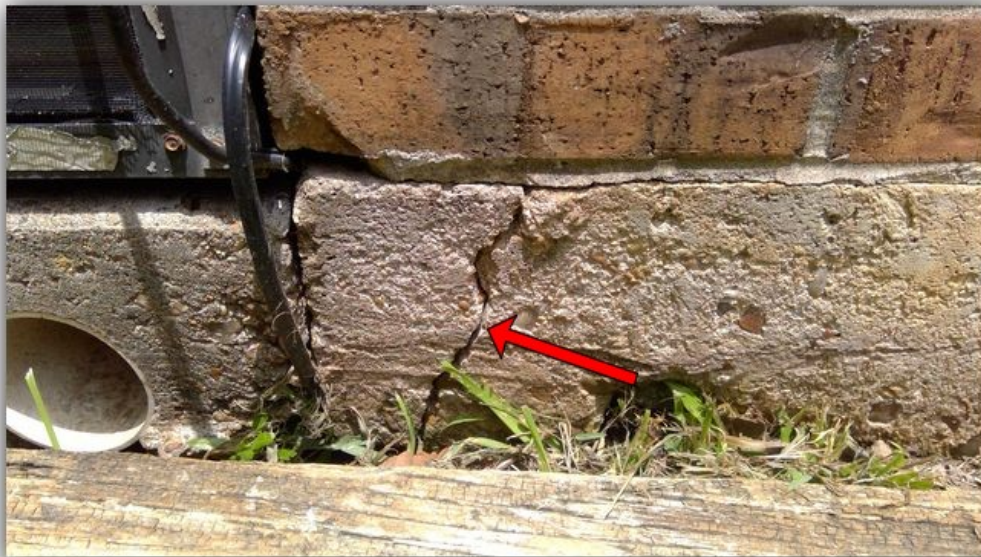
Shear cracks were noted on the corner of the foundation walls. While this condition is typical and not a structural concern, it is important to note that in the event the crack continues below the soil surface it could provide an entry point for termites.

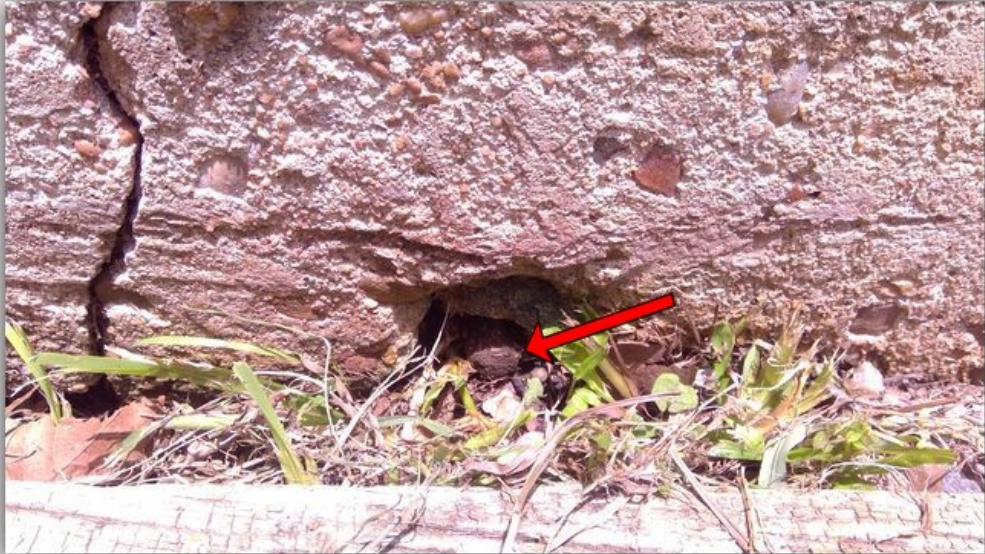
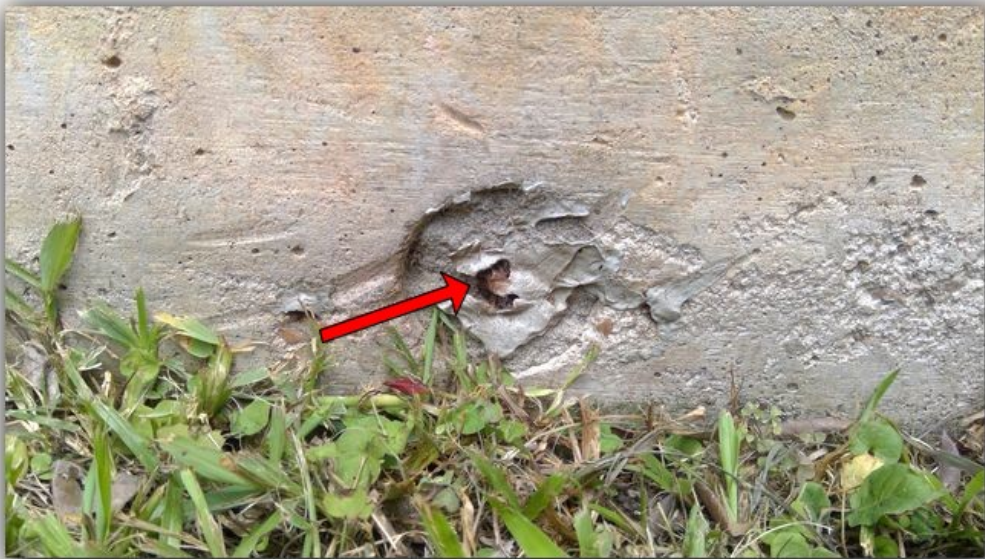
Post tension cable ends were observed on the exterior of the foundation. This should be repaired to prevent corrosion.

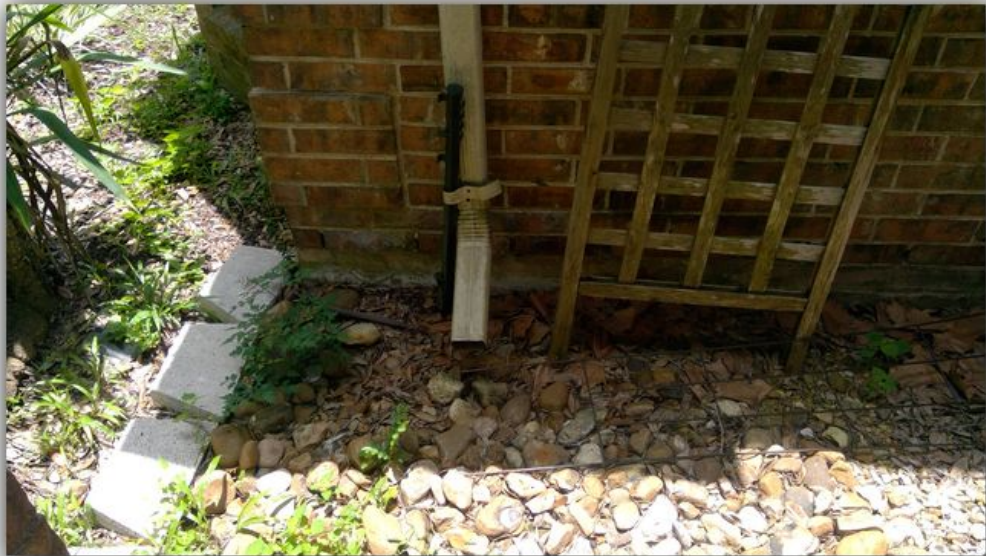
The downspout(s) should discharge water at least five (5) feet from the house. Storm water should be encouraged to flow away from the building at the point of discharge.

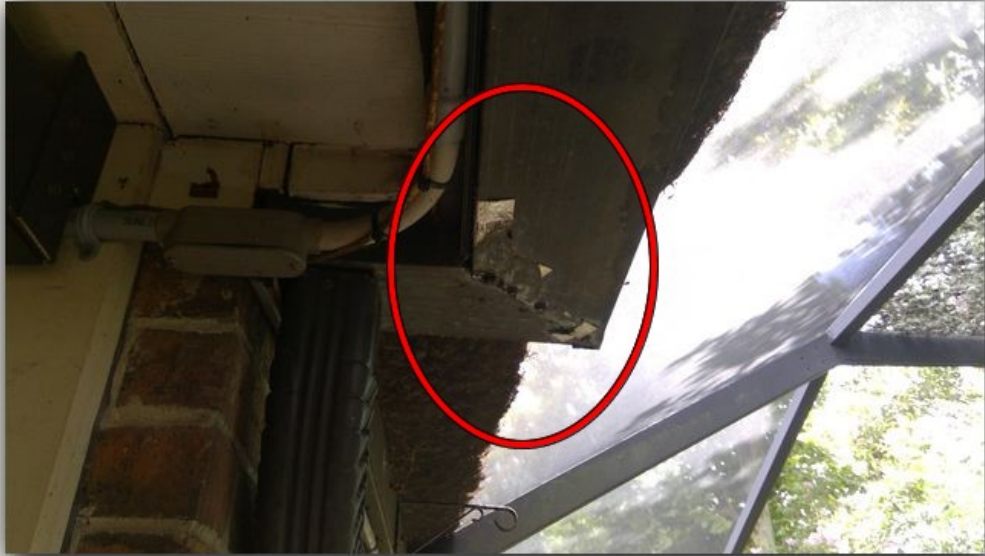
The seams in the gutter system are leaking and should be improved as necessary.

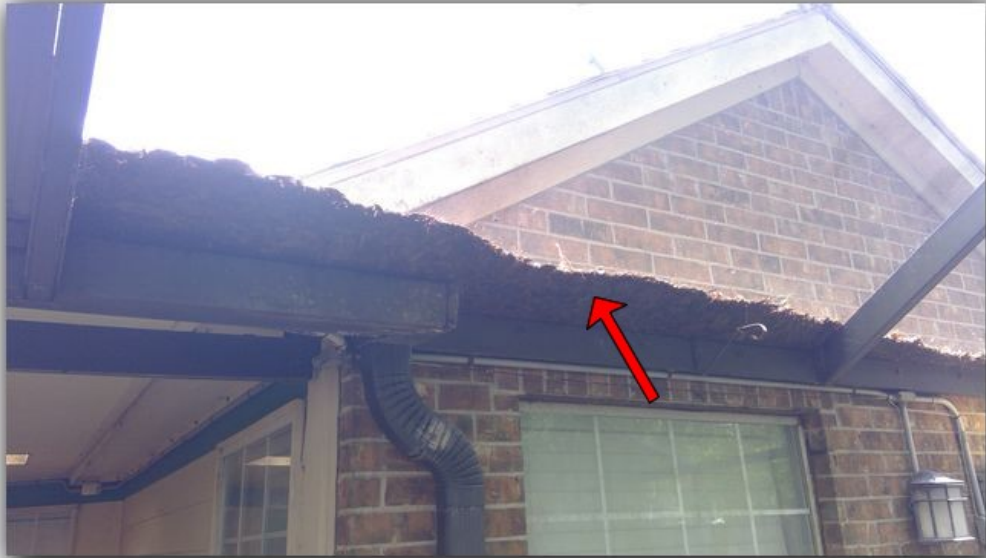
Older roof, nearing end (last 1/4) of serviceable life. Observed one or more of the following conditions: brittle, cracked, curled ends, and/or excessive granular loss of shingles.

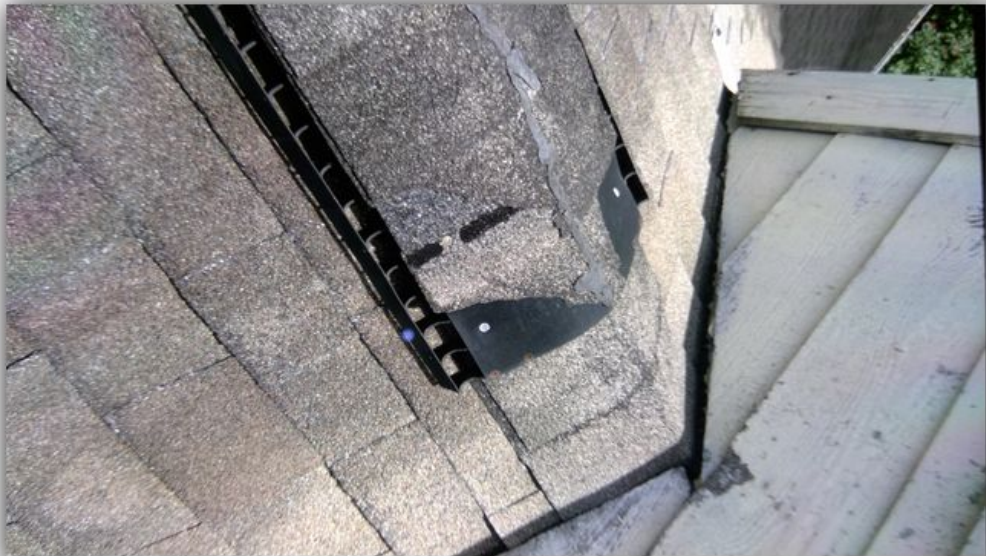
Minor repairs to the roofing are recommended. Damaged or missing roofing material should be repaired. All roof penetrations should be examined and sealed as necessary.

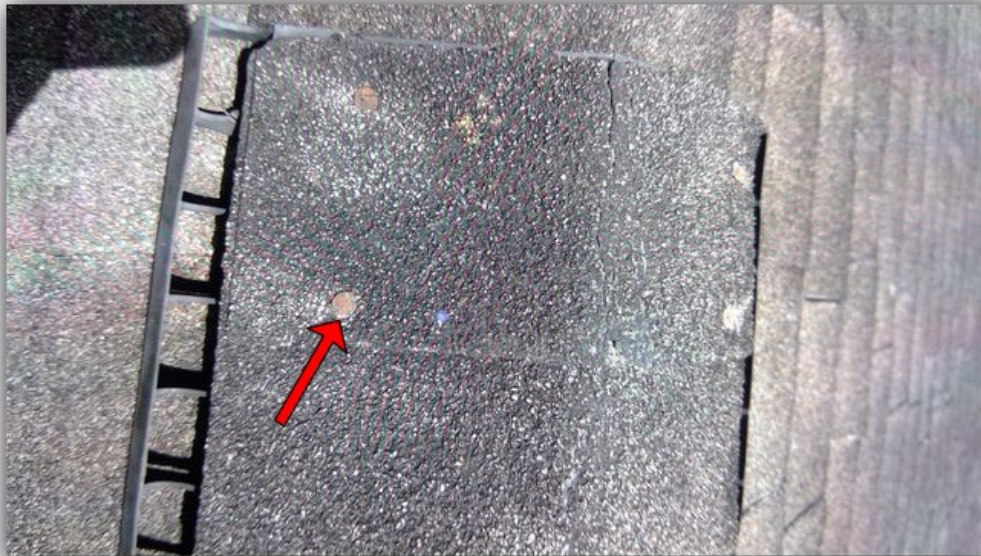
It is recommended that exposed nail heads be caulked or sealed appropriately.

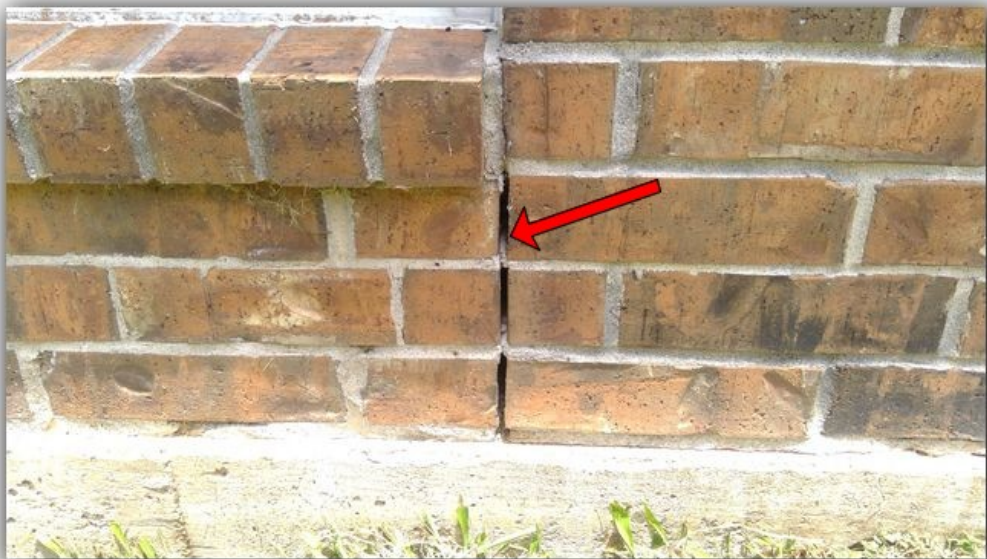
The expansion joint should be sealed properly to prevent water infiltration.

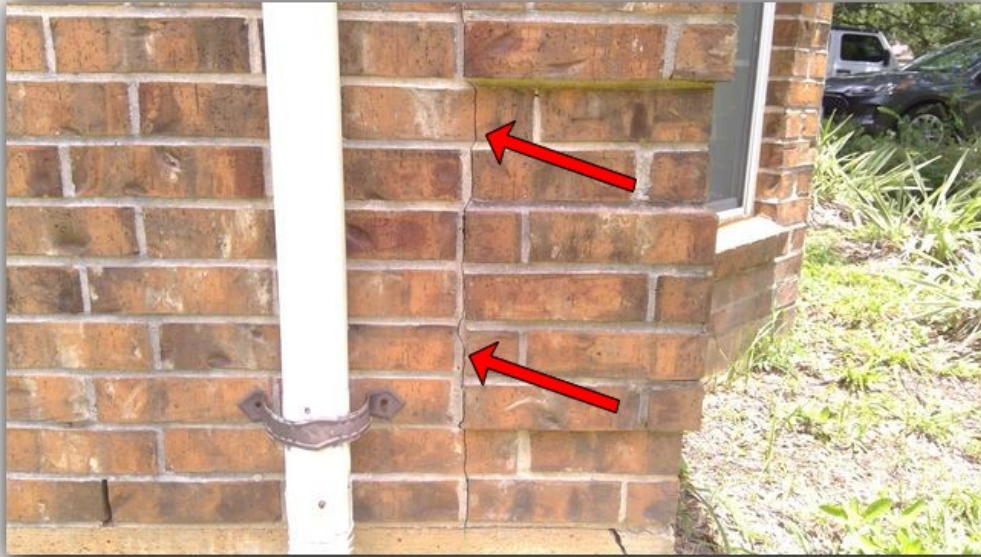
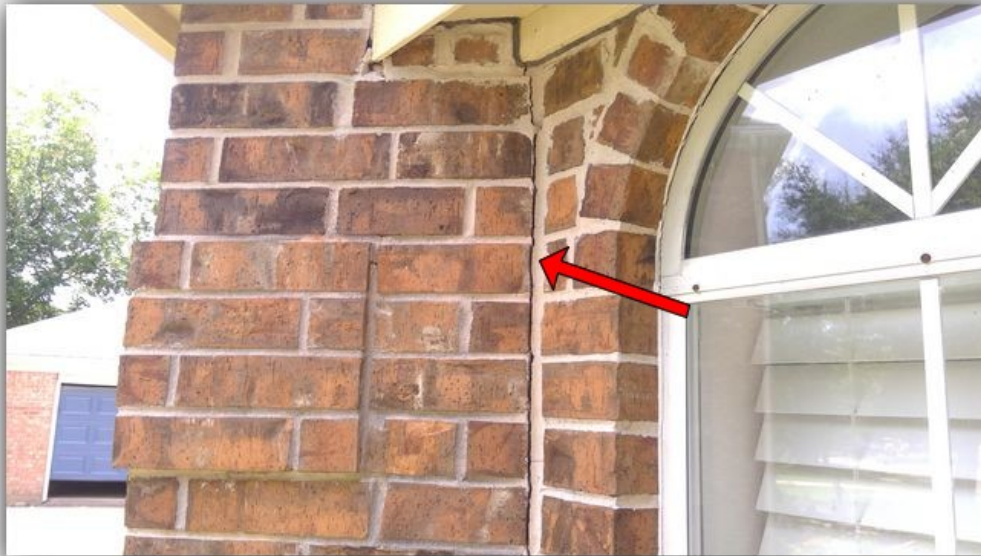
Slightly greater than typical cracking was observed on the exterior wall. The amount of movement does not suggest a serious structural problem. This area should, of course, be monitored. The rate of movement cannot be predicted during a one-time inspection.

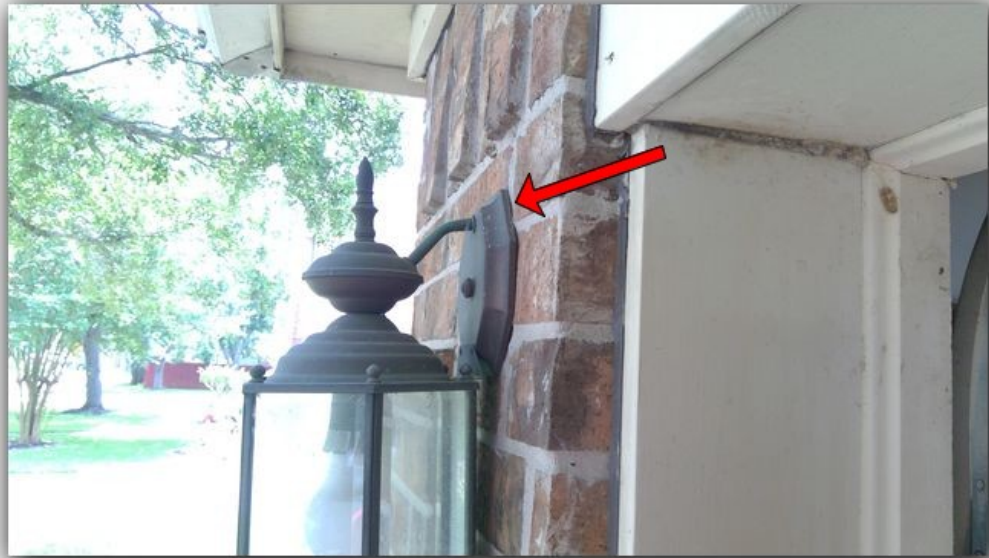
Exterior wall penetrations should be examined and sealed as necessary.

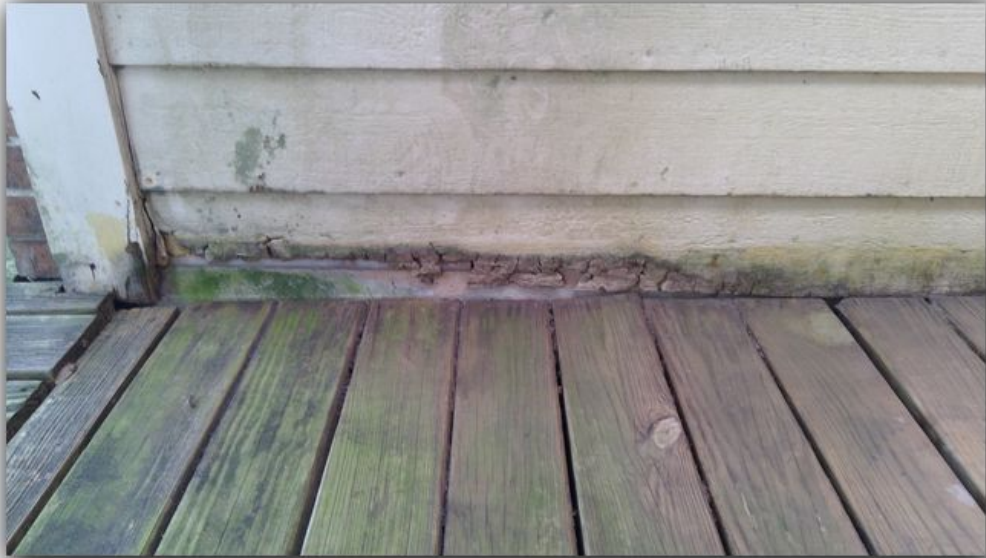
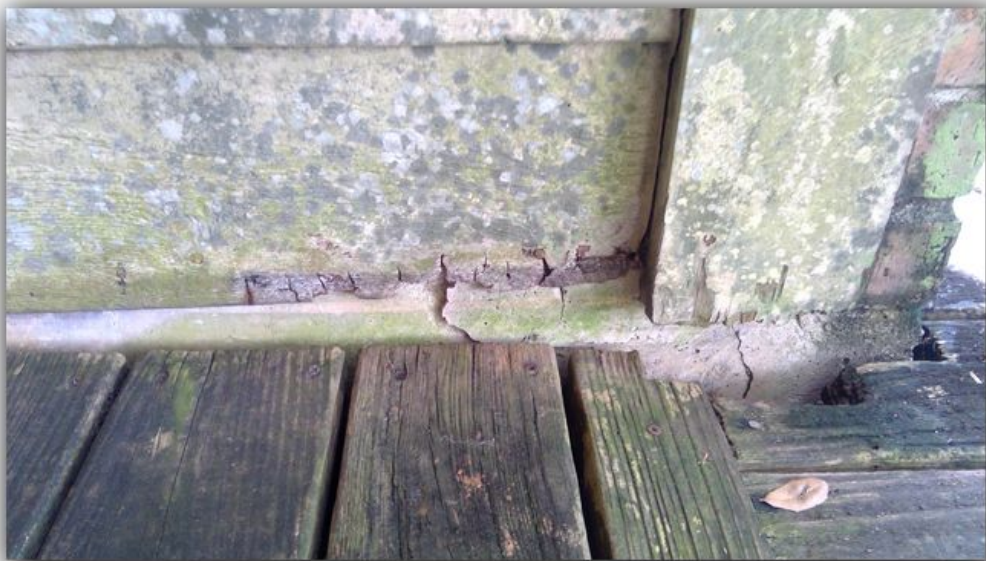
Water damage was observed to the exterior wall on the rear elevation.

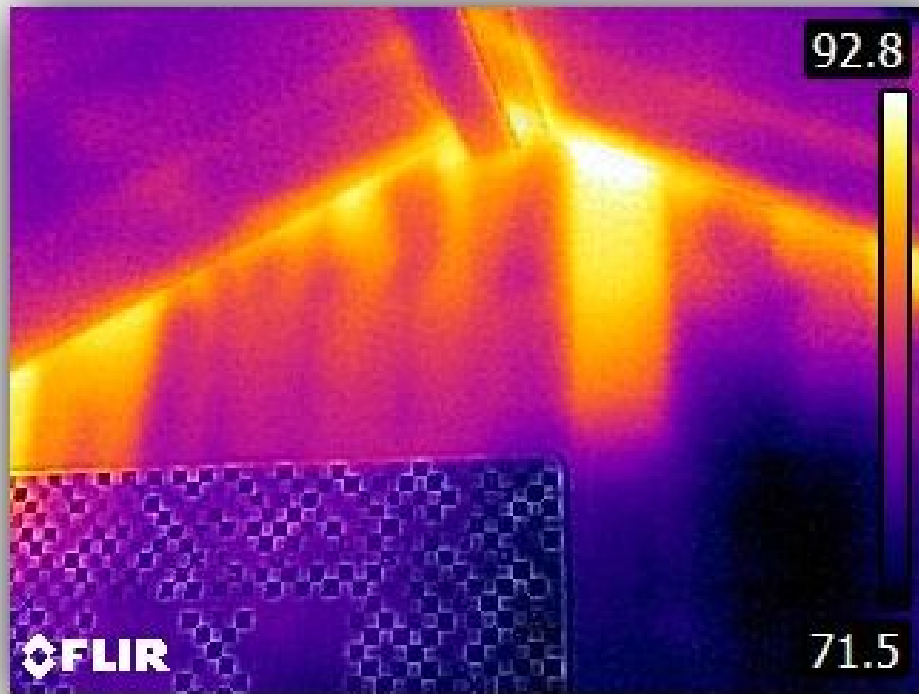
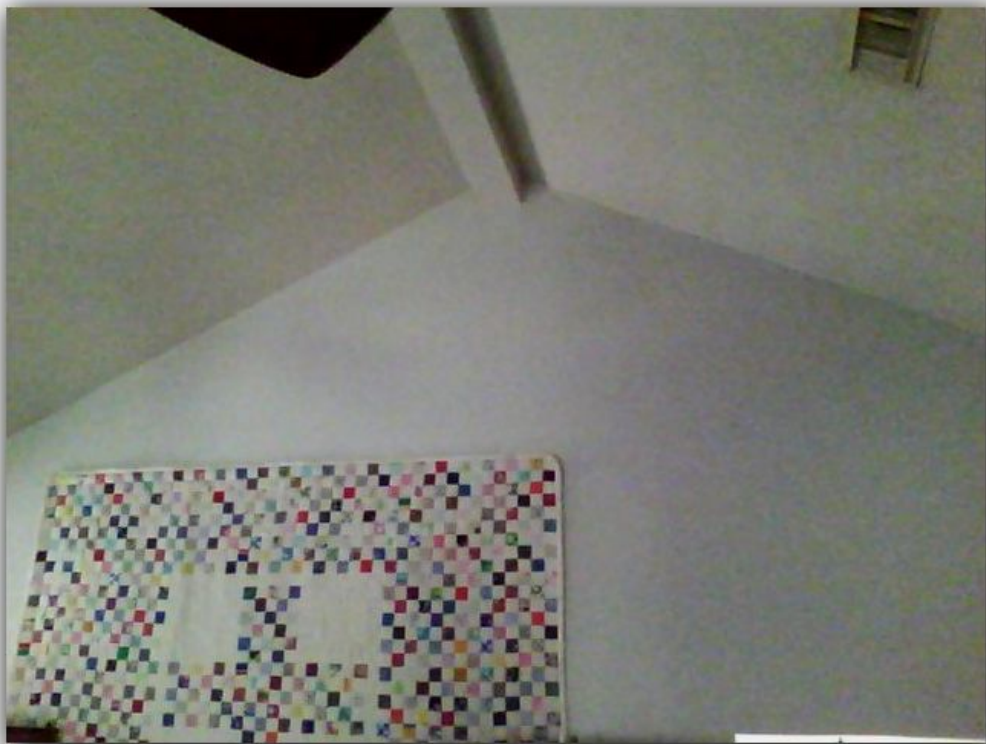
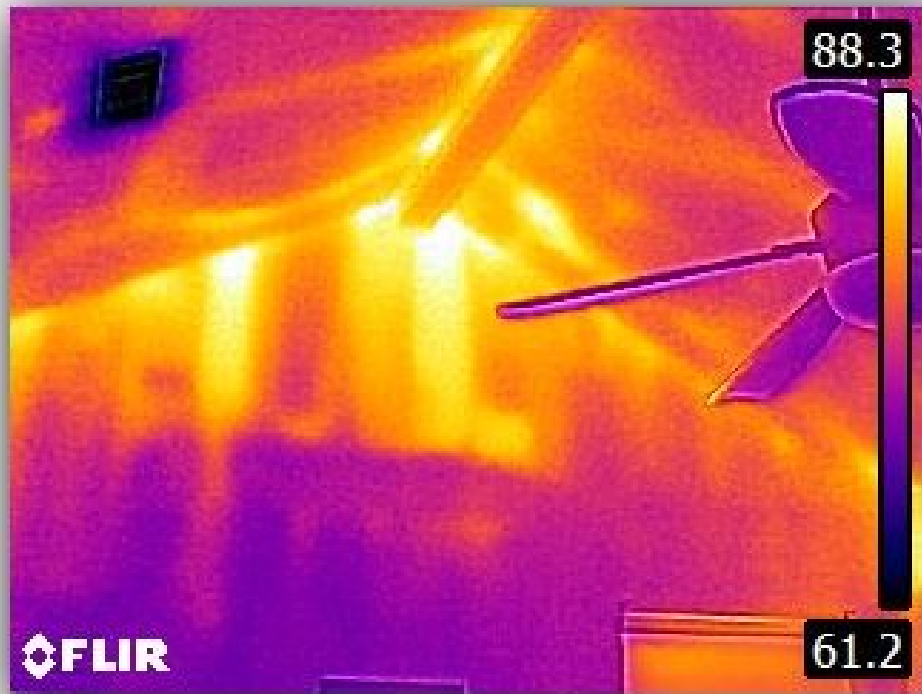
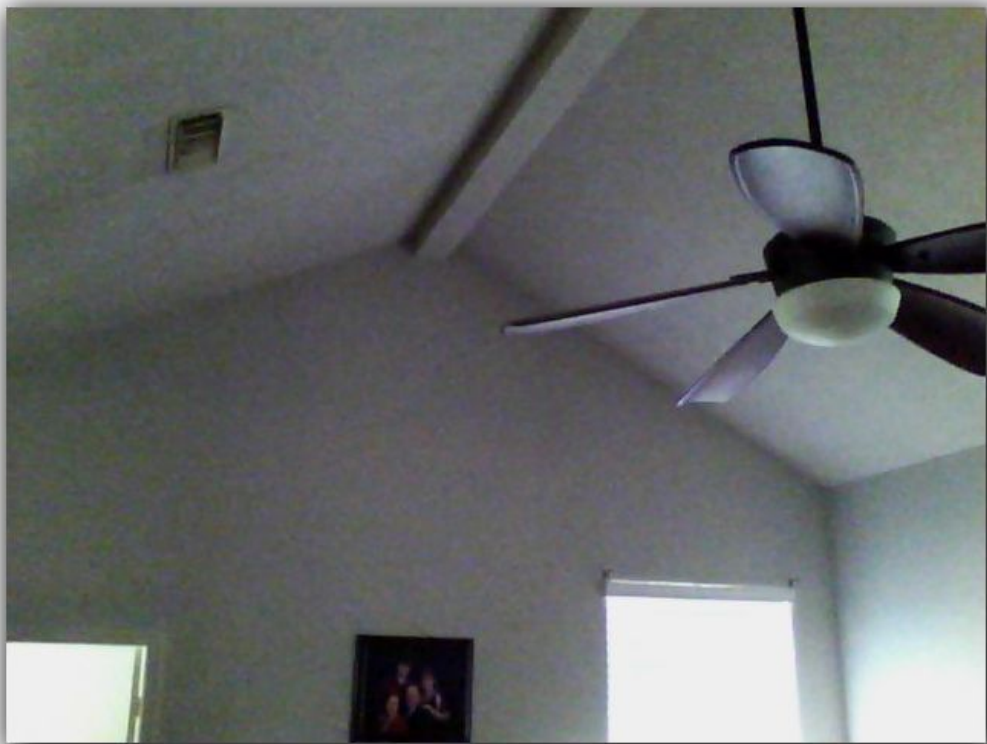
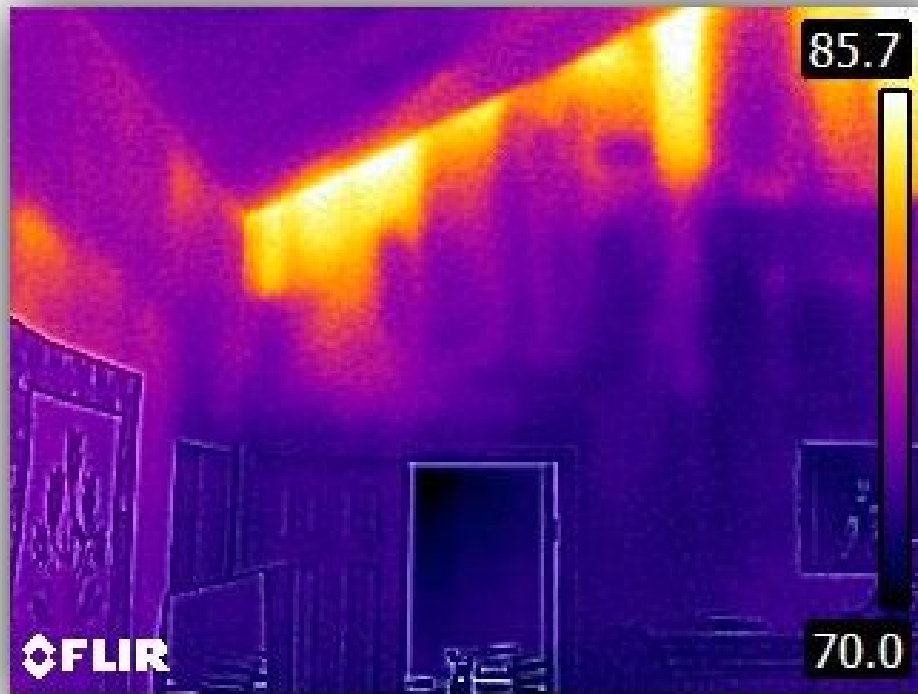
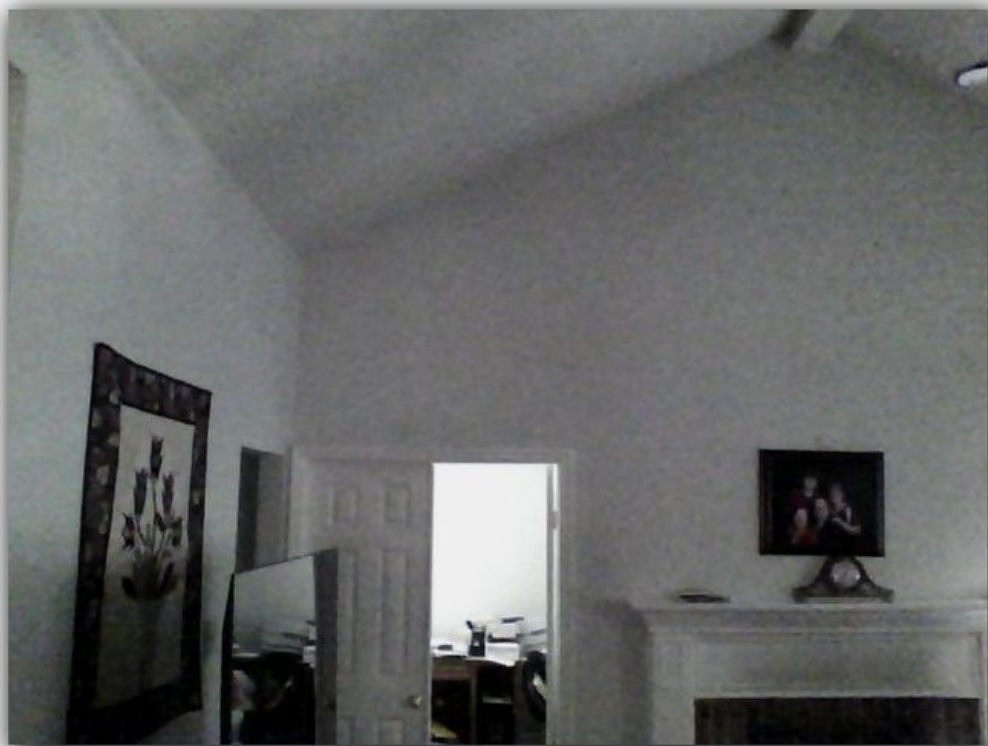
Thermal anomalies were observed in the walls of the home in various locations indicating fallen vertical insulation. Further investigation and repair should be made as necessary.

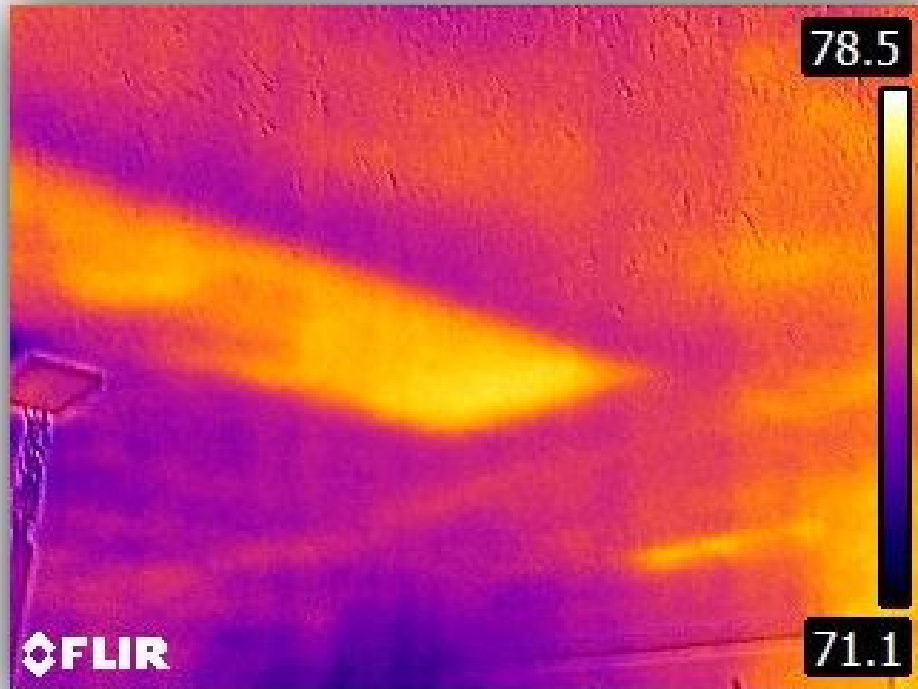
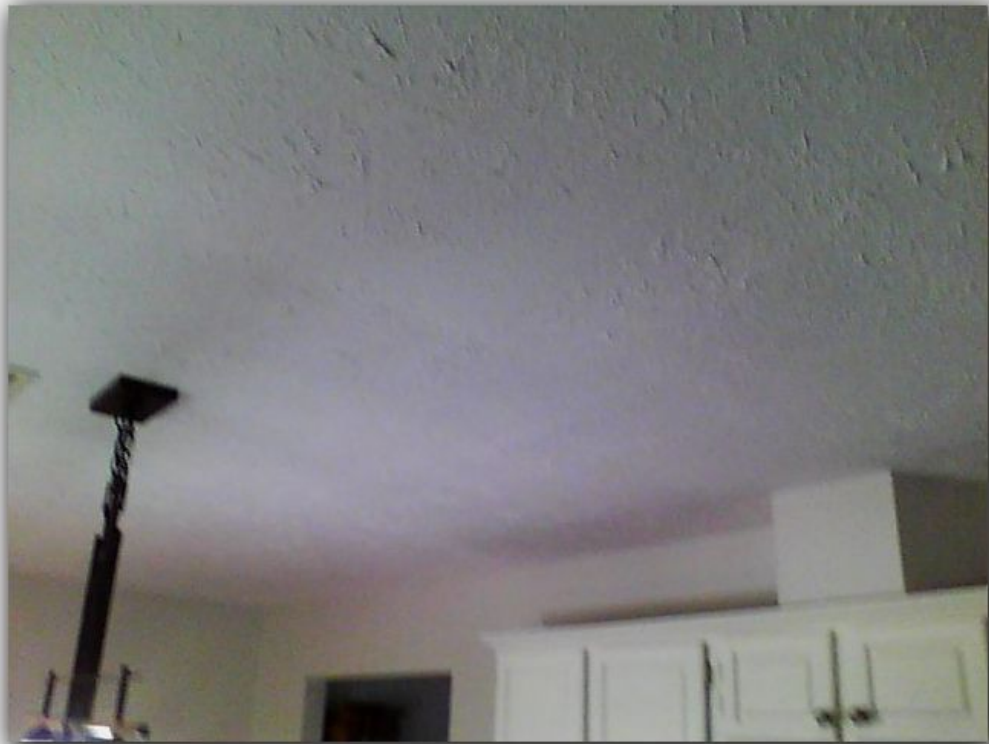
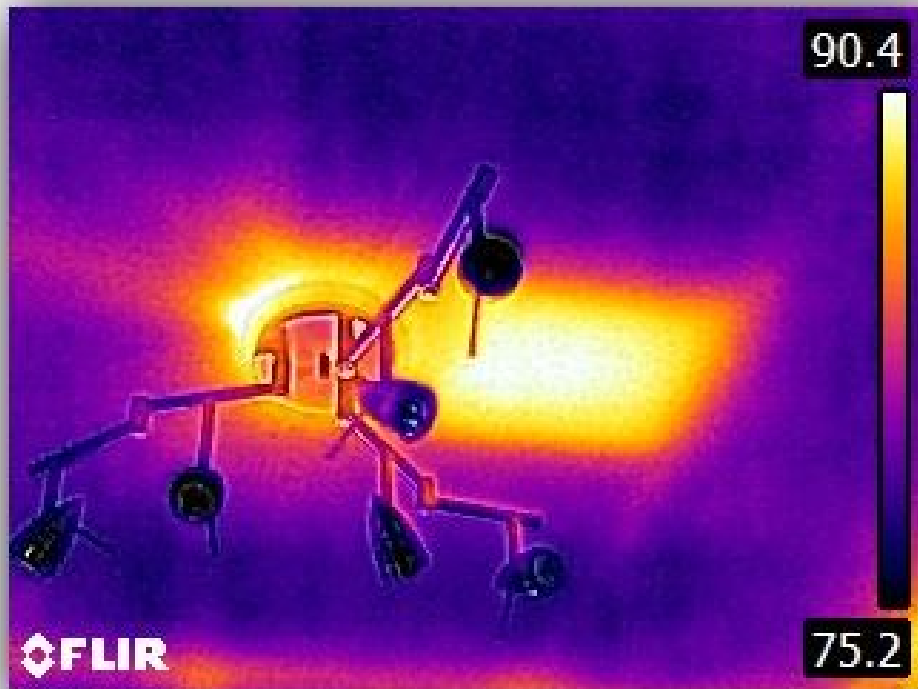
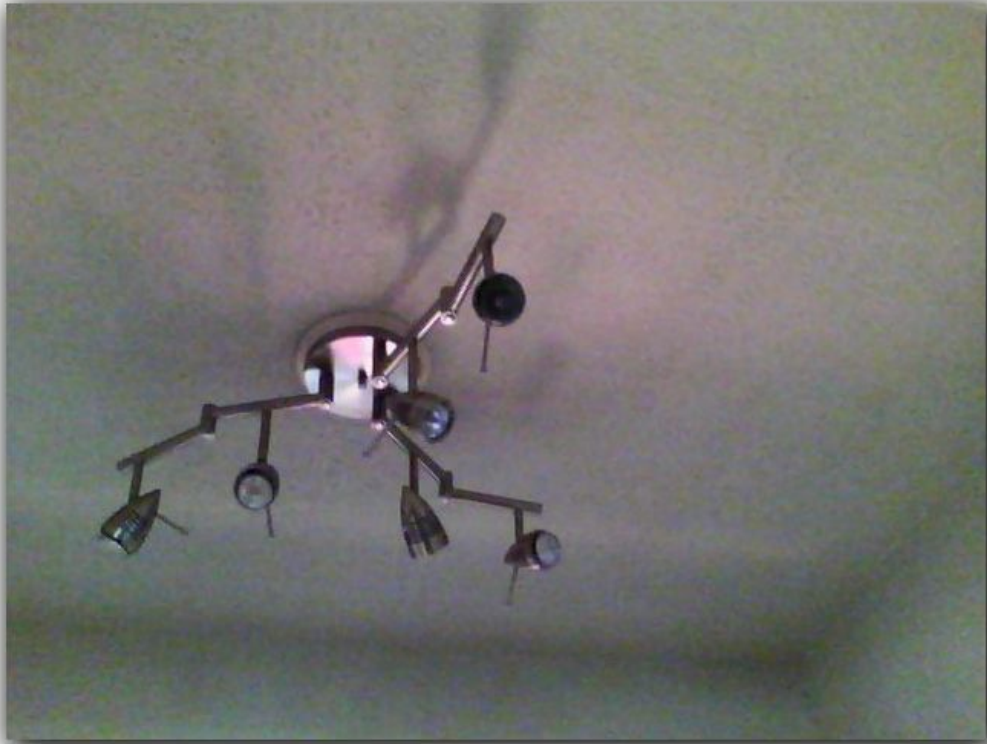
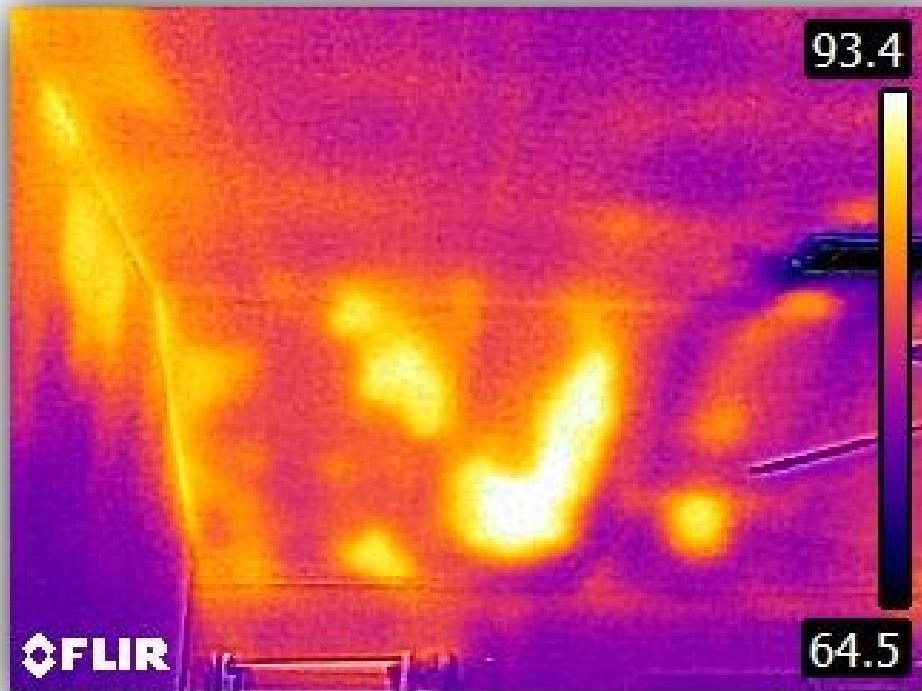
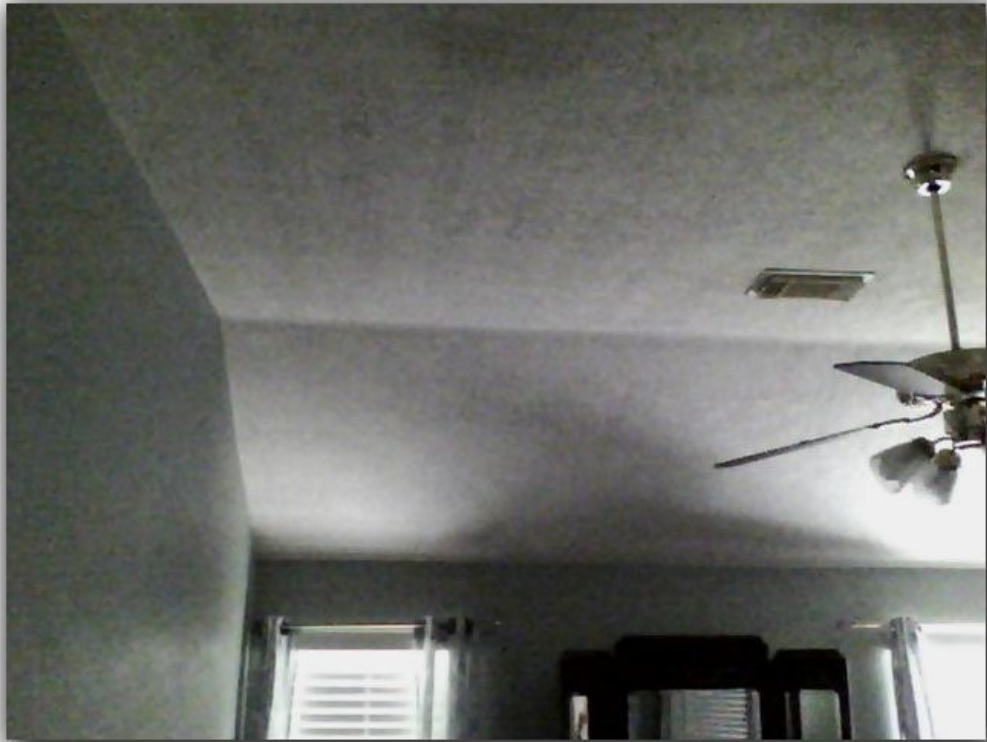
Thermal anomalies were observed in the ceilings of the home in various locations indicating missing or compressed insulation. Further investigation and repair should be made as necessary.

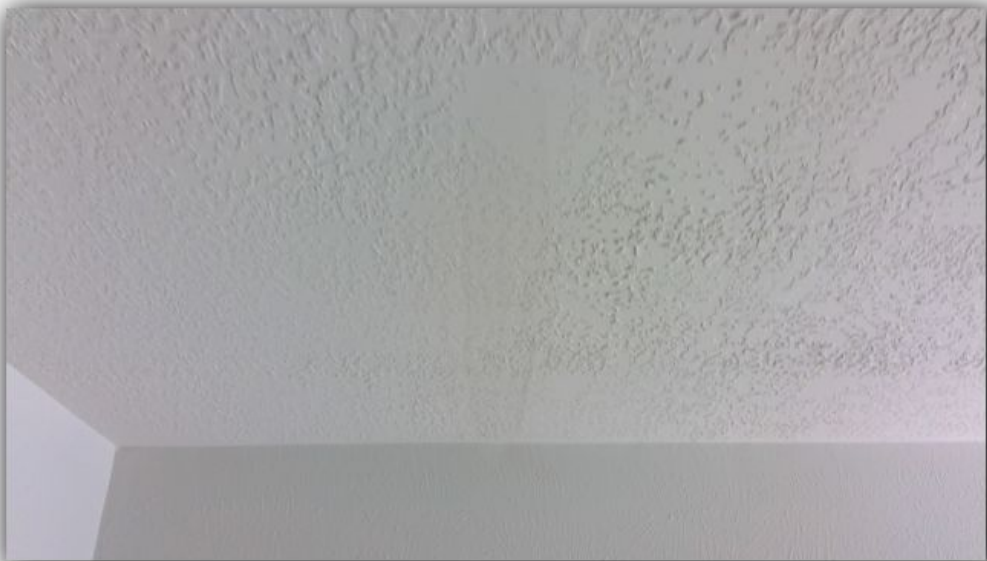
Water stains were noted on the ceiling in the in the study.

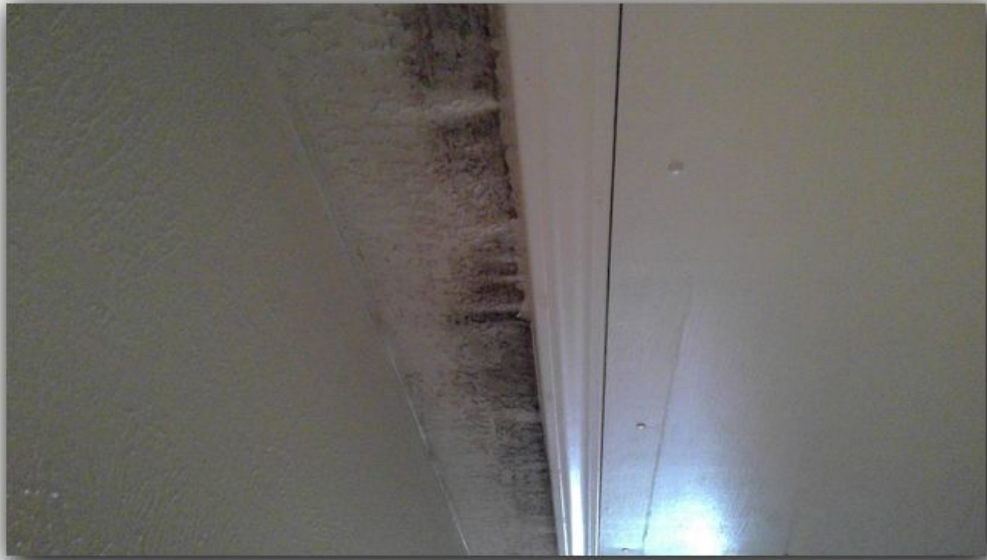
Signs of mildew were observed on the ceiling in the hallway. The cause should be investigated and/or repaired to prevent further damage.

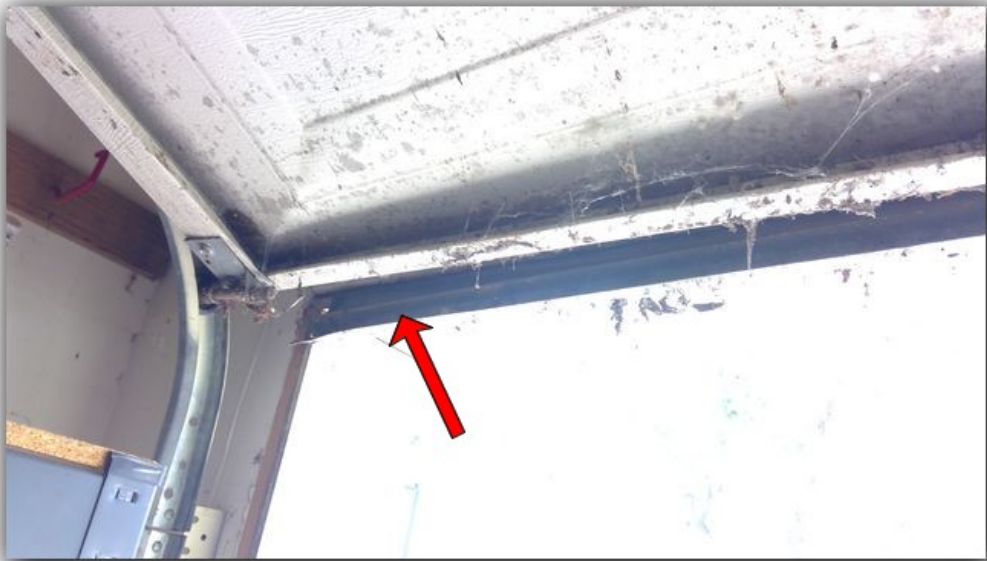
The overhead garage door is damaged and needs repair.

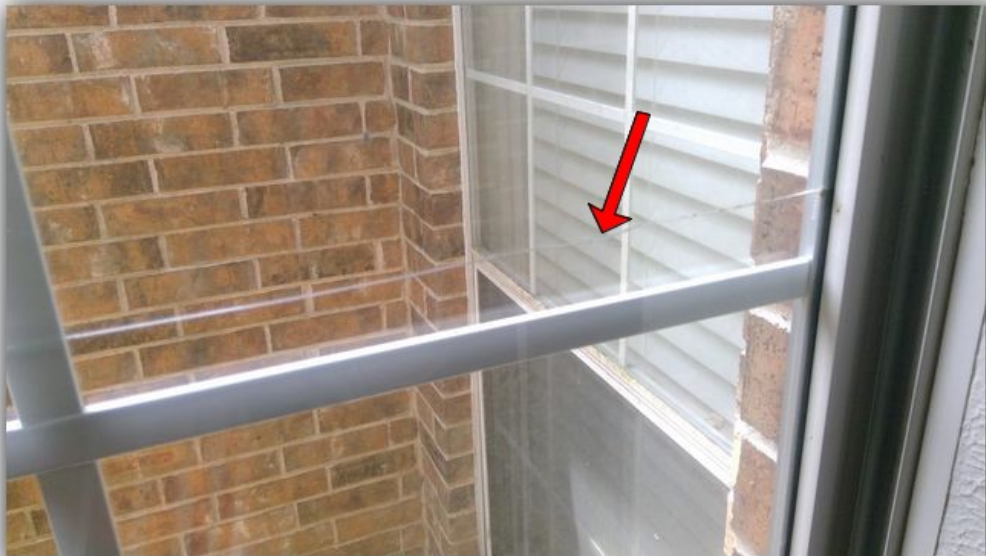
The window(s) in the front entrance/foyer are cracked and should be repaired.

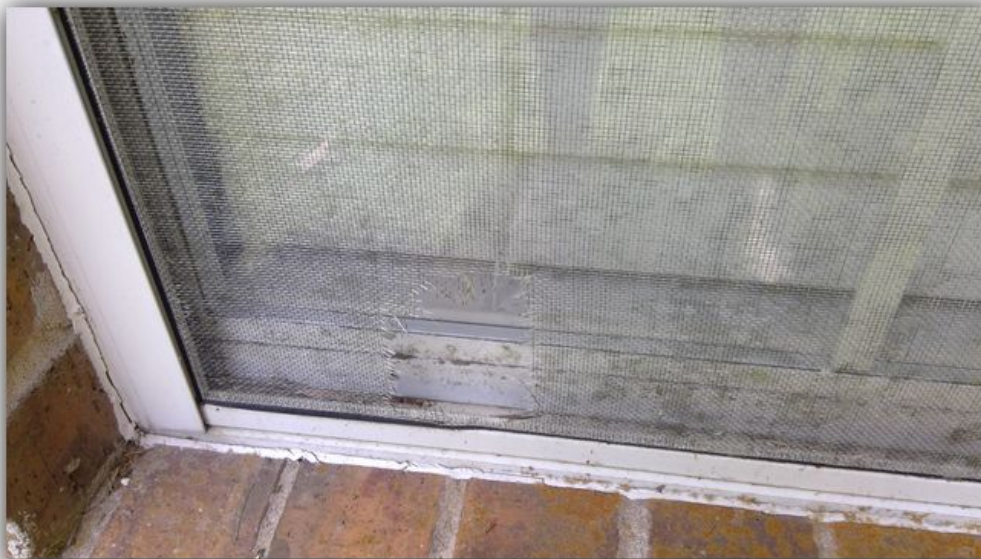
Damaged screen(s) were found on the window(s) should be repaired or replaced.

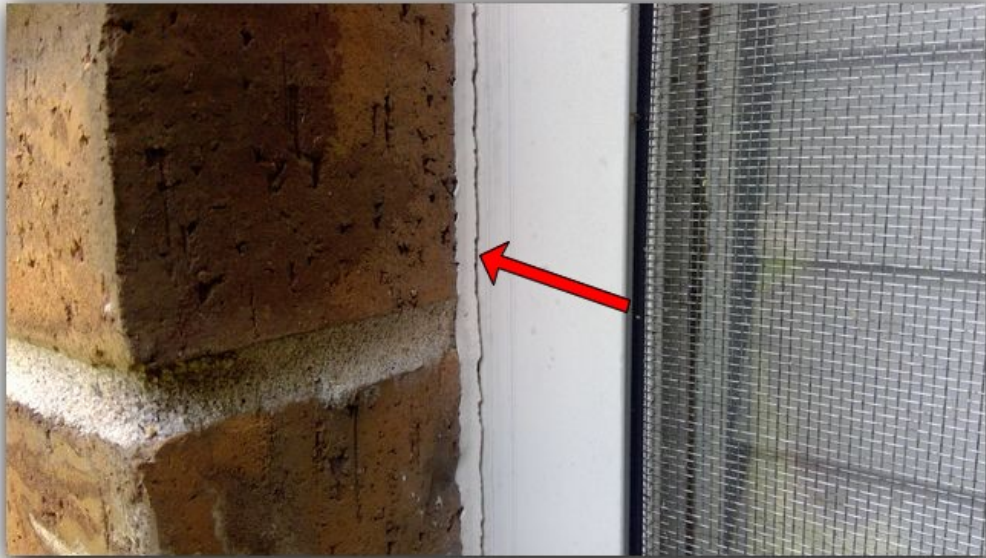
The windows should be examined and sealed at the exterior to prevent water infiltration and to improve efficiency.

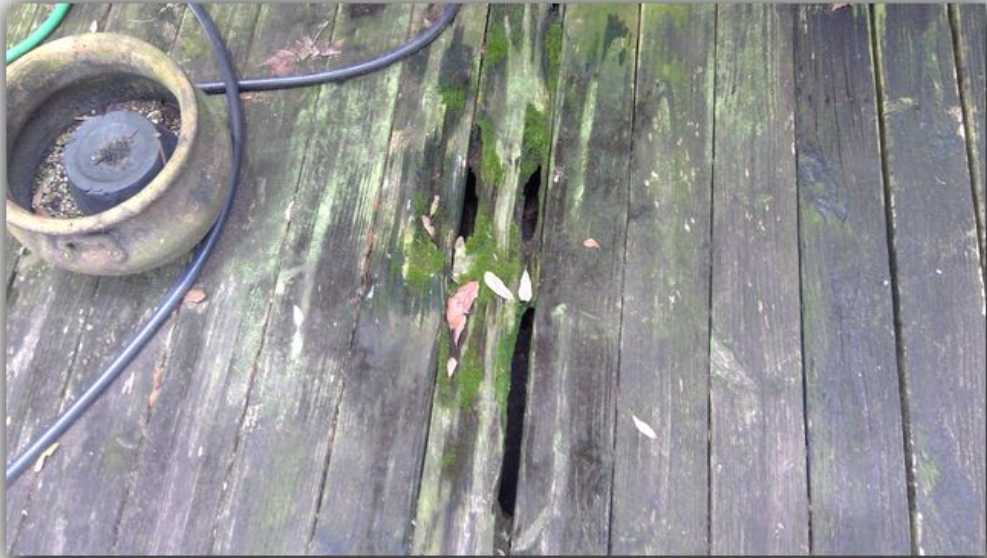
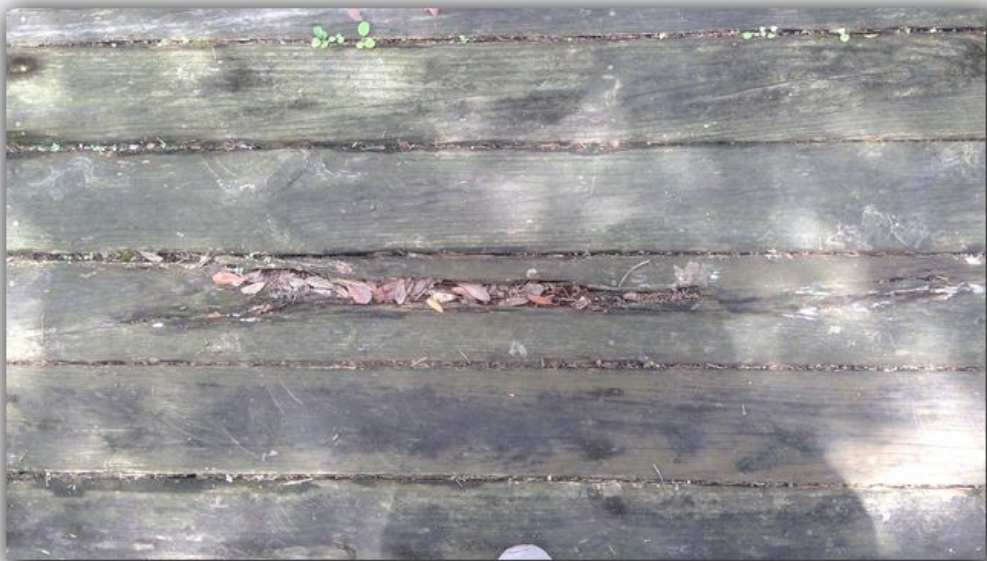
The deck shows evidence of rot. Replacement may eventually be desired. In the interim, localized repairs could be undertaken.

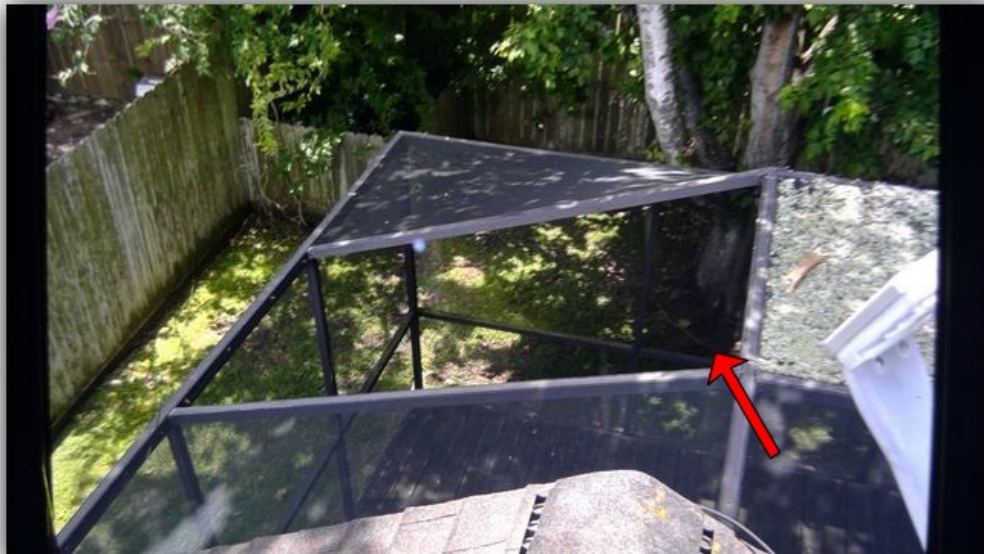
The screened enclosure was damaged and should be repaired.

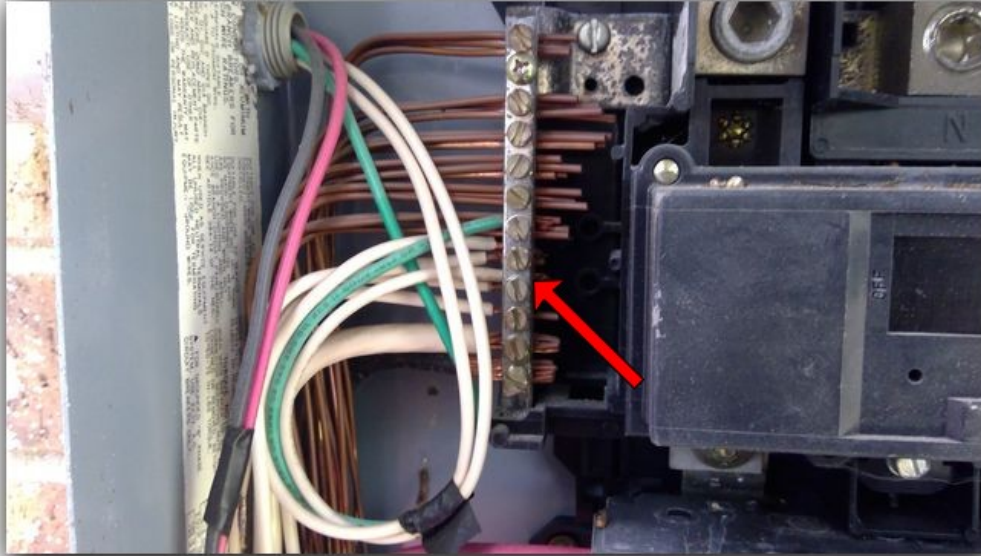
Double lugged neutrals were observed in the breaker box and should be improved as necessary. Neutral wires under the same lug can present problems when attempting to isolate a circuit to perform work or can become loose and cause a fire.

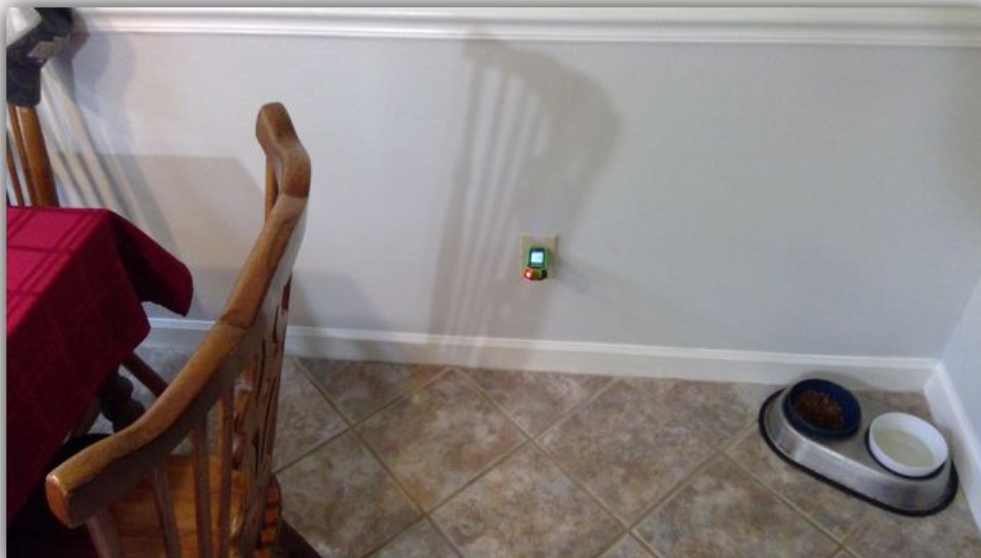
An outlet in the breakfast room and hallway was observed to have either an open neutral. Further investigation by a licensed electrician and repairs should be made as necessary.
