GC Home Inspection

PROPERTY INSPECTION REPORT FORM

John Settlemyre <i>Name of Client</i>	06/30/2025 <i>Date of Inspection</i>
113 Plum Cir, Lake Jackson, TX 77566 <i>Address of Inspected Property</i>	
Chad Gregory Langston Jr. <i>Name of Inspector</i>	25839 <i>TREC License #</i>
Chad Langston <i>Name of Sponsor (if applicable)</i>	7946 <i>TREC License #</i>

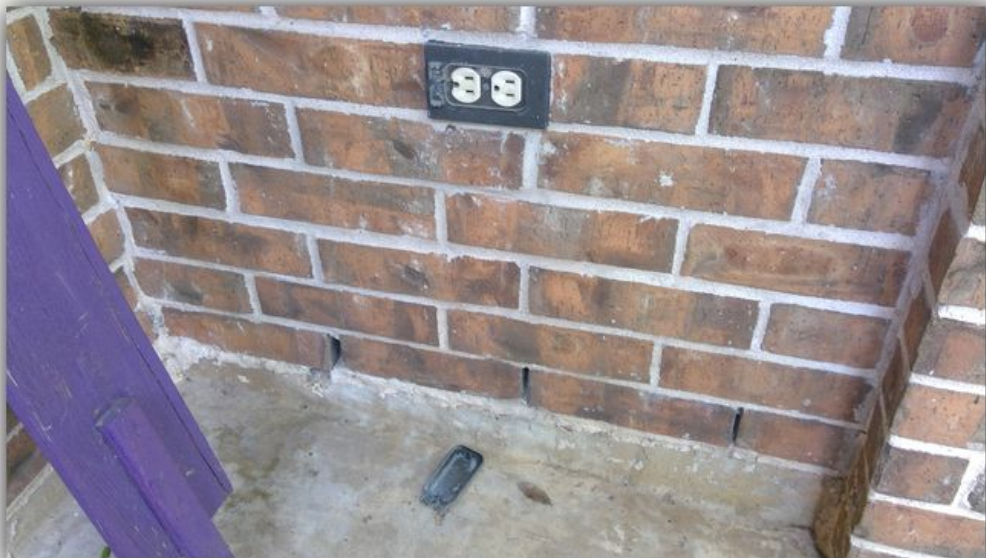
The weather cap on the exterior outlet on the front elevation is damaged and should be replaced.
