# **ALLSPEC** Property Inspection Report

2700 Fairway Dr , Orange, TX 77630 Inspection prepared for: Carey Demahy Real Estate Agent: Magen Wright - Remax Platinum

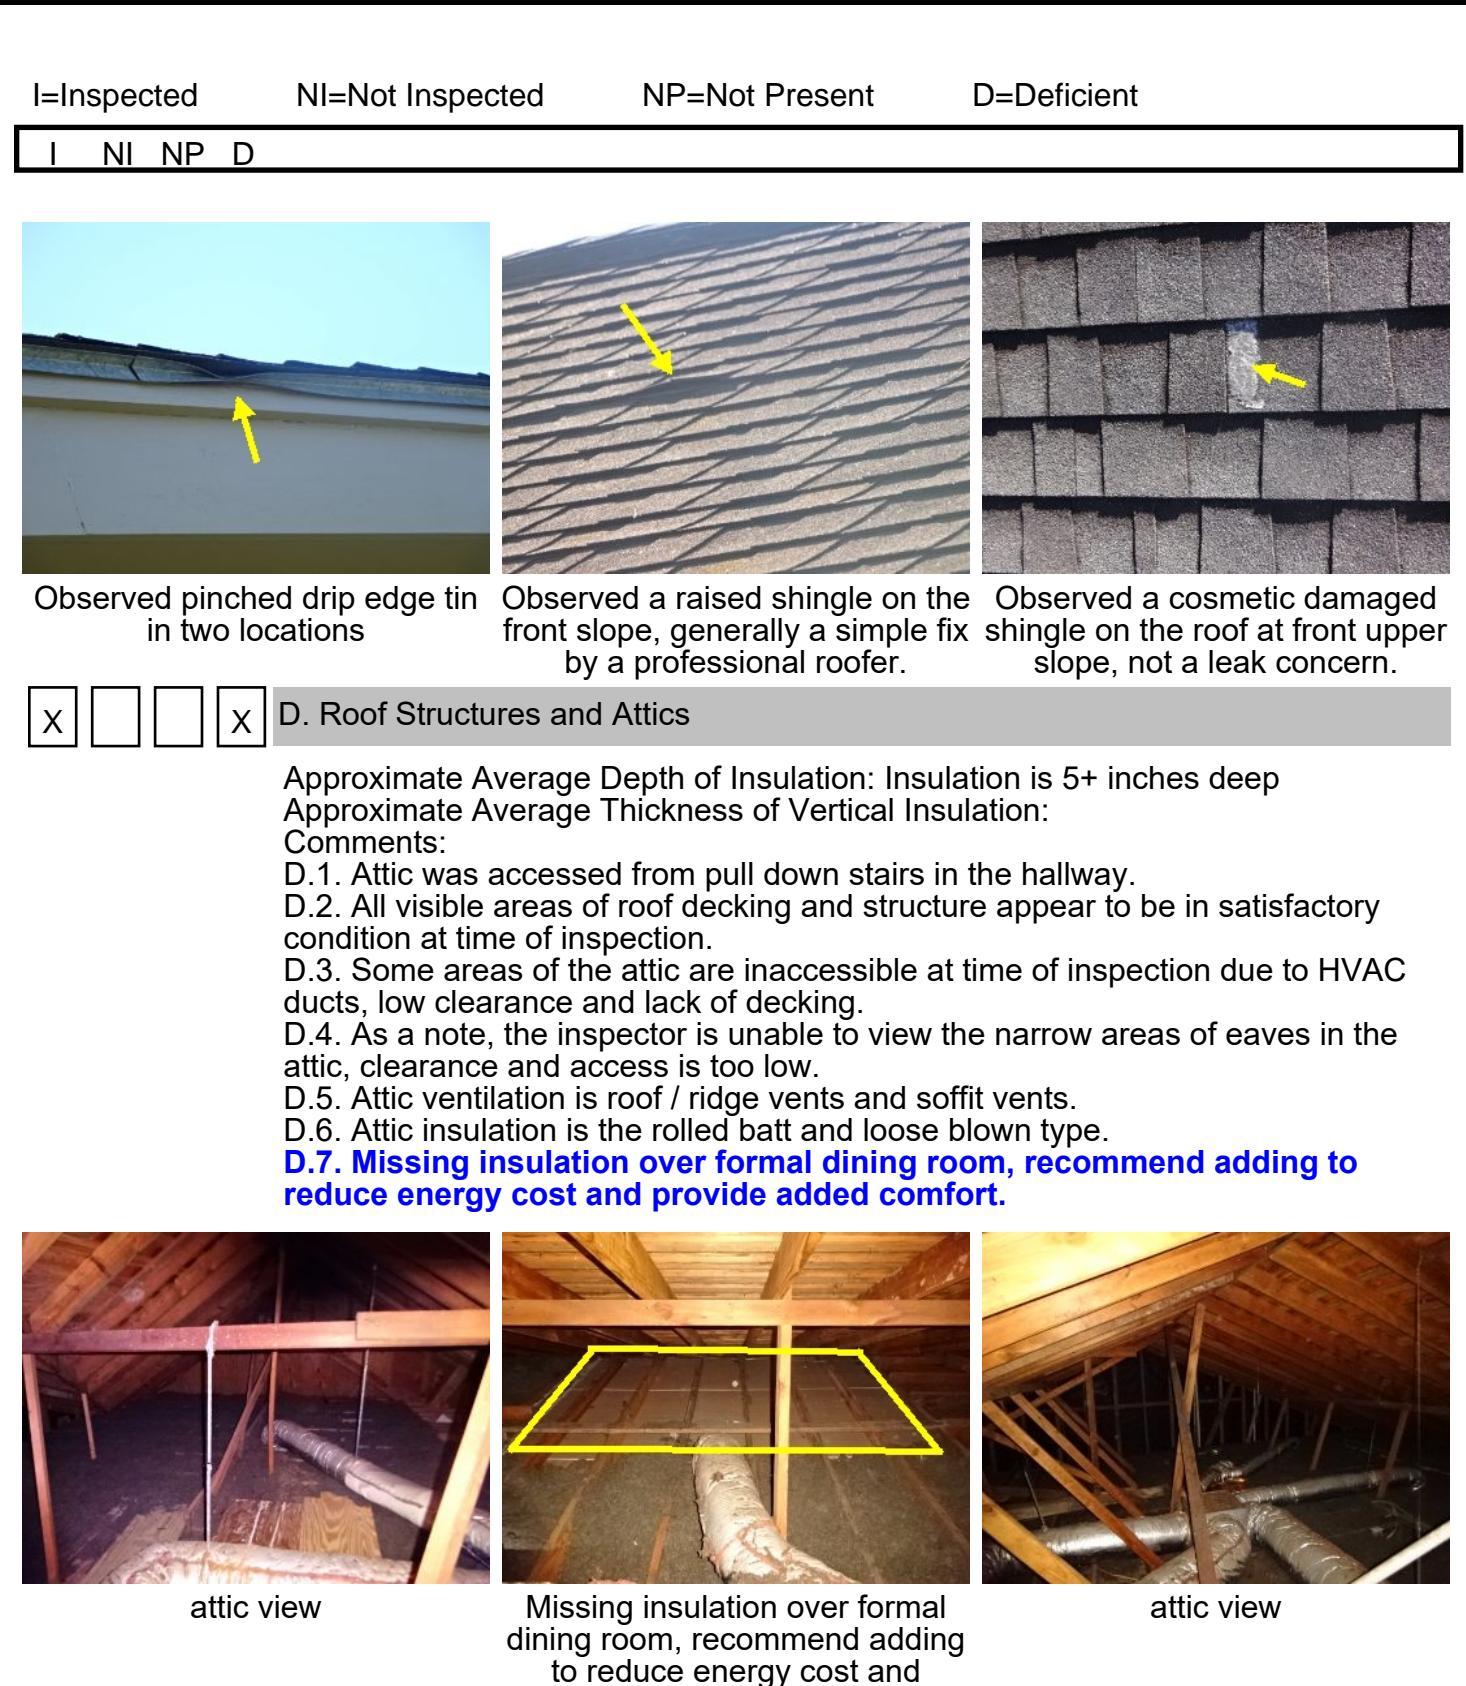
provide added comfort.

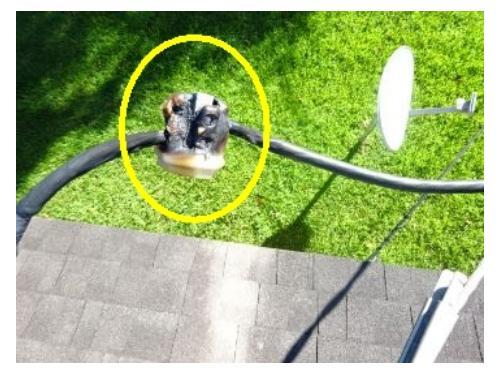
While on the roof inspector observed evidence of excessive heat to plastic connection cover at one of the service entrance wires.

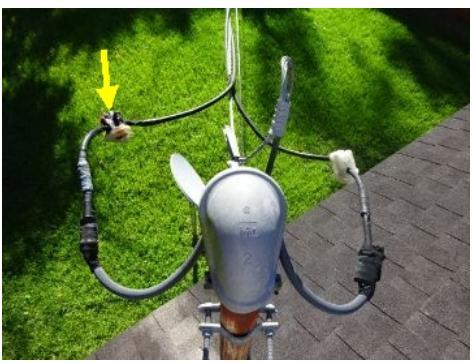
The interior cover (dead plate) in both exterior panels are missing, recommend installing for safety reasons.

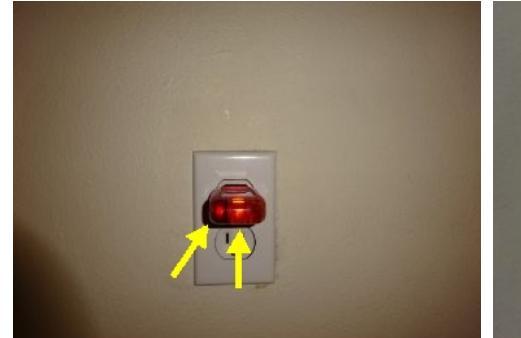
Reverse polarity at receptacles in and around the home in various locations

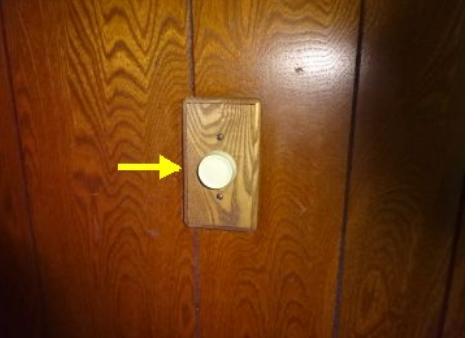
Possible worn rheostat wall switch at fan light in the living room.

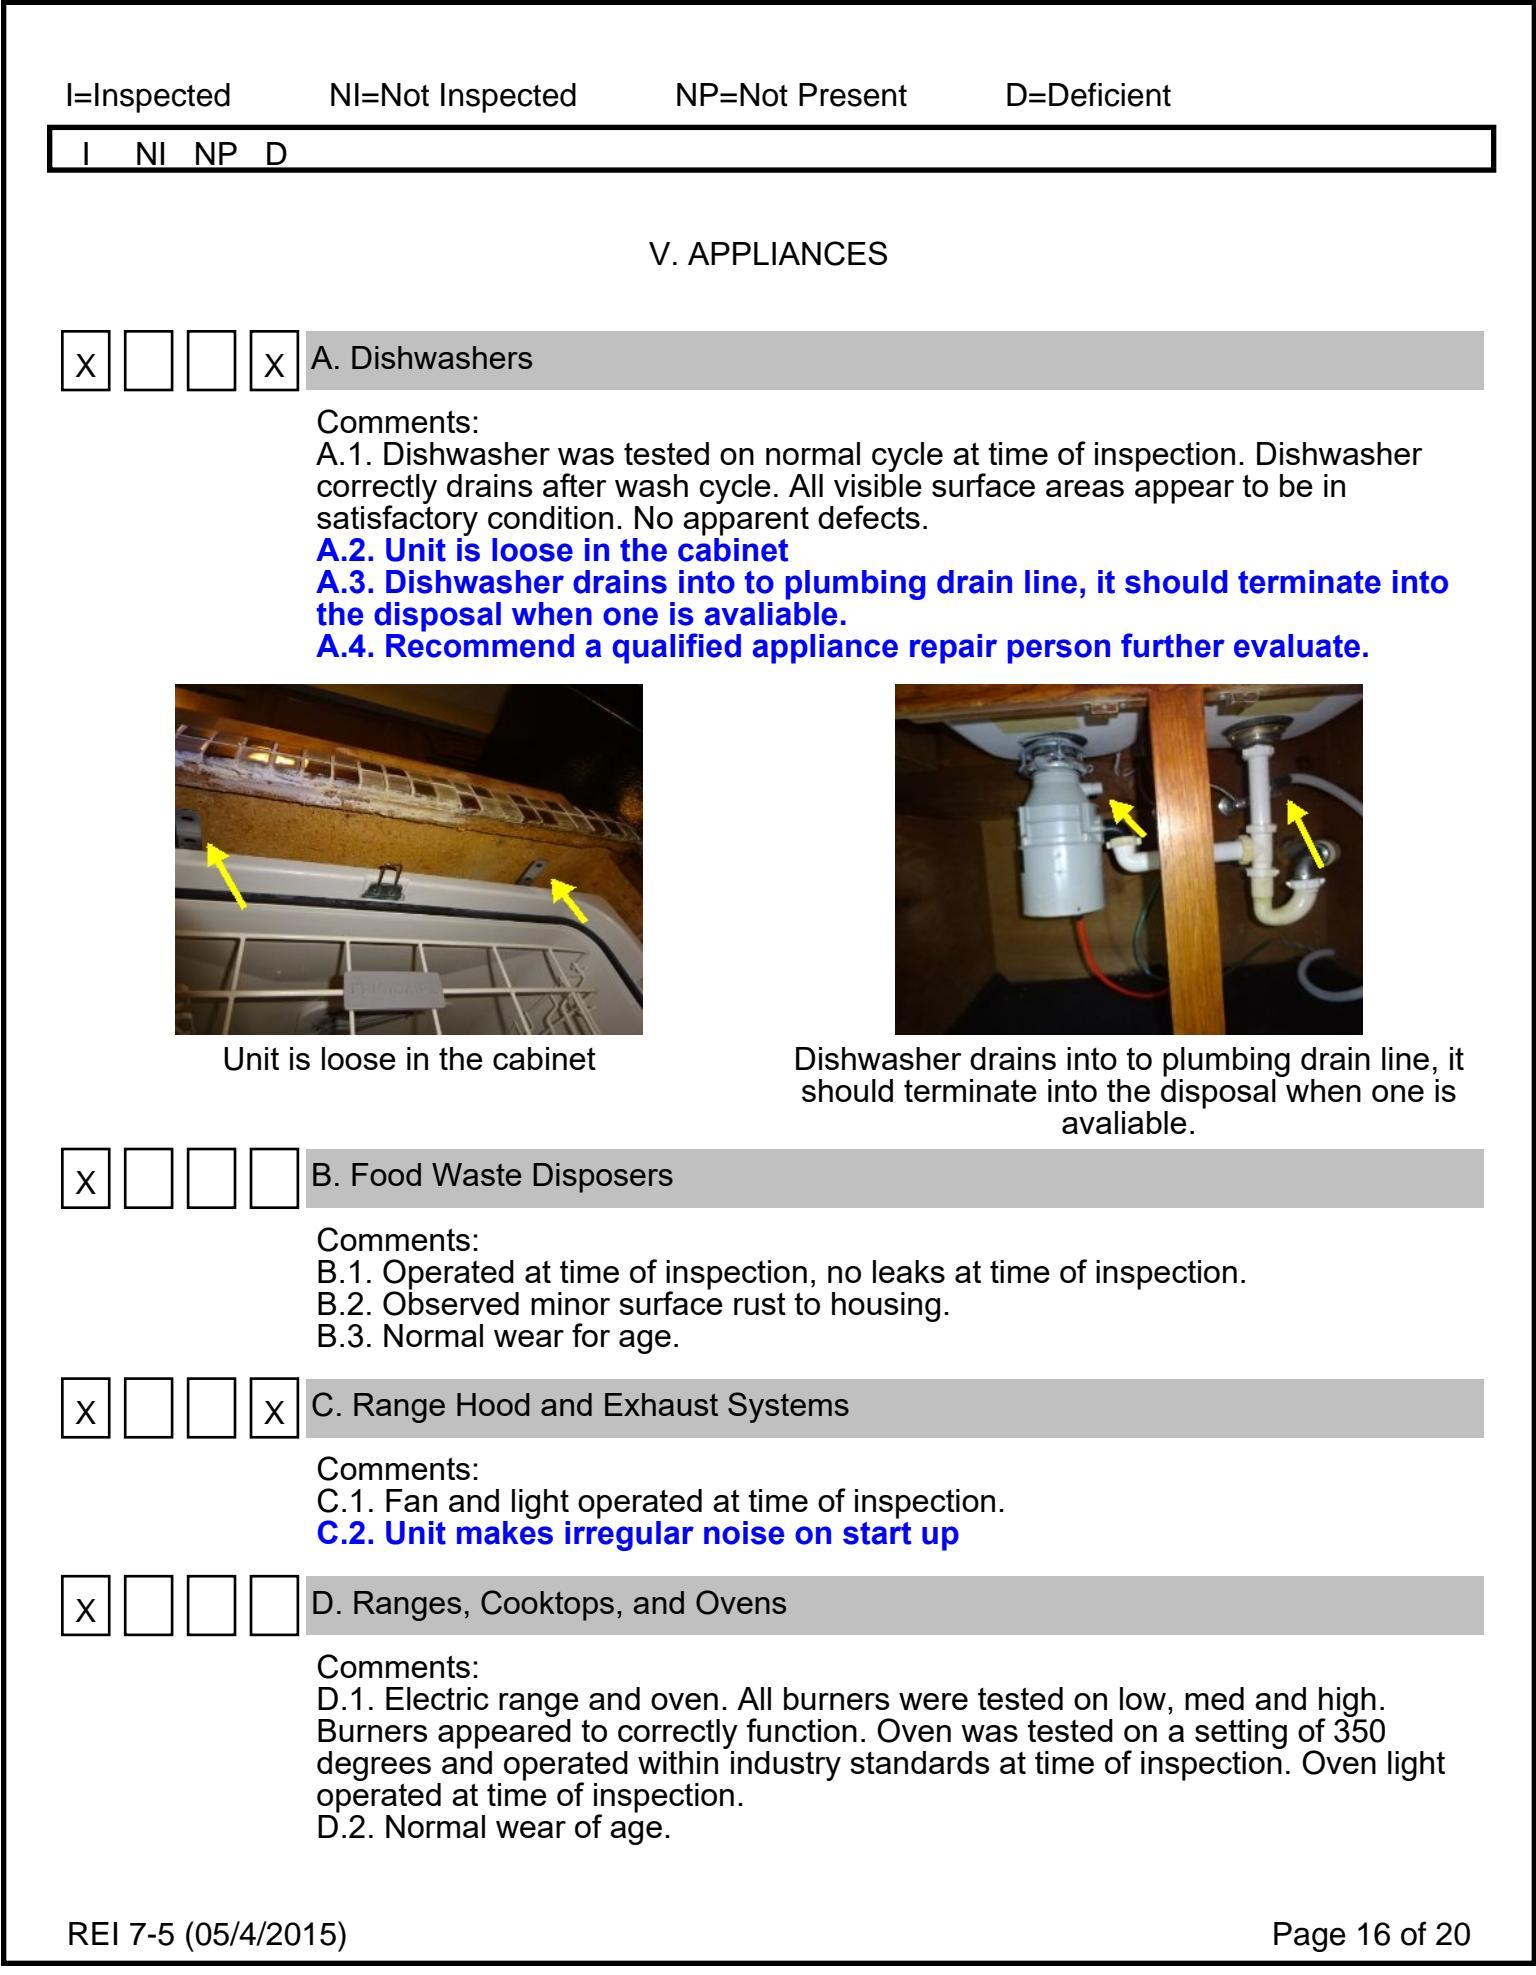
| I=Inspected | NI=Not Inspected NP=Not Present D=Deficient |
