Total Home Inspection

Property Inspection Report

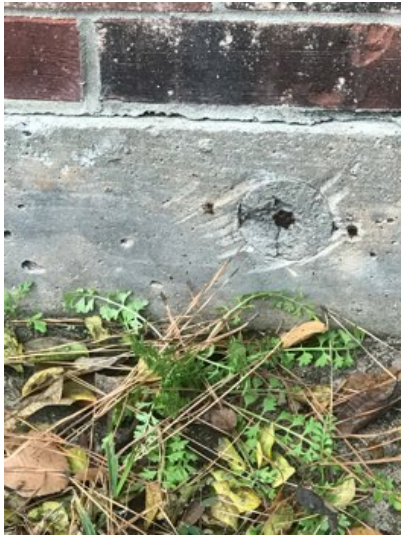
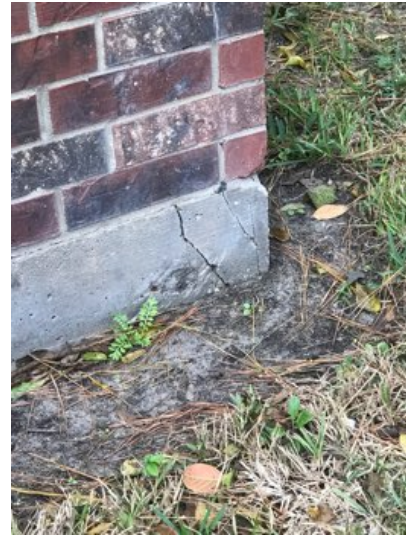
Ends of post tension cables were exposed. These should be properly repaired and sealed to avoid further deterioration.

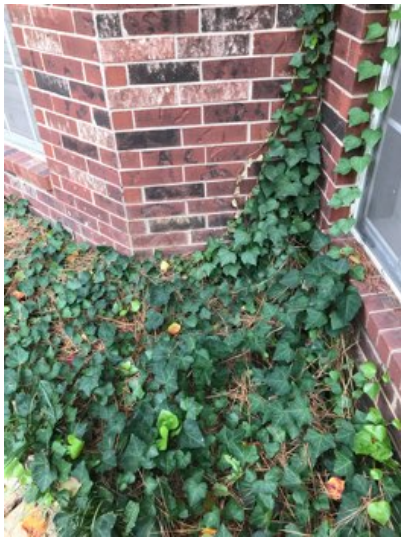
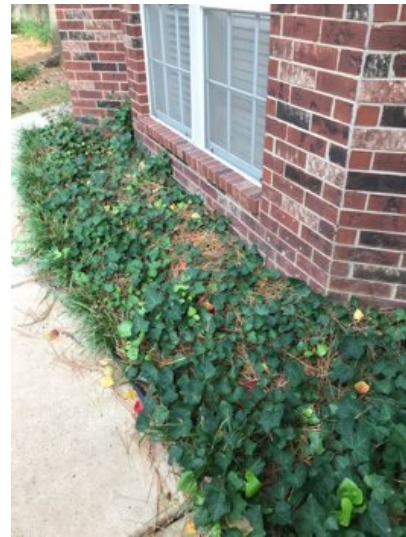
Excessive vegetation was noted in some areas of the home. In our opinion vegetation should be cleared at least 12" from the exterior walls.

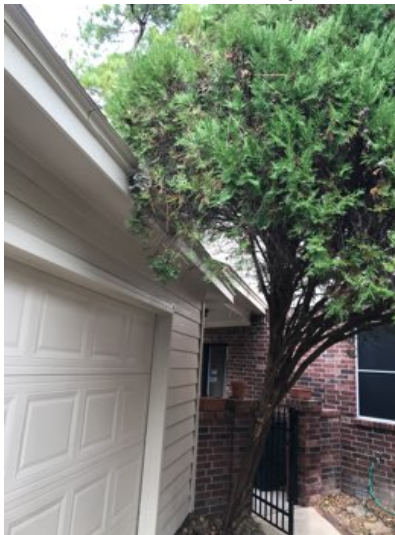
Excessive vegetation was noted in some areas of the home. In our opinion vegetation should be cleared at least 12" from the exterior walls.

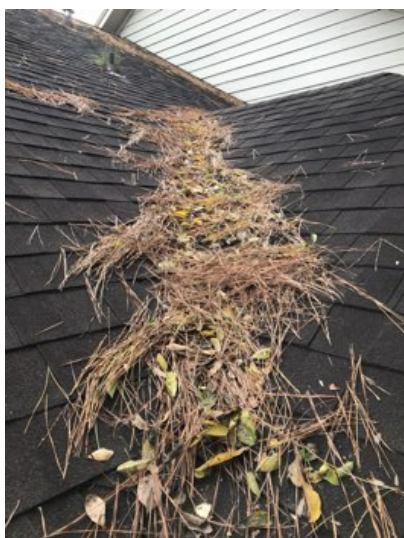
Pine needles and tree debris should be cleared from valleys to allow unimpeded flow of rain water.

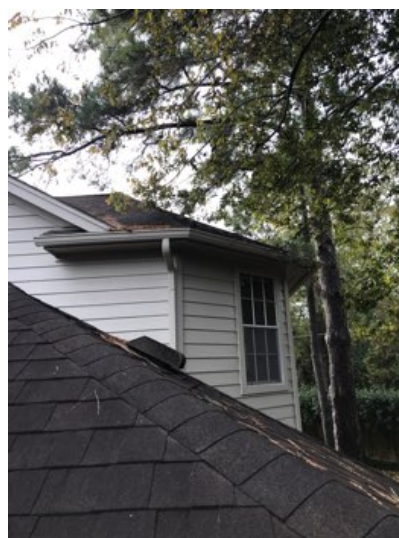
Trees were close to the roof surface. Tree limbs and vegetation may prematurely wear or damage shingles.

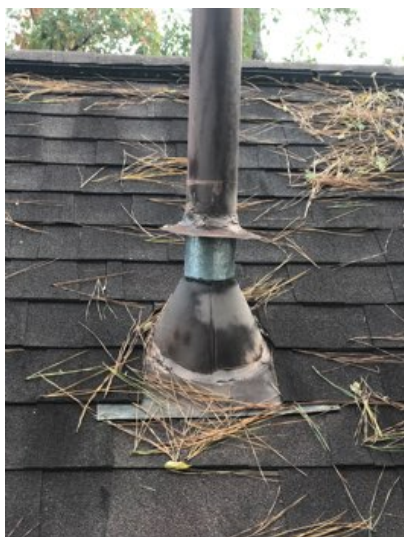
B-type vents should be adjusted and resealed.

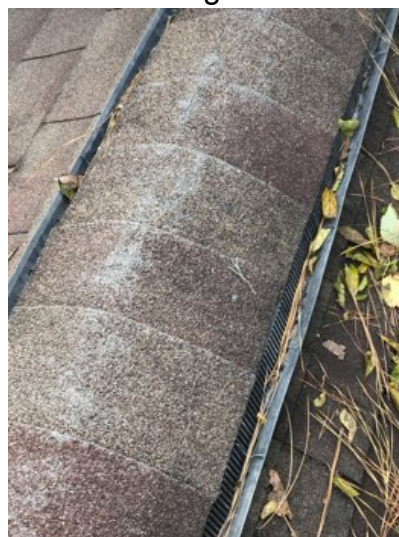
Ridge shingles showed significant wear and we recommend replacement of ridge shingles.

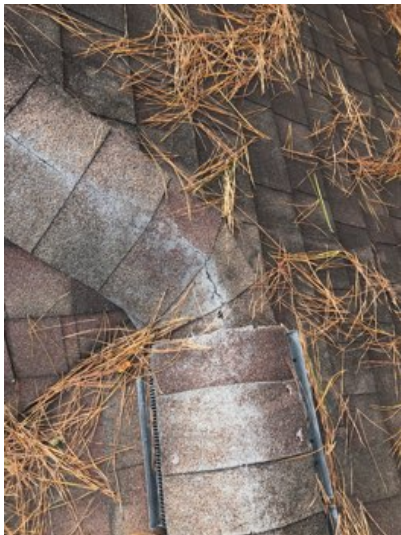
Ridge shingles showed significant wear and we recommend replacement of ridge shingles.

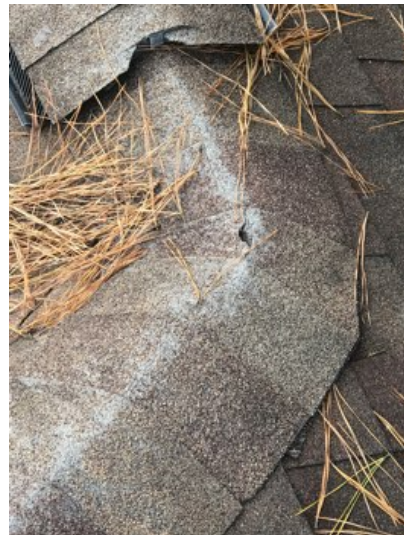
Ridge shingles showed significant wear and we recommend replacement of ridge shingles.

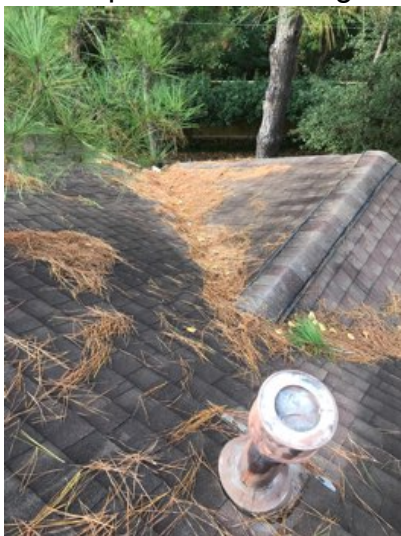
Pine needles and tree debris should be cleared from valleys to allow unimpeded flow of rain water.

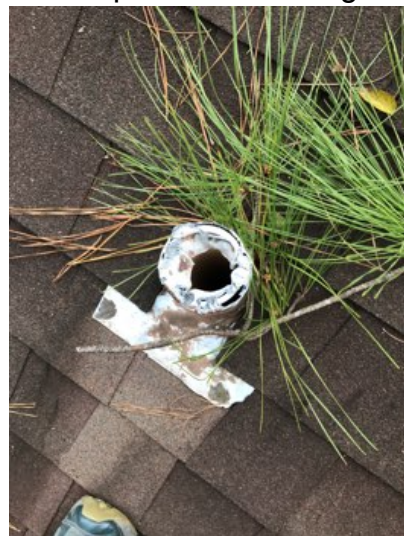
Lead plumbing flashings have been damaged by varmints in random locations and will likely leak. Damaged flashings should be replaced as necessary.

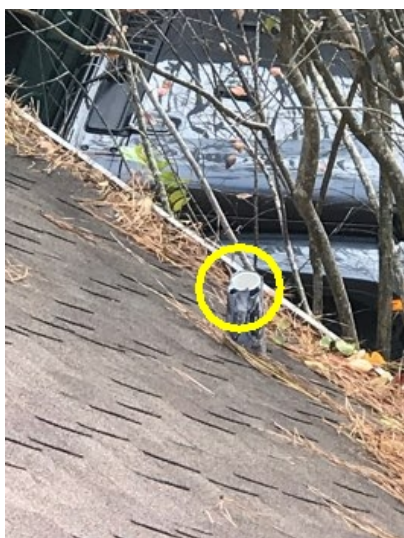
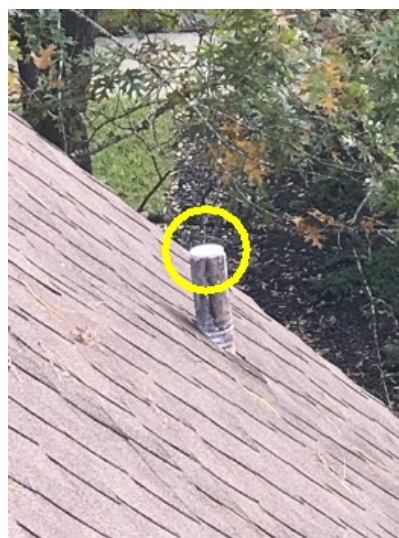
Lead plumbing flashings have been damaged by varmints in random locations and will likely leak. Damaged flashings should be should be replaced as necessary.

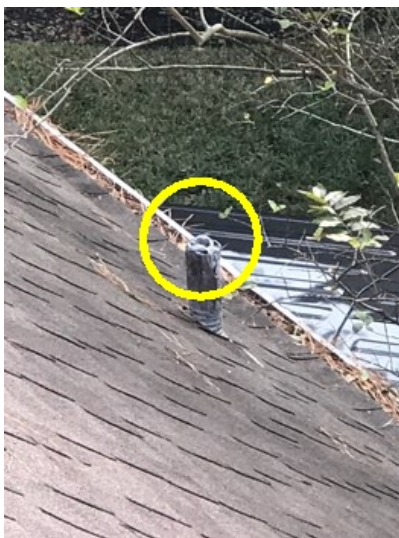
Lead plumbing flashings have been damaged by varmints in random locations and will likely leak. Damaged flashings should be should be replaced as necessary.

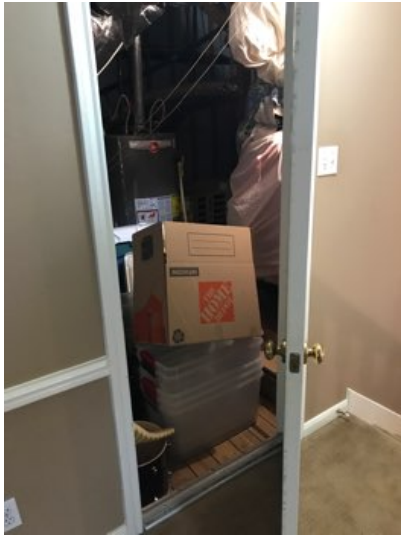
Attic access door was missing fasteners at door hinges .Attic access door was inadequately sealed and insulated.

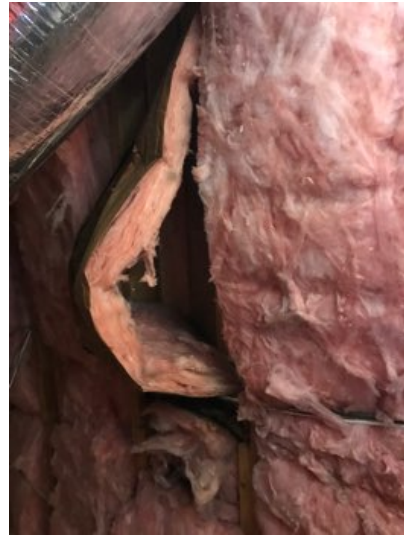
There was missing and displaced insulation in several locations including the lower attic along the vertical wall.

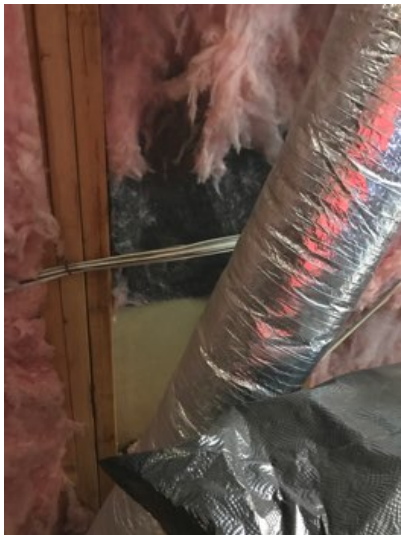
There was missing and displaced insulation in several locations including the lower attic along the vertical wall.

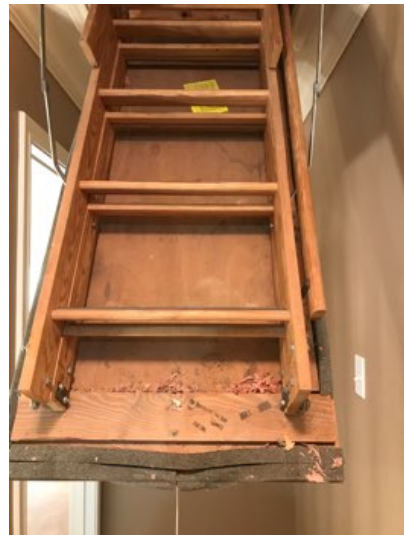
Attic access door was missing fasteners at door hinges .Attic access door was inadequately sealed and insulated.

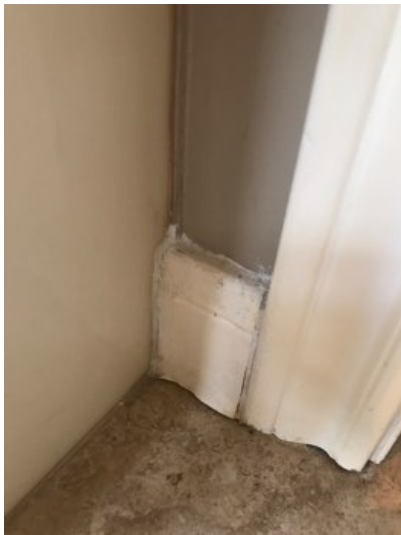
Damaged trim at the corner of the shower should be replaced.

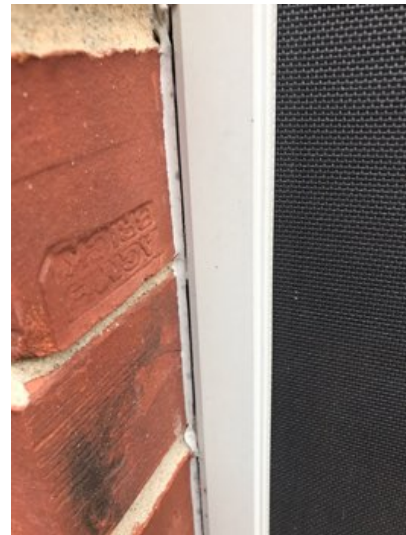
Gaps were noted at some door/windows frame junctions with brick. All exterior wall penetrations, changes of materials and direction should be properly sealed to prevent water and pest intrusion.

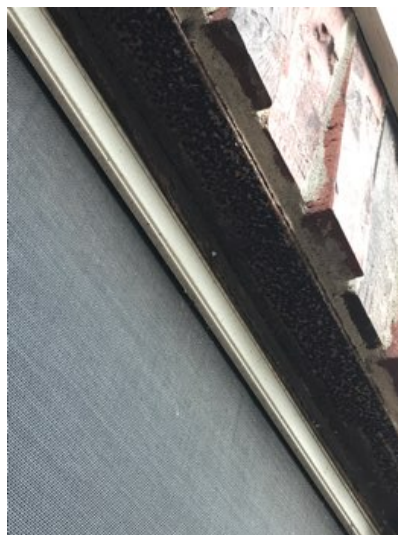
Lintels around the home showed signs of rust. These should be sealed with rust inhibitor to arrest oxidation.

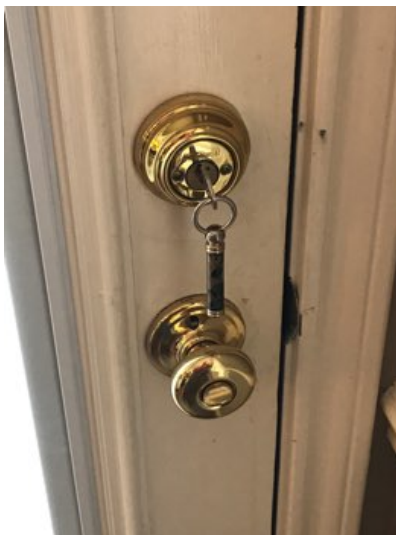
Exterior doors were double keyed. Egress doors should be openable from the inside without the use of a key or special knowledge or effort.

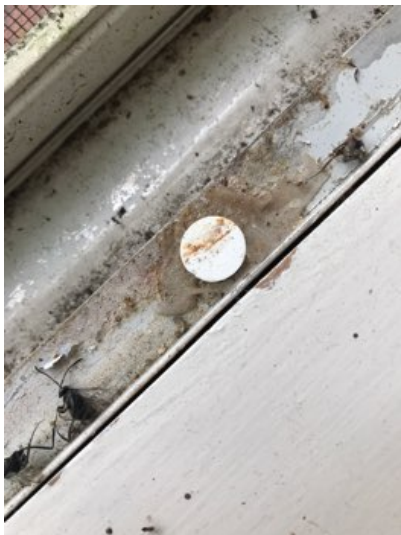
Lower window frames were drilled for security sensors. The sensors should be sealed and checked periodically to prevent water intrusion.

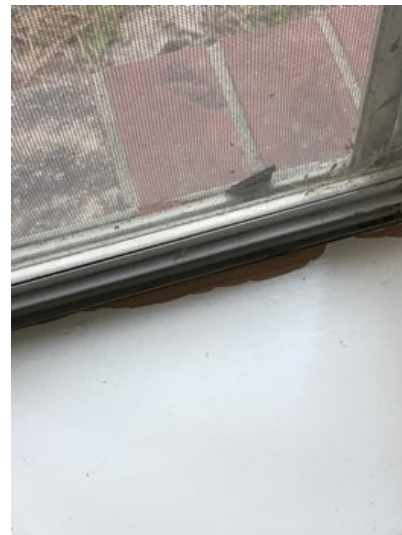
Some interior window sills showed signs of paint deterioration. This may be caused by typical condensation at window frames. Moisture was not present at the time of inspection.

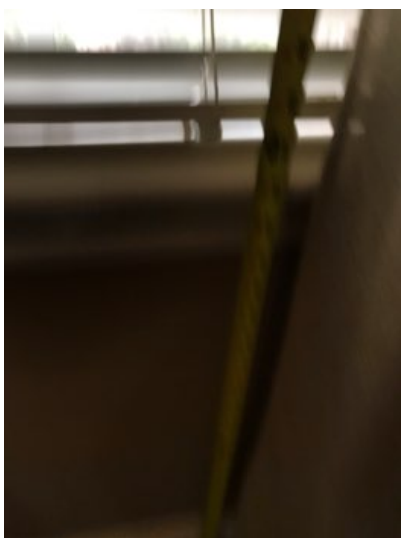
Windows on the upper level within 24" of the floor may present a fall hazard to children. Fall protection should be considered at these windows.

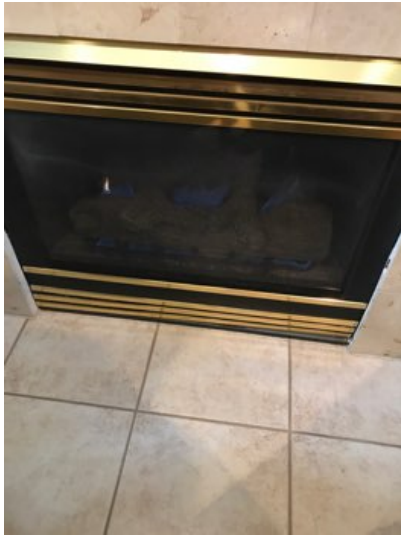
Structural Systems Fireplace/Chimney

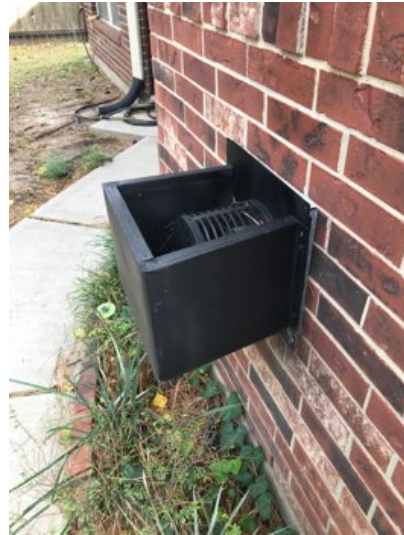
Direct vent fireplace termination may be missing a baffle.

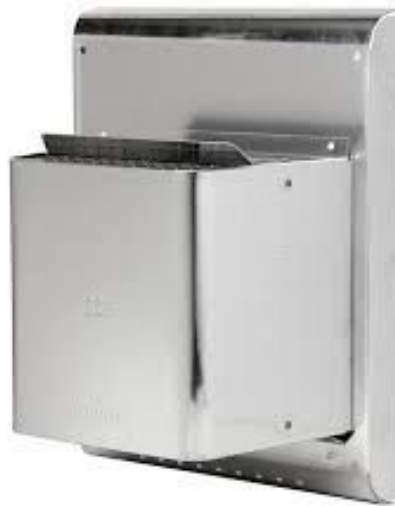
Direct vent fireplace termination may be missing a baffle.

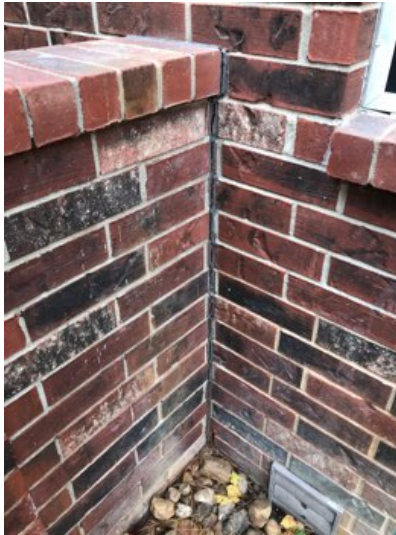
Brick fence between the garage and house should be resealed.

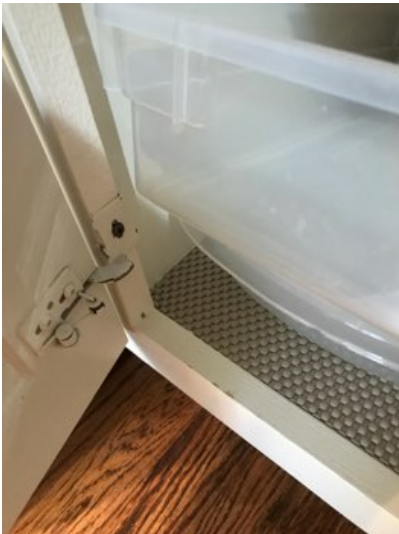
Loose door hinge noted on the base cabinet Ashanti the refrigerator.

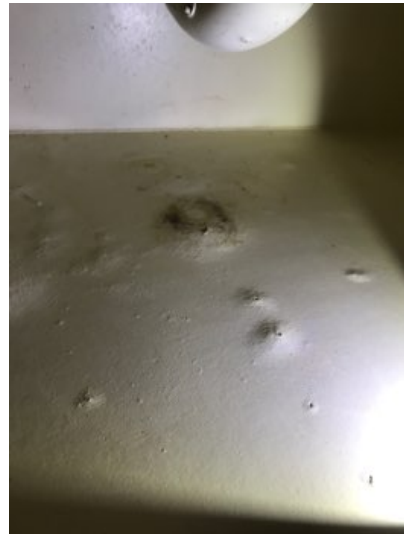
Base cabinet in the left upper bathroom has damage from previous water leakage.

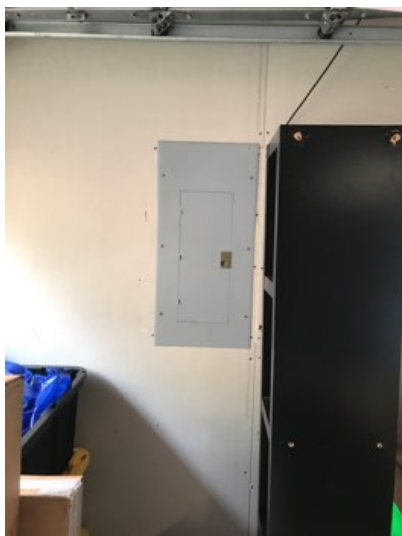
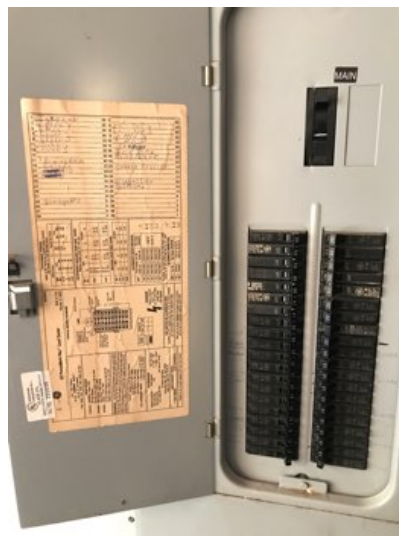
Electrical Systems Service Entrance and Panels All breakers for the panel boxes and/or sub panels must be clearly and permanently labeled for identification of particular circuit.

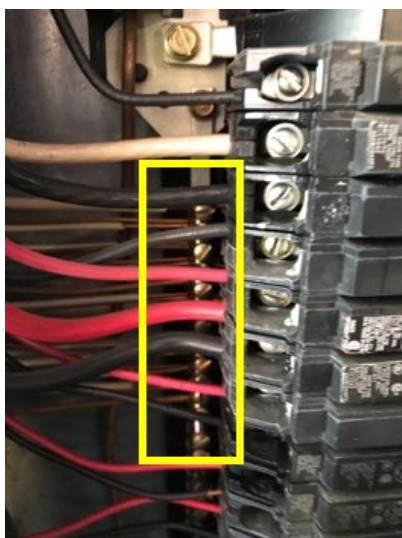
There were neutral wires in the panel that were sharing terminals on the bus bar. One neutral wire per terminal screw is permitted.

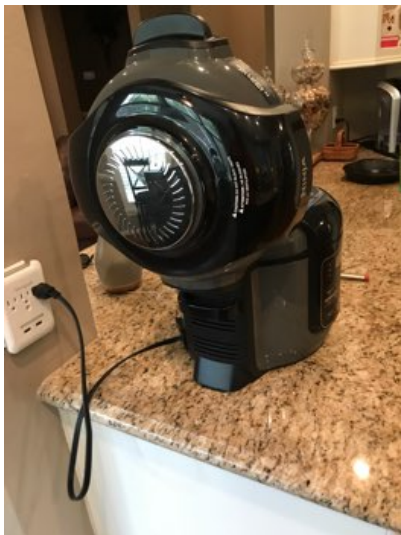
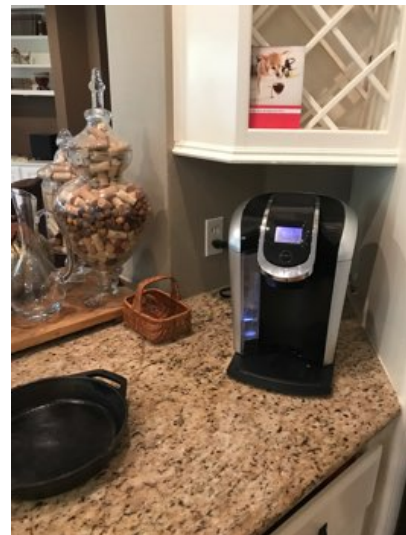
Not all outlets in the kitchen, and master bathroom were ground fault protected.

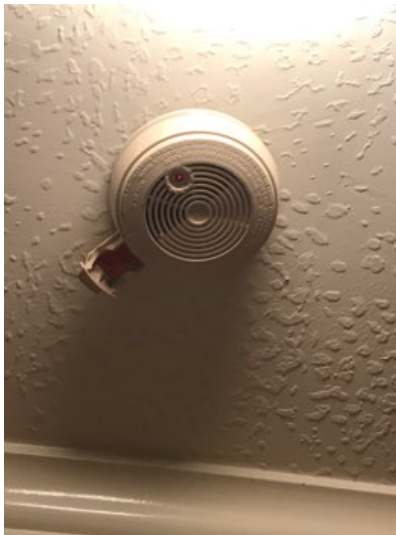
Smoke alarms were present but not all were functioning.

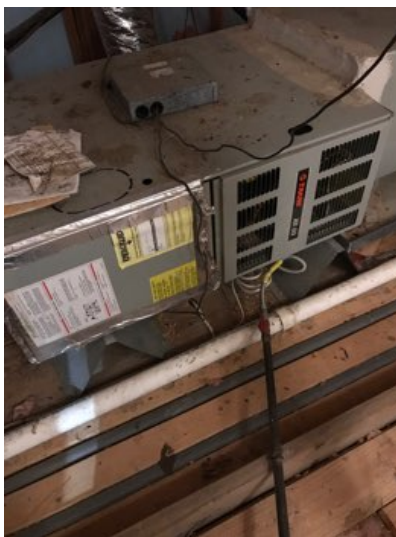
Heating, Ventilation and Air Conditioning Systems Heating Equipment

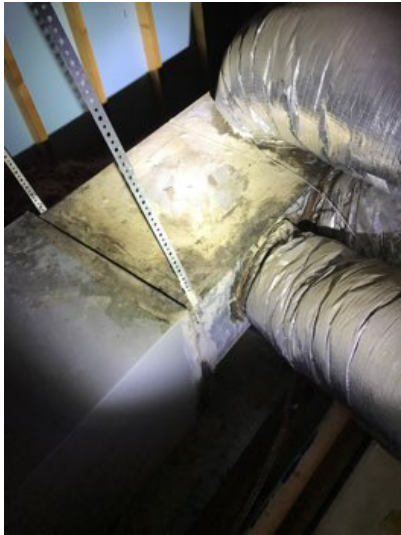
Wipe down Air Handlers and plenums.

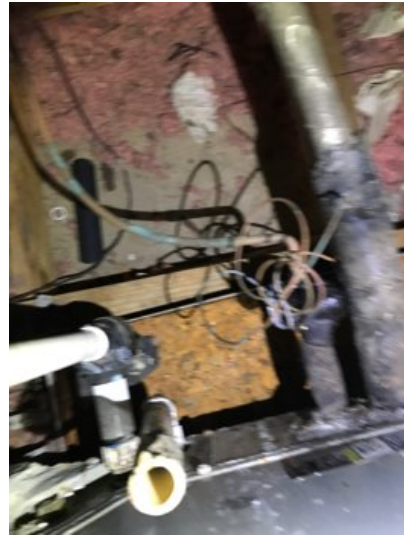
Rust from condensate was noted in the in secondary evaporator drain pan of the lower level unit and rust was noted on the exterior of the home indicating condensate was draining from the emergency condensate discharge pipe. This is a sign of improper drainage of the main drain line. We were unable to run the air conditioners due to low temperatures and recommend that unit be evaluated and serviced by an HVAC professional.

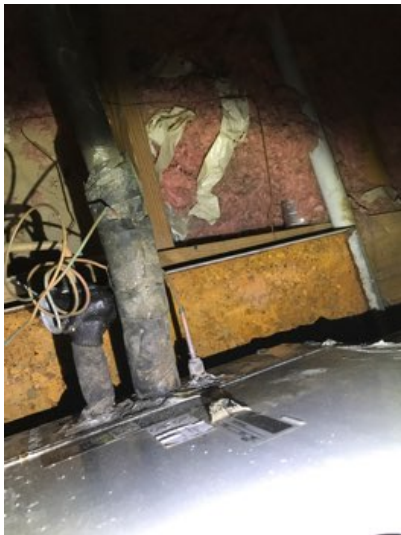
Rust from condensate was noted in the in secondary evaporator drain pan of the lower level unit and rust was noted on the exterior of the home indicating condensate was draining from the emergency condensate discharge pipe. This is a sign of improper drainage of the main drain line. We were unable to run the air conditioners due to low temperatures and recommend that unit be evaluated and serviced by an HVAC professional.

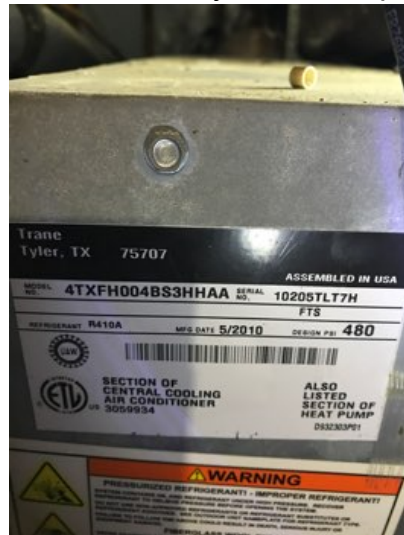
Heating, Ventilation and Air Conditioning Systems Cooling Equipment

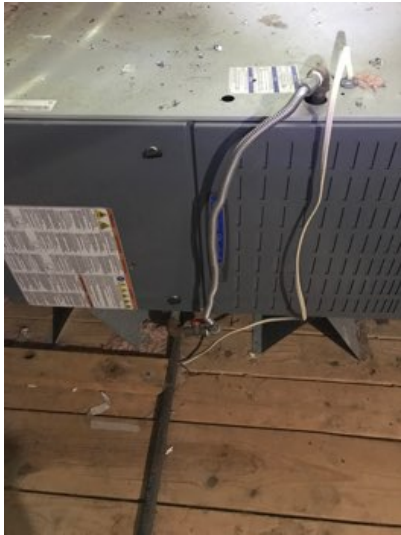
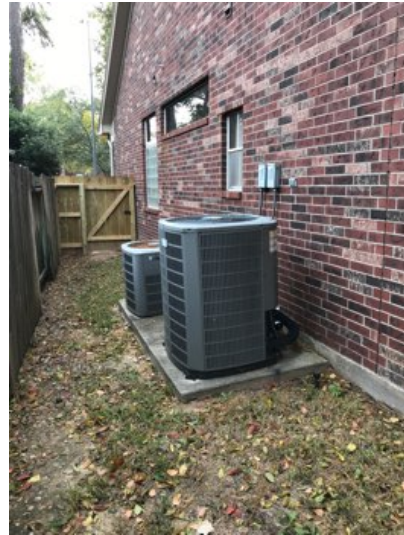
Heating, Ventilation and Air Conditioning Systems Cooling Equipment

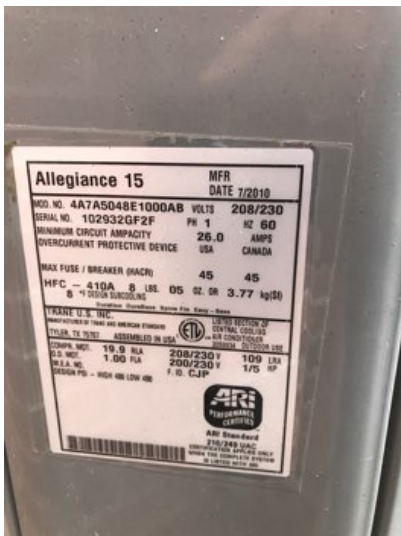
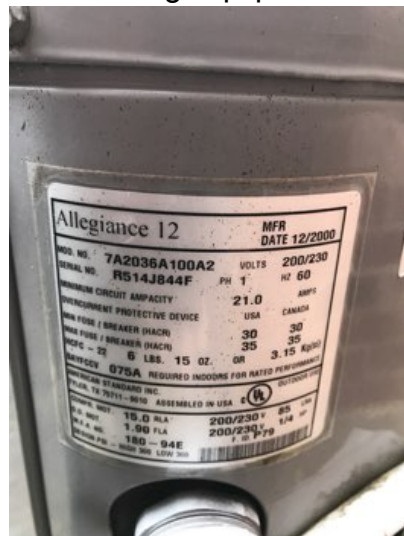
Heating, Ventilation and Air Conditioning Systems Cooling Equipment

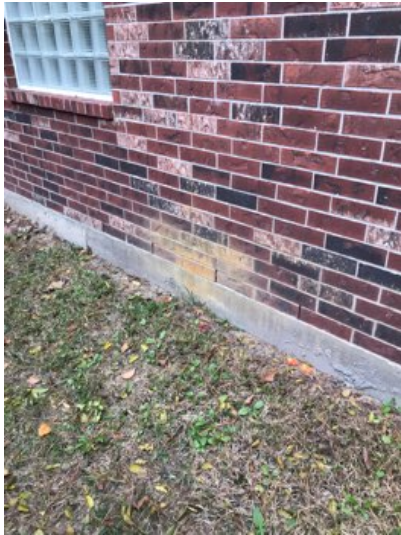
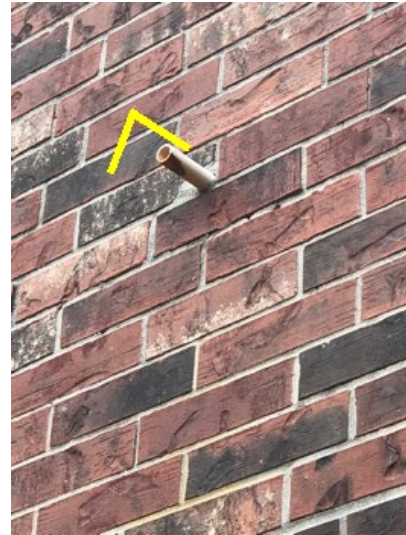
Rust from condensate was noted in the in secondary evaporator drain pan of the lower level unit and rust was noted on the exterior of the home indicating condensate was draining from the emergency condensate discharge pipe. This is a sign of improper drainage of the main drain line. We were unable to run the air conditioners due to low temperatures and recommend that unit be evaluated and serviced by an HVAC professional.

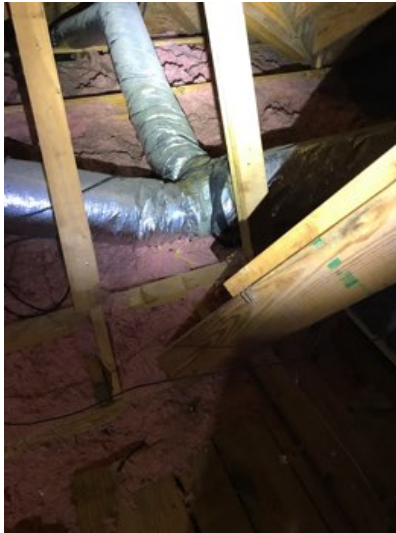
Some air ducts did not appear to be properly supported and were touching other ducts or resting on the attic floor. (Flexible duct should be supported every 5 feet.) This may cause condensation and in turn may produce mildew in these area.

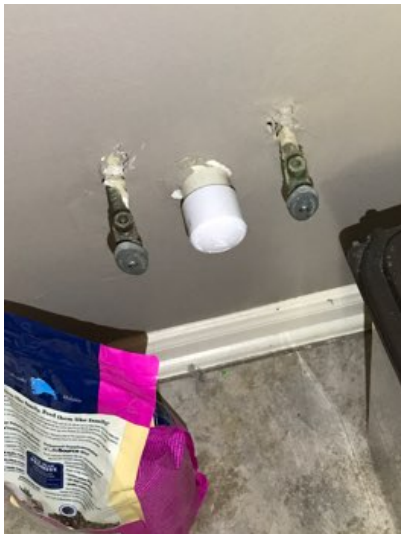
Supply stops for laundry sink should be capped if not used.

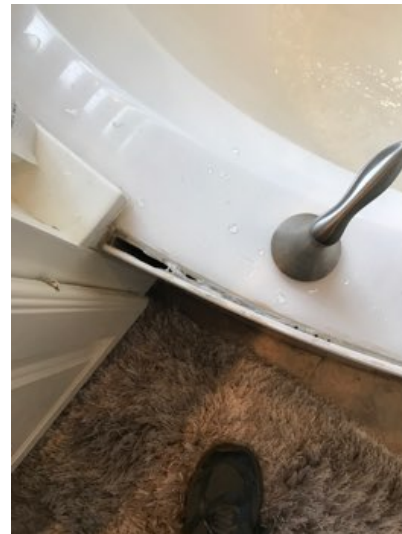
Spa tub trim is loose at the front of the tub.

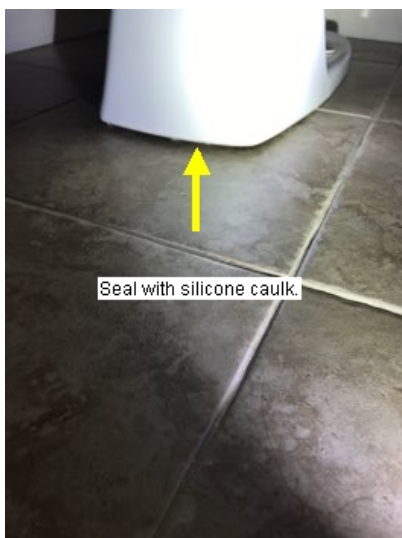
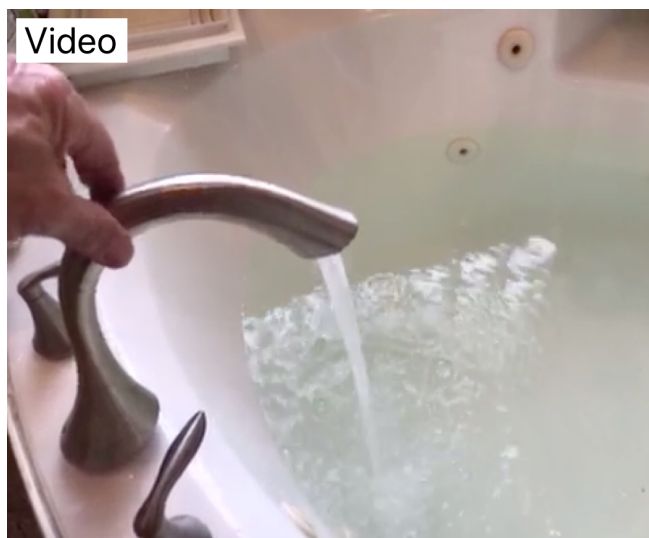
Where fixtures contact floors and walls (toilet bases, tubs, sinks) contact area should be water tight.

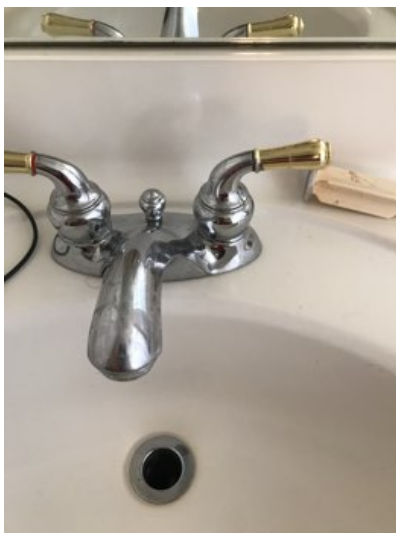
Plunger was not attached in the left upper bathroom.

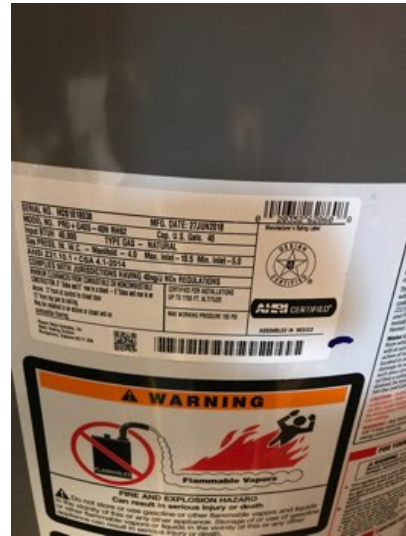
Plumbing Systems Water Heating Equipment

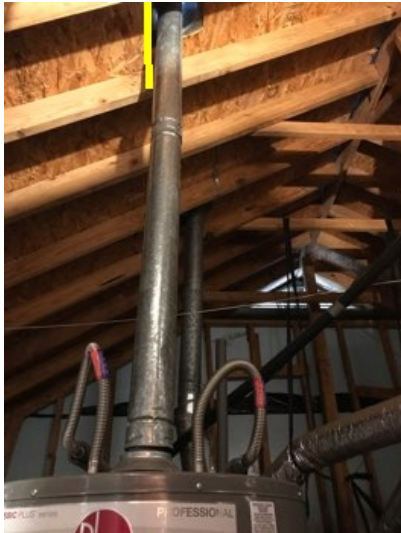
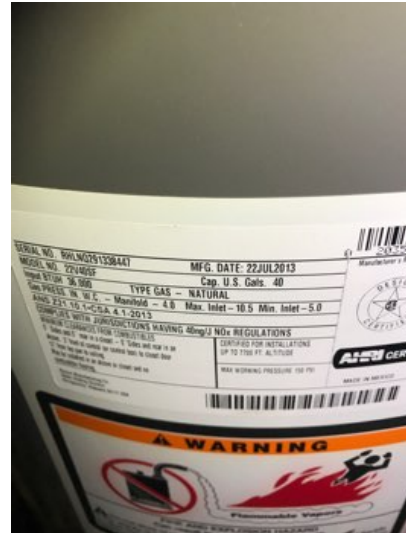
Flue vent is not adequately secured at the roof framing.

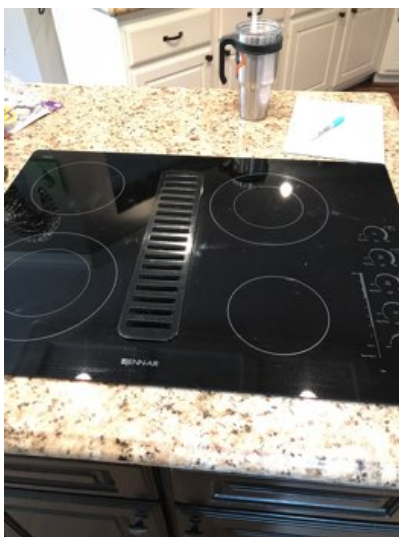
JennAir four burner electric cook top operated normally.

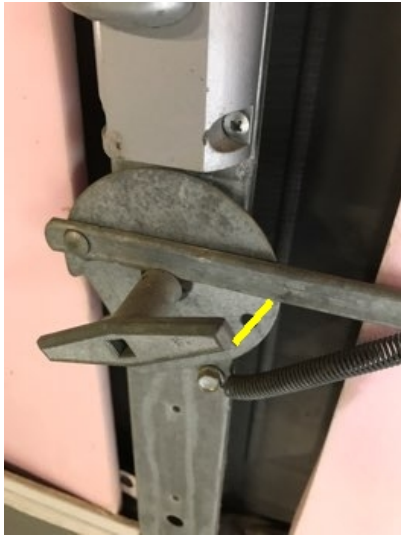
Door lock should be disabled since opener is present.

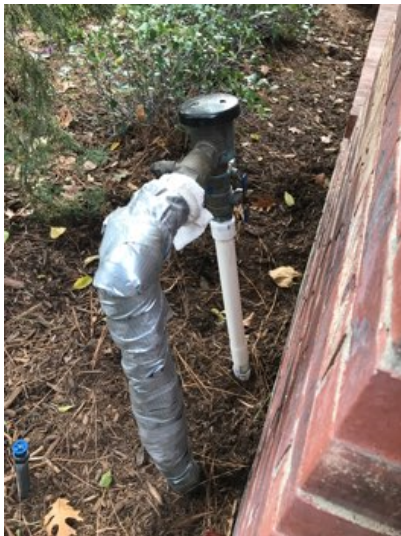
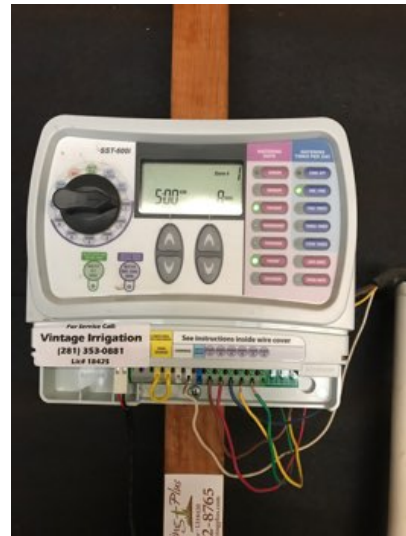
Insulation at vacuum break valve was missing or deteriorated. Optional Systems Landscape Irrigation (Sprinkler) Systems
