Texas Home Auditors

Inspection Report For:

7210 Stewart Street Hitchcock, Texas 77563

PROPERTY INSPECTION REPORT

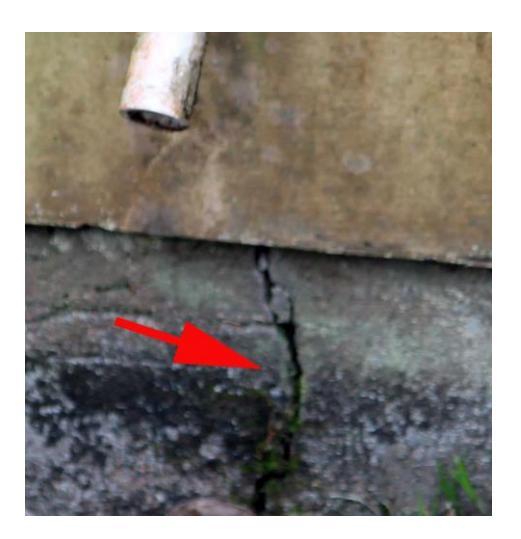
Performance Opinion: There was one area outside the kitchen or the edge of the foundation was cracked.

It needs to be noted here that there was one area of the exterior edge of the foundation cracked along with the ceiling and the floor in the kitchen. The majority of the walls were covered with paneling concealing any potential cracks in those areas. Is recommended that a certified foundation company evaluate and make recommendations.

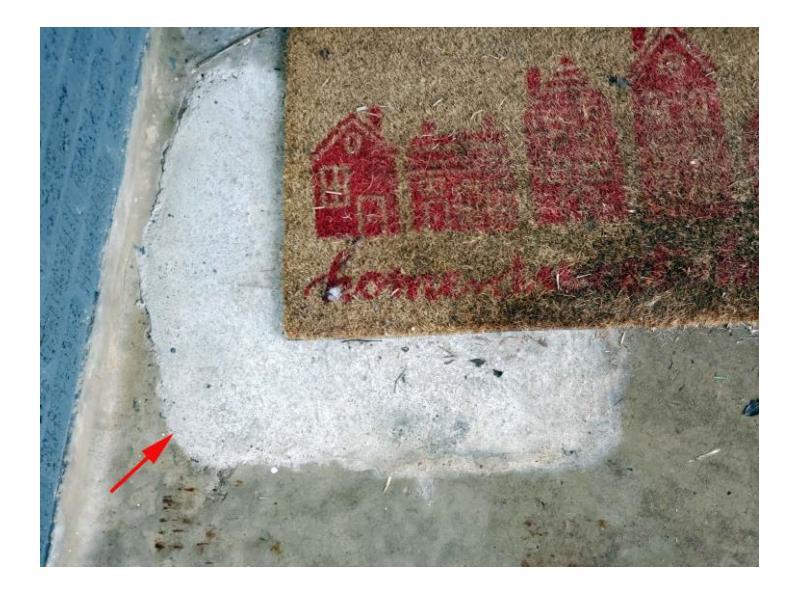
The foundation has been repaired in the past. Make sure that a diagram showing the location and number of peers installed is available.

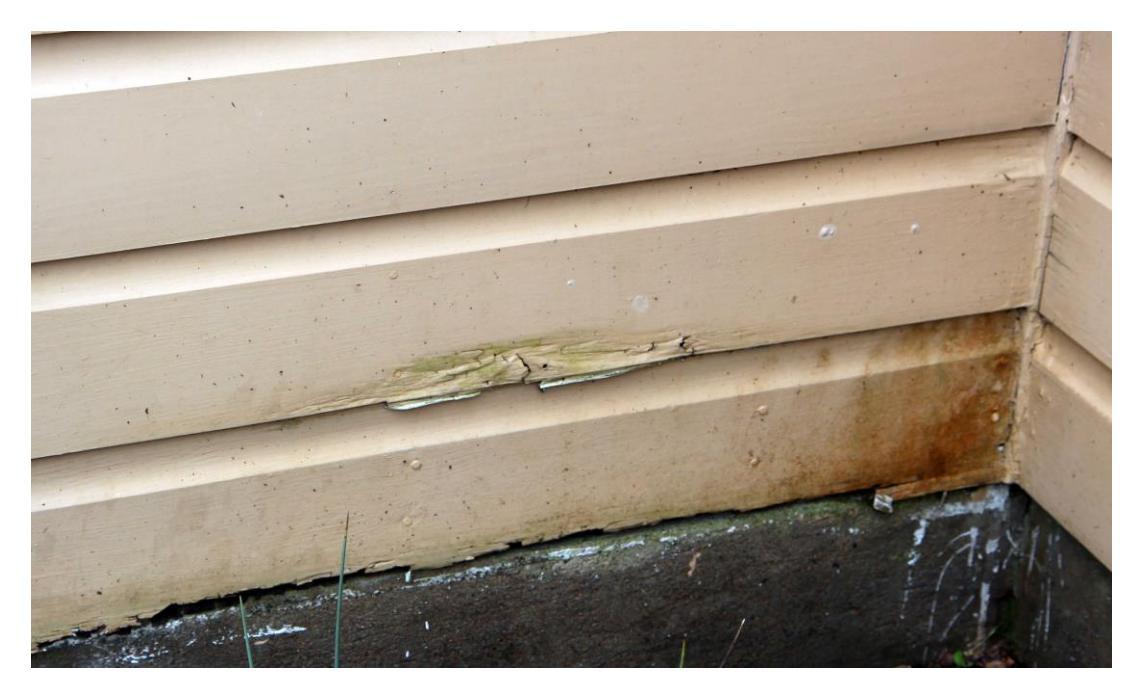
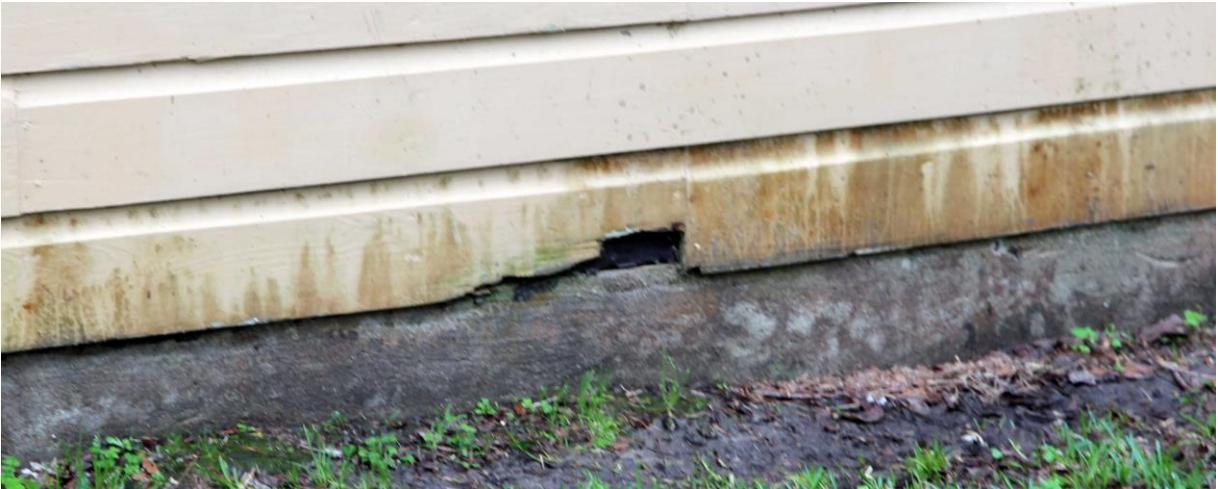
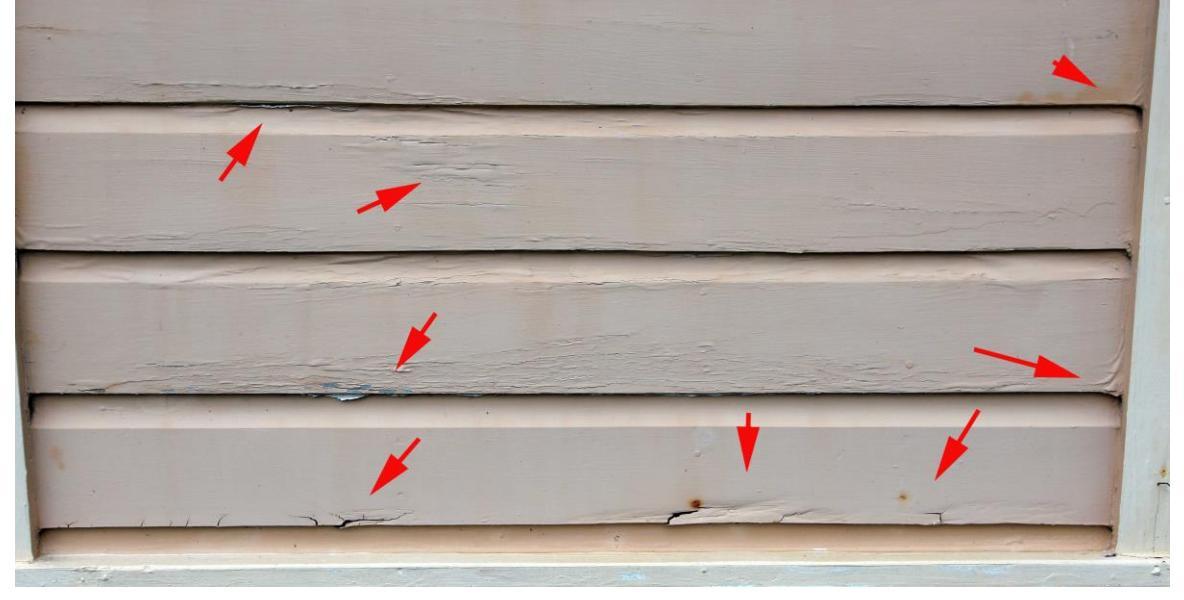
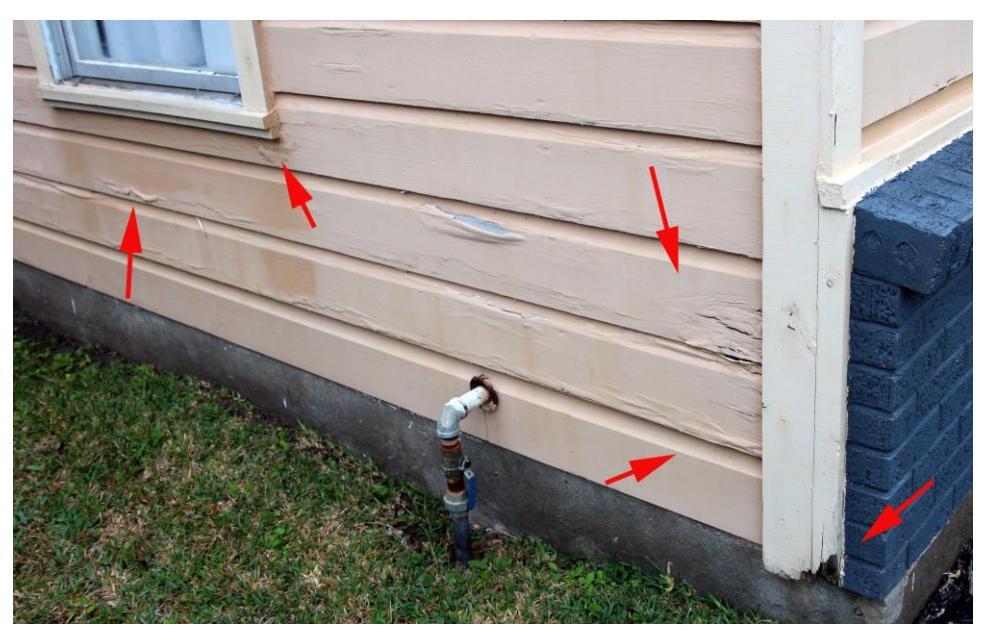
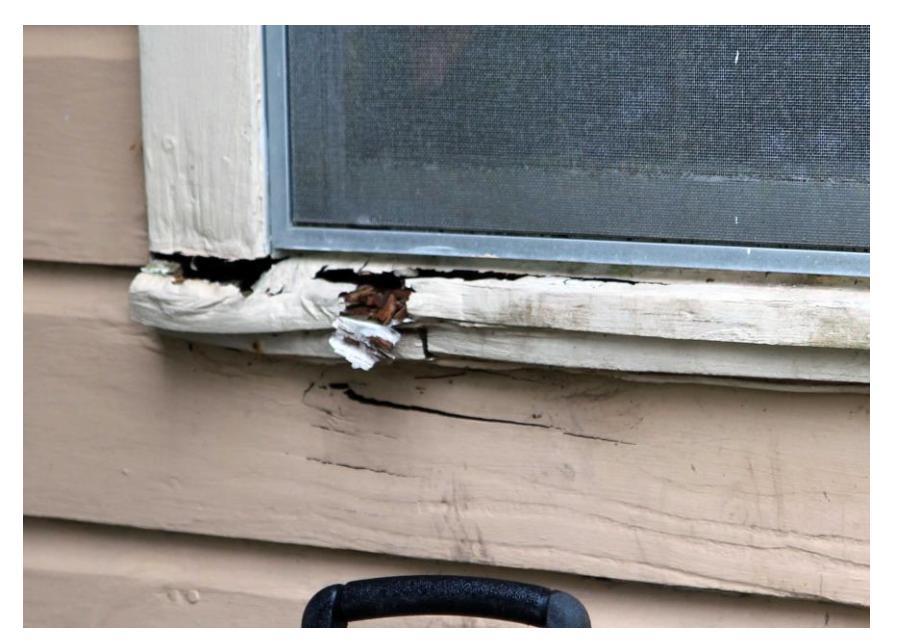
There is extensive wood deterioration around the exterior of the house.

It is recommended that a certified siding contractor evaluate and make recommendations.

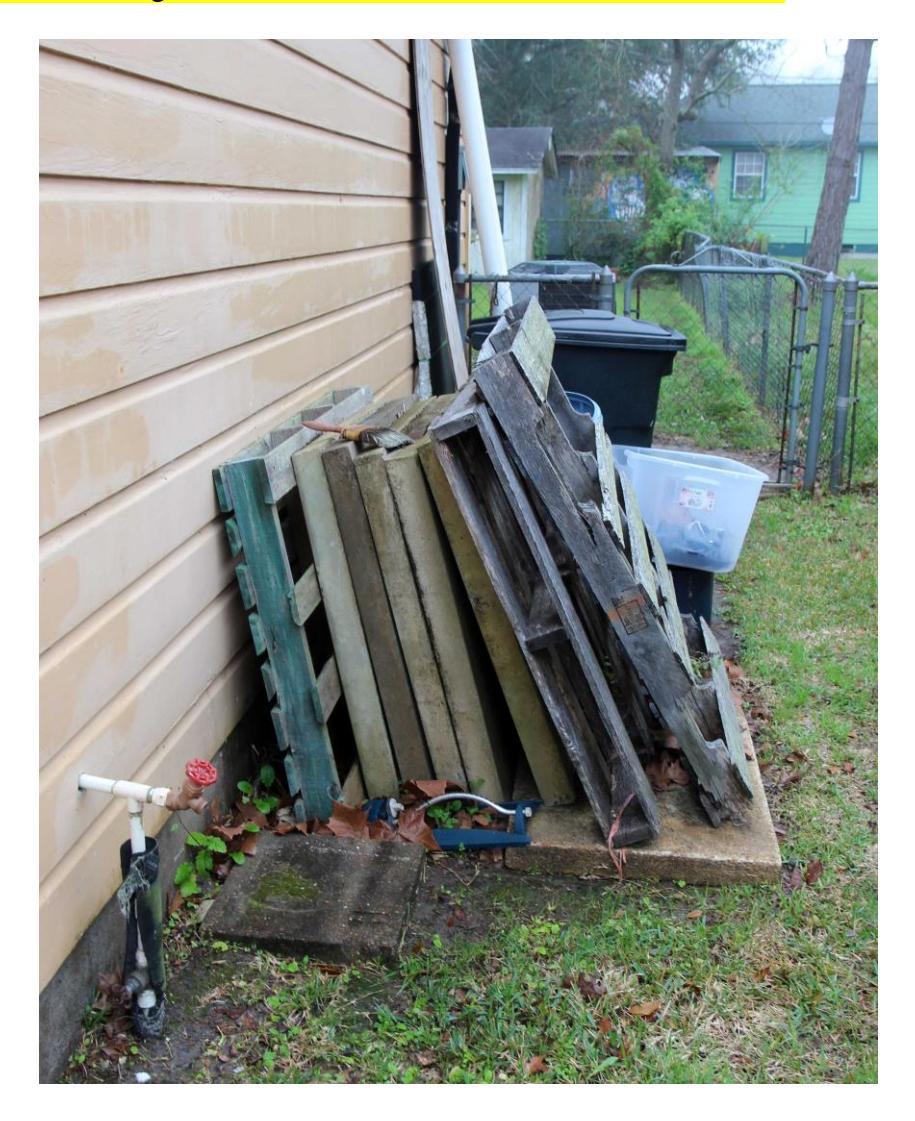
Property Identification: Robert Fuentes Date: 2/17/2020 Debris stored against exterior walls increases moisture retention.

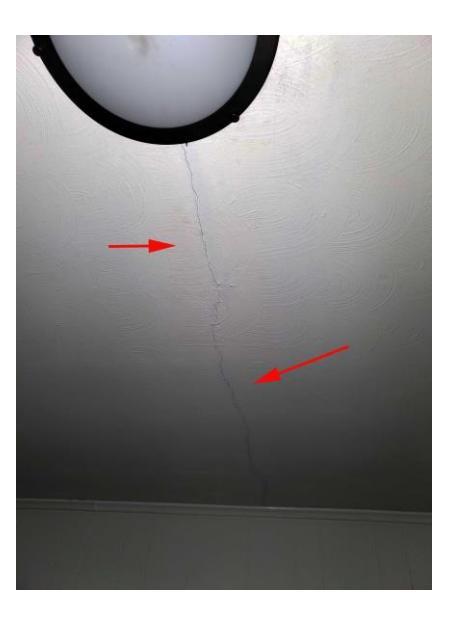
Cracked or damaged sheetrock located in the kitchen ceiling.

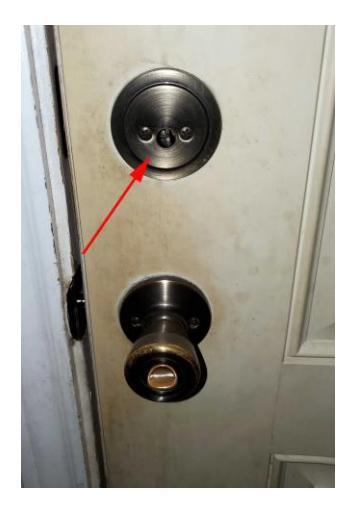
The deadbolt lock the front door is missing a latch.

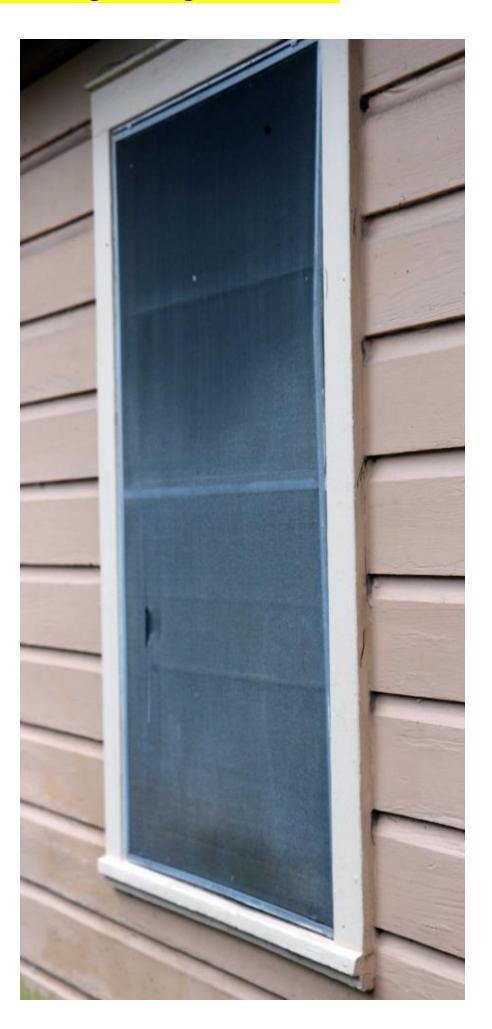
There are numerous missing/damaged screens.

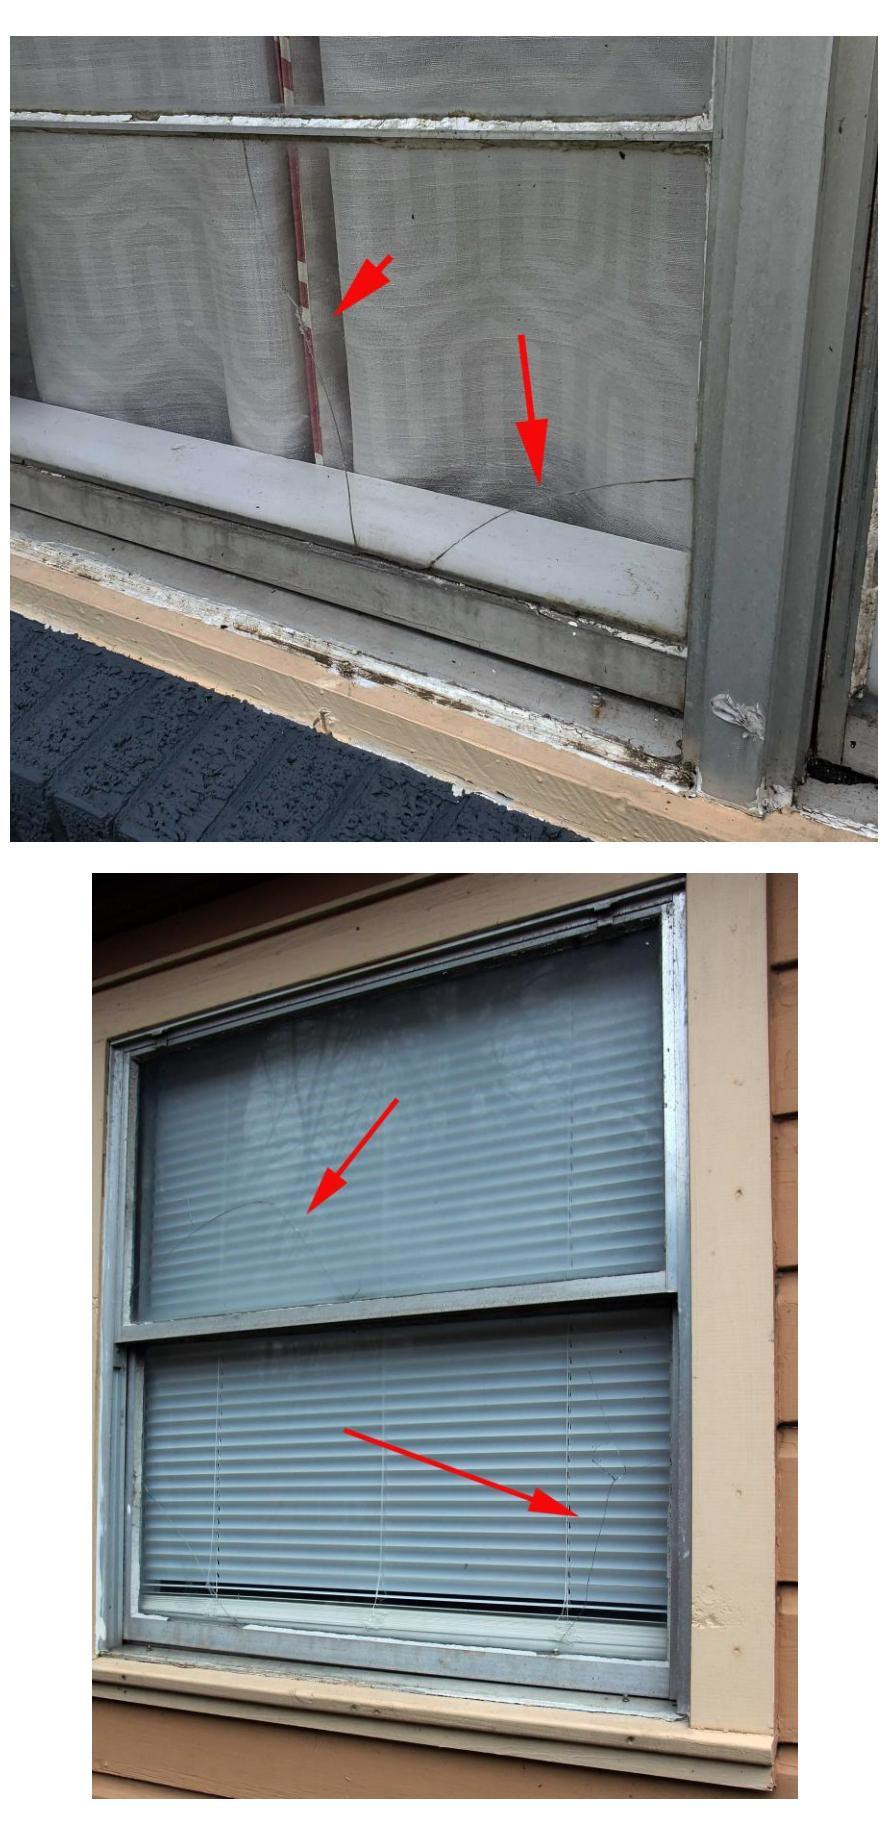
Property Identification: Robert Fuentes There are several windows with broken glass.

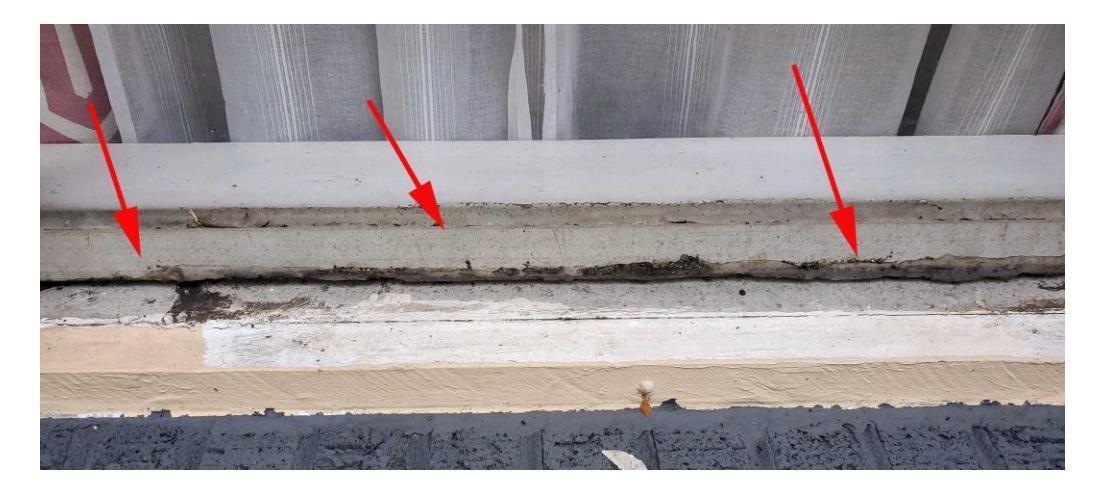
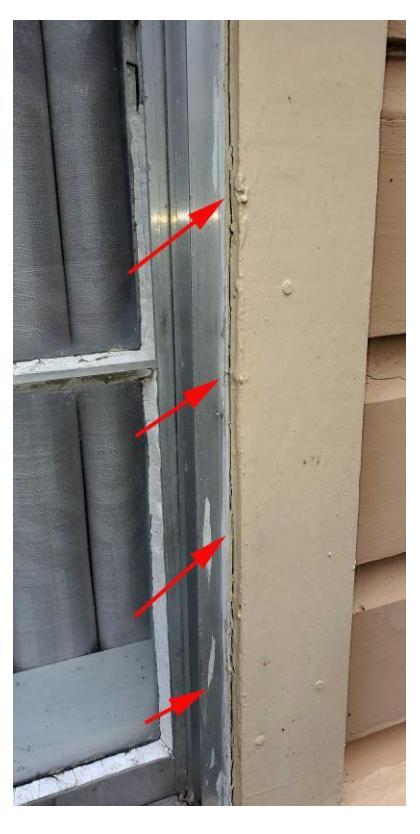
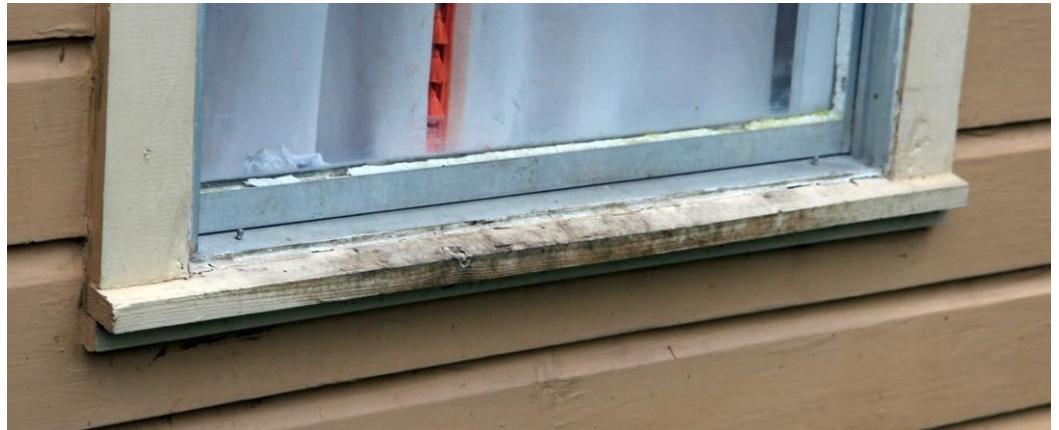
Property Identification: Robert Fuentes Date: 2/17/2020 All windows need to be recaulked/properly sealed.

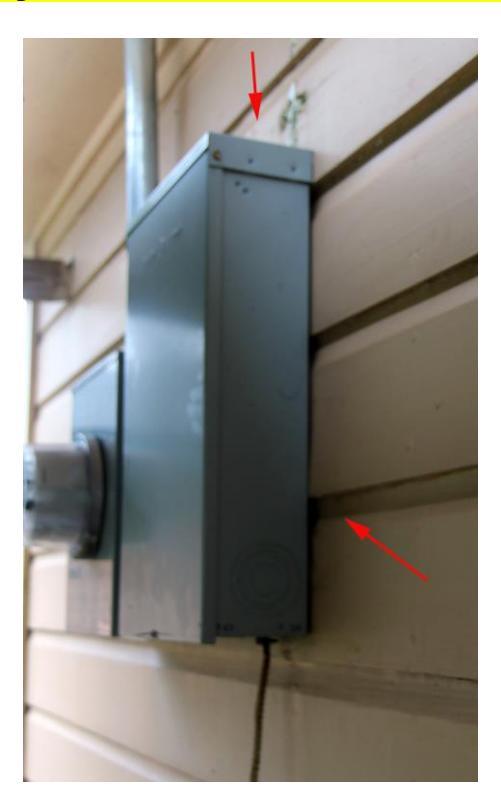
Residential electrical panels are not rated to be installed on exterior surfaces. As a result caulking the panel top and sides is recommended for moisture control.

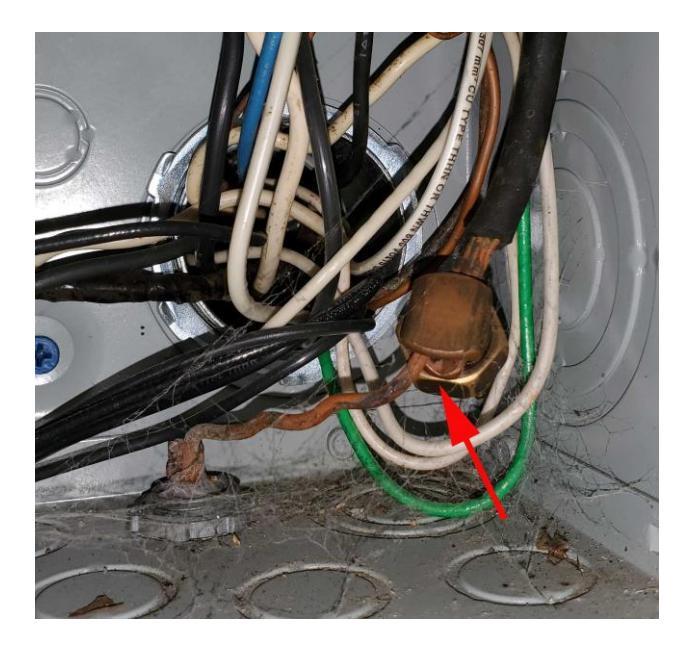
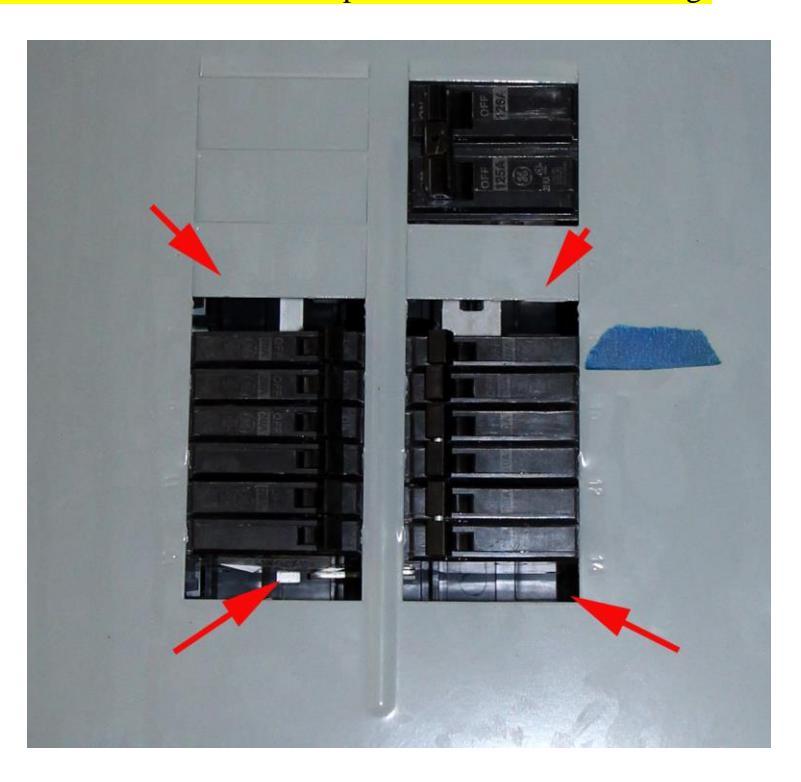
The grounding wire is not properly attached.

There are knockouts for the inside panel cover that are missing.

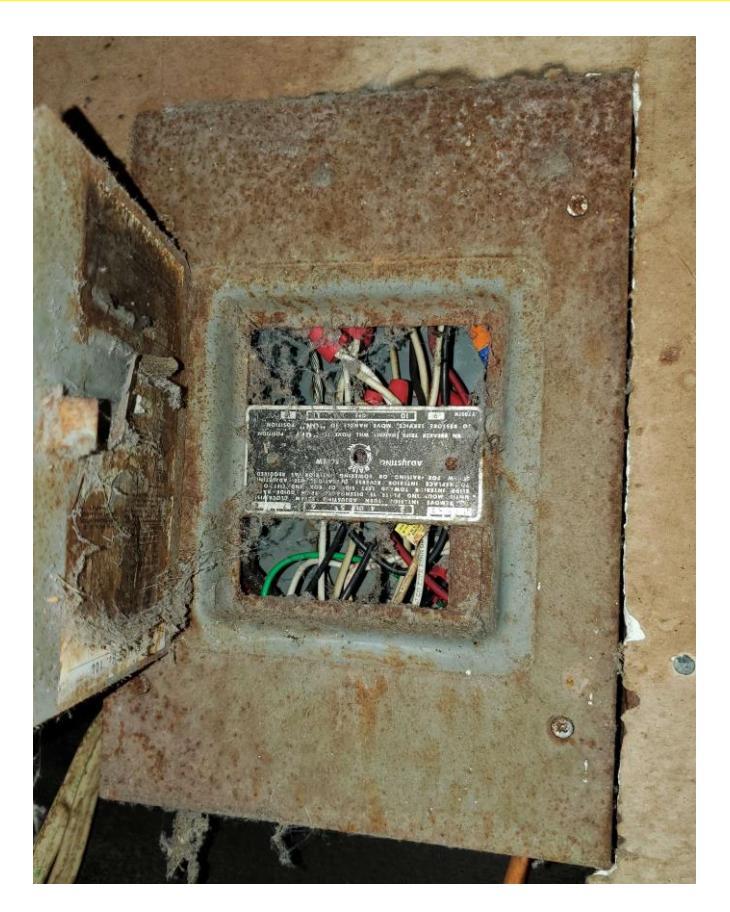
There is some type of subpanel located in the garage behind the clothes washing machine. There were several exposed wires in this panel and as a result the panel was not open.

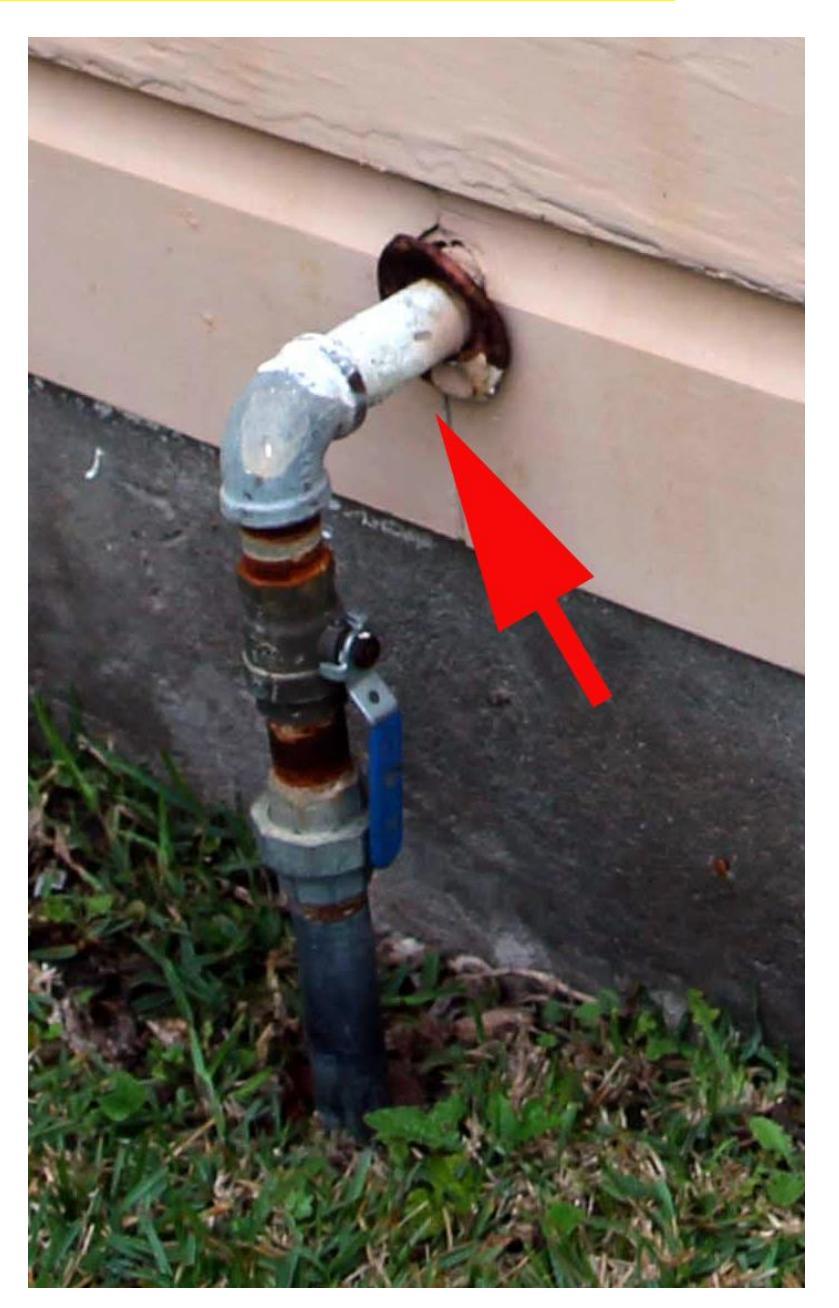
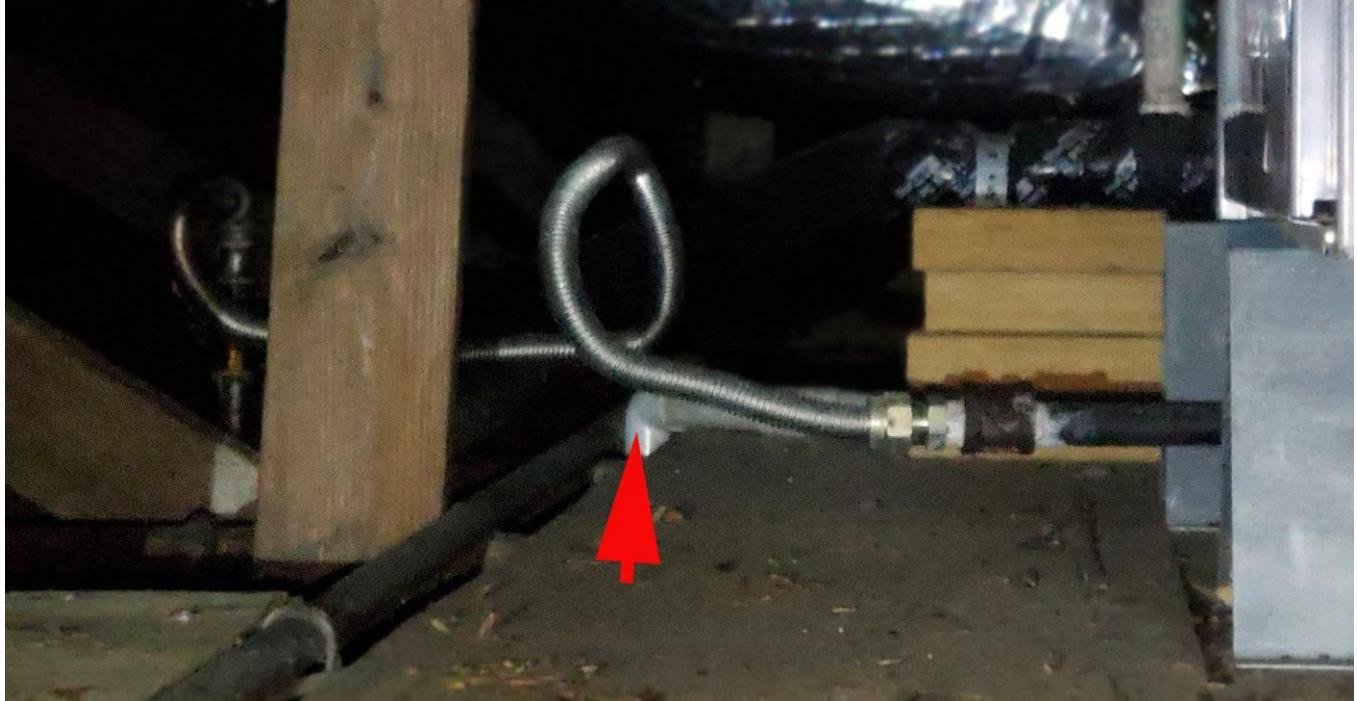
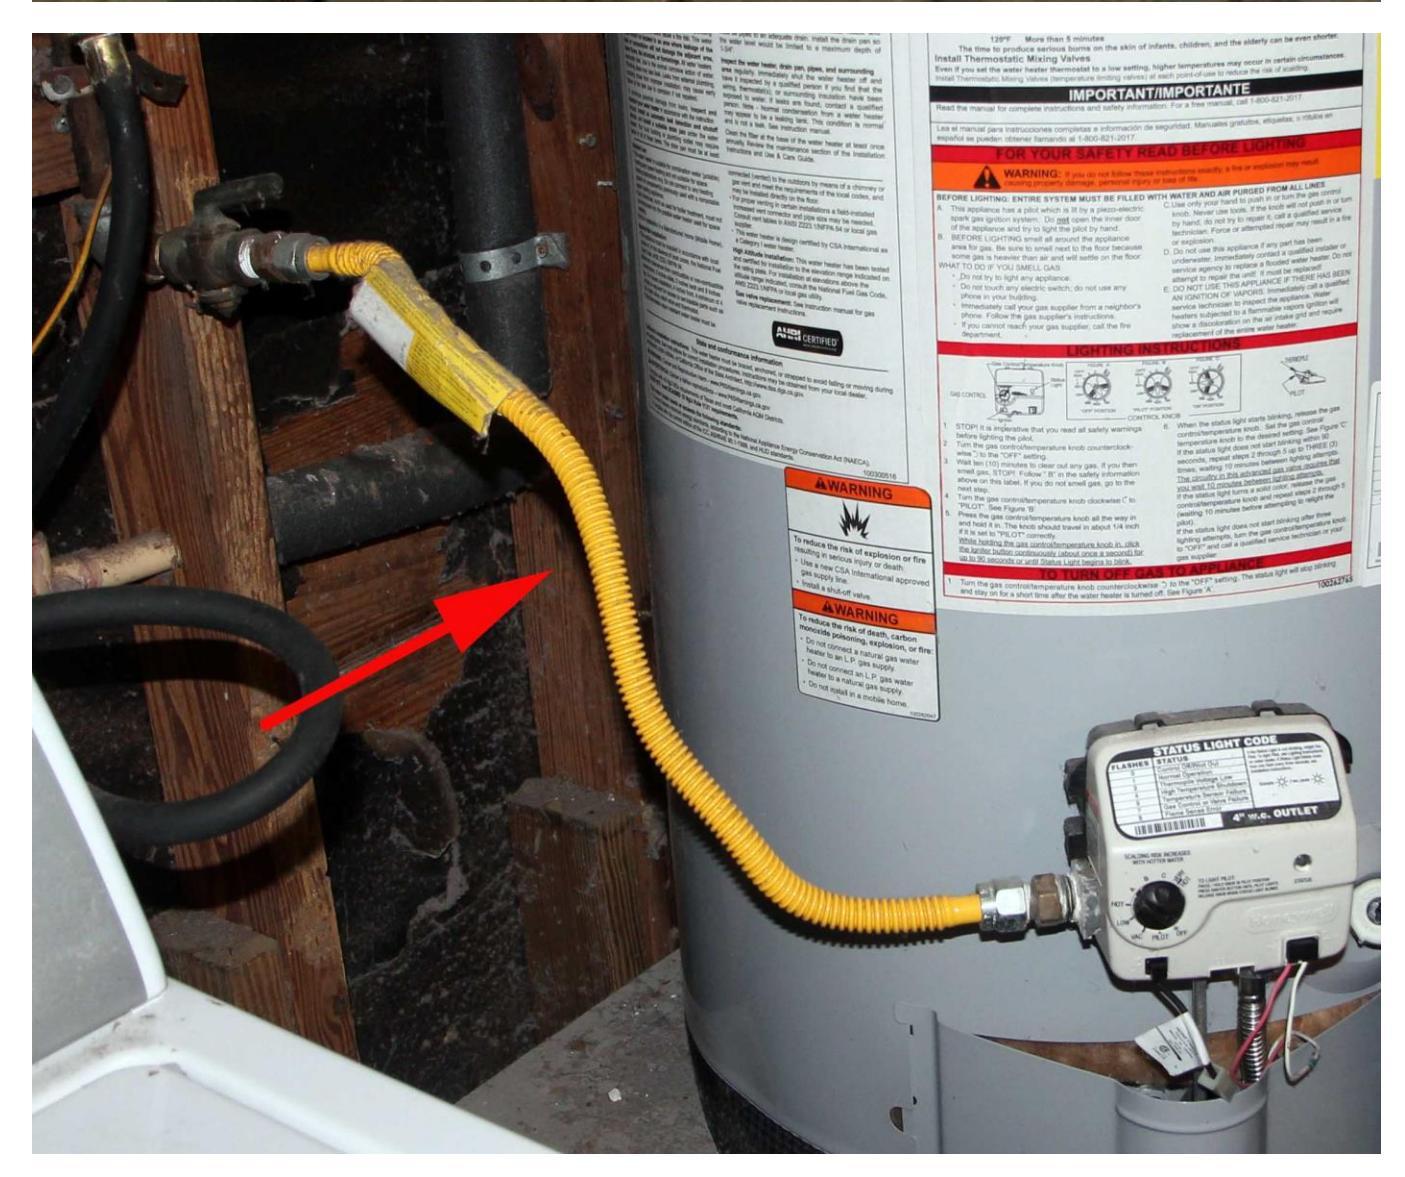
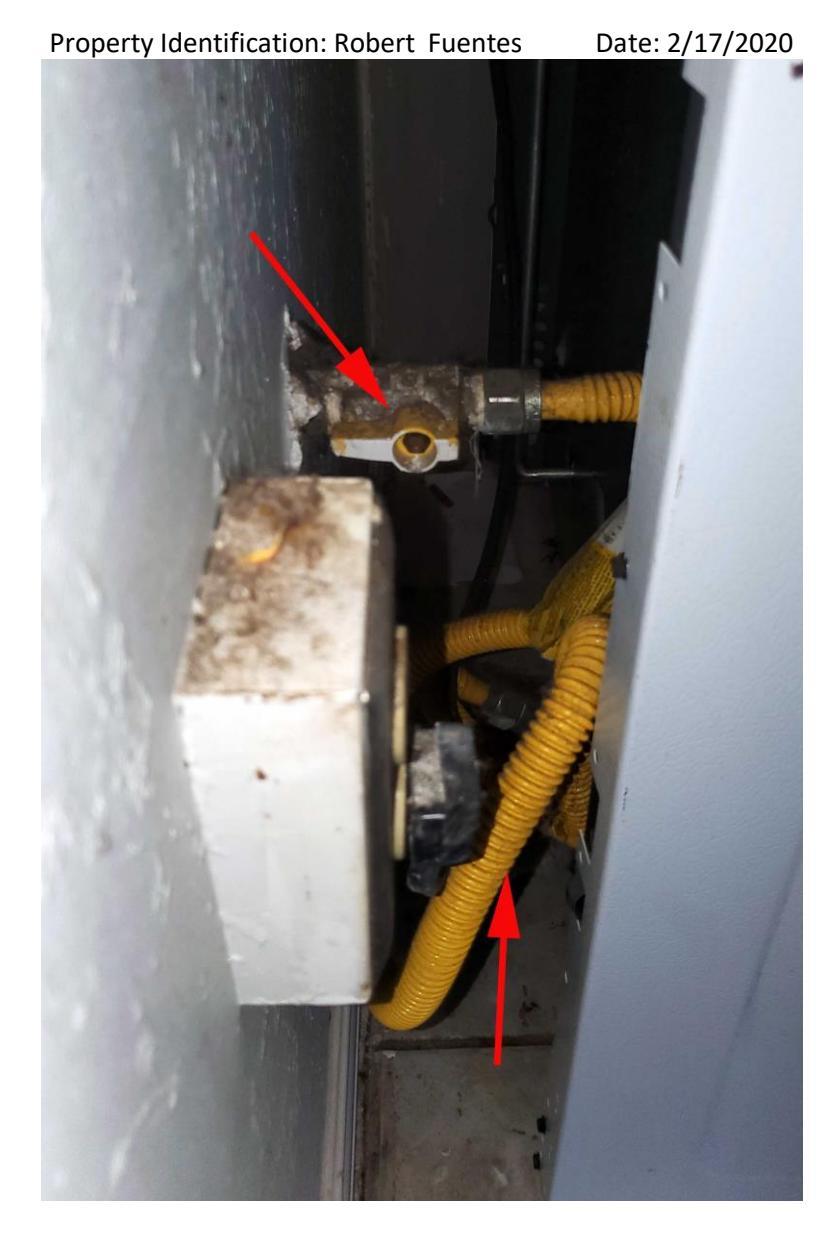
There is no evidence of electrical bonding for the gas lines, the flexible gas appliance connectors (for all gas appliances), and the gas meter itself.

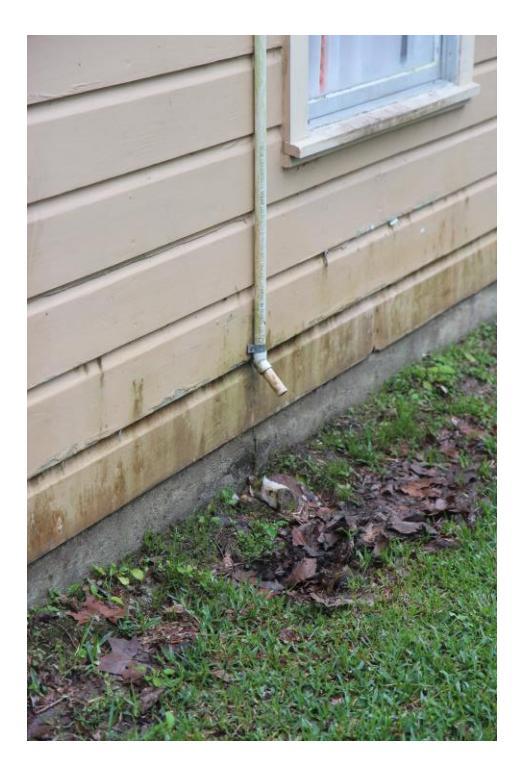
Date: 2/17/2020 The primary drain is currently set up to drain on the ground just outside the house. This needs to be drained into the main drain line of the house.

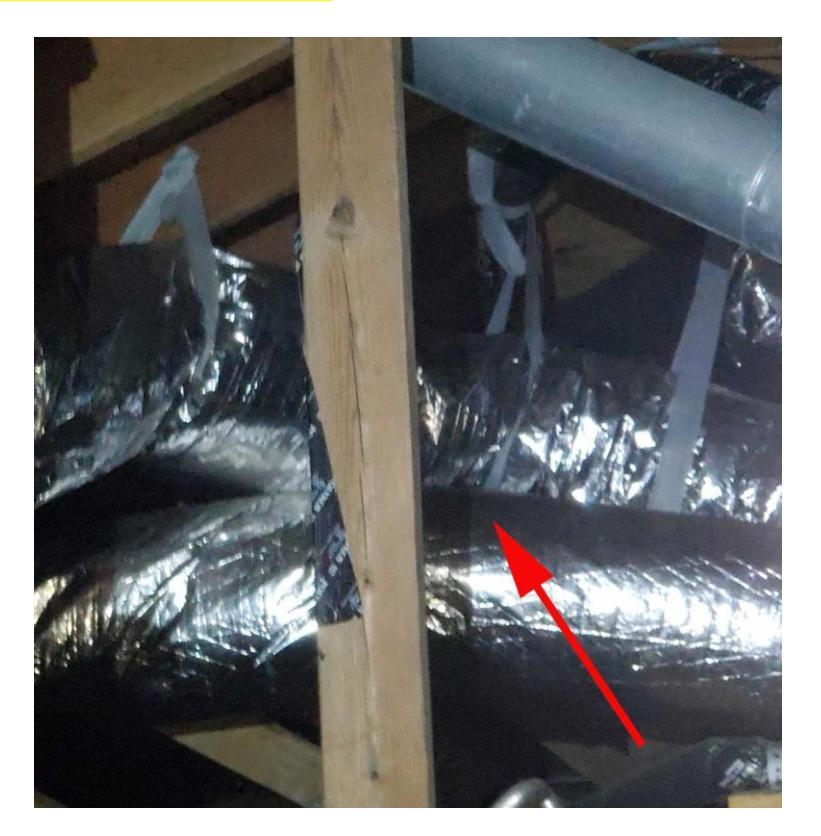
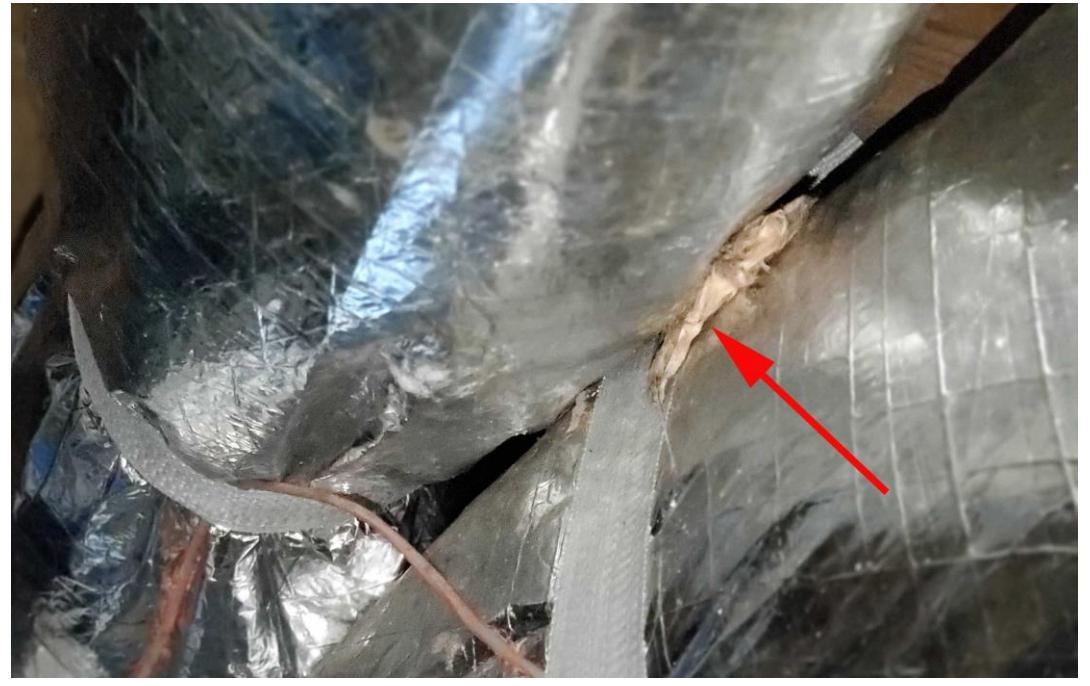
There are ducts in contact with each other in the attic. This can potentially cause the formation of water condensation.

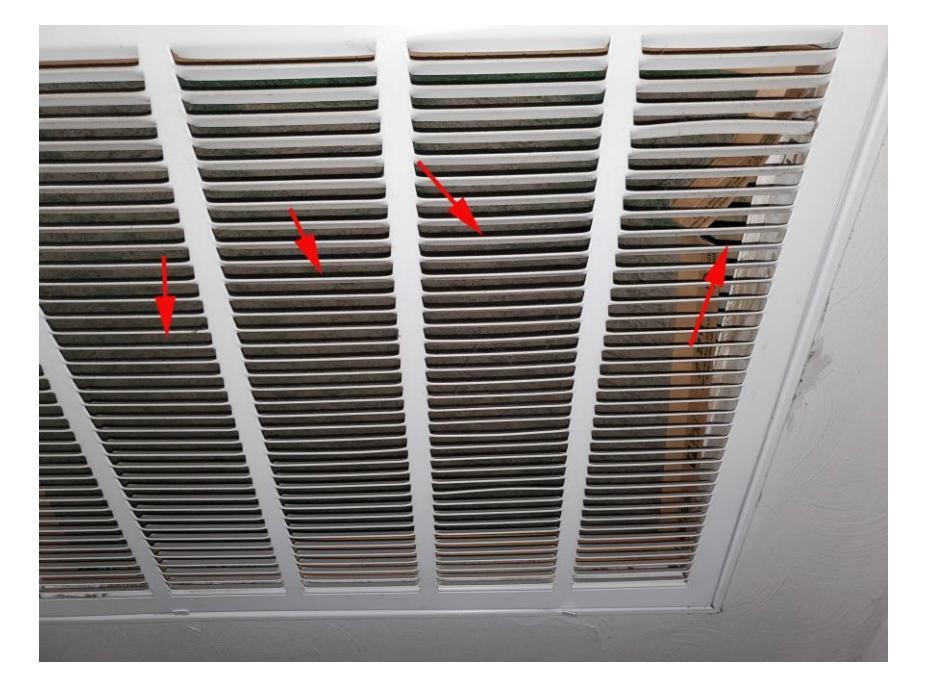
Property Identification: Robert Fuentes Date: 2/17/2020 The return filter is clogged/leaking reducing airflow and allowing unfiltered air through. As a result it is advised that a HVAC technician check the coils and clean if necessary.

It is recommended that a licensed HVAC technician evaluate the system to include but not limited to checking for the properly sized breaker, verifying that the system is correctly sized, correcting duct issues, and cleaning the coils if necessary.

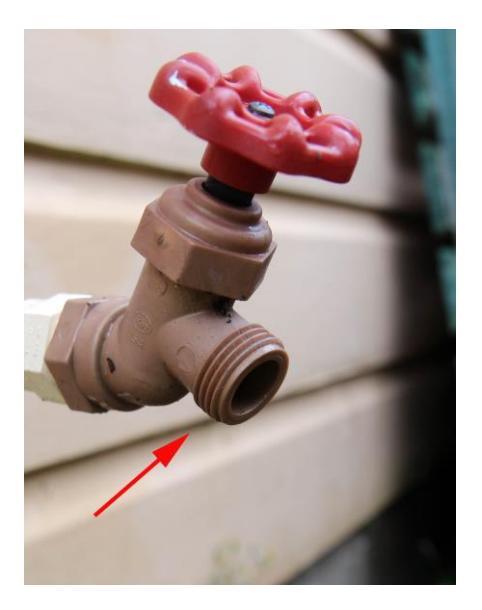
Missing anti-siphon fittings on exterior faucets.

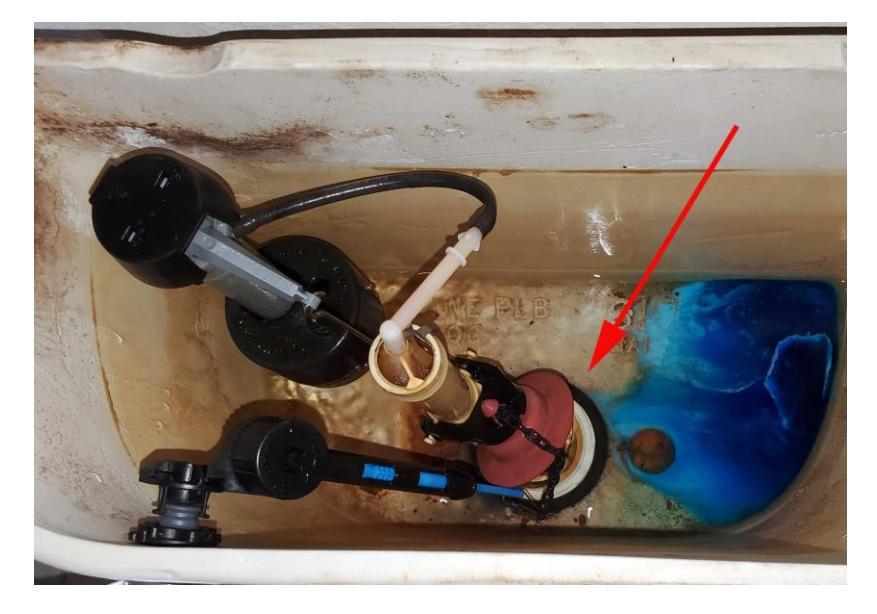
Property Identification: Robert Fuentes Date: 2/17/2020 The valve for the commode is not properly sealing.

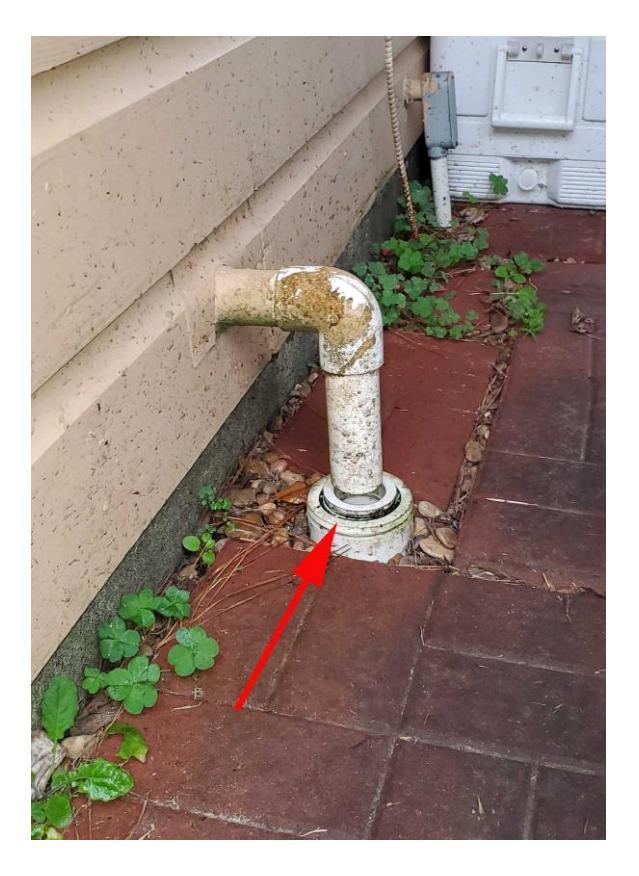
The close washing machine drains directly into an open sewer pipe. This needs to be sealed.

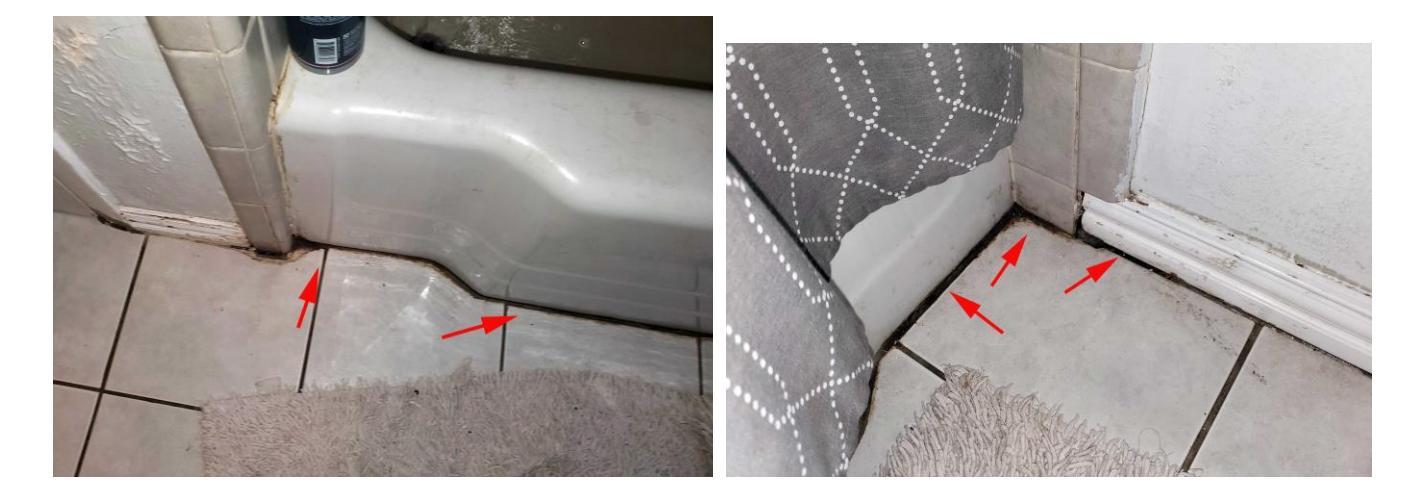
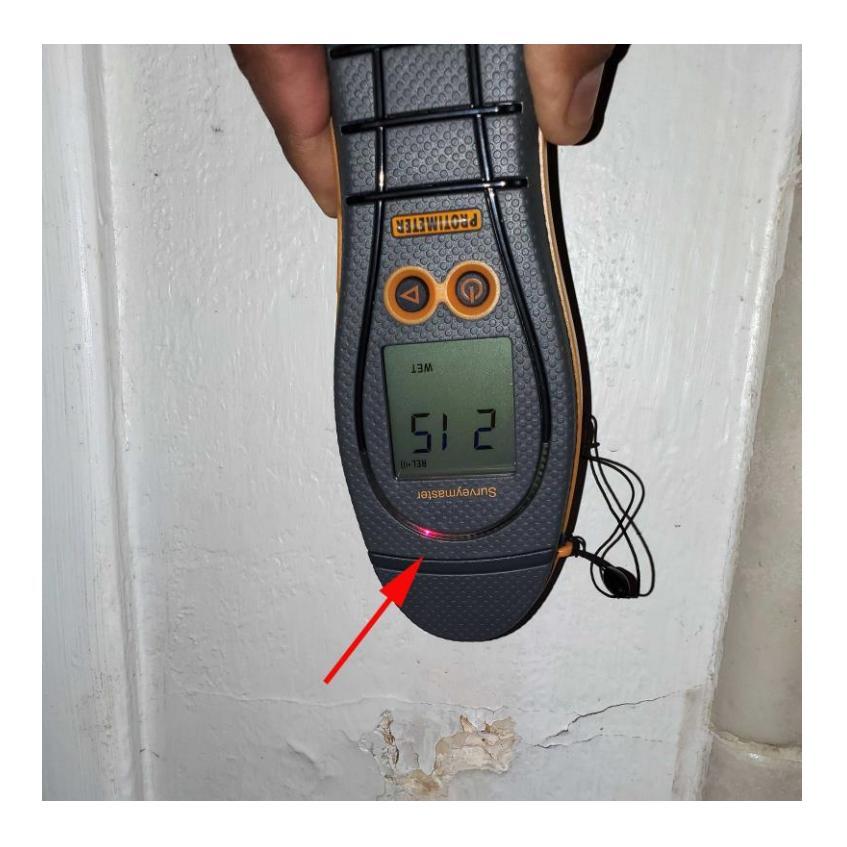
Property Identification: Robert Fuentes Date: 2/17/2020 There are signs of water penetration alongside the bathtub. There was a high level of moisture present in the wall between the tub and the closet.
