Texas Home Auditors

Inspection Report For:

7210 Stewart Street Hitchcock, Texas 77563

PROPERTY INSPECTION REPORT

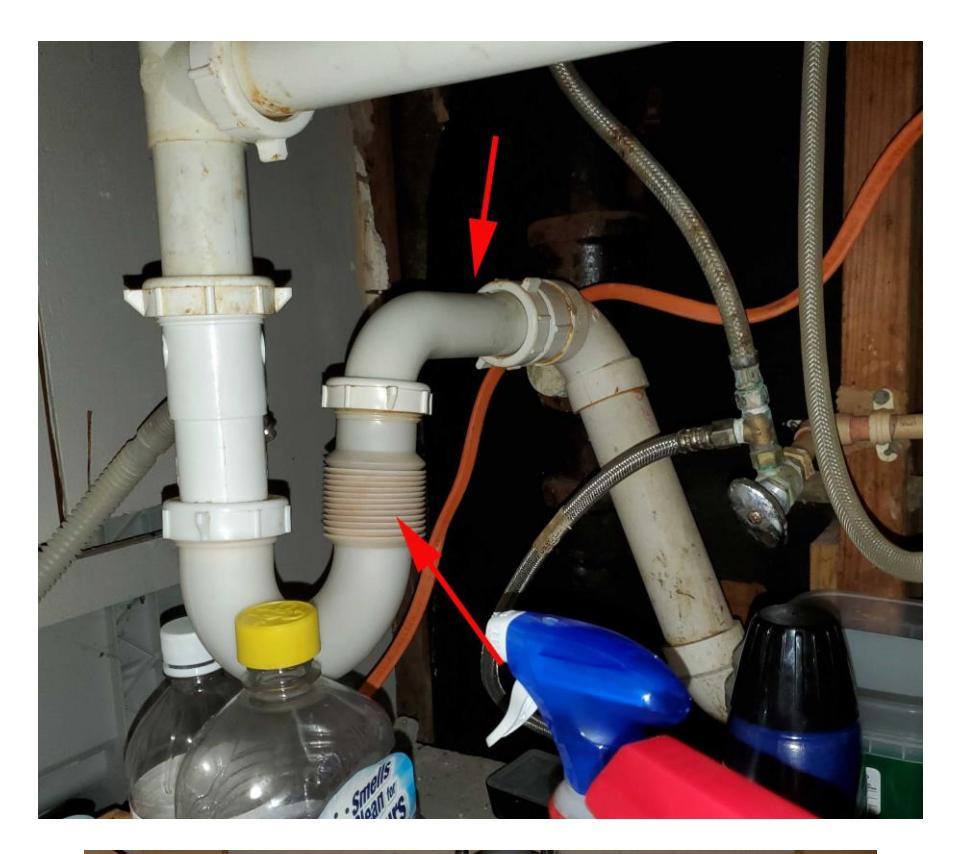
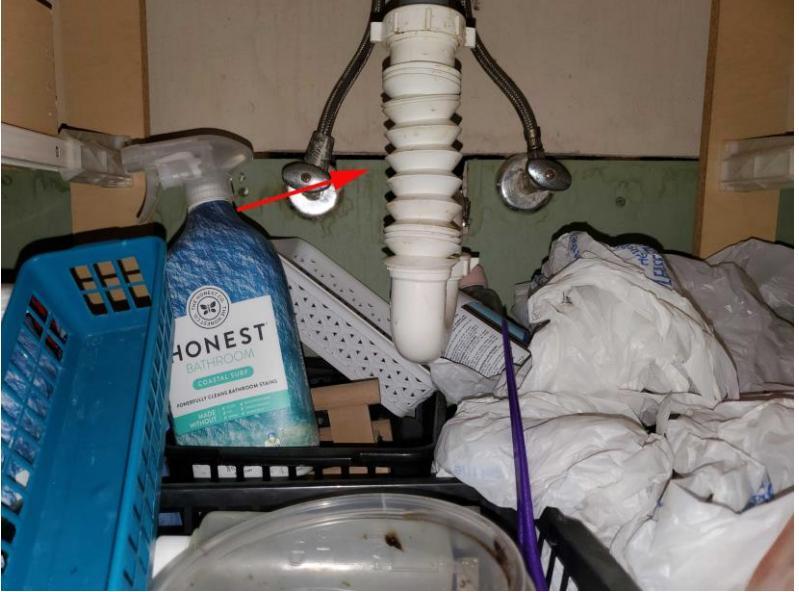
Flexible drain lines are not approved for residential use.

The horizontal drain line just after the P-trap (under the kitchen sink) needs to be lowered. The current installation will allow water to to build up above the P trap causing possible leaks.

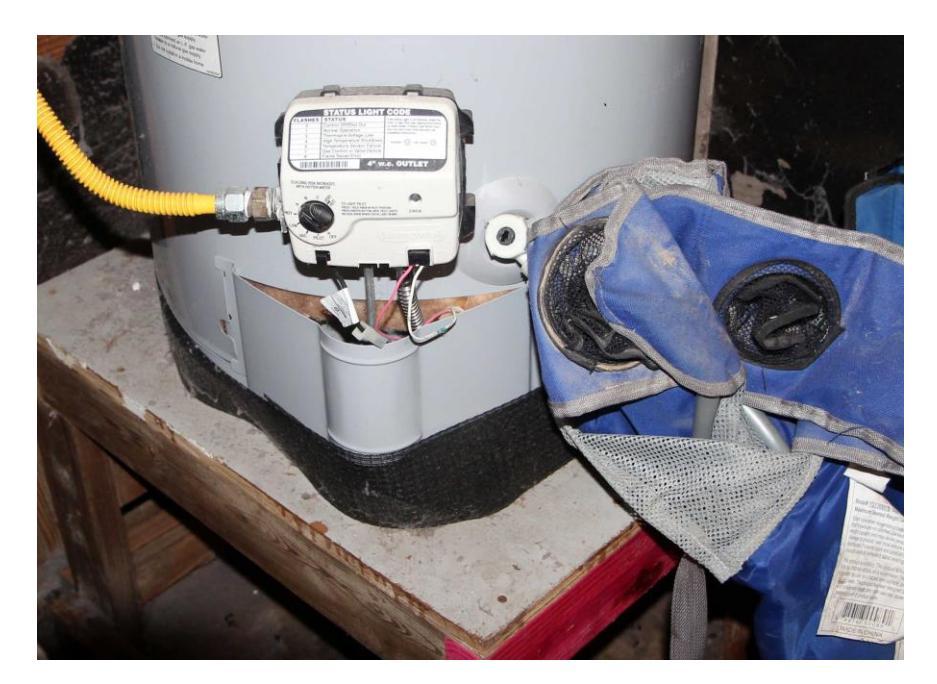
The water heater is not sitting in a pan.

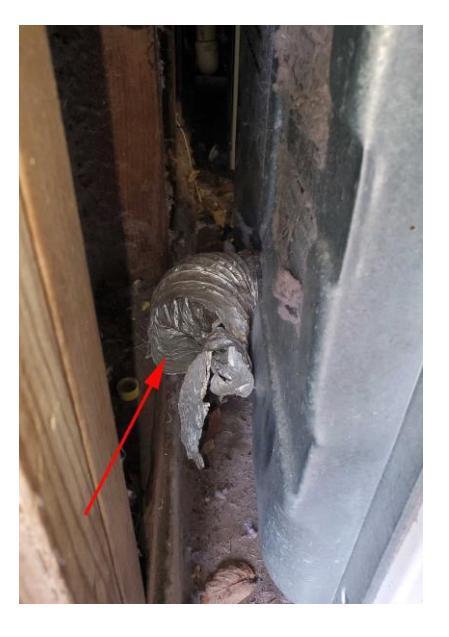
The dryer vent is not properly terminated. The dryer is venting directly into the garage.

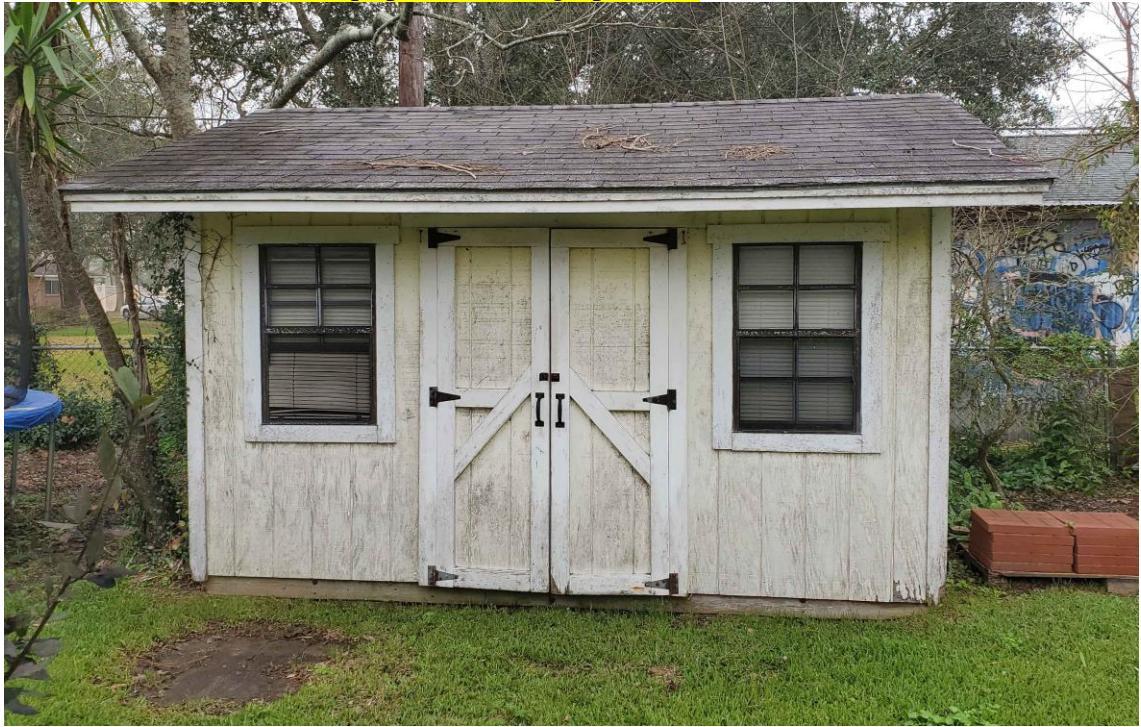
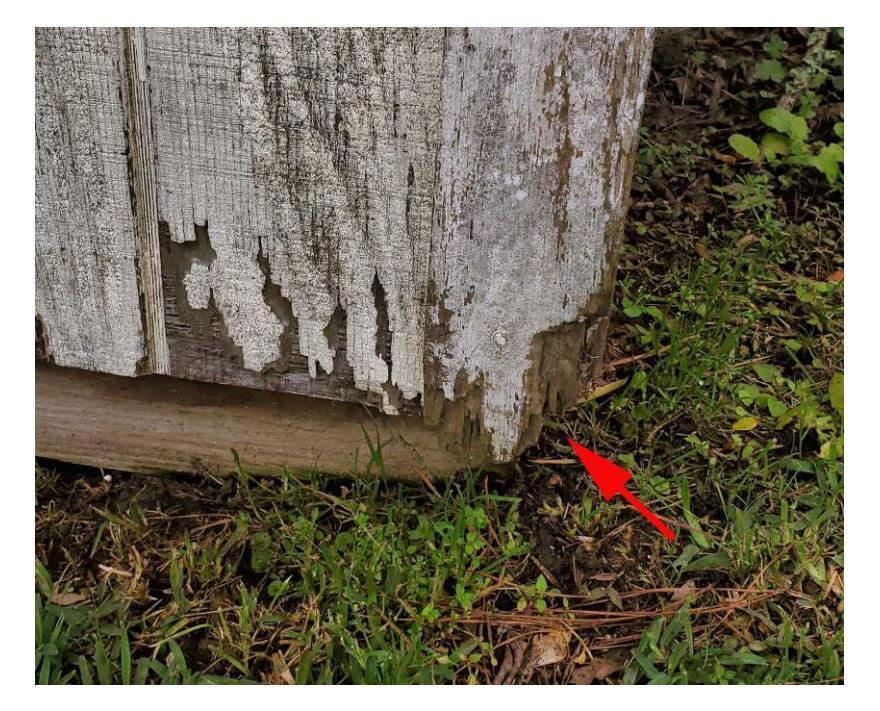
The storage building appears to have the original roof and there is some wood deterioration/lawn equipment damage present.
