Gene Inspections

623 St. Andrews

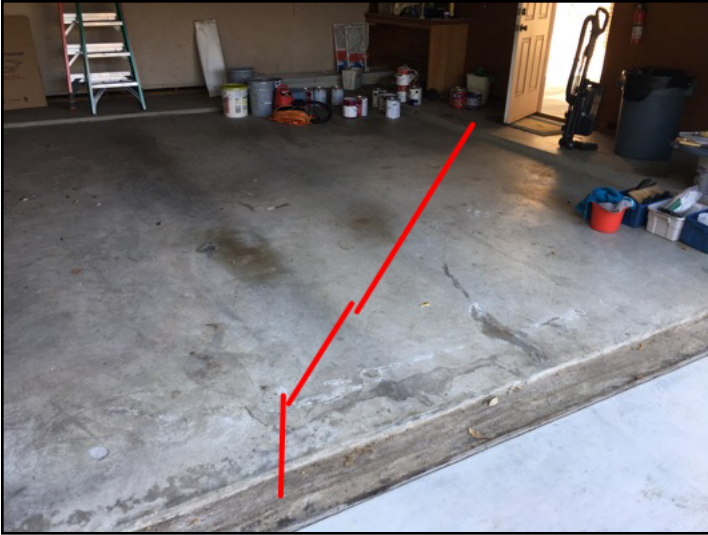
Stress crack observed on the garage slab extending from the garage door to the garage side door and penetrating the foundation beams at both locations

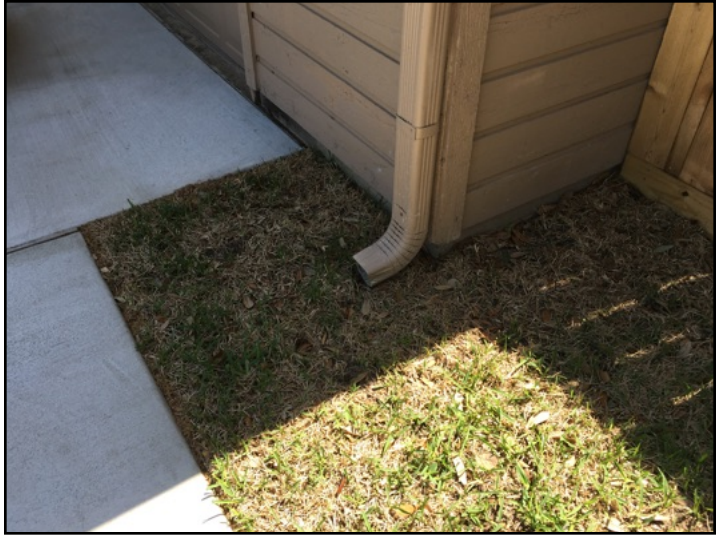
The garage slab crack may be caused by a gutter downspout (to the right of the garage door) not properly extended away from the foundation

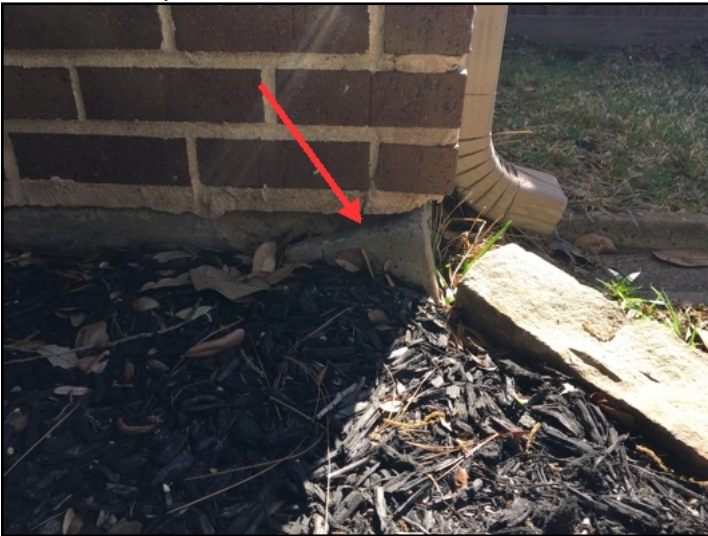
Foundation corner pops (common hairline cracks at the corner of the slab) were noted

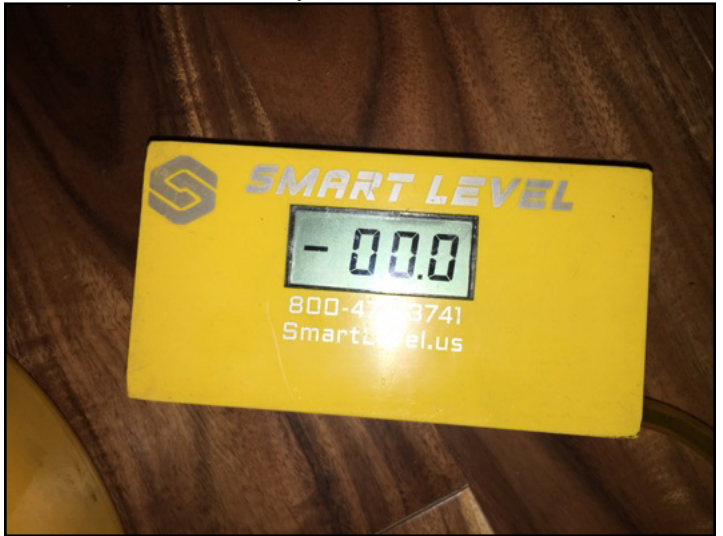
Foundation Elevation: Front left corner of home

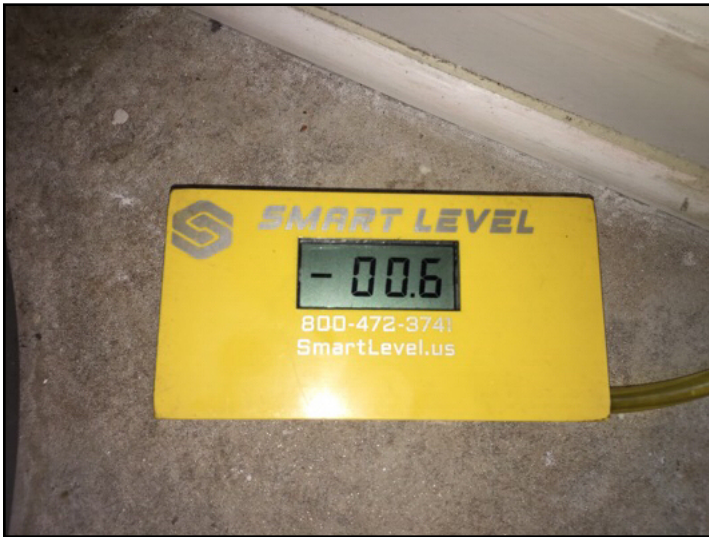
Foundation Elevation: Back left corner of home

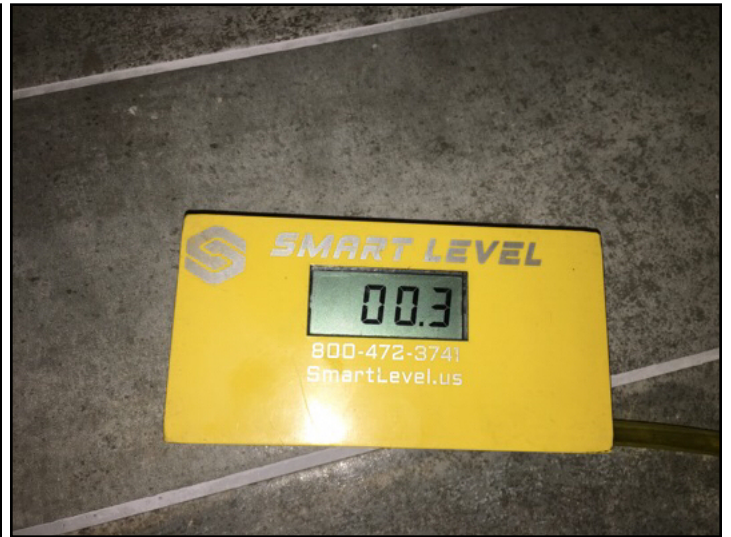
Foundation Elevation: Front right corner of home

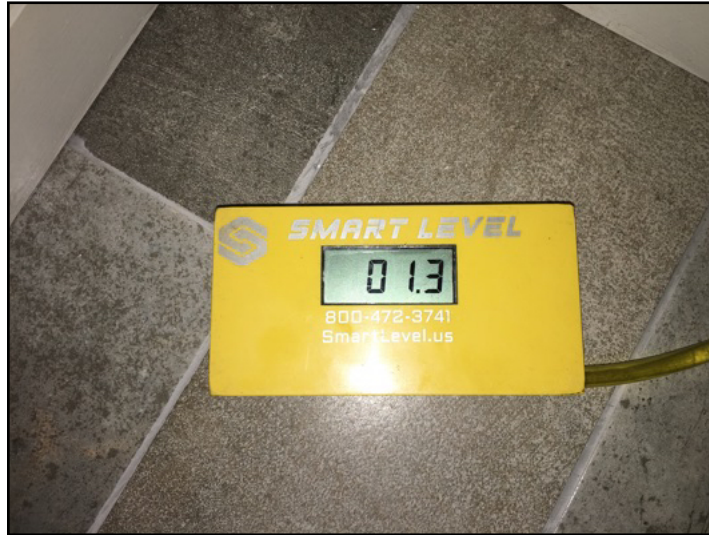
Foundation Elevation: Back right corner of home

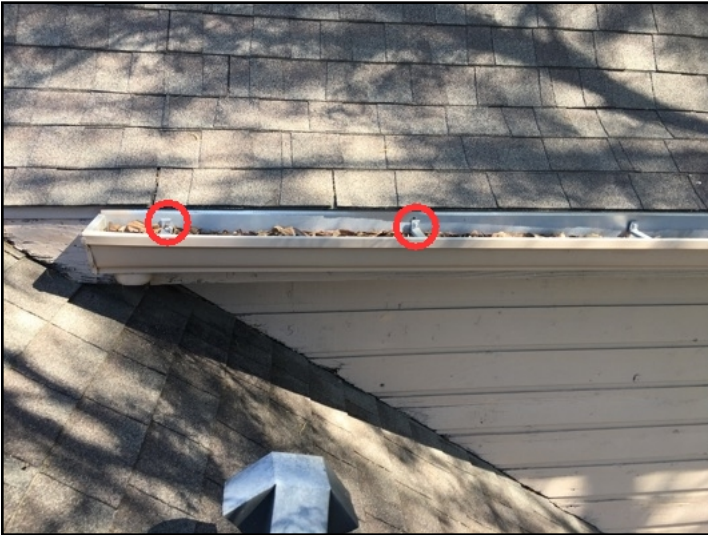
The nails/screws were coming loose and pulling out on a gutter section on the back right side of the roof

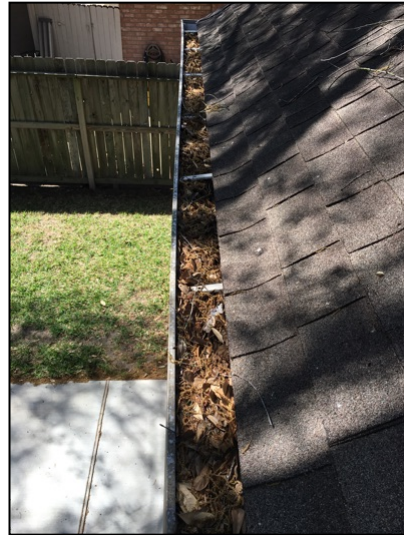
Recommend leaves and debris be cleaned from gutters and downspouts for more effective drainage of roof run-off water

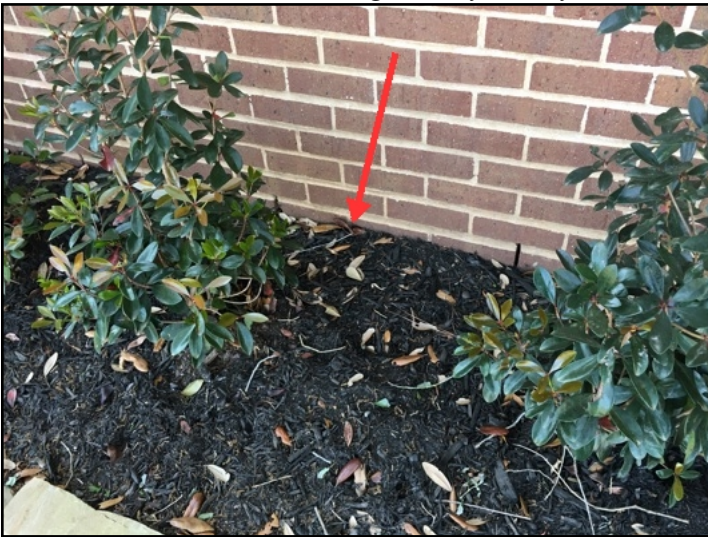
Areas next to the foundation on the left side of the home had high soil that may allow water/insects in

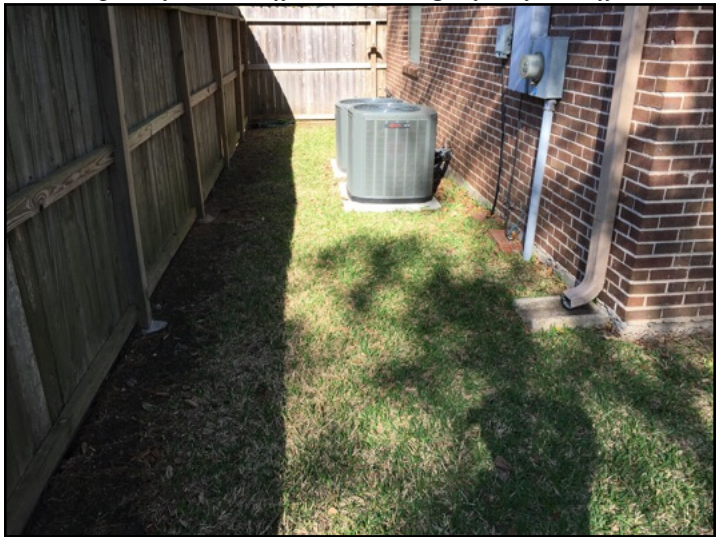
Grading appeared to be inadequate and does not slope away from the foundation on the right side of the home

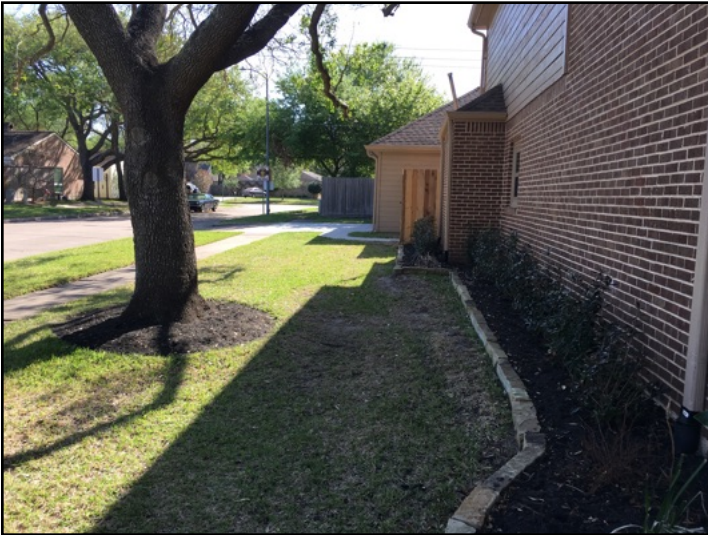
Trees were located within 15 feet of the foundation on the left side and front right corner of the home

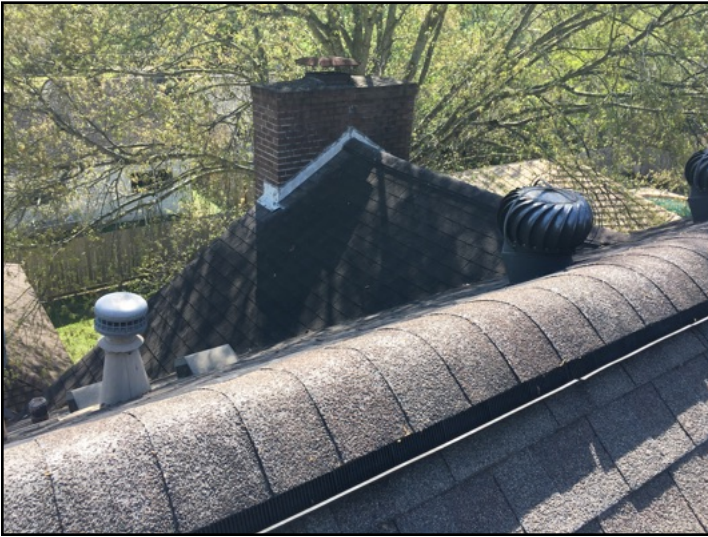
I	NI	NP	D
---	----	----	---

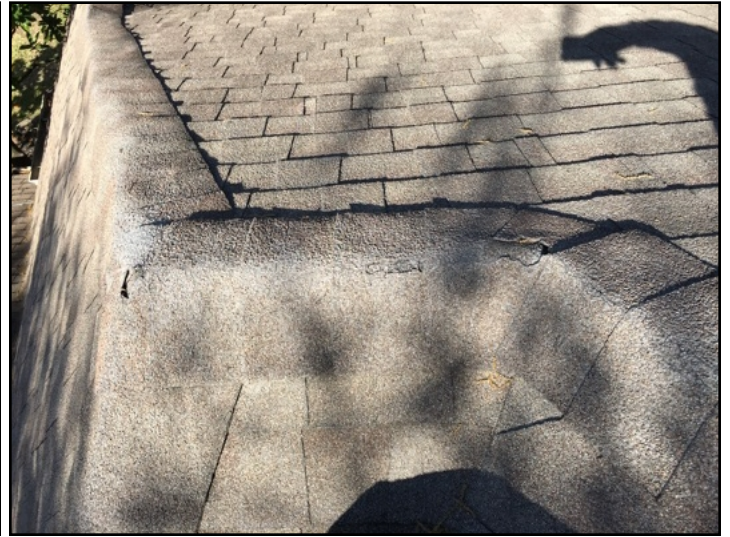
Granular loss, exposed felt and damage observed to the ridge shingles

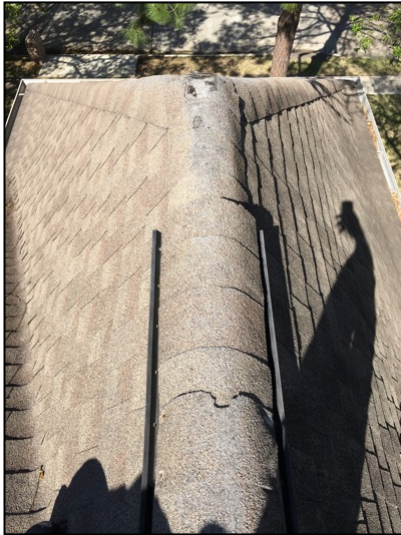
Granular loss, exposed felt and damage observed to the ridge shingles

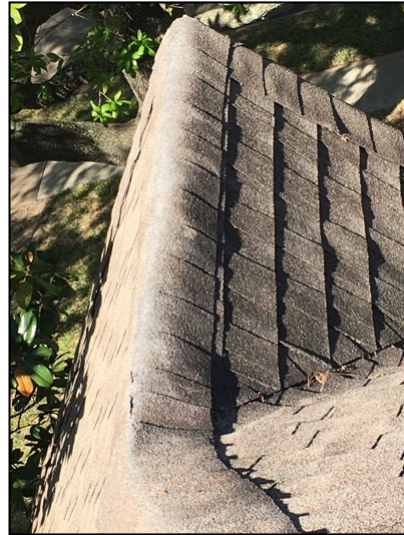
Granular loss, exposed felt and damage observed to the ridge shingles

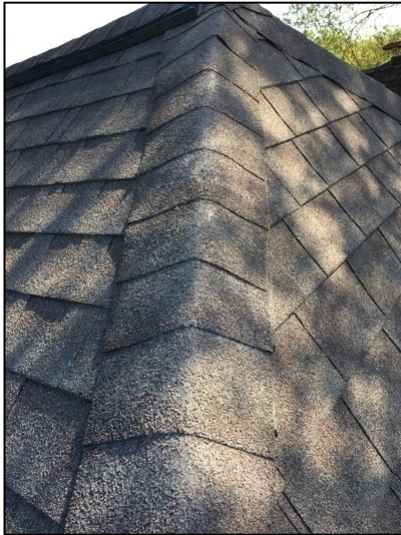
Granular loss, exposed felt and damage observed to the ridge shingles

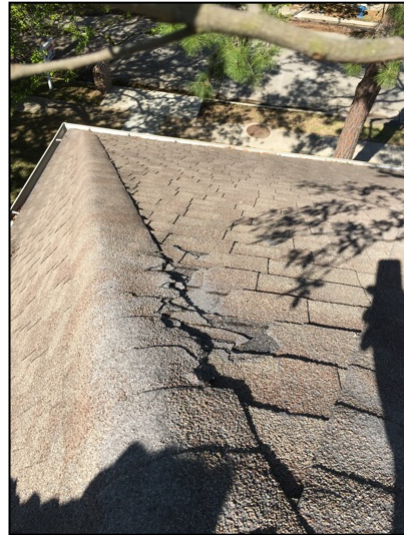
Damaged hip shingles and roof shingles observed on the front side of the roof apparently from tree abrasion

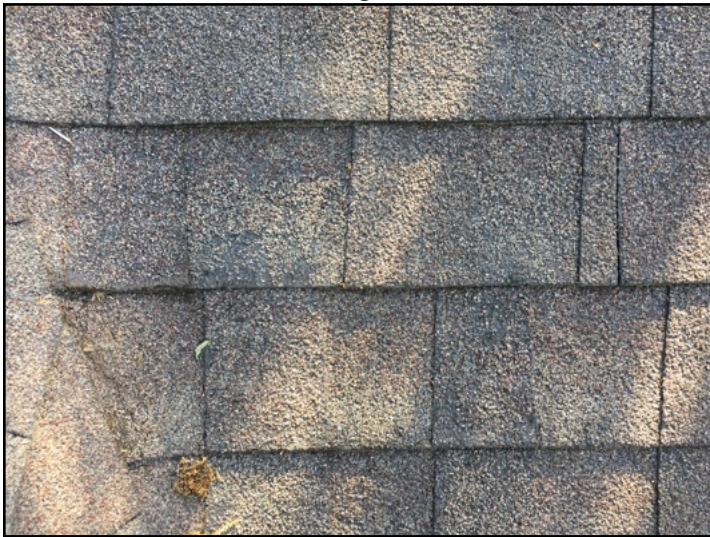
Granular loss (and loose granules) observed on the roof shingles

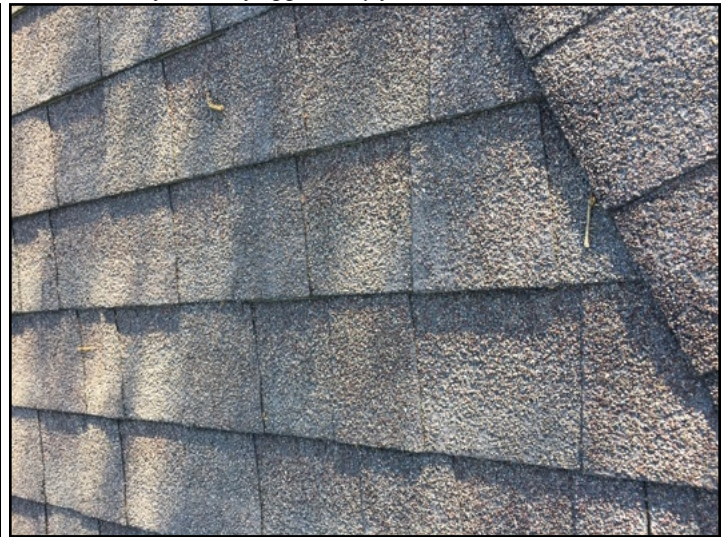
Granular loss (and loose granules) observed on the roof shingles

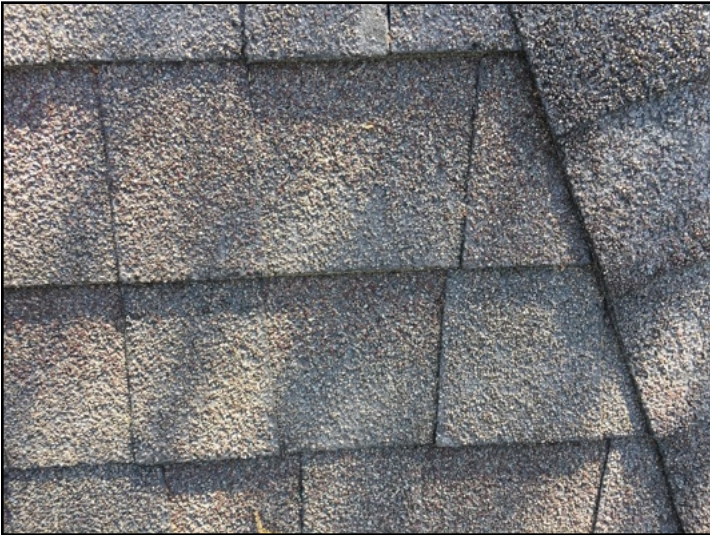
Granular loss (and loose granules) observed on the roof shingles

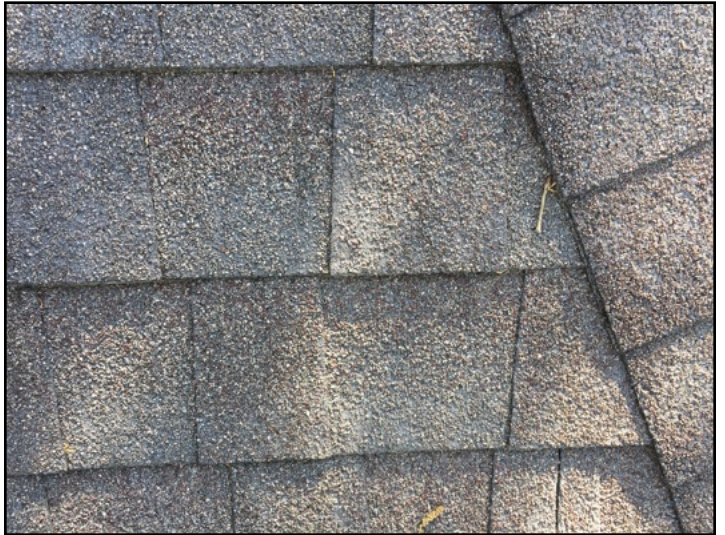
Granular loss (and loose granules) observed on the roof shingles

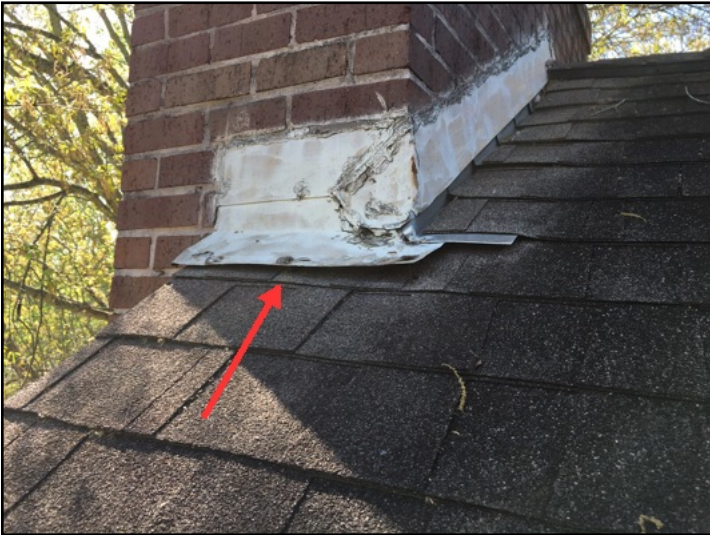
The base flashings on both sides of the chimney were lifted and should be resealed/re-secured to ensure leak free conditions

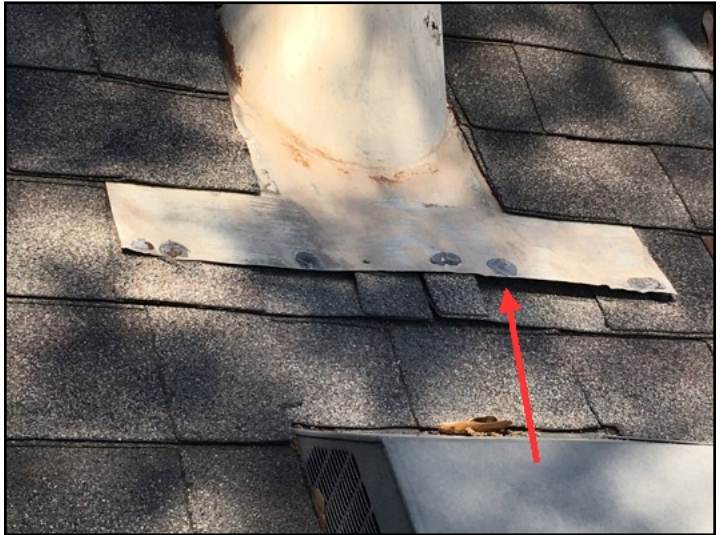
The furnace flue vent flashing on the back side of the roof was lifted and should be resealed/re-secured to ensure leak free conditions

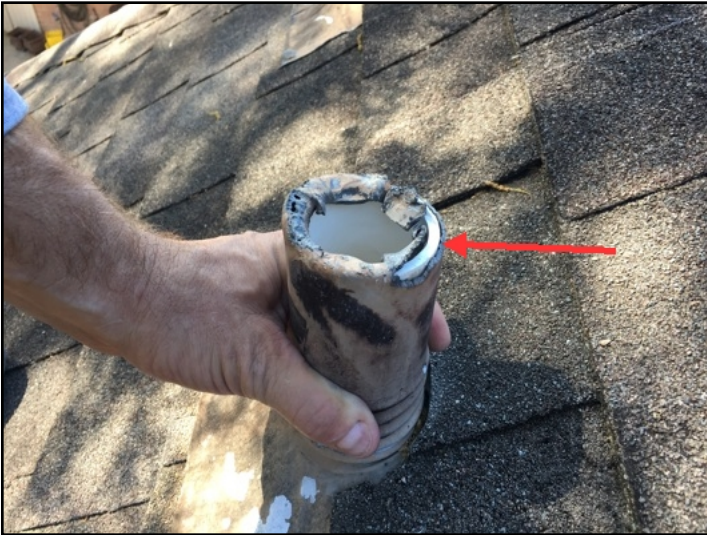
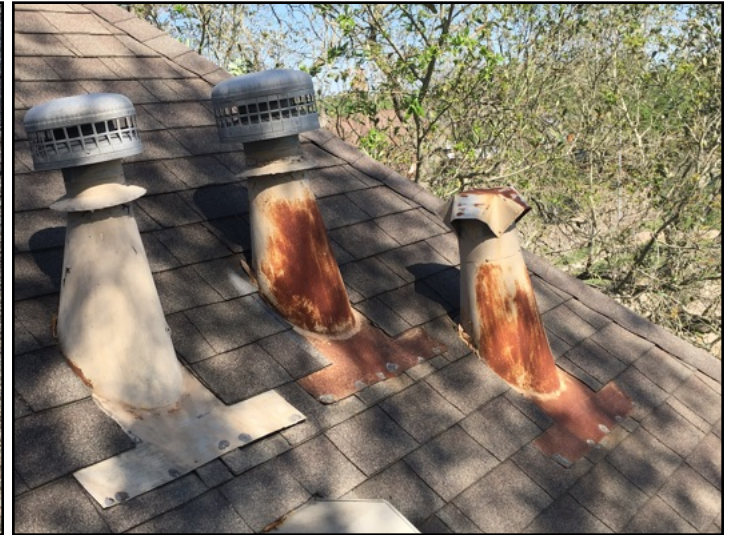
4 lead roof jacks covering the waste stacks on the back side of the roof were deteriorated around the vent pipe openings, which will allow water to run down the outside of the pipes into the attic

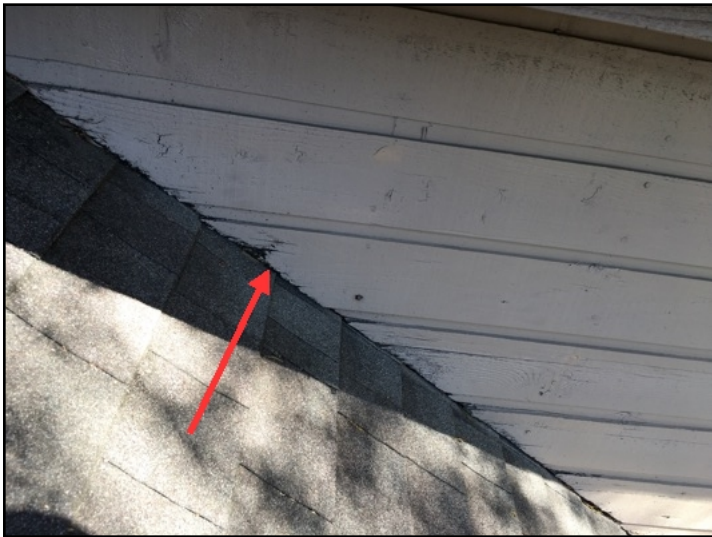
The siding had inadequate clearance between the lower edges of the siding and roof, where it intersects the roof plane on the back right side of the roof

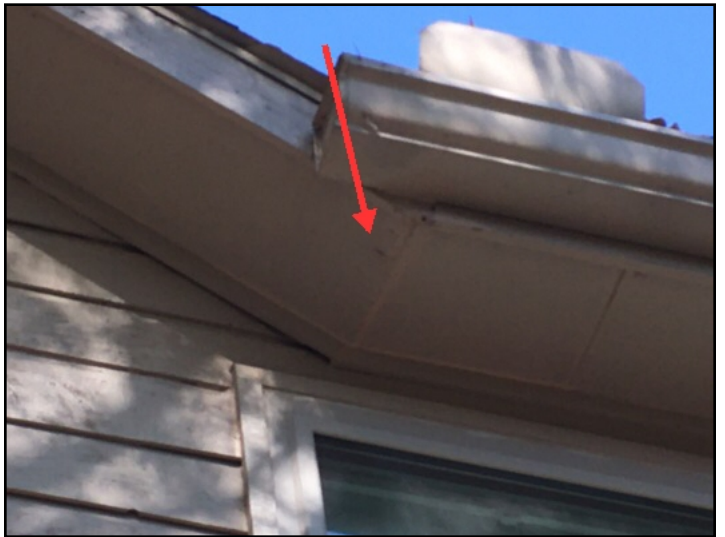
Observed a moisture deteriorated section of soffit trim on the backside of home

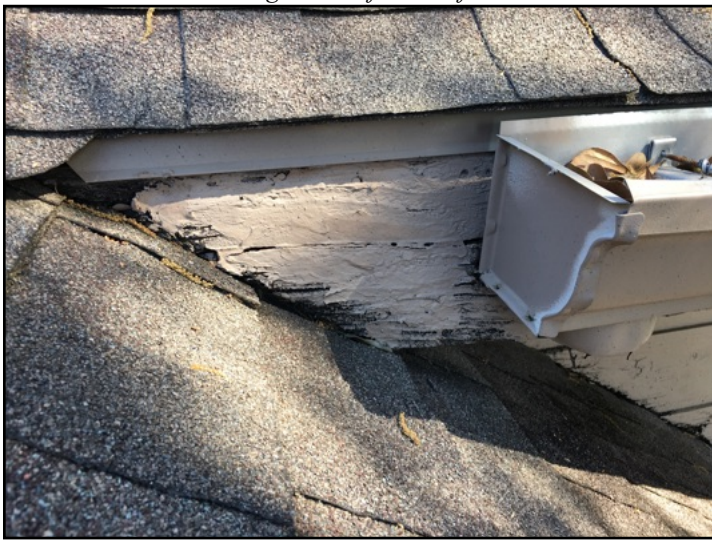
6. Observed a moisture deteriorated section of fascia trim on the back right side of the roof

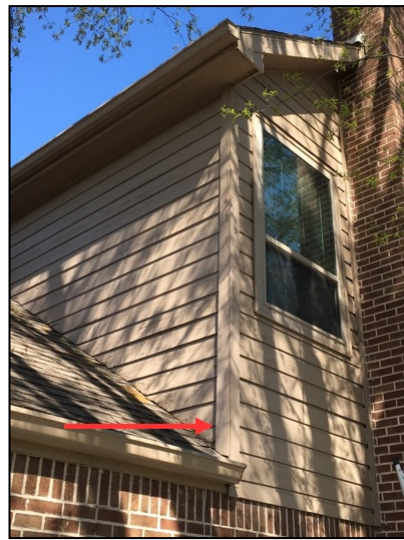
Observed loosely attached corner trim on the back side of the home

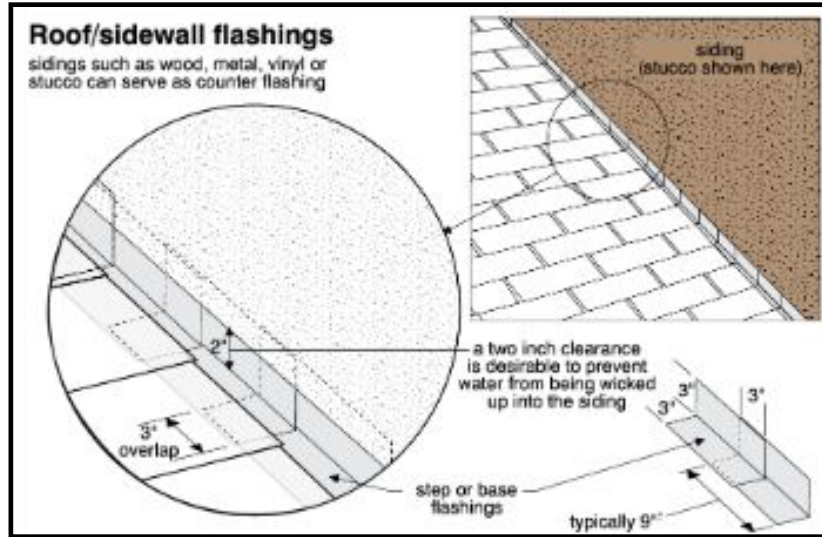
<input checked="" type="checkbox"/>	<input type="checkbox"/>	<input type="checkbox"/>	<input type="checkbox"/>
-------------------------------------	--------------------------	--------------------------	--------------------------

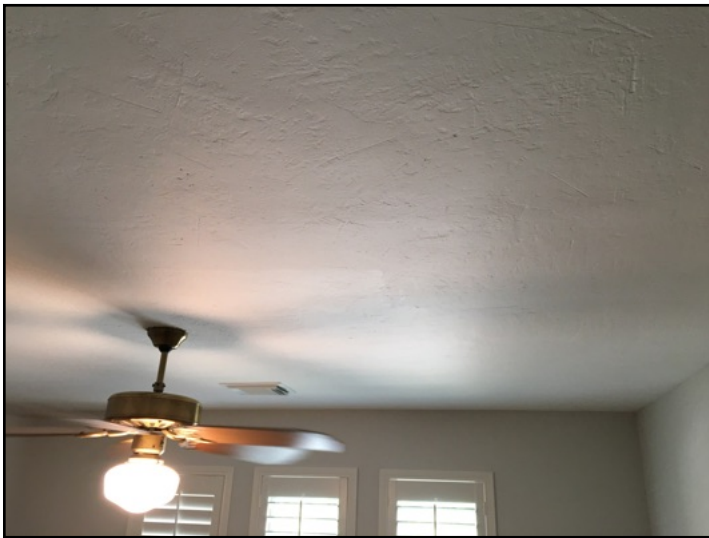
Indications of repairs (different type of texture) observed on the upstairs front bedroom ceiling

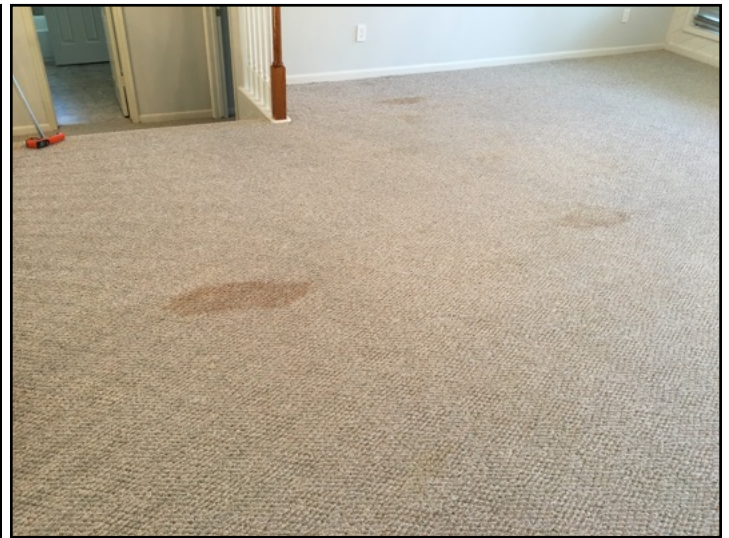
Carpet stains observed in the game room

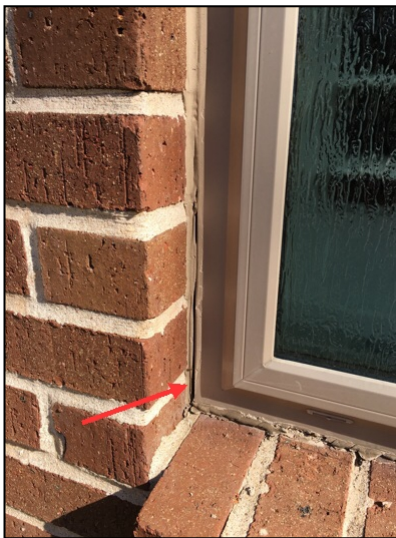
Observed areas where sealant should be applied around the windows and/or voids in the brick ledge, which penetrate the exterior veneer

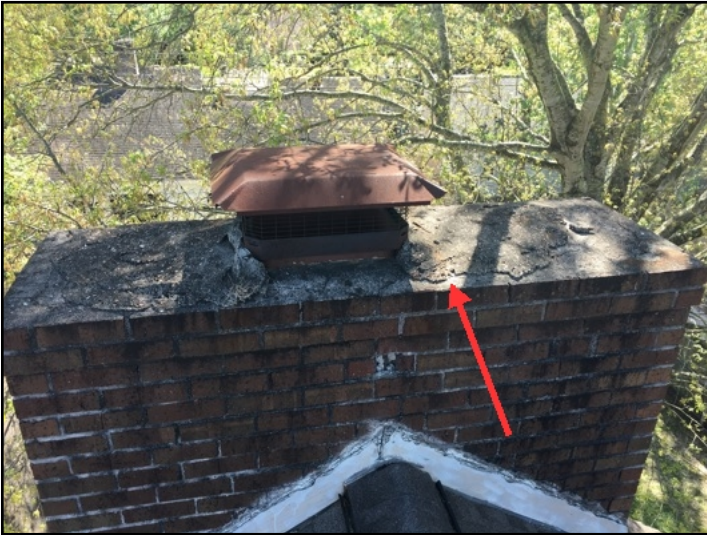
The chimney crown was deteriorated/cracked and needs to be sealed/replaced to prevent moisture from entering the chimney

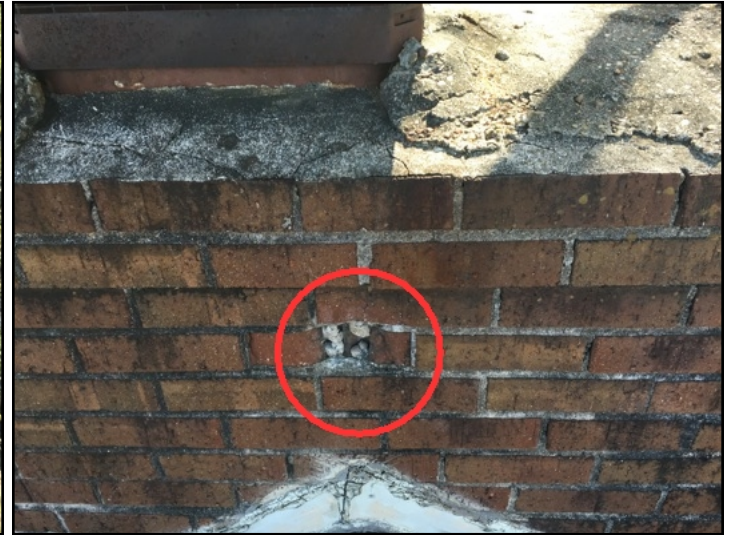
A chimney brick was deteriorated/damaged on the left side of the chimney

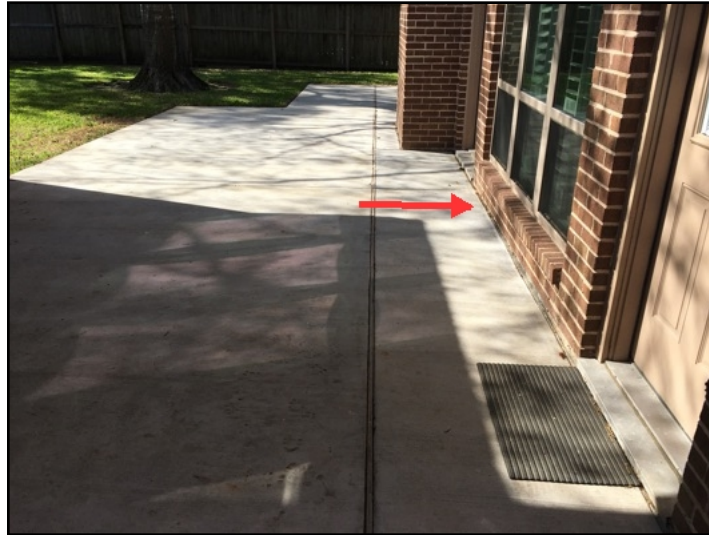
The back patio was sloping toward the home, which can cause water to settle next to the home foundation

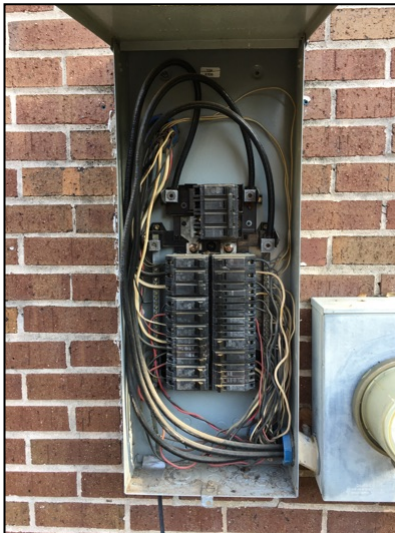
- The main panel was not bonded to the neutral bar, which may result in improper grounding of the panel; recommend a bonding jumper be installed.

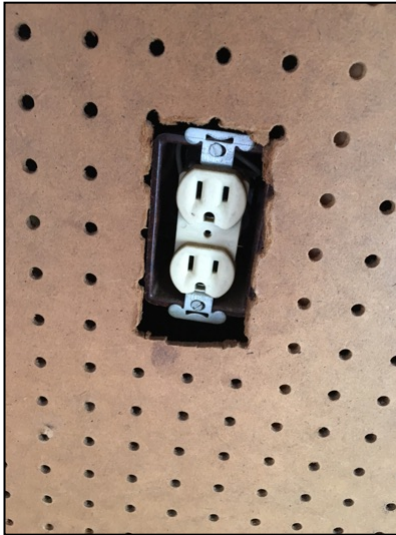
Observed missing receptacle cover plates in the garage

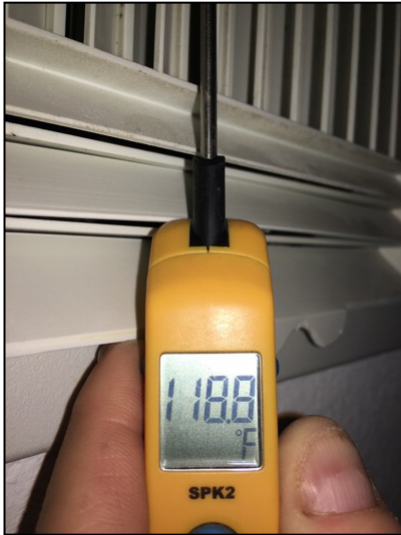
Downstairs supply temperature

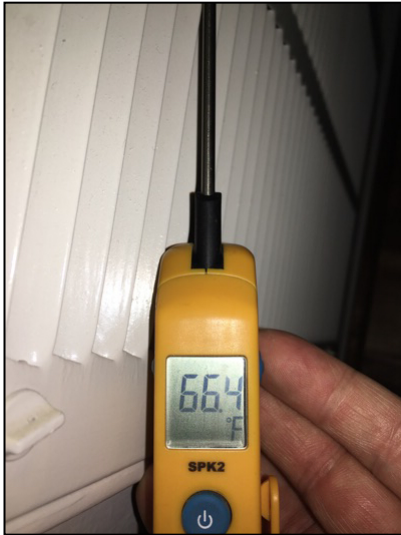
Downstairs return temperature

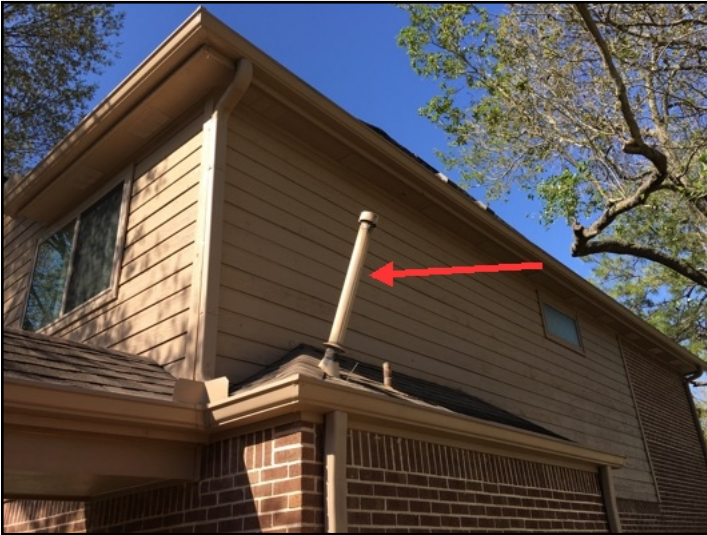
The water heater flue vent termination at the back left corner of the home was improper

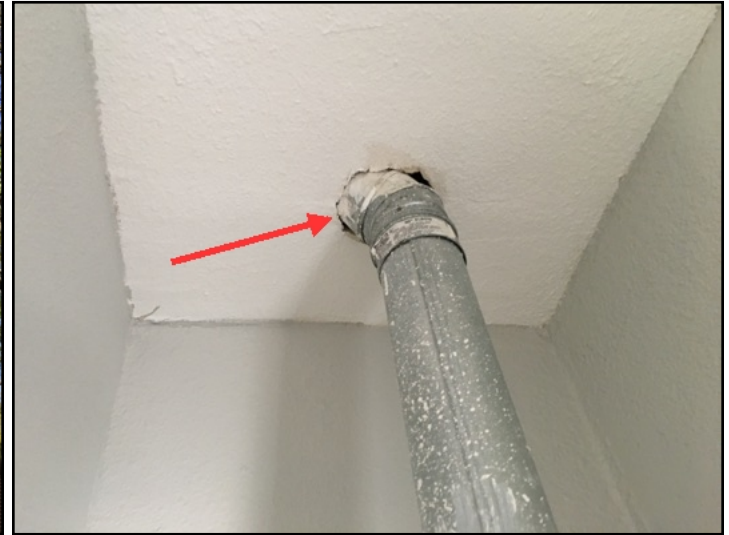
A fire-stop plate was not installed for the water heater flue vent at the ceiling penetration in the laundry room

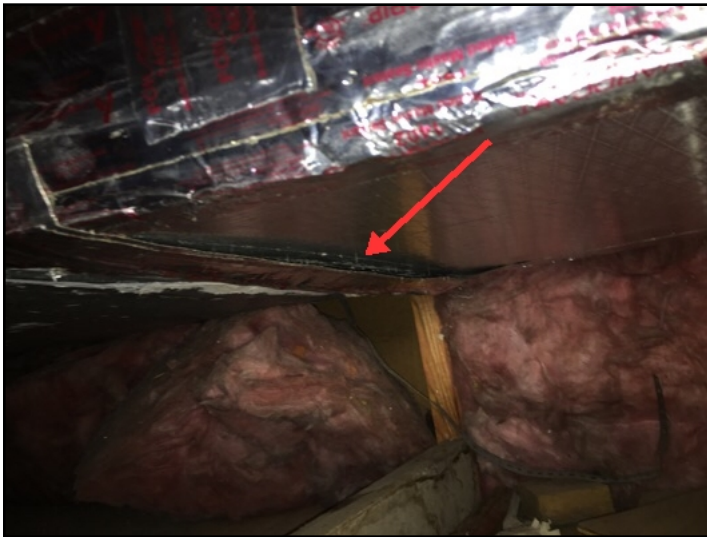
A joint in the supply plenum for the right HVAC unit was not secured properly, which was allowing conditioned air to escape

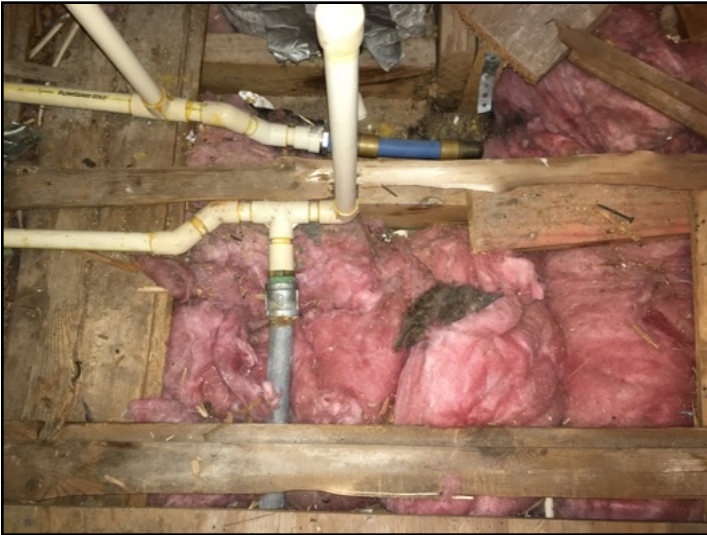
3 different water supply lines were observed in the home- galvanized, CPVC and PEX

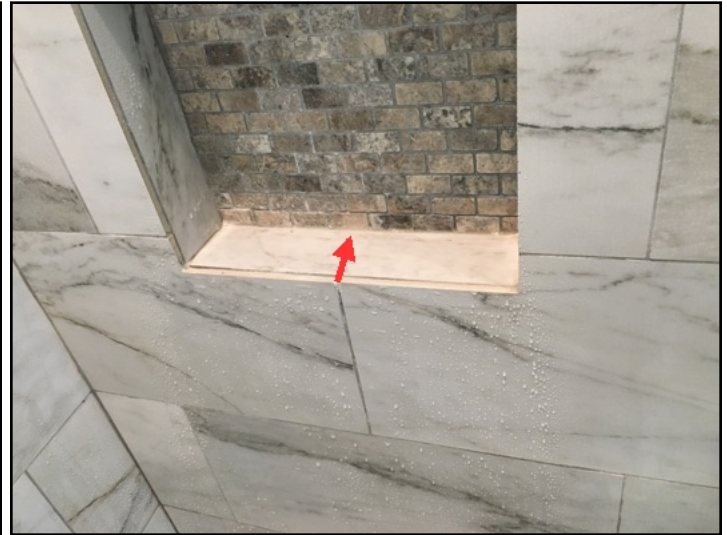
The master bathroom shower soap shelf was sloped towards the wall which can cause standing water and possible moisture penetration behind the wall

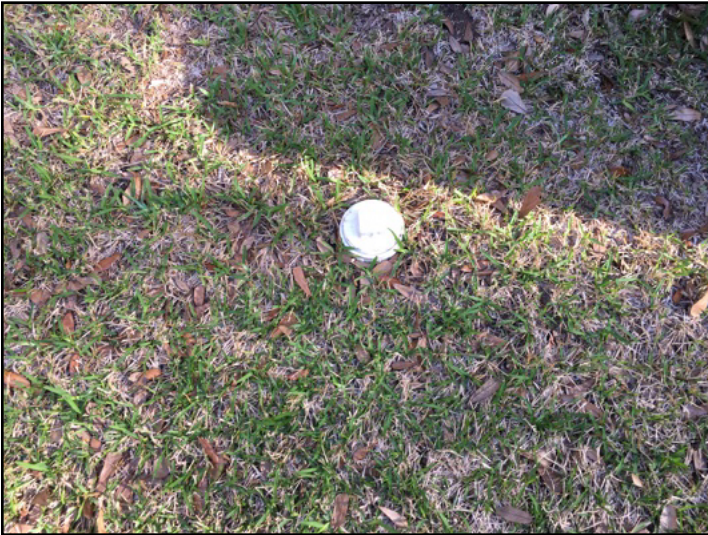
The main waste clean out was located on the right side of the home

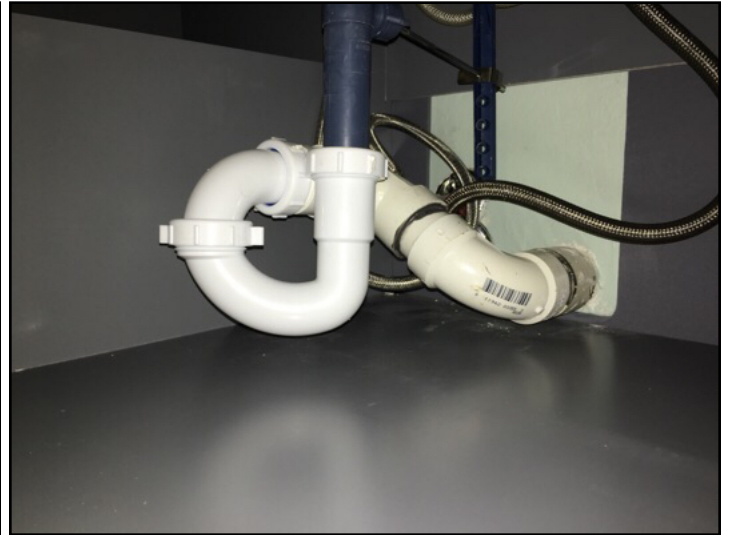
An improper S-trap was installed for the half bathroom lavatory

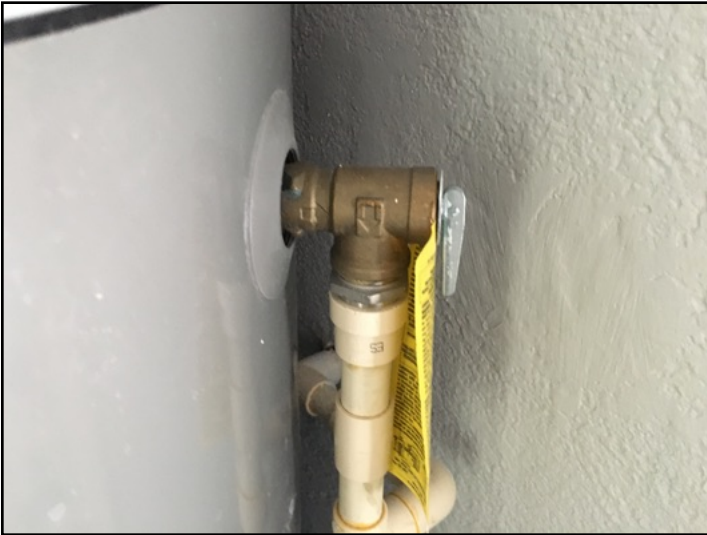
Water heater TPR safety valve

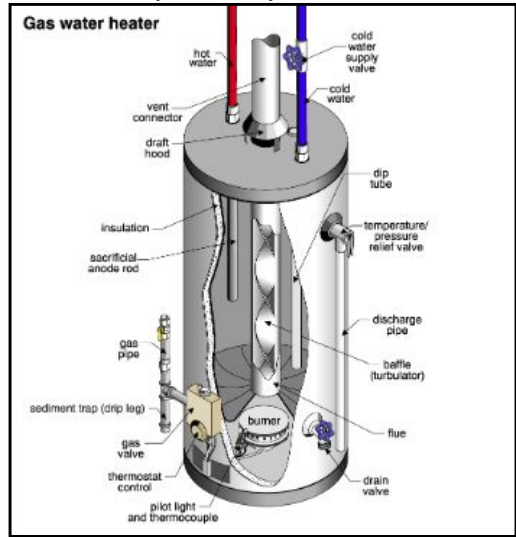
I=Inspected NI=Not Inspected NP=Not Present D=Deficient

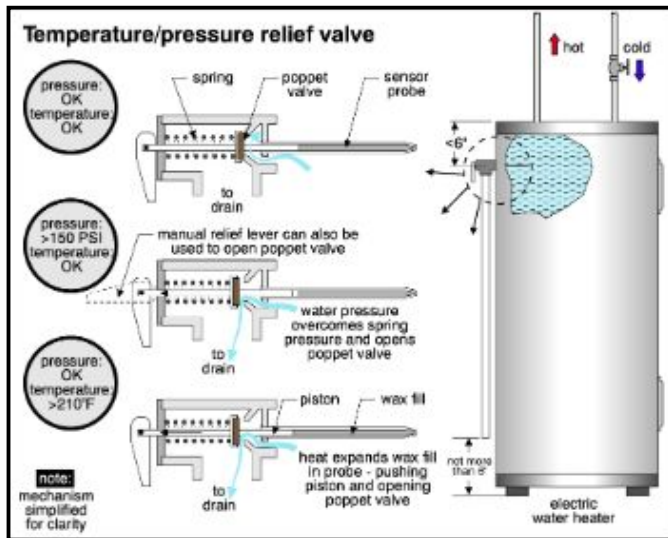
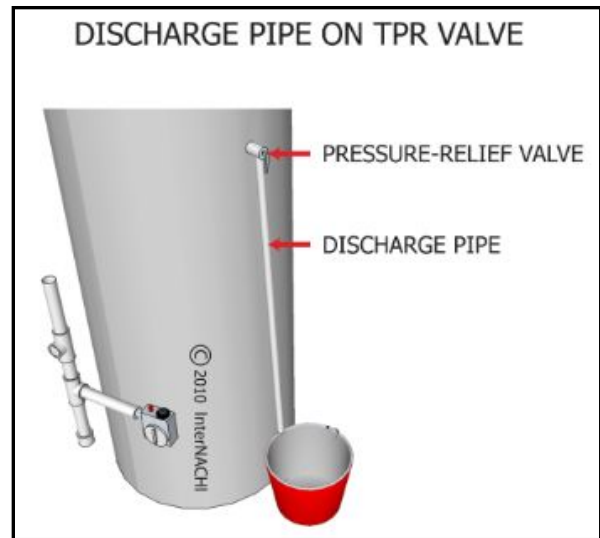
D. Hydro-Massage Therapy Equipment

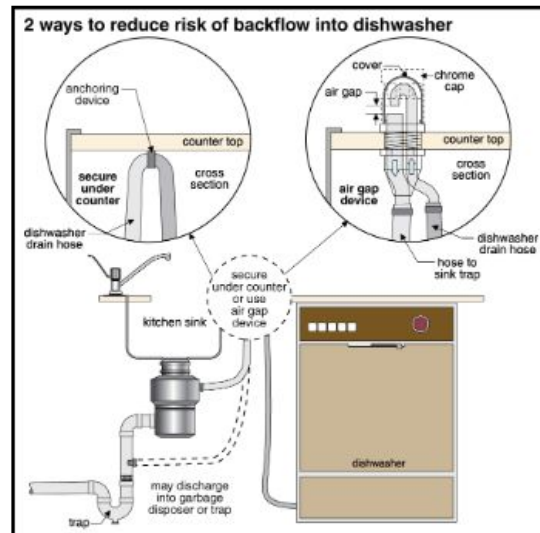
B. Food Waste Disposers

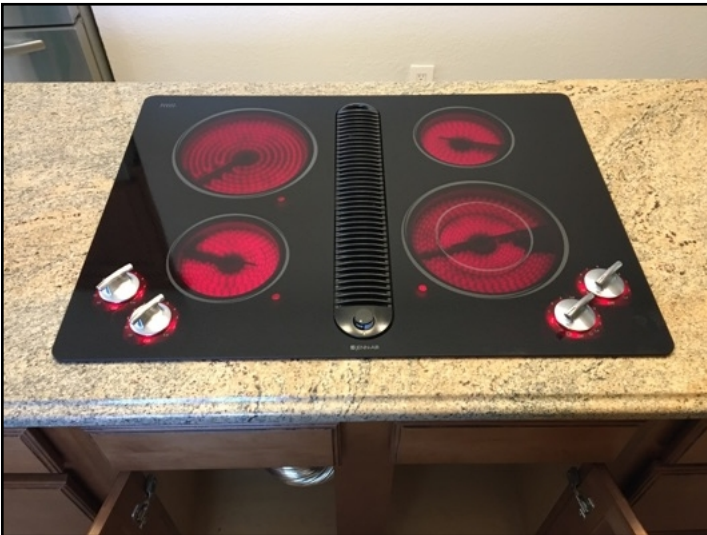
- The cooktop elements were functional on low, medium and high settings. These can fail at anytime without warning. No warranty, guarantee, or certification is given as to future performance or life expectancy.
- The oven was tested using normal controls at the time of inspection and the elements appeared to function properly. The self cleaning and timer operations are not inspected. These can fail at anytime without warning. No warranty, guarantee, or certification is given as to future performance or life expectancy.
- When both ovens were set for a temperature of 350°F, the actual temperature in the upper oven was 365°F and the lower oven was 360°F. Within +/- 25 degrees is considered the normal range.
