# Syncryy Home Inspections

## **PROPERTY INSPECTION REPORT**

Prepared For:	Rudi Herrera	
	(Name of Client)	
Concerning:	28703 Leon River Ct., Spring, TX 77386	
	(Address or Other Identification of Inspected Property)	
By:	Synergy Home Inspections - 9041	08/25/2017
	(Name and License Number of Inspector)	(Date)
	(Name, License Number Sponsoring Inspector)

### Report Identification: 28703 Leon River Ct. Spring, TX 77386

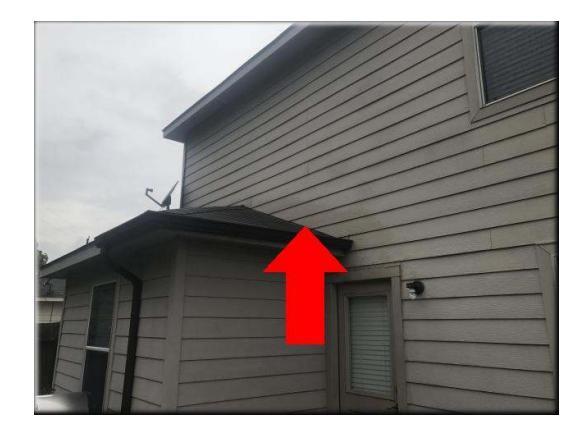
- Observed shingles that have little sealant bond strength and can easily be lifted by hand.
- Shingles lifted in on roof. Due to possible wind lift. All shingles should lay flat. Inspector found that the shingle nails were not properly driven flush with under shingle causing current condition. Recommend having nails driven flush with under shingle and if necessary use T114 or some other roof mastic to insure shingles lay flat. Recommend repairs by a licensed roofing company.

- J-Flashing is installed where the vertical side wall and roof meet together. The International Residential Code for One and Two family dwellings in section R905.2.8.4 states flashing against a vertical sidewall shall be by the "step-flashing" method and shingle manufacturers specify the flashing should be "step flashing" also. Although the City of Houston has removed this section from the City of Houston adopted code, the client is advised that "J-Flashing" offers no protection for wind uplift of the shingles and this flashing is more prone to water intrusion. If replacing the roof, it is recommended to have your roofing contractor use "step flashing".

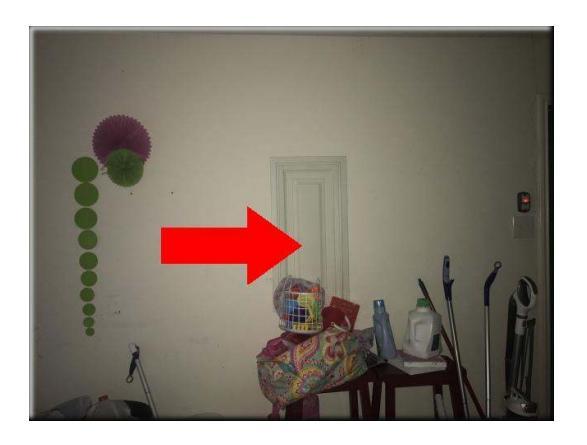
• Firewall between the attached garage and living area has been damaged with the PEX plumbing system installation. The firewall should not be broken and is considered a safety concern in this Inspectors' opinion. The following 2009 International Residential Building Code is provided for your reference: R302.6 Dwelling/garage fire separation. The garage shall be separated as required by Table R302.6. Openings in garage walls shall comply with Section R302.5.

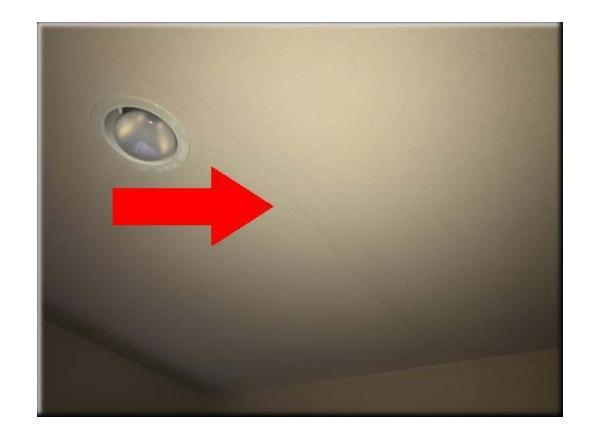
Living Room

• There is evidence of moisture penetration from an undetermined source to the ceiling.

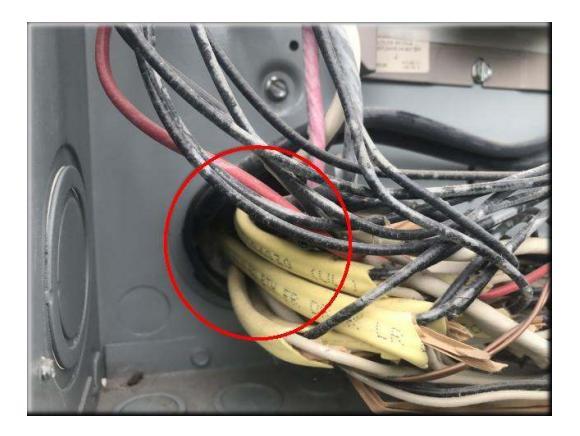
• Numerous branch circuit cables are improperly entering the main service entrance panel through a single large knock out located at the bottom of the panel box. Under current and past electrical standards branch circuit cables shall be individually secured to the panel box, cabinet, cut out box, or meter socket enclosure with appropriate clamps at the knock out interface. The panel, as installed, does not comply with current and past fire regulations.

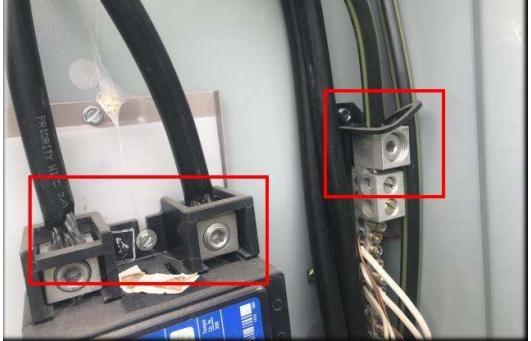
• There is no antioxidant paste on the aluminum feeder wires where they connect to the main breaker.

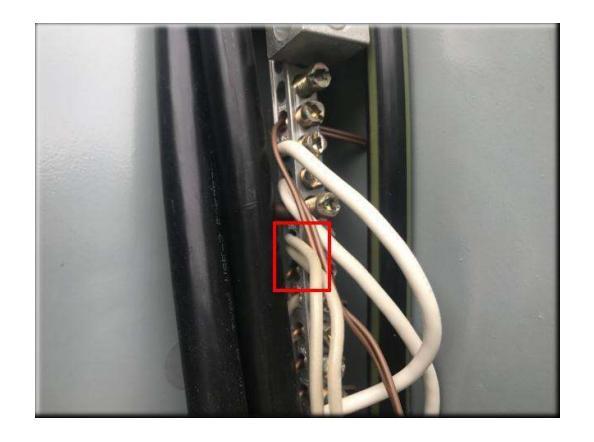
• More than one Neutral and or Grounding conductor (wires) improperly clumped together under one terminal connection. Terminals in general are listed to accept no more than one wire per termination.

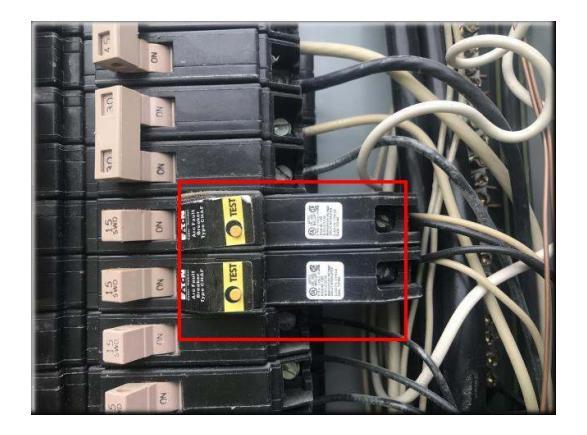
• Observed branch feeder AFCI's and not the combination type.

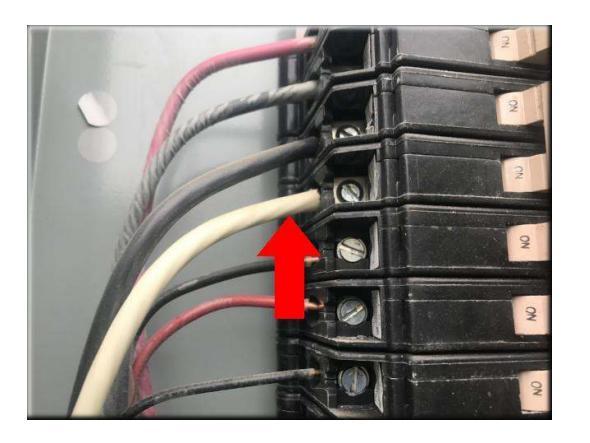
Observed improper use of normal wire conductor colors. Observed black wire used for other than ungrounded / hot conductors, <u>white wire used for other than grounded /</u> <u>neutral</u>, and/or bare green wire use for other than grounding conductors.

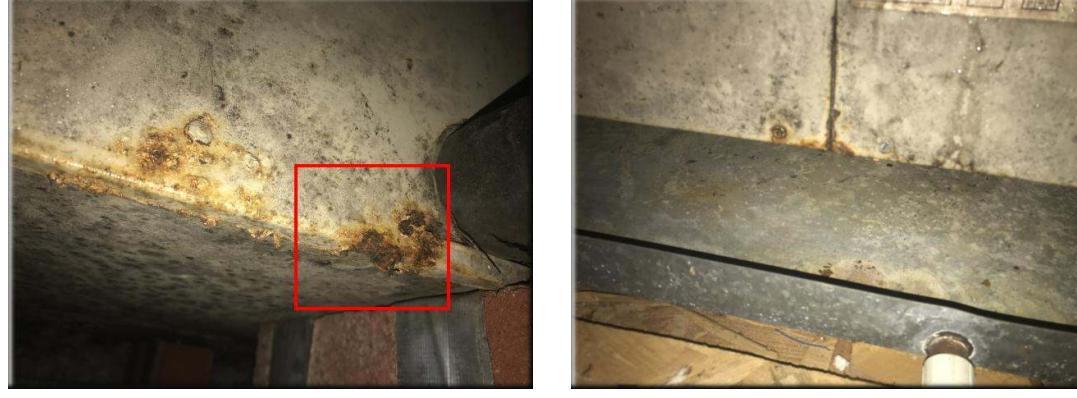
Notice: Temperature differential readings are a fundamental standard for testing the proper operation of the cooling system. The normal acceptable range is considered
approximately between 15 to 23 degrees F. total difference between the return air and sup
air. Unusual conditions such as excessive humidity, low outdoor temperatures, and restrict
airflow may indicate abnormal operation even through the equipment is functioning basic
as designed and occasionally may indicate normal operation in spite of an equipment
malfunction.
Issues:
<ul> <li>Bottom of casing has rust pitting, consistent with limited serviceable life.</li> </ul>

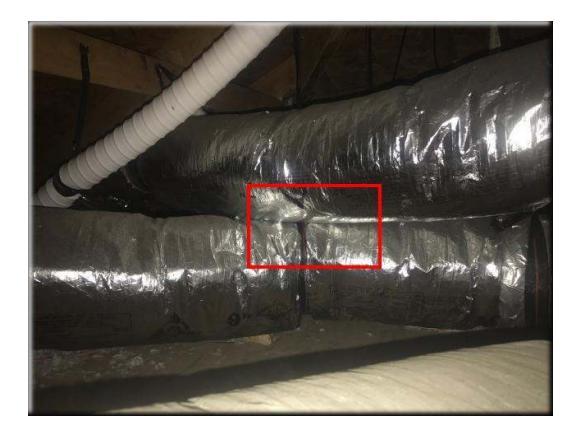
• Areas where the a/c ducts are touching. These areas are likely to produce condensation and cause an inefficient system.

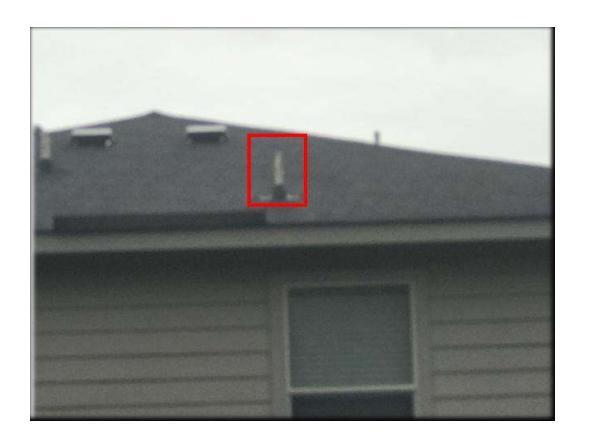
All exterior PVC roof plumbing should be painted to prevent damage from the sun.

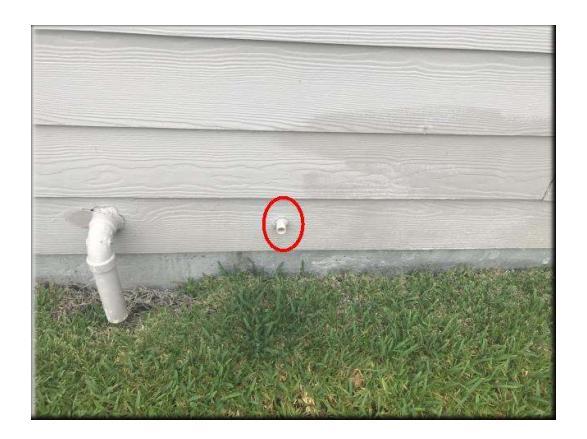
• The 90 degree elbow is missing / damaged on the water heater drain line termination.
