# **PROPERTY INSPECTION REPORT**

## 15 Taupewood Place, Conroe, TX, 77384

YEAR BUILT: 2001 SIZE: 3077 Sq Ft sq ft INSPECTION PREPARED FOR: Matt Short INSPECTOR: Robert Saji LICENSE: License # 10287

DATE & TIME OF INSPECTION: 9/7/2020 WEATHER: Clear & Hot

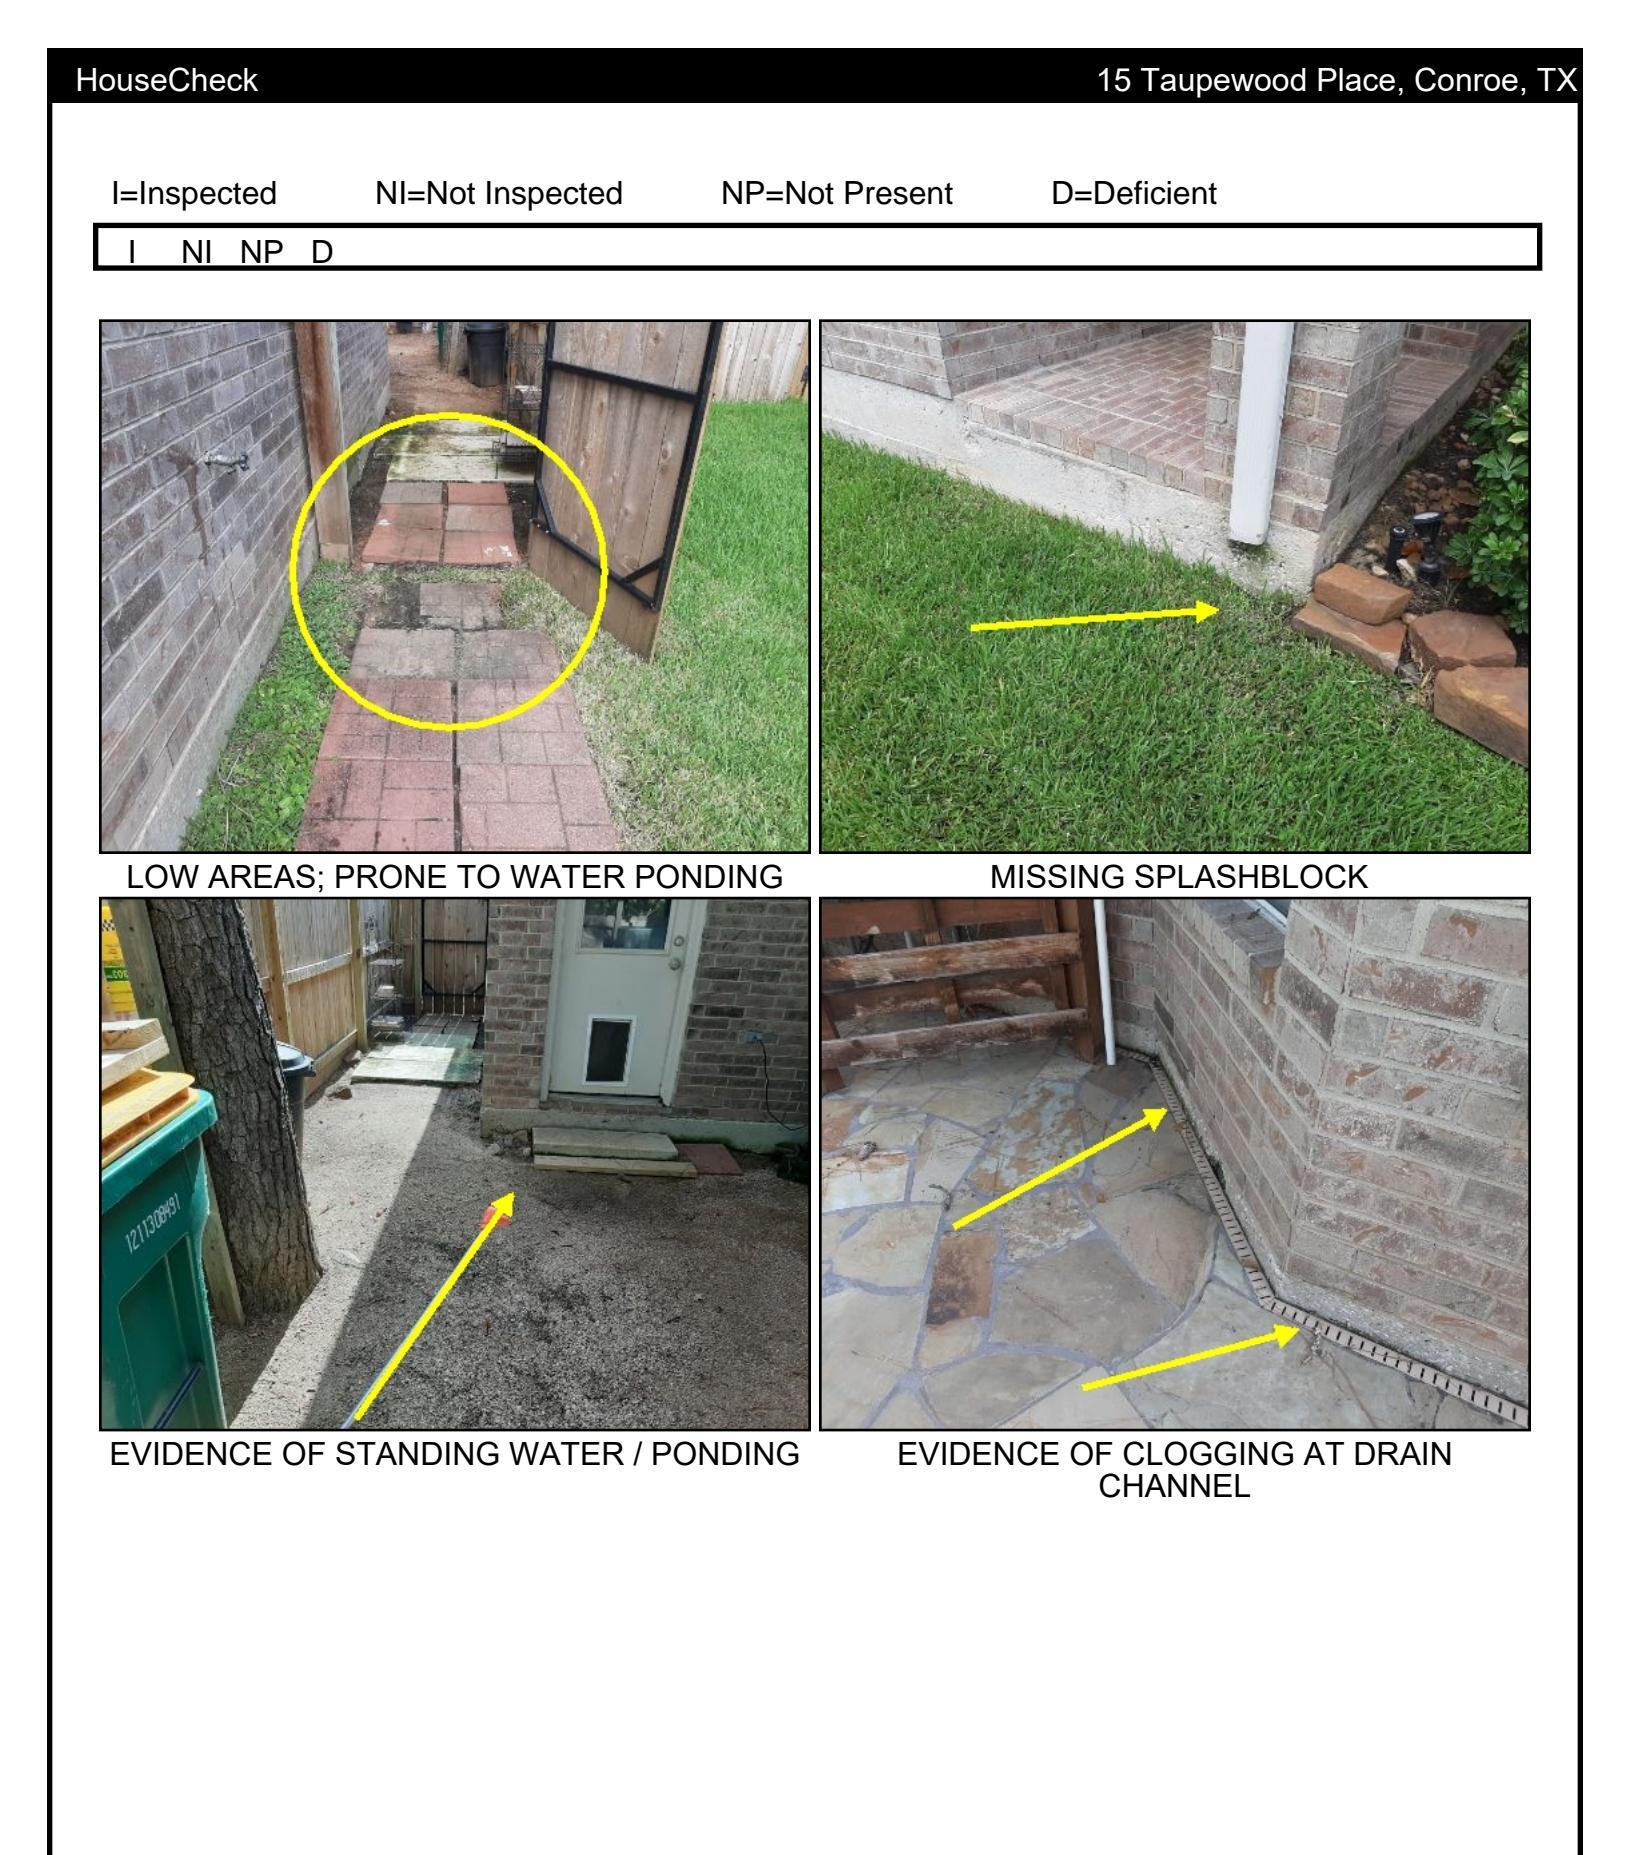
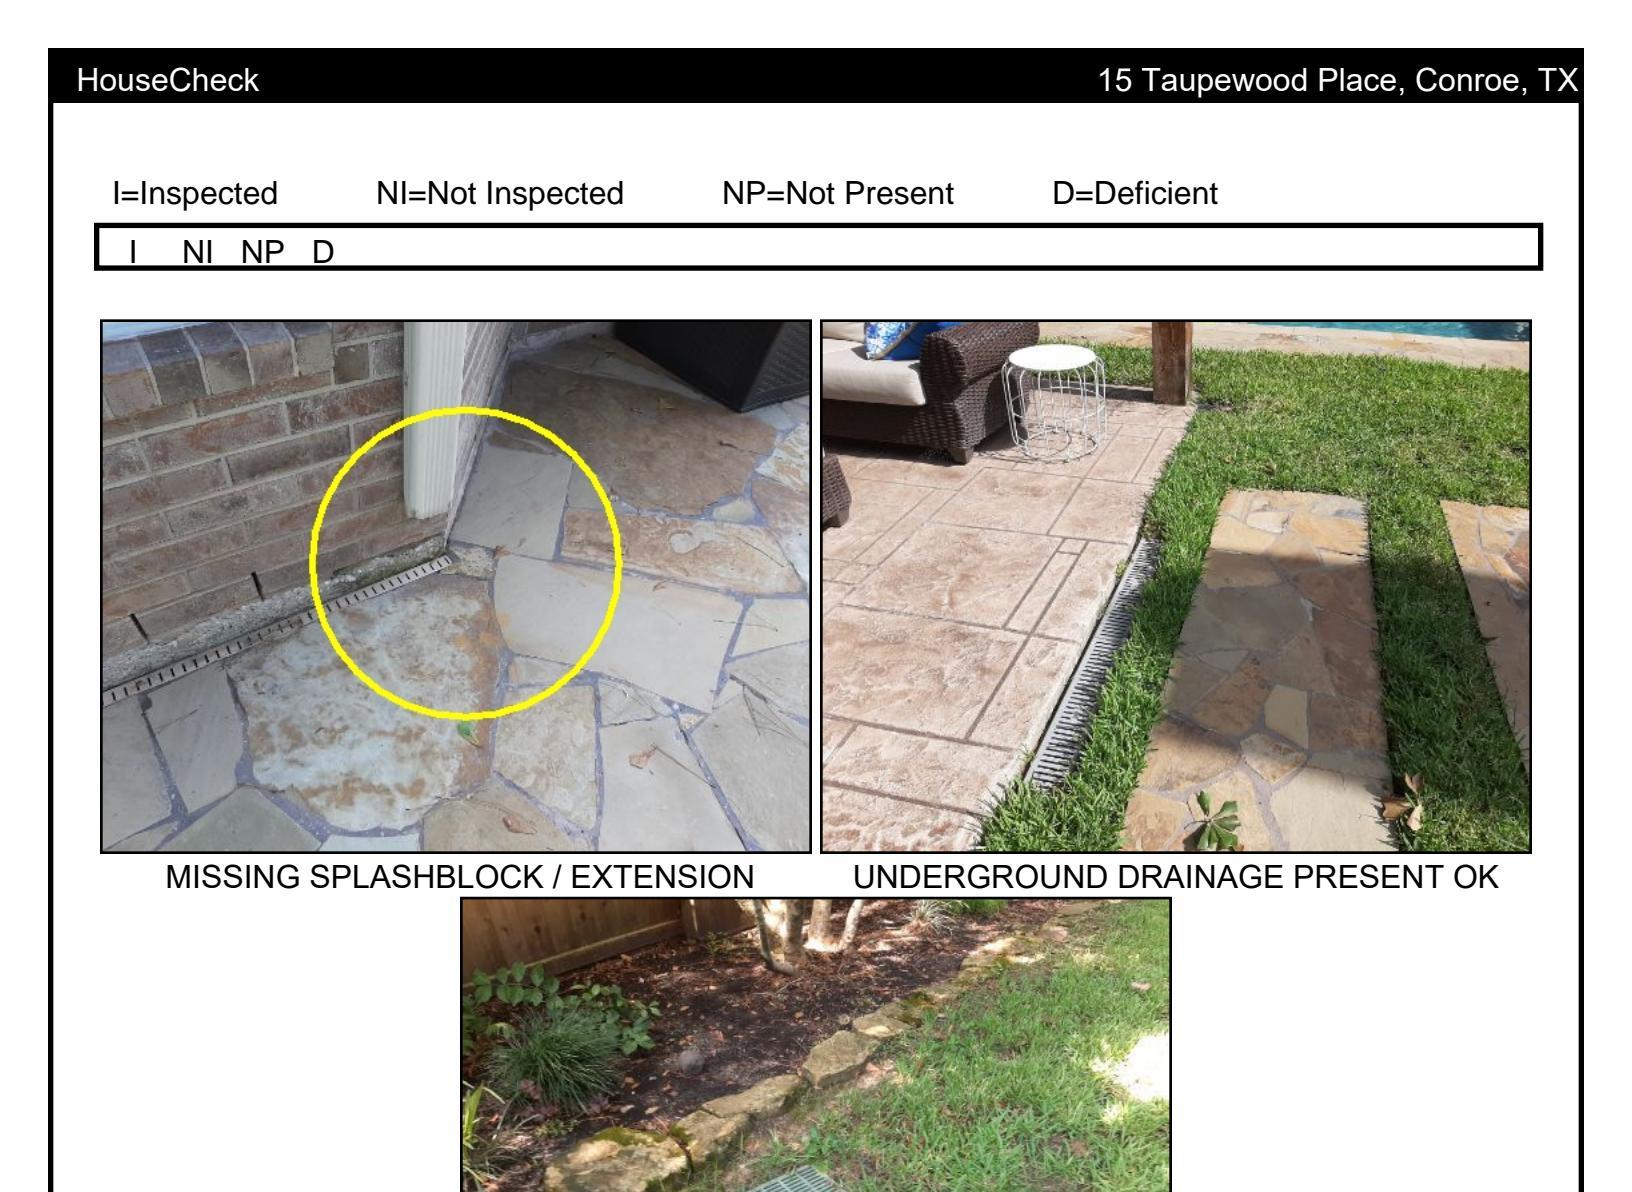
## HouseCheck 15 Taupewood Place, Conroe, TX NP=Not Present D=Deficient I=Inspected NI=Not Inspected NI NP D B. Grading and Drainage Х Comments. About Grading and Drainage: Proper grading and drainage away from the structure is vital to the performance of the foundation. Water intrusion can cause wood rot, attract insects and encourage growth of possible organic materials. As a general rule, the ground should slope 6" within the first 10' away from the house. Clearance to wall siding should be at least 4" for brick, stone, or fiber cement and 6" for any other siding materials. Grading and drainage is inspected visually around the site. Flood plain research, soil and topographical studies are not performed as a part of the inspection. Any deficiencies found could be an indication of a more serious condition and should be evaluated by a qualified professional if there are concerns. Underground drainage was observed at the time of inspection. This is not tested as it is beyond the scope of this inspection. • NOTE: all slopes of the roof should be guttered to ensure that water is adequately diverted away from the structure. Evidence of standing water (ponding) was observed against or near the foundation. Poor grading was noted. This condition should be improved to promote the flow of water away from the structure. • Splash block(s) at the base of the gutter downspouts should be added to prevent erosion of soil from grade. Downspouts should be present to adequately direct water away from the foundation. NO GUTTER SECTIONS NO GUTTER SECTIONS

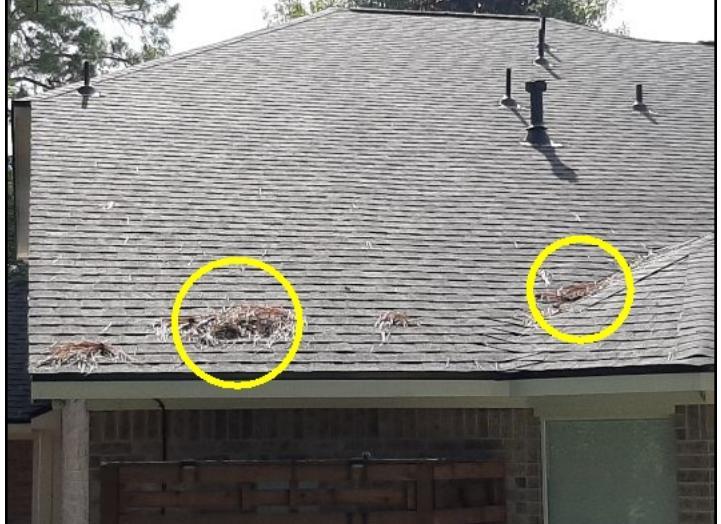
<ul> <li>This generally consists to-roof intersections.</li> <li>The roof covering wa time of inspection.</li> <li>There is debris from a roof coverings ability to</li> </ul>	s of resealing gaps at th s inspected and show t nearby tree on roof cov	an annual or semi-annual basis. rough-the-roof projections and wall- ypical signs of wear and age at the ering. This debris can impede the aks and premature aging of the roof n debris.

DEBRIS AT ROOFTOP

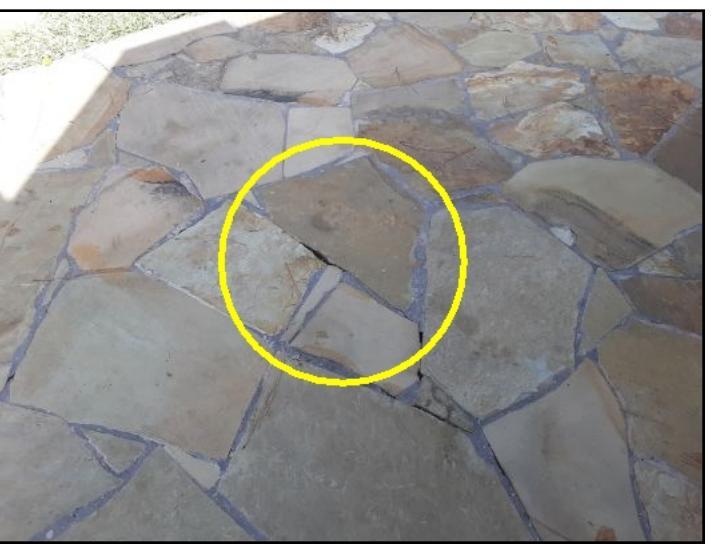
DAMAGE / VOIDS AT PATIO MORTAR

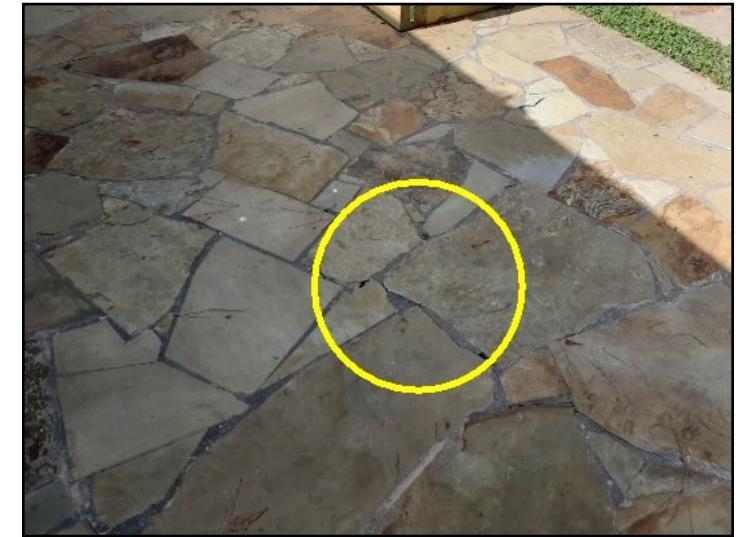
DAMAGE / VOIDS AT PATIO MORTAR

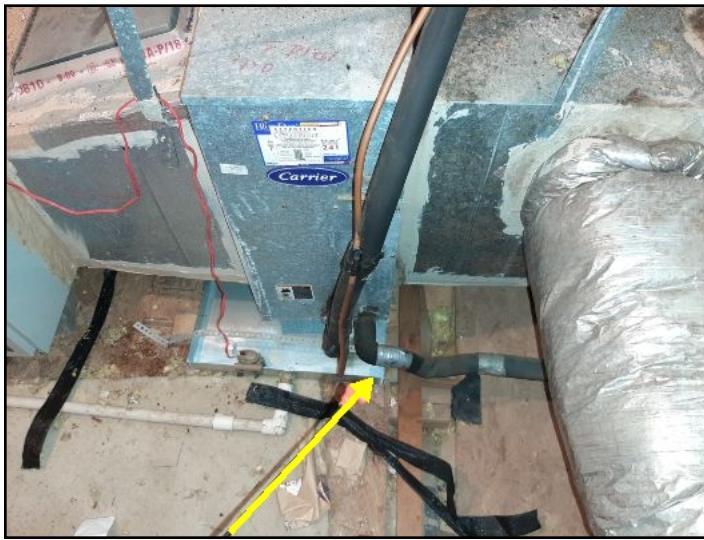
Drain pan does not fully cover evaporator. Ensure all areas are protected from water leaks and overflow.

DRAIN PAN DOES NOT FULLY COVER EVAPORATOR

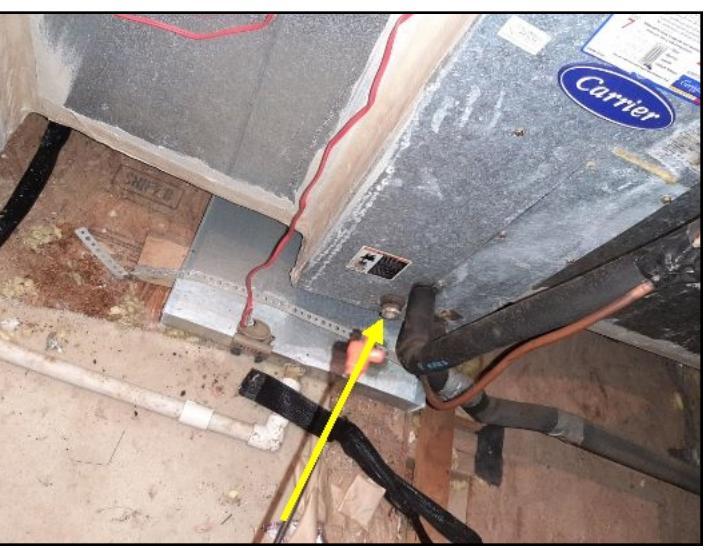
MISSING OVERFLOW DRAIN PIPE

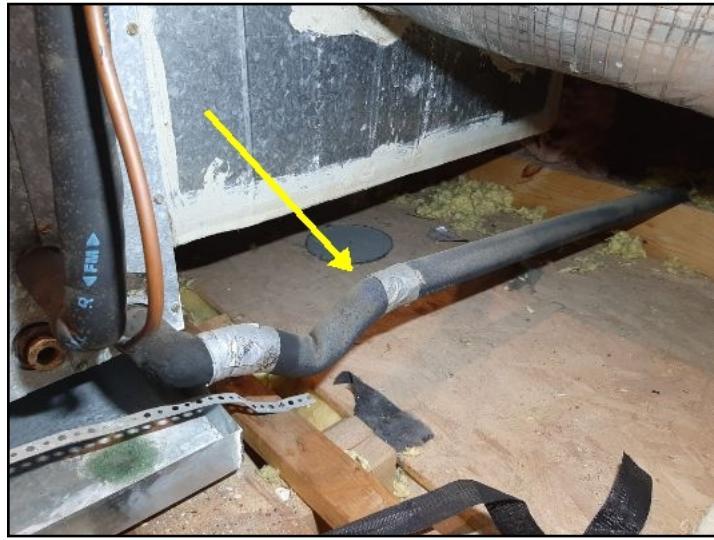
MISSING / NO ACCESS TO PIPE FOR CLEANING AND MAINTENANCE

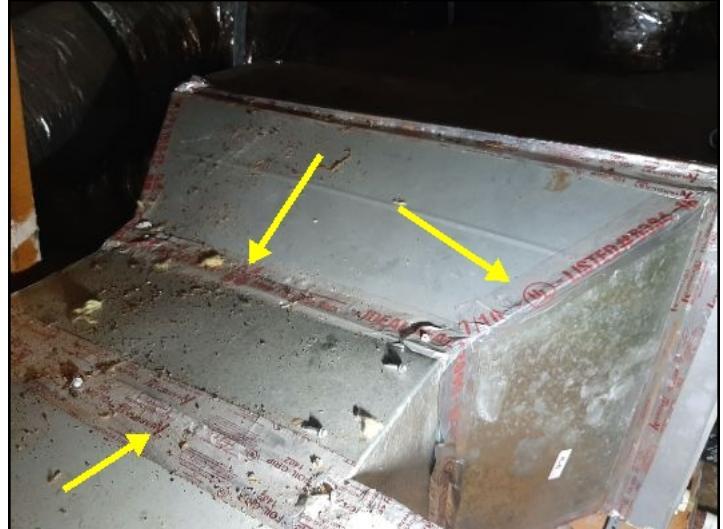
**MISSING / NO FIBER PAINT**

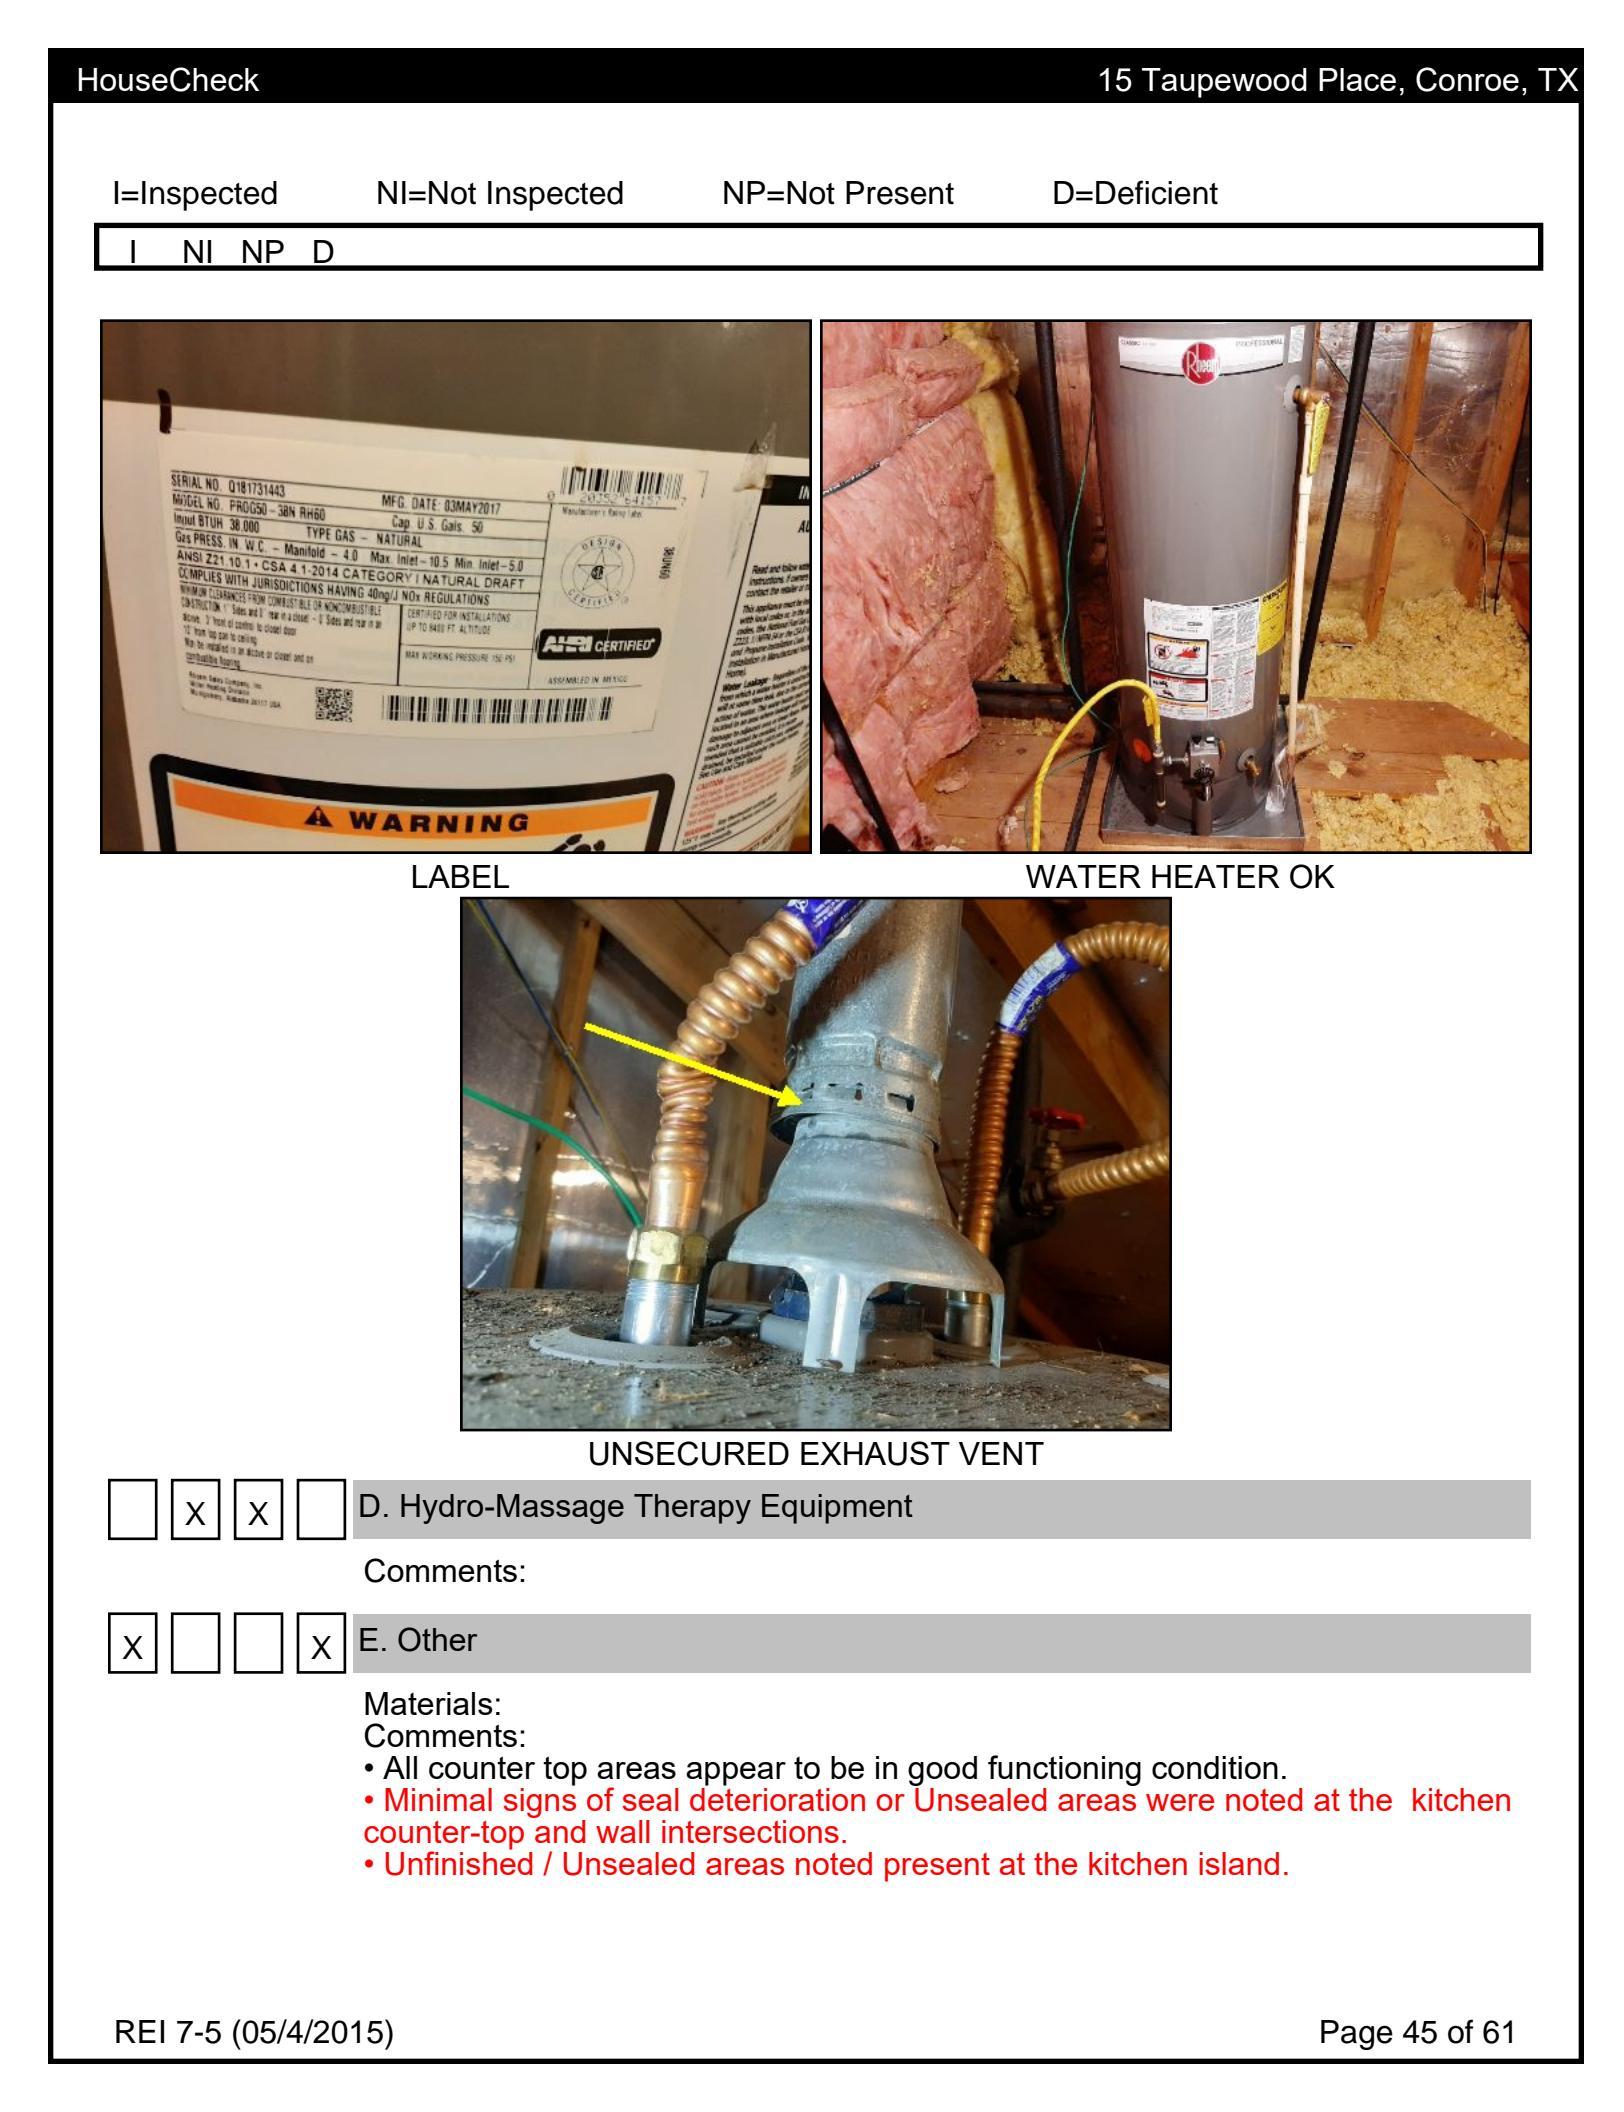
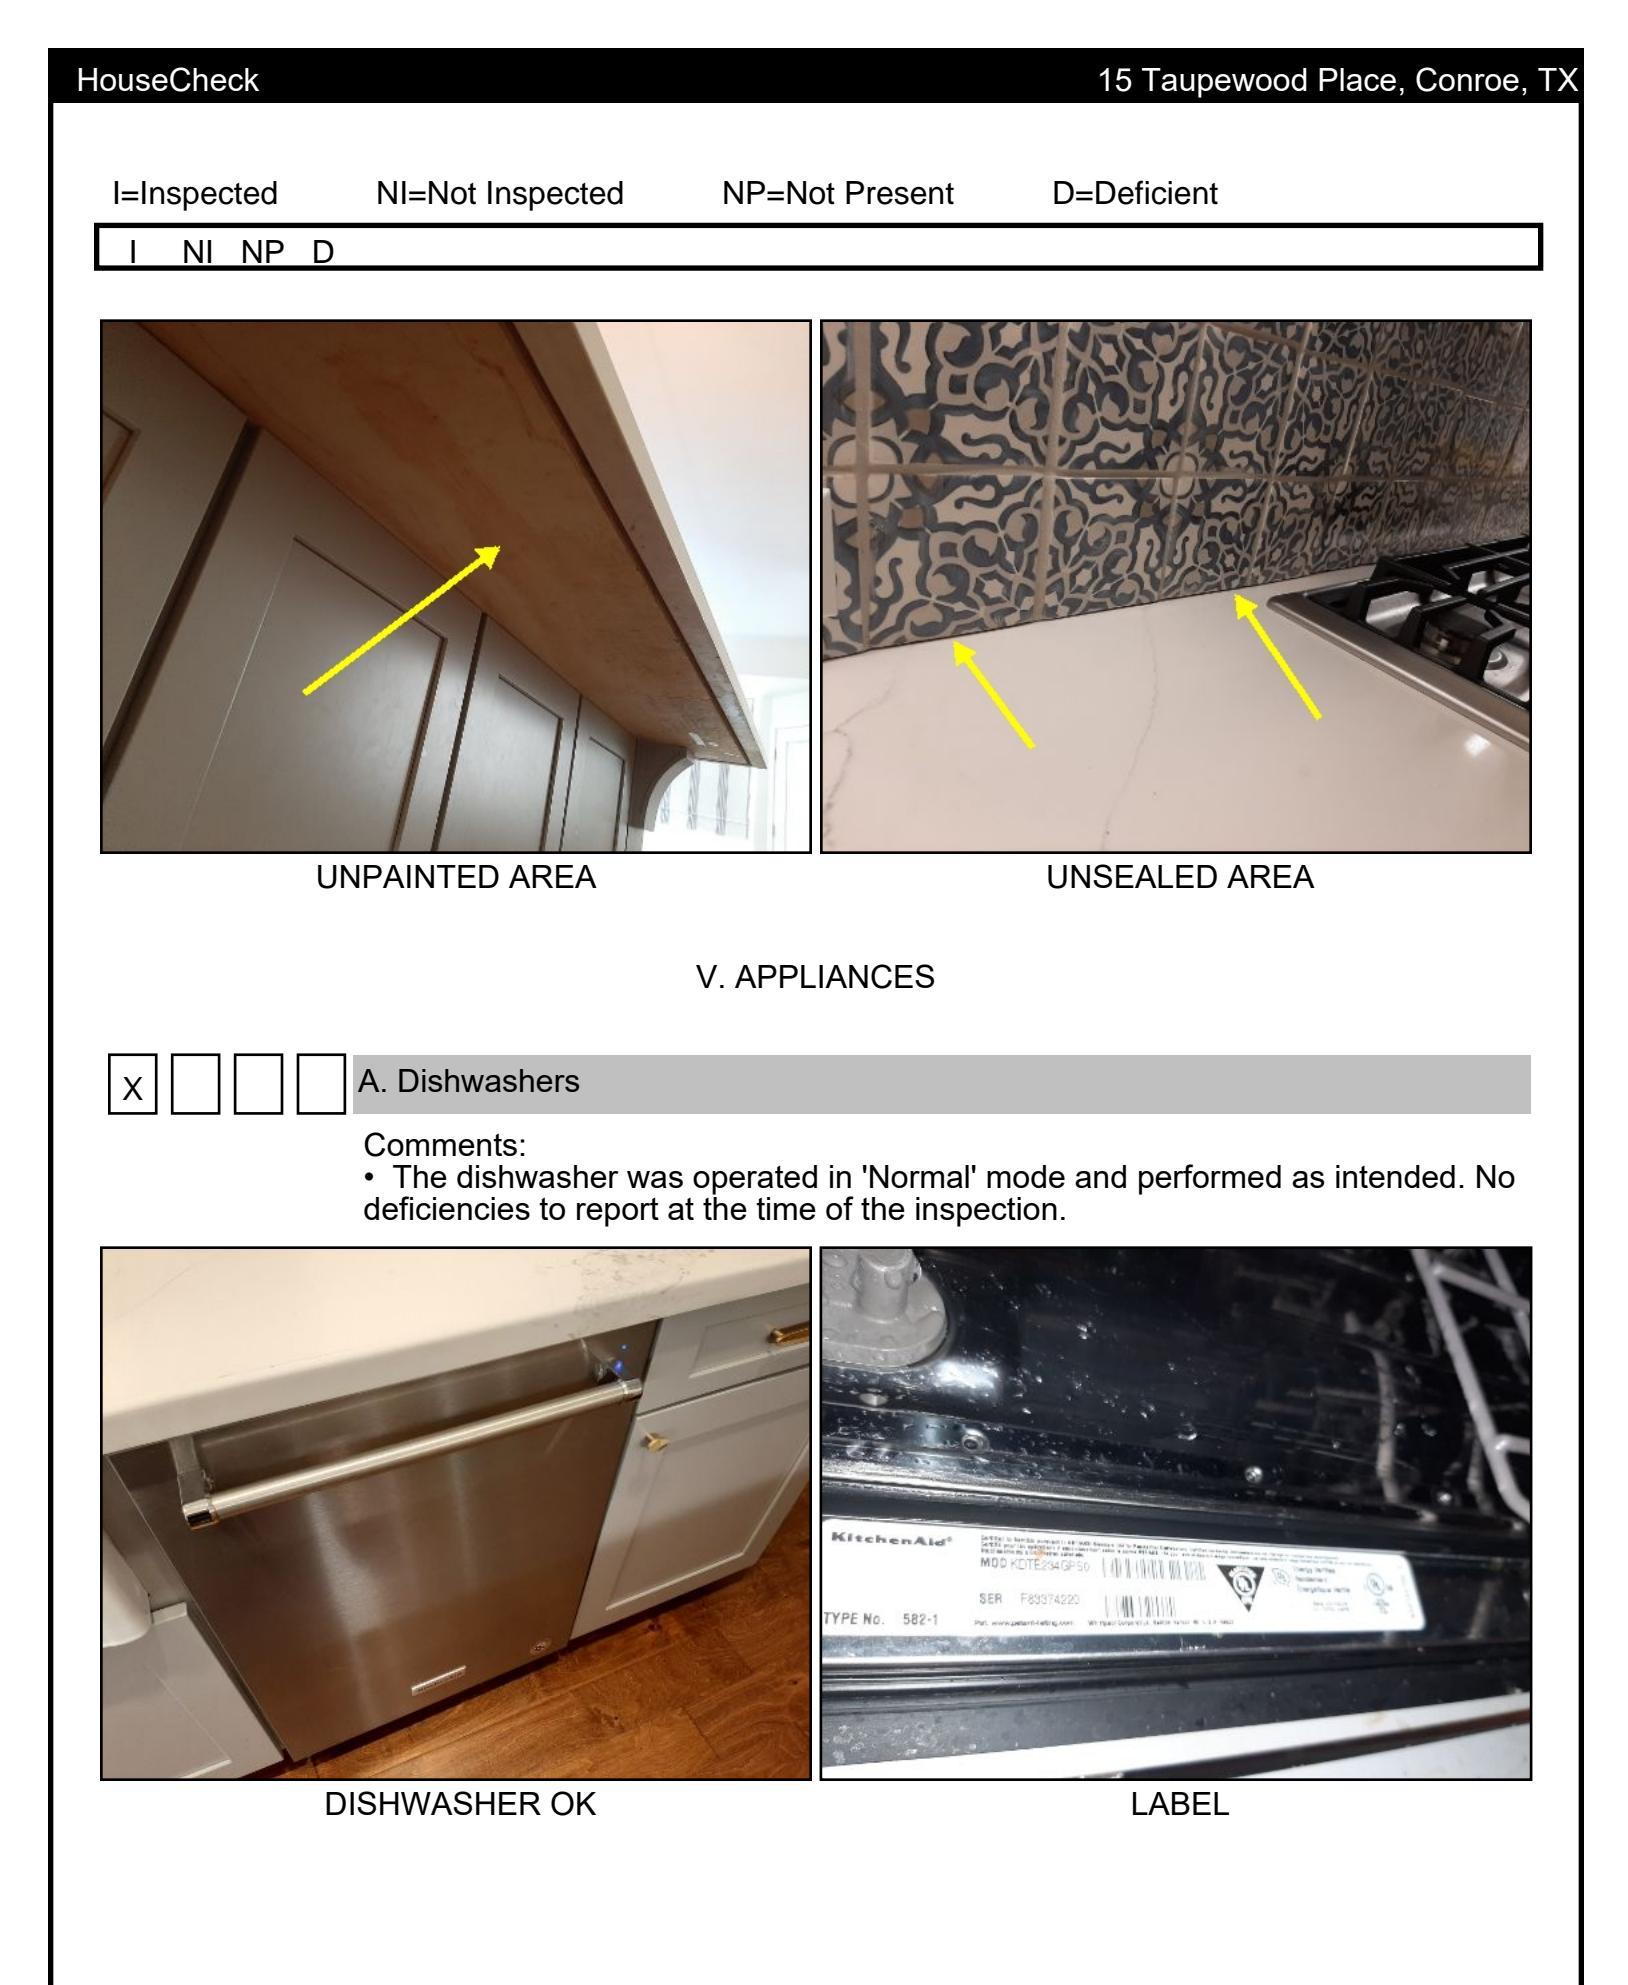
• The metal "B" vent or flue from the heater was noted incorrectly installed / secured. (not properly secured over the exhaust chamber). Ensure this vent is properly installed as needed to prevent overheating and CO2 buildup.

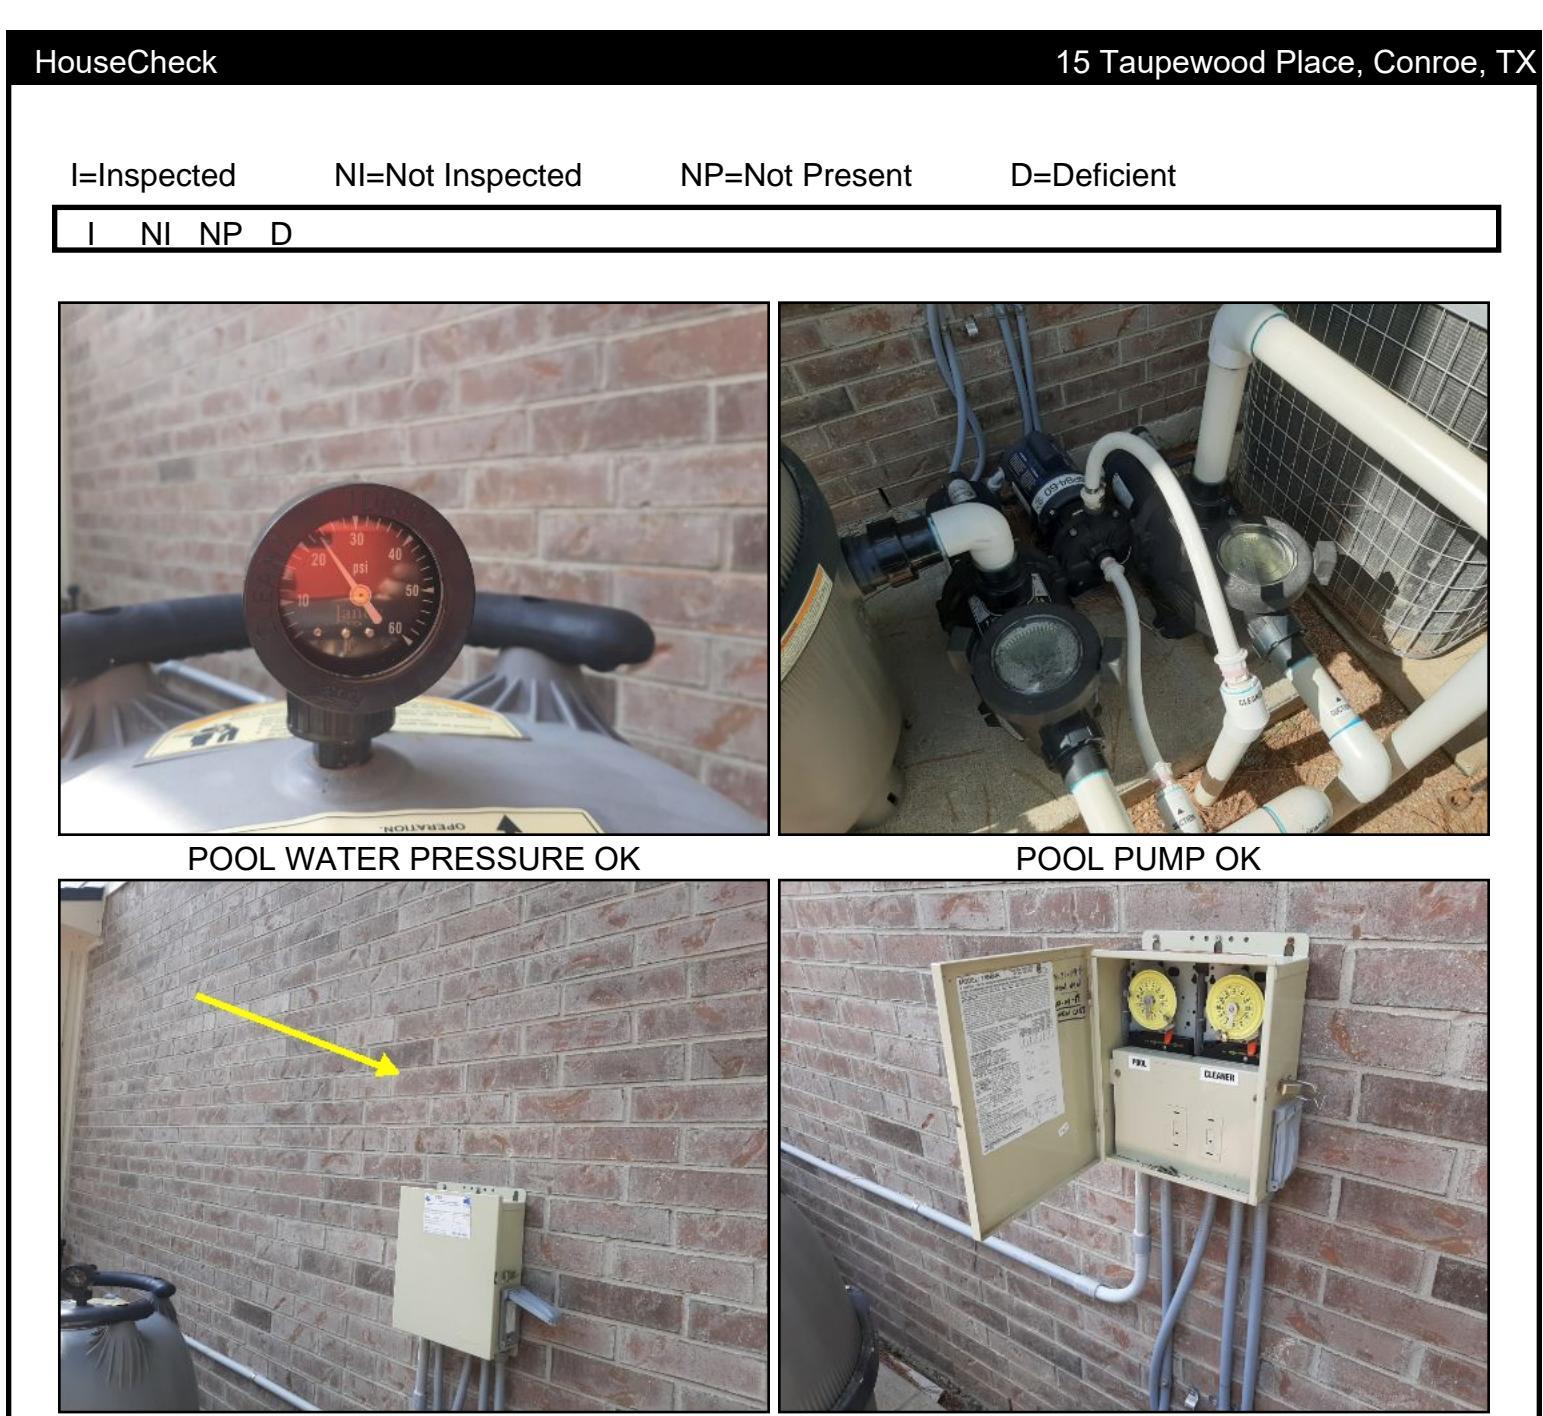
• Missing / No light fixture or electrical outlet was noted present at the pool equipment area. Recommend proper repairs and updates as required to properly service equipment when necessary.

MISSING LIGHT FIXTURE AT POOL EQUIPMENT AREA
