PROPERTY INSPECTION REPORT

Juliana Maldonado	
(Name of Client)	
229 Cunningham Fir Trail, Conroe, TX	
(Address or Other Identification of Inspected Property	y)
Ali Quiroz / TREC #23448 / Key Rose Inspections LLC	12/2/2020
(Name and License Number of Inspector)	(Date)
	(Name of Client) 229 Cunningham Fir Trail, Conroe, TX (Address or Other Identification of Inspected Propert Ali Quiroz / TREC #23448 / Key Rose Inspections LLC

Report Identification: 229 Cunningham Fir Trail

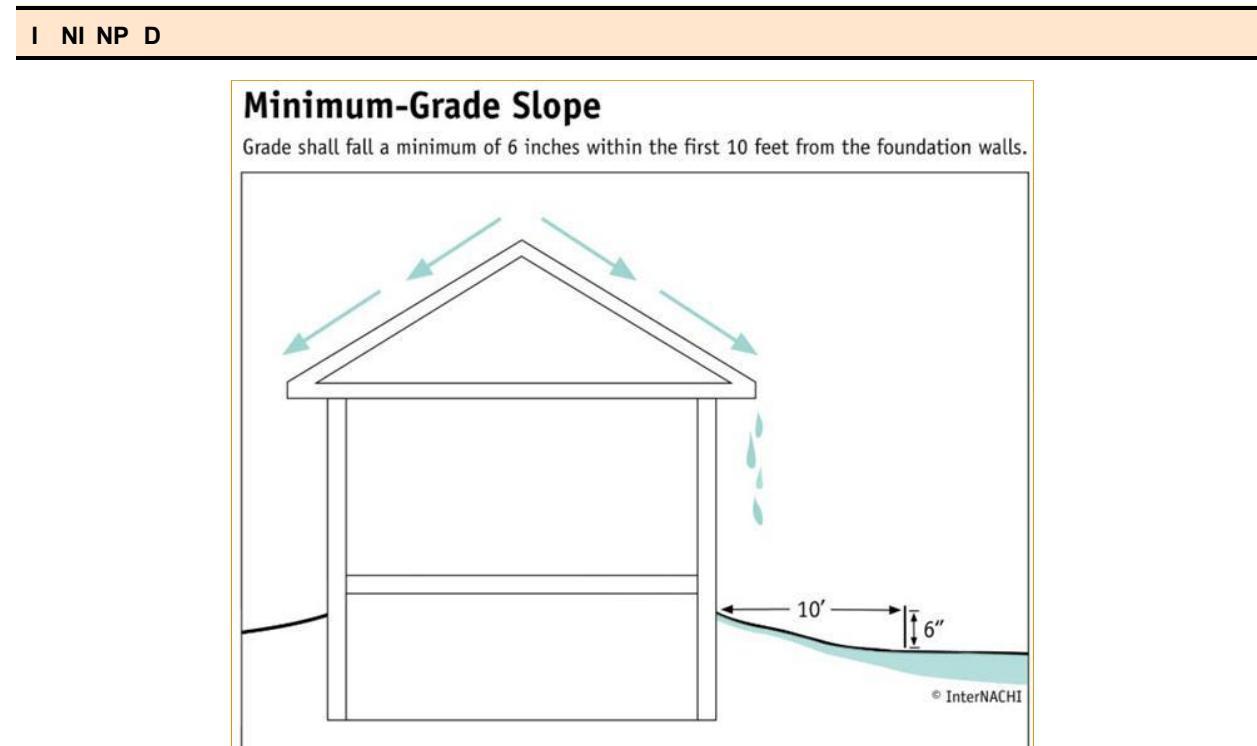
Depressions and/or negative drainage (sloping back toward the building) in the landscape around the home can cause improper drainage and contribute to puddles & standing water that can consequently cause deterioration of materials, erosion and breeding grounds for mosquitos.

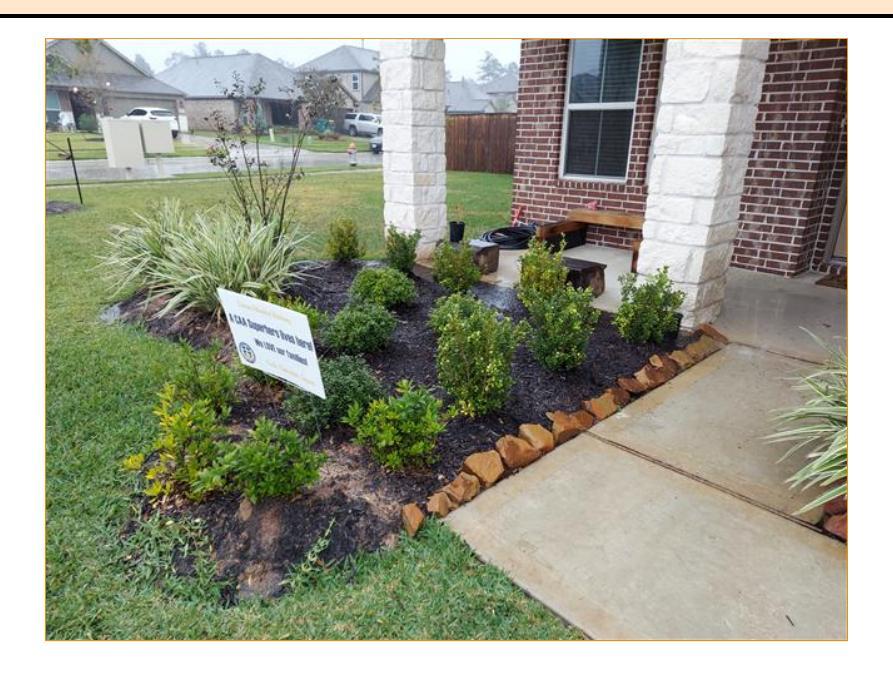
Some type of complete and proper guttering system is recommended all around the house as to create controlled drainage away from the building. Ideally, gutters should terminate away from the structure.

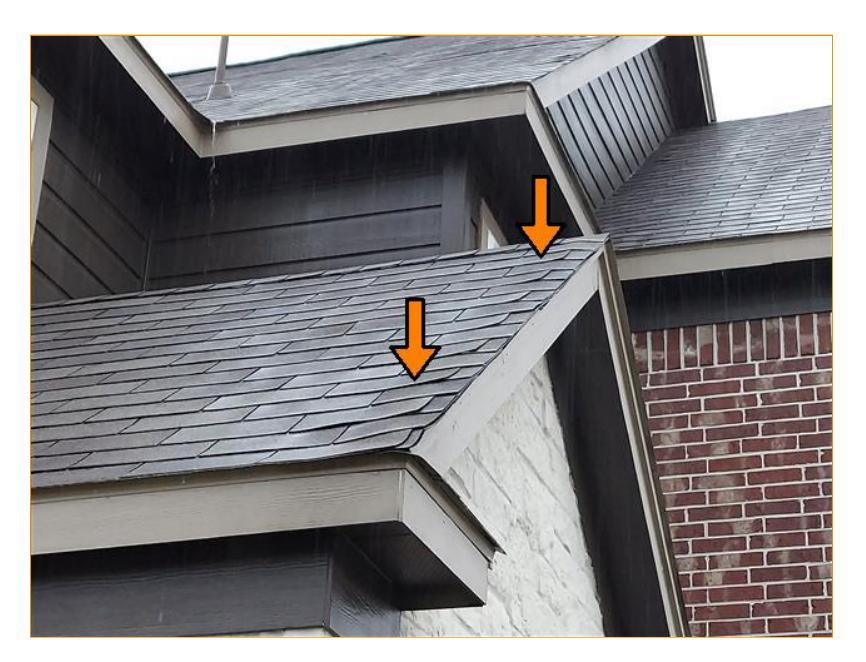
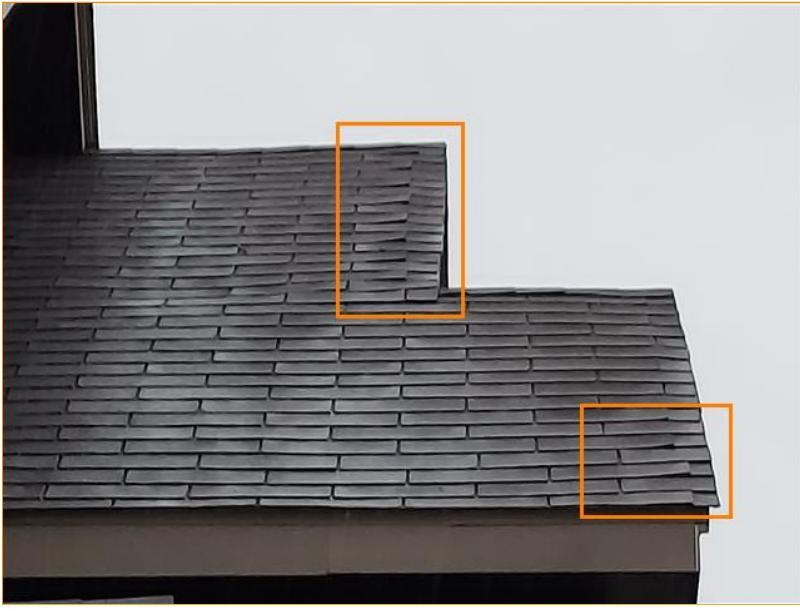
The roof covering did not appear properly adhered together at some areas.

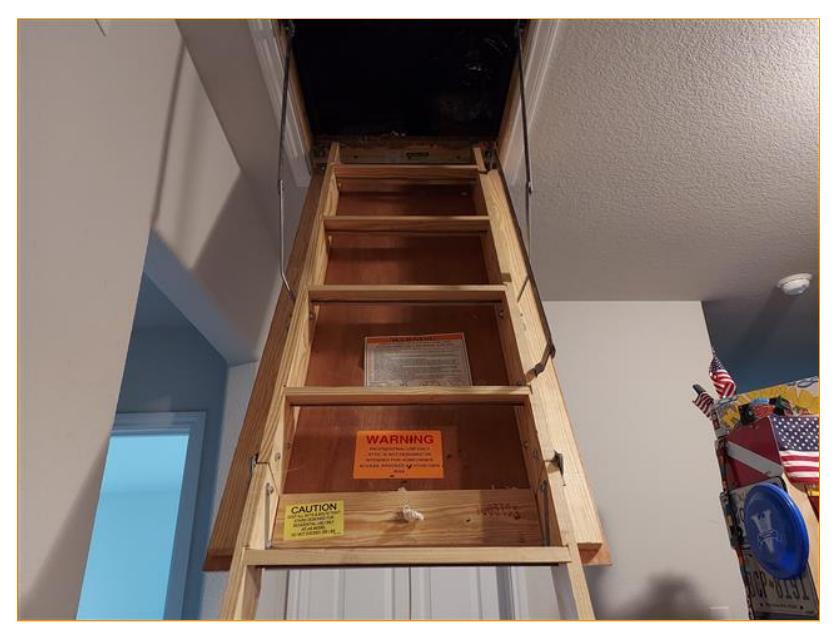
The attic access should be insulated and sealed to prevent energy loss when trying to condition a home (this area is overlooked commonly and needs to have insulating means).

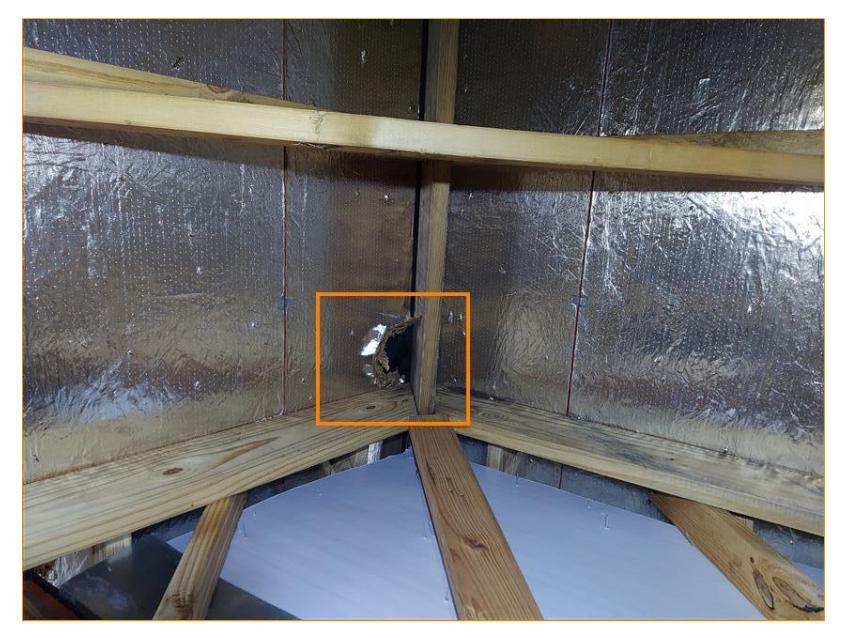
The roof sheathing was broken in areas.

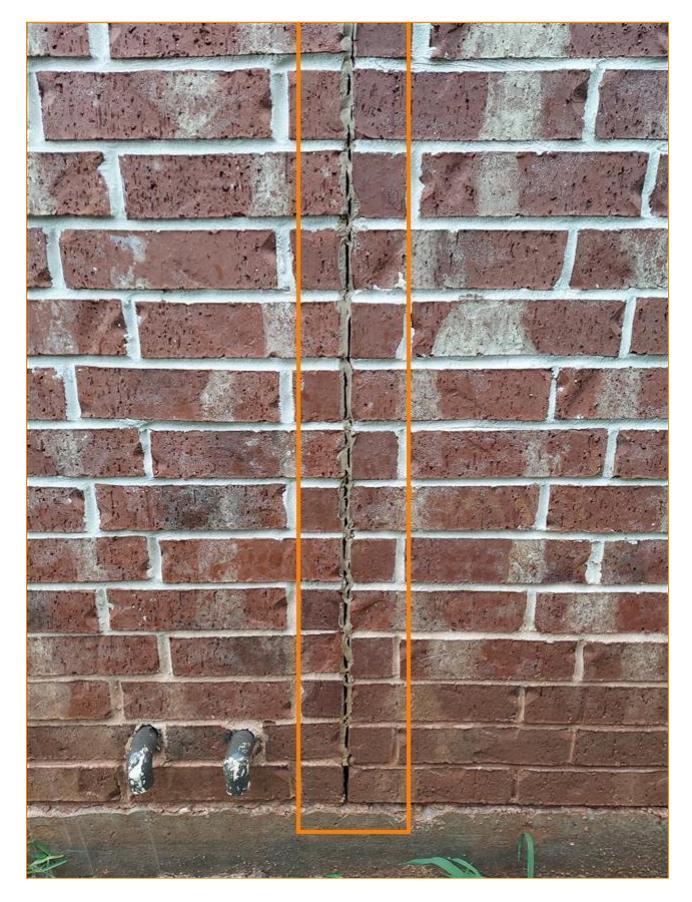
The expansion joint sealant has started to crack and should be reapplied to prevent water and/or insect intrusion.

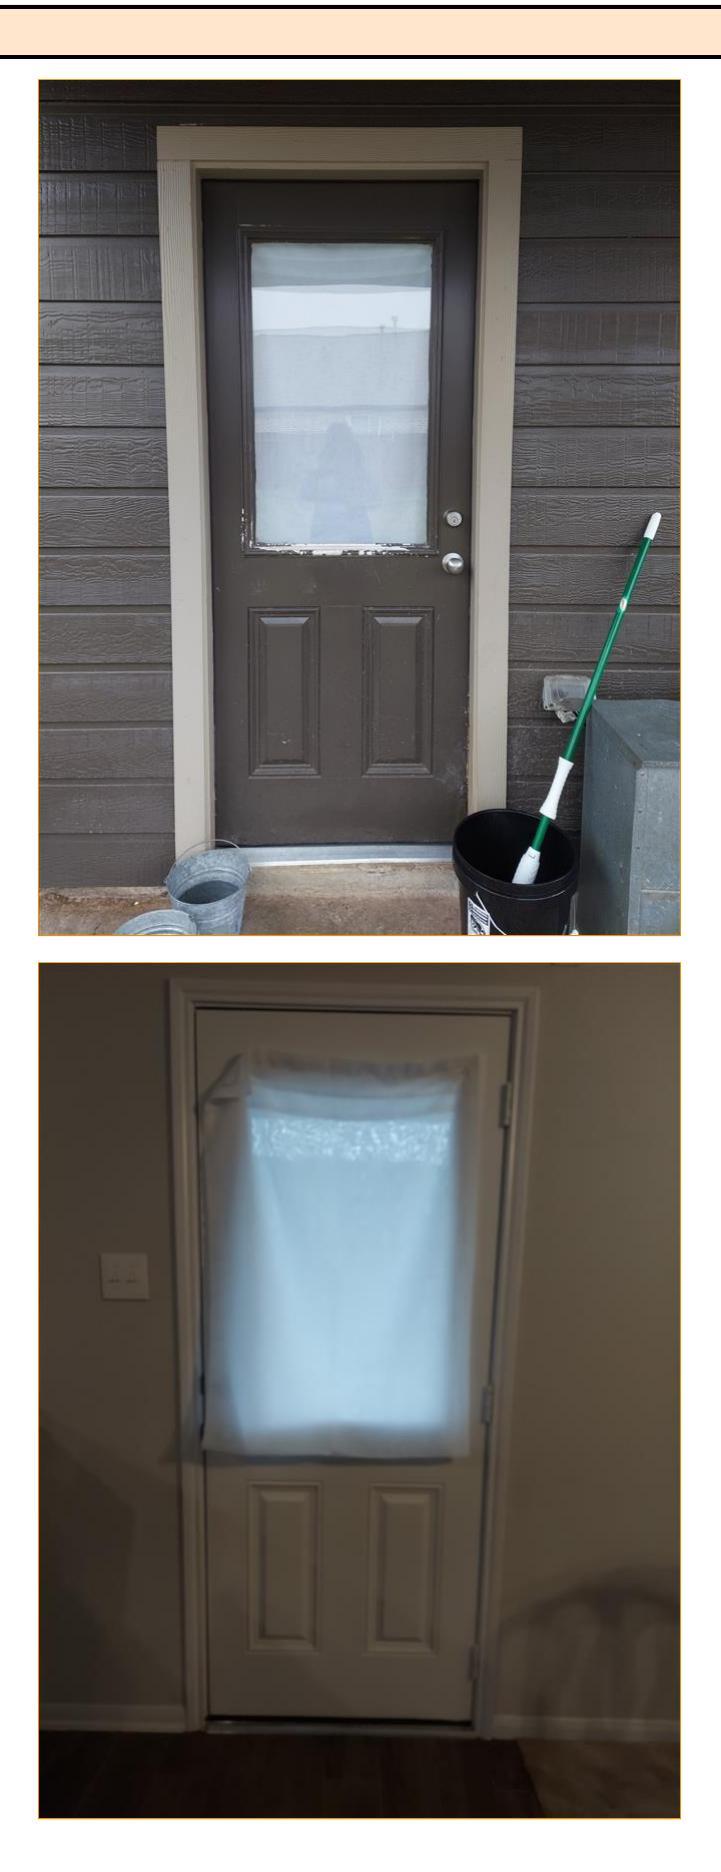
The exterior door at the rear had damaged weather-stripping and pet damage.

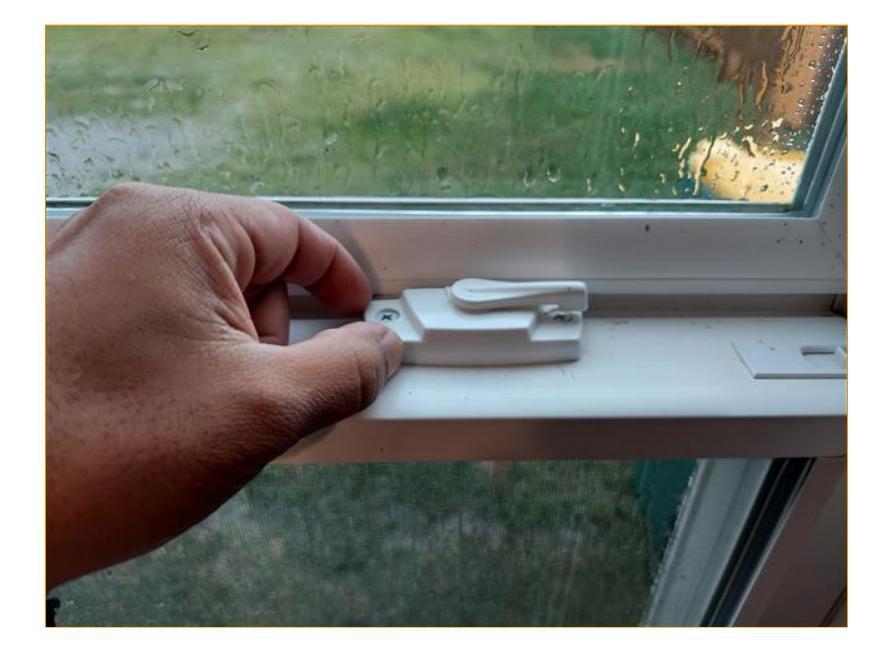
Some interior window units had loose hardware.

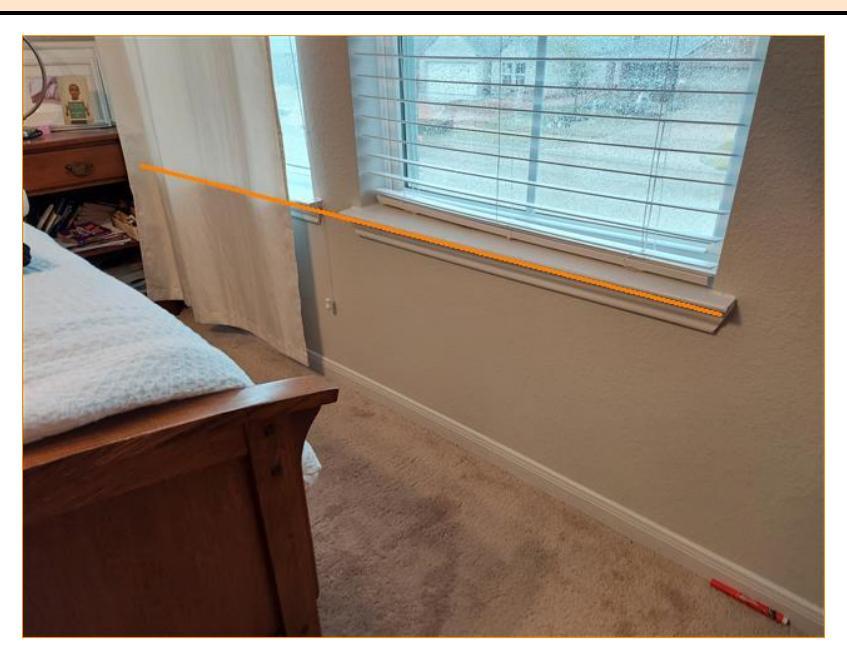
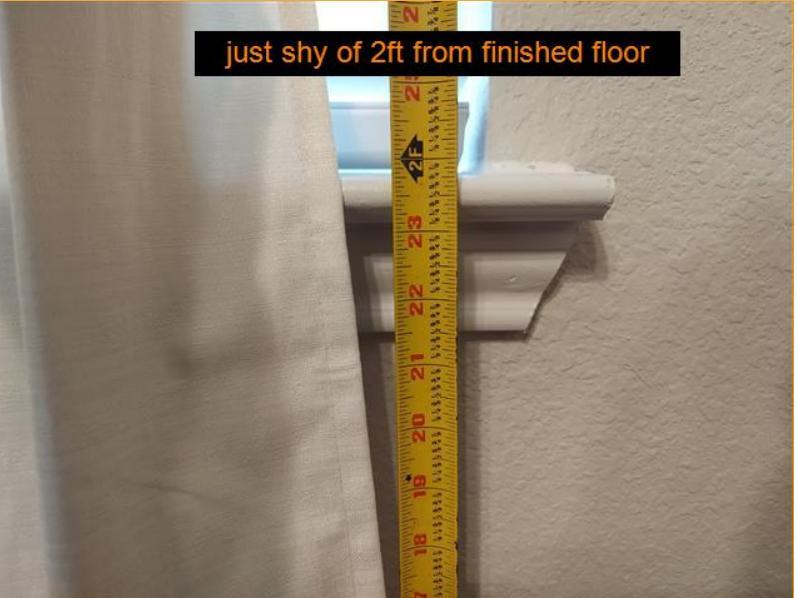
The height of some window sills on the second story may be too low. Where the opening of an operable window is located more than 72 inches (6ft) above the finished grade (soil) or surface below, the lowest part of the clear opening of the window shall be a minimum of 24 inches (2ft) above the finished floor. (exception, where proper window guards are in place or where the window unit will open a maximum of 4 inches). The subject windows did not have proper guards in place.

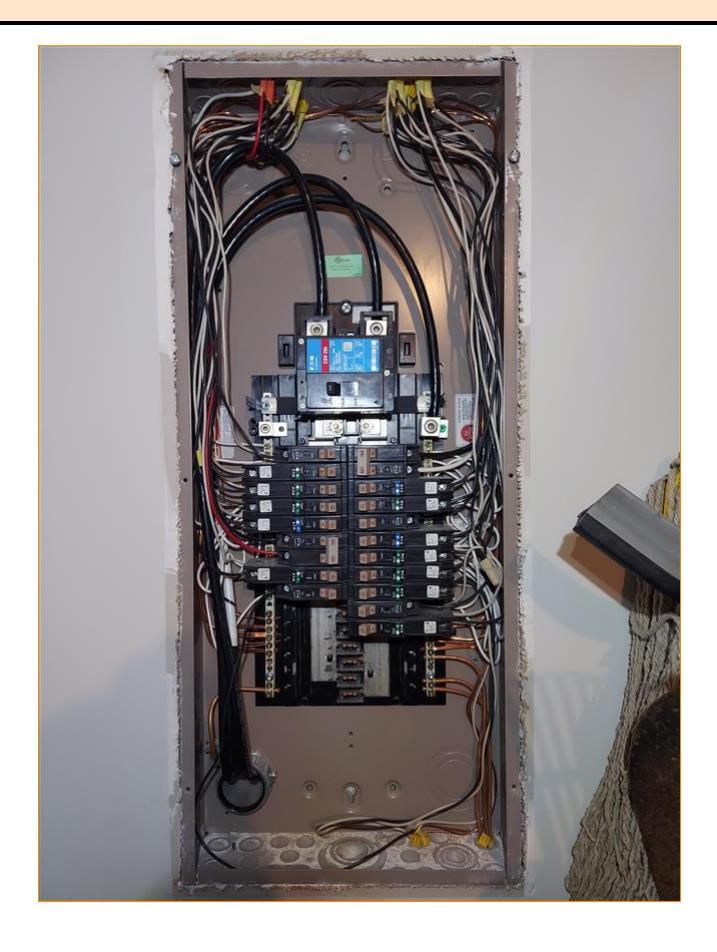
The main electrical panel had wires other than black/red used in hot/live slots without proper marking and occupant mentioned that the kitchen GFCI breaker would trip for no reason at times.

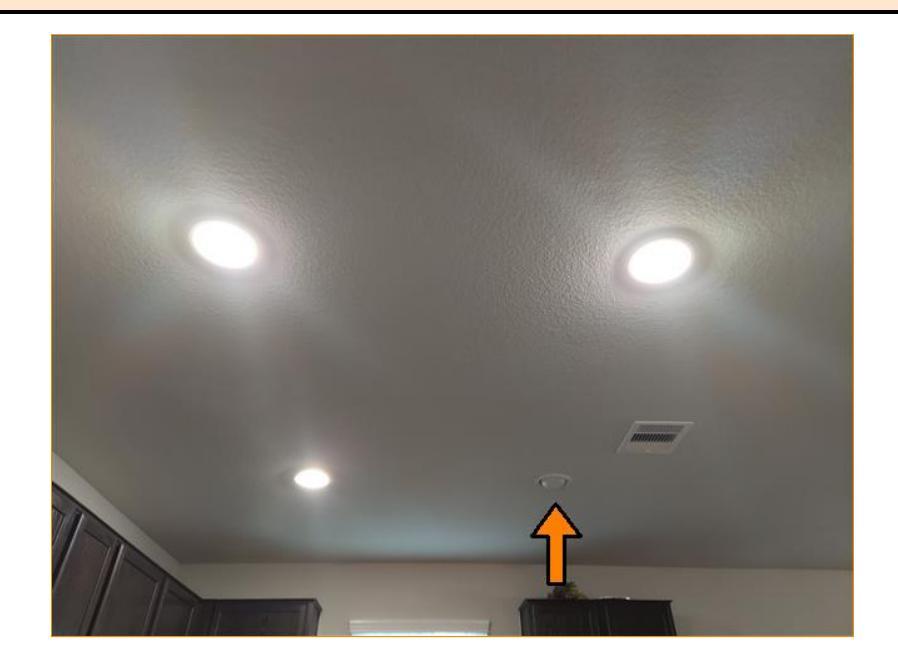
Type of wiring: Copper Wiring Methods: NM Sheathed (Romex) Comments: Noted an light fixture that was not working.

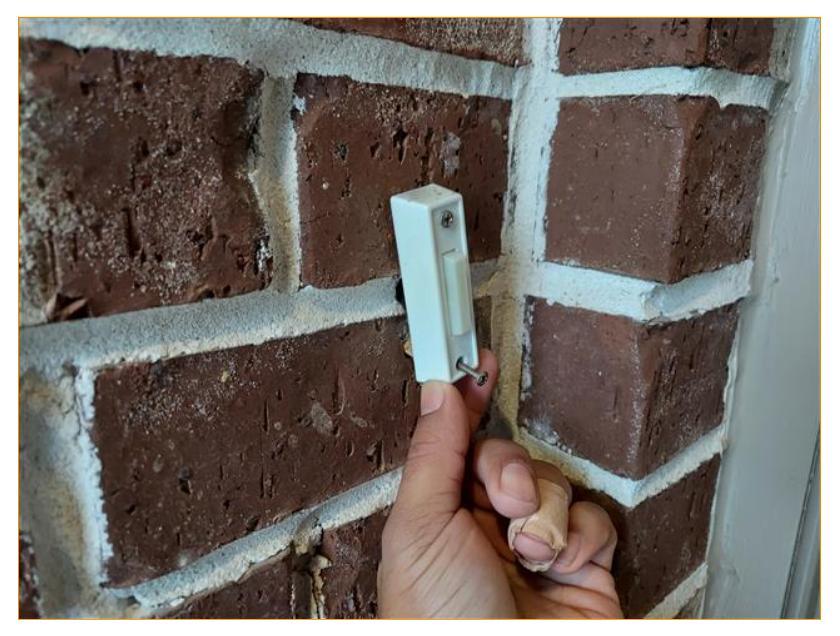
The doorbell for the home was working as intended however loose in the wall.

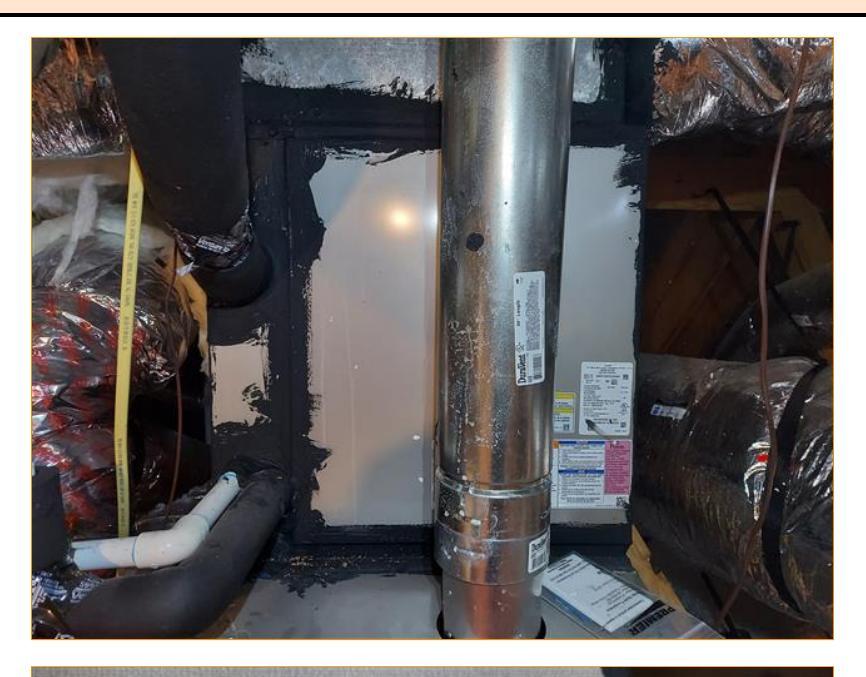
The attic evaporator unit needs the drip pan cleaned to prevent clogging of drain line and could use a float switch as an additional security means (a float switch is a type of sensor used to detect the level of liquid. Should water reach a certain level, the sensor sends a signal to the AC unit to shut off preventing overspill of liquid). Evaporator units should be cleaned and maintained periodically throughout the year to extend the life of the unit and keep it at optimal performance.

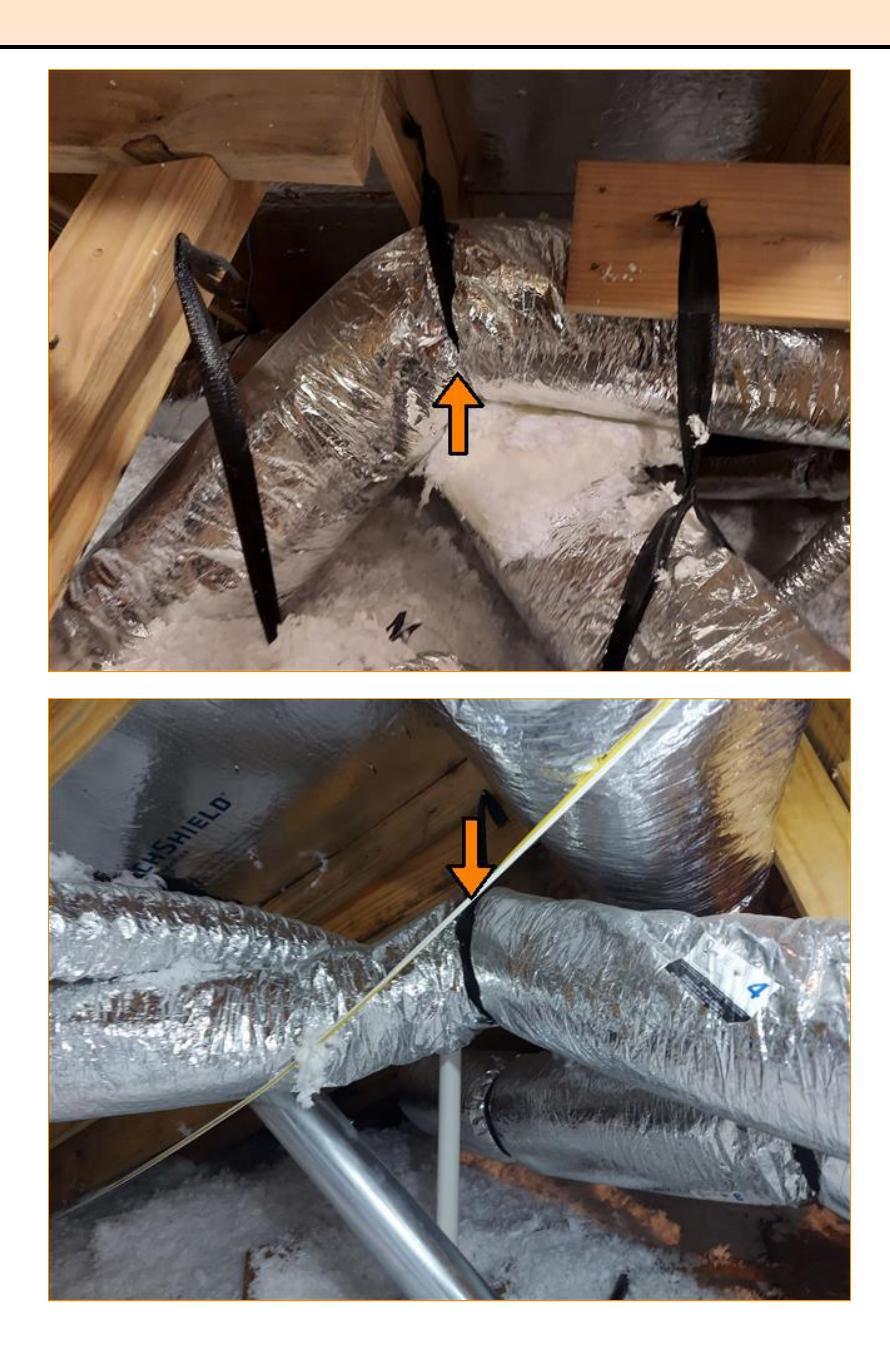
Location of Thermostat(s): Hallway Comments: The duct system had a sharp bend and/or kinked in areas which can restrict air flow.

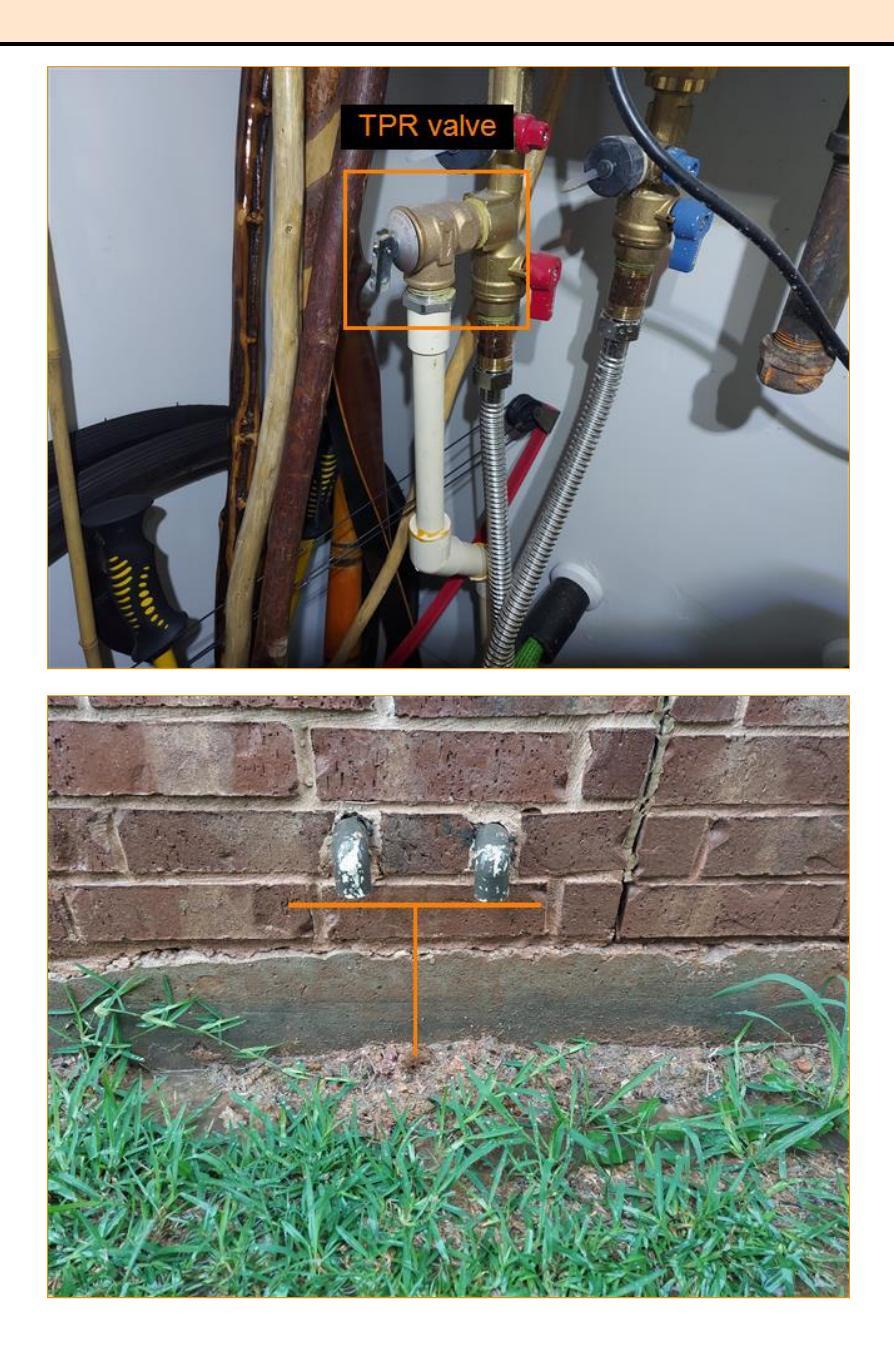
The T&P (Test and Pressure) valve on water heater terminated higher than 6" from the ground.

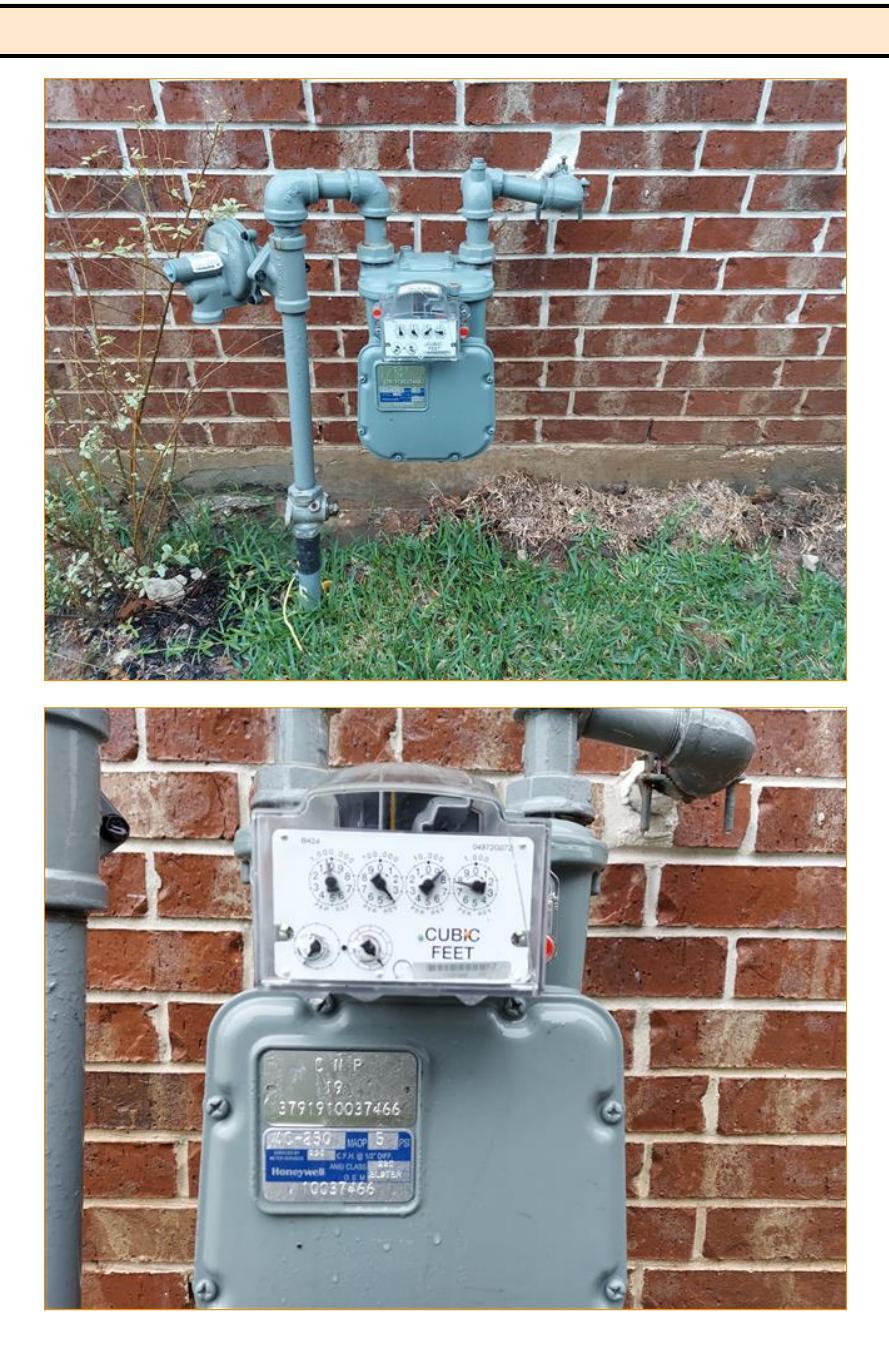
The gas utility meter may be leaking gas (odor around the unit).

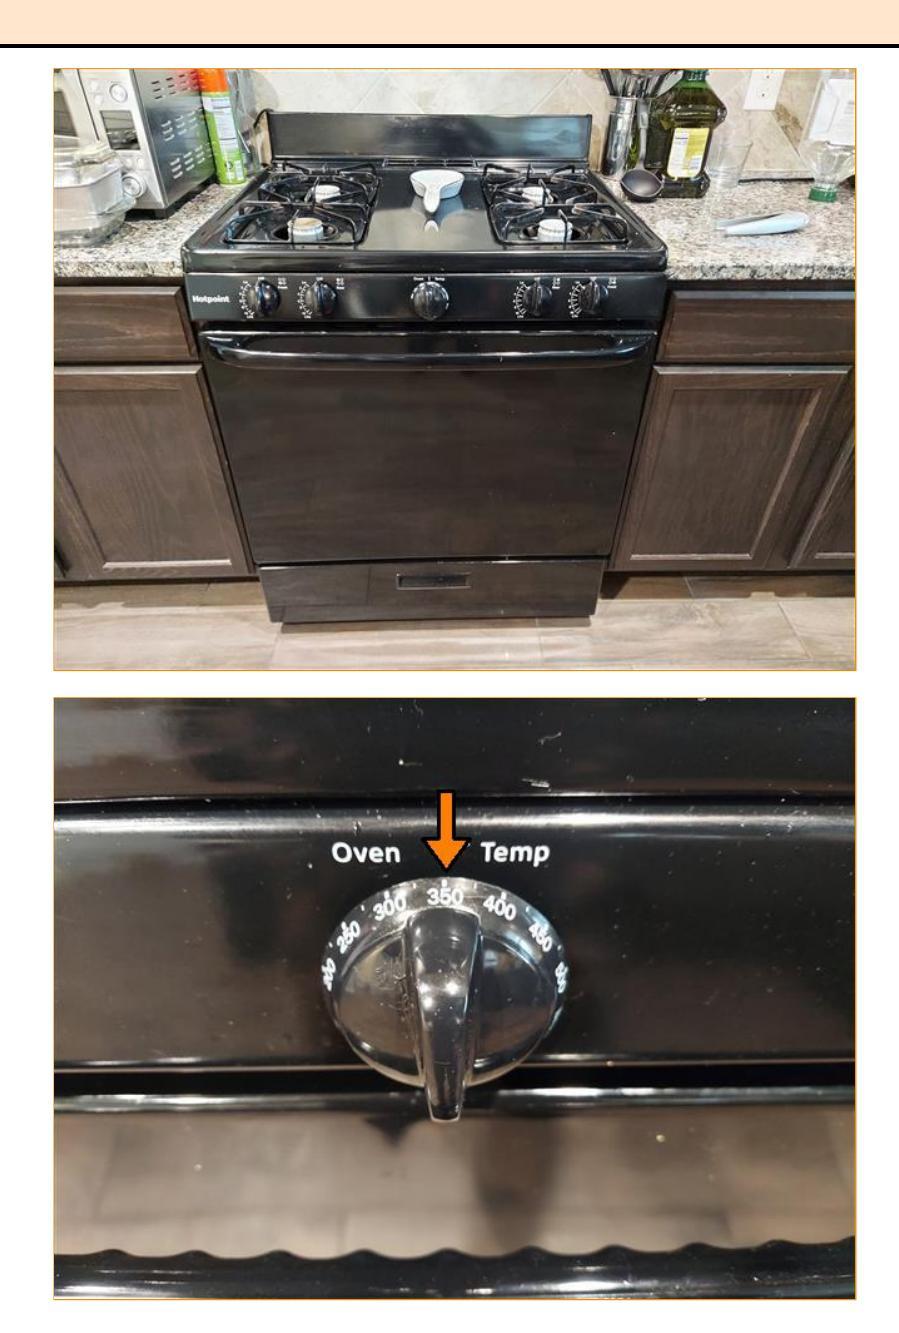
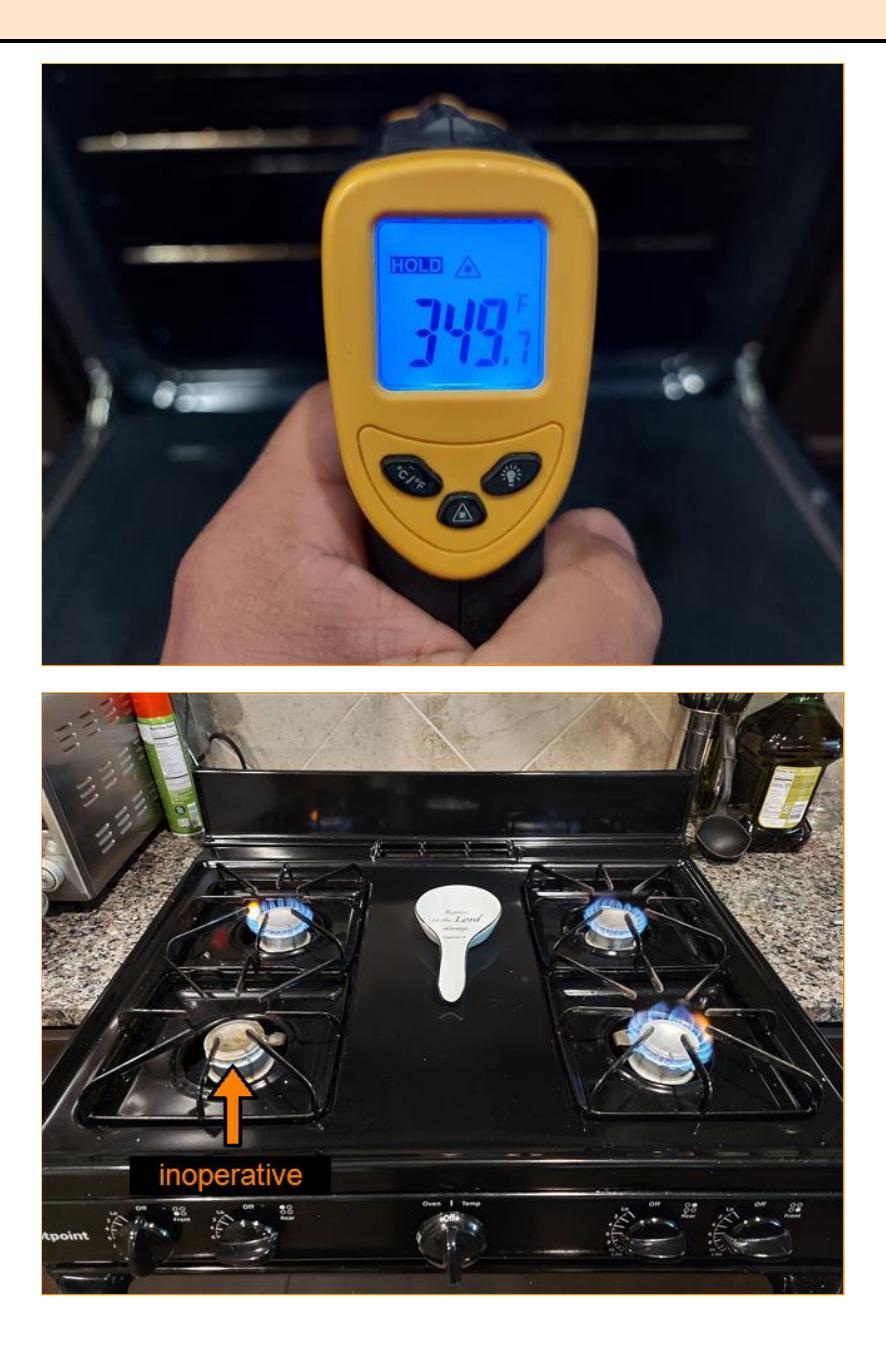
Range/Oven Brand: HOTPOINT Comments: The appliance unit had an inoperative burner.
