PROPERTY INSPECTION REPORT

18303 Saxon Creek Dr Humble TX 77338

Concerning: 18303 Saxon Creek Dr, Humble TX 77338				
(Address or Other Identification of Inspected Property)				
Michael Garcia - TREC #20817, TBPE FIRM #20170, MOLD				
By: FIRM #ACO1162, TPCL FIRM #0761253	07/29/2021 9:30 am			
(Name and License Number of Inspector)	(Date)

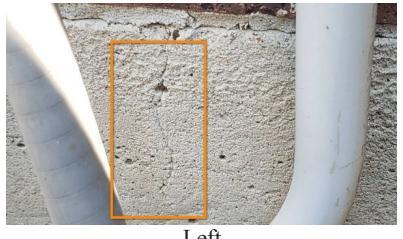
1: Foundation Wall Cracking Recommendation

Cracks were observed in the foundation wall.

Recommendation: Recommend monitoring.

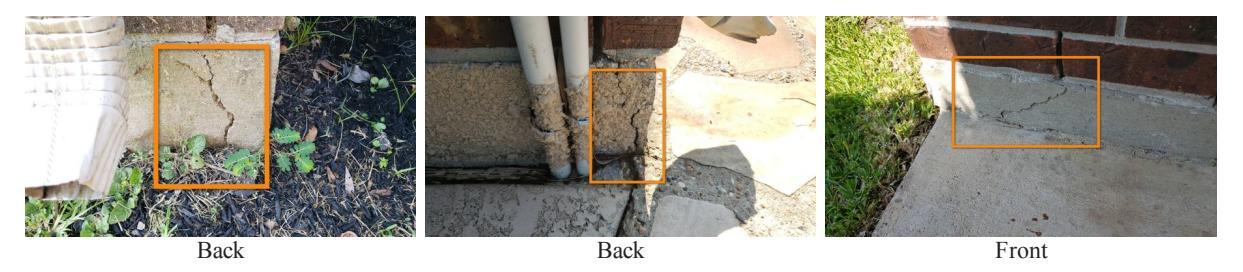
Left

There were corner pops noted on some of the foundation corners.

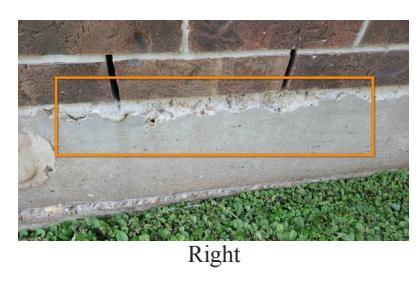
3: Honeycombing

Honeycombing was present at the foundation wall. These areas should be monitored.

Recommendation: Recommend monitoring.

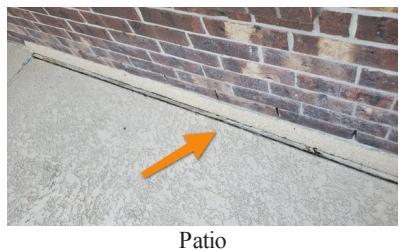
4: Form Boards Recommendation

There is a form board that is in the foundation that should be removed to minimize the potential for termite infestation.

Recommendation: Contact a qualified professional.

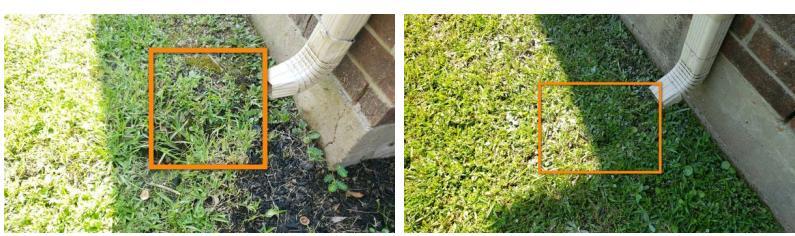
1: Splash Block Missing

There were missing splash blocks present.

Recommendation: Contact a qualified professional.

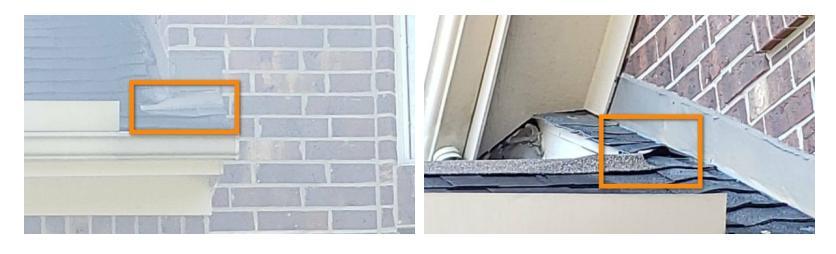
3: Uplifted Flashing Recommendation

Flashing was uplifted and not properly sealed.

Recommendation: Contact a qualified professional.

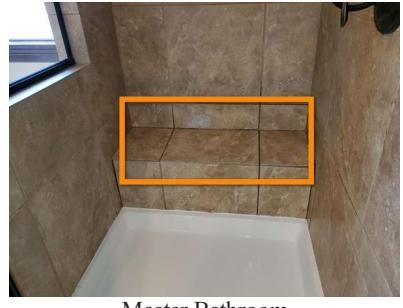
2: Wall Tiles - Grout Cracked and damaged Recommendation

The grout was cracked and damaged at the wall tiles.

Recommendation: Contact a qualified tile contractor

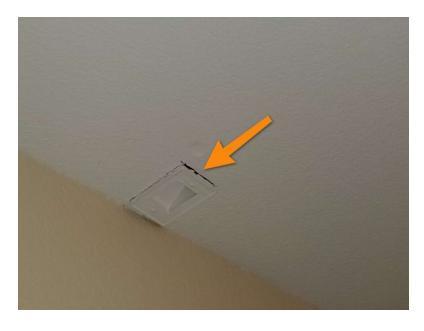
2: Missing Drywall Commendation

Missing drywall was observed at the time of inspection.

Recommendation: Contact a qualified drywall contractor.

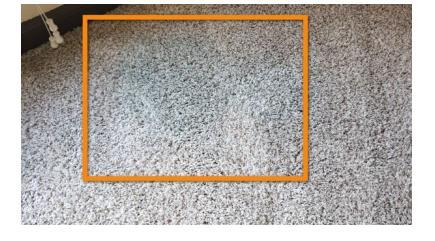
2: Carpet Stains Recommendation

Carpet had areas of staining or discoloration. Recommend a thorough steam clean by a qualified carpet cleaning company

Recommendation: Contact a qualified cleaning service.

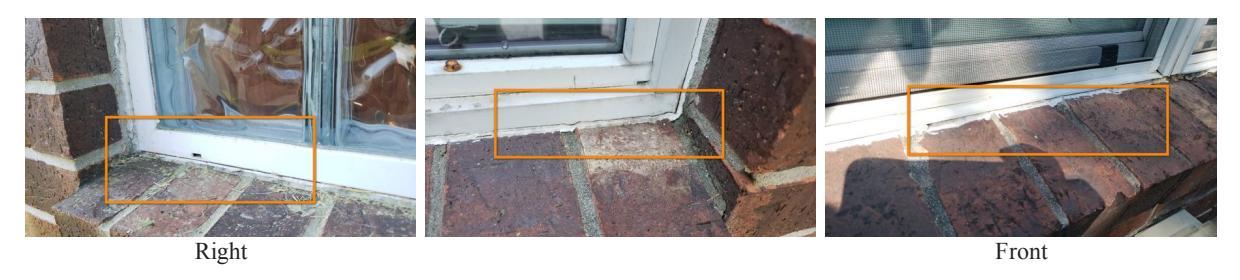
The caulking has separated around some windows at the exterior.

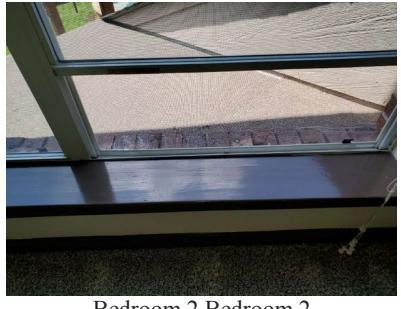
2: Torn Screens Recommendation

There were torn window screens observed at the time of inspection.

Recommendation: Contact a qualified window repair/installation contractor.

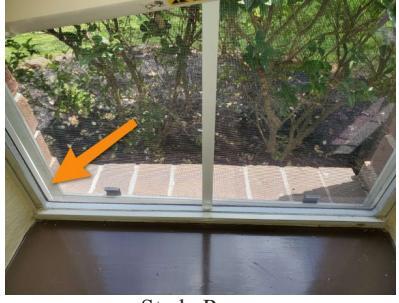
3: Loose Screens Recommendation

Various screens were bent and loose.

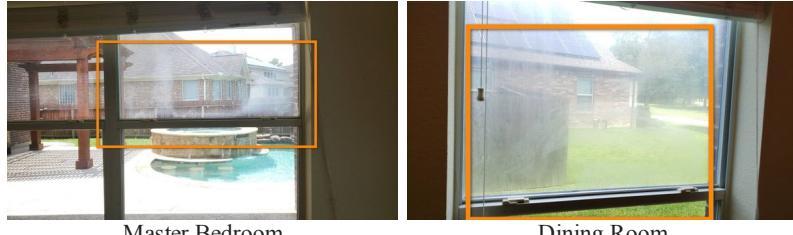
5: Voided General Comment Recommendation

There were voided or possibly voided thermal pane windows throughout home. Refer to "Window" note at miscellaneous section.

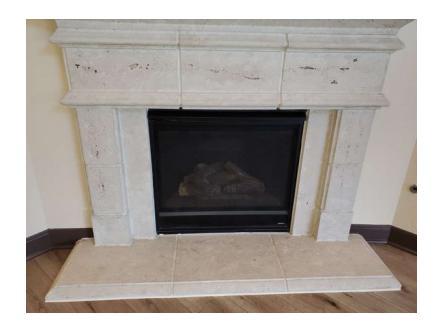
Remote not present : Remote not present to turn on fireplace.

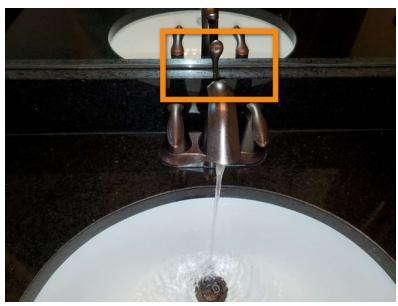
The sink stopper did not hold water when engaged.

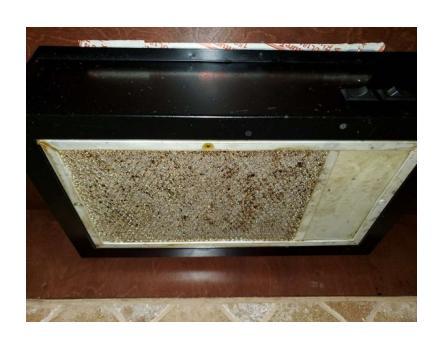
1: Dirty Filter ➡Recommendation Dirty filter at time of inspection.

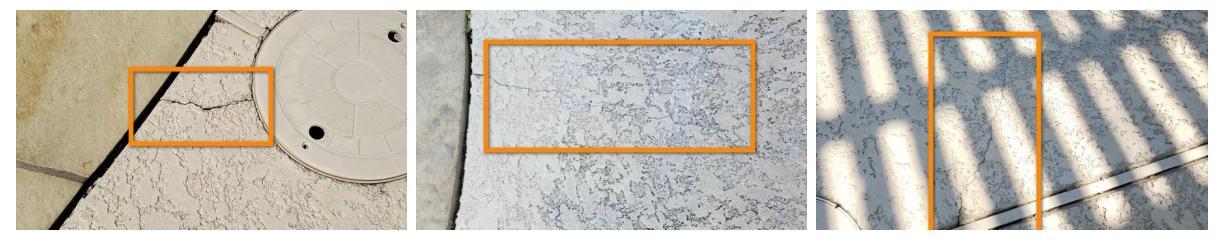
4: Cracked Decking Recommendation

There are cracks in the decking around the pool.

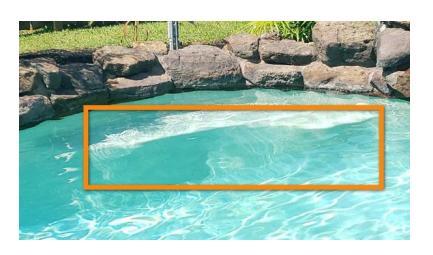
6: Not Clearly Marked - Bench Clearly Marked - Bench

The bench is not clearly marked.

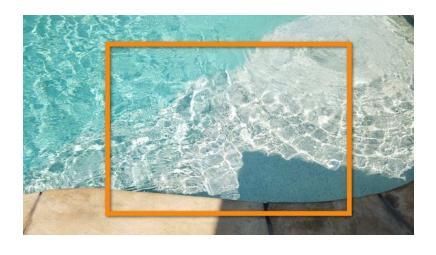
7: Not Clearly Marked - Steps Recommendation

The steps are not clearly marked.

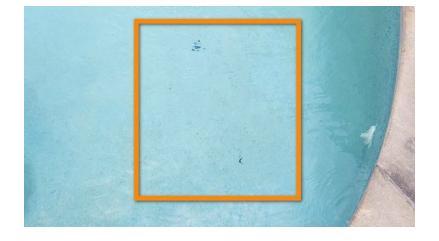
8: Pool Light Not Responding ©Recommendation

The pool light did not respond to testing.

Recommendation: Contact a qualified professional.
