**GLOBAL  
REAL ESTATE INSPECTIONS**

**2115 & 2117 33rd Street  
Galveston, Texas**

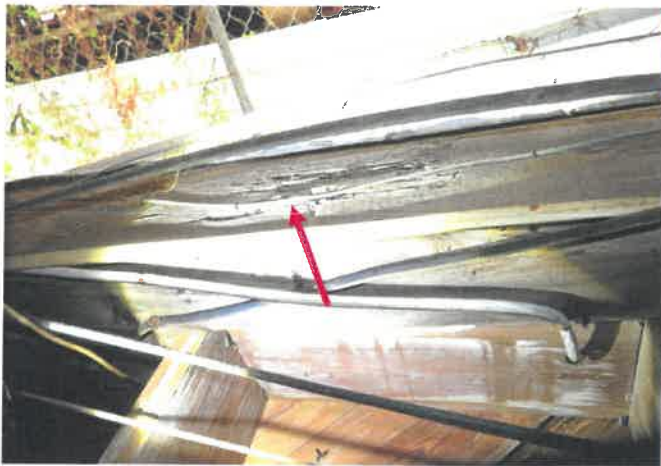
Minor deterioration to beams in spotted areas

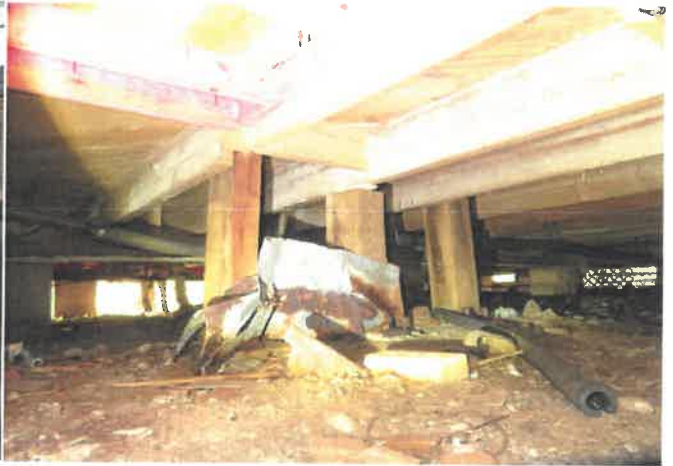
Spotted piers propped under individual joist not beams

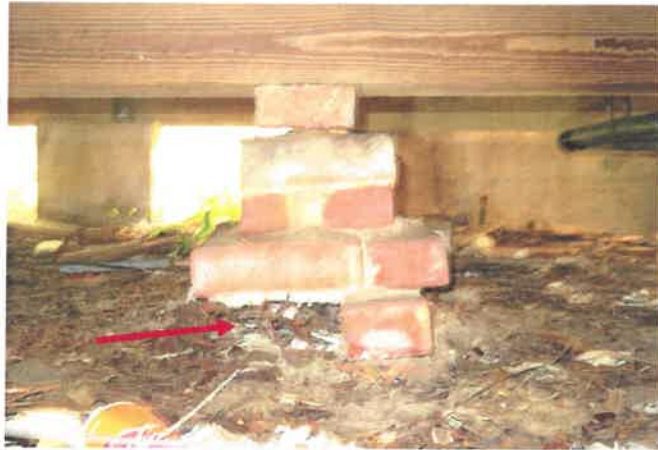
Make shift masonry piling along front beam is damaged, and does not make a good support due to a missing brick,

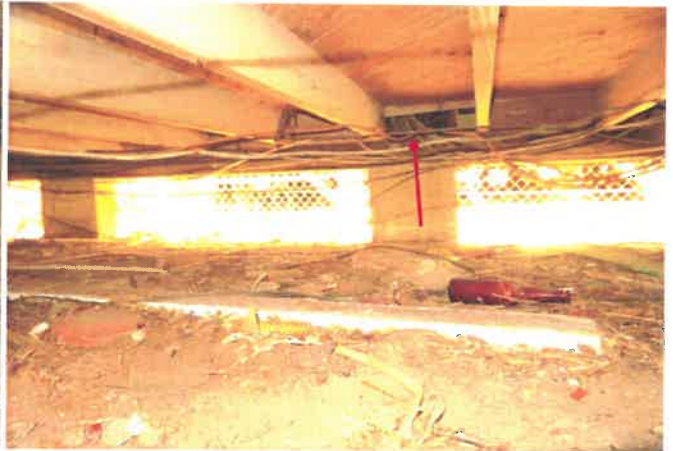
One of the areas above the beam is not block where wires pass which may allow pest to enter.

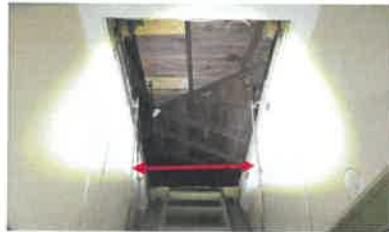
Both of the attic drop staircase springs or loose or damaged and get hung up on the pulleys.

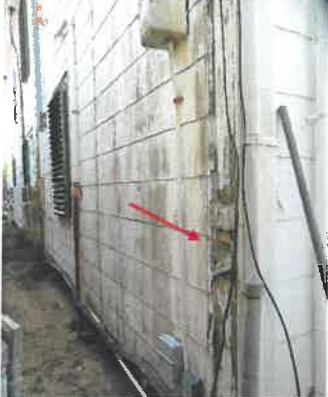
The corner trim on the house is damaged in spotted areas and the paint is gone leaving the wood unprotected.

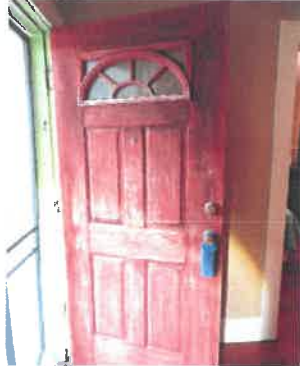
The original covering on the front door is wearing thin and needs to be reapplied to provide the door with adequate protection.

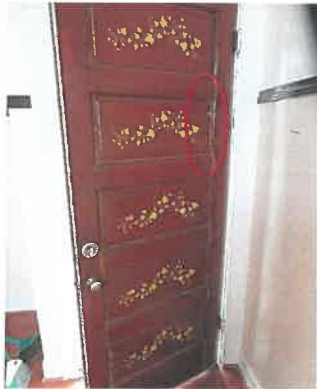
Damaged panel of exterior back door of upstairs apt.

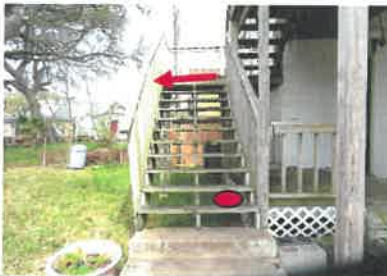
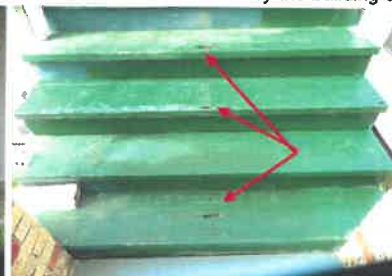
Several of the treads on the front staircase are damaged.

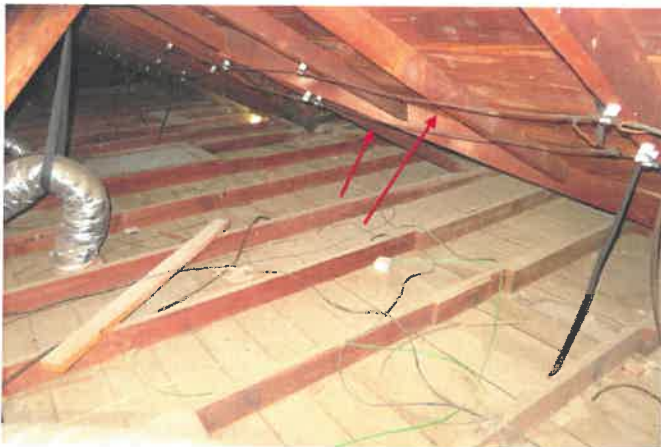
*Knob and tube wiring observed in attic*

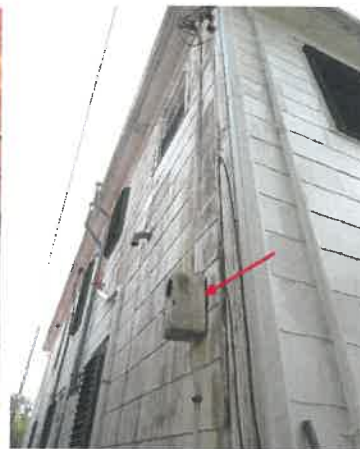
*The meter which provides power to the sub panel is not weather sealed*

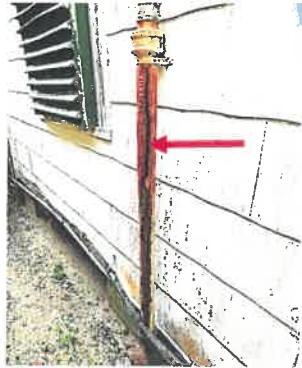
Vertical drain line damaged

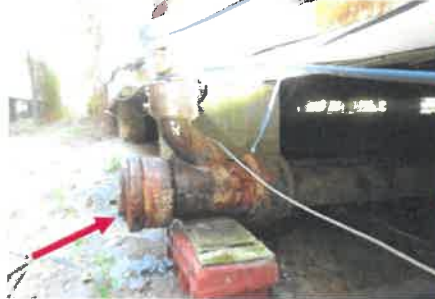
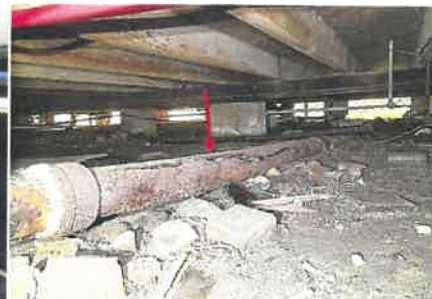
Entire main drain is cracked and in need of repair
