Cal-Pro Home Inspections Team 5903 Barkaloo Rd., Baytown), Texas I=Inspected NI=Not Inspected NP=Not Present D=Deficient I NI NP D Tile in the was noted to be cracked/damaged.

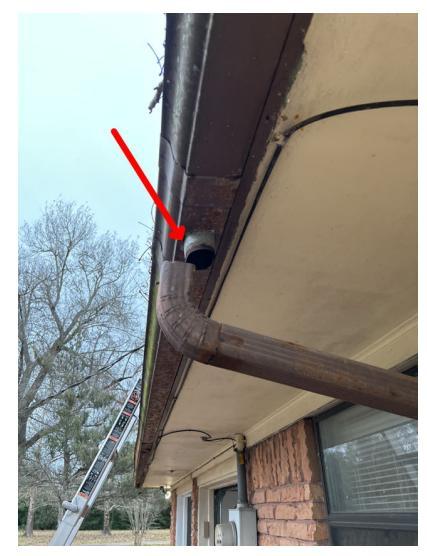
Damaged/leaking gutters noted, repairs may be necessary to help the runoff of water onto or near the structure.

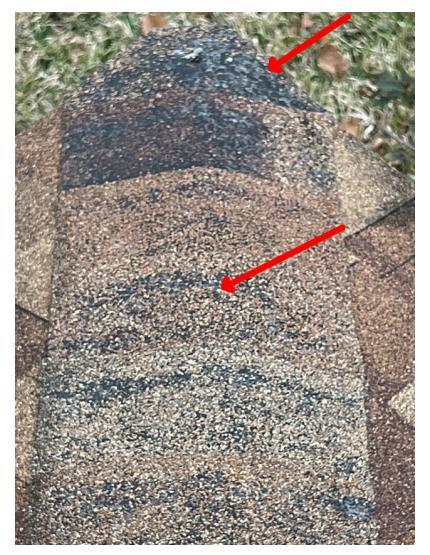
Damaged roof shingles noted, repairs to the roofing are recommended. Damaged or missing roofing material should be repaired. All roof penetrations should be examined and sealed as necessary.

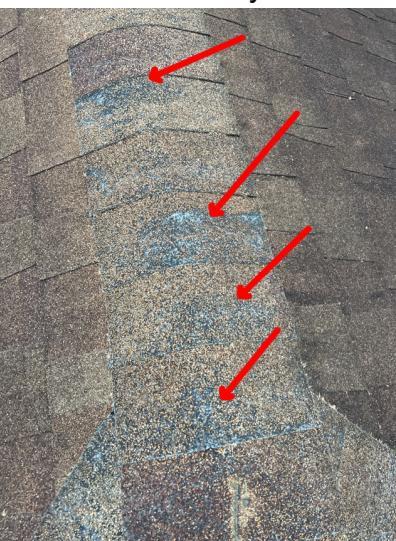
The roofing is nearing the end of its life cycle. Minor repairs are recommended in the short term to maintain the weather tightness of the roof. Damaged or missing roofing material should be repaired. All roof penetrations should be examined and sealed as necessary.

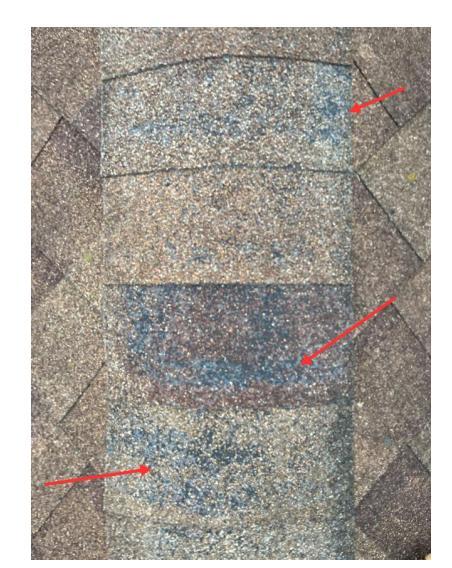
Damaged roof shingles noted, repairs to the roofing are recommended. Damaged or missing roofing material should be repaired. All roof penetrations should be examined and sealed as necessary.

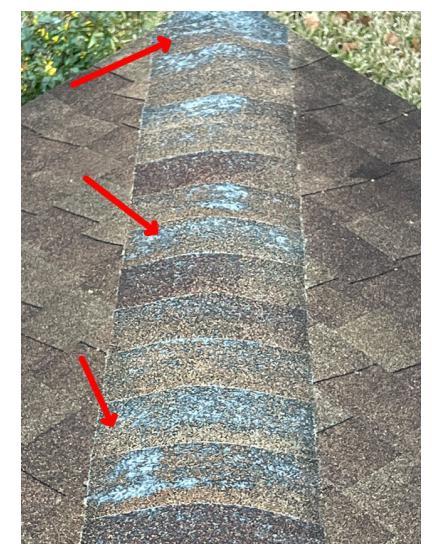
Damaged roof shingles noted, repairs to the roofing are recommended. Damaged or missing roofing material should be repaired. All roof penetrations should be examined and sealed as necessary.

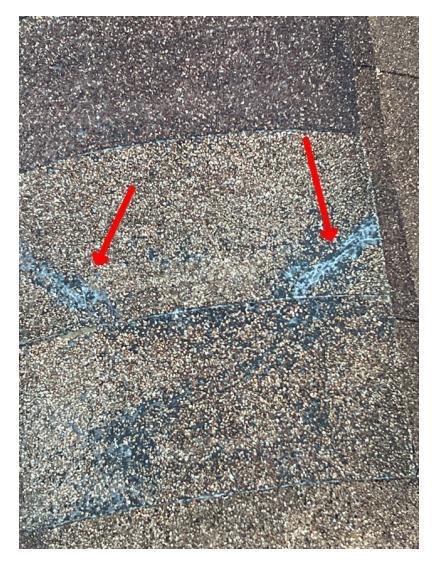
Damaged roof shingles noted, repairs to the roofing are recommended. Damaged or missing roofing material should be repaired. All roof penetrations should be examined and sealed as necessary.

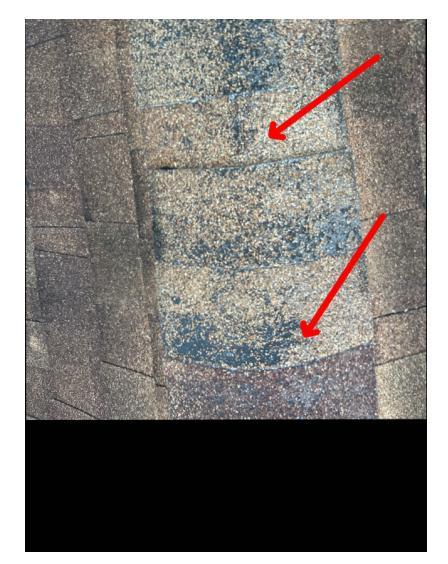
The roofing is nearing the end of its life cycle. Minor repairs are recommended in the short term to maintain the weather tightness of the roof. Damaged or missing roofing material should be repaired. All roof penetrations should be examined and sealed as necessary.

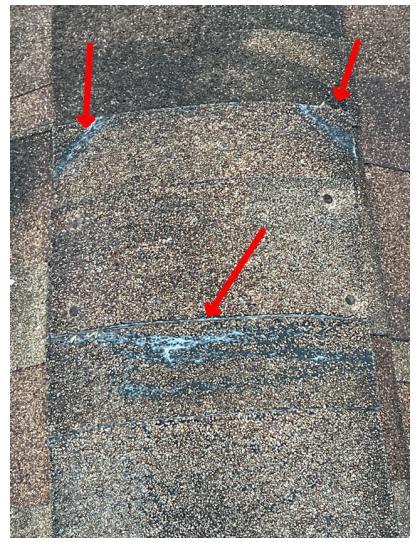
Damaged roof shingles noted, repairs to the roofing are recommended. Damaged or missing roofing material should be repaired. All roof penetrations should be examined and sealed as necessary.

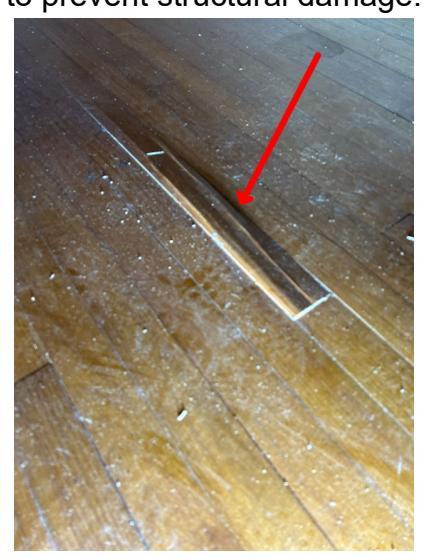
The floor covering is damaged and may be in need of repair or replacement.

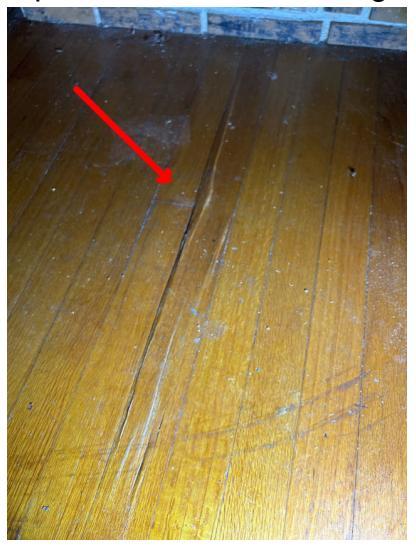
The floor covering is damaged and may be in need of repair or replacement.

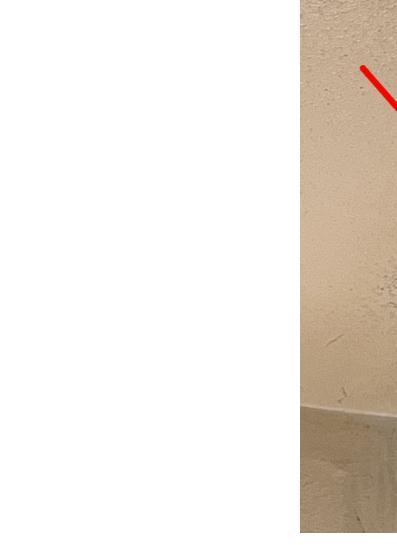
Evidence of repairs was noted on the ceiling of the dining room and the first bathroom.

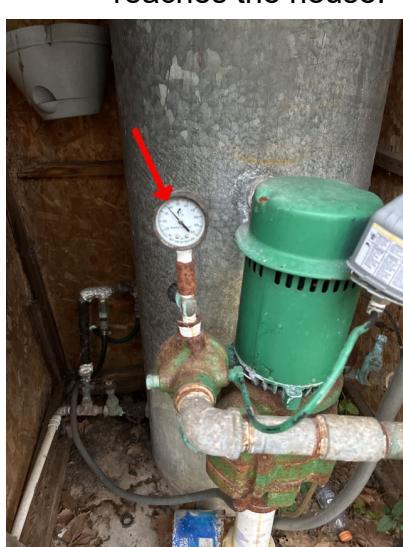
The well psi gauge is not working. It shows pressure even though the well is off.

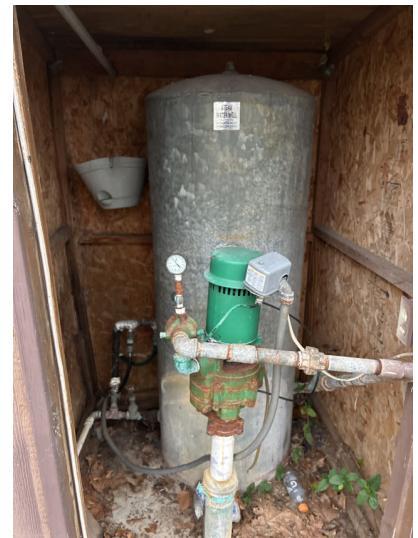
Even though the well is running, and the valves are open, no water pressure reaches the house.

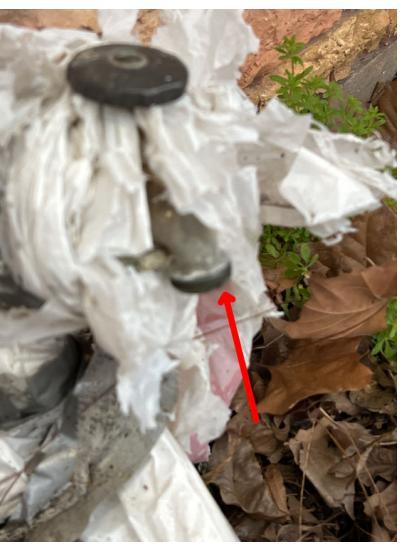
Even though the well is running, and the valves are open, no water pressure reaches the house.

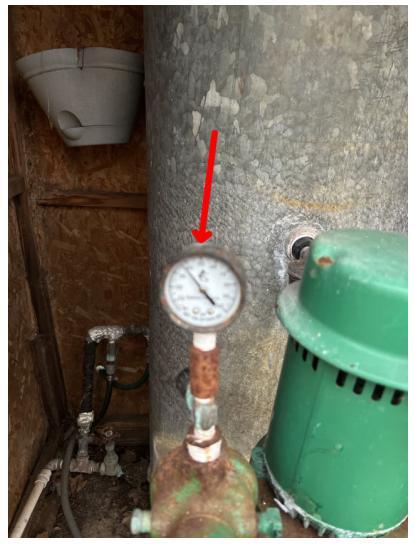
Even though the well is running, and the valves are open, no water pressure reaches the house.

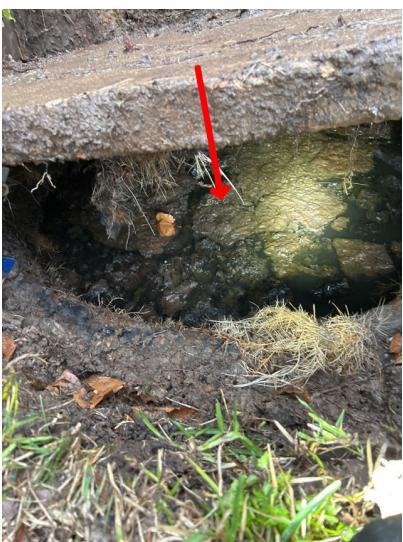
The Liquid level in the tank was noted to be above the drain lines in the tanks into the baffles. Recommendation is to have the tanks pumped out. Septic tank interior was not inspected.

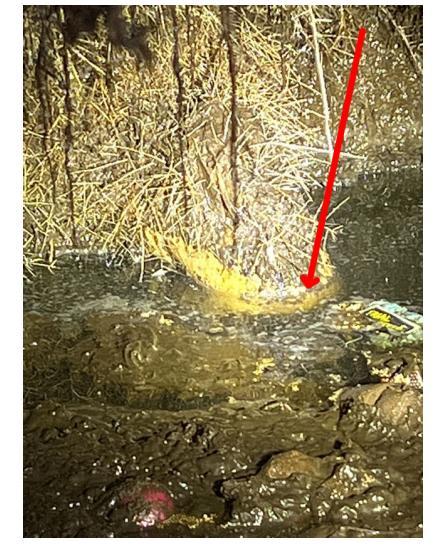
The Liquid level in the tank was noted to be Recommendation is to have the tanks pumped out. Septic tank interior was not inspected.

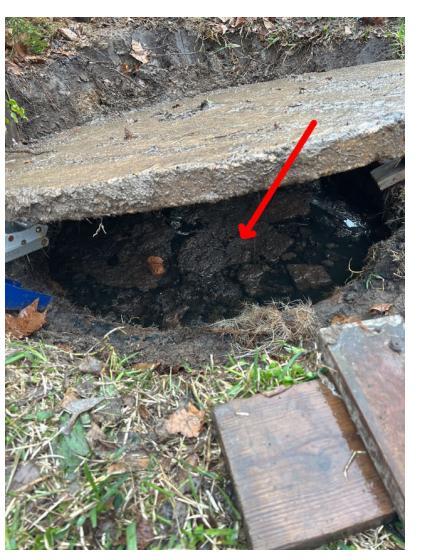
The Liquid level in the tank was noted to be above the drain lines in the tanks into the baffles. above the drain lines in the tanks into the baffles. Recommendation is to have the tanks pumped out. Septic tank interior was not inspected.

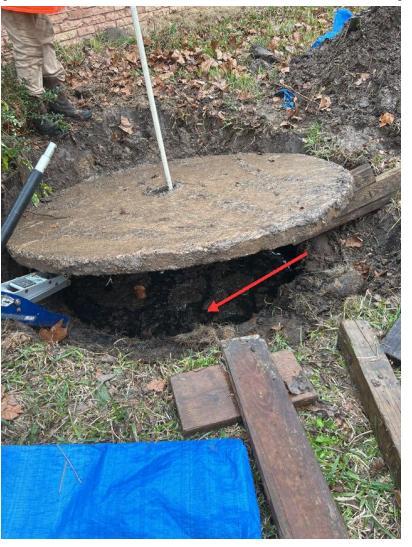
There appears to be debris in the bottom of the septic tank, recommend having it pumped and debris removed.
