*"1st class inspections
brought to you by
1st Rate Inspections!"*

Property Inspection Report

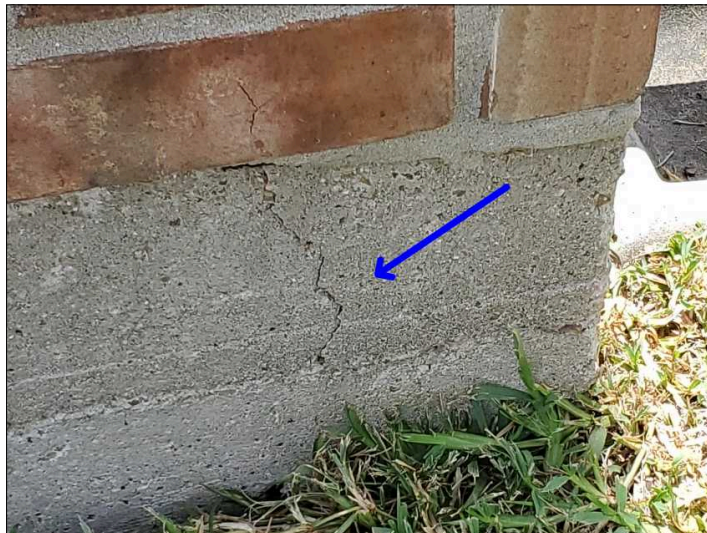
- Corner pops were noted on one or more corners of the foundation, these are usually considered cosmetic nature unless other movement is noted. Recommend sealing all cracks to help prevent further deterioration.

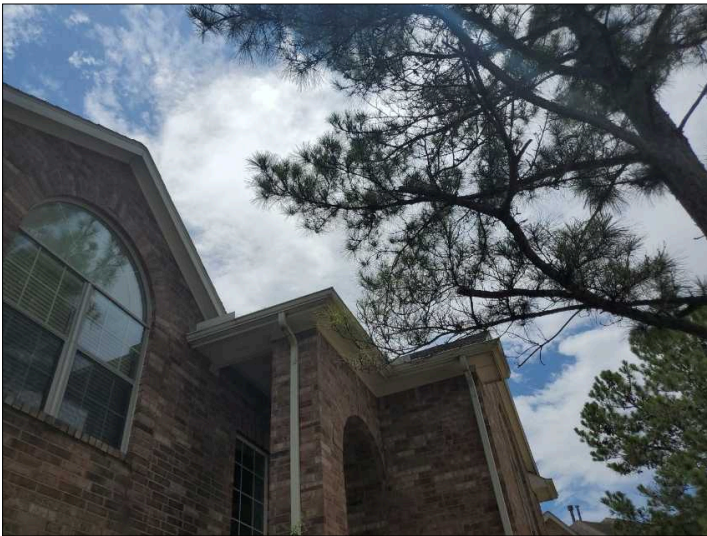
- Tree limbs should be kept trimmed at least 5' from roof to help prevent damage to the roof during windy conditions.

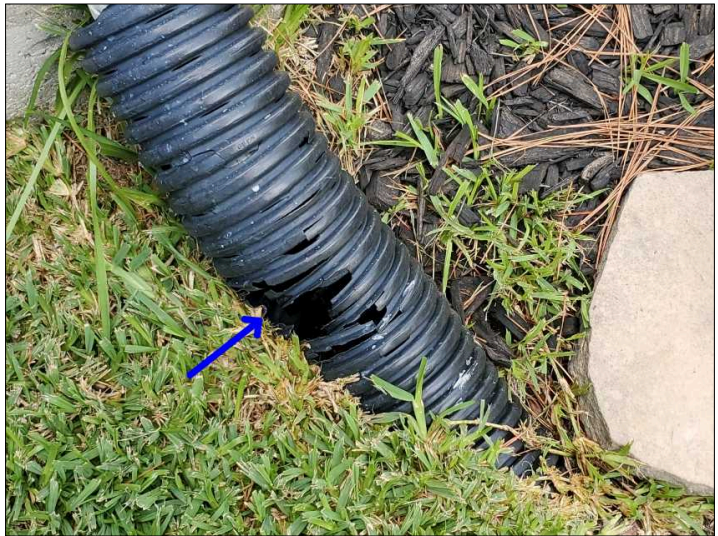
Gutter extensions damaged. Mainly at - front left

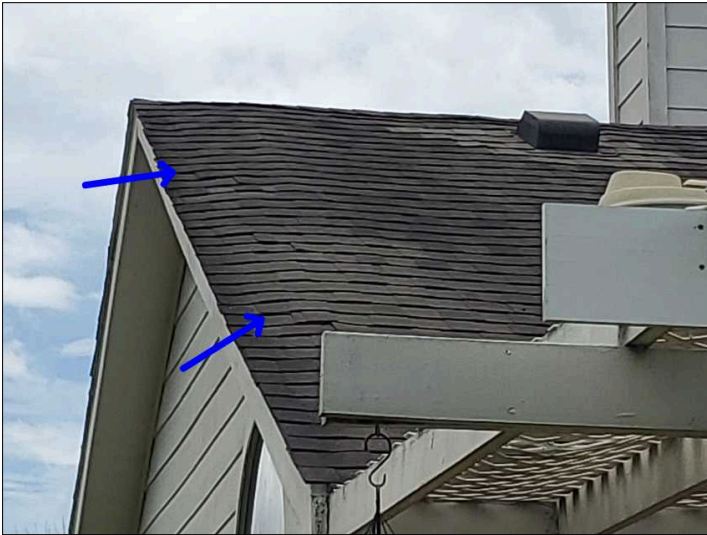
- The decking is buckling on the roof, this is often caused by an improper gap for expansion of the decking materials, recommend consulting a roofing contractor for evaluation and repairs as needed.

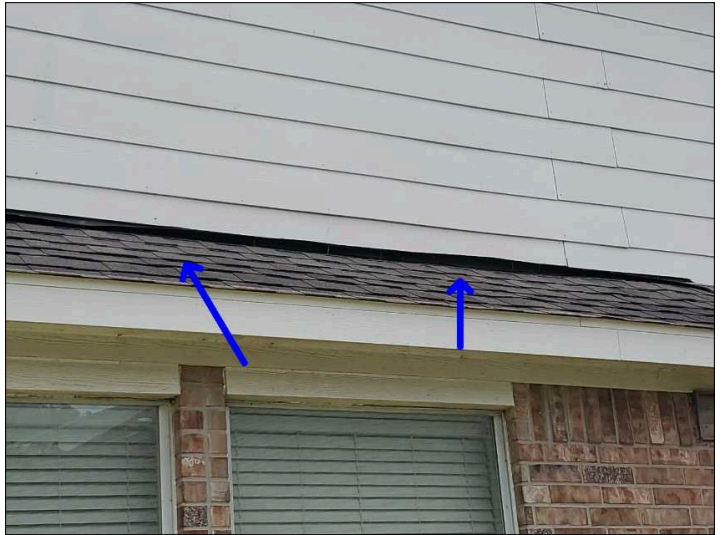
- The roof flashing is lifted. Recommend securing all loose or lifted flashing and sealing nails to help prevent water penetration. Mainly at - left

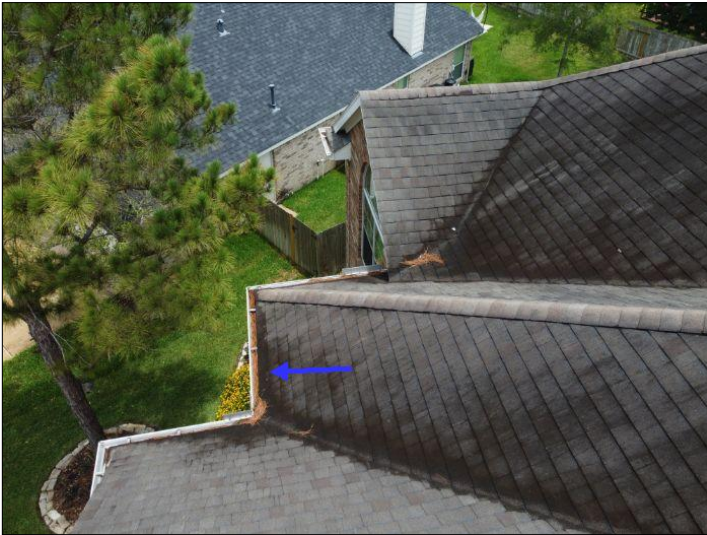
-There is debris in the gutters, recommend cleaning gutters to restore to proper operation.

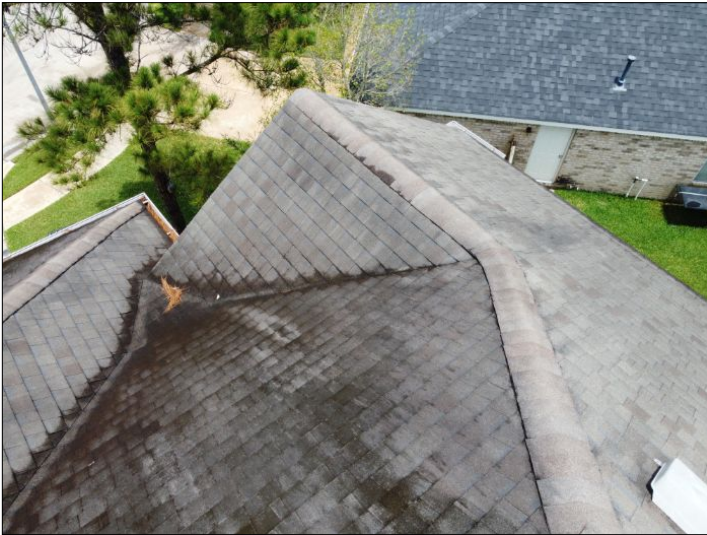
I	NI	NP	D
---	----	----	---

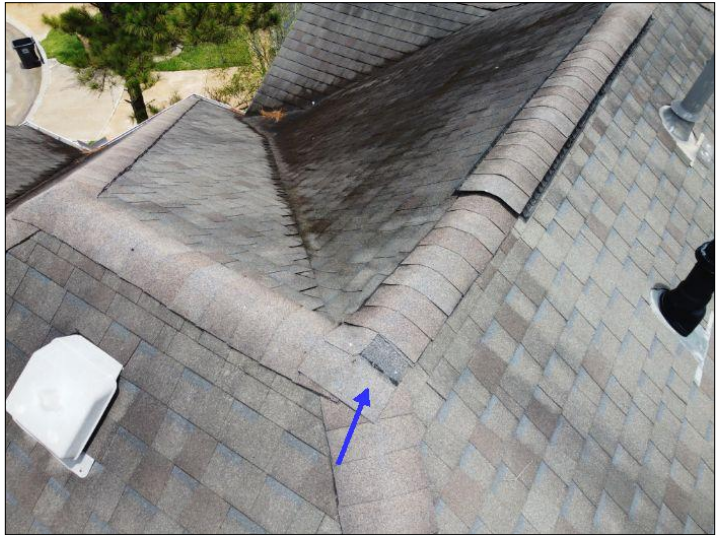
-There are damaged or missing ridge shingles on the roof, recommend repairs or replacement of damaged ridge shingles.

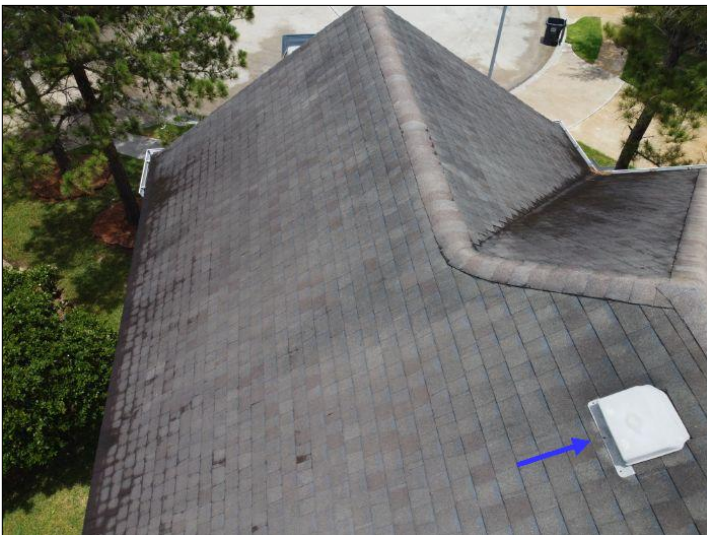
-There were exposed nails noted on the roof it is recommended that all exposed nails and fasteners on roof be sealed at all penetrations, ridges and roof to wall connections.

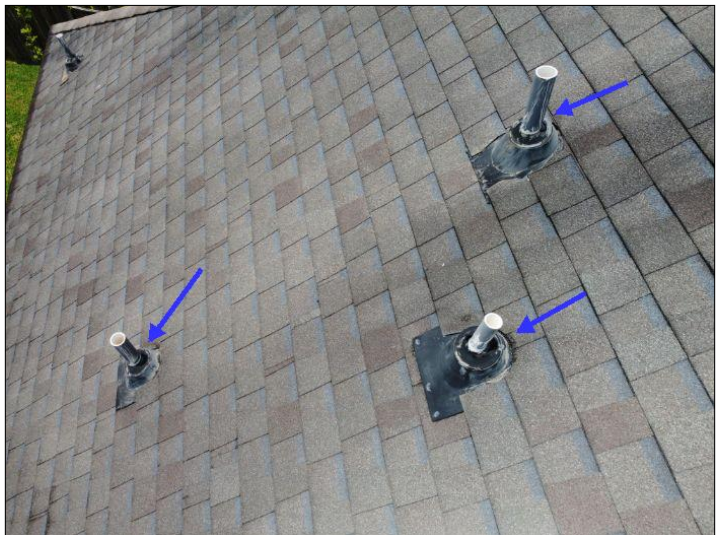
-The rubber plumbing vent boots are showing signs of deterioration and should be replaced or sealed depending on condition. Recommend a roofer check all plumbing boots for repairs or replacement as needed and check entire roof for other issues that may be of concern. If roof jacks are 11-15 years of age and some are showing signs of deterioration it is recommended that all roof jacks be replaced as they are at the end of there useful life.

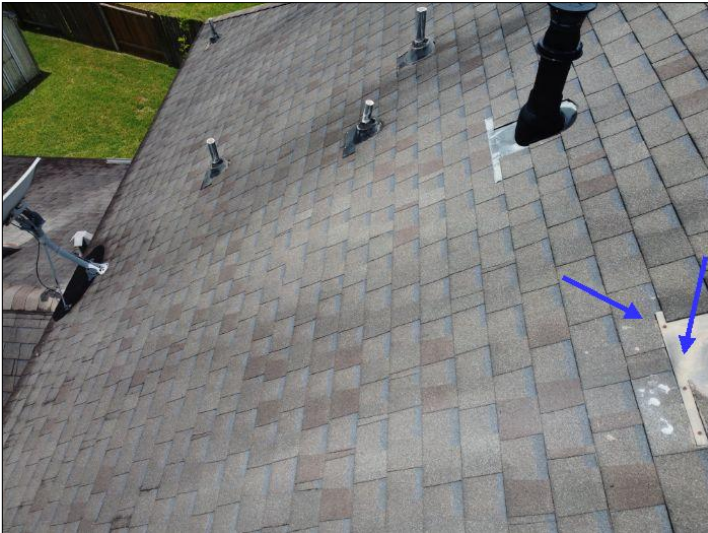
-There were exposed nails noted on the roof it is recommended that all exposed nails and fasteners on roof be sealed at all penetrations, ridges and roof to wall connections.

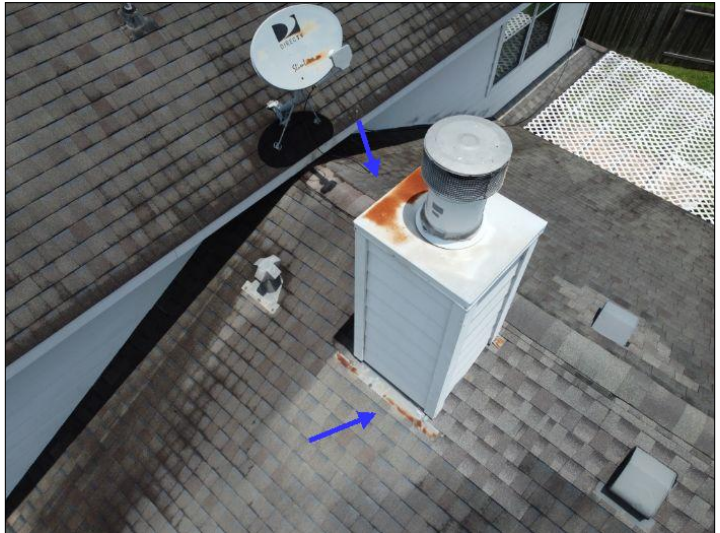
-There are signs of rusted flashing on the rooftop. We recommend painting or replacing all rusted or deteriorated flashing as needed.

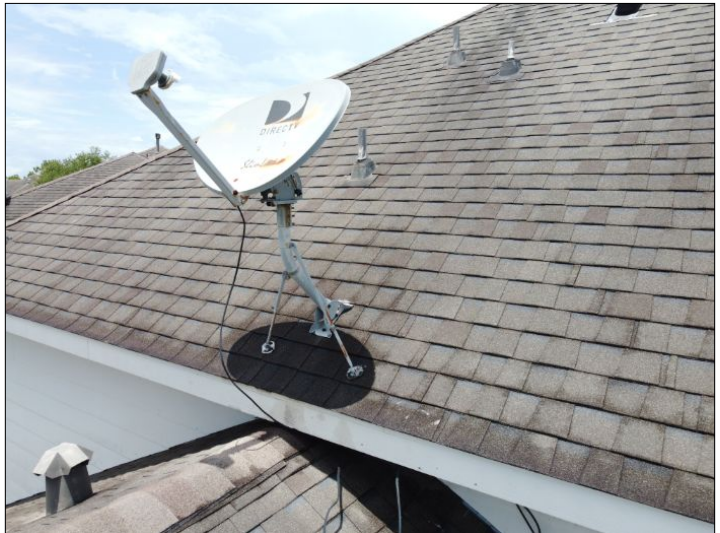
- There is/was a satellite dish mounted to the roof structure. It is recommended that the Satellite dish be properly mounted at the siding of the home or on a stand alone base in the yard. Recommend sealing the mounting hardware to help prevent water penetration.

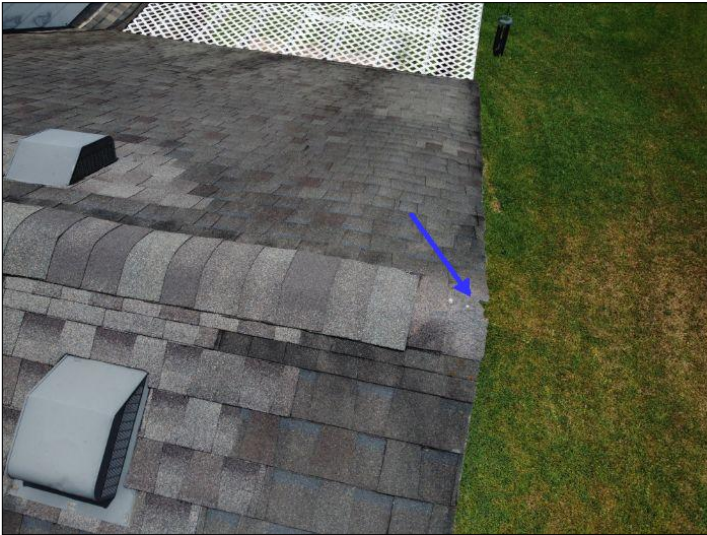
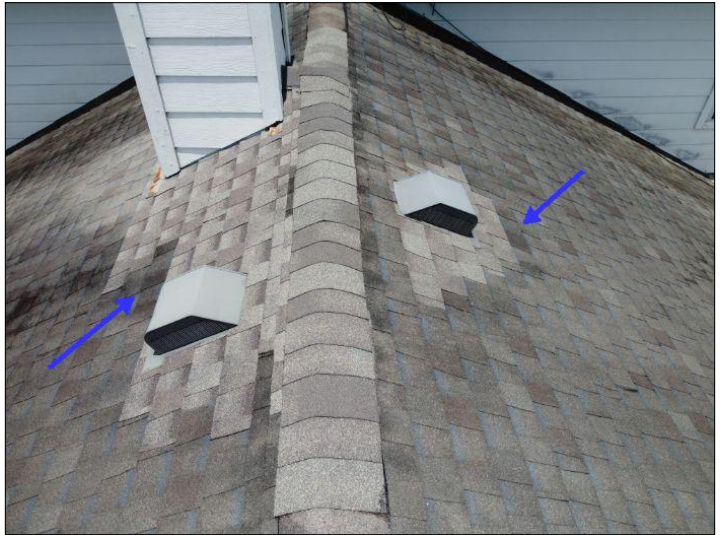
-There are damaged or missing ridge shingles on the roof, recommend repairs or replacement of damaged ridge shingles.

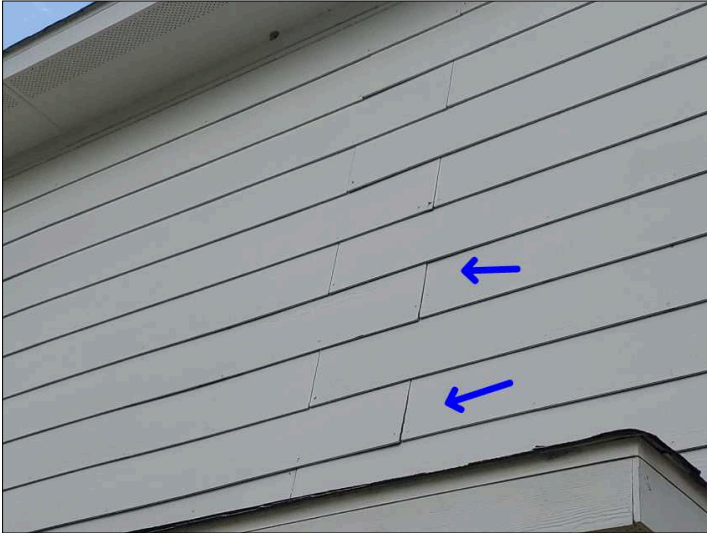
- There are gaps at the joints in the siding in various locations due to shrinking and expansion of siding materials, recommend sealing all open joints in the siding to help prevent water penetration.

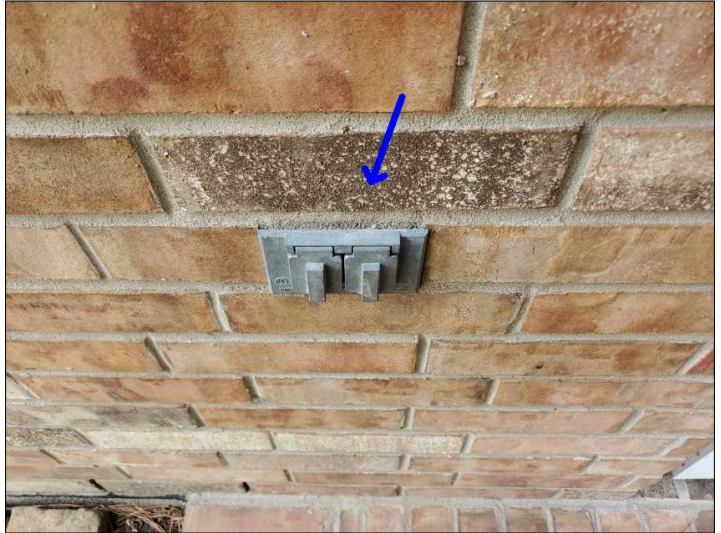
- Seal all exterior receptacles at wall connection to help prevent water penetration into walls.

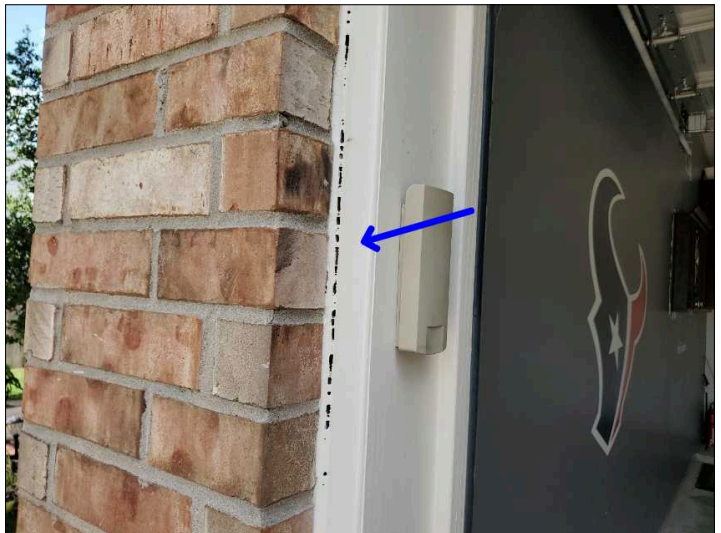
- Recommend sealing between the trim and brickwork to help prevent water penetration. Mainly at - front

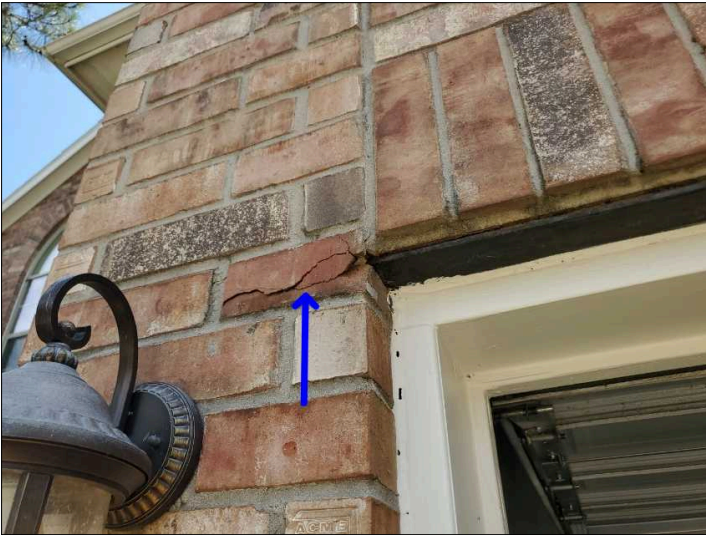
Damaged/cracked brickwork noted. Mainly at - front

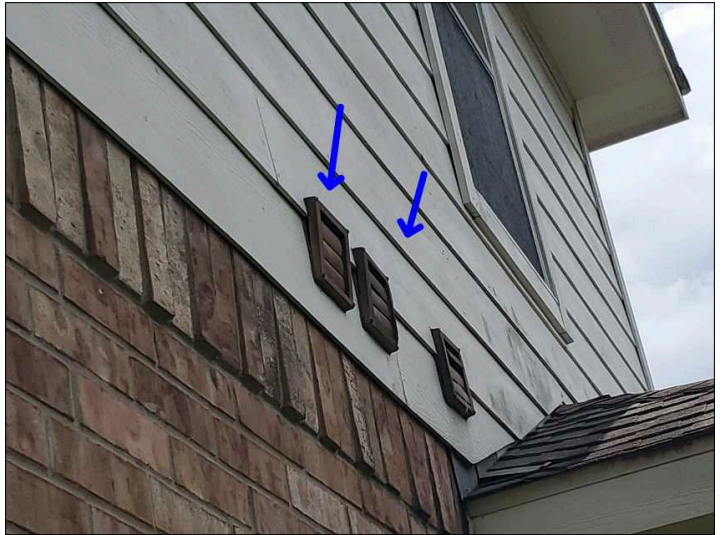
- Seal all vents at wall connection to help prevent water penetration into walls. It is a good idea to leave a small opening at the bottom to allow any water penetrating to escape.

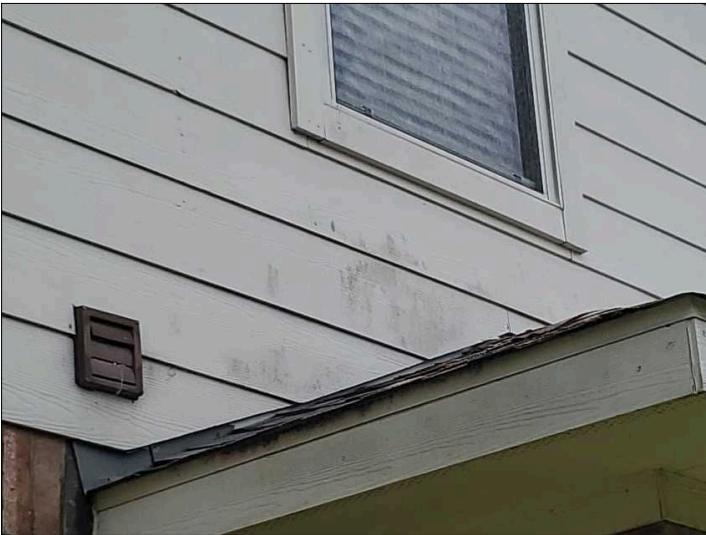
- There are signs of growth on exterior brickwork/siding, recommend cleaning to help prevent deterioration.

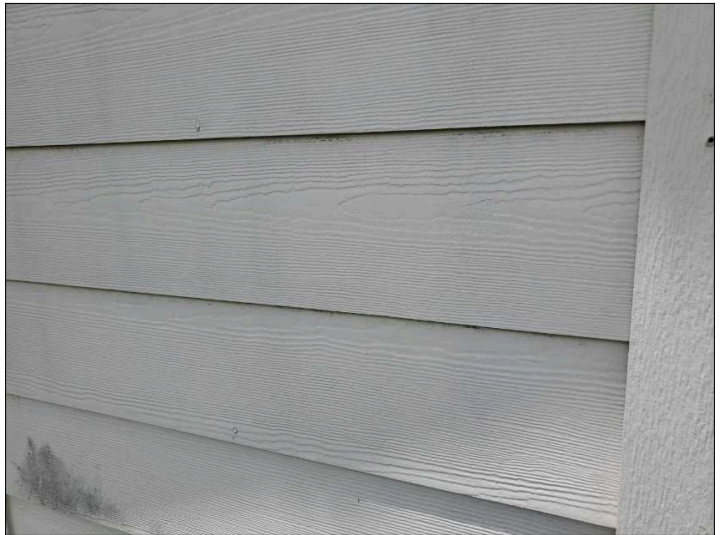
- Paint is chalking meaning it is losing its protection values, recommend repainting.

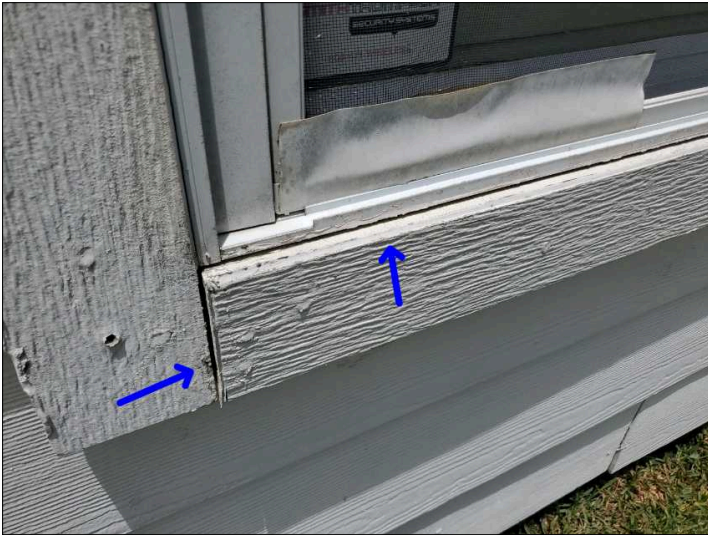
- Recommend sealing trim to help prevent water penetration. Mainly at - rear

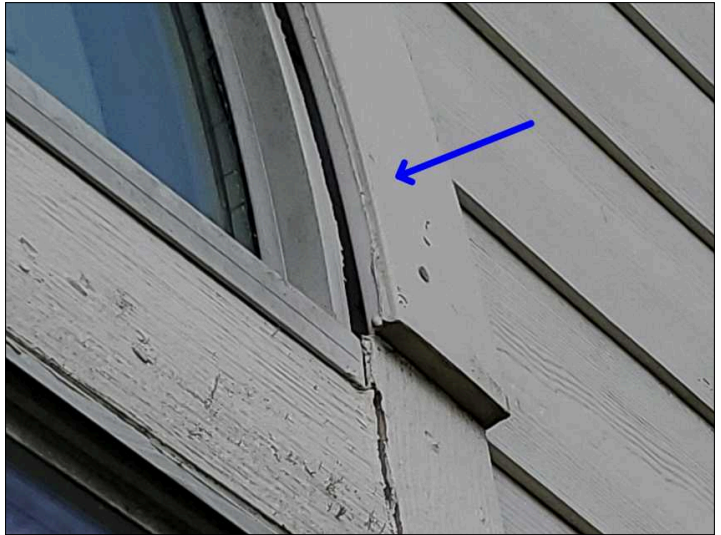
- There is loose trim on the home, recommend securing to help prevent future damage and water penetration. Mainly at - rear

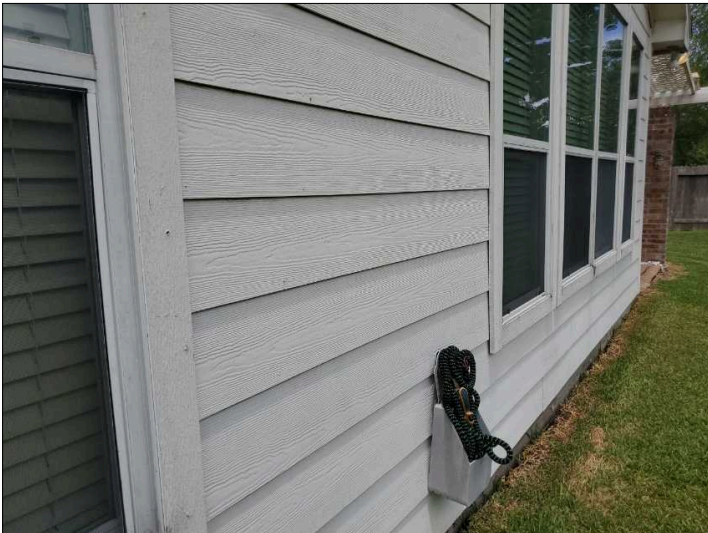
- Paint is chalking meaning it is losing its protection values, recommend repainting.

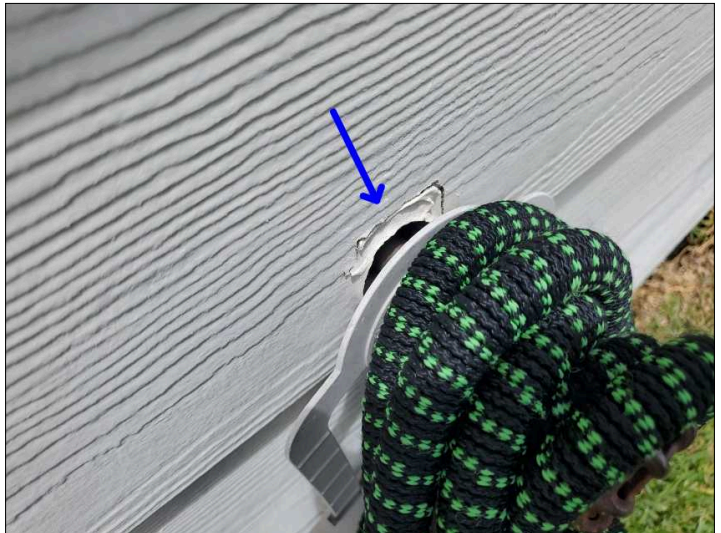
- Seal all gaps and holes in brick or siding to help prevent moisture intrusion. Mainly at - rear

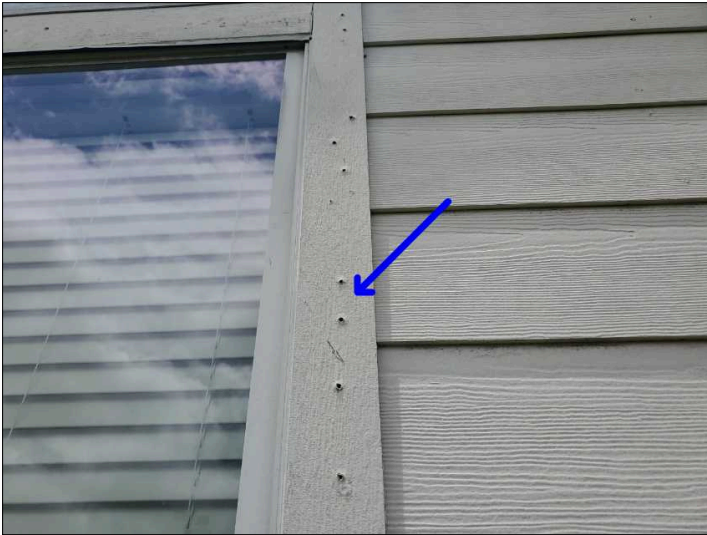
- Seal all gaps and holes in brick or siding to help prevent moisture intrusion. Mainly at - rear

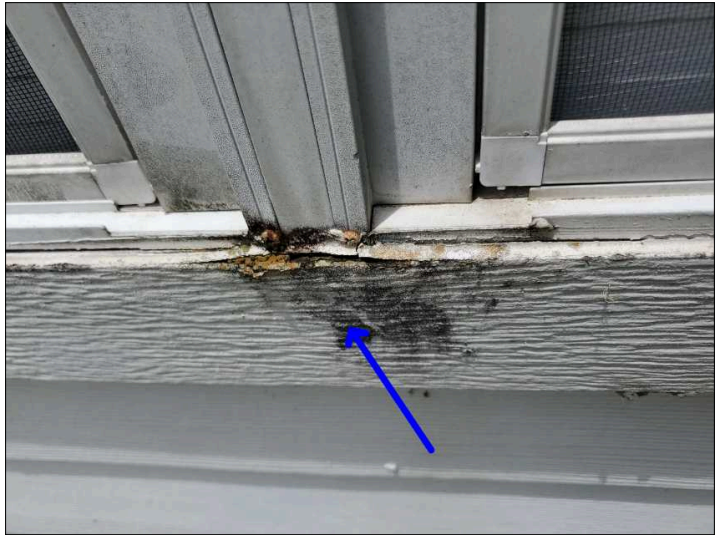
- Deterioration was noted at the trim, recommend replacing all deteriorated trim. Unable to determine the condition of the underlying materials. Mainly at - rear

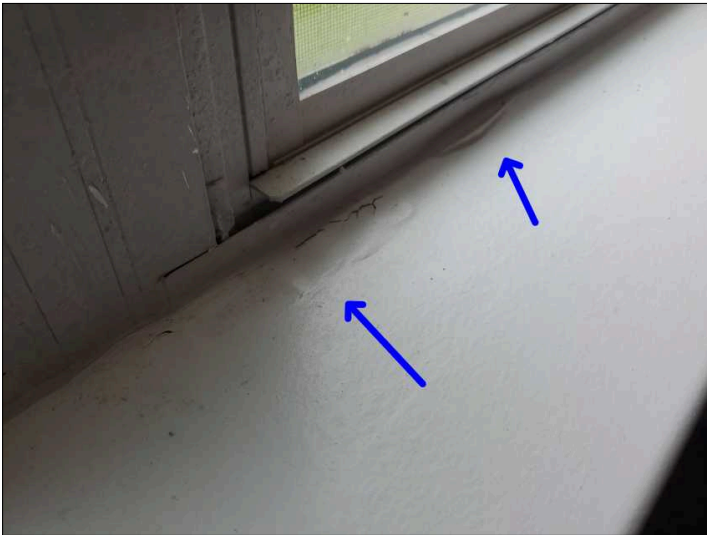
- Paint is cracked and peeling, recommend repairs to help prevent deterioration. Mainly at - master bedroom window sill

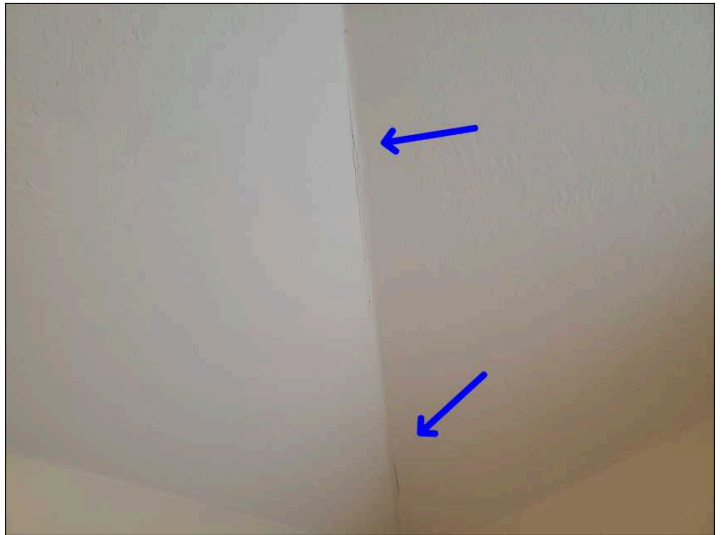
- Settlement cracks were noted at the tape joint in the drywall. Mainly at - upstairs rear right bedroom

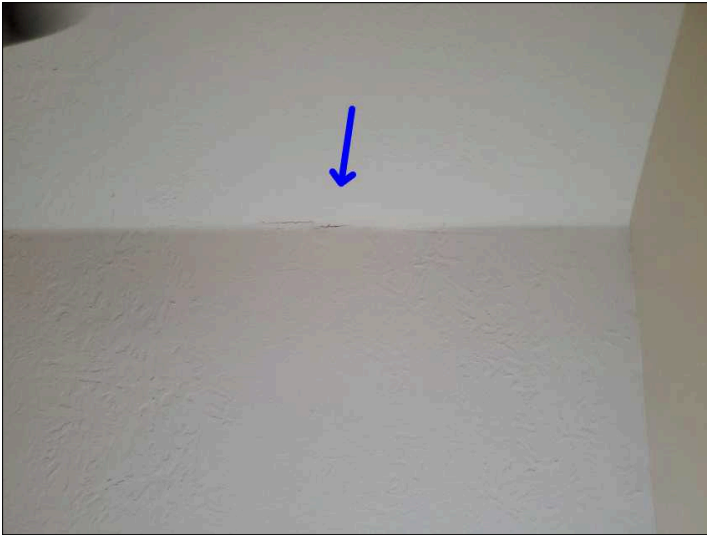
- Settlement cracks were noted at the tape joint in the drywall. Mainly at - upstairs rear right bedroom

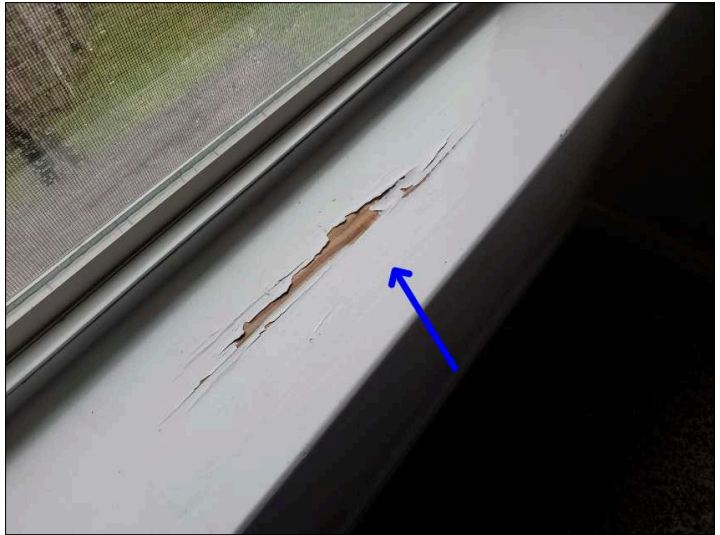
- Paint is cracked and peeling, recommend repairs to help prevent deterioration. Mainly at - upstairs rear right bedroom window sill

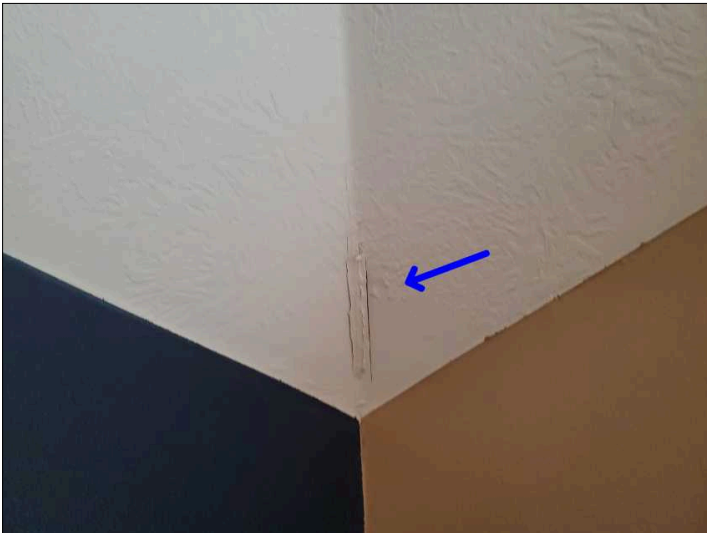
- Settlement cracks were noted at the tape joint in the drywall. Mainly at - upstairs family room

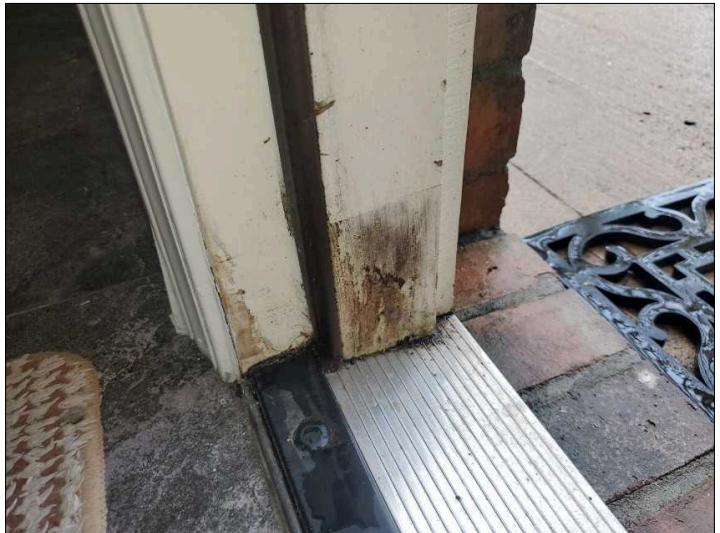
- Deterioration was noted at the trim, recommend replacing all deteriorated trim. Unable to determine the condition of the underlying materials. Mainly at - rear door

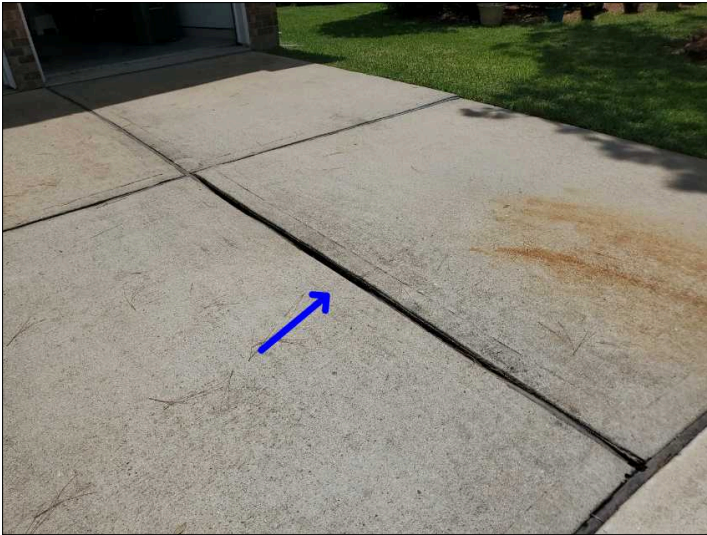
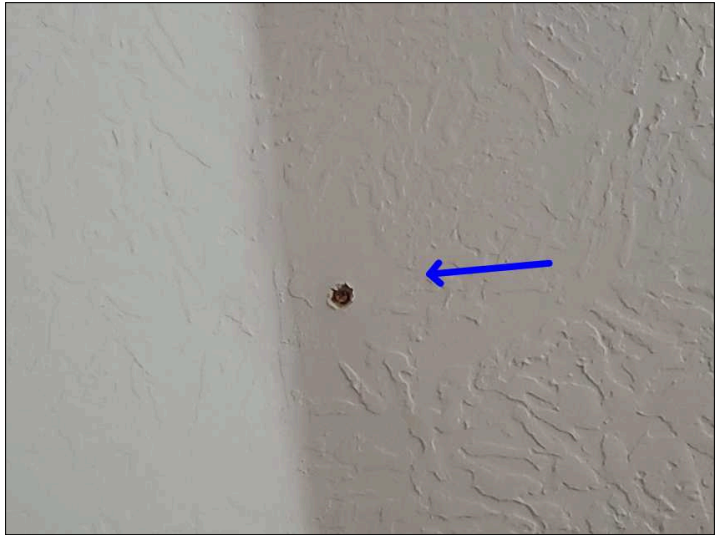
- Uneven pavement was noted, recommend repairs to help prevent tripping. Mainly at - driveway

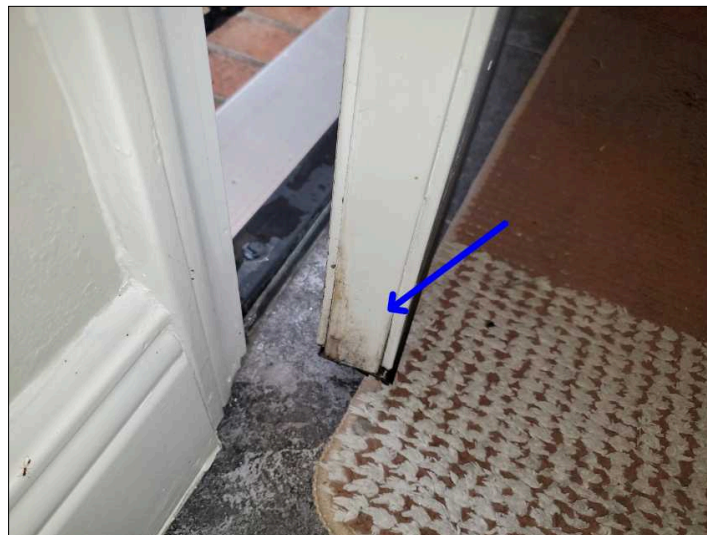
- Deterioration was noted mainly along the door, recommend repair or replacement to help prevent water penetration. Unable to determine the condition of the underlying materials. Mainly at - rear door

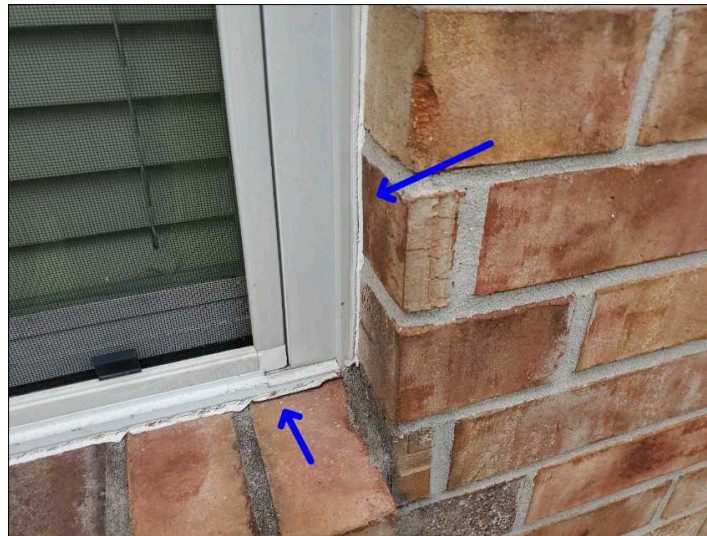
- Sealant is needed around various windows between the window framing and exterior brickwork or trim to help prevent water penetration, recommend checking all windows for proper sealant.

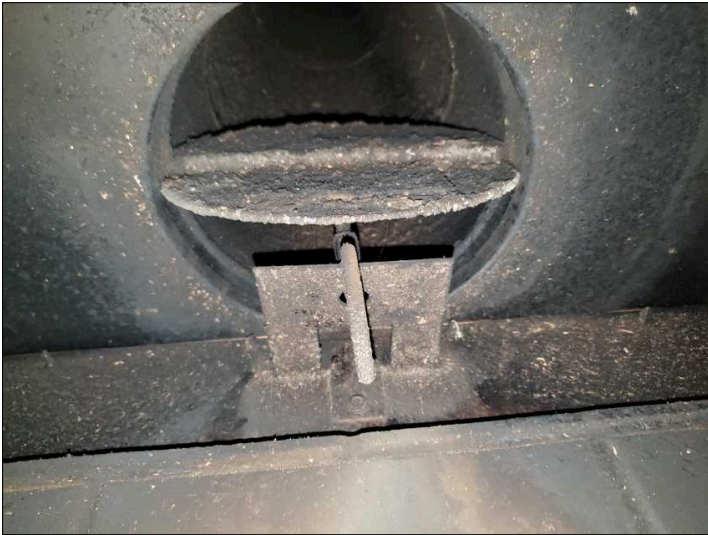
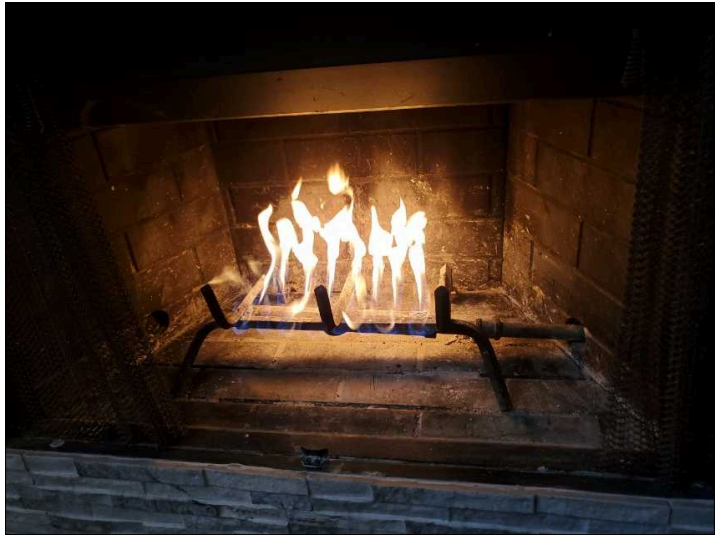
Overview of fireplace

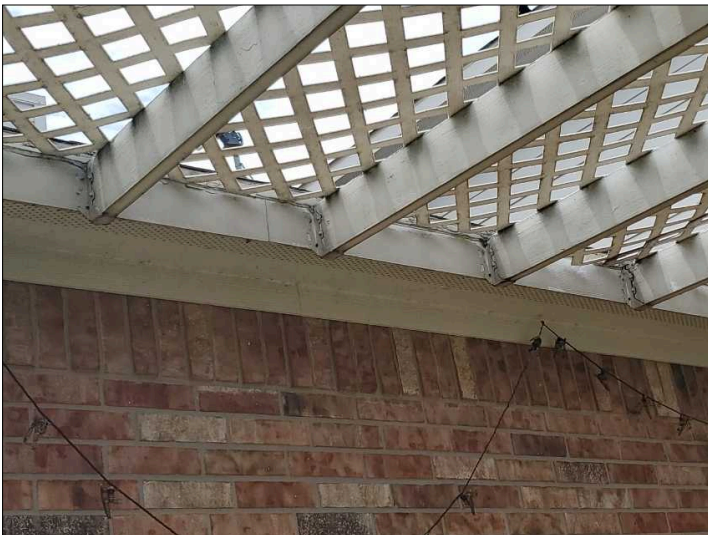
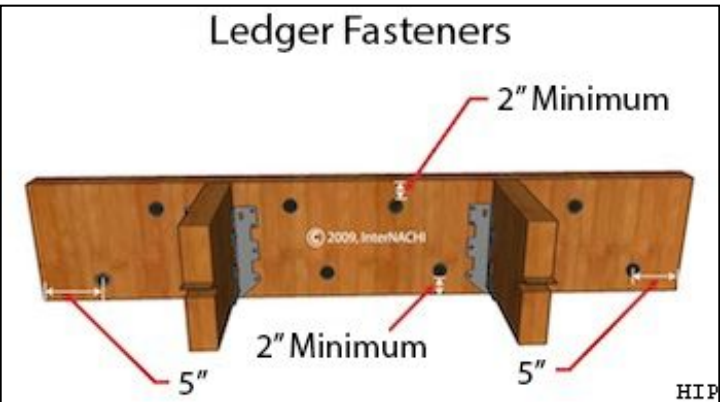
- The patio cover is improperly supported, recommend patio covers be installed with lag screws or bolts. Screws are not recommended fasteners.

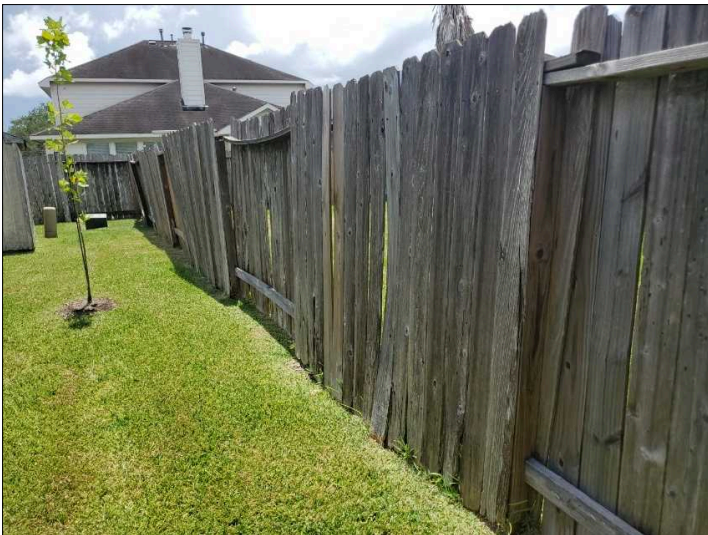
- Although fences are not inspected it was noted that the fence is showing some signs of damage or deterioration.

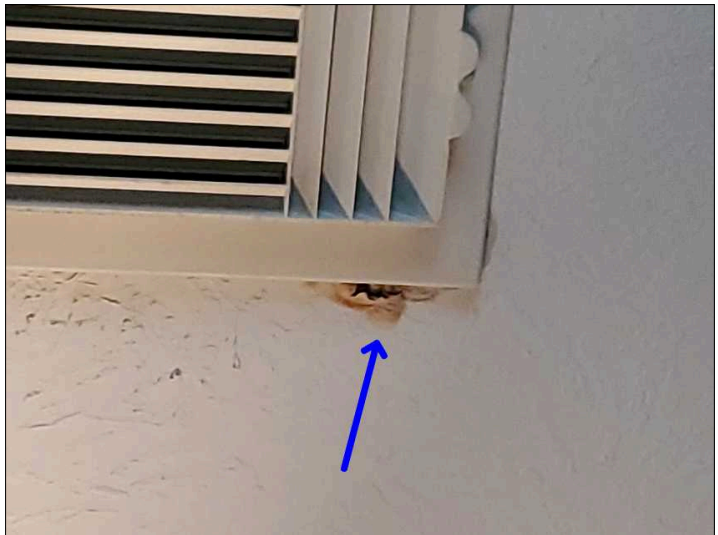
- There are indications of water penetration to the ceiling evident mainly by deterioration. Unable to determine condition of the underlying materials. Mainly at - upstairs family room

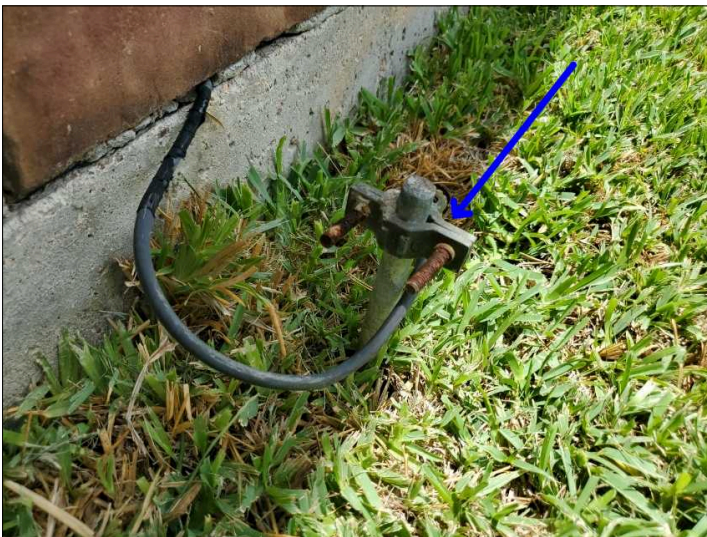
- There is an improper ground rod clamp, it is recommended that ground wires be secured with the proper acorn style clamp for proper protection.

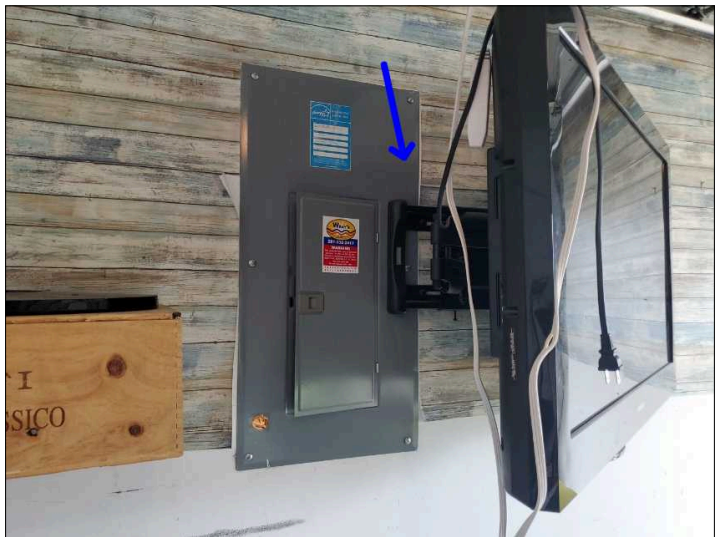
- There was no access to the electrical panel.

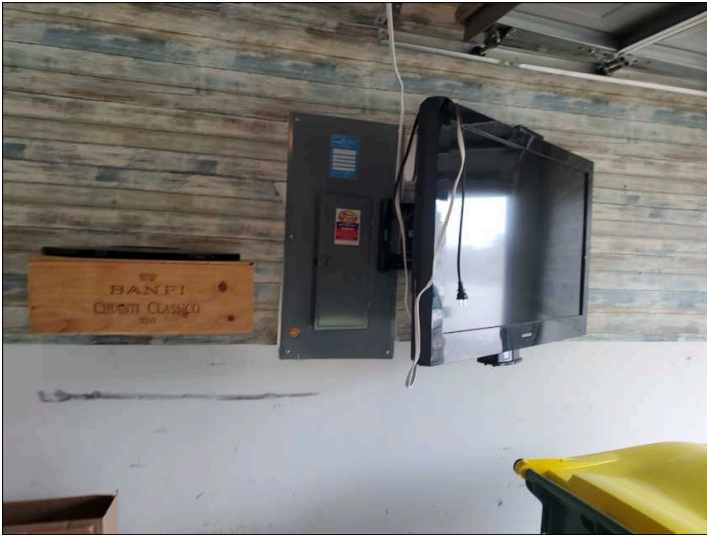
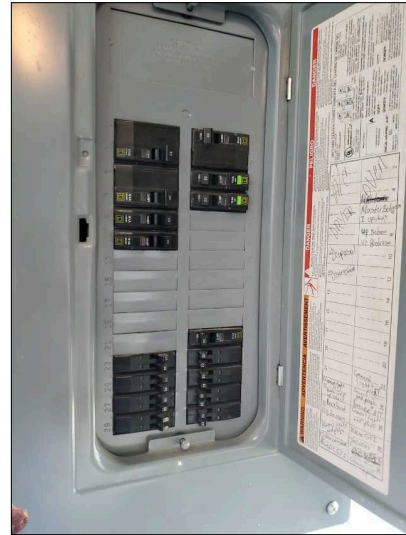
- There is improper clearance in front of or around electrical panel box, recommend proper clearance for access.

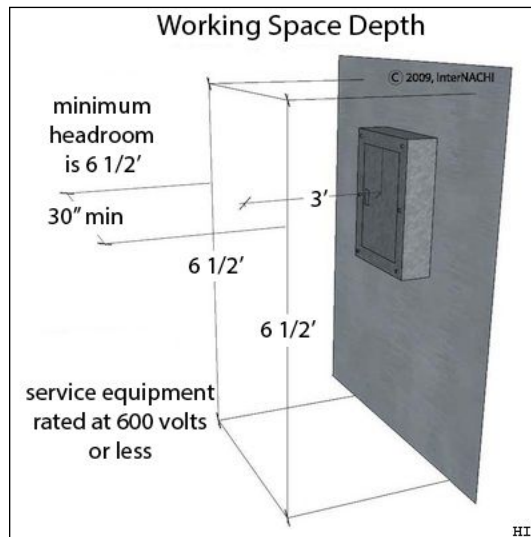
Overview of main electrical panel

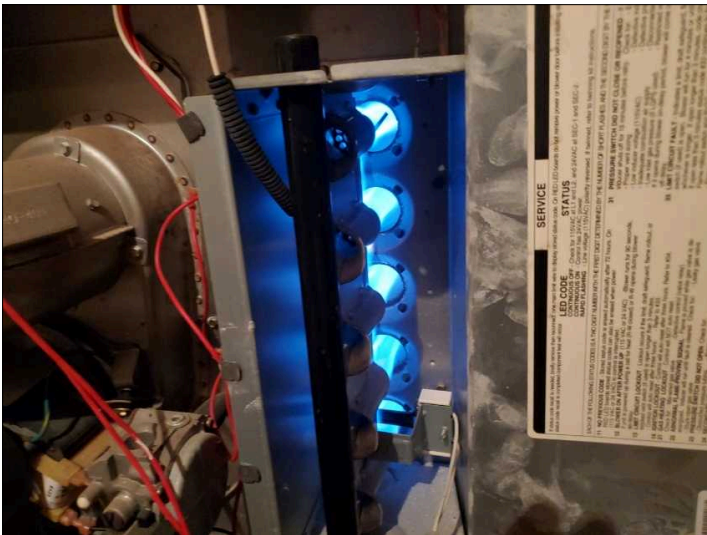
Overview of furnace burner compartment.

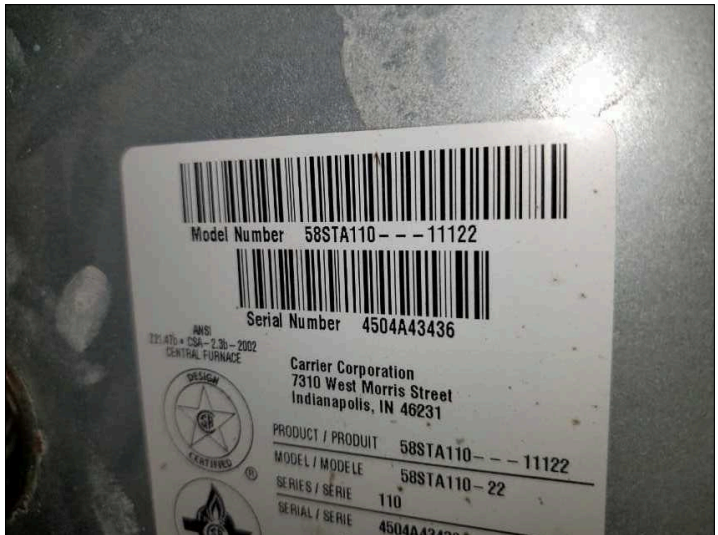
B. Cooling Equipment

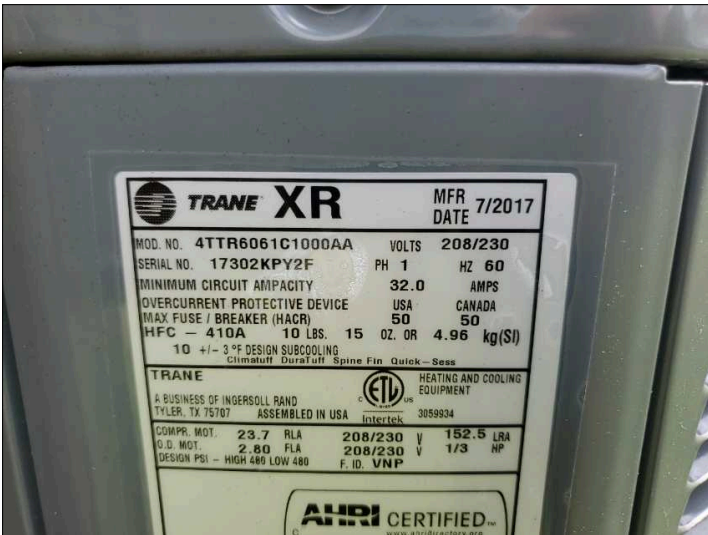
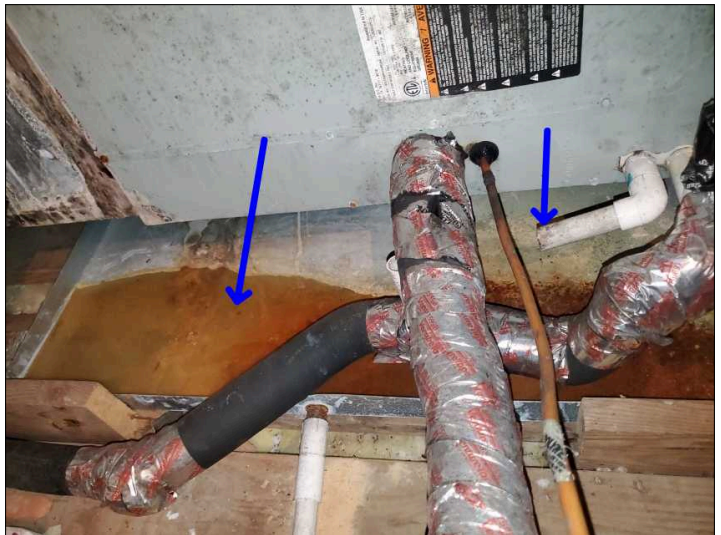
- There is water noted in the A/C pan. This is an indication that the main condensation line is clogged. Recommend contacting an A/C specialist to remove clog and restore drain to normal operation. It is also recommended to have the unit checked for proper operation and for cleanliness.

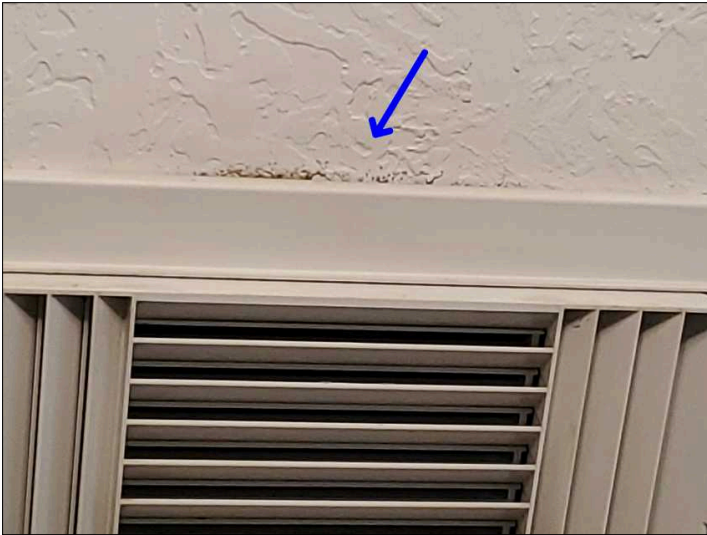
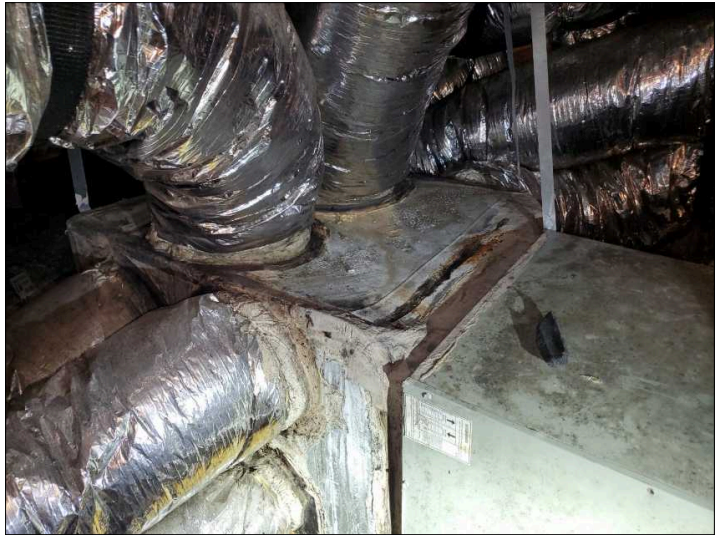
- Registers are showing signs of growth, recommend cleaning vents and ducts as needed. Air sampling will most likely not identify microbial growth, however a swab or tape sample will determine if there is microbial growth.

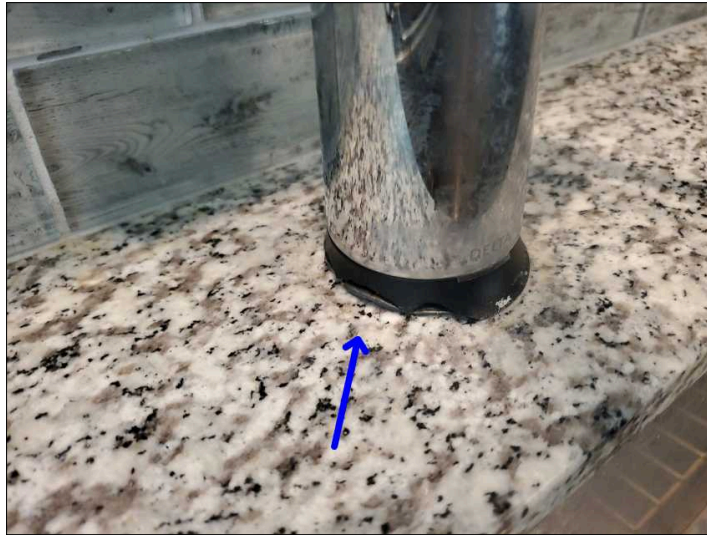
Faucet base damaged. Mainly at - kitchen
