*"1st class inspections
brought to you by
1st Rate Inspections!"*

Property Inspection Report

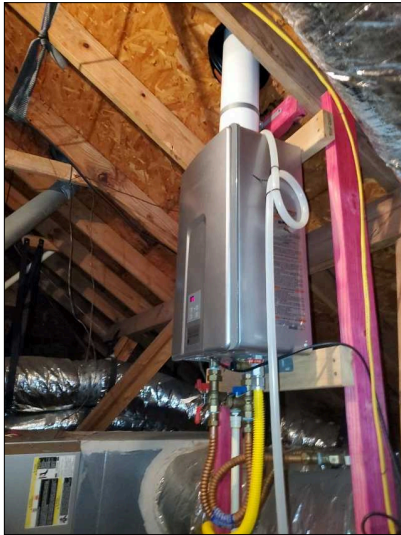
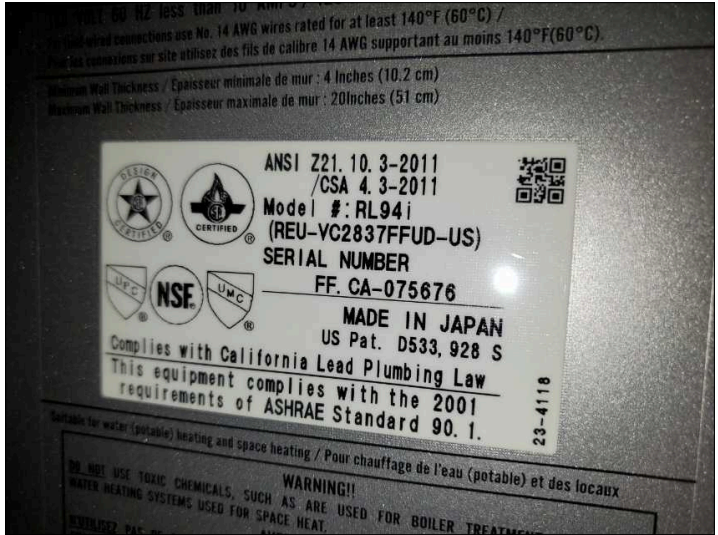
Overview of water heater(s)

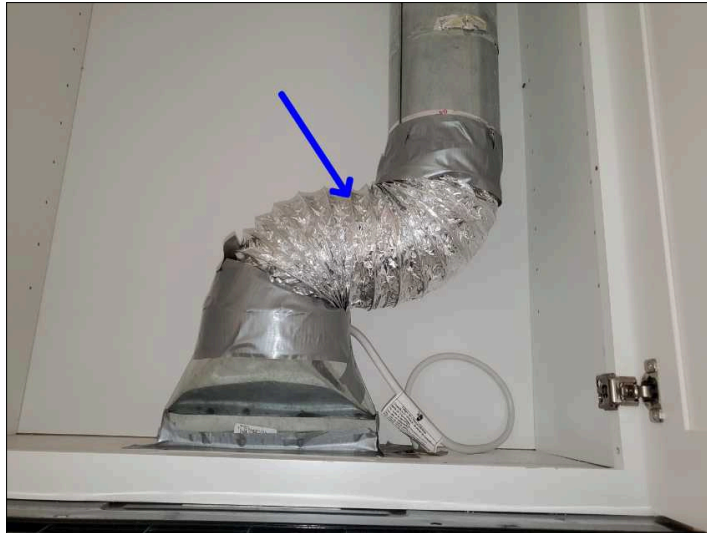
- Range/cooktop vents should be made of smooth pipe not corrugated pipe so that grease does not accumulate in crevasses. This is a potential fire hazard and should be corrected.

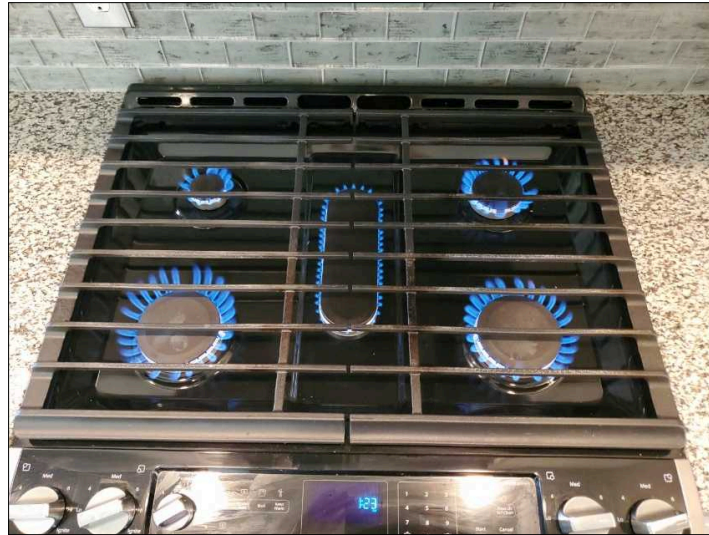
I	NI	NP	D
---	----	----	---

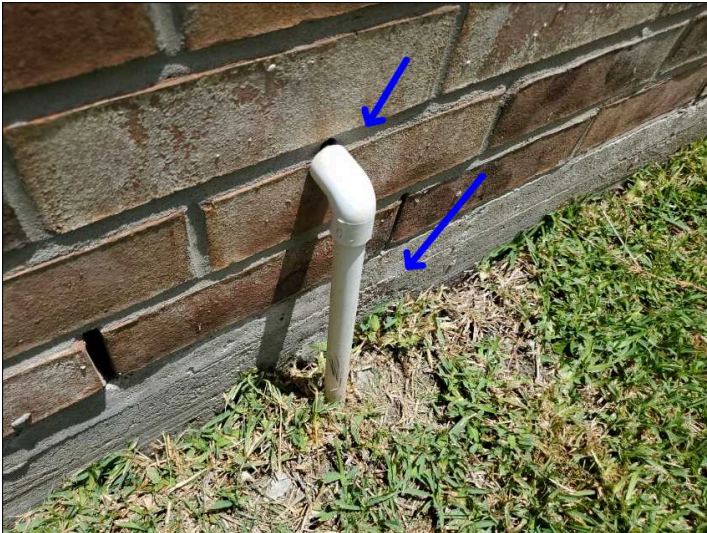
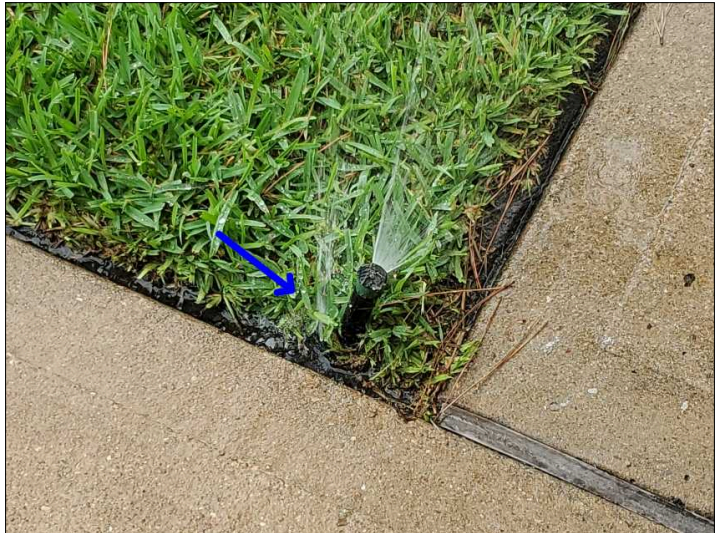
- All exterior PVC pipe should be painted to prevent premature deterioration from UV rays. Also recommend sealing all pipes at wall penetrations.
