# **Inspection Report**

Property Address: 6315 Settlers Square Lane Katy TX 77449

# **PROPERTY INSPECTION REPORT FORM**

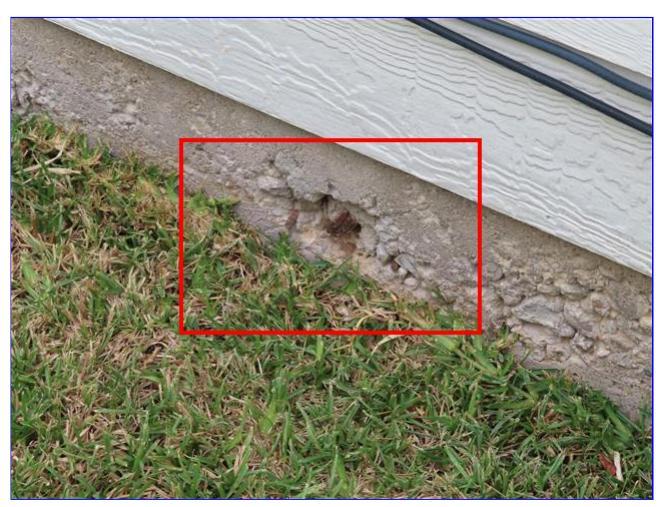
A. Item 1(Picture)

Foundation was working as intended at time of inspection. All foundation penetrations, gaps and cracks should be sealed properly. Conducive to moisture and WDI (Wood Destroying Insect) intrusion.

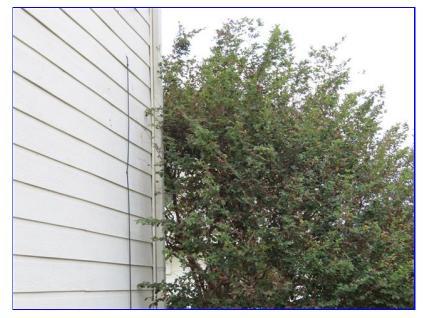
B. Item 1(Picture)

(1) All trees should be cut back from the structure. Conducive to WDI (Wood Destroying Insects) and possible damage to structure.

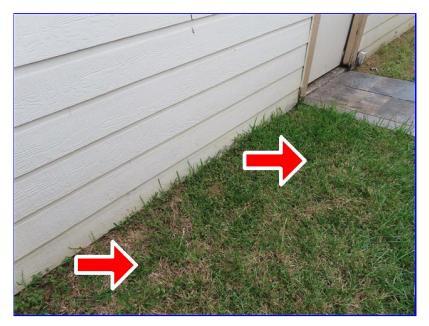
B. Item 2(Picture)

(2) Soil was too high to the foundation and siding in several areas at time of inspection. Soil should be graded 6" in 10' away from the foundation. Soil should be at least 4" from bottom of brick and 6" from bottom of siding.

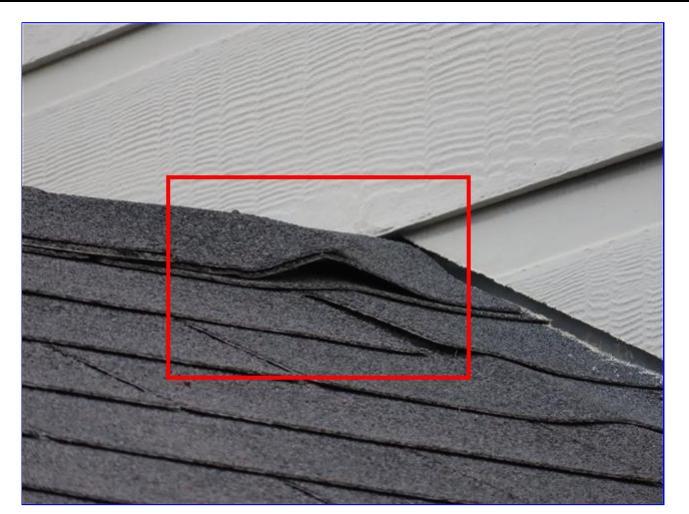
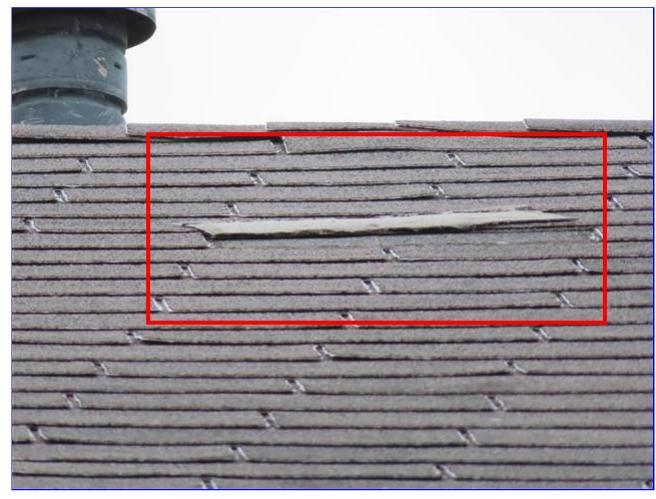
(1) All lifted roof shingles should be corrected and sealed properly by a professional roofer. Conducive to moisture intrusion and causing possible damage. Should have a professional roofer inspect and evaluate roofing.

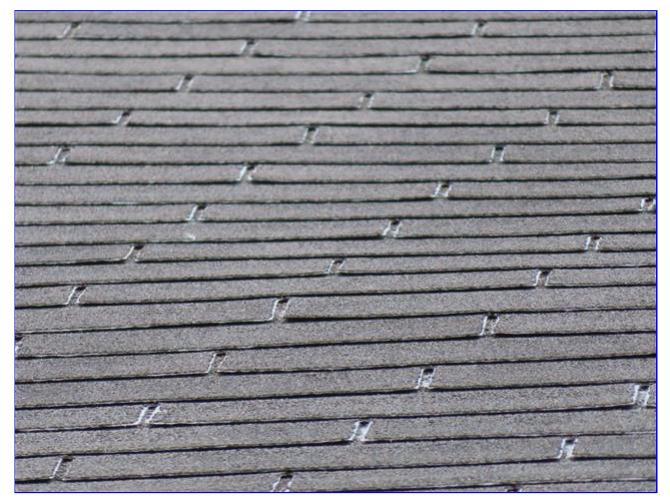
C. Item 3(Picture)

(2) Roofing has wear and tear at time of inspection. Should have a professional roofer further evaluate.

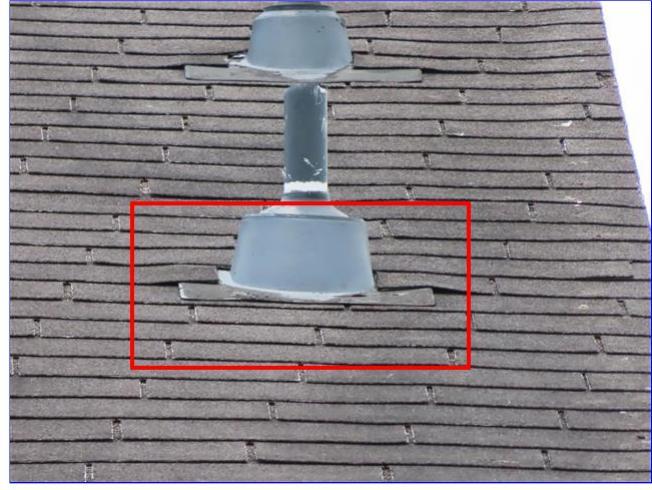
C. Item 4(Picture)

(3) Roof plumbing vent jacks were not installed properly at time of inspection. Should have a professional roofer correct properly. Conducive to moisture intrusion and causing possible damage.

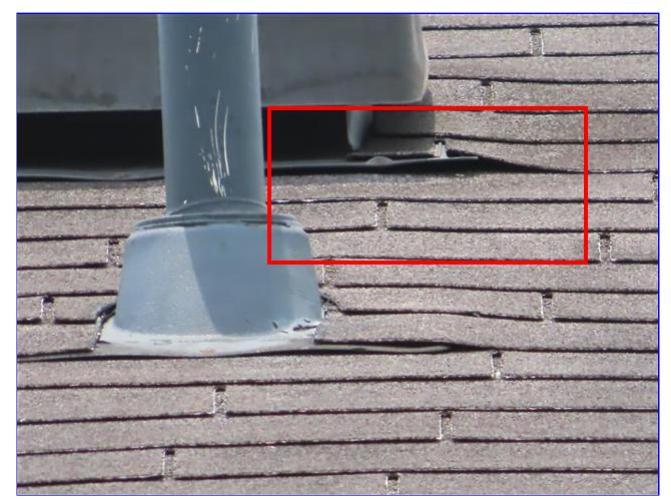
C. Item 5(Picture)

(4) All lifted roof exhaust vent lifted flashing should be corrected and sealed properly by a professional roofer. Conducive to moisture intrusion and causing possible damage.

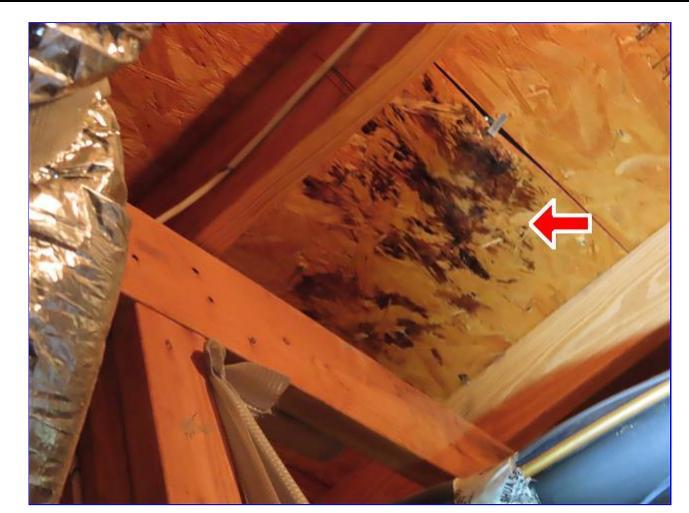
C. Item 6(Picture)

(5) Roof sheathing has moisture staining from possible roof leak at time of inspection. Should have a professional roofer inspect and correct properly.

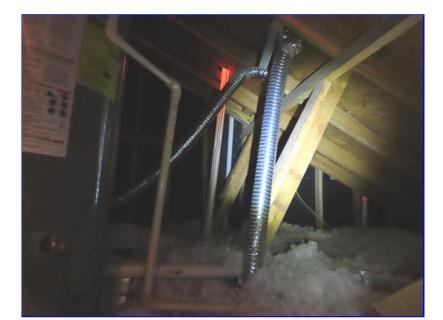
D. Item 1(Picture)

(1) Areas of the attic was not accessible to inspect at time of inspection. These areas were not inspected for any defects or deficiencies at time of inspection.

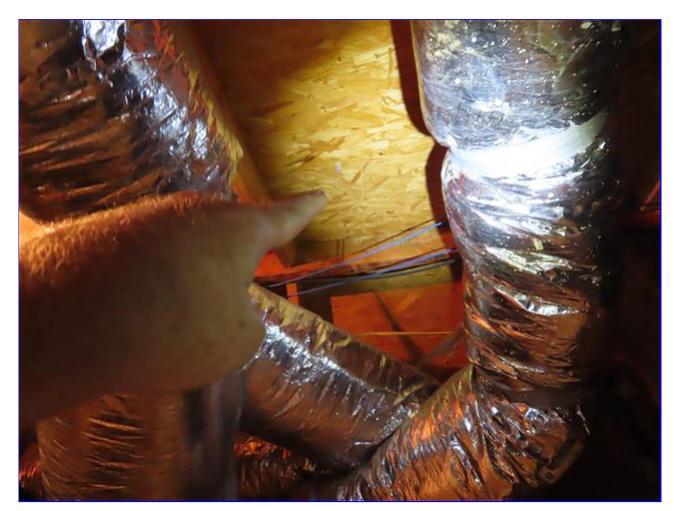
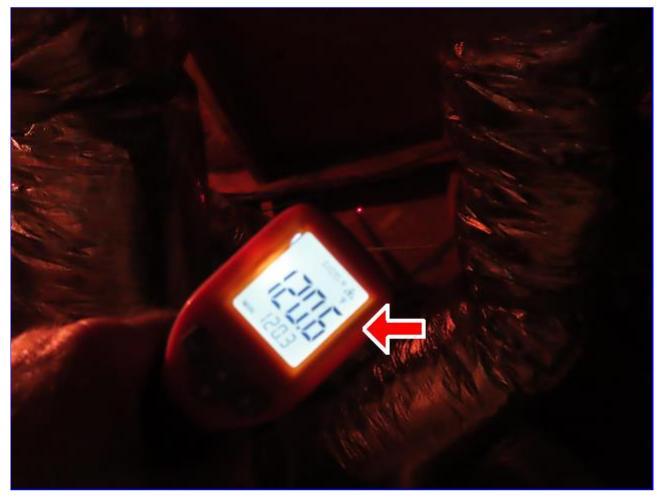
(2) Attic did not have proper ventilation at time of inspection. Should have a professional roofer correct properly.

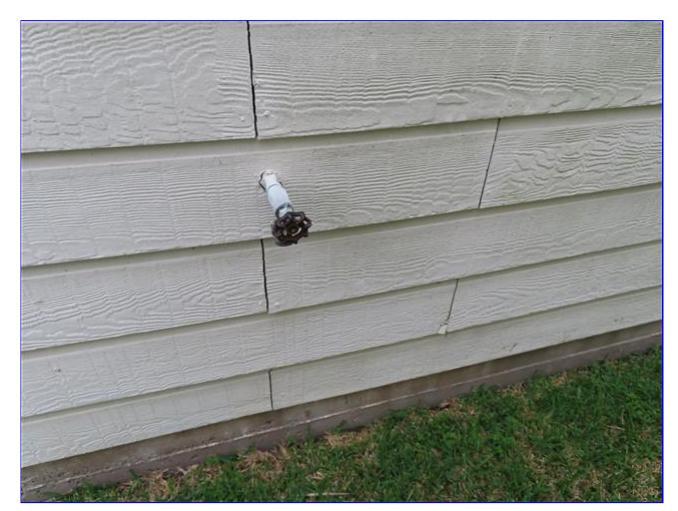
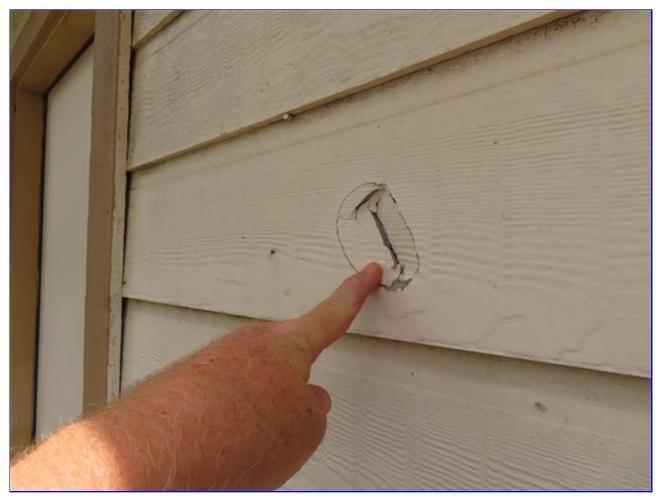
(1) All exterior siding seams, penetrations and damage should be sealed and corrected properly. Conducive to moisture and WDI (Wood Destroying Insect) intrusion.

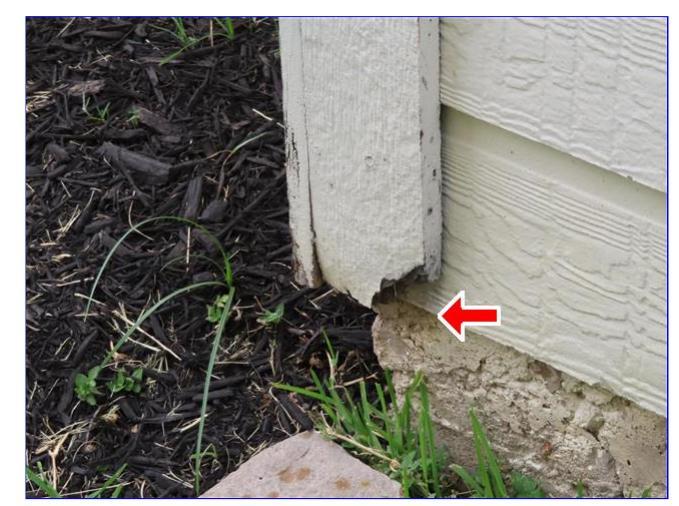
E. Item 4(Picture)

(2) Exterior wall trim has moisture damage and rot in several areas at time of inspection. Should have a professional correct properly.

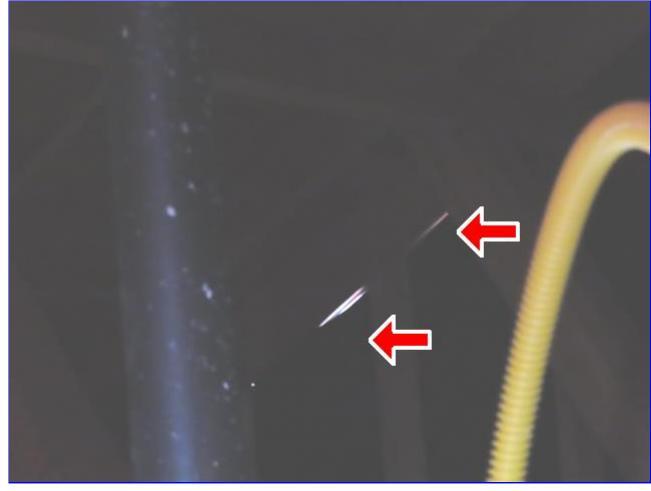
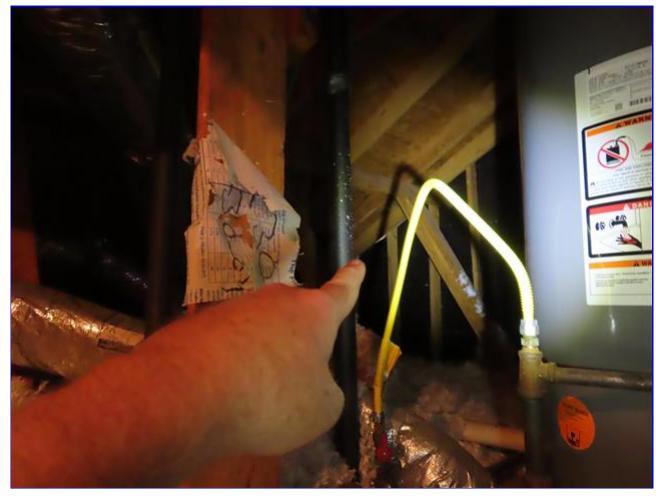
(3) Attic wall was leaking daylight into the interior of attic in several areas at time of inspection. Should correct and seal properly. Conducive to moisture intrusion and causing possible damage.

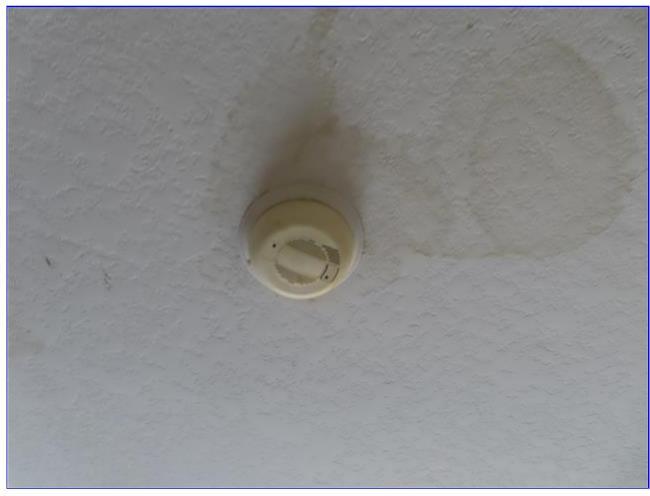
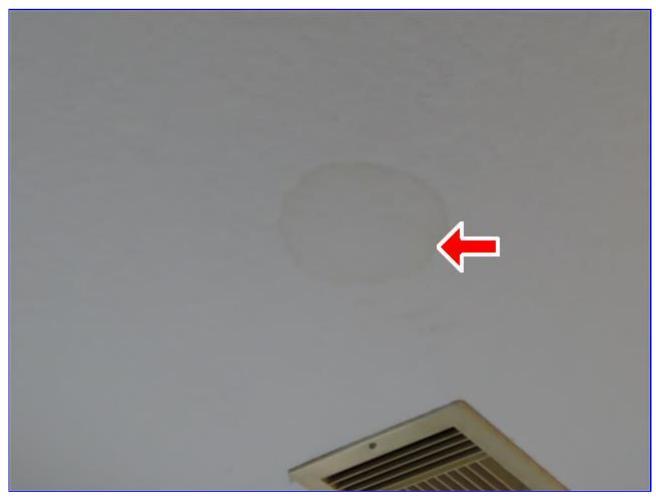
(1) Second floor bedroom ceiling has moisture staining in several areas from a possible roof leak at time of inspection. Should have a professional inspect and correct properly.

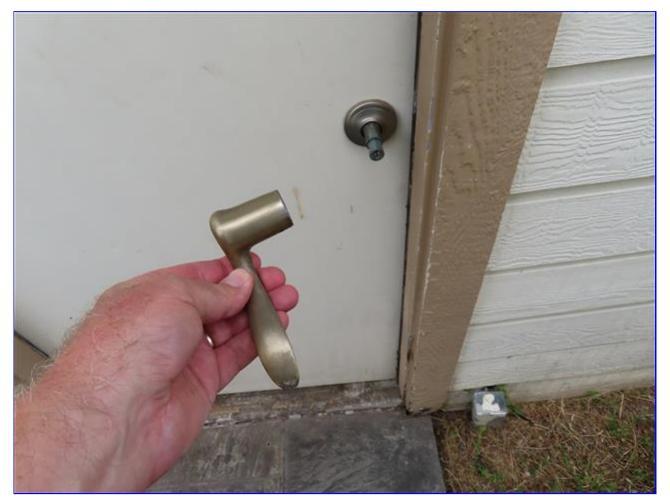
G. Item 6(Picture)

(2) Rear garage door handle was loose at time of inspection. Should correct properly.

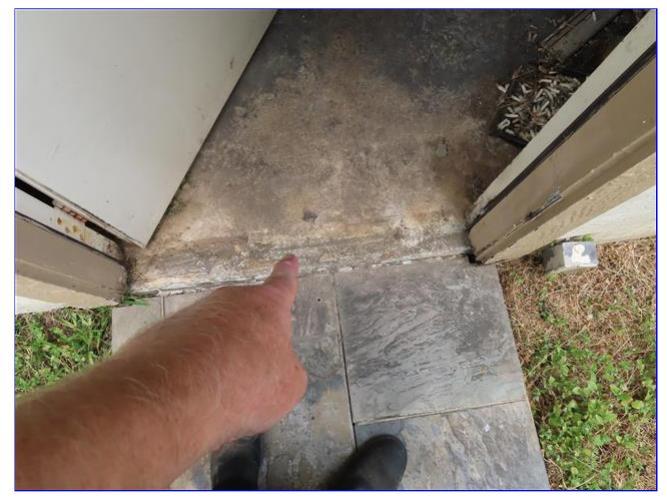
G. Item 7(Picture)

(3) Rear exterior garage door was missing sill plate at time of inspection. Should have a professional correct properly. . Conducive to moisture intrusion and causing possible damage.

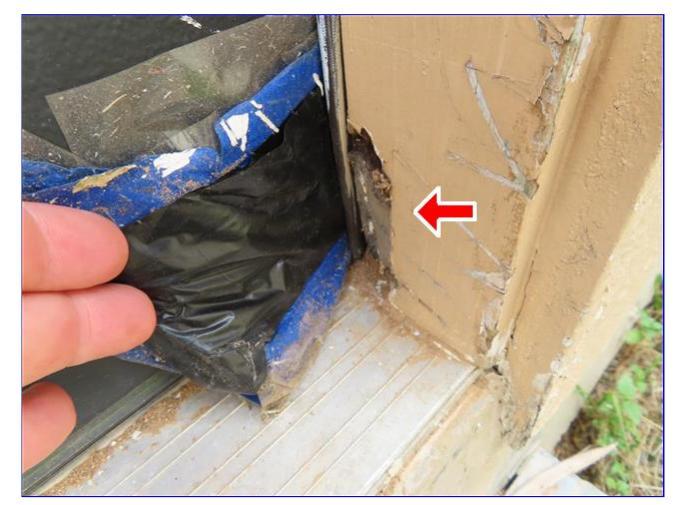
G. Item 8(Picture)

(4) Rear exterior door frame has moisture damage and rot at time of inspection. Interior door frame has signs of exterior moisture intrusion at time of inspection. Should have a professional correct and seal properly. Conducive to moisture intrusion and causing possible damage.

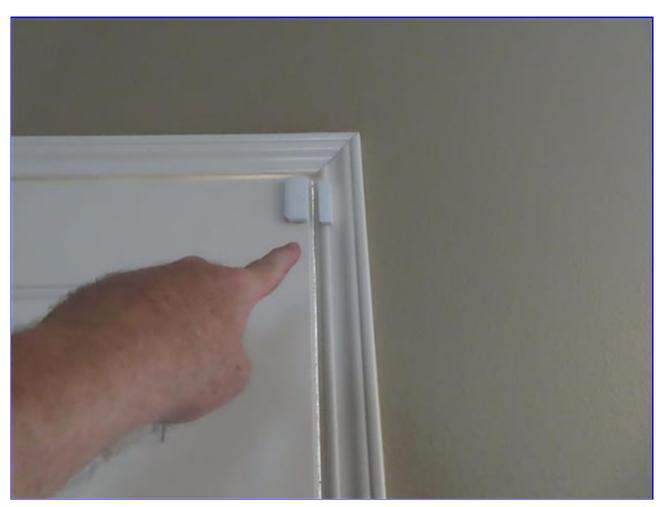
G. Item 10(Picture)

(5) Front exterior door was catching door frame at time of inspection. Should have a professional correct properly.

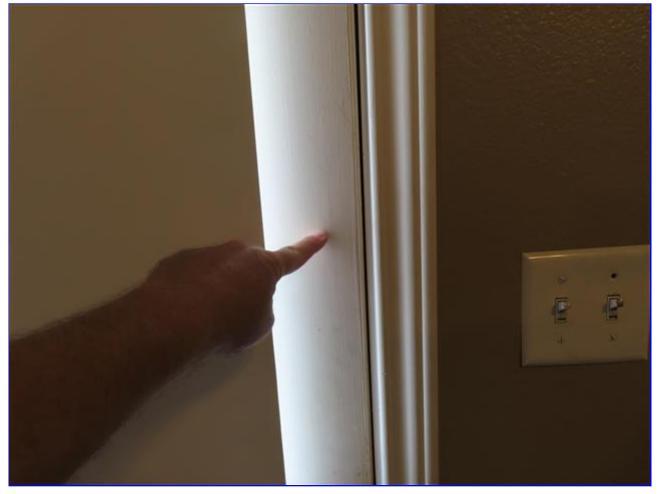
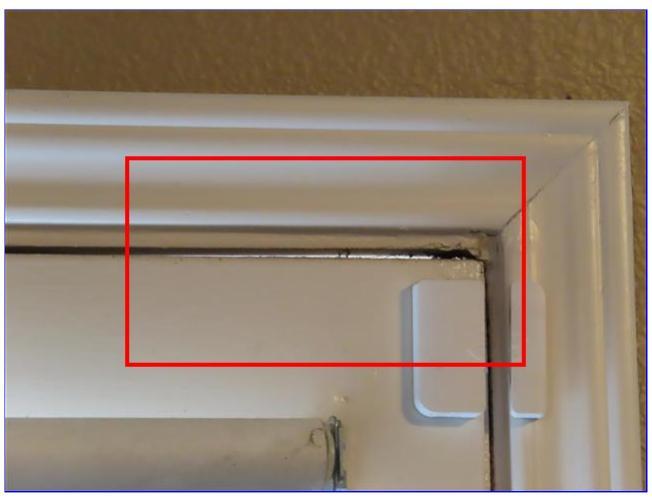
(6) Rear exterior door was not level in door frame, was not seating properly and leaking daylight into the living space at time of inspection. Should have a professional correct properly.

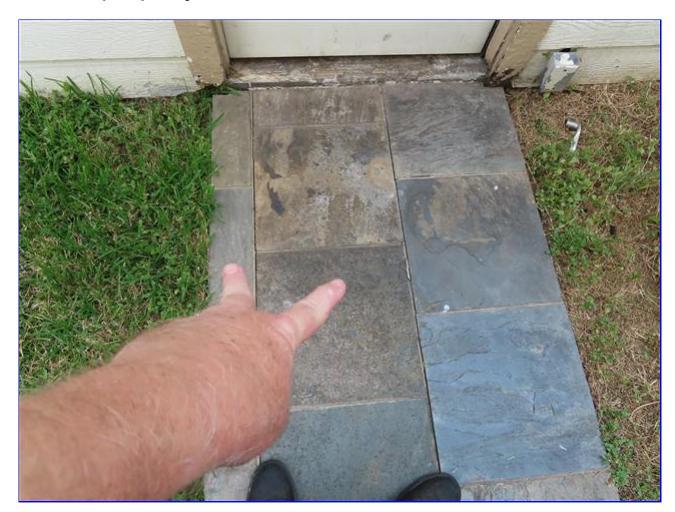
K. Item 2(Picture)

(2) Tiles on rear sidewalk are loose in several areas at time of inspection. Should have a professional correct properly.

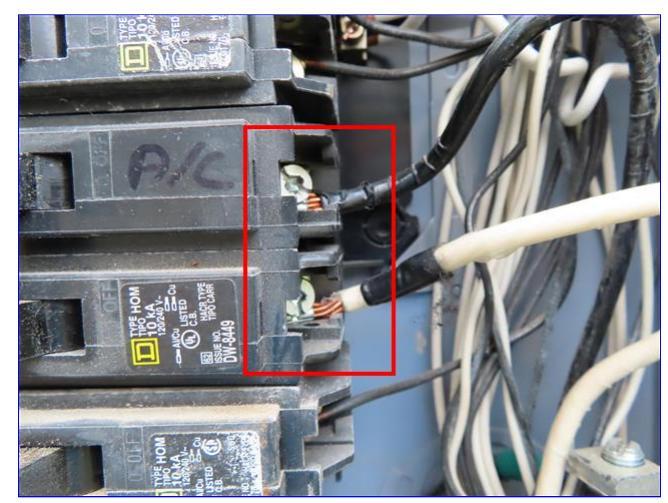
B. Item 4(Picture)

(3) All wire sheathing in the breaker box should go all the way to the breaker. No bare wires should be showing. Should have a professional electrician correct.

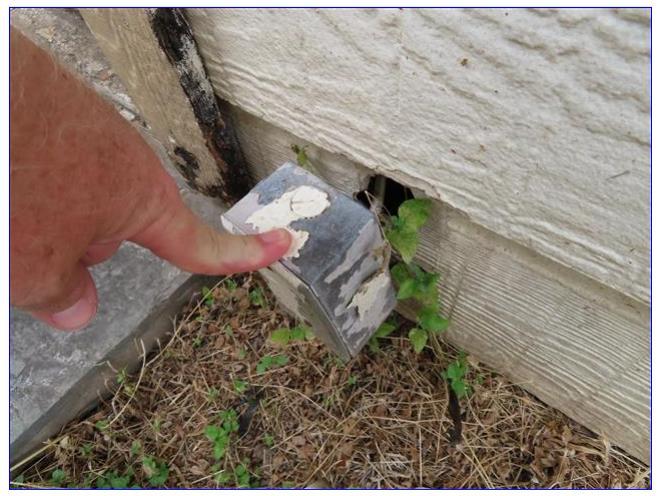
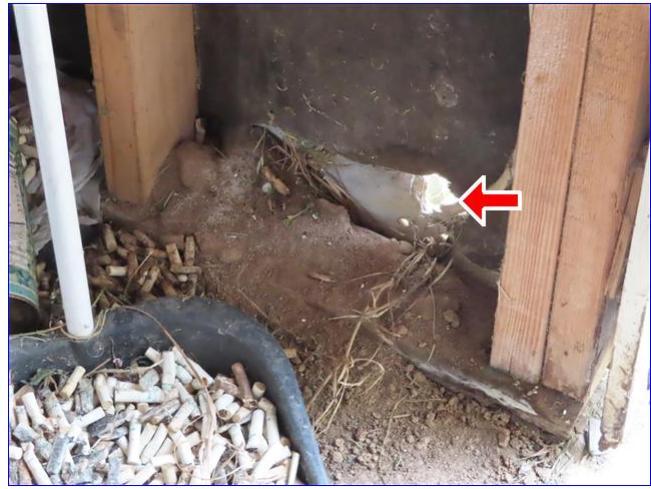
(4) Rear exterior garage electrical box was loose from wall creating large penetration into the interior of

garage at time of inspection. Should have a professional electrician correct properly. Conducive to moisture and WDI (Wood Destroying Insect) intrusion.

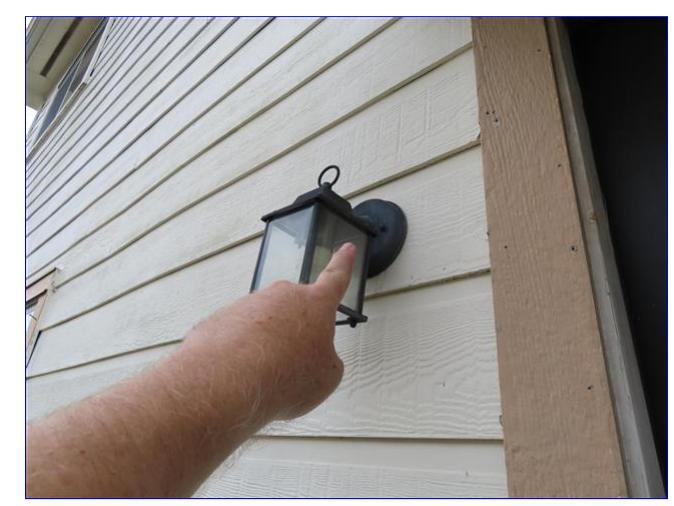
B. Item 7(Picture)

(5) Exterior lighting was loose to structure in several areas at time of inspection. Should be secured and sealed properly to the structure by a professional electrician.

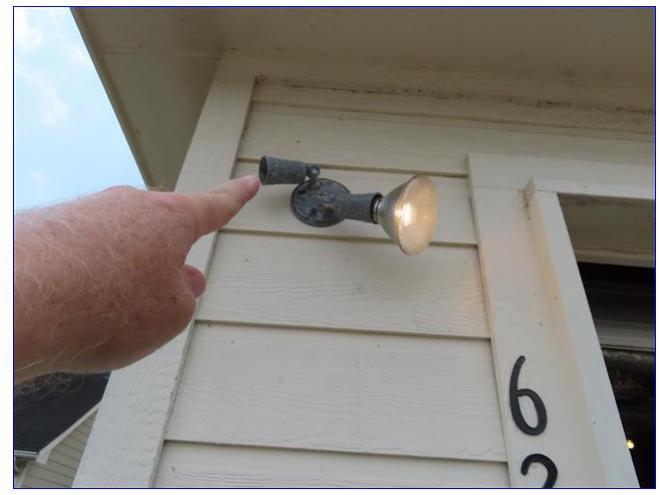
B. Item 8(Picture)

(6) Exterior light was missing bulb at time of inspection. Should replace properly.

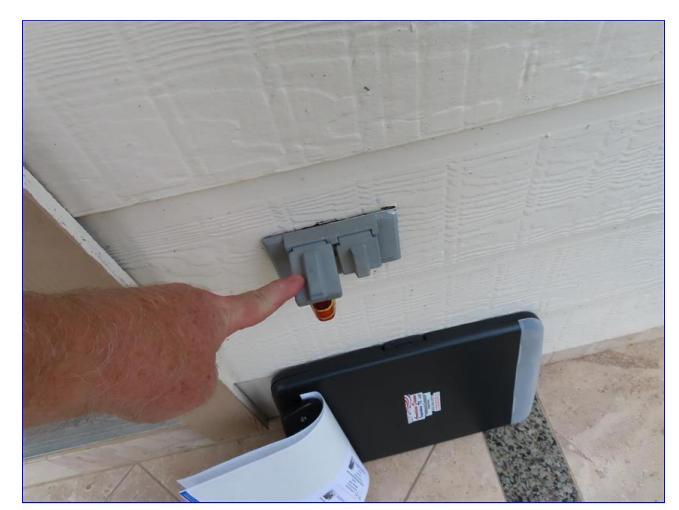
B. Item 9(Picture)

(7) Several exterior electrical outlets were loose to the wall at time of inspection. Should have a professional electrician secure and seal to the structure.

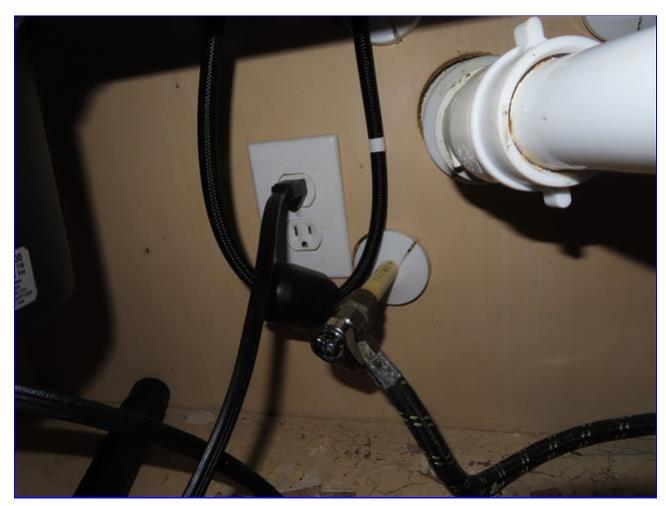
B. Item 10(Picture)

(8) Electrical outlet under kitchen sink should be GFCI protected outlet. Should have a professional electrician correct properly.

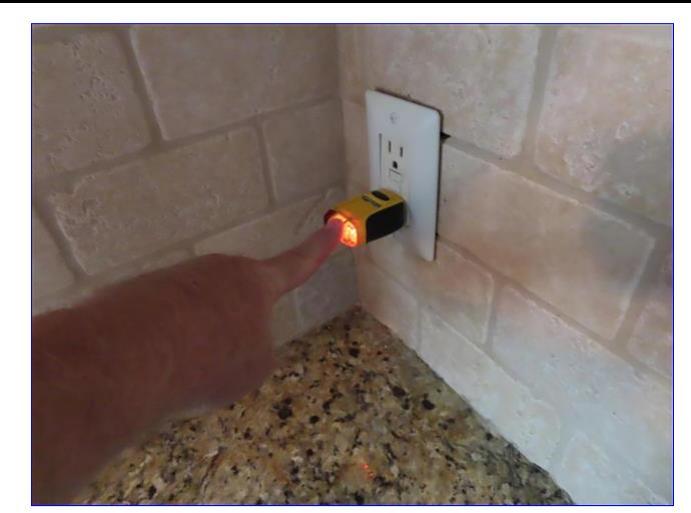
B. Item 11(Picture)

(9) Several interior electrical outlets were loose to the wall at time of inspection. Should a professional electrician secure properly.

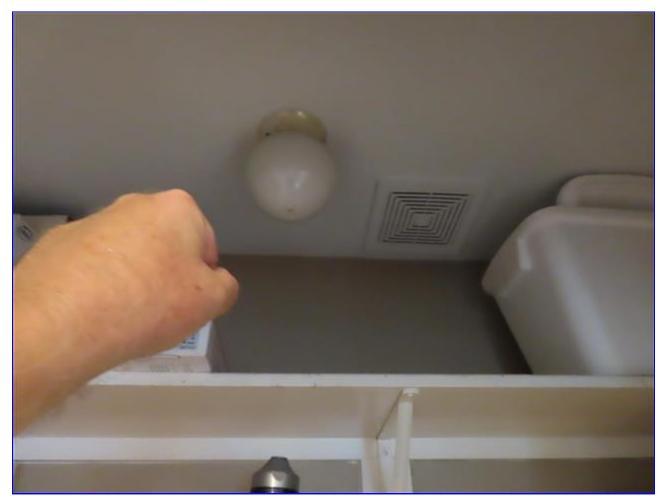
B. Item 12(Picture)

(10) Utility light was not operating at time of inspection. Should have a professional electrician inspect and correct properly.

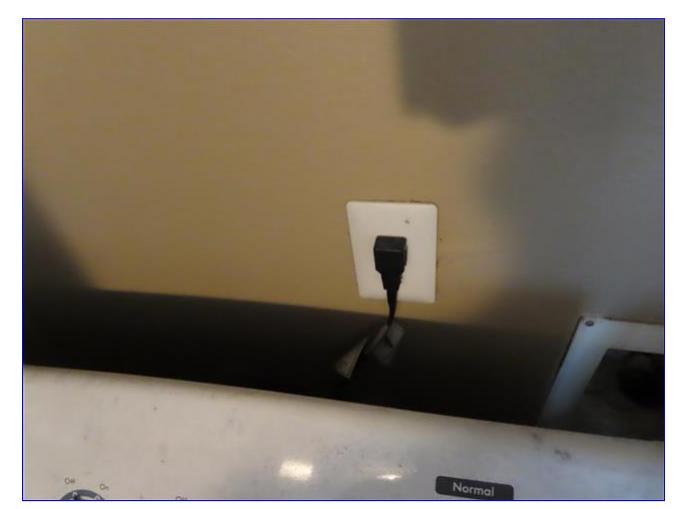
B. Item 13(Picture)

(11) All utility room electrical outlets should be GFCI protected. Electrical covers were missing GFCI protected label at time of inspection. Should have a professional inspect and correct.

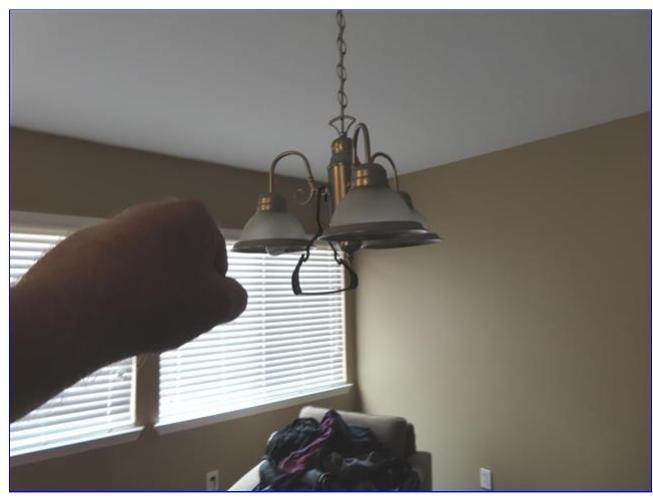
B. Item 14(Picture)

(12) Many lights were not operating at time of inspection. Possible burnt or missing bulbs at time of inspection. Should correct properly.

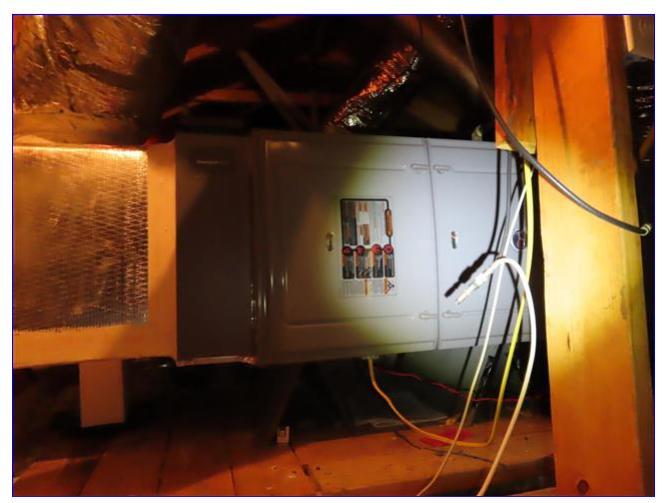
B. Item 1(Picture)

RUUD gas furnace in the attic was not working properly in Cool Mode at time of inspection. Did not test in Heat Mode since the outside temperature was over 60 degrees at time of inspection. Should have a professional AC Tech inspect and service unit properly.

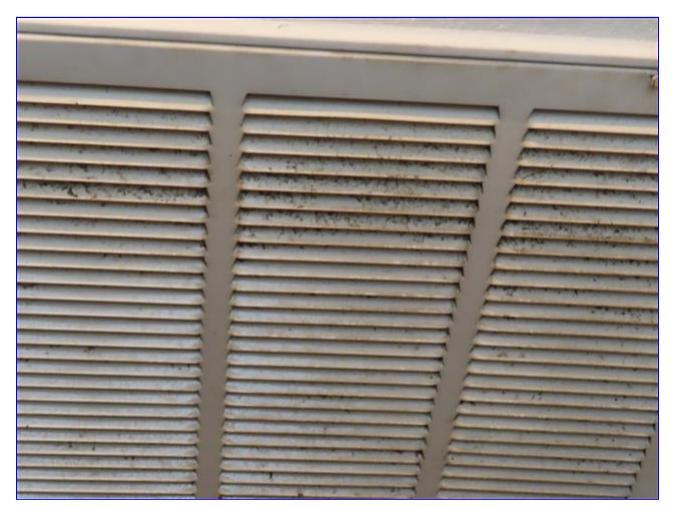
C. Item 1(Picture)

(1) Return grill was full of debris at time of inspection. Should be cleaned properly.

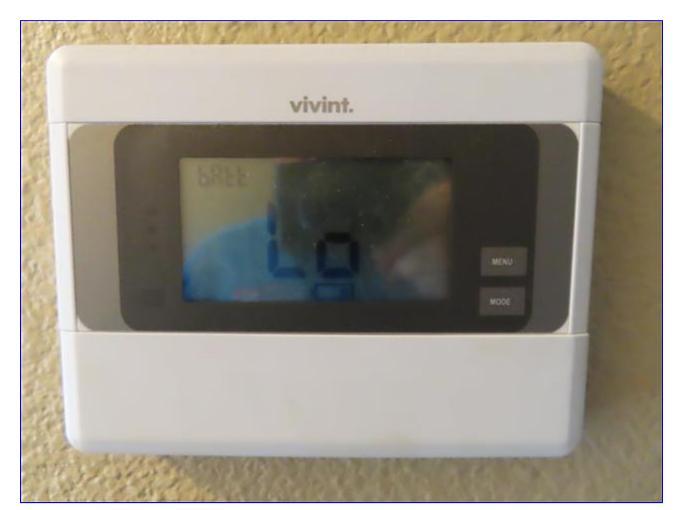
C. Item 2(Picture)

(2) HVAC thermostat has low battery at time of inspection. Should replace batteries properly.

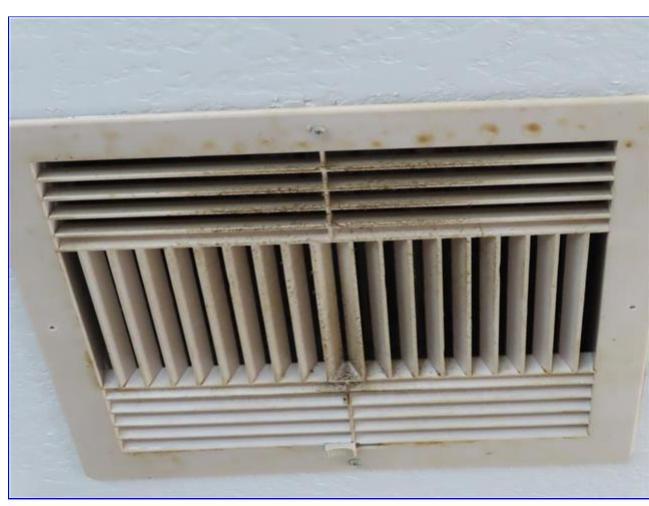
C. Item 3(Picture)

(3) HVAC registers were dirty in several areas at time of inspection. Should have a professional correct properly.

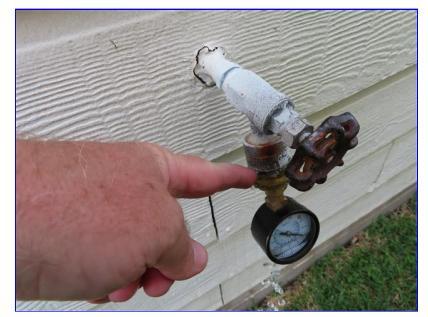
A. Item 2(Picture)

(2) Exterior hose bibb was not operating properly at time of inspection. Should have a professional plumber correct properly.

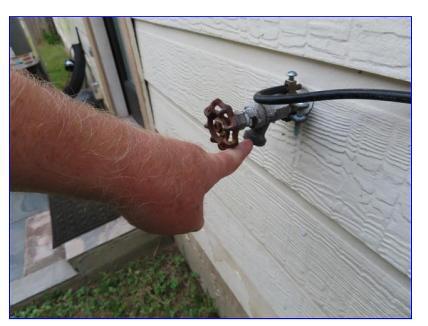
A. Item 3(Picture)

(3) Rear exterior faucet was missing hose bibb at time of inspection. Should have a professional plumber correct properly.

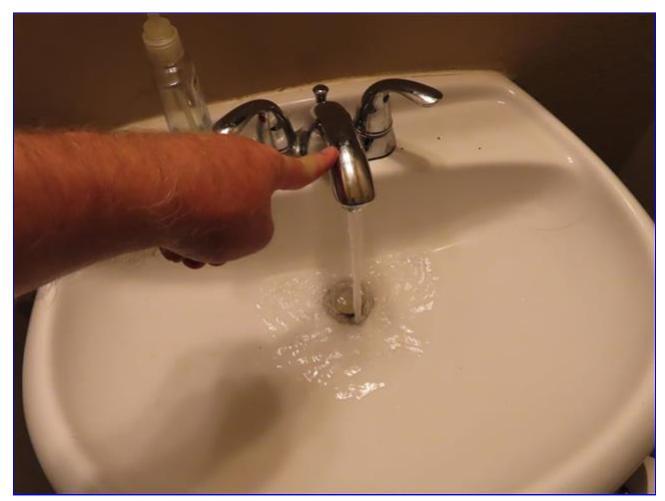
A. Item 4(Picture)

(4) 1st floor bathroom sink faucet was loose at time of inspection. Should have a professional plumber correct properly.

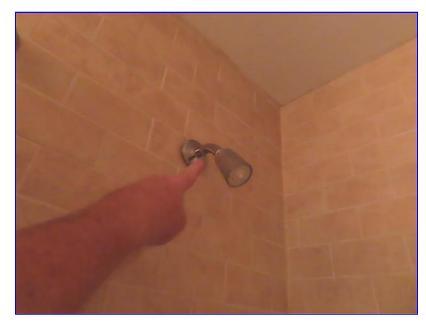
A. Item 5(Picture)

(5) Several plumbing fixtures were loose at time of inspection. Should have a professional plumber correct properly.

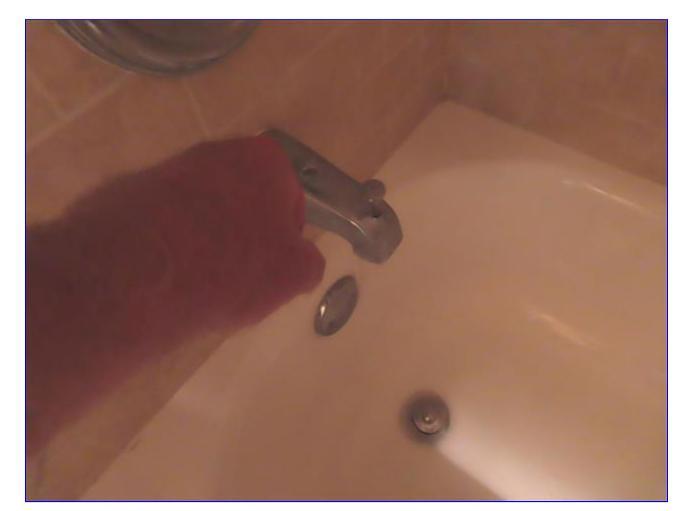
A. Item 6(Picture)

(6) Bathroom shower diverter was not operating properly at time of inspection. Should have a professional plumber inspect and correct properly.

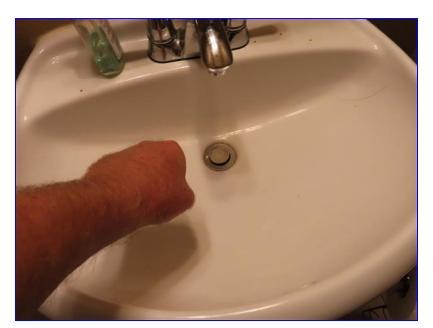
B. Item 1(Picture)

(1) Several bathroom drain stoppers did not operate at time of inspection. Should have a professional plumber correct properly.

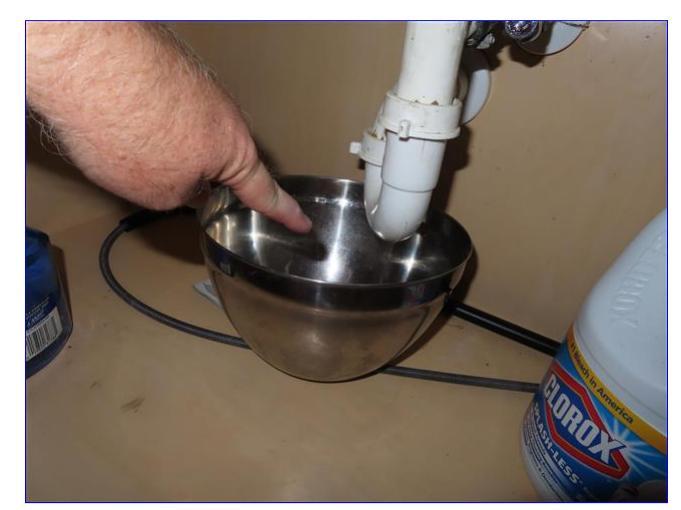
B. Item 2(Picture)

(2) Several bathroom plumbing drains have bowl under them to catch possible moisture at time of inspection. Should have a professional plumber inspect and correct properly.

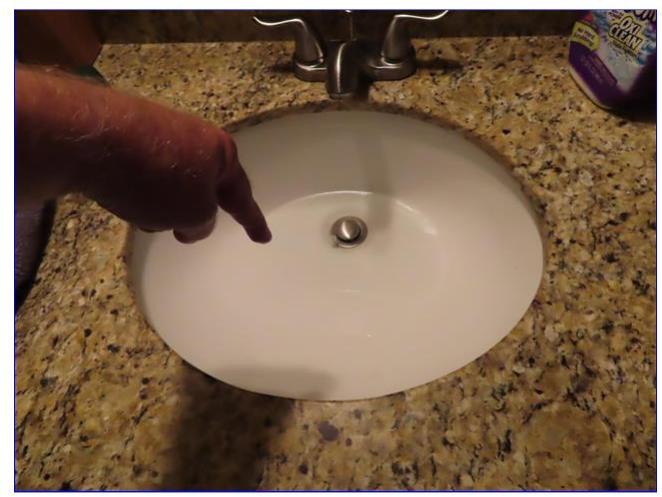
B. Item 3(Picture)

(3) Second floor bathroom sink was not draining properly at time of inspection. Should have a professional plumber inspect and correct properly.

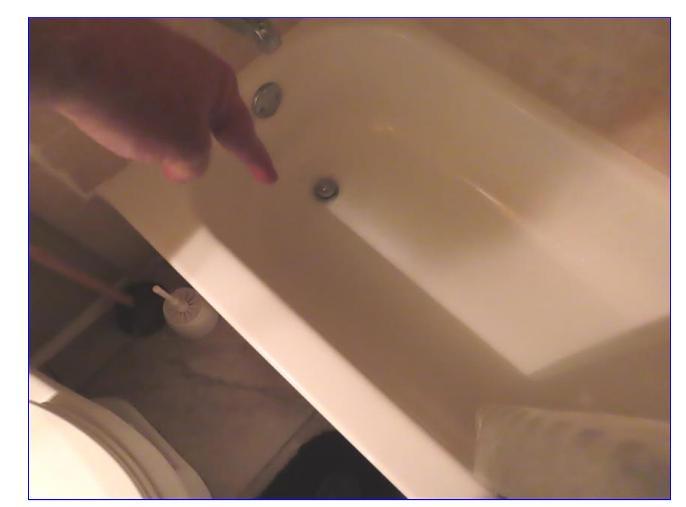
B. Item 4(Picture)

(4) Second floor bathtub was not draining properly at time of inspection. Should have a professional plumber inspect and correct properly.

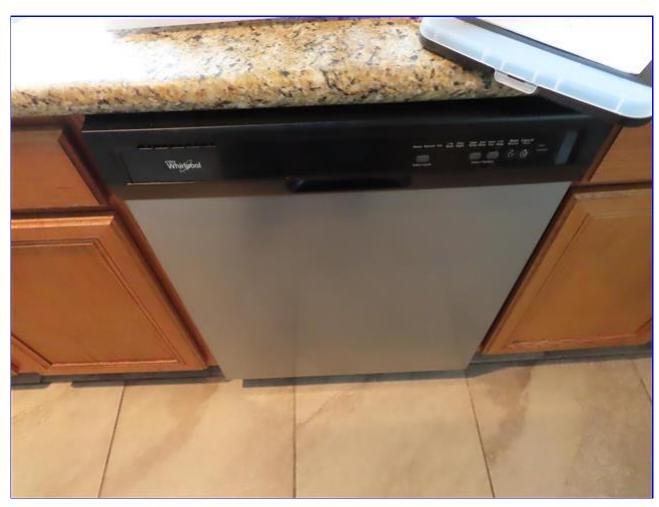
A. Item 1(Picture)

Whirlpool dishwasher was not operating and could not test or operate unit at time of inspection. Possible defective electrical outlet. Should have a professional correct properly.

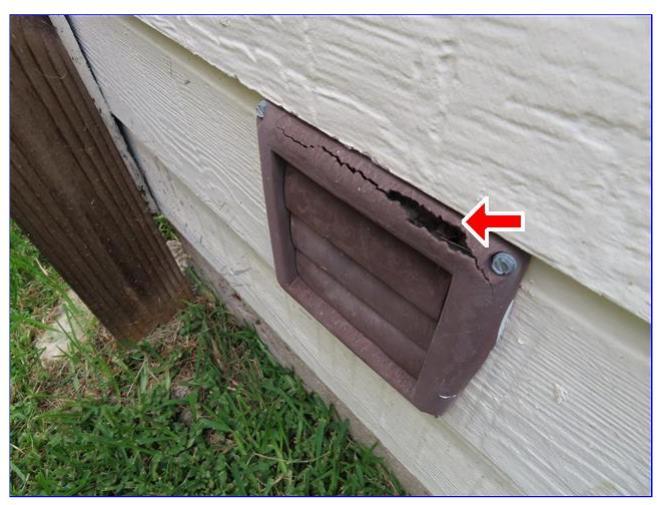
F. Item 1(Picture)

(1) Exterior exhaust vents are damaged in several areas at time of inspection. Should have a professional correct properly.

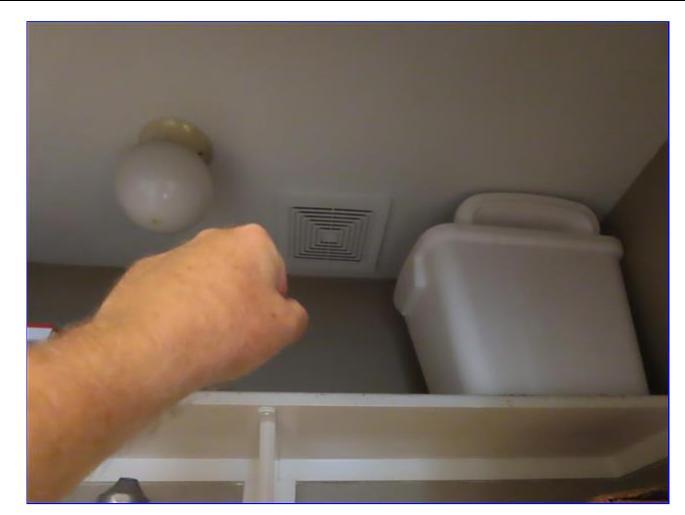
F. Item 2(Picture)

(2) Utility exhaust fan was not operating properly at time of inspection. Should have a professional inspect and correct properly.
