Arsenal Inspection Services
Property Inspection Report

**ARSENAL
INSPECTION
SERVICES**

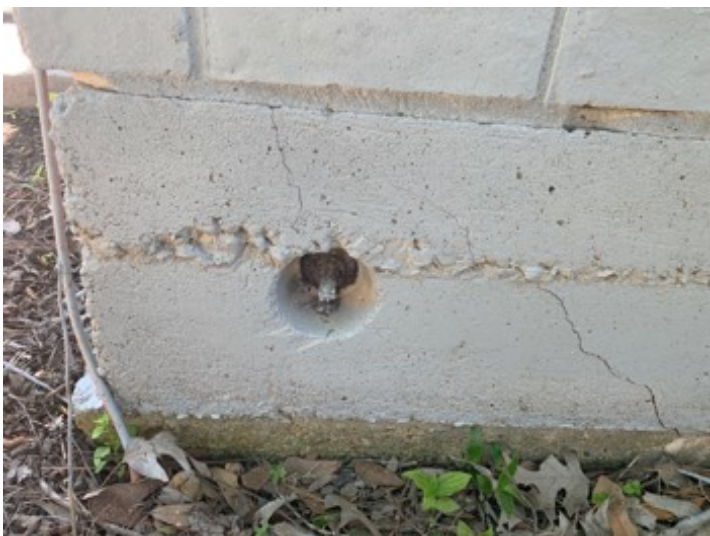
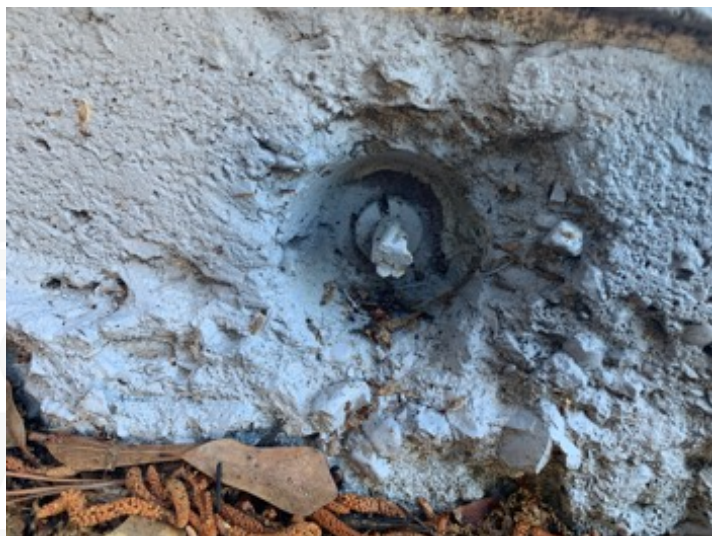
Special note: foundation has what is known as a corner pop, this is not a structural issue as it is located at the very corners of the house where the foundation bears no weight and cannot be structurally affected. The inspector does recommend at some point patching this and observation over time to make sure that the foundation does not crack in further in this area.

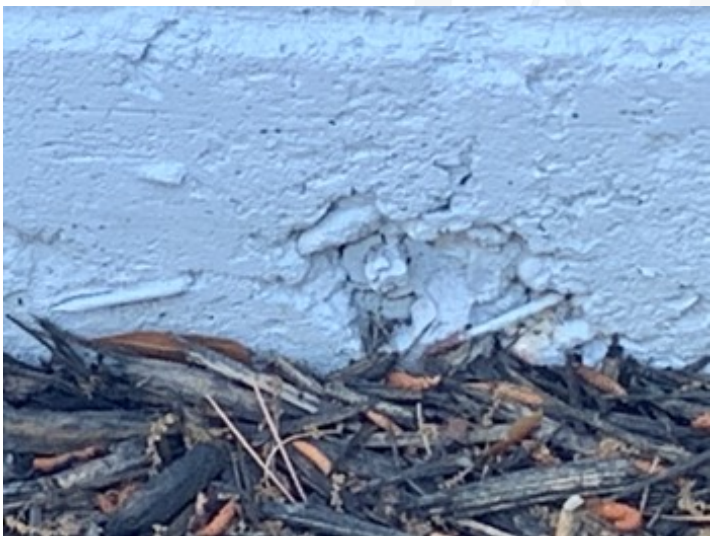
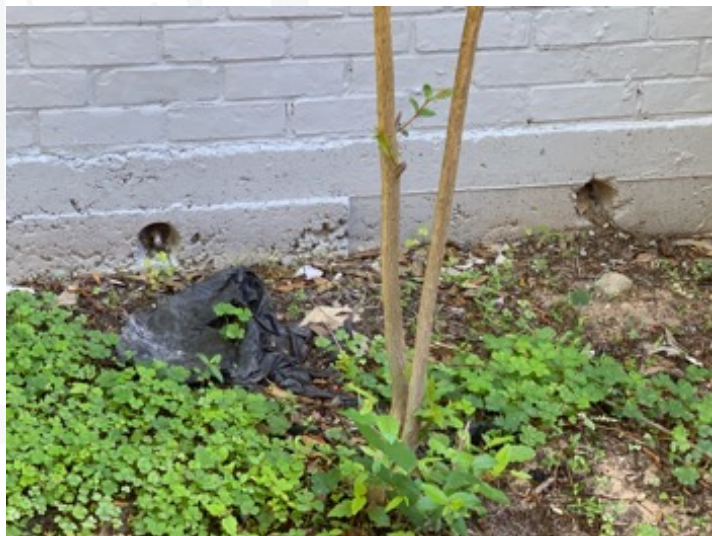
Post tension cables are exposed at the ends where the concrete caps are missing. Those ends should be capped to prevent rusting of these cables inside of the foundation.

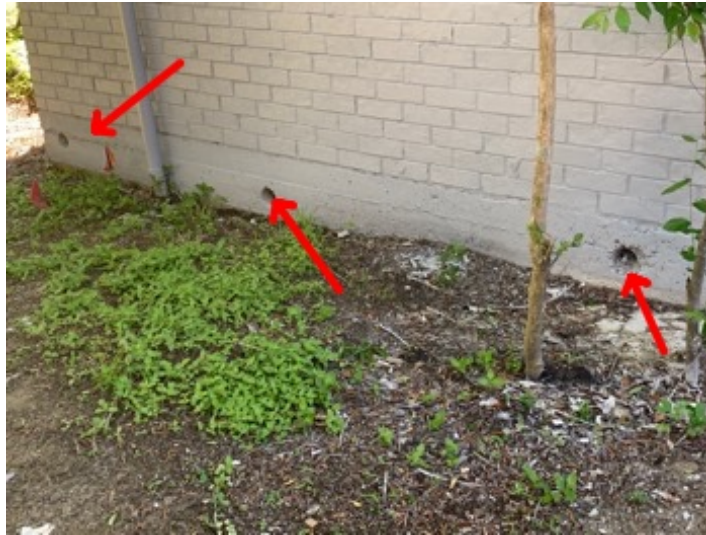
Post tension cables are exposed at the ends where the concrete caps are missing. Those ends should be capped to prevent rusting of these cables inside of the foundation.

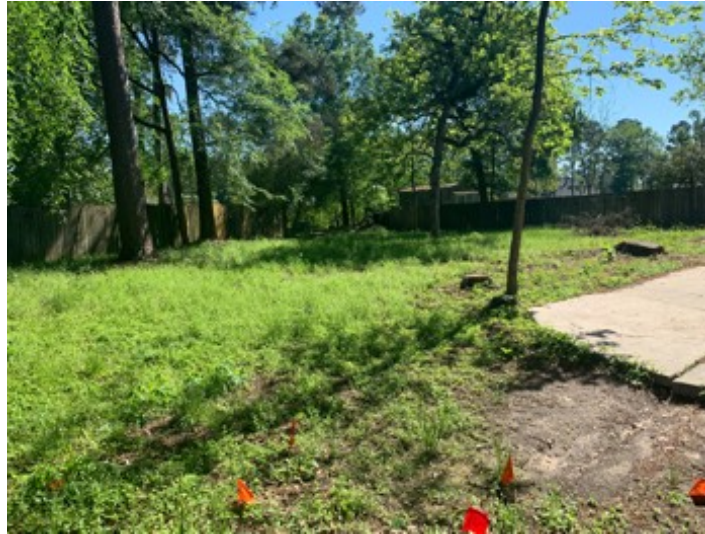
There did not appear to be a 6% (6-inches in 10 feet) positive drainage flow away from the rear perimeter of the foundation (to the street). [ref: International Residential Code R401.3 Drainage.] Disposal of water away from post-tension foundations is one of the requirements for this type of foundation under the Post Tension Institute design guidelines for the life of the structure. Grading should be designed by a civil engineer. Berming of landscaped beds near the foundation should be avoided, since they can prevent the water from draining away.

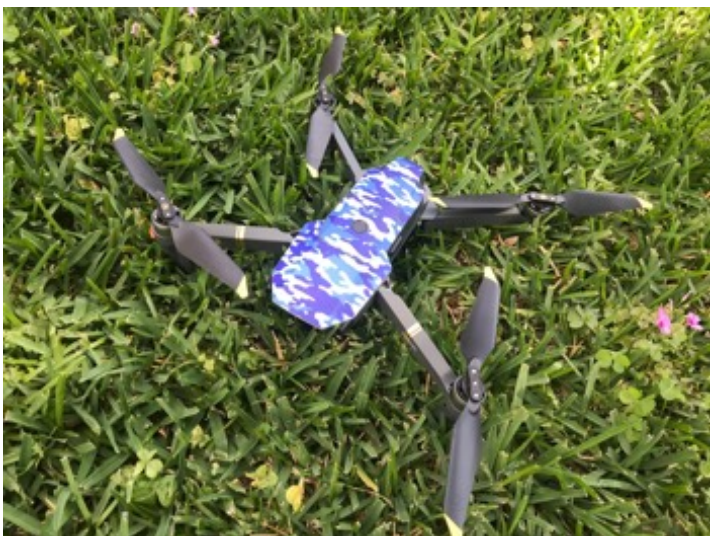
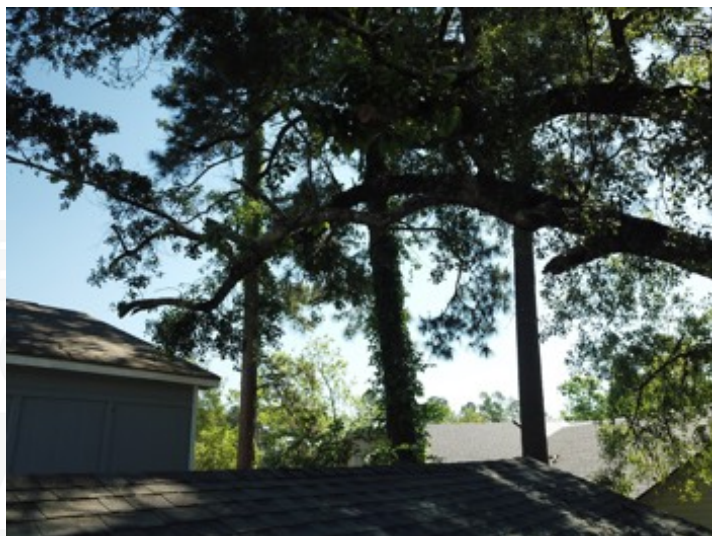
Due to the height, poor vantage point, lack of an adequate access point, and steep pitch of the roof, the inspector finds that the roof could not be safely walked and has partially inspected the roof through the use of aerial drone. This method, however, could more than likely not reveal smaller issues like exposed nails or other smaller deficiencies. The inspector does strongly recommend that for additional information about roof condition, maintenance and repairs that the previous owner or a roofing contractor be contacted.

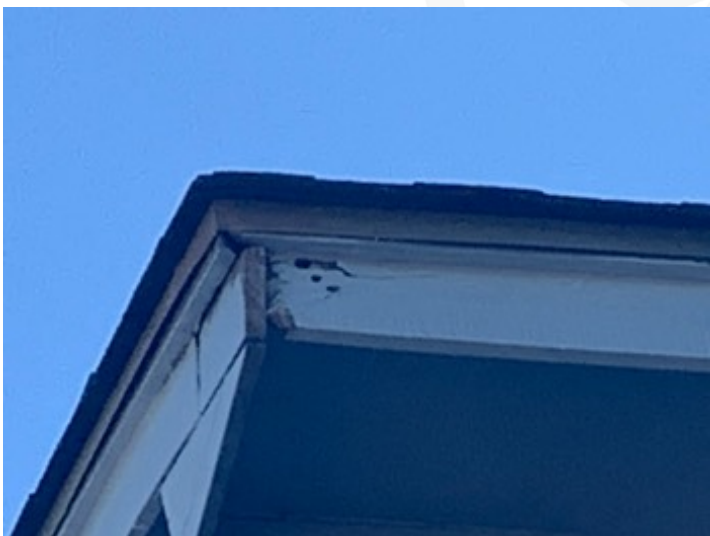
Damaged fascia board

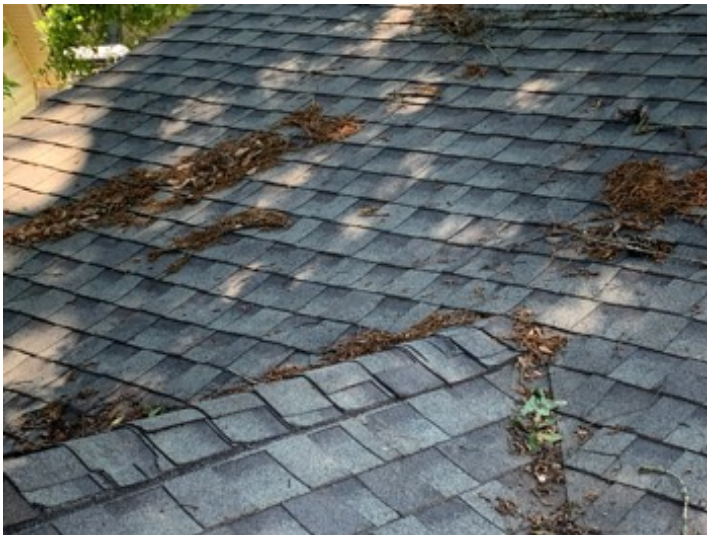
Excessive debris found on the rooftop. This can prevent water from properly draining off the roof, increasing the chances of moisture penetrating into the roof structure. This also could be considered a fire hazard as the debris in dry conditions could increase chances fire starting with the right ignition source.

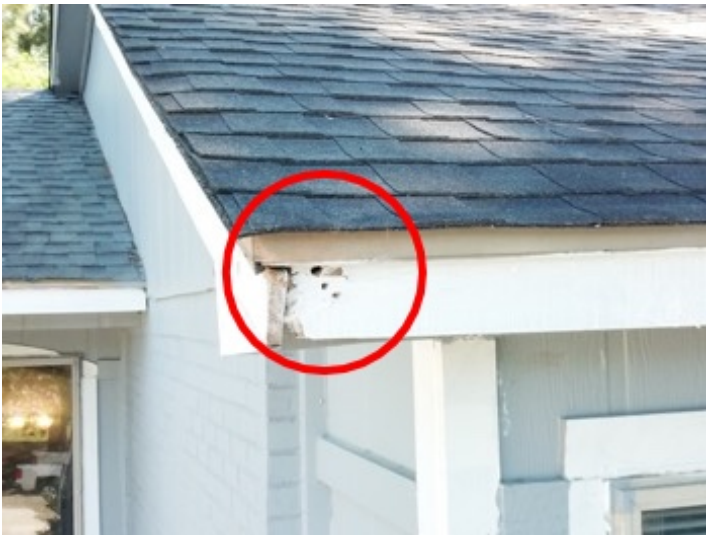
Damaged fascia board

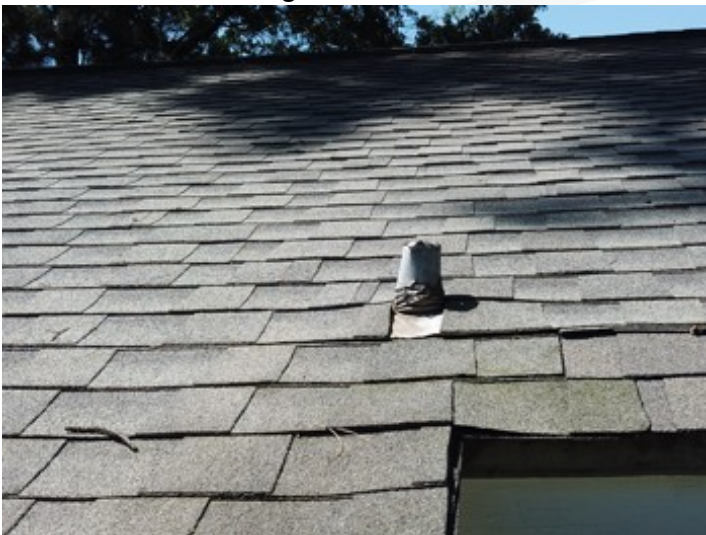
Plumbing vent penetration does not meet it's required 6 inch height

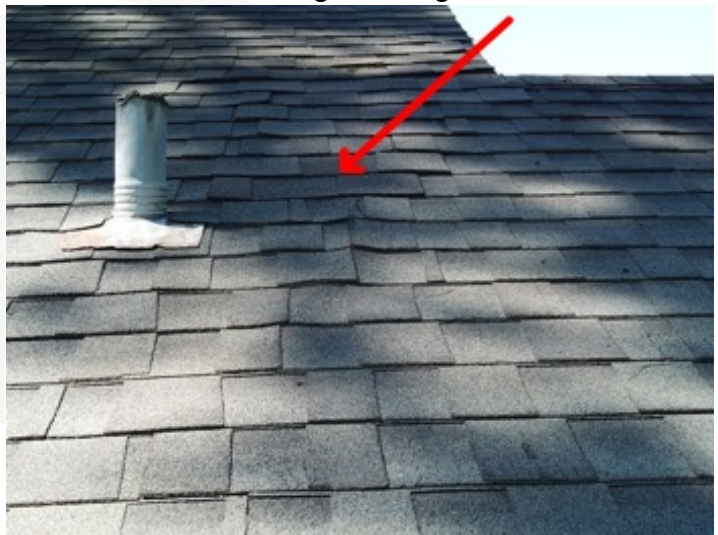
Shingles lifting, shingles are lacking the proper amount of adhesive to keep the roof integrity intact causing shingles to lift, because of this, the shingles could be damaged by high winds at some point.

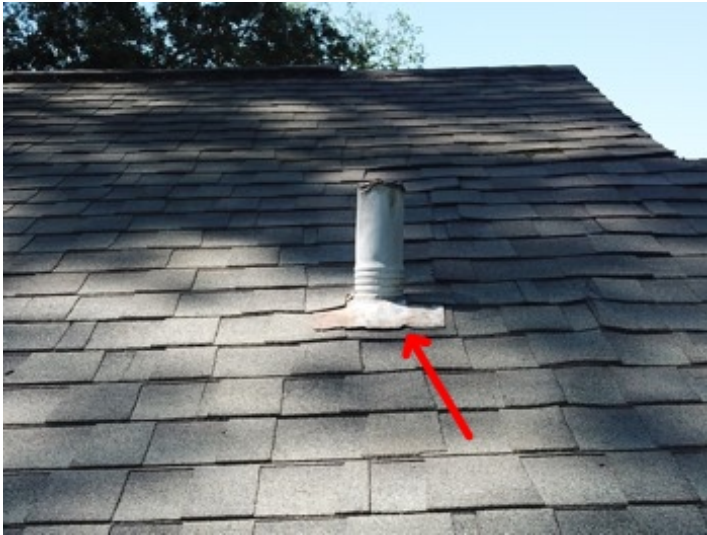
Roof jack flashing is lifting

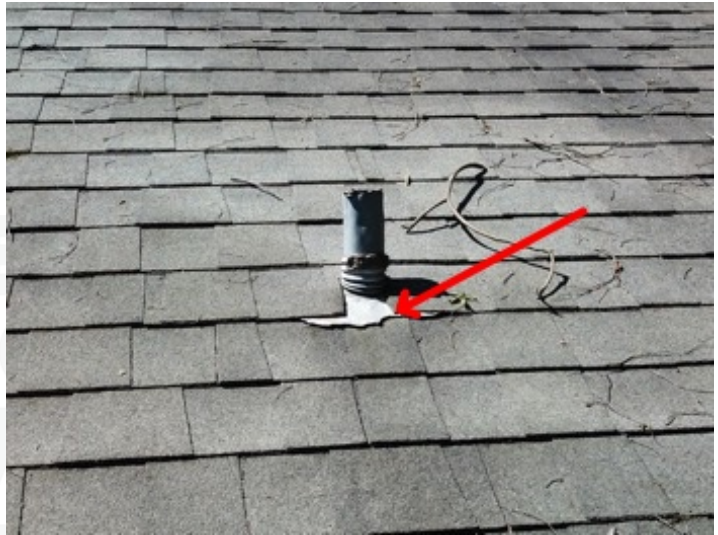
Damaged roof jack flashing

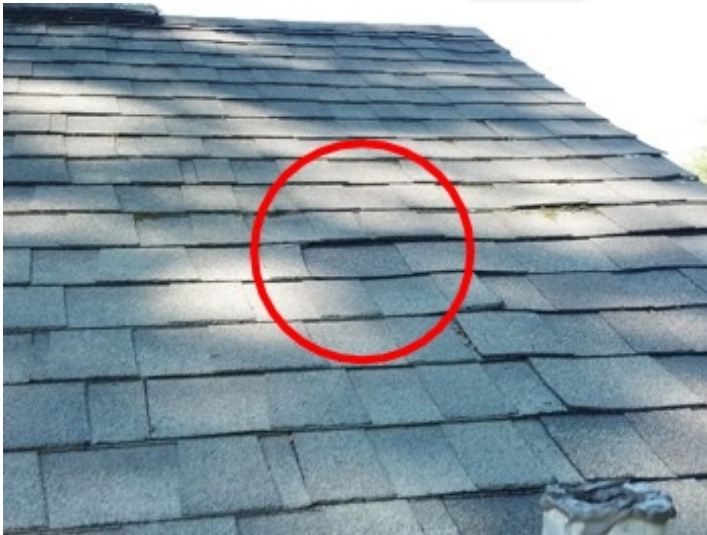
Shingles lifting, shingles are lacking the proper amount of adhesive to keep the roof integrity intact causing shingles to lift, because of this, the shingles could be damaged by high winds at some point.

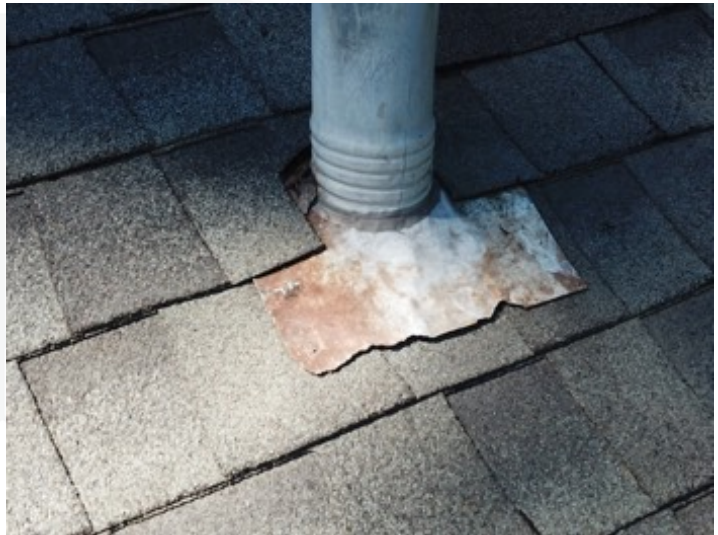
Damaged roof jack flashing

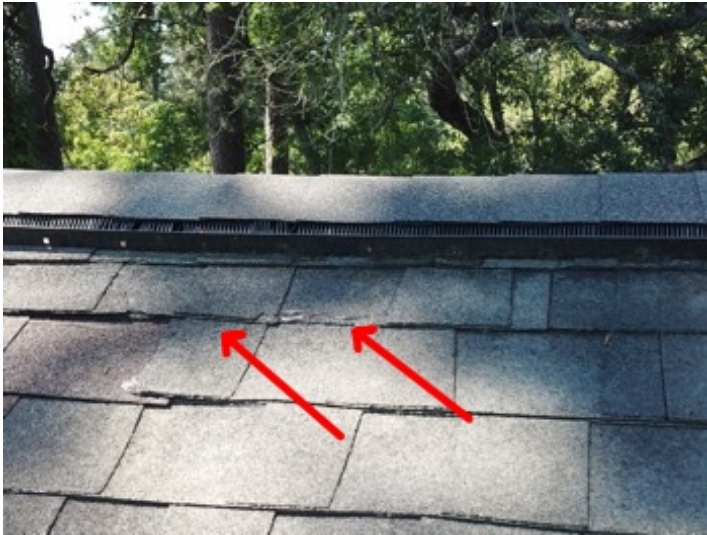
I	NI	NP	D
---	----	----	---

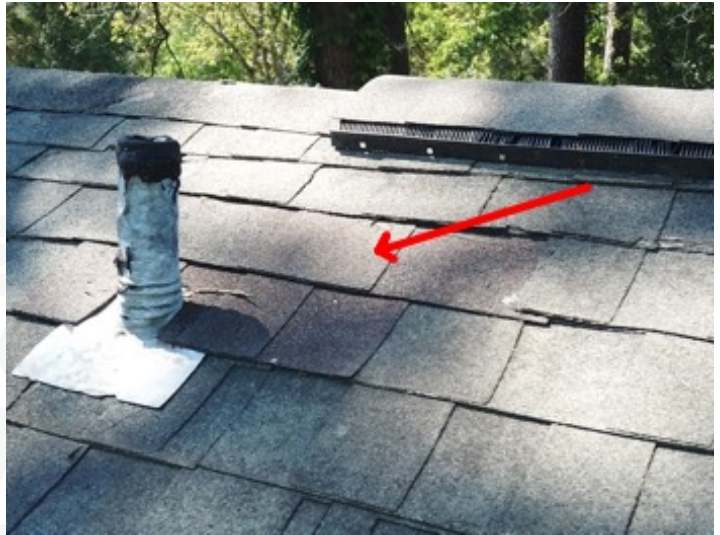
Repairs to the roof covering materials have been observed and appear to be done in a less than workmanlike manor. The repairs should be observed over time to make sure that, in time, moisture penetration has not occurred at any point.

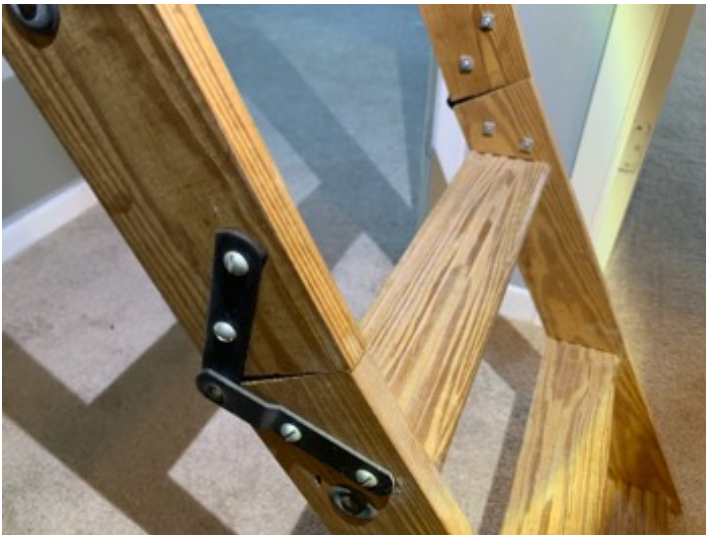
Attic Ladder appears damaged may not be able to handle the weight of both a person and appliance moving up and down the ladder. Recommend an evaluation possible repair or replacement

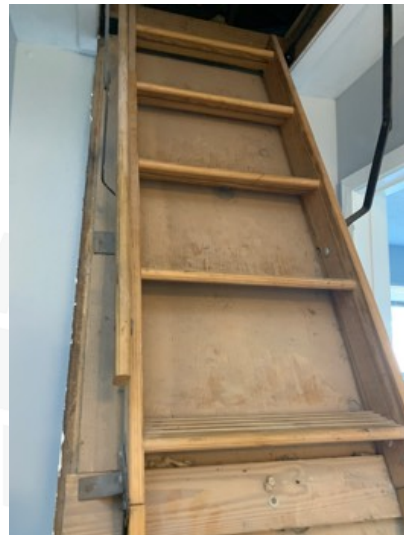
Missing insulation on the attic access door.

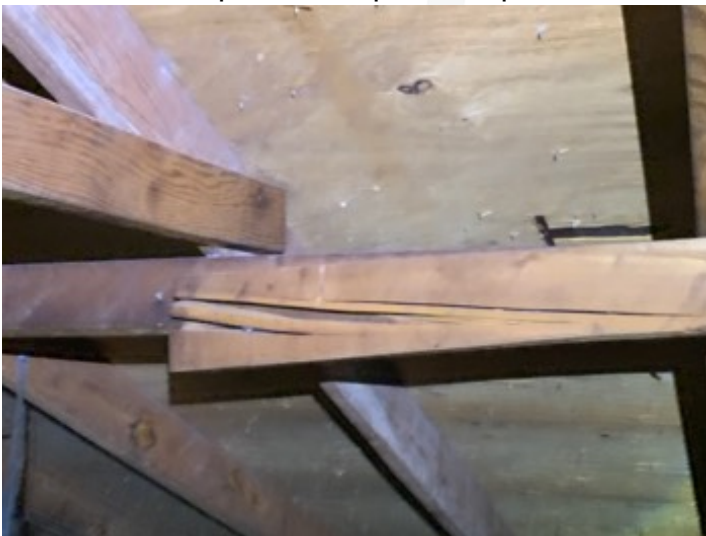
Split/Broken framing boards observed.

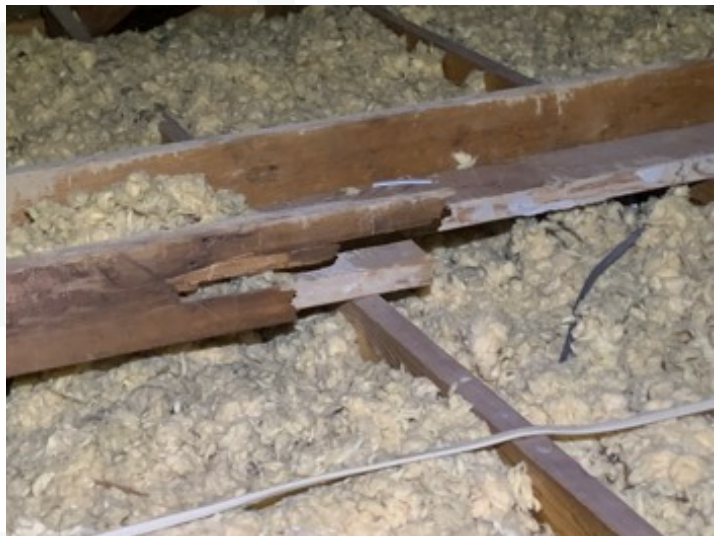
Split/Broken framing boards observed.

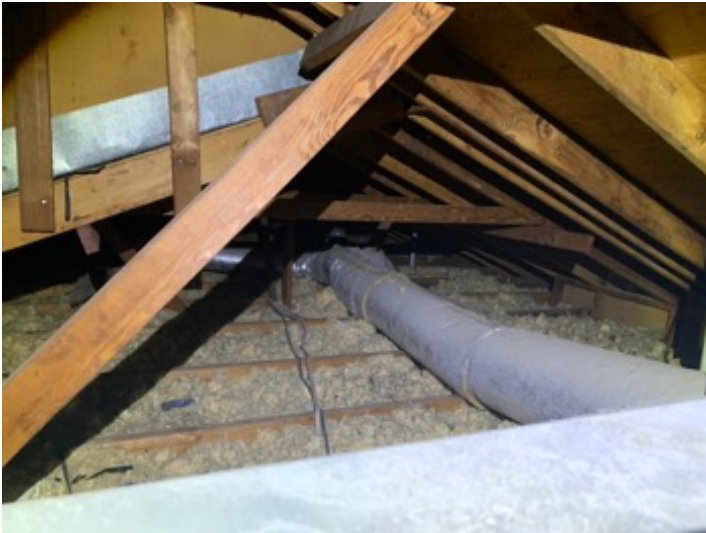
Roof Structures and Attic space

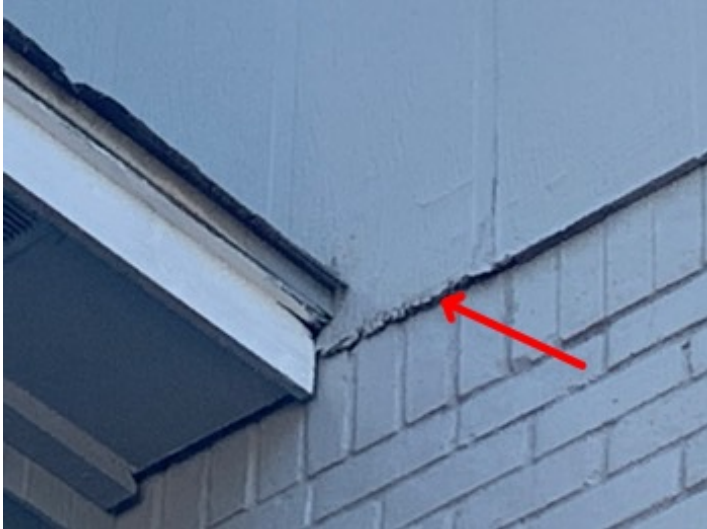
Exterior siding is deteriorated

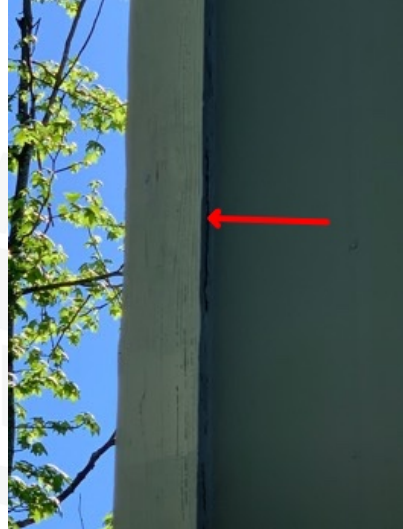
Missing or deteriorated caulking in between joints in the siding(exterior)

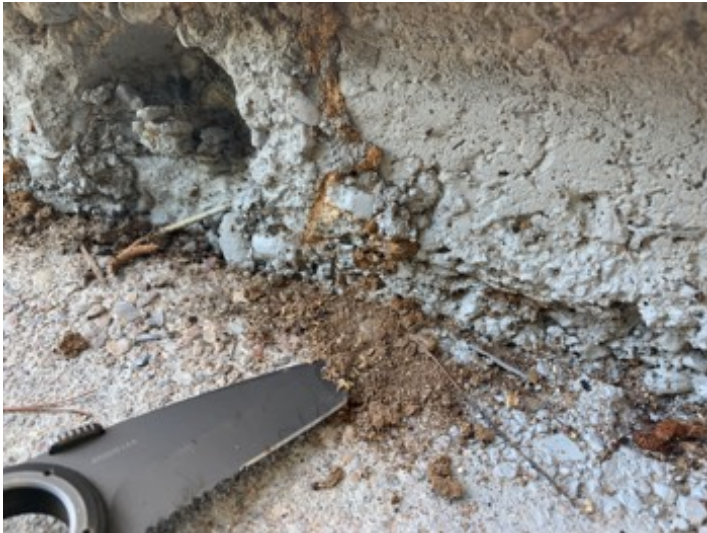
Wood destroying insects found present at the exterior of the structure by professionals from Scientific Exterminators Of Texas.

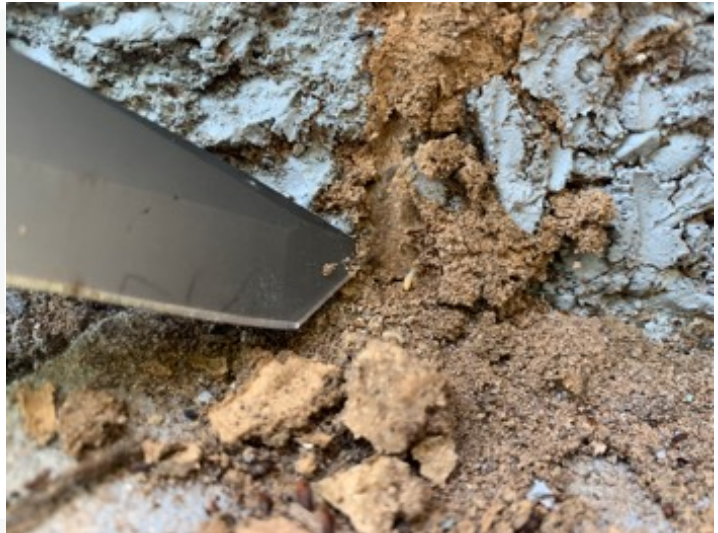
Wood destroying insects found present at the exterior of the structure by professionals from Scientific Exterminators Of Texas.

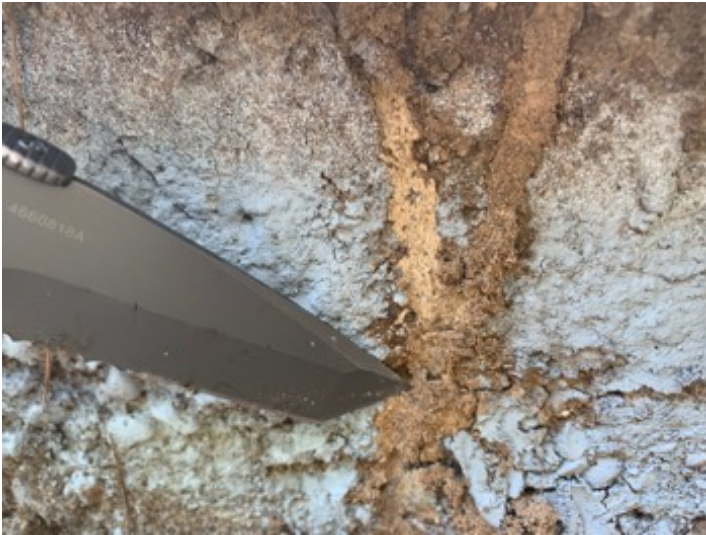
Wood destroying insects found present at the exterior of the structure by professionals from Scientific Exterminators Of Texas.

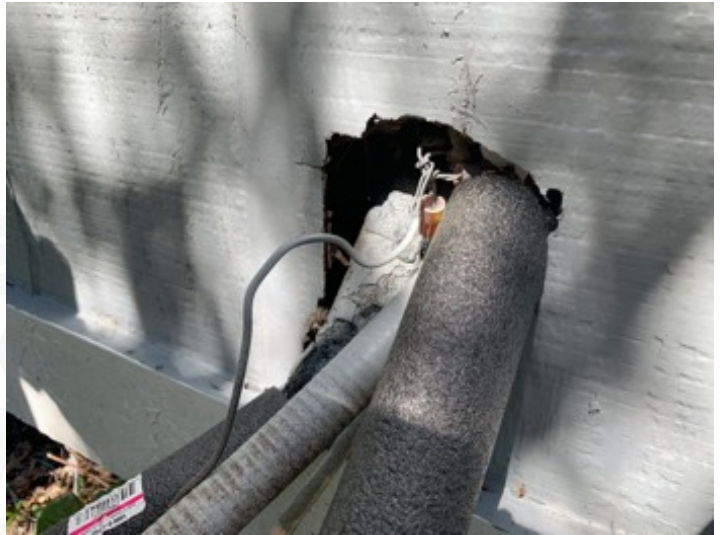
Wall penetrations for the A/C unit entering into the wall is not properly flashed.

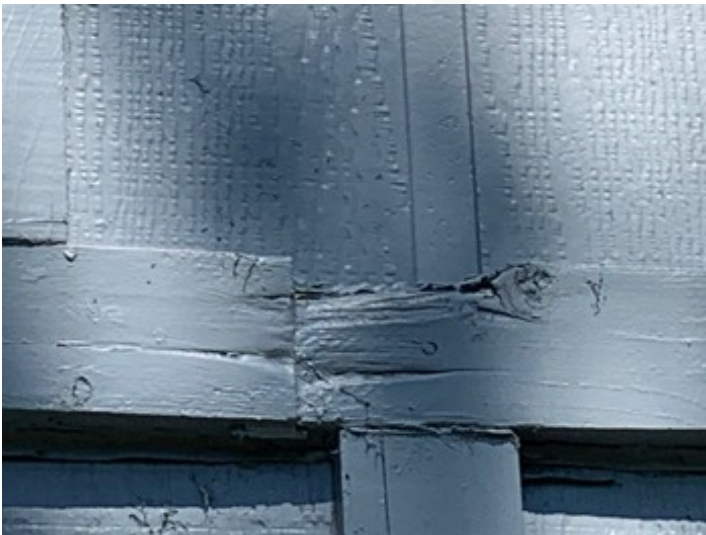
Exterior siding is deteriorated

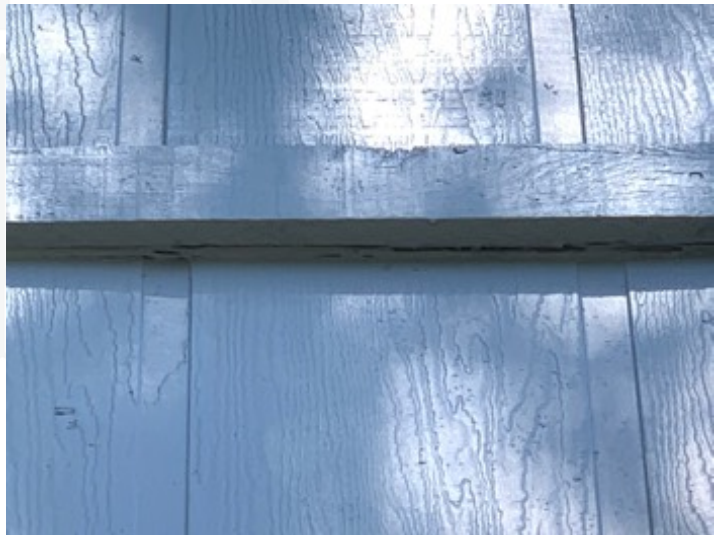
Missing or deteriorated caulking in between joints in the siding(exterior)

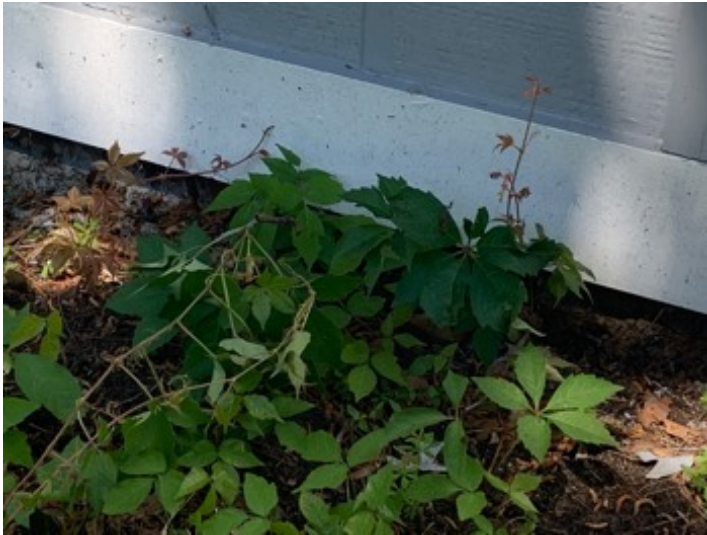
Earth to wood contact on the exterior siding

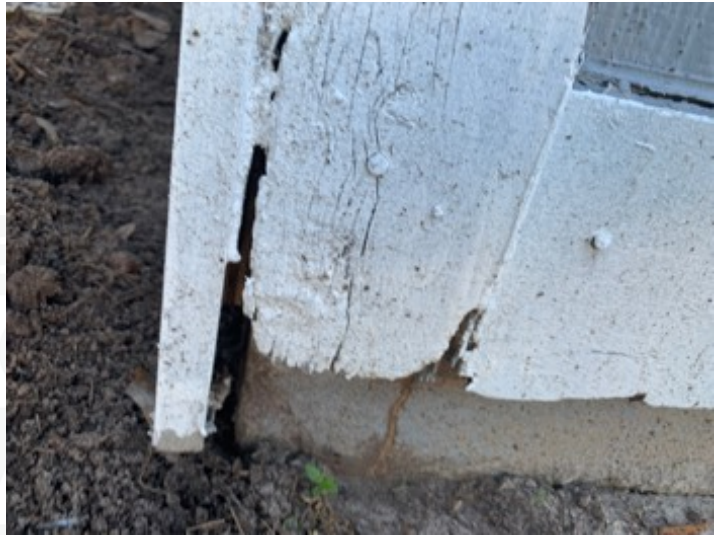
Exterior siding is deteriorated

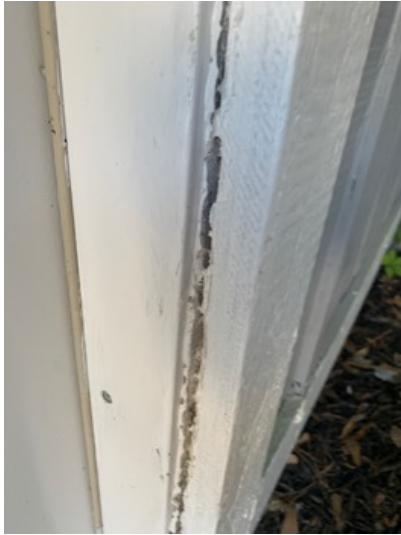
Missing or deteriorated caulking in between joints in the siding(exterior)

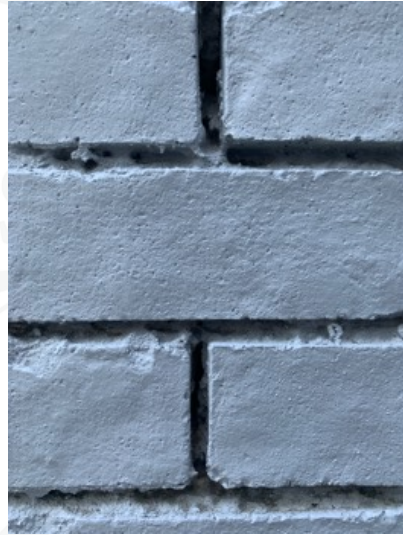
Missing or deteriorated mortar joints in between the brick(exterior)

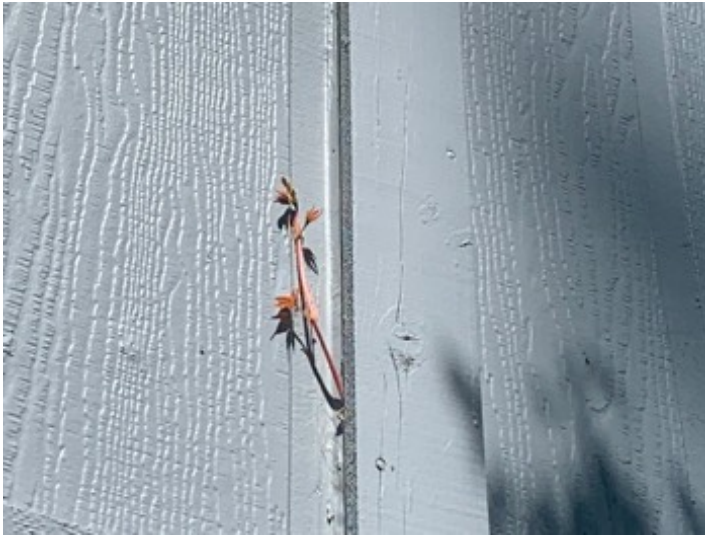
Vegetation growing through the wall system.

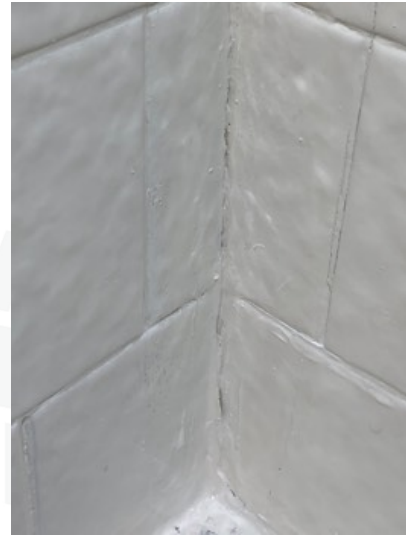
Missing or deteriorated grout lines around the guest bathroom tub area , this can allow water to penetrate behind the tiles and damage walls and or floor areas.

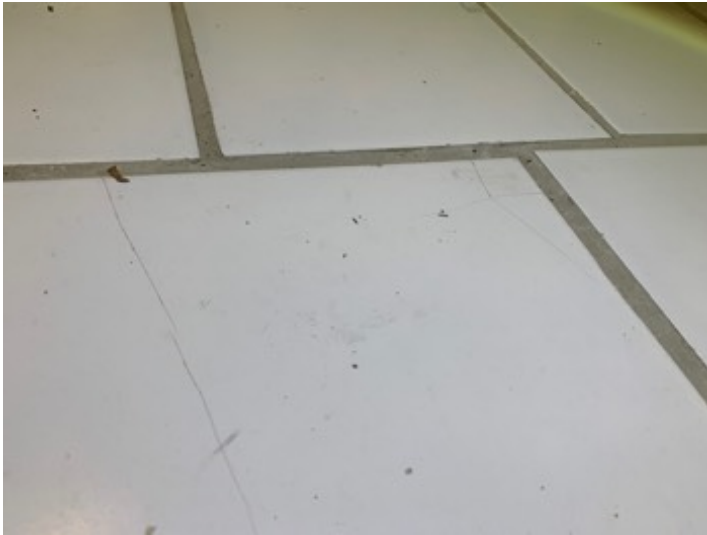
Cracked/Damaged flooring present

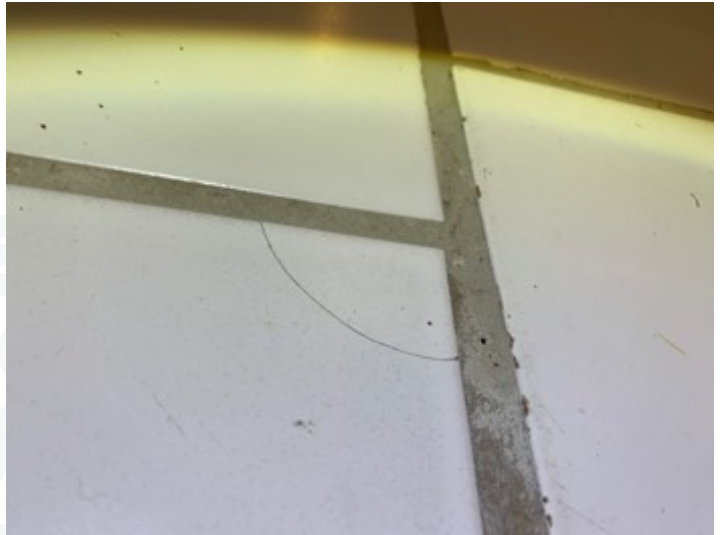
Cracked/Damaged flooring present

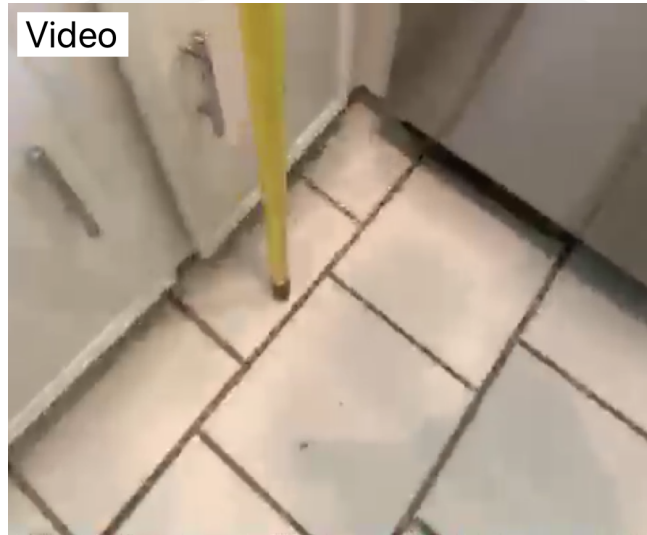
Thinset used underneath tiles to adhere the tile flooring to the floor concrete is not properly installed. This can cause cracking of the tile under heavy weight and in situations of indoor temperature fluctuation, can cause tile to pop loose. Recommend repairing.

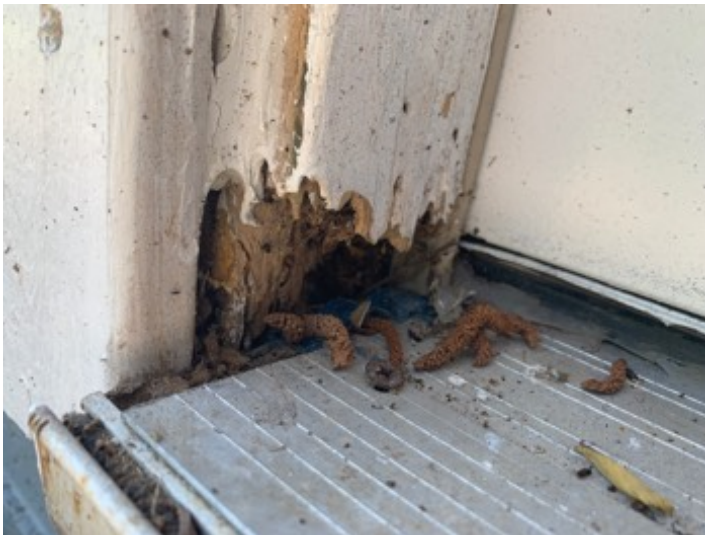
Damaged door frame at the rear exterior of the house

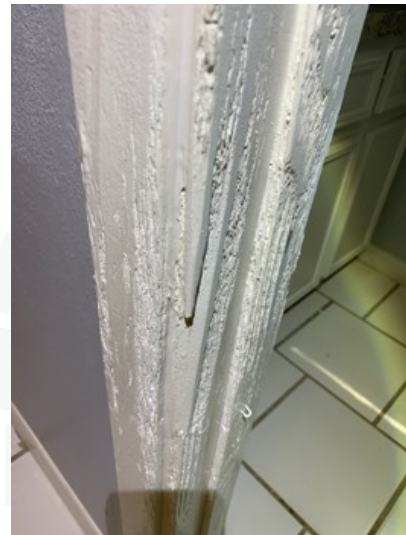
Bathroom door jamb has been repaired with a less the workmen like quality

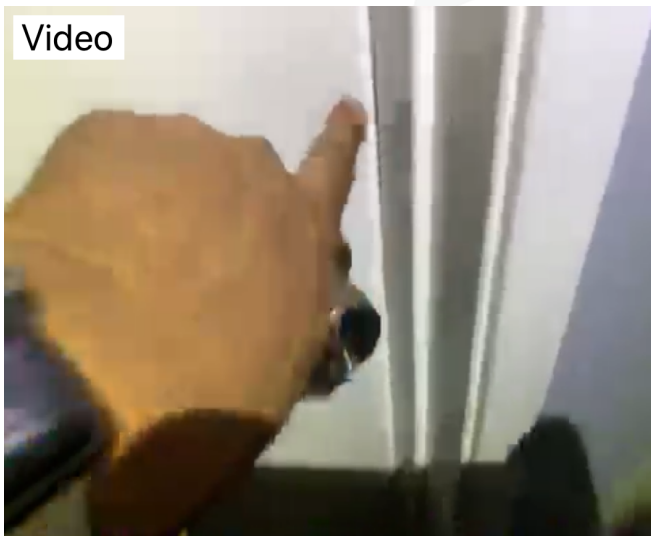
Master bedroom closet door did not latch properly, may be in need of striker plate adjustment.

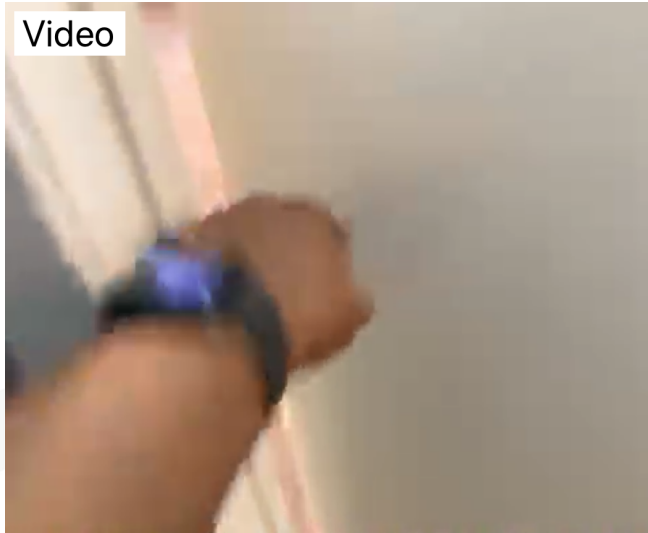
Bedroom door did not latch properly, may be in need of striker plate adjustment.

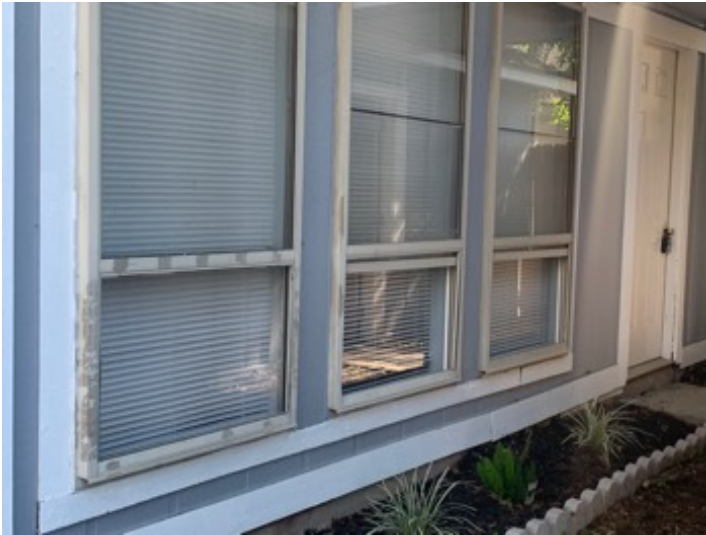
I	NI	NP	D
---	----	----	---

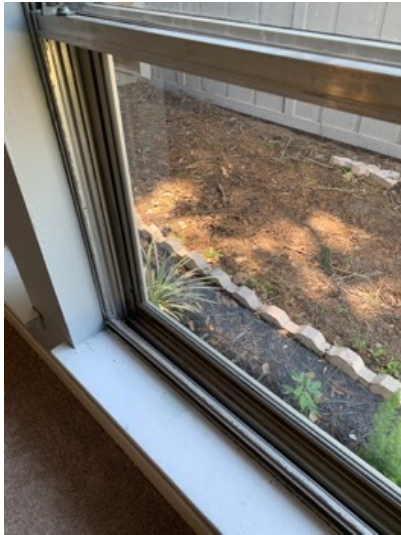
I	NI	NP	D
---	----	----	---

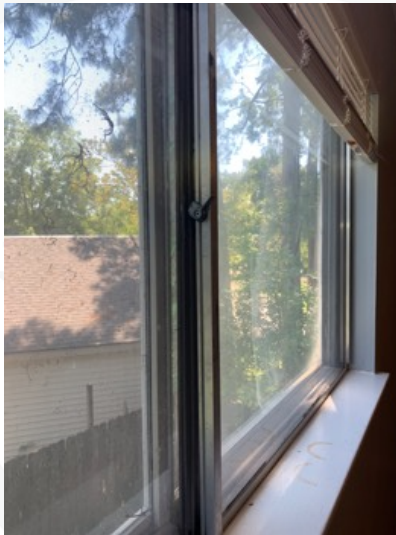
Bedroom window did not lock/latch

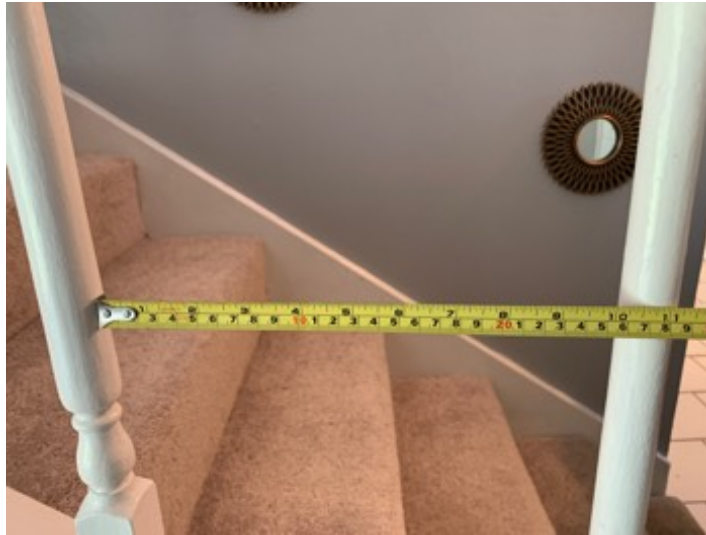
Open space between balusters too wide, baluster opening should be 4 inches, baluster openings are currently at 10 inches.

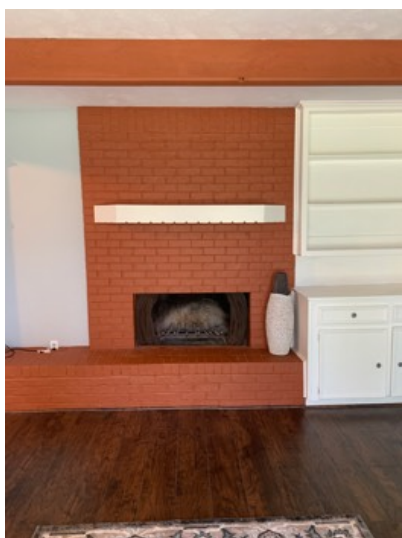
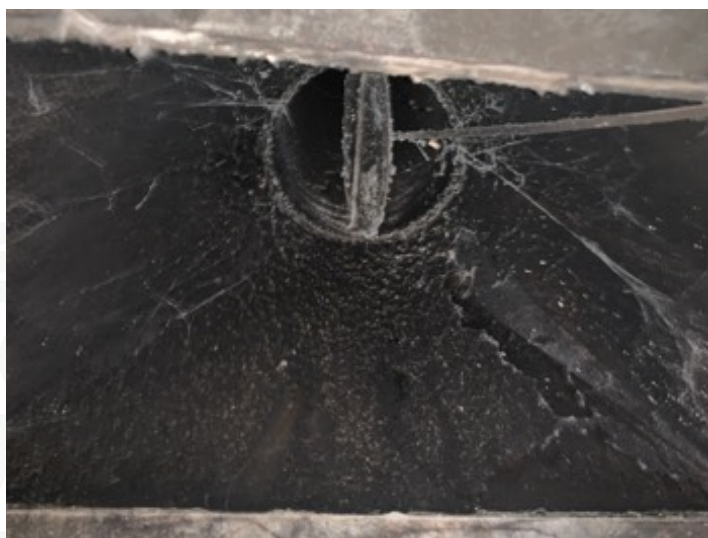
Note: Fireplace is a wood burning fireplace. Inspector does not test to see the actual operation of the fireplace, inspector looks for proper ventilation, positioning of dampers and fire stops within the structure.

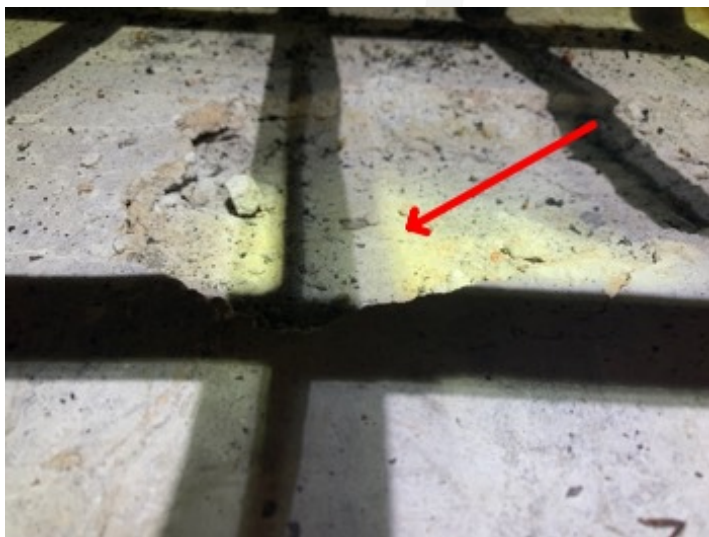
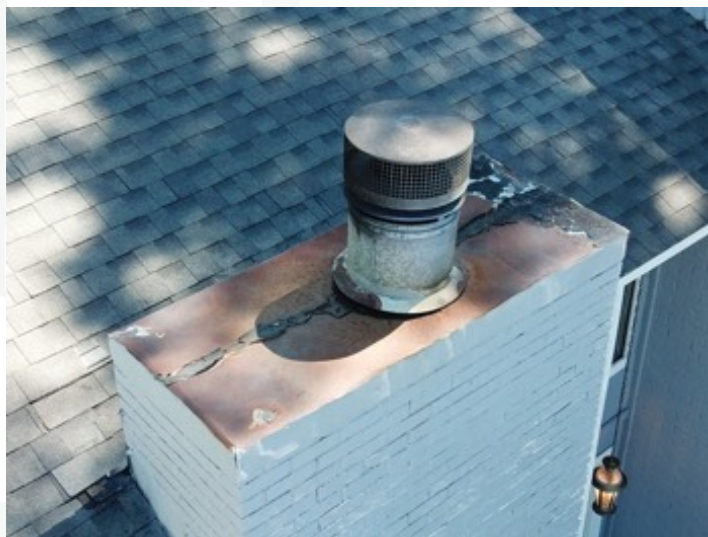
Evidence of creosote build up, recommend having a complete cleaning performed.

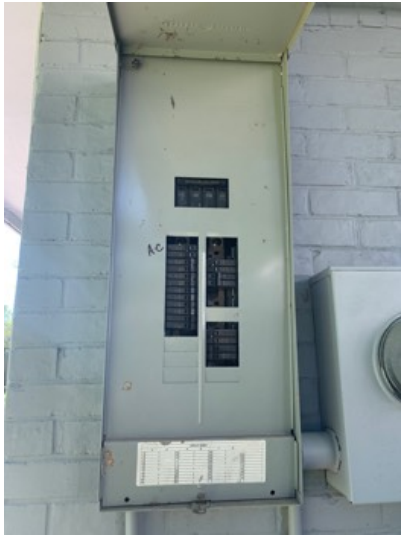
Electrical Service Panel

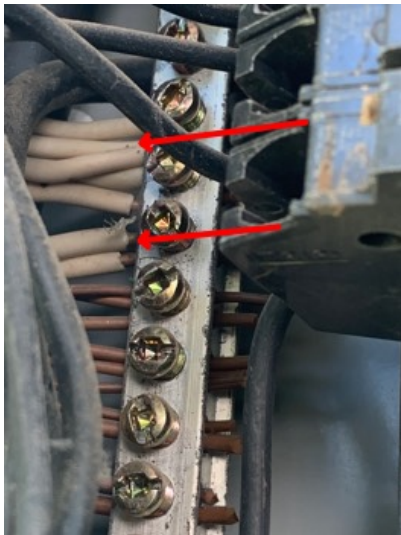
There are multi tapped neutral wires in the panel. Each neutral wire should be individually lugged.

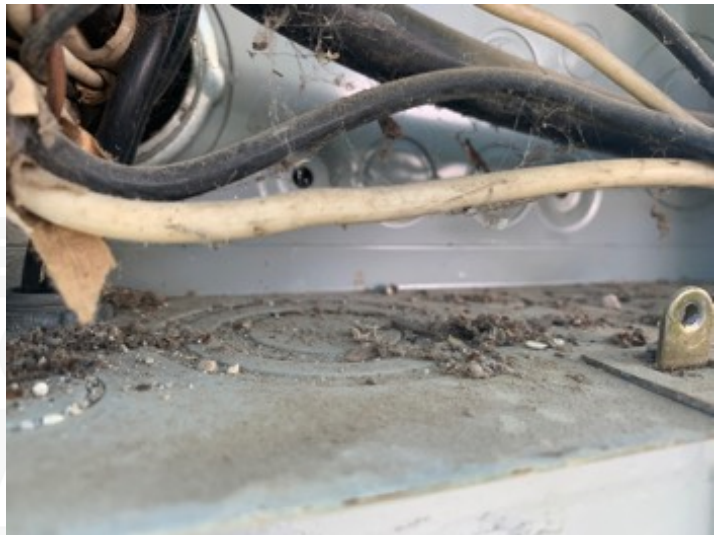
Debris/dust from drywall in the bottom of the electrical service panel. Can be considered a fire hazard at some point.

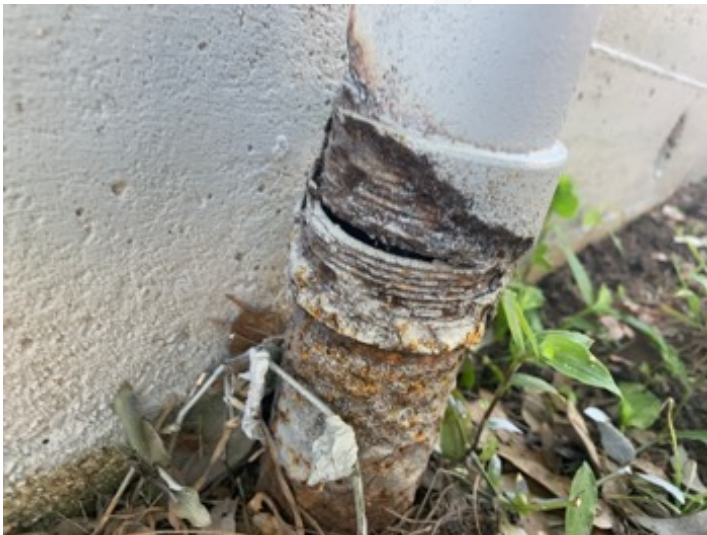
Rusted union at the base of the service entry conduit.

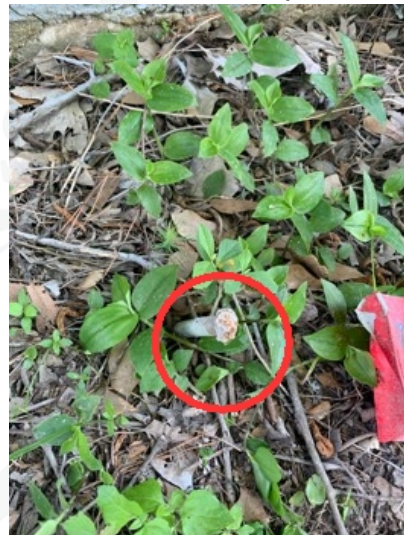
Electrical service panel is not properly grounded, no ground wire leading from the panel.

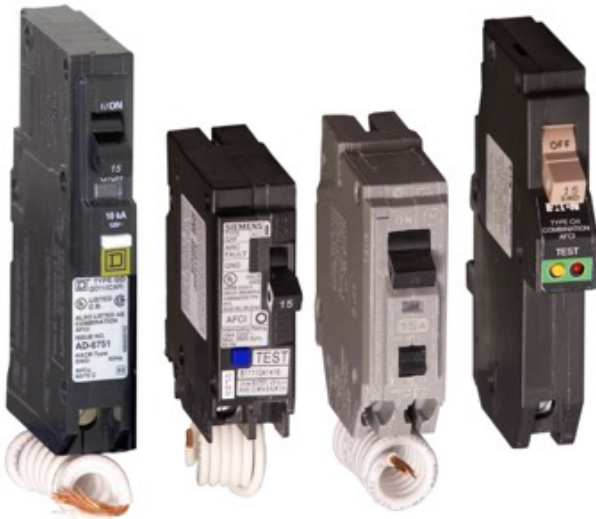
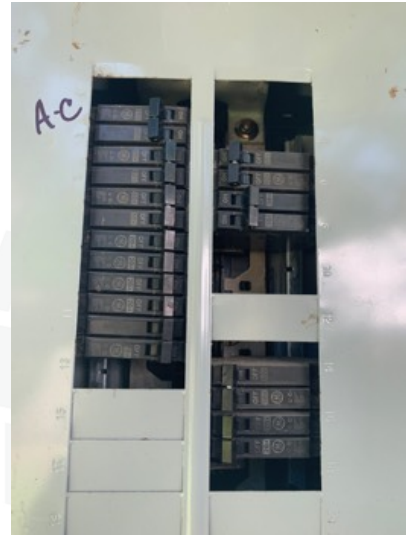
Arc Fault Circuit Interrupters (AFCI) may not have been in existence when this home was built. As of 2002, Arc Fault Circuit Interrupters were introduced for use in bedrooms only and as of September of 2008 the technology was implemented and required for all habitable rooms of houses that were newly built. Arc Fault Circuit Interrupters contain solid state circuitry that will recognize the unique voltage and current wave form combinations that are the signature of an electrical arc, like a loose connection or if a child inserts a paper clip into an outlet. The Arc Fault breaker will then trip, turning power to the circuit off immediately.

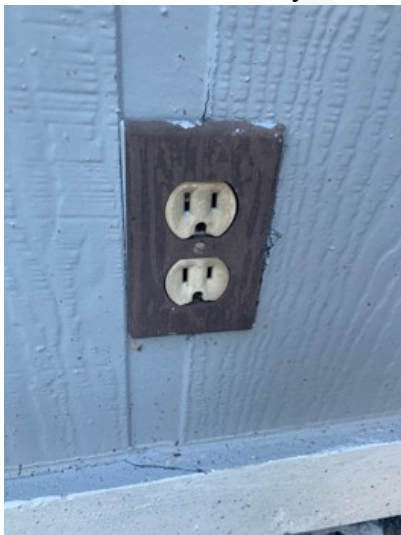
External electrical outlets are missing its waterproof covering

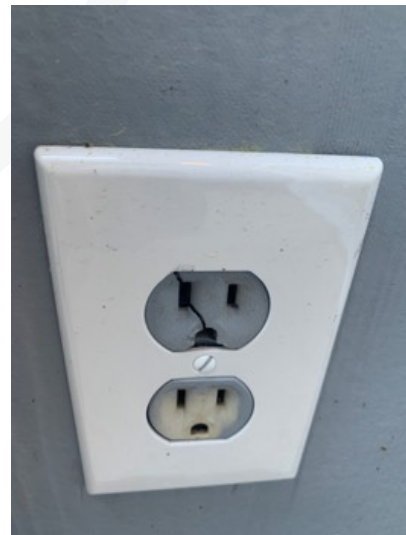
External electrical outlets are missing its waterproof covering

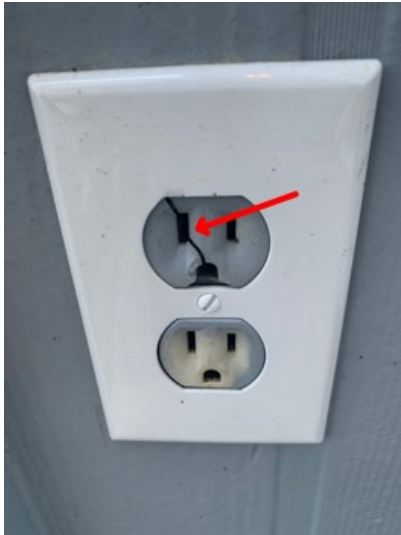
Exterior electrical outlet top receptacle is damaged.
