Arsenal Inspection Services
Property Inspection Report

**ARSENAL
INSPECTION
SERVICES**

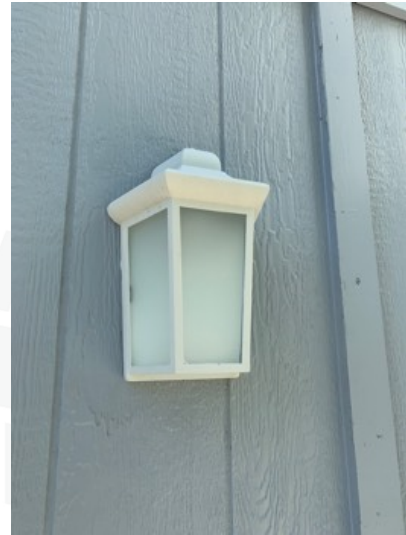
Light fixture not working properly, may have a short or may be in need of light bulb replacement.

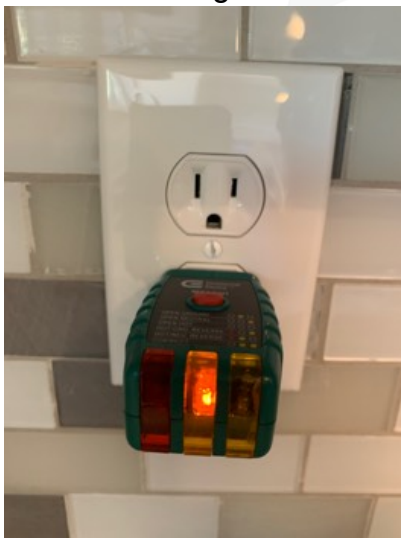
Electrical outlet wired with an open ground

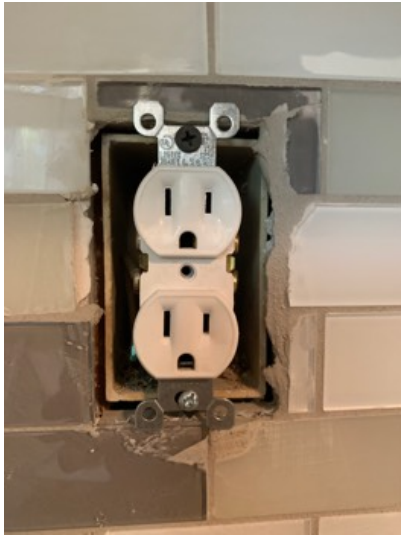
Missing box extender for electrical outlet in the kitchen area.

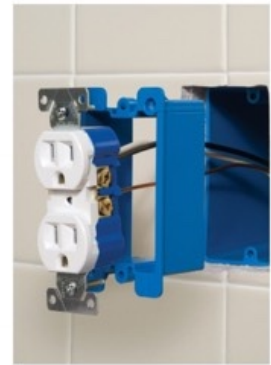
Example of a box extender

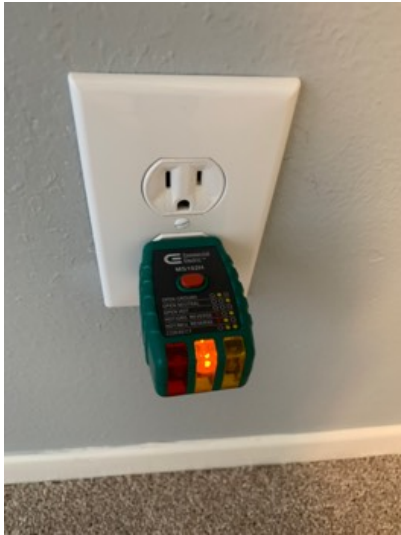
Electrical outlet wired with an open ground

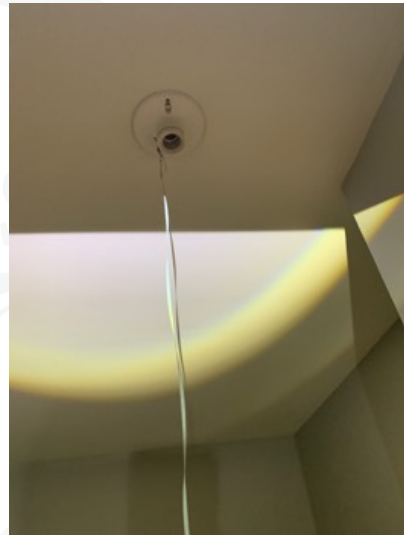
Light fixture not working properly, may have a short or may be in need of light bulb replacement.

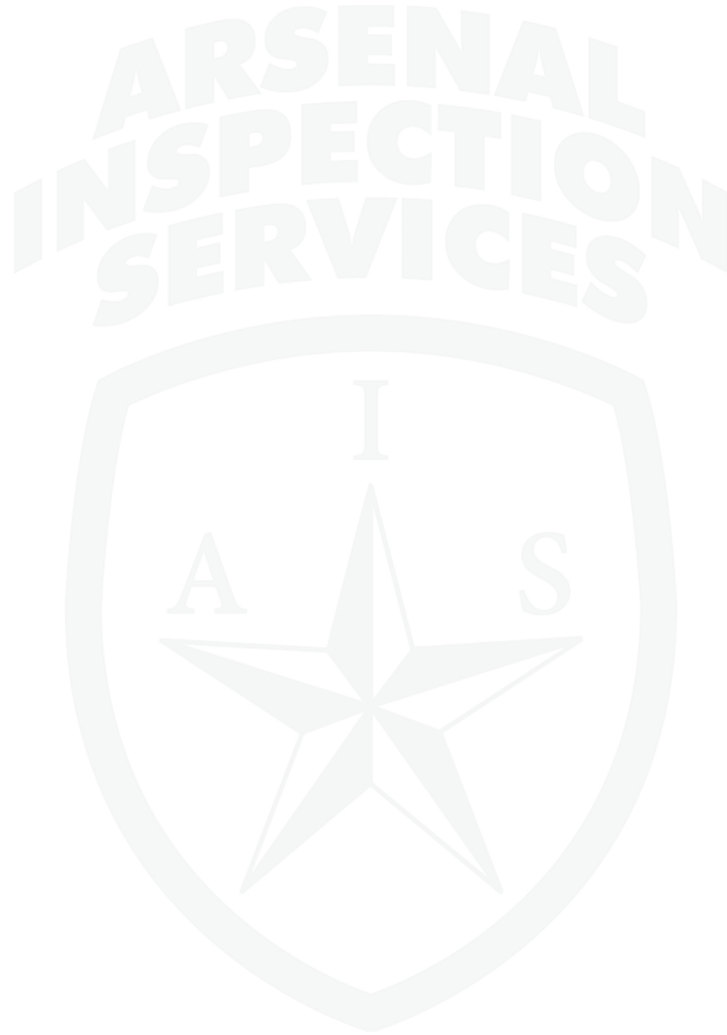
III. HEATING, VENTILATION AND AIR CONDITIONING SYSTEMS

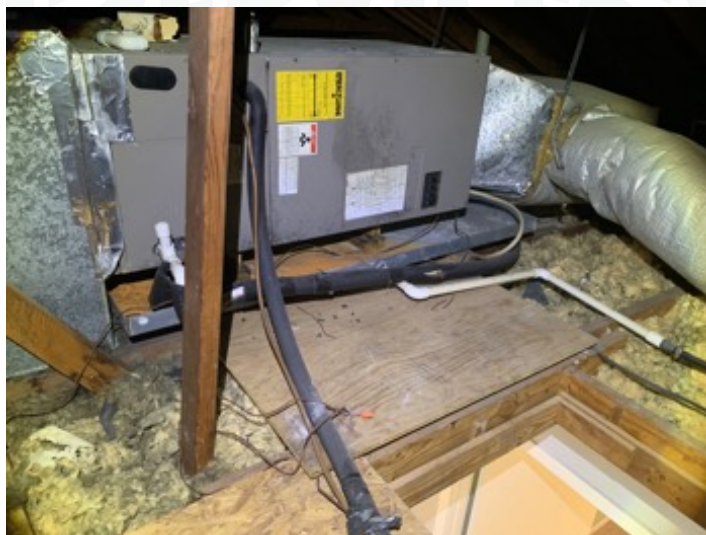
Access to heater in the attic is not the proper size, there should be at least 36 inches of workable space in front of the furnace unit.

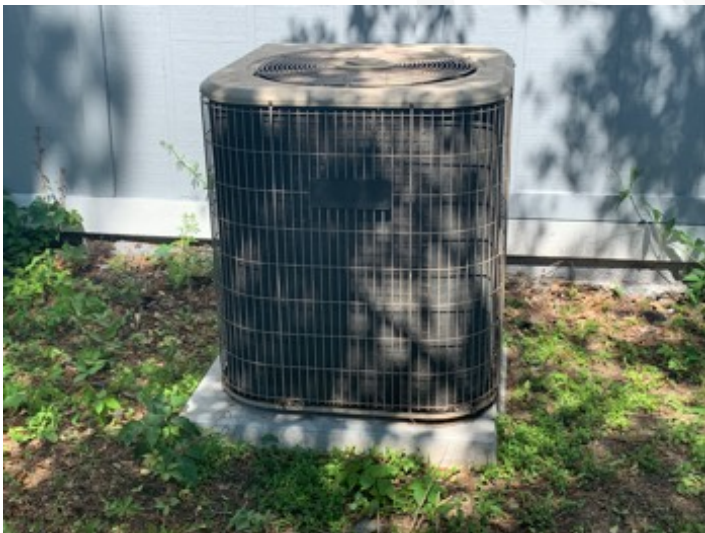
Recommend a HVAC technician to perform a complete system evaluation for any other possible hidden or unseen issues and repair of listed items.

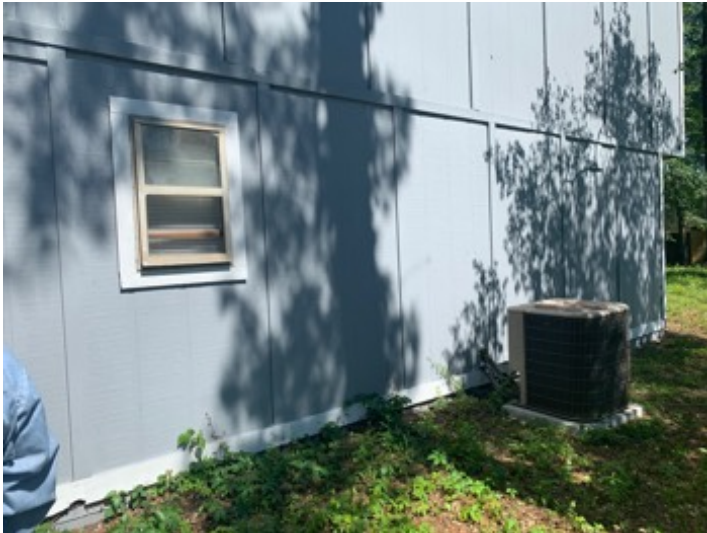
No emergency shut off switch within 50 feet of the AC unit

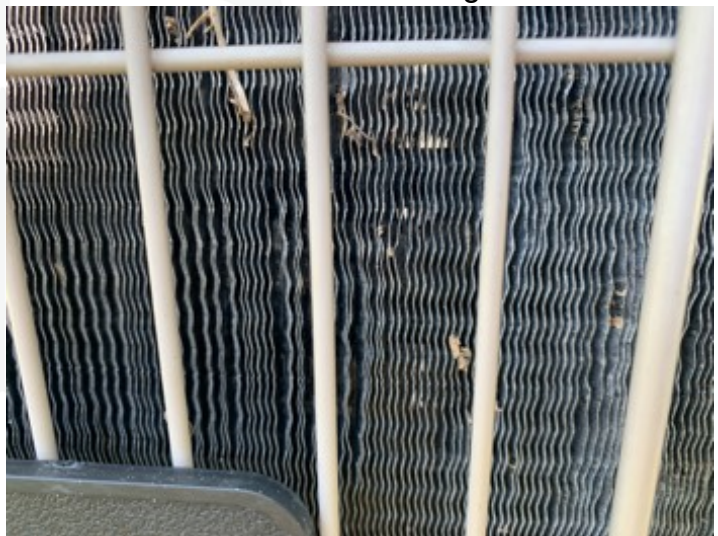
Air-conditioning unit condenser coil fins are damaged, recommend an HVAC technician to repair by combing the fins.

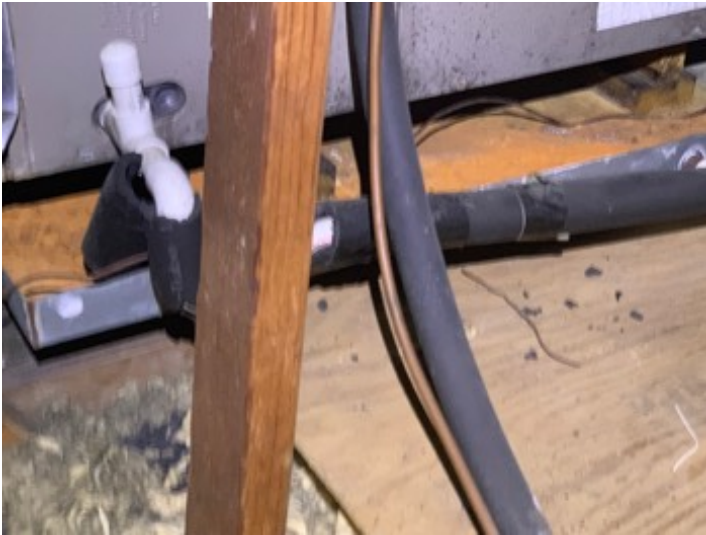
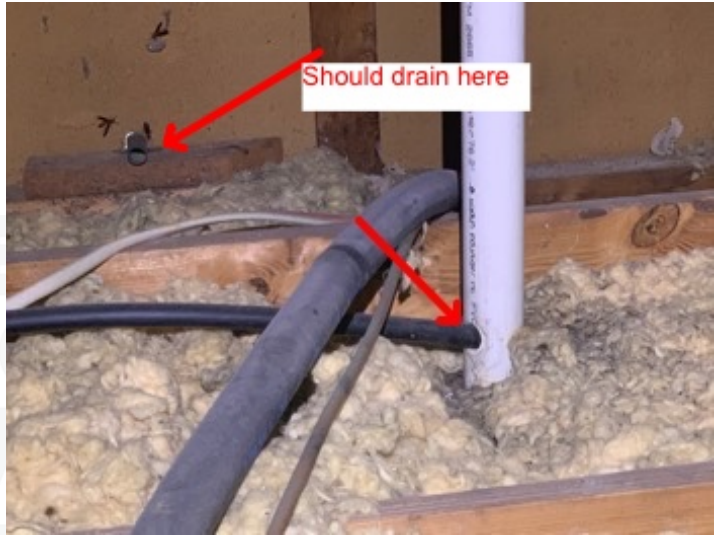
Rusted drip pan found, this is from a past accumulation of condensation in the pan, possibly creating pin holes in the pan where moisture could leak.

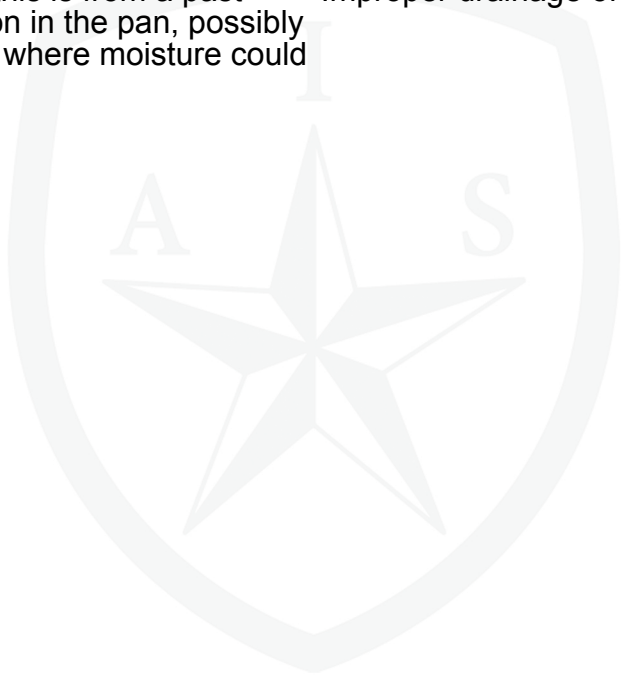
Improper drainage of the AC unit secondary drain line.

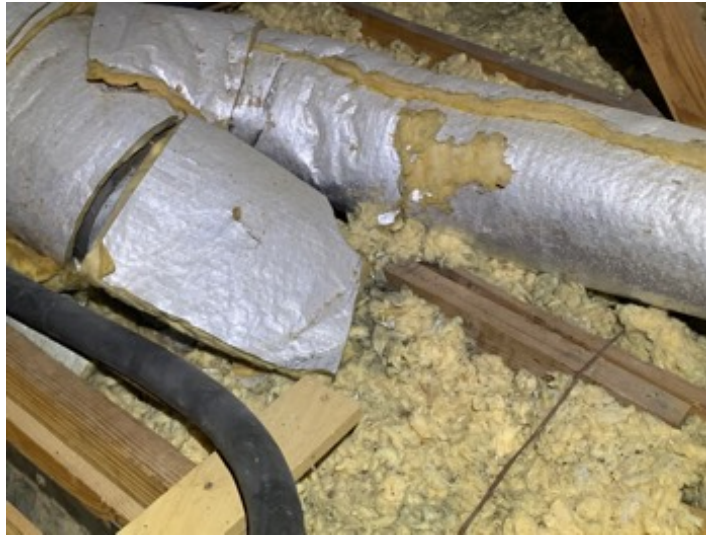
Ductwork is making contact with attic insulation. Condensation from the ductwork could damage insulation and ceiling drywall.

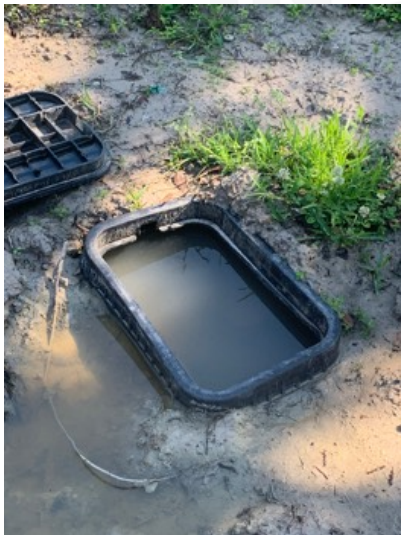
Recommend a plumber to perform a complete system evaluation for any other possible hidden or unseen issues and repair of listed items.

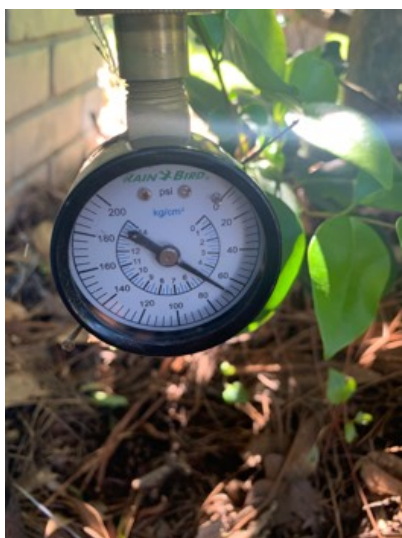
Static Water Pressure Reading: 65 PSI

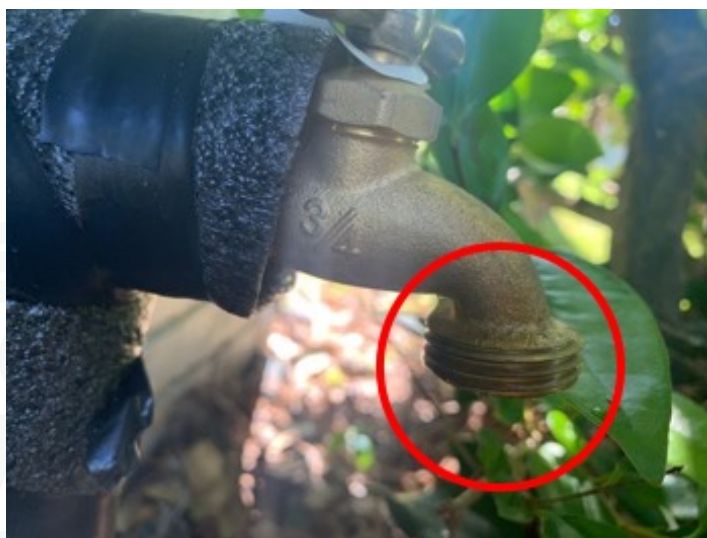
Back flow preventer missing on hose bibs outside of the house. A back flow preventer is used to protect potable water supplies from contamination or pollution due to back flow. In water supply systems, water is normally maintained at a significant pressure to enable water to flow from the tap, shower etc. When pressure fails or is reduced, as may happen if a water main bursts, pipes freeze or there is unexpectedly high demand on the water system, then such reduced pressure in the pipe may allow contaminated water from the ground, from storage or from other sources to be drawn up into the system.

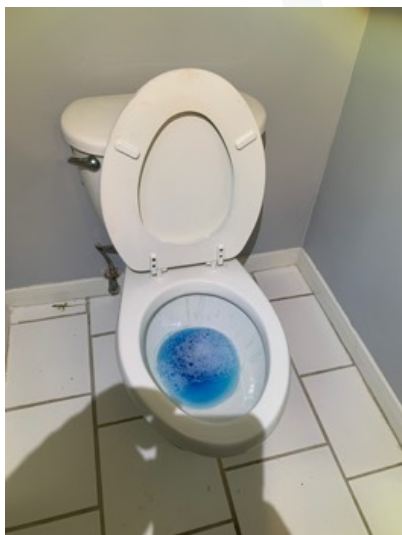
The toilet in the downstairs guest bathroom is loose, may need a wax seal replacement and it does need to be properly secured to the floor

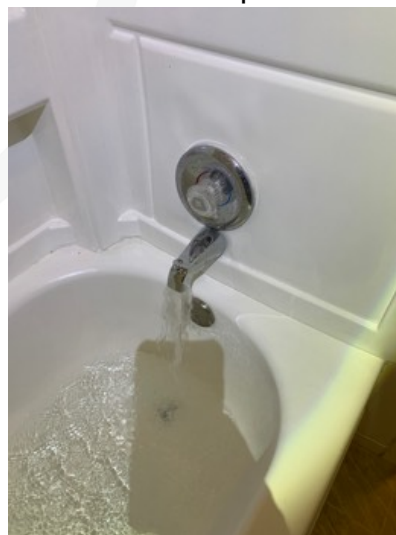
Hot & cold reversed (master bath)

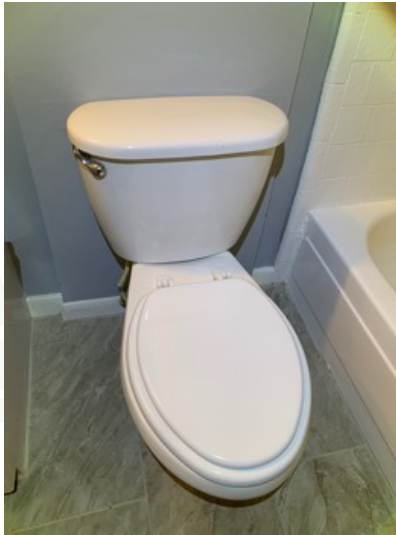
Upstairs guest bathroom toilet does not flush.

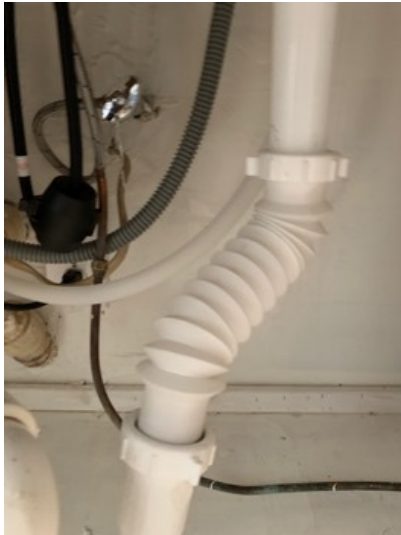
Flexible drain pipe present, drain tail piece pipes are required to have smooth interiors to prevent blockage.

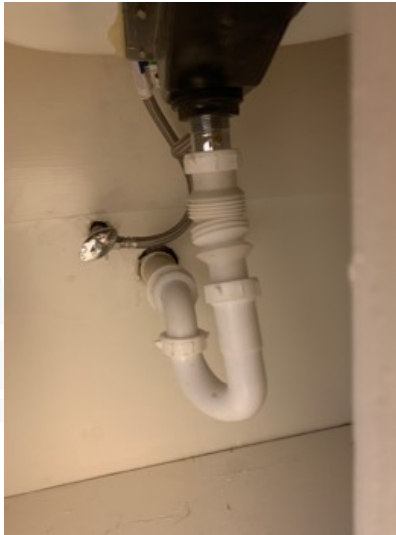
Flexible drain pipe present, drain tail piece pipes are required to have smooth interiors to prevent blockage.

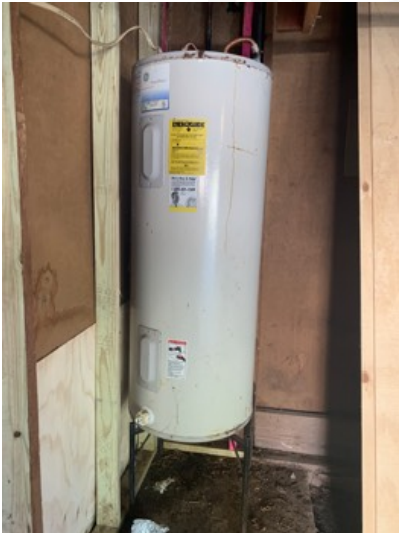
Recommend a plumber to perform a complete system evaluation for any other possible hidden or unseen issues and repair of listed items.

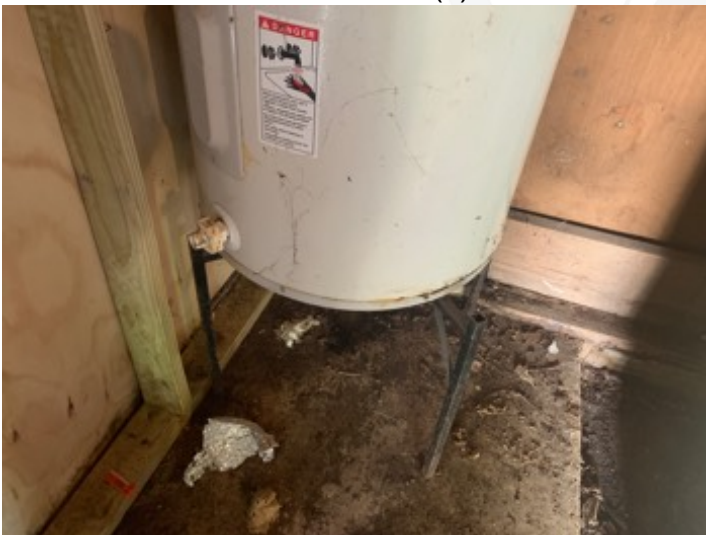
water heater is missing drain pan at the bottom of the water heater.

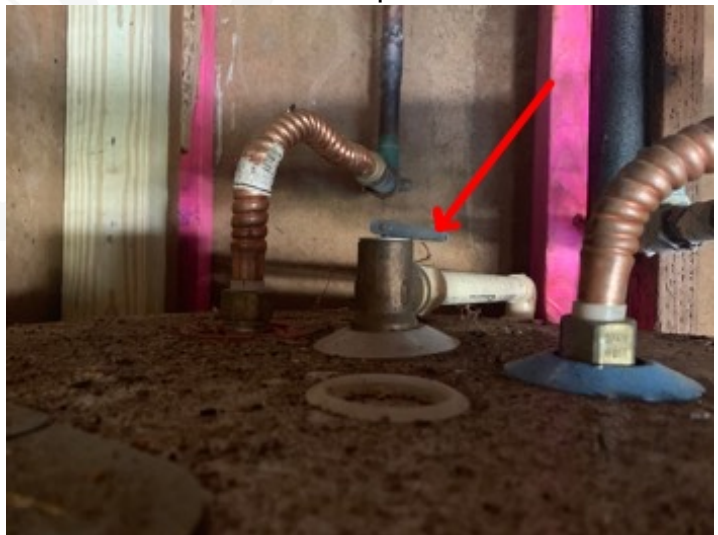
Temperature pressure relief valve

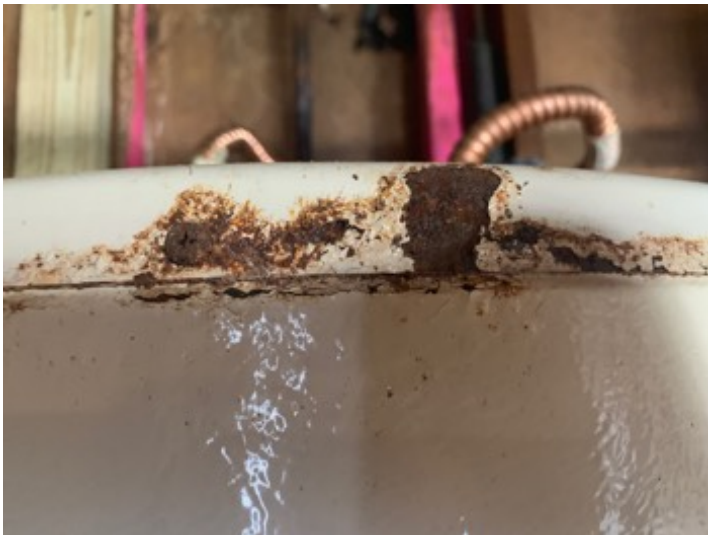
Rust is visible on the casing

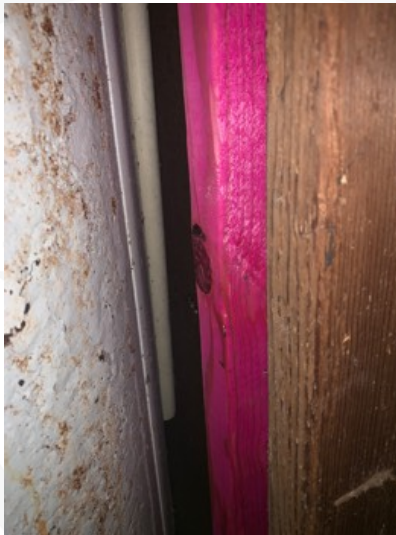
TPR valve and drain pan drain pipes discharges above six inches from grade/surface, an extension to the drain pipes for the lines is recommended to prevent possible injury from water discharged through these lines.

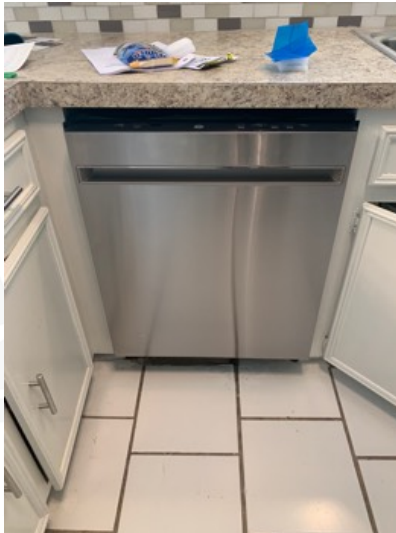
The dishwasher did not operate when tested, consult with the seller about servicing the unit.

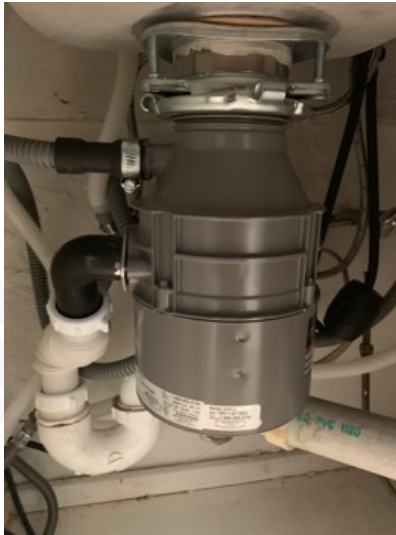
Operated - appeared functional at time of inspection.

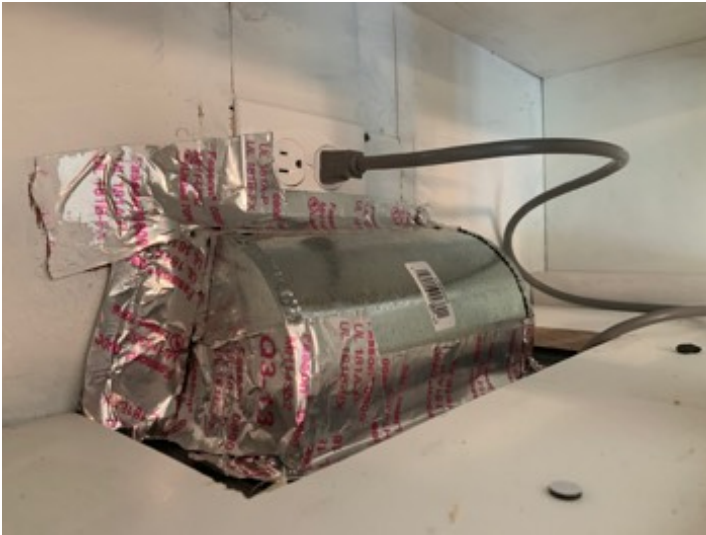
Self filtering with vent to the exterior

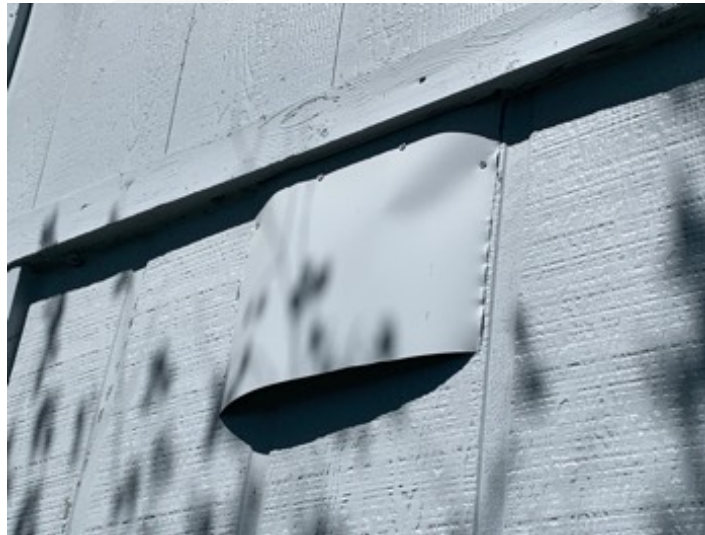
Irregular materials were used for vent cover

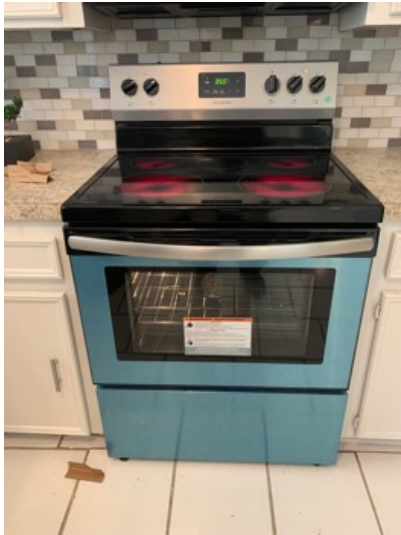
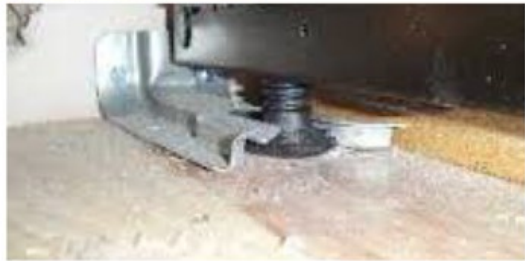
SAFETY CONCERN: Free standing range missing anti-tip bracket/device. Should be installed.

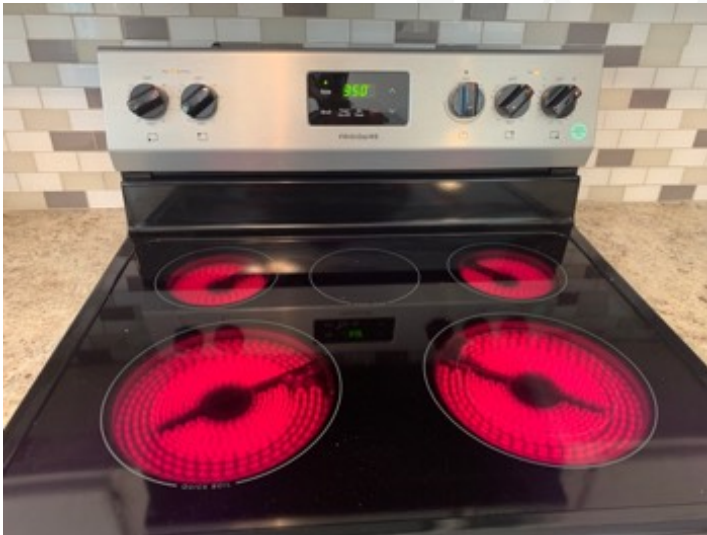
Cooktop: All heating elements operated when tested.

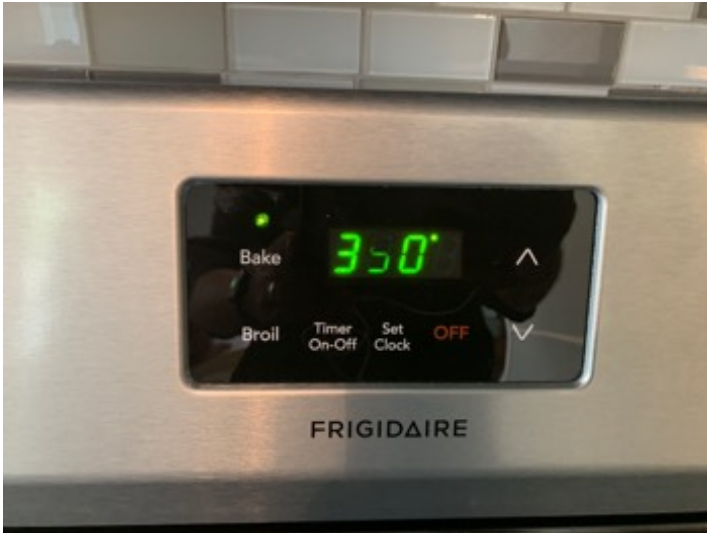
set oven temperature

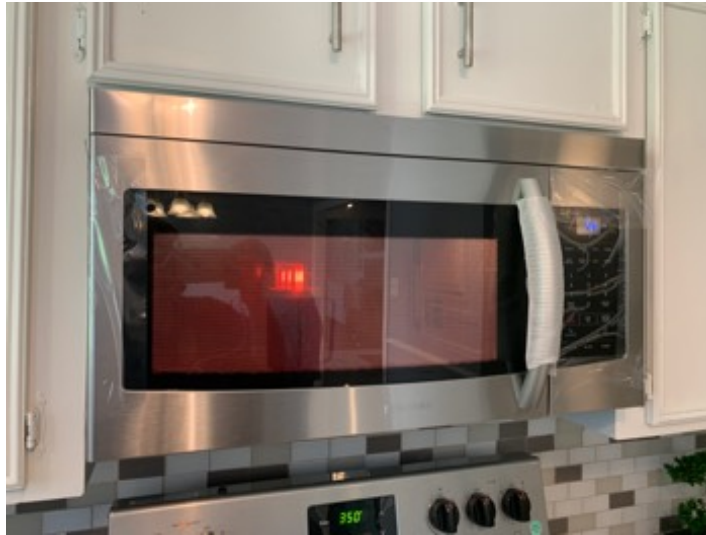
Built-in microwave ovens are tested using normal operating controls. Unit was tested and appeared to be serviceable at time of inspection. Leak and/or efficiency testing is beyond the scope of this inspection. If concerned, client should seek further review by qualified technician prior to closing.

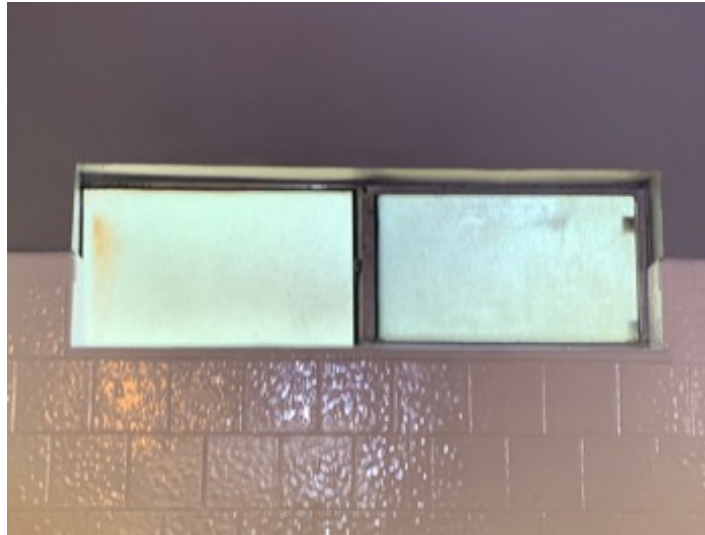
No fans were observed, central ventilation is present through required glazing.

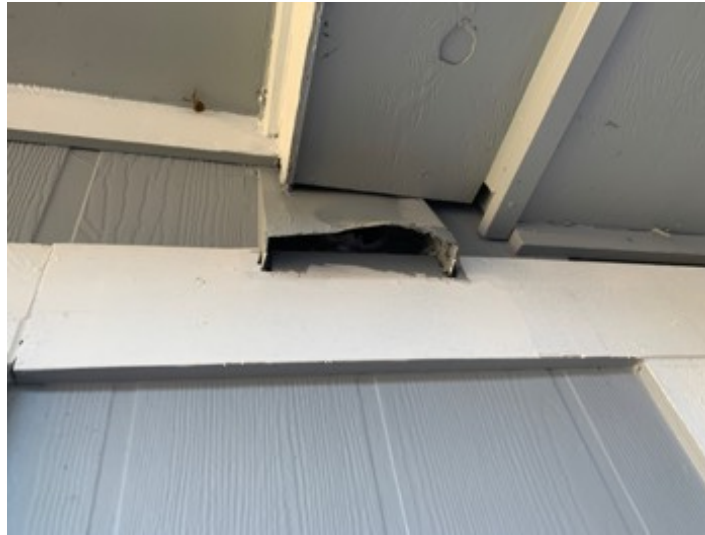
The dryer vent has a damaged exterior cover.

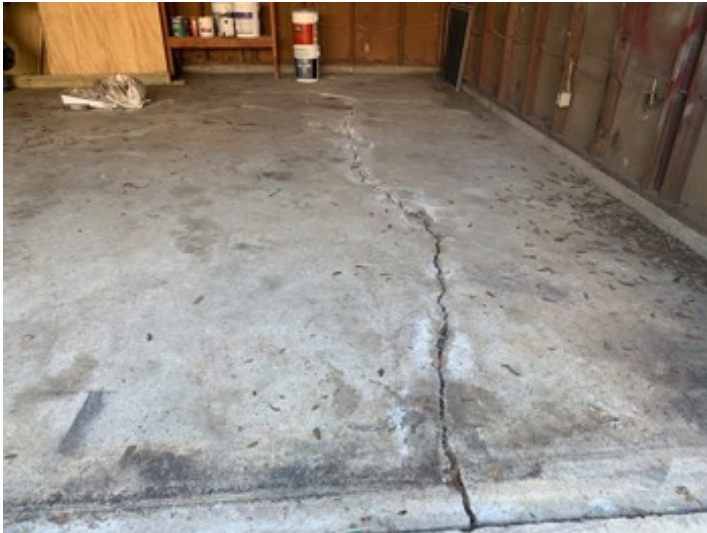
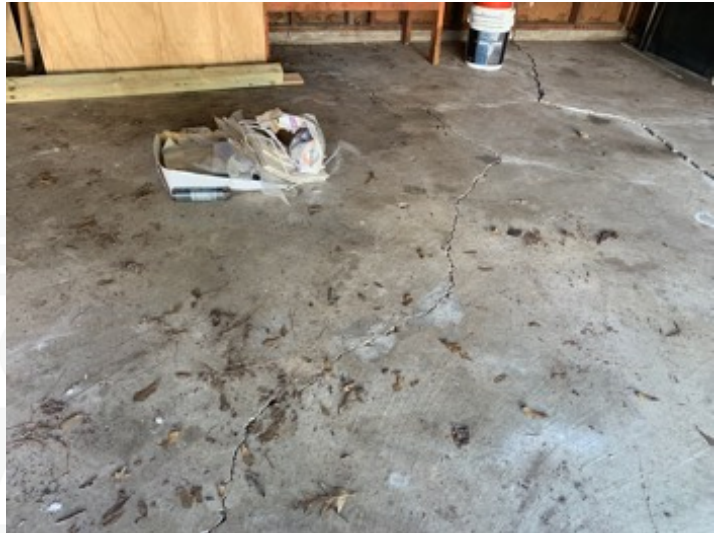
Detached garage foundation is cracked extensively.
