# *Before You Buy Inspection Services*

## Property Inspection Report

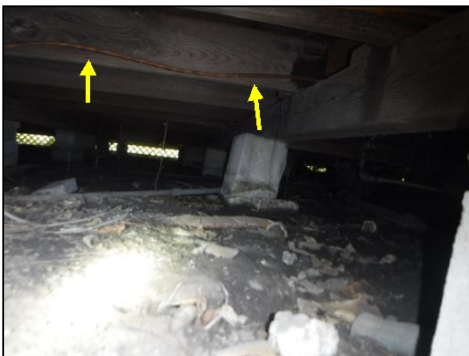
*Wiring in crawl space not covered in conduit*

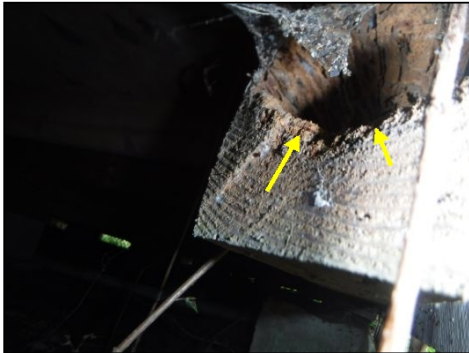
Wood damage in crawl space should be further investigated

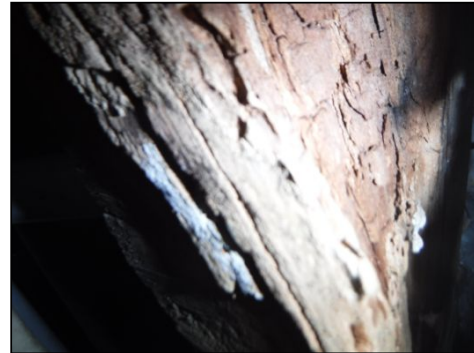
Recommend having pest control specialist review wood damage under unit

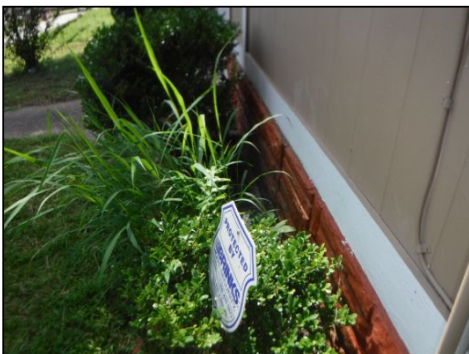
Maintenance: Shrubs planted too close to the house creating conditions conducive to infestation by Wood Destroying Insects (WDI). Shrubs should not be planted closer to the slab than half of the mature width of the shrub.

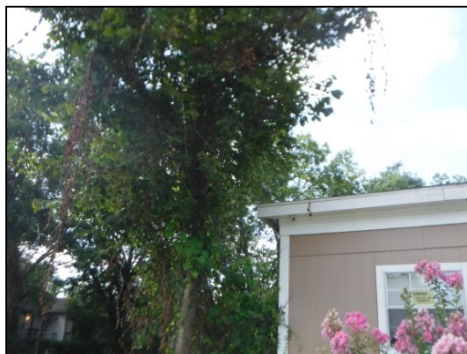
Trees too close to structure.

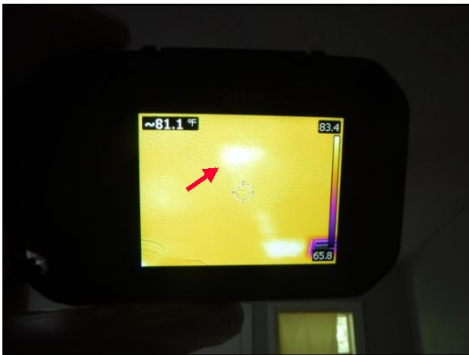
Insulation opportunities in attic

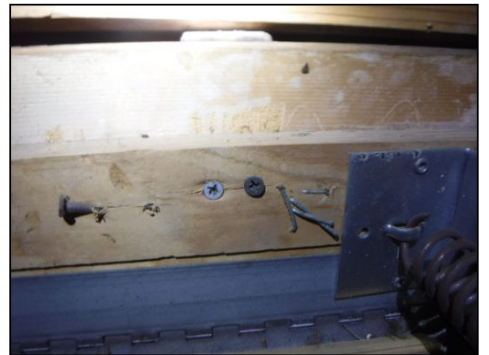
NOTE: The attic ladder was observed to be installed with improper fasteners. The frame should be secured with {16d} nails or {3"} lag screws. This condition should be further evaluated and corrected as necessary for safety concerns.

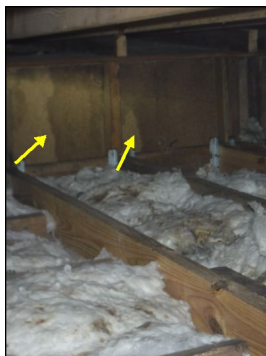
Evidence of previous moisture intrusion in the attic

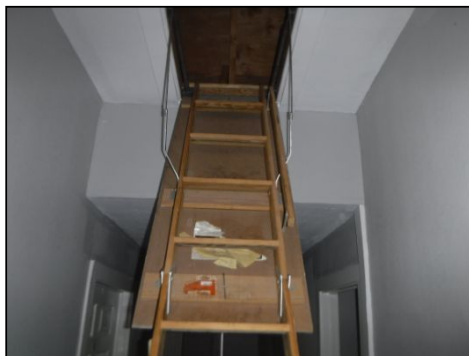
NOTE: The pull-down attic ladder is not insulated or weather stripped at this time. This is an "As Built" condition that does not meet current energy standards. It is recommended to insulate the hatch door after taking ownership of the property

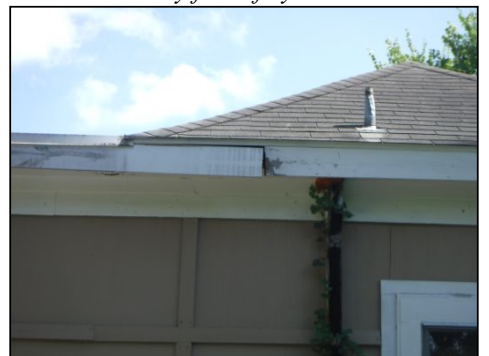
The fascia board has some deterioration on more than one location on the structure

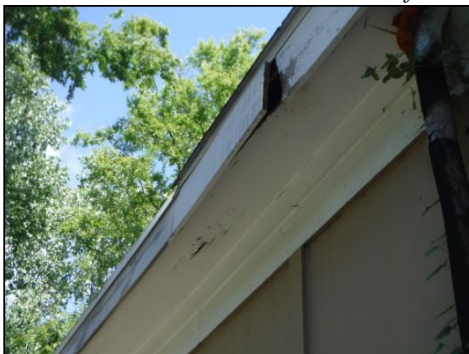
The fascia board has some deterioration on more than one location on the structure

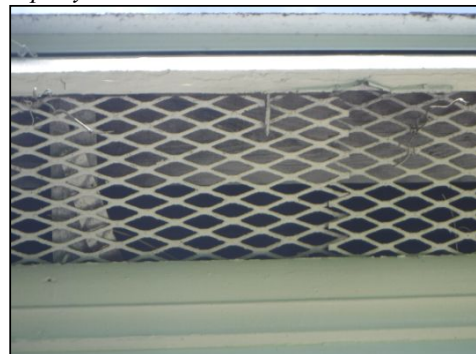
Soffit on left side of house is metal grate

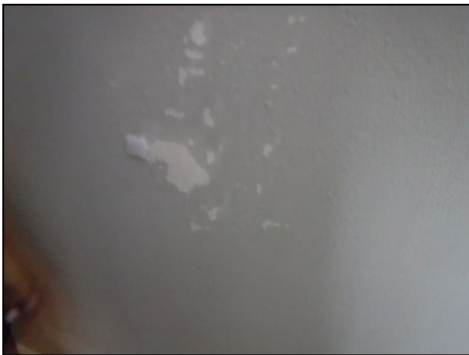
Previous repair and refinish did not appear to be of professional contractor quality.

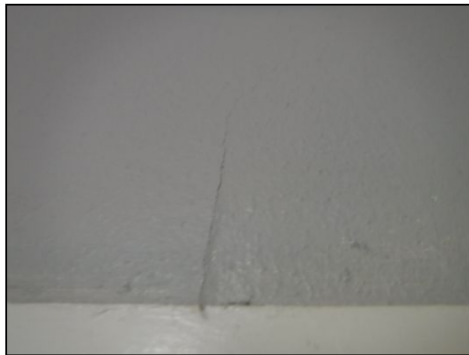
Wall cracks noted in one or more areas around the home. Further evaluation is recommended.

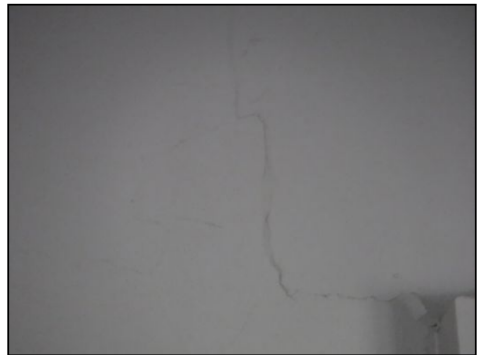
Wall cracks noted in one or more areas around the home. Further evaluation is recommended.

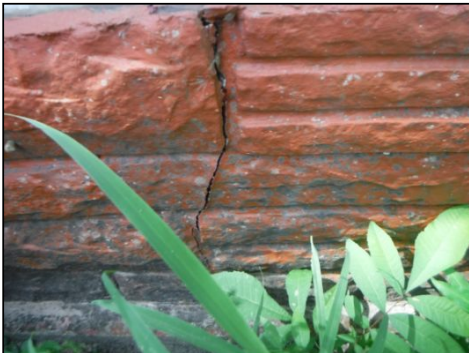
Cracks noted in the exterior veneer in one or more areas of the home. Repair is recommended.

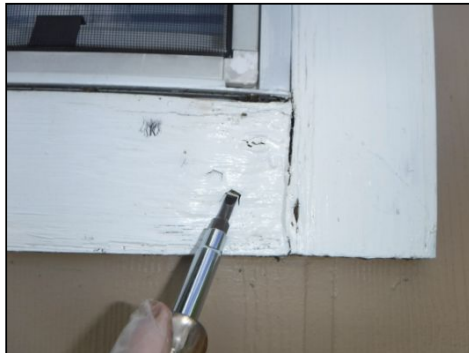
**IMPORTANT NOTICE:** Wood rot noted on the exterior trim in one or more areas. Replacement is recommended.

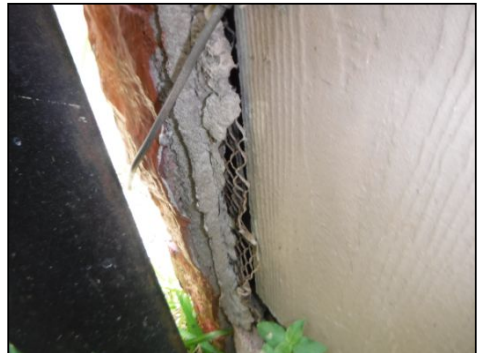
Gaps in siding noted on corner of home

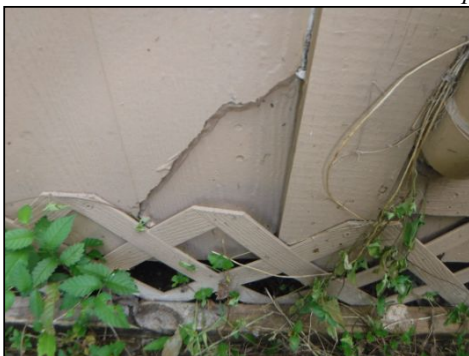
Damaged noted to exterior siding in one or more areas.

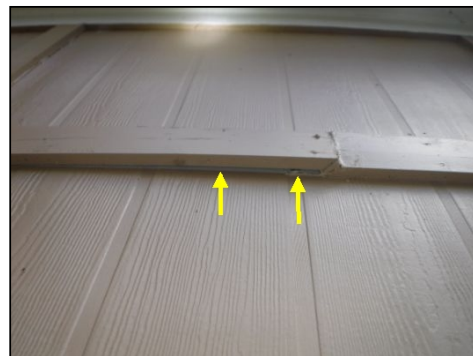
Loose trim boards on siding

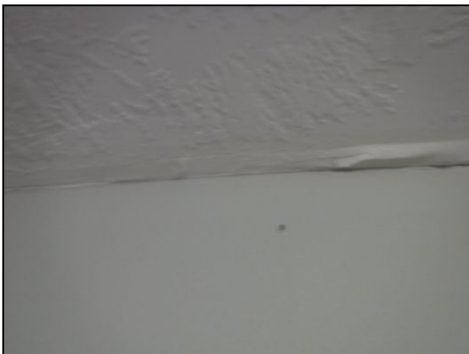
*Tape seam showing in the bathroom. Proper repair is recommended.*

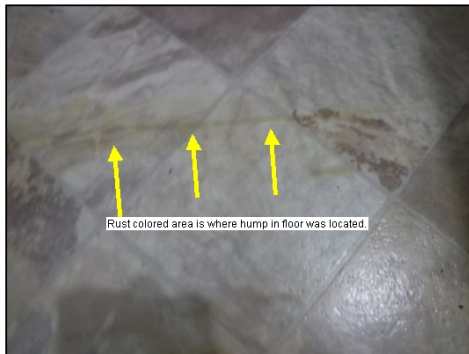
***IMPORTANT NOTICE:** The flooring in the bathroom was out of level in multiple areas.*

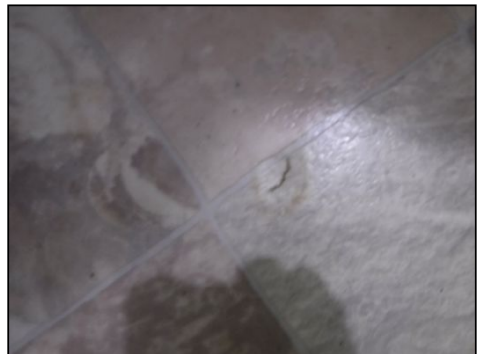
***IMPORTANT NOTICE:** Damage to the flooring noted in the bathroom. Proper repair is recommended.*

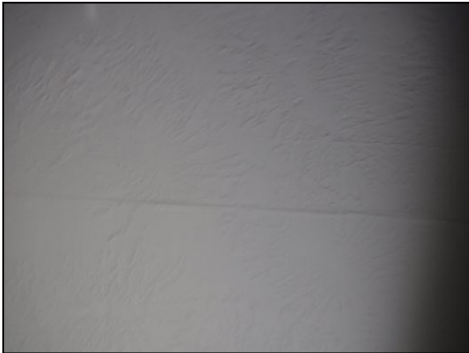
Previous repairs to ceiling did not appear to be of professional contractor quality.

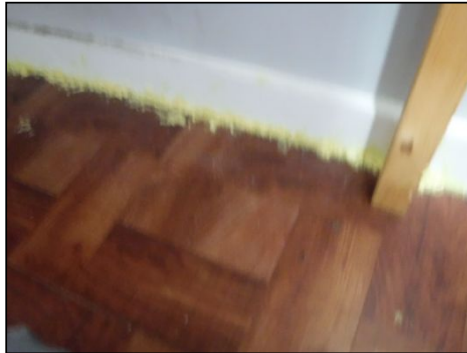
Spray foam used along gap of flooring in one of the bedrooms

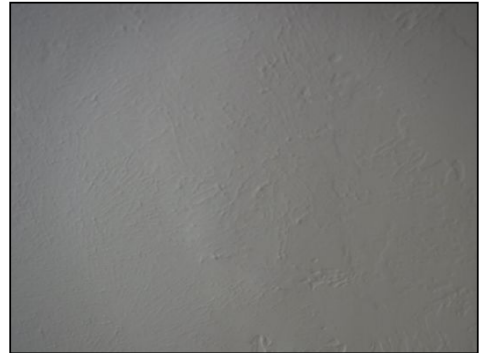
Previous repairs to ceiling did not appear to be of professional contractor quality.

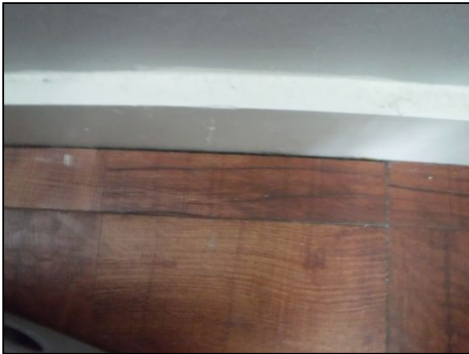
Caulk opportunities noted on the baseboard in multiple areas.

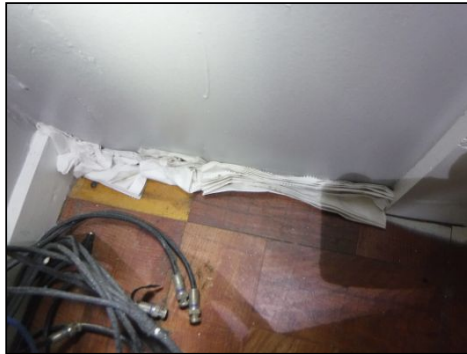
Paper towels stuffed into area where baseboard was missing

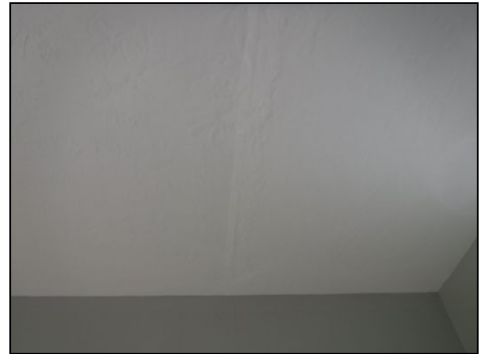
Previous repairs to ceiling did not appear to be of professional contractor quality.

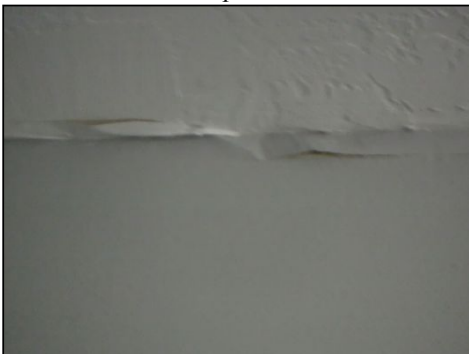
Tape seam showing in the bathroom. Proper repair is recommended.

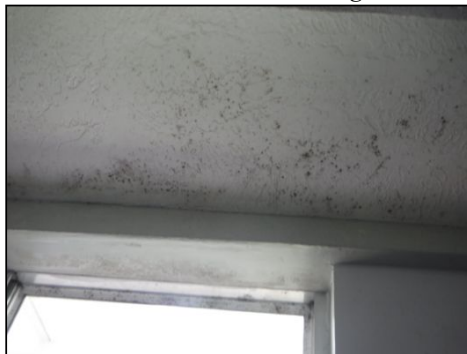
**IMPORTANT NOTICE:** A mold like substance was found growing on the ceiling of the bathroom. Further evaluation and proper repair is recommended.

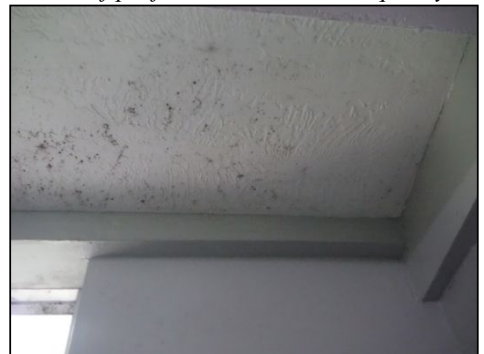
**IMPORTANT NOTICE:** A mold like substance was found growing on the ceiling of the bathroom. Further evaluation and proper repair is recommended.

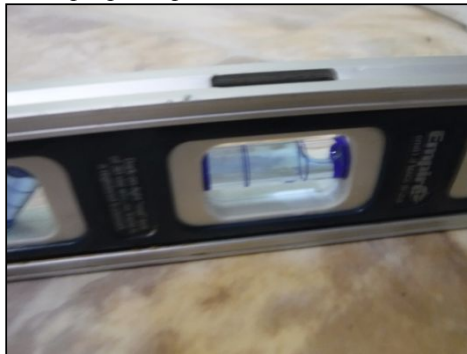
**IMPORTANT NOTICE:** The flooring in the bathroom was out of level in multiple areas.

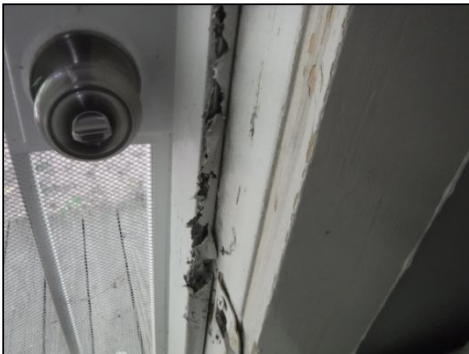
*The weather strip on the side door was noted to be damaged. Replacement is recommended.*

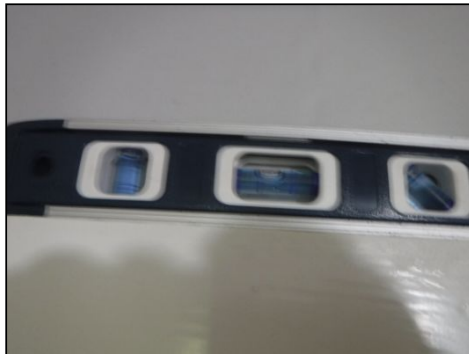
*IMPORTANT NOTICE: One or more door frames was noted to be out of level. Further evaluation as to the cause is recommended.*

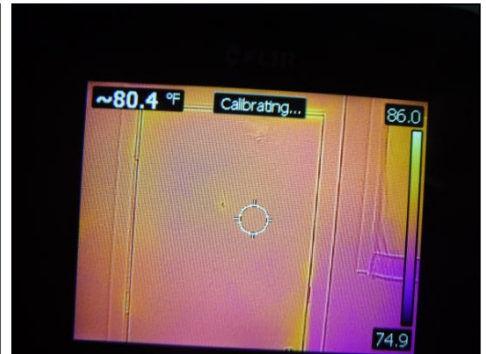
*Air leaks noted around doors*

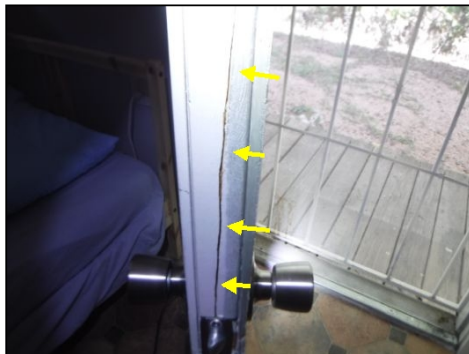
*IMPORTANT NOTICE: The side entry door was noted to have a crack in it. Replacement is recommended.*

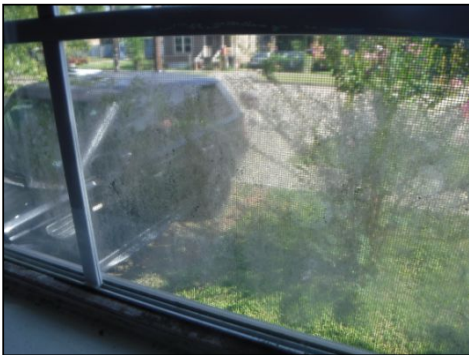
Front window would not open

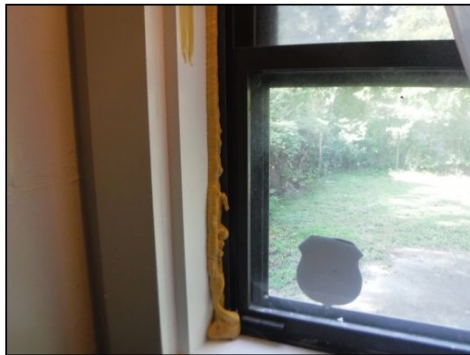
**IMPORTANT NOTICE:** Spray foam was noted to fill gaps around windows in one or more areas. Further evaluation and proper repair is recommended.

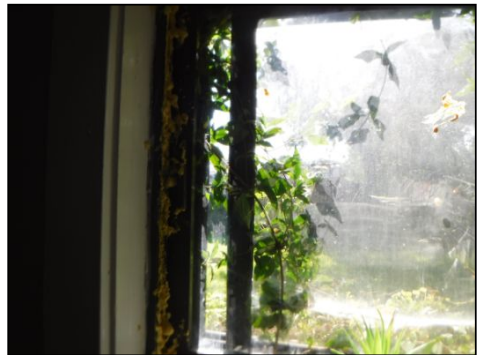
**IMPORTANT NOTICE:** Vines were growing inside the window frame on one of the bedroom windows. Removal of the vines and sealing of the window is recommended.

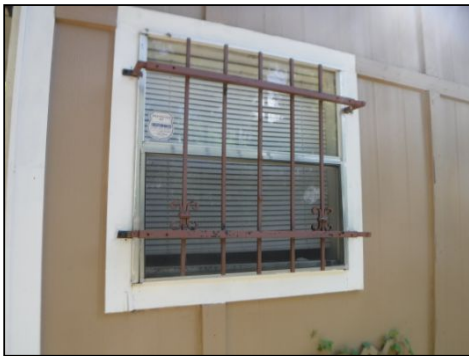
**IMPORTANT NOTICE:** Non-removable bars, grilles or screens were observed over one or more of the bedroom windows. When these obstructions are placed over emergency escape windows; they should be removable from the inside without the use of special tools or keys. At least one window in each bedroom should fully open with free access to the outside for safety concerns

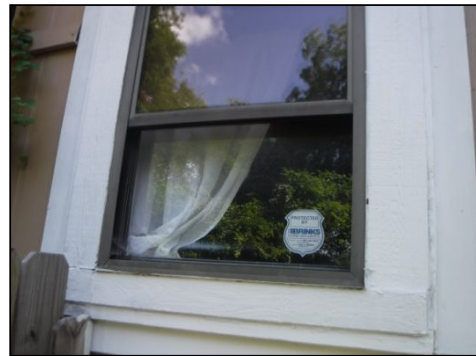
**IMPORTANT NOTICE:** Missing or damaged screens noted in one or more areas around the home.

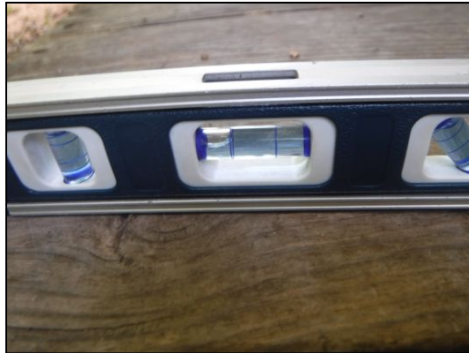
*IMPORTANT NOTICE: The porch on the side of the home was noted to have a negative slope. Further evaluation and proper repair is recommended.*

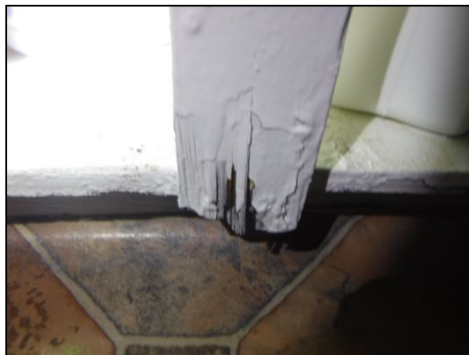
*Damage noted to the cabinets in one or more areas around the home.*

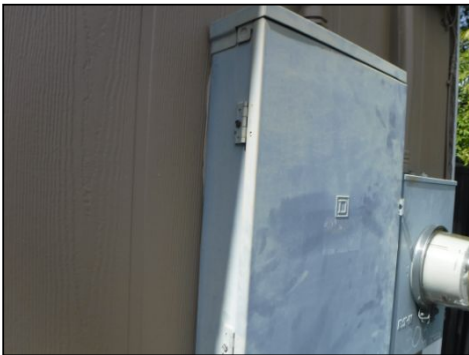
Gaps wider than {1/8"} around the service panel must be sealed.

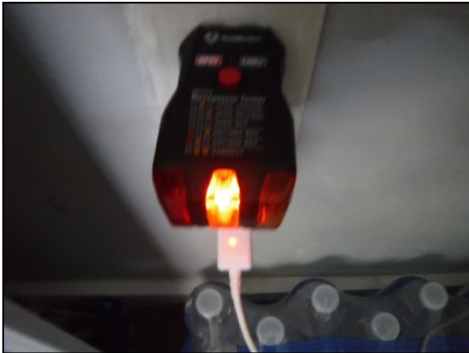
*IMPORTANT NOTICE: One or more of the receptacles were noted to have an open ground. Review and repair by a licensed electrician is recommended.*

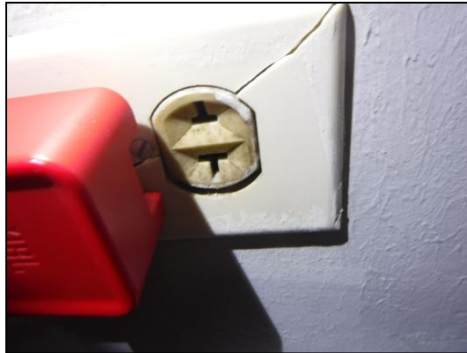
*IMPORTANT NOTICE: Older two prong outlets were noted in one or more areas of the home. Updating to current standards is recommended. Damaged outlet cover noted as well.*

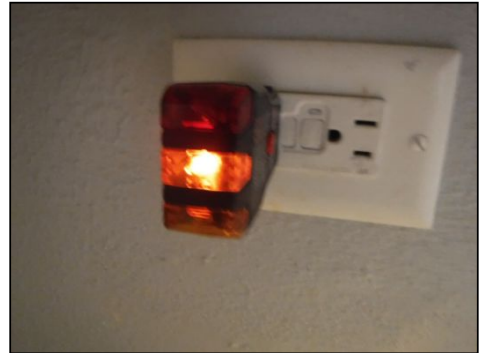
*GFCI outlet with open ground is not GFCI protected*

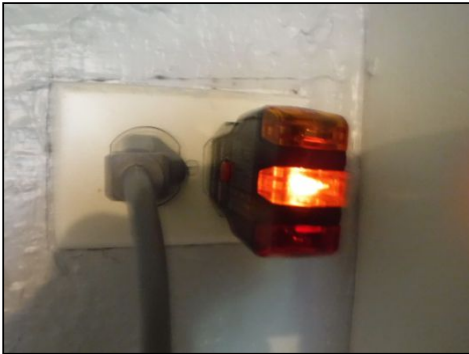
*IMPORTANT NOTICE: One or more of the receptacles were noted to have an open ground. Review and repair by a licensed electrician is recommended.*

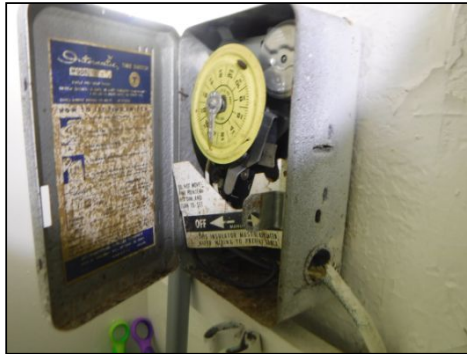
*Timer in kitchen pantry was disabled*

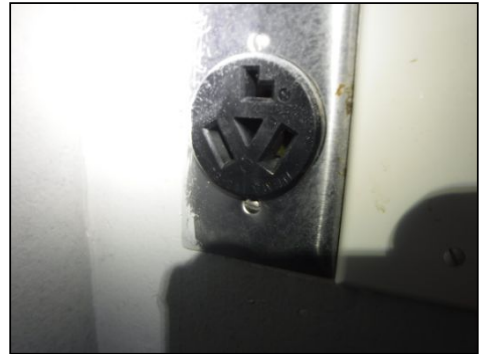
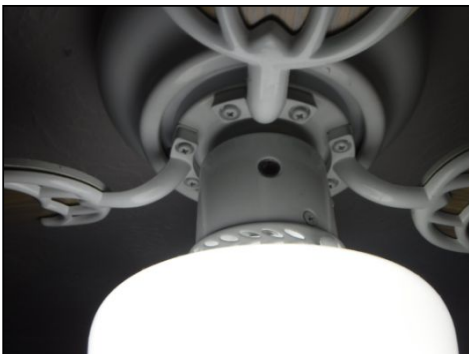
*The ceiling fan pull chain was missing in one of the bedrooms.*

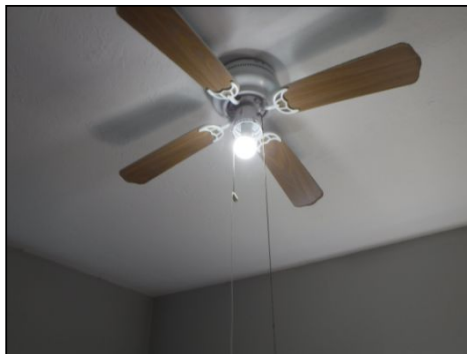
*NOTE: Multiple light fixtures were missing covers. Replacement is recommended.*

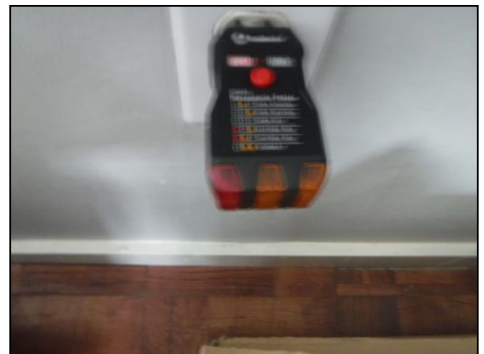
*No power to outlet for unknown reason*

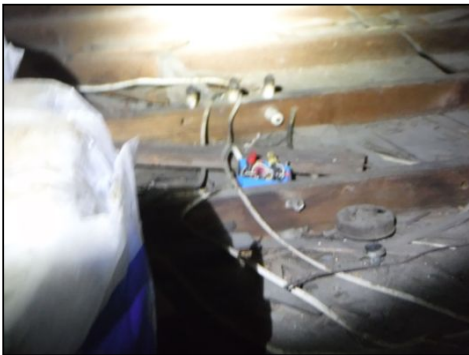
*IMPORTANT NOTICE: Open junction boxes noted in the attic. Covering is recommended.*

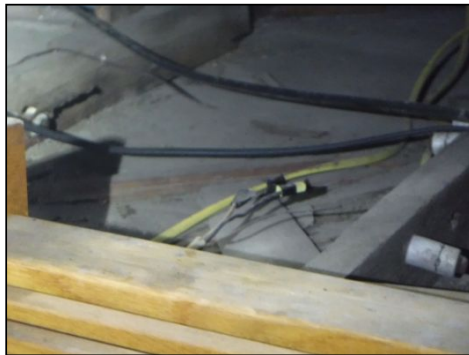
*IMPORTANT NOTICE: Wiring connections were not installed in junction boxes in the attic. Further evaluation and proper repair is recommended.*

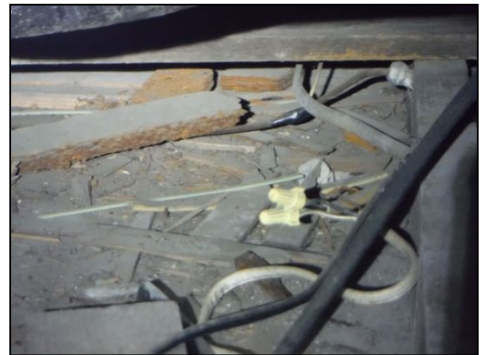
*IMPORTANT NOTICE: Two wire to three wire electrical was noted to be connected in the attic space. Further evaluation and repair by a licensed electrician is recommended.*

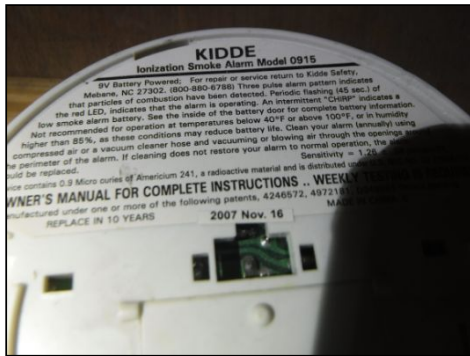
*Smoke detector over ten years old*

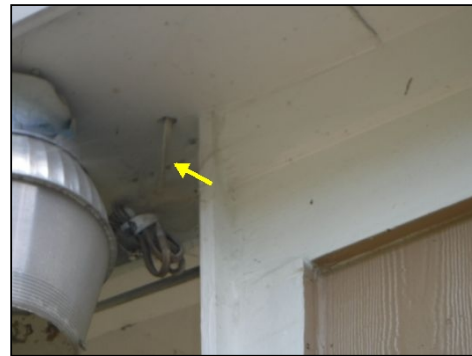
*Exposed romex type wiring on exterior of home*

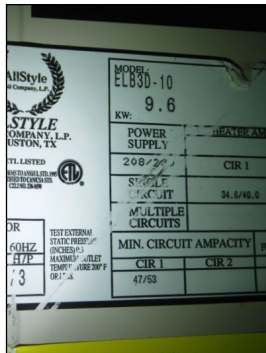
Furnace Model # ELB30-10

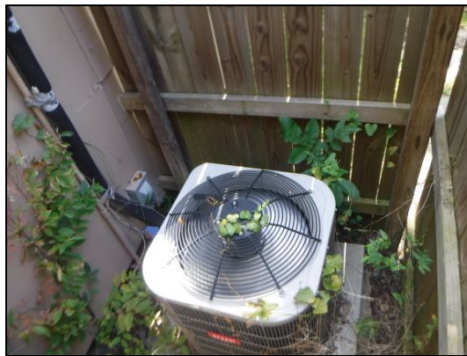
*IMPORTANT NOTICE: The exterior condensing unit was fenced in and could not be fully inspected. Although it appeared to be fully functioning, it is recommended to have a licensed HVAC technician review the unit prior to the end of the option period.*

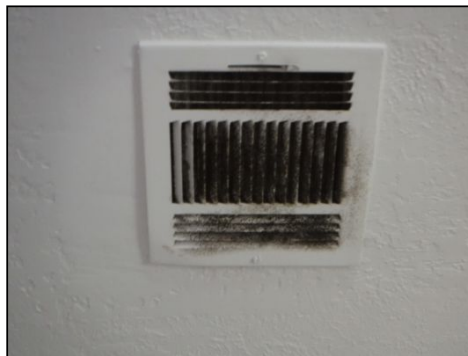
*IMPORTANT NOTICE: A mold like substance was noted to be growing on one or more registers. Further review and cleaning is recommended.*

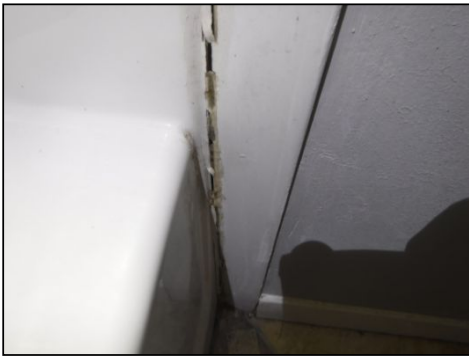
*Caulk opportunities noted around the shower insert in one or more areas. Replacement is recommended to help maintain a water tight seal.*

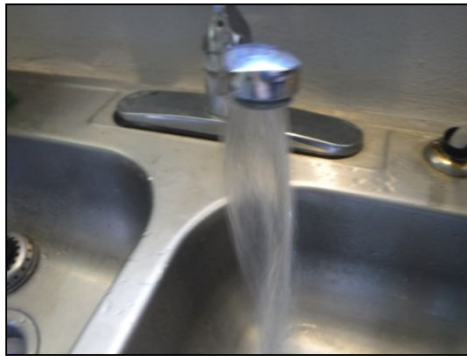
*The kitchen faucet was missing an aerator. Replacement is recommended.*

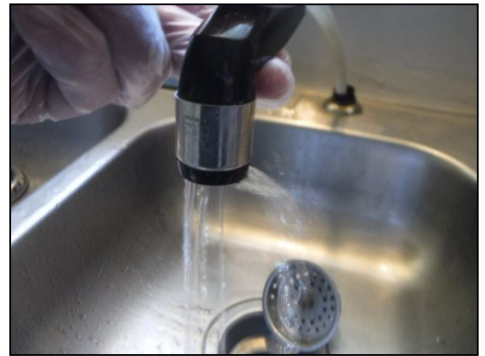
*The kitchen sprayer appeared to be clogged..*

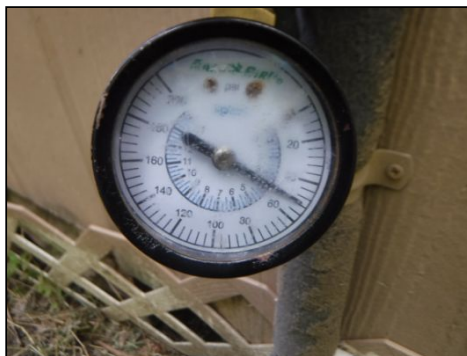
*The anti static water pressure was observed at 49 psi.*

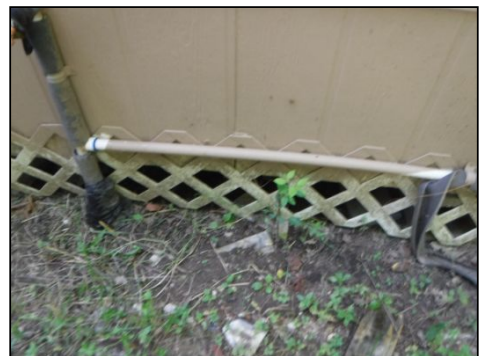
***IMPORTANT NOTICE:** Exposed water lines noted on the exterior of the home. Insulating the lines is recommended.*

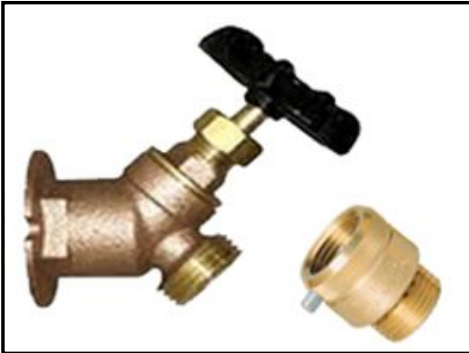
Example of back flow prevention for exterior hose bibs

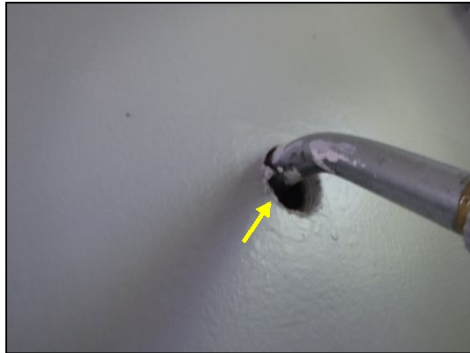
IMPORTANT NOTICE: Shower collar was missing. Replacement is recommended.

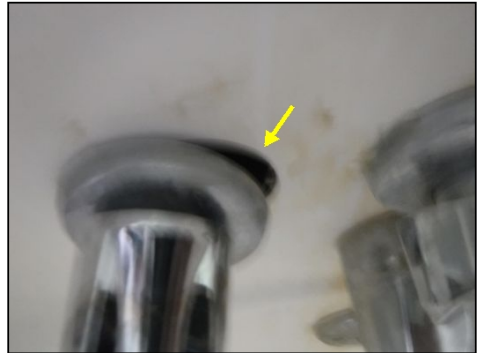
IMPORTANT NOTICE: Tub faucet handles were not sealed to the wall. Updating is recommended.

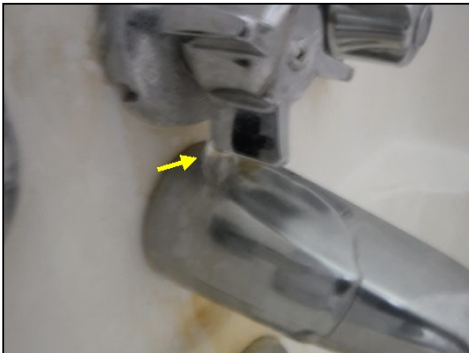
IMPORTANT NOTICE: The shower diverter was noted to leak. Further evaluation and proper repair is recommended.

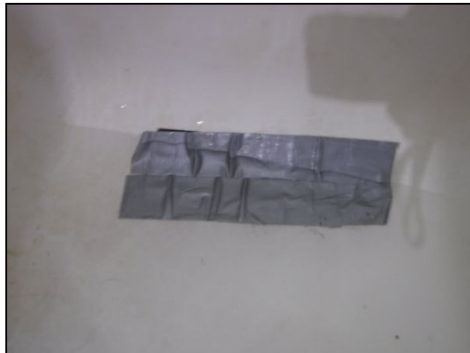
IMPORTANT NOTICE: There was duct tape in the bathtub. Presumably this was covering damage to the tub. Further evaluation and proper repair is recommended.

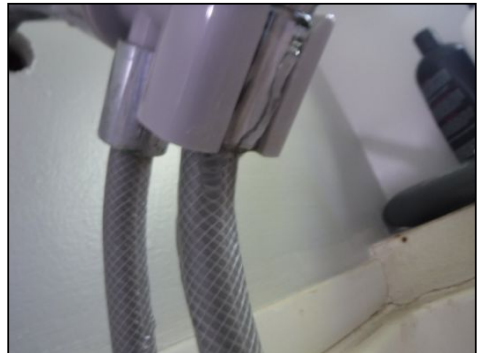
IMPORTANT NOTICE: The shower head leaks at the connection. Further evaluation and proper repair is recommended.

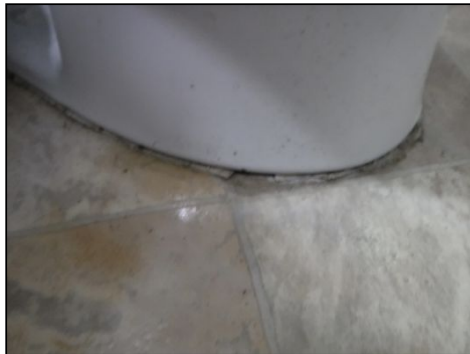
Caulk opportunities noted around the base of the toilet. Replacement is recommended.

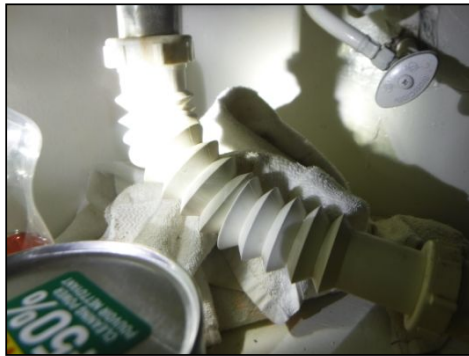
*IMPORTANT NOTICE: Accordion pipe used for the drain in the kitchen. This does not meet current standards and updating is recommended.*

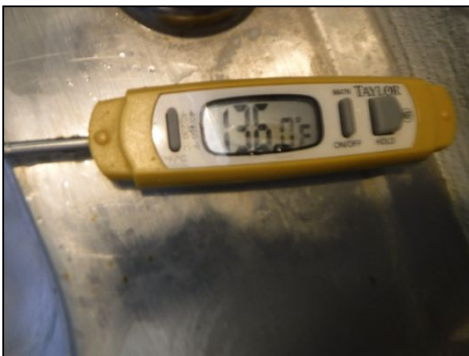
Supply temperature: 136.0° F
