RESIDENTIAL HOME INSPECTIONS

PROPERTY INSPECTION REPORT

Concerning: <u>749 Sierra Dr</u>, Port Neches TX 77651 (Address or Other Identification of Inspected Property)

06/28/2021 8:30 am (Date)

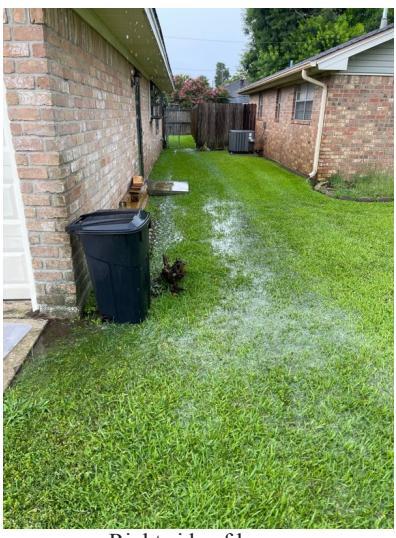
Right side of home

1: Ponding water

Ponding was observed in one or more areas. Recommend re-grading or installing a drainage system so water will not reach the foundation. Moisture at the foundation can cause foundation movement in clay soils.

Recommendation: Contact a qualified professional.

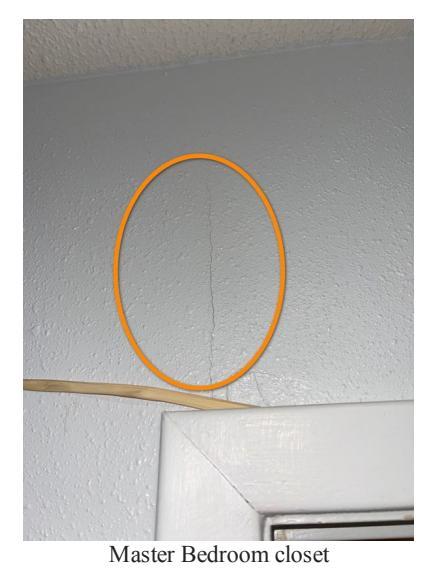
1: Interior Cracks - Minor Recommendation

Cracking was observed on interior wall structure. This appears to be sheetrock cracking. Most drywall cracks occur on the seams, where two pieces of drywall meet. Usually the seams are invisible due to the use of drywall mud and tape. The mud fills in the seam, and the tape covers it up. Cracks form due to stress placed on the seams. These cracks tend to occur around high-stress areas like windows, door frames, and corners. Recommend having a qualified professional evaluate and repair.

Recommendation: Recommended DIY Project

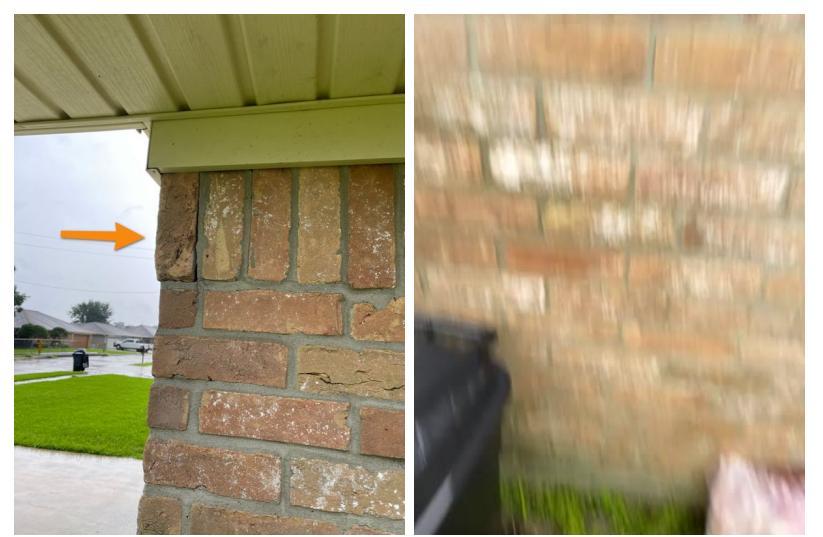
Front/Right of home

2: Loose brick Recommendation

Loose brick observed on the exterior siding of the home. It is recommended to have brick reset by a mason.

Recommendation: Contact a qualified professional.

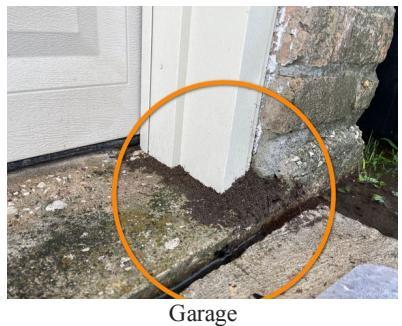
3: Ant pile

Damage from ants vary. Mostly, they're a nuisance and they usually do cause some damage. Termites can also build tubes through any piles and enter a structure. It is recommended to have ants treated by a professional exterminator.

Recommendation: Contact a qualified professional.

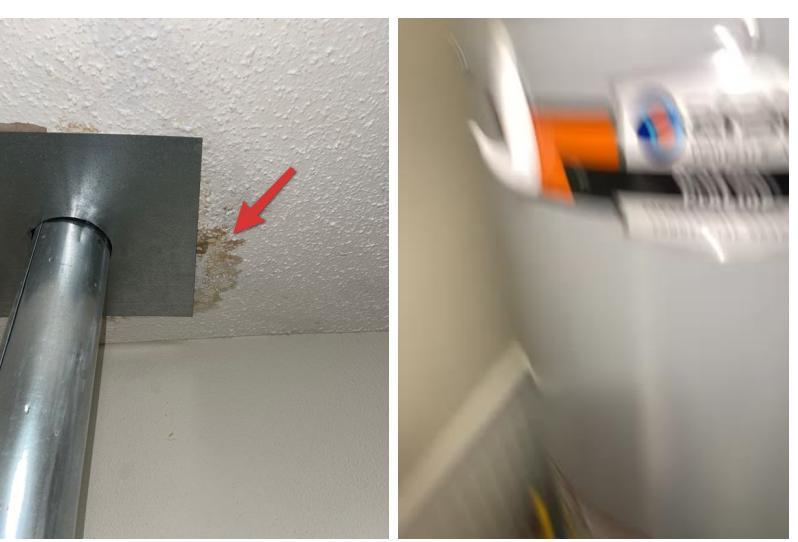
Laundry Room

1: Evidence of Water Intrusion ASafety Hazard

Ceiling structure showed signs of possible water intrusion, which could lead to more damage if not remedied. Recommend a qualified contractor identify source or moisture and remedy.

Recommendation: Contact a qualified structural engineer.

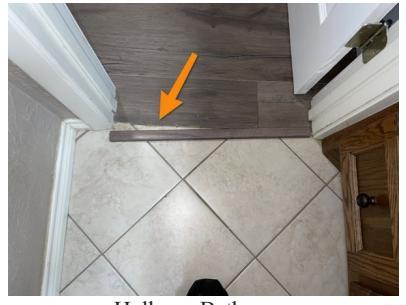
Hallway Bathroom

1: Threshold Damage Recommendation

The threshold to the bathroom door was loose when stepped on. Recommend repairing threshold.

Recommendation: Contact a qualified professional.

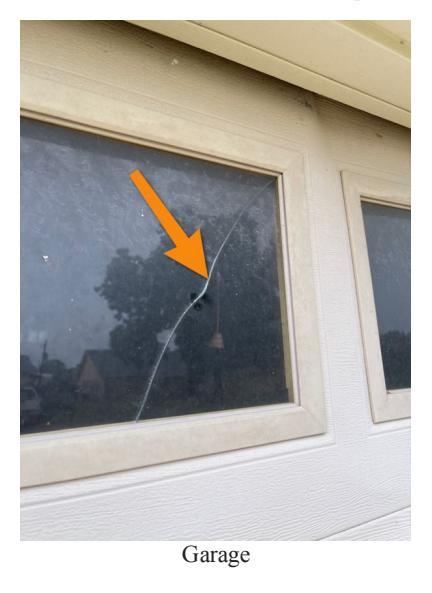
1: Cracked or Broken pane Cracked or Broken pane

One or more windows in the home had a cracked or broken pane. Recommended to be properly repaired or replaced.

Recommendation: Contact a qualified professional.

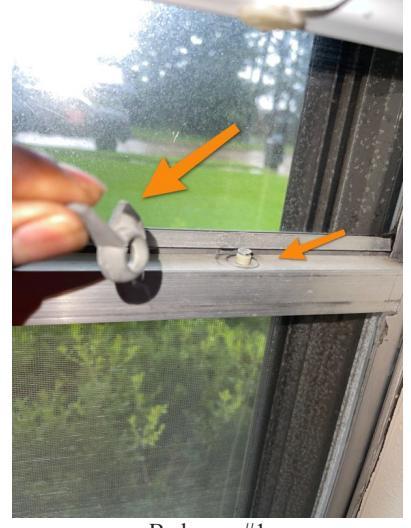
Bedroom #1

2: Window locks broken ©Recommendation

Window locks appeared to be broken. Recommend to be repaired/replaced by licensed professional.

Recommendation: Contact a qualified professional.

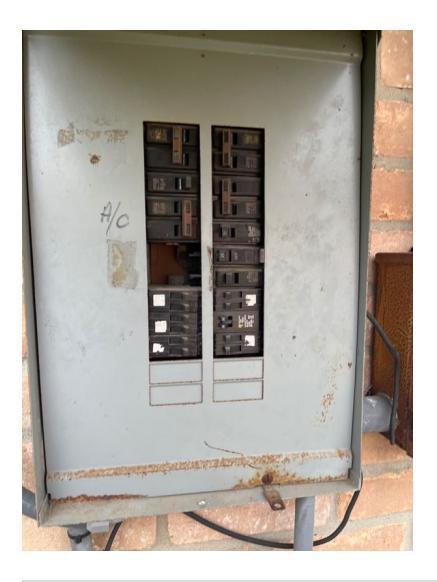
1: Panel Missing Labels — Recommendation

A Circuit Directory identifying individual electrical circuits were missing/illegible at this panel. An unsafe condition can easily exist if the homeowner turns off a breaker, believing to have killed the power on the circuit, only to find that s/he tripped the wrong breaker. The panel should contain a clearly-marked label identifying individual circuits so that in an emergency, individual circuits can be quickly shut off.

Recommendation: Contact a qualified electrical contractor.

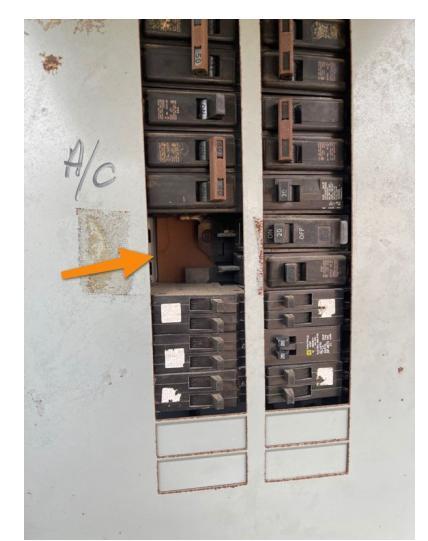
2: Missing Circuit Breakers Recommendation

Circuit breakers missing in the electrical panel. It is recommended that the space for the circuit breaker be covered with a blank to close off the opening.

Recommendation: Contact a qualified professional.

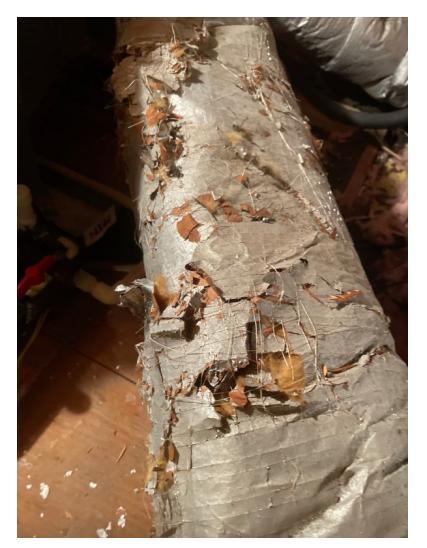
1: Duct Damaged Recommendation

Air supply ducts were damaged and should be repaired or replaced by a qualified HVAC contractor.

Recommendation: Contact a qualified HVAC professional.
