Re: 6628 Bayou Glen, Houston, Texas

# **MOLD REMEDIATION PROTOCOL**

AIG Project # 1304

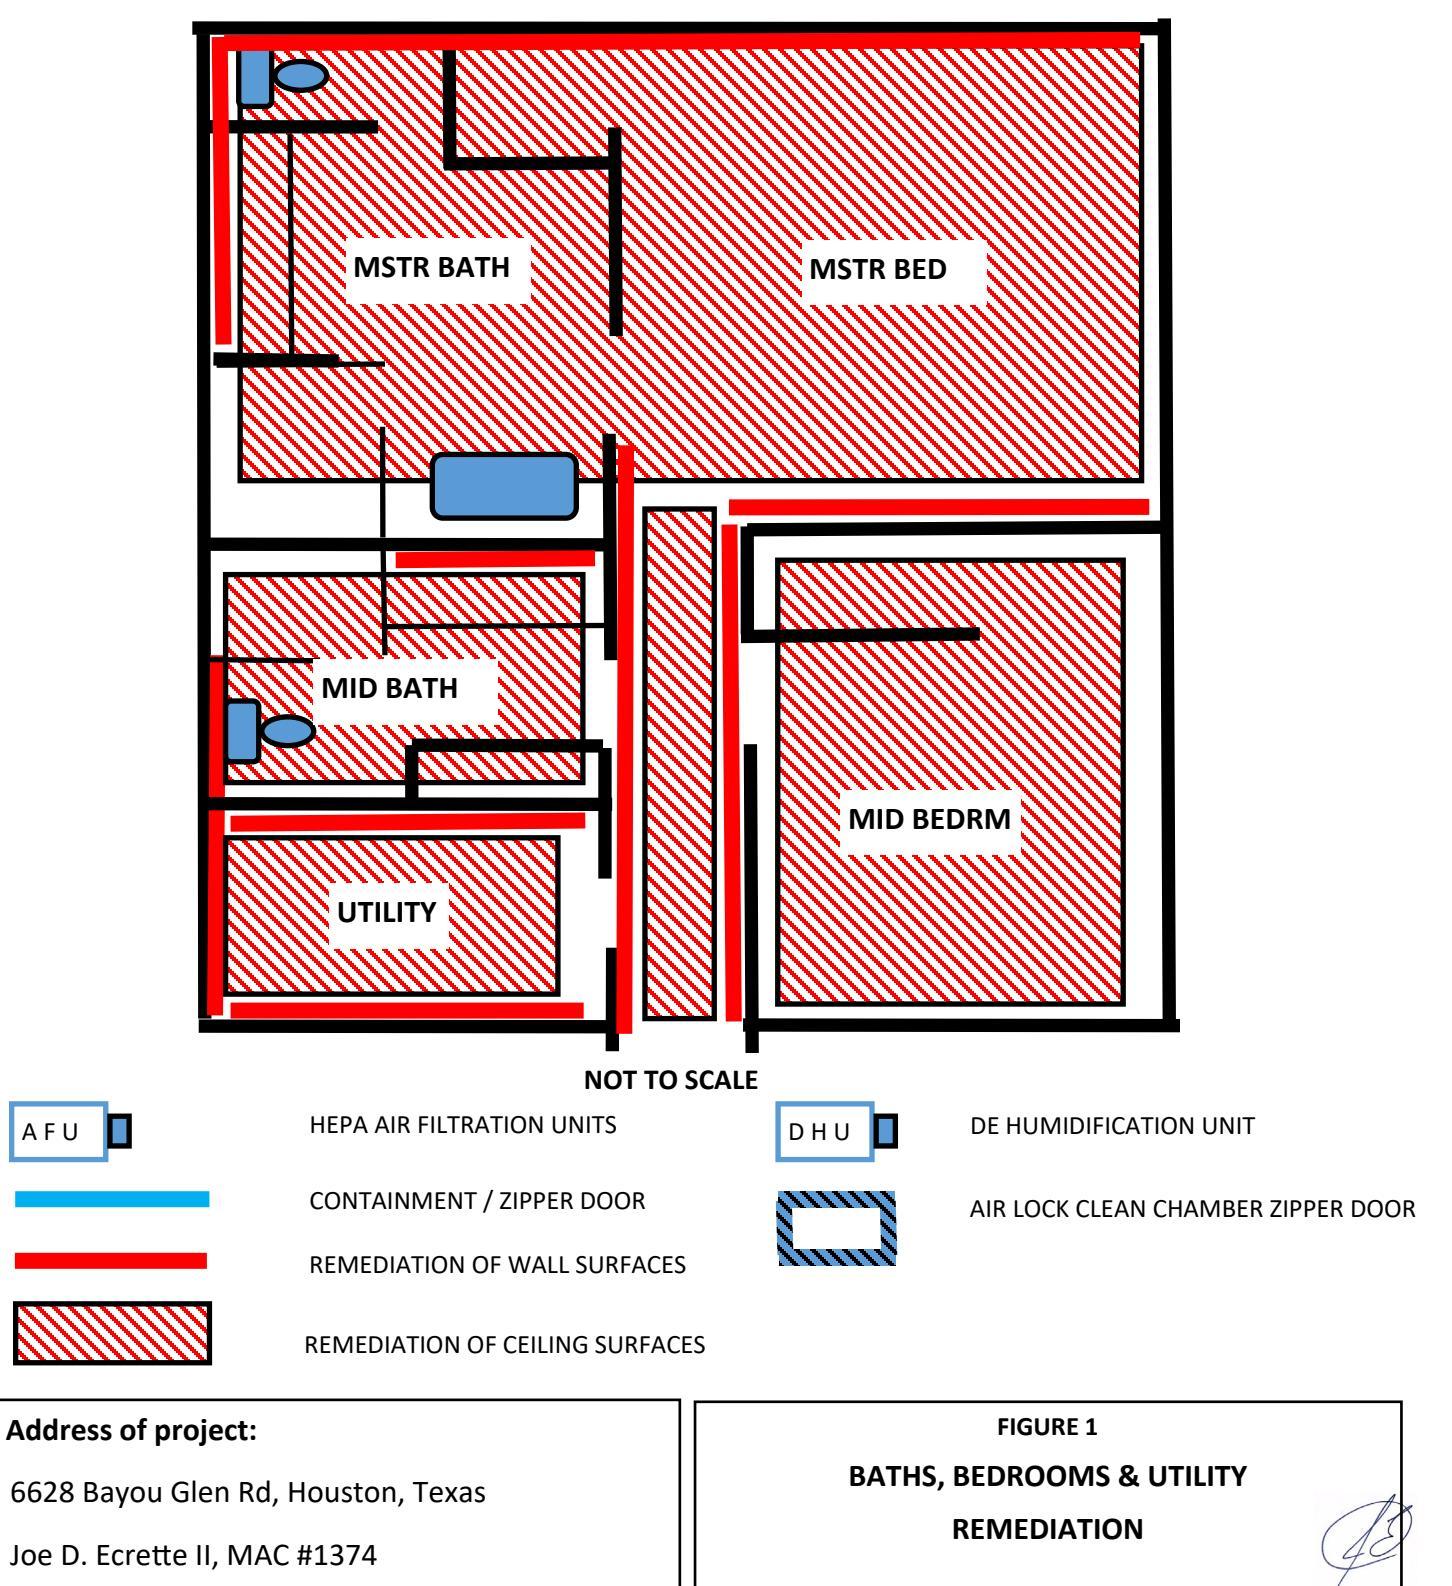
## 3.4 — Remediation Project Scope

CONTRACTOR TO FIELD VERIFY SURFACE AREAS
