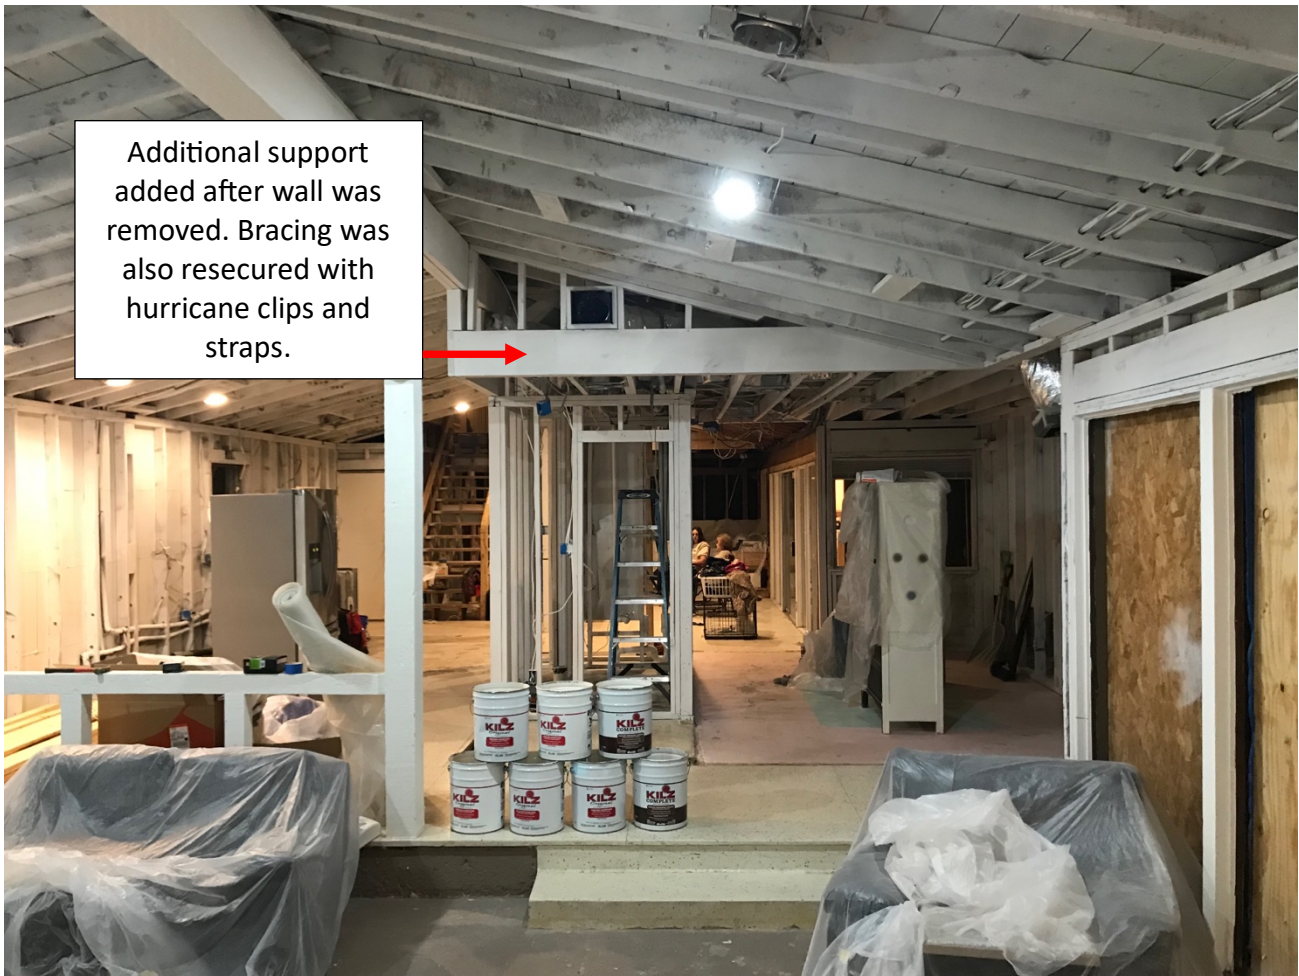
Additional support added after wall was removed. Bracing was also resecured with hurricane clips and straps.

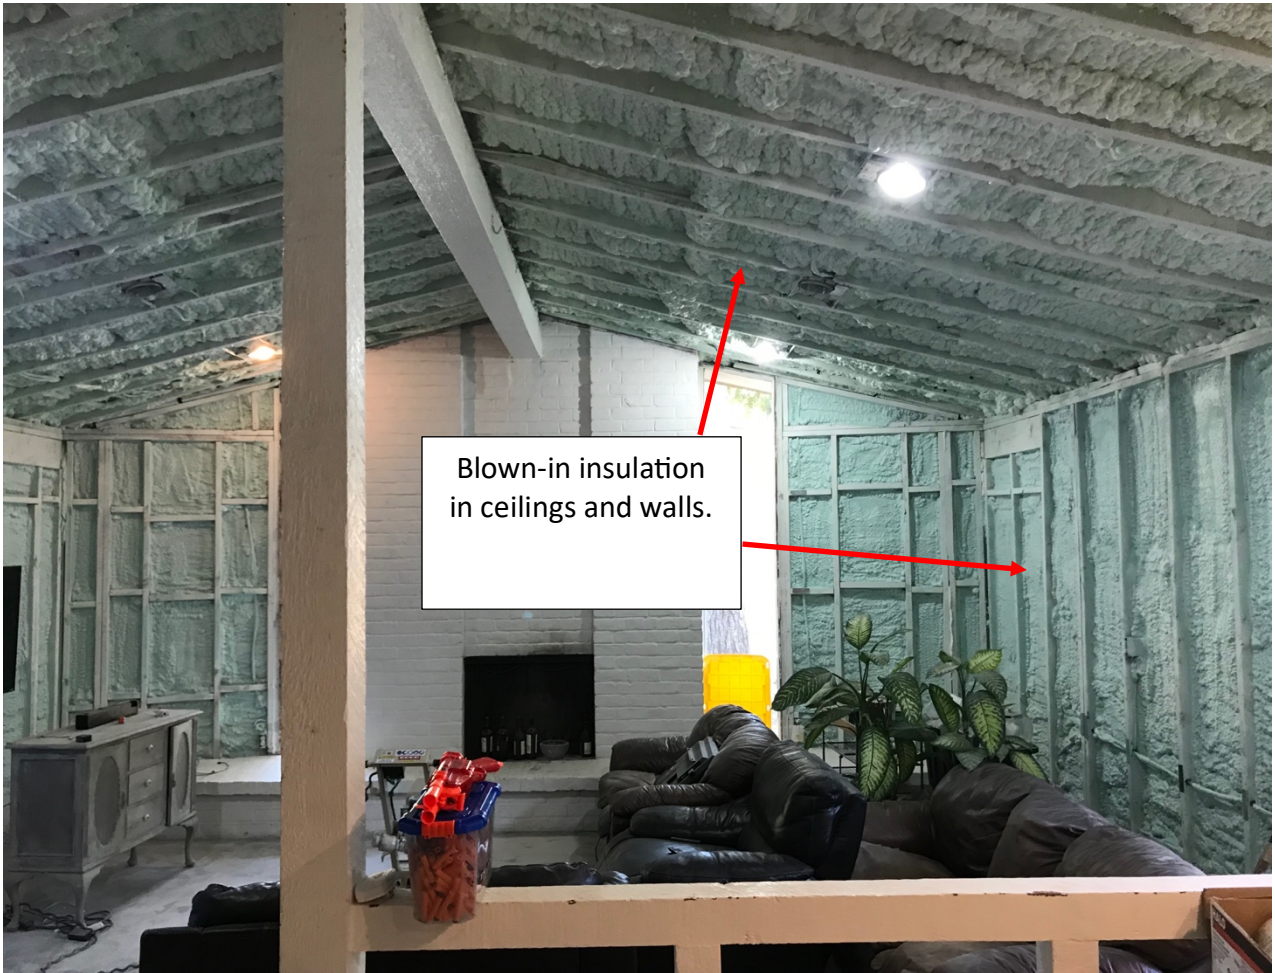
Blown-in insulation in ceilings and walls.

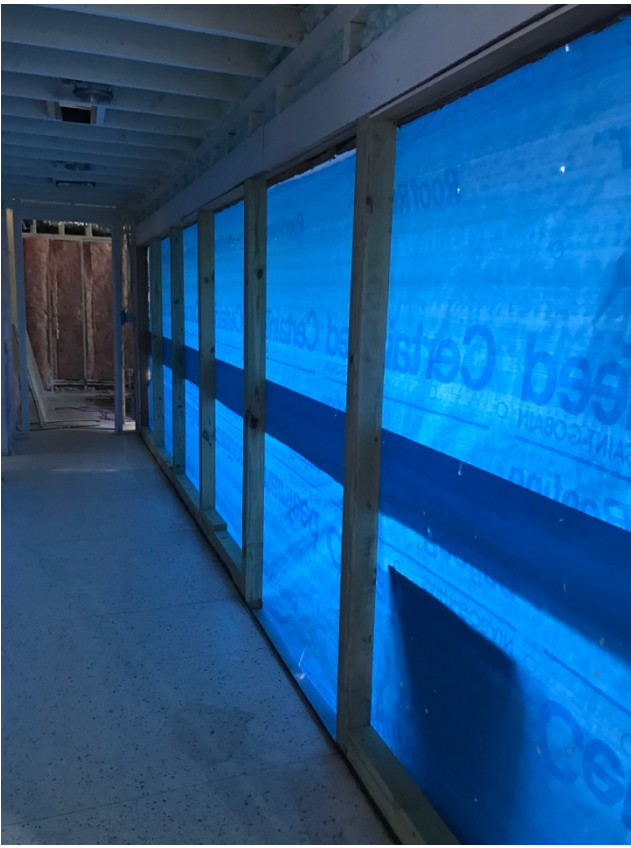
Windows in hall were removed and reframed.

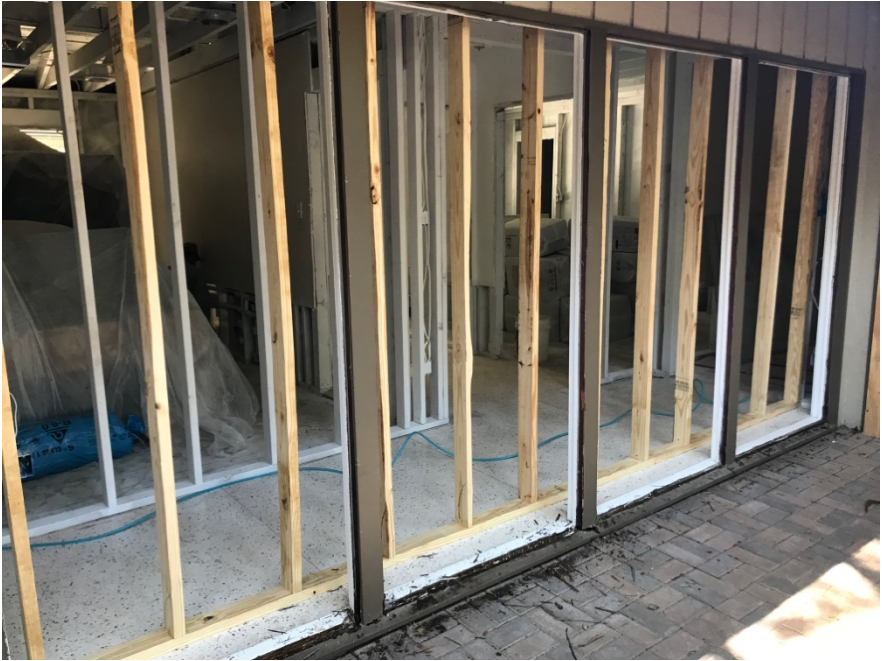
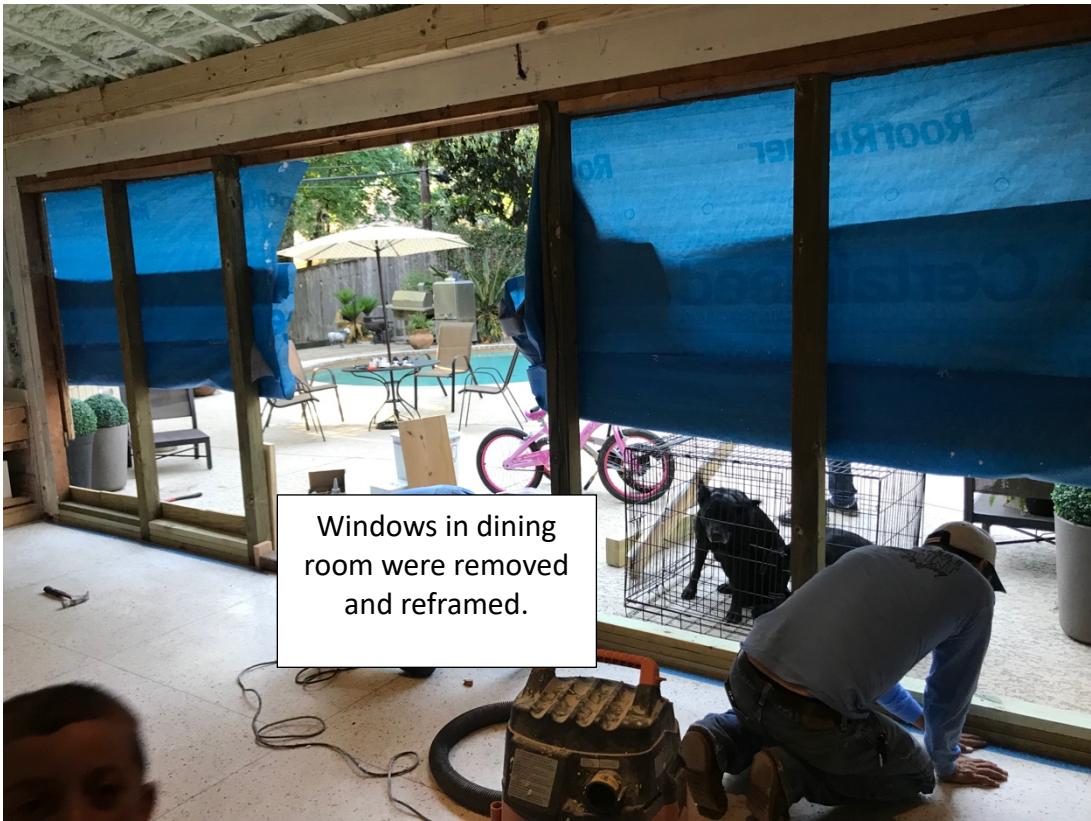
Windows in dining room were removed and reframed.

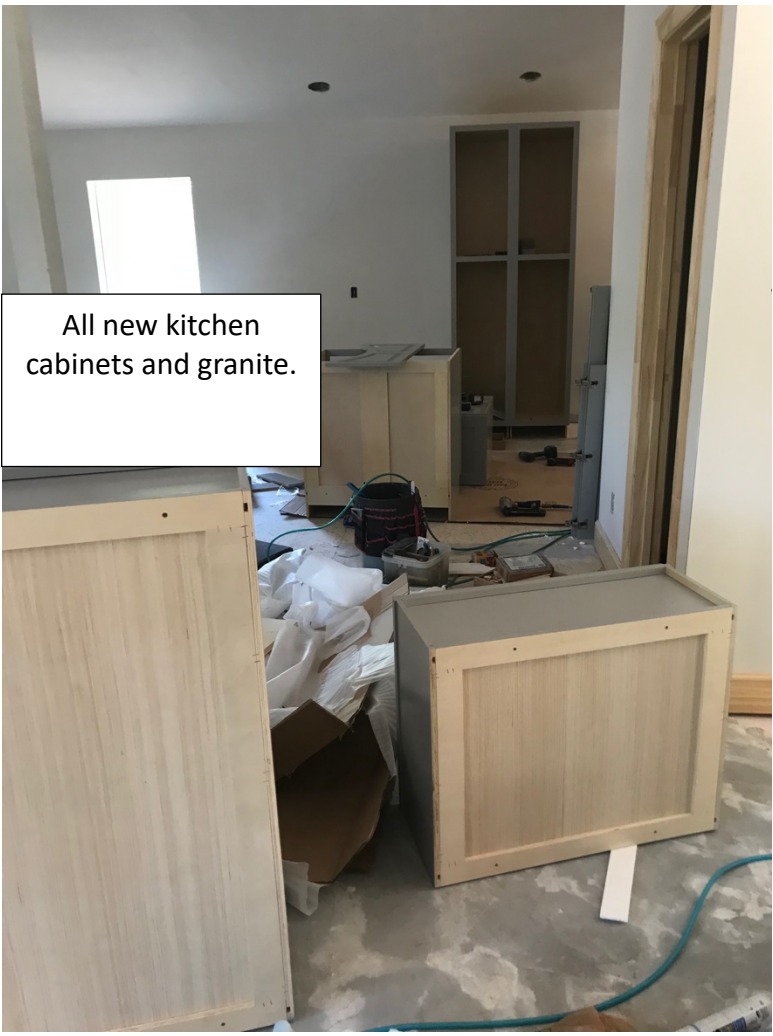
All new kitchen cabinets and granite.
