Property Inspection Report

**Stan and Sandee Davis
1003 Sable Drive
Friendswood, TX 77546
Sablewood
Galveston County**

Wednesday, September 6, 2023

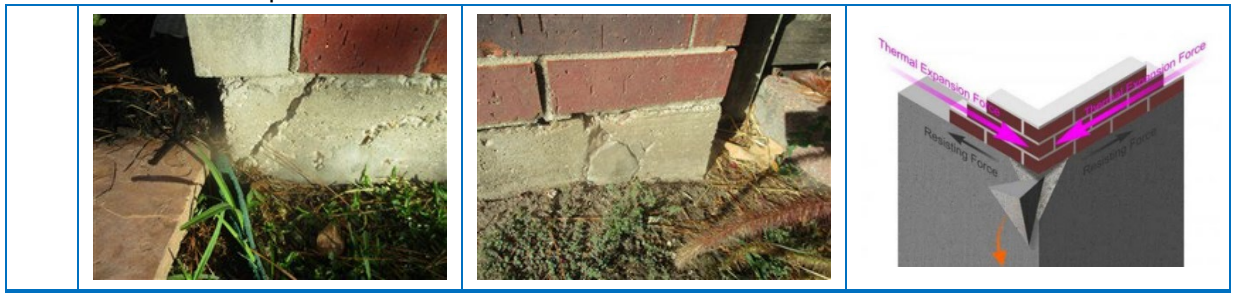
Maintenance: Spalling found within 12" of the foundation's corners may occur because of bonds between the brick and brick ledge and/or differential thermal movement. Spalling was noted at self-evident corners. This damage did not appear structurally significant and was not in need of repair at the time of this inspection.

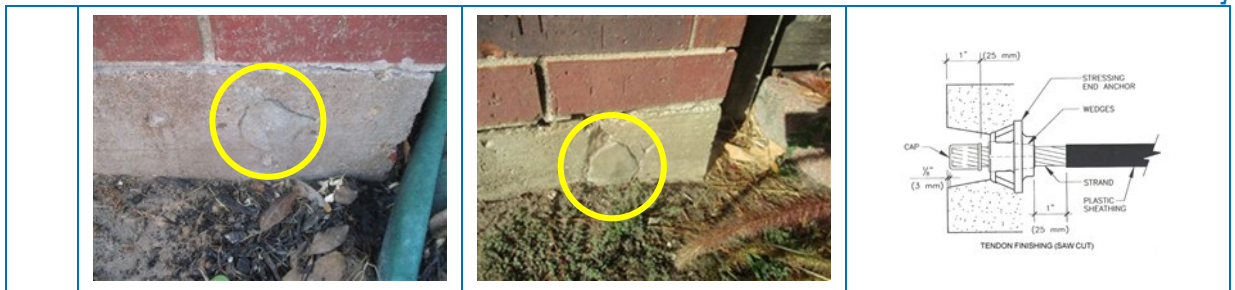
Information: Foundation appeared to be reinforced and strengthened by post-tensioned cables, utilizing cables within sheathing placed under high tension. Determination of the type of reinforcement was based on observation of covered, or uncovered, ends of tendons. [*Construction and Maintenance Procedures Manual for Post-Tensioned Slab-on-Ground Construction 3rd Edition.*]

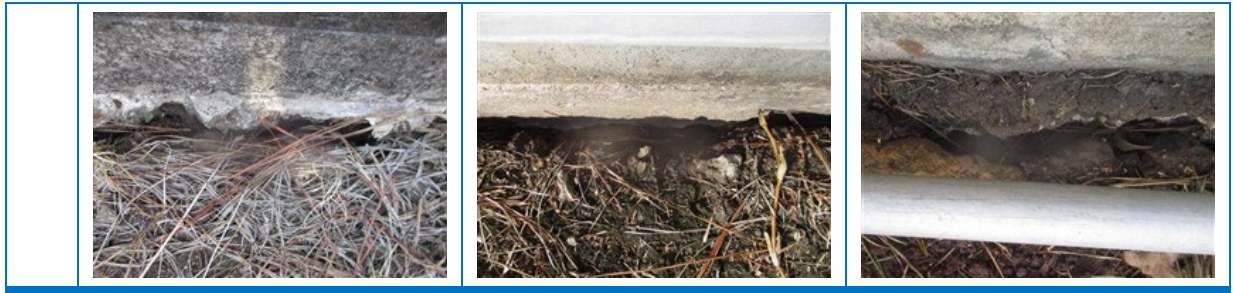
Maintenance: Soil was separating from the foundation grade beam. Controlled irrigation of the foundation may serve to preserve the foundation's performance. Useful information on foundations, including Inspection, Care, Root Barriers and Watering is available at: [Foundation Information - Professional Engineering Inspections, Inc. \(profengineering.com\)](http://www.profengineering.com).

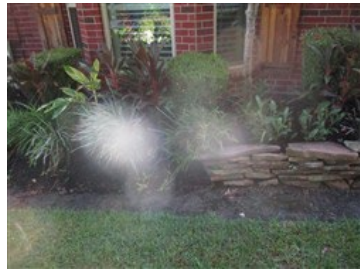
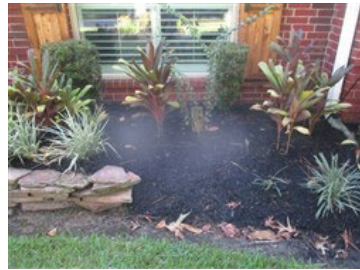
Maintenance: Shrubs planted too close to the foundation will hide the slab from view as they mature, creating conditions conducive to infestation by Wood Destroying Insects (WDI). Shrubs should not be planted closer to the slab than half of the mature width of the shrub.

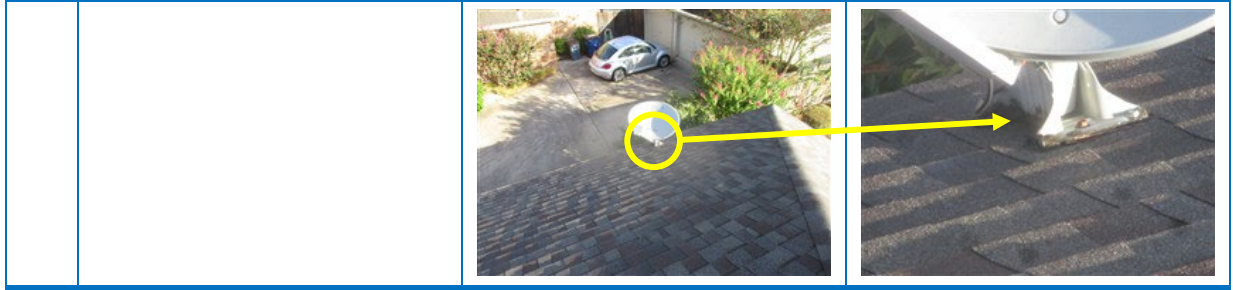
Information: Dish-type antenna was/were secured to the roof. Drilling holes through the roof damaged the roof cover and the gasket, caulk or sealant applied is not a guarantee against moisture penetration. Items mounted to the roof such as satellites, antennas, basketball backboards, etc., may allow water penetration. As these items move (wind, adjustments to position, use, etc.), screws and

bolts may enlarge mounting holes. An elastomeric material was observed, intended to make the penetrations watertight, but I could not access this portion of the attic space to evaluate its integrity. Recommend closely monitoring these areas and making repairs as soon as possible when necessary.

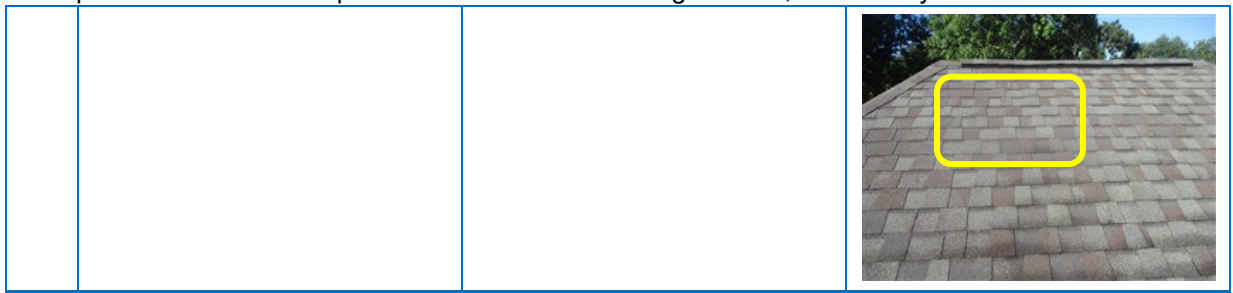
One or more pieces of decking were not well secured and moved when stepped upon. I did not see a practical or feasible repair. Recommend monitoring the roof, as with any roof.

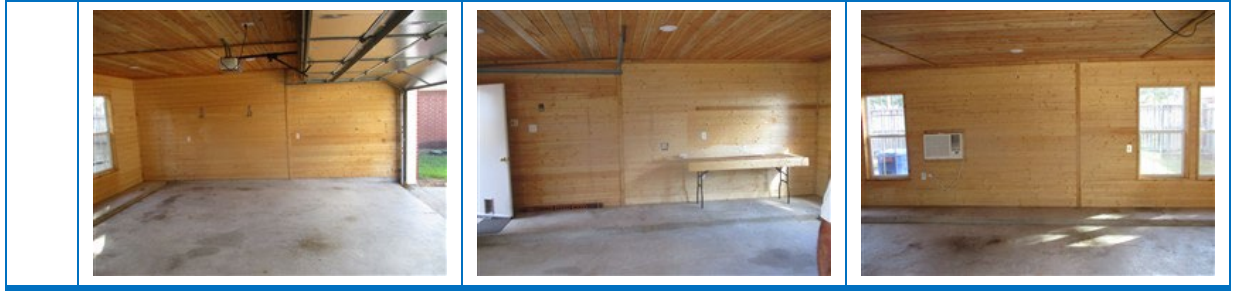
No visible fire blocking or separation between the detached garage and house through the breezeway. The garage space had been covered with wood which did not have an adequate fire resistance. Garages should be separated from the residence and its attic area by 1/2" or thicker gypsum board applied to the garage side, or 3/8" thick fire retardant-treated plywood or covered with a minimum of 16 gage sheet metal. In addition, fire blocking should be provided to cut off all

concealed draft openings (both vertical and horizontal) and to form an effective fire barrier between stories, and between a top story and the roof space. [§535.227 \(a\)\(5\)\(B\)](#)

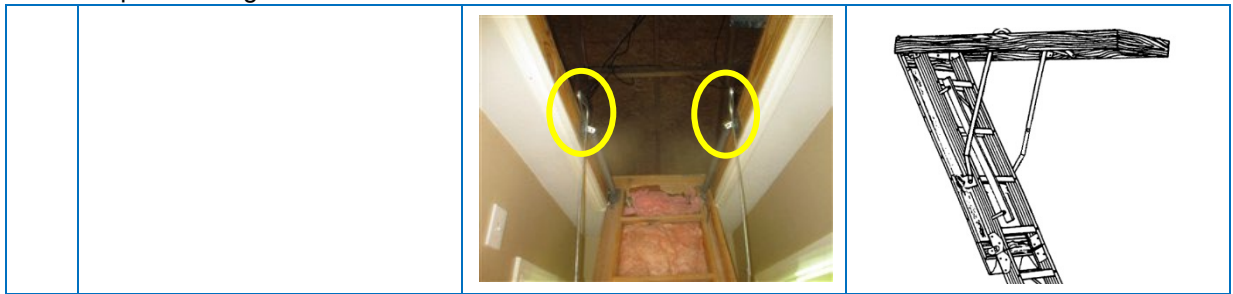
Spring arm assemblies were bent or damaged. Note that, once bent, these are “damaged” and attempts to straighten the arm will further weaken the material.

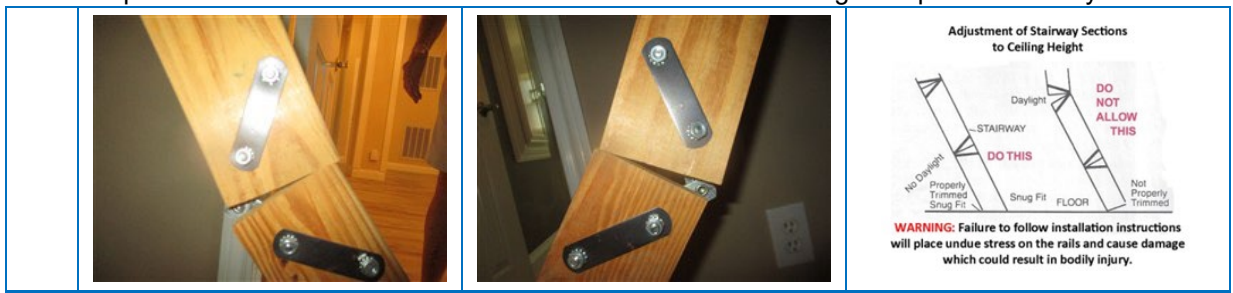
The stairway rails were not flush at the hinged sections. This may lead to personal injury should the rails split or crack while in use. The stair should be trimmed-to-height for personal safety.

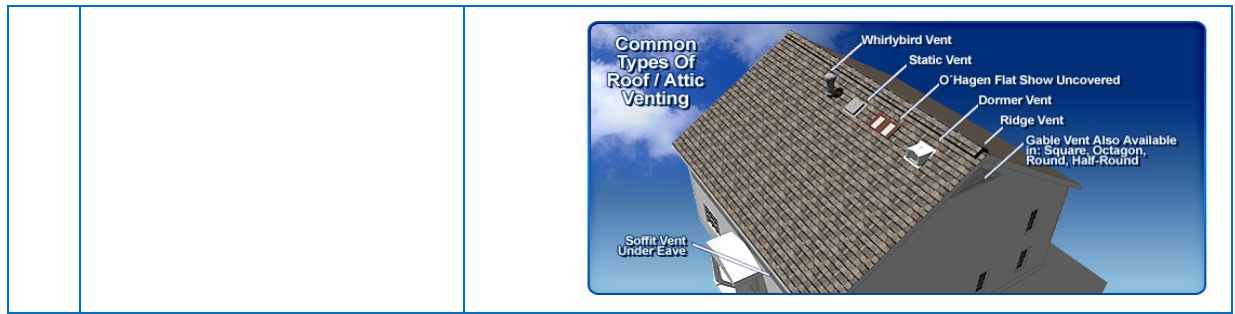
Garage attic space did not appear to be adequately ventilated. There was a ridge vent, but there were not soffit vents.

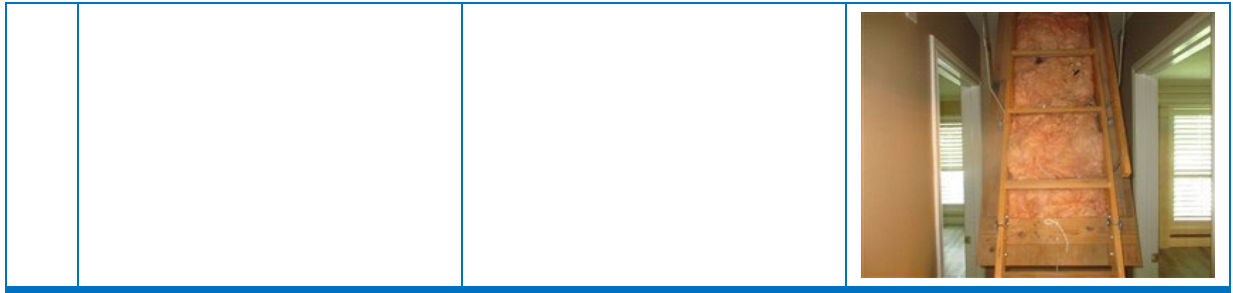
Safety: Stairway was insulated with batt insulation, creating a trip hazard. Recommend that only rigid insulation be used for personal safety.

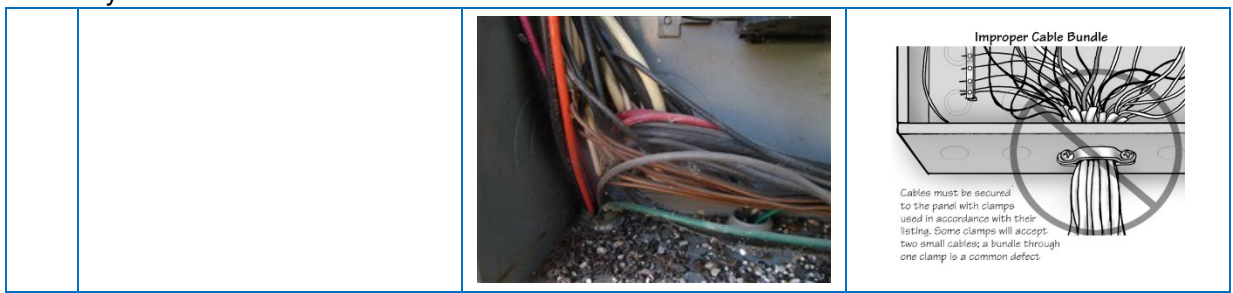
Overcurrent devices were not all accurately or adequately identified as to **use, purpose, and location** (Lights and Receptacles, or variations thereof, are not specific enough). I may not be able to comply with the minimum inspection standards of practice requiring evaluation of breaker sizes against manufacturer specifications. [NEC - Circuit Directory or Circuit Identification. "Every circuit and circuit modification shall be legibly identified as to its clear, evident and specific purpose or use. The identification shall include sufficient detail to allow each circuit to be distinguished from all others. Determining the accuracy of device labeling is outside the scope of this inspection.

Information: Branch conductors filled more than 75% of a raceway and individual conductors were not secured to the panel cabinet. Such constriction of conductors may generate excessive heat and de-rate the amperage of the cables. Each cable is to be secured to the panel box. While not technically correct, this method of installation is used on virtually all exterior-mounted cabinets and many cabinets installed within stud cavities on inside walls. No recommendation.

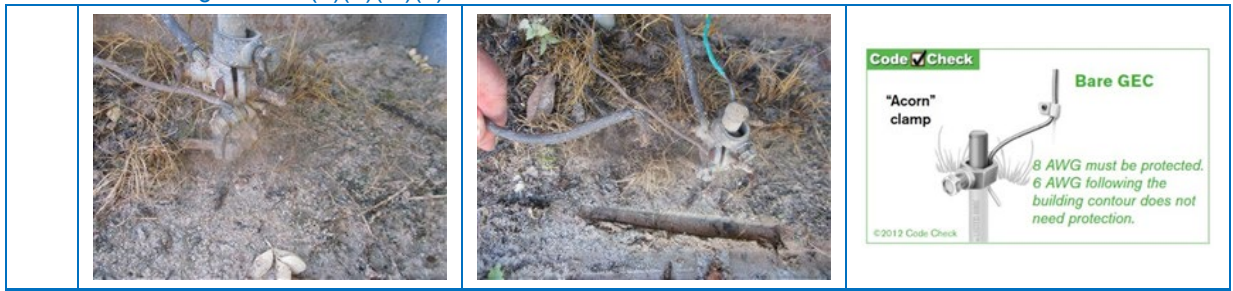
At least one of the clamps was loose at the ground rod compromising continuity. The clamp observed was listed as a pipe clamp for metal water or gas lines. Recommend the use of a brass "acorn" style clamp, U.L. listed and approved for direct burial, on the ground rod for a more secure, longer lasting connection. [§535.229\(a\)\(1\)\(G\)\(v\)](#)

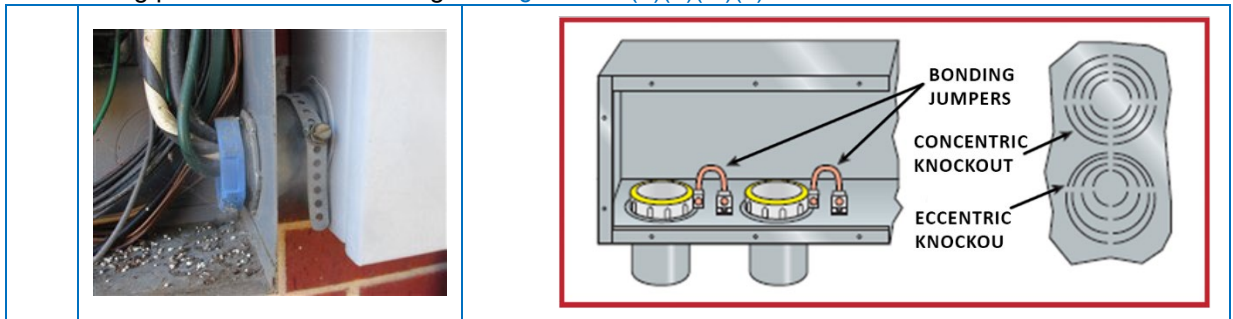
The raceway was not bonded to the electrical grounding system. Short Sections of Raceway. Isolated sections of metal raceway or cable armor, where required to be grounded, shall be connected to an equipment grounding conductor. When the retaining ring does not fully cover the knockout, the bonding path is limited to the ring tabs [§535.229\(a\)\(1\)\(G\)\(v\)](#)

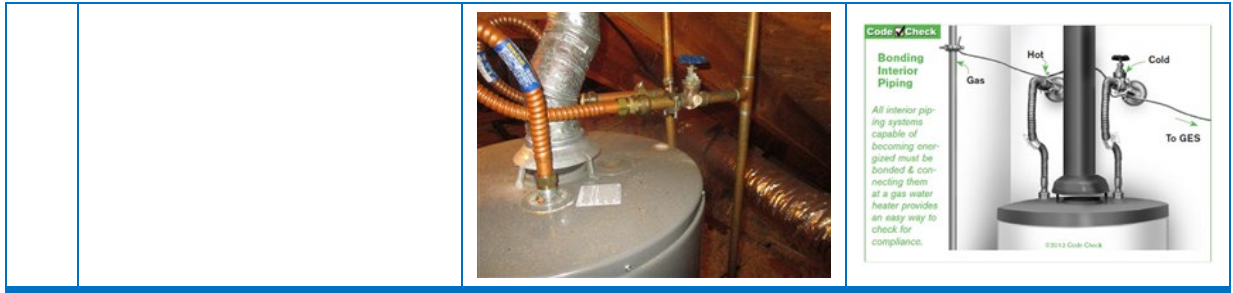
Metallic water pipes did not appear to be bonded, or there was no evidence of bonding, to the electrical grounding system. [§535.229\(a\)\(1\)\(G\)\(v\)](#)

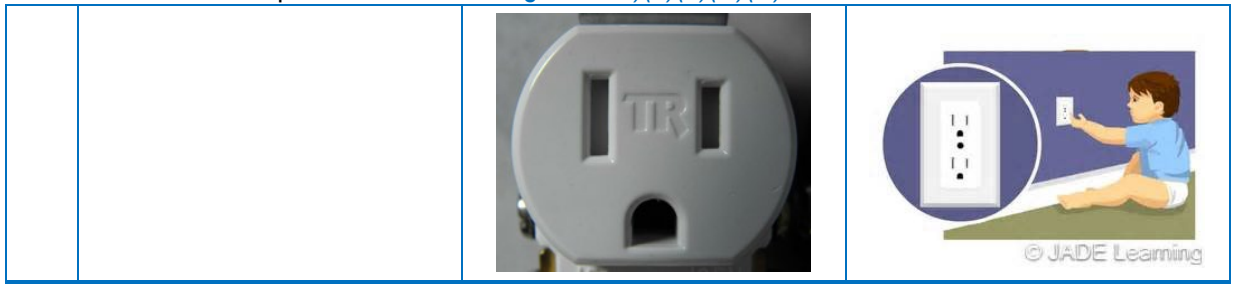
Fan blades at fixture in casual dining room were loose. I tightened them for immediate safety, but did not torque them for permanence. [§535.227\(a\)\(5\)\(B\)](#)

Receptacles less than 5-1/2 feet above the floor were not tamper resistant (TR) type. TR receptacles have shutters installed to prevent insertion unless two prongs enter the device at the same time. While not introduced into code until 2005, these are considered “safer”, and I am required to report the lack of TR receptacles as Deficient. [§535.229\(b\)\(1\)\(C\)\(vi\)](#)

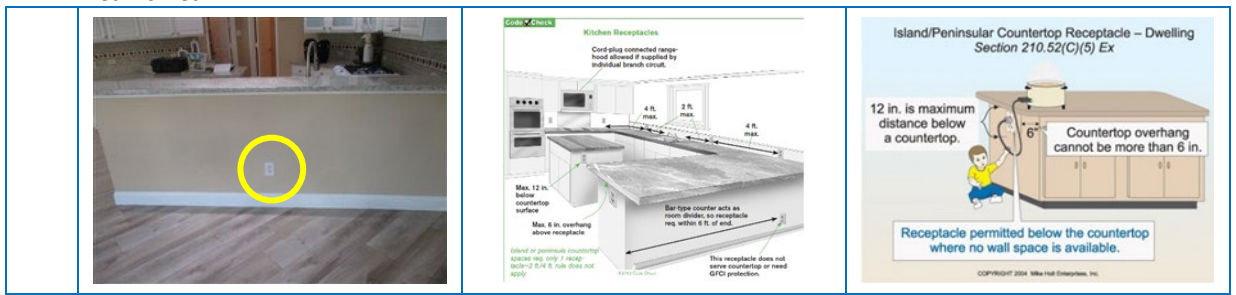
Information: One or more receptacles on the back side of the island counter at the kitchen sink was placed more than 12” below a countertop. In kitchens, pantries, breakfast rooms, dining rooms and similar areas or dwelling units (IRC 2009 and newer), an outlet may be located no more than 12” inches below the countertop only when the countertop extends no more than 6” beyond its support base. I recognize that this has been treated as a wall space receptacle distinctly separate of the countertop receptacles but note that the occupant will not make the distinction and the safety concern will still exist.

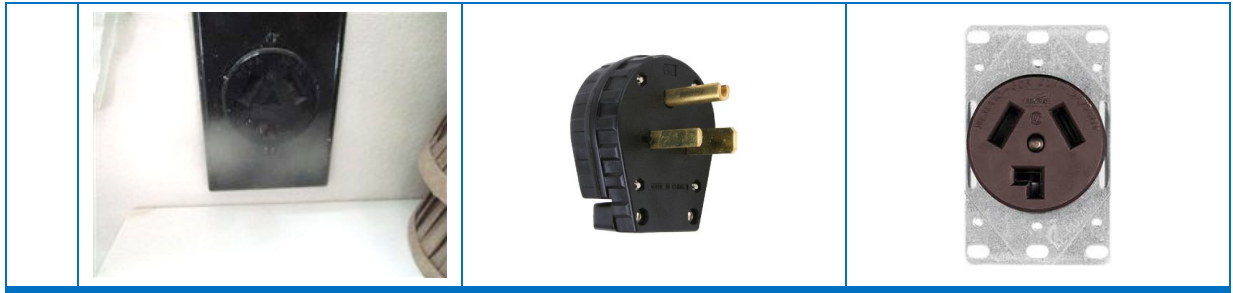
Information: The electric outlet/receptacle at the clothes dryer connection was a 3-prong outlet. Today’s Code and appliances require that this be a 4-prong outlet for safety. While there was no apparent need to upgrade this to current Code it is necessary to know which plug configuration will be necessary for an electric dryer.

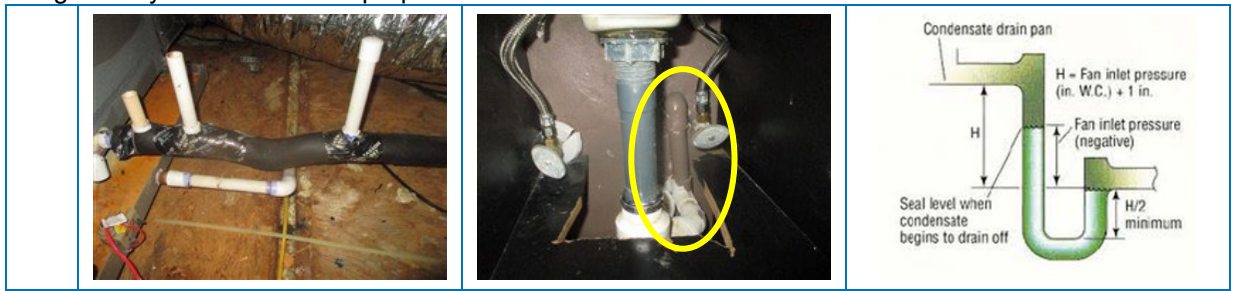
Information: Scaling and corrosion in the secondary drain pan beneath the evaporator in the attic space was indicative of condensate bypassing the primary drain system. While there was no standing water in the pan at the time of this inspection, the common recommendation is that the system be monitored and that the primary drain be cleaned periodically. I could not positively determine whether the pan had been compromised and my test was limited to visual examination. I cannot warrant that the pan will not fail at some point in time.

Information: Both the international Plumbing Code (IPC) and the Uniform Plumbing Code (UPC) require that the condensate piping, as an indirect drain line, be trapped. The line was trapped beneath a lavatory which may satisfy the Authority Having Jurisdiction (AHJ).

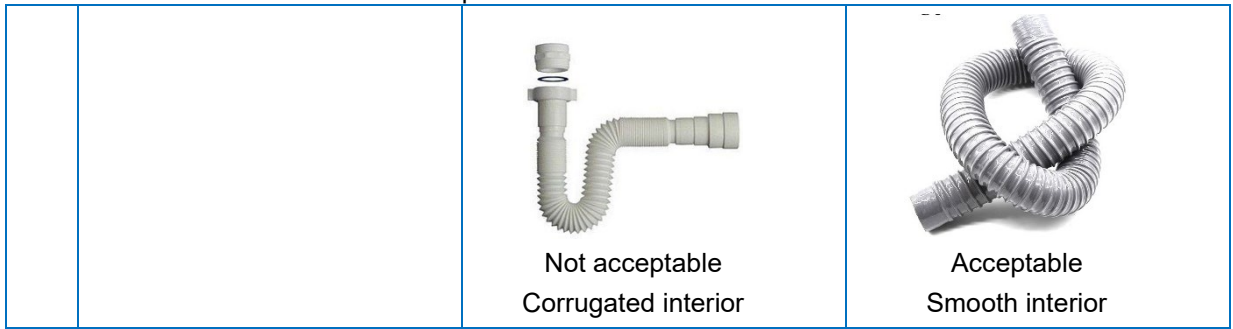
Hall bathroom sink leaked at connection the basin.

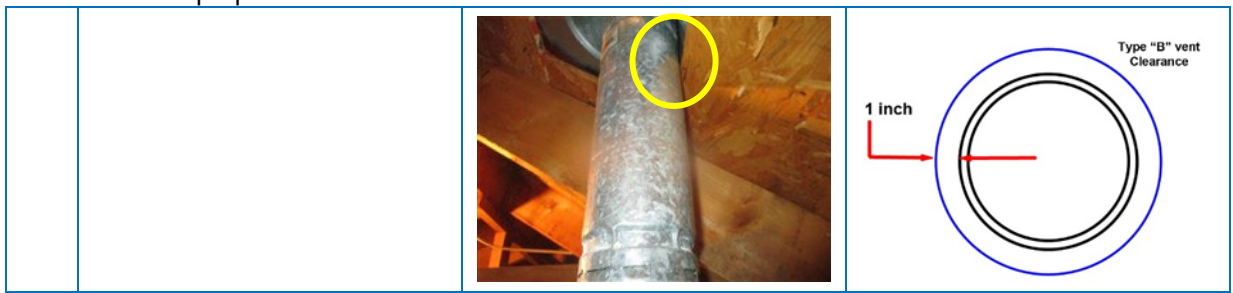
There was direct contact, or insufficient clearance between the water heater vent and the combustible roof decking. There should be at least 1" clearance between the Type "B" double wall vent pipe and the combustibles. The vent should be repositioned, or portions of the combustible material removed to allow the proper clearance.

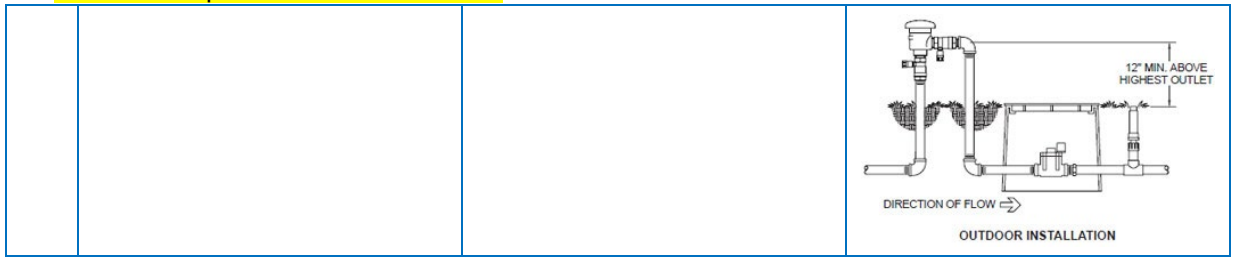
No backflow protection was observed.

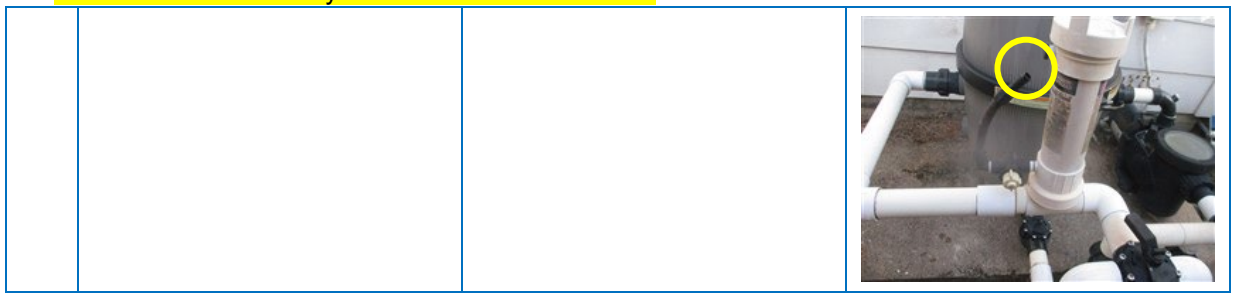
Chlorinator was not fully assembled and functional.

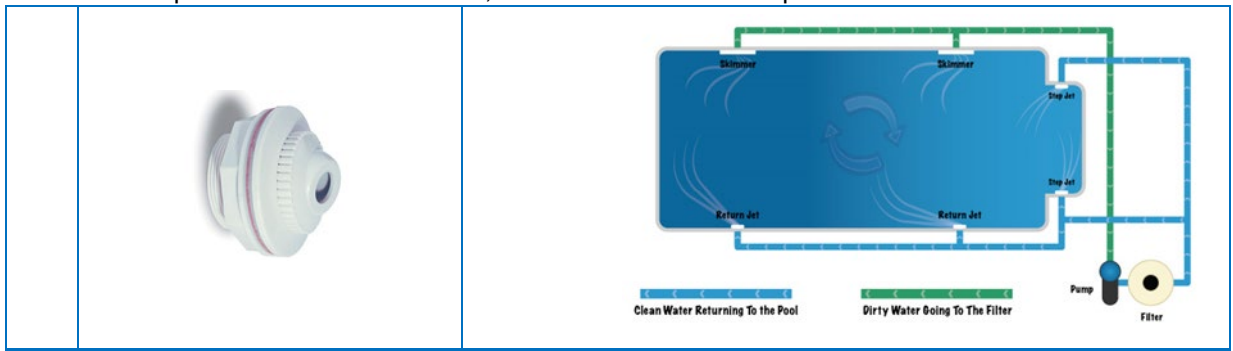
Return inlets (aka discharge outlets or inlet fittings) were not positioned for effective circulation. This is a common cause of cloudy water. "Eyeball" fittings are used to direct the flow of water in a pool and consist of spherical exteriors so they can be turned to different angles. If the eyeball is not pointing in the right direction, the water on top of the pool will keep circulating but water at the bottom will not be moving, resulting in irregular temperature and cloudy water. Pointing the eyeball in the right direction is the key to maintaining a steady water flow and regular water temperature. These should all point in the same direction, at about 45° toward the pool and down.

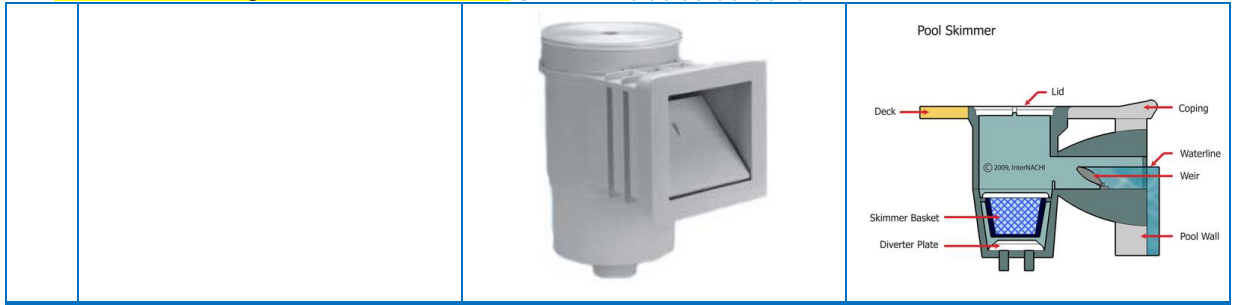
Weir was missing from both skimmers. §532.233(d)(1)(B)(vi)(IV)
