Water Damage Remediation Inspection Report

CLIENT: FT Resources
Jeff Perry

ADDRESS: 4903 Berry Knoll Ct

DATE: January 30, 2019

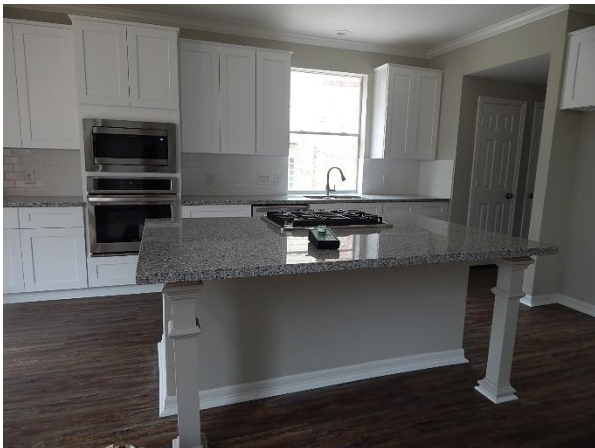
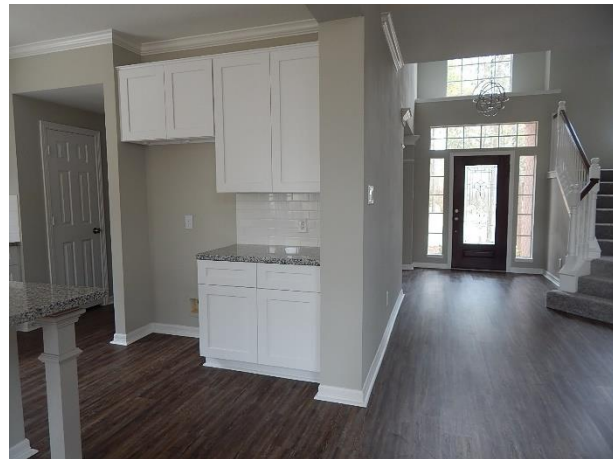
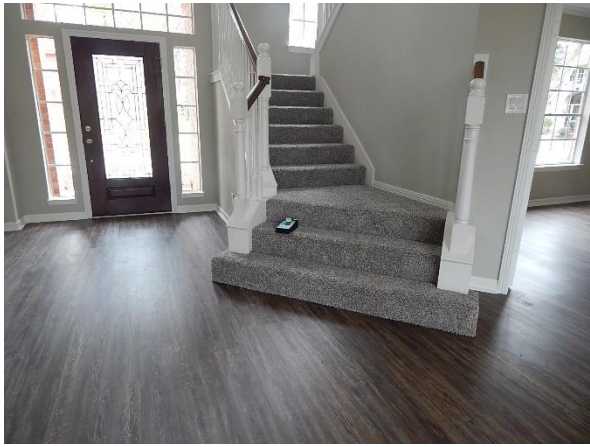
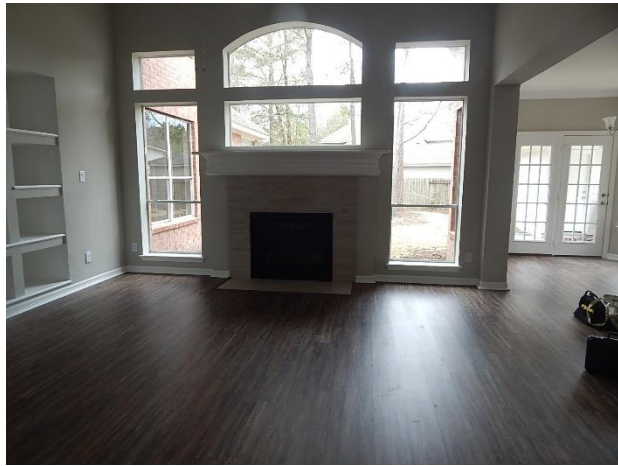
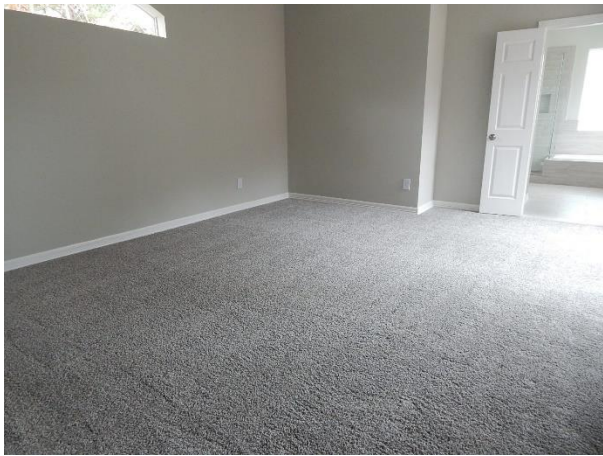
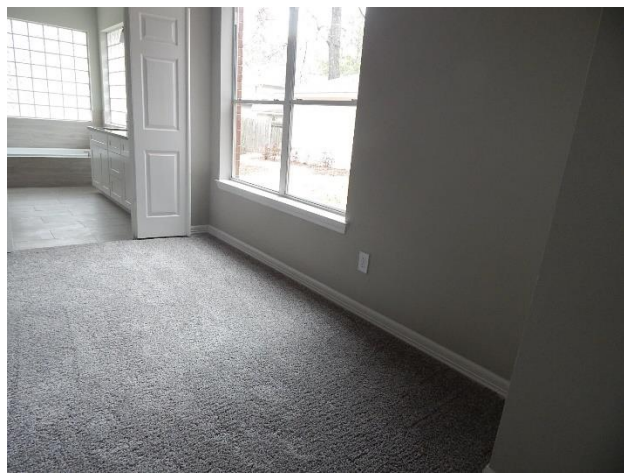
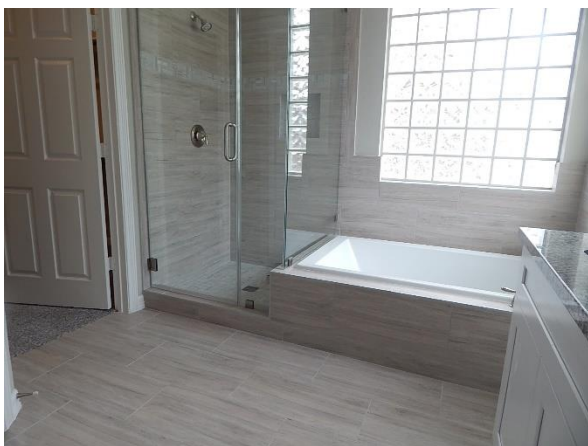
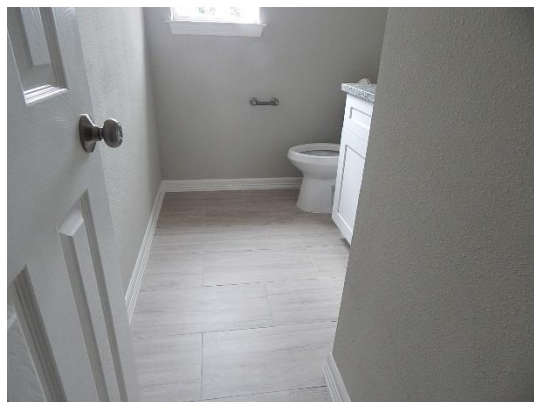
- Throughout the impacted first level new flooring, lower cabinets and sheetrock and insulation were installed. A cursory inspection of the upstairs showed updated flooring and cabinetry in that area as well.
- There was no evidence of residual water or mold damaged materials in the house. No water damage or mold growth was observed through wall openings, such as the downstairs return air chase.
- The area was free of visible mold growth
- No moisture elevation was detected on building materials that were tested.
- No musty odor was detected in the house.
- There was no evidence of mold growth in the detached garage.

Conclusion: Remediation can be considered complete from a mold remediation perspective. Rebuild can be completed.
