Inspection Report

Property Address:
3101 Miller Road
Rosharon Texas 77583

PROPERTY INSPECTION REPORT

By: Donovan Harvey / RSCH-ONE Inspections 5/22/2019

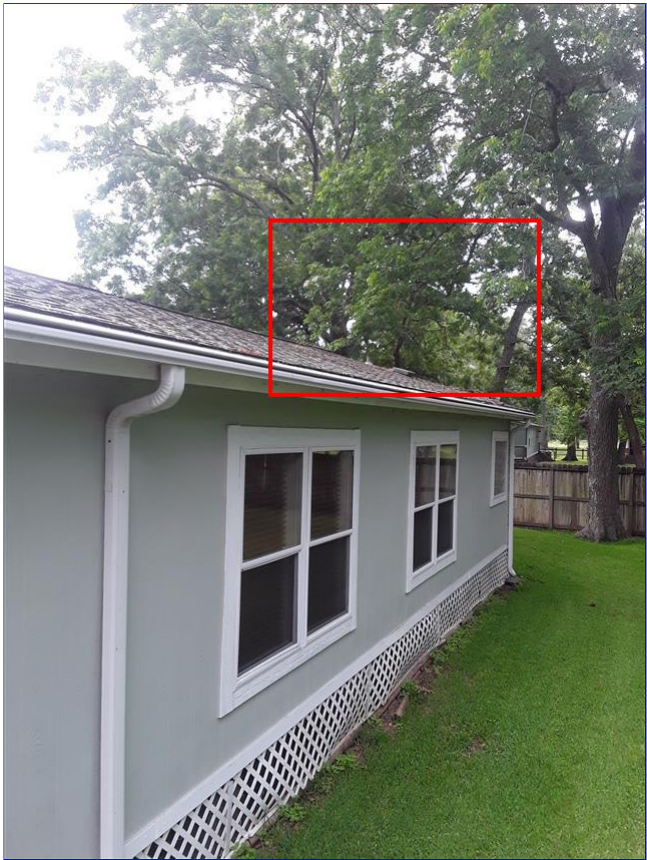
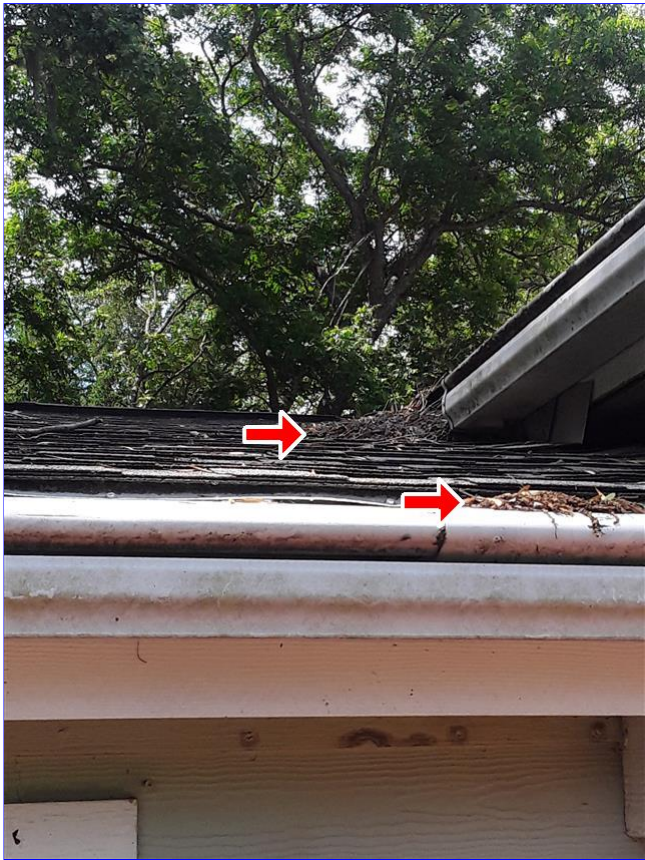
Types of Roof Covering: 3-Tab fiberglass, Architectural
Viewed roof covering from: Ground, Binoculars
Comments:
The roof covering material (shingles) is covered with debris, this will prevent water from draining off the roof properly, and can lead to the roof covering material (shingles) aging faster then intended. This is considered deficient and does not meet the minimum standard of practice.

Recommend having the debris removed and tree over the roof cut back by a licensed tree removal company.

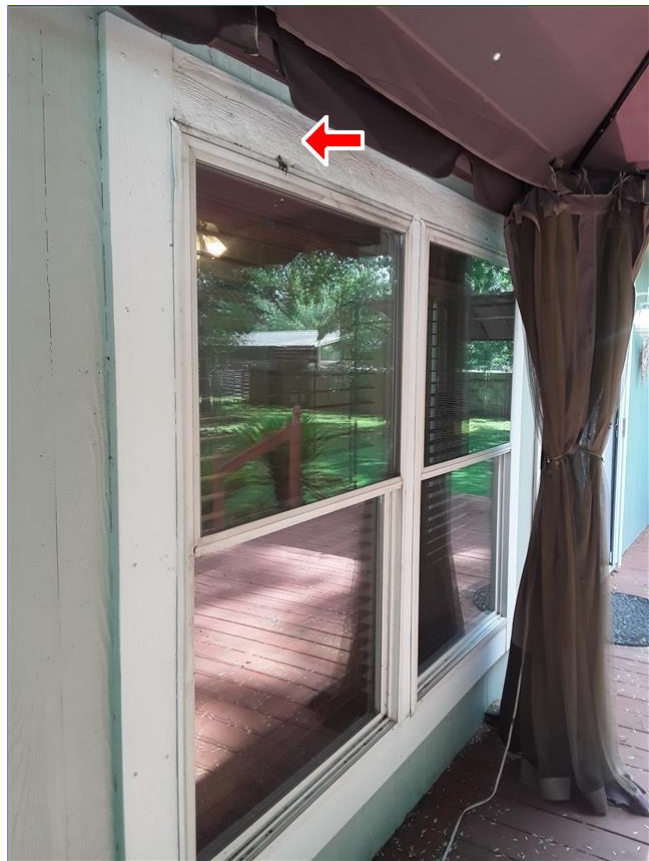
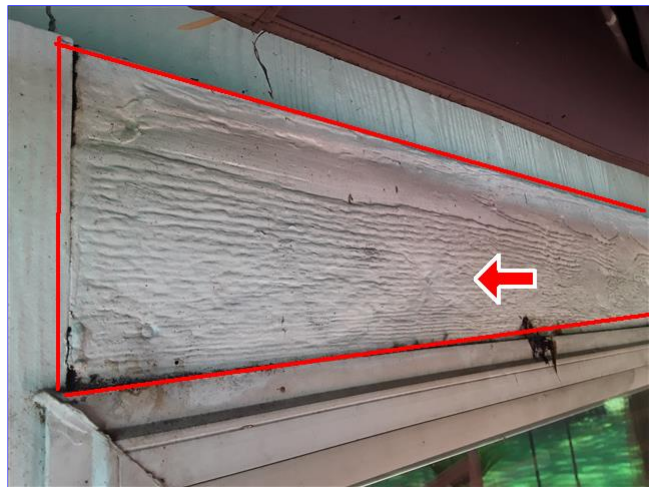
The trim over the double windows by the pergola at the back of the home has water damage, this can lead to water getting behind the degraded and cause water damage to the structural components behind the siding. This is considered deficient and does not meet the minimum standard of practice.

Recommend having this looked at further by a licensed general contractor to be repaired.

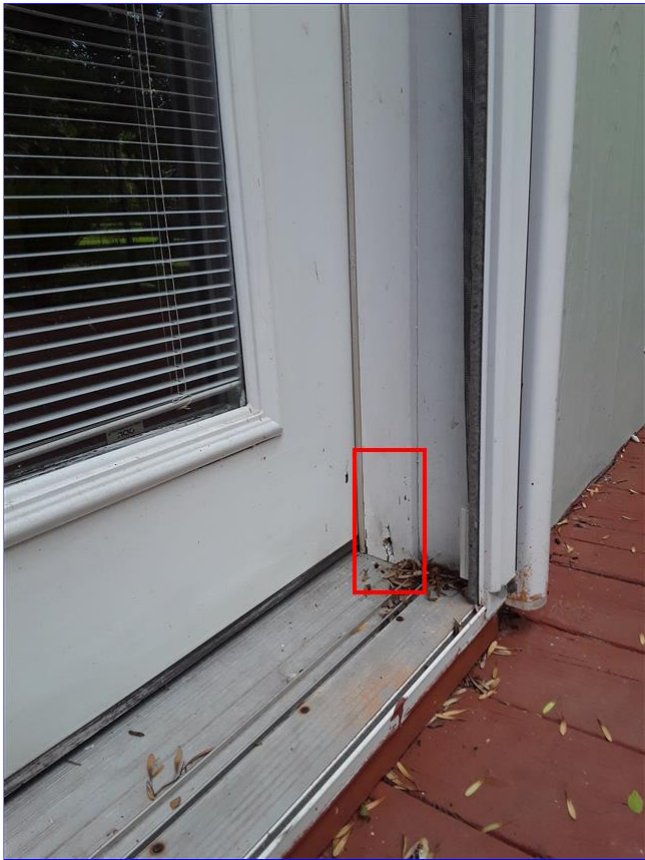
G. Item 1(Picture)

1) The bottom right corner of the wood frame, on the outside of the french doors at the back of the home has water damage. This can prevent the door from performing as intended, and lead to the door frame possibly having water damage. This is considered deficient and does not meet the minimum standard of practice.

Recommend having this looked at further by a licensed general contractor to be repaired.

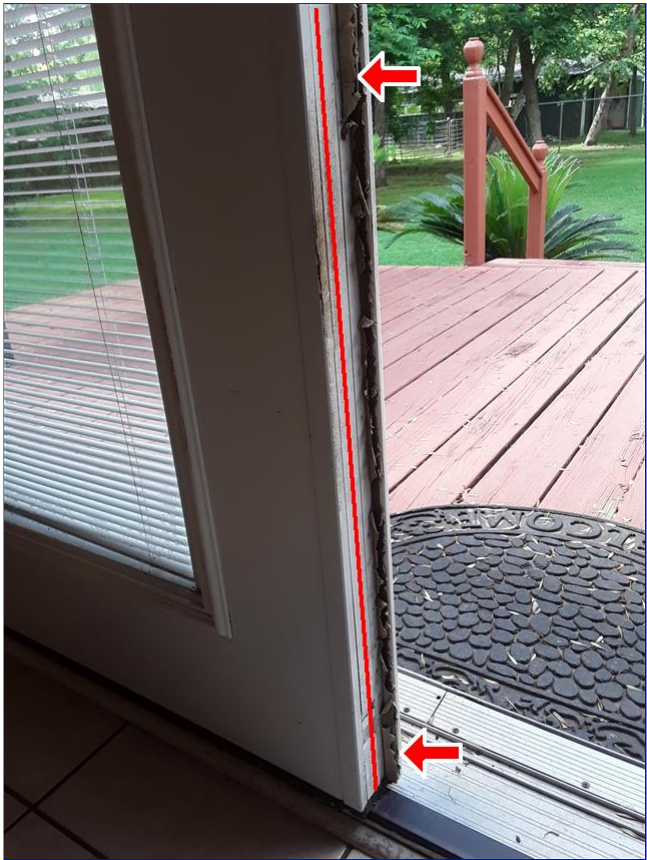
G. Item 2(Picture)

2) The weather stripping on the inside lips for all the doors leading the outside of the home are damaged and no longer functioning as intended. This can lead to air leaking from the home, and no sealing the door properly when closed.. This is considered deficient and does not meet the minimum standard of practice.

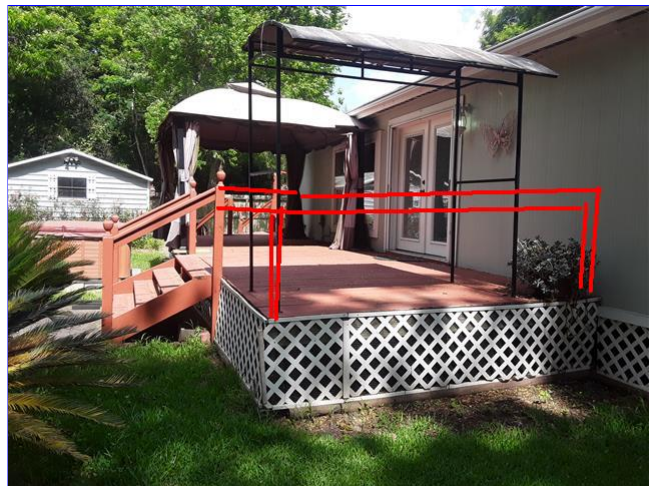
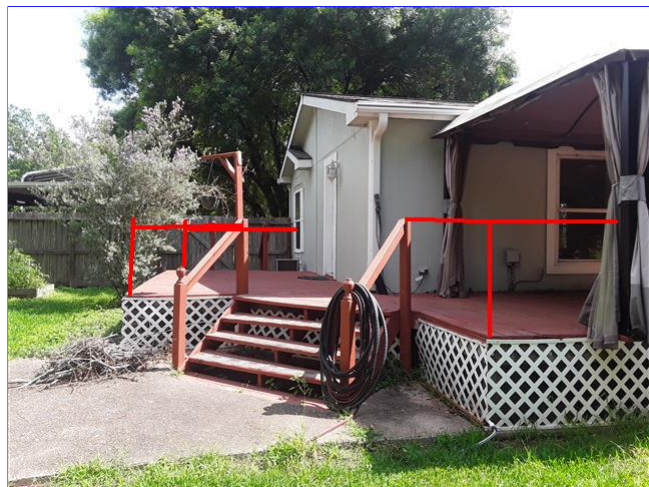
☒ ☐ ☐ ☒ **K. Porches, Balconies, Decks and Carports**
Appurtenance: Deck
Driveway: Gravel
Comments:
No guard railing was noted on the deck at the back of the home, standard states that guard railing must be around the edge of the decking, the decking must be a minimum of 3 feet in height front he top of the

railing to the walking surface of the deck, and the balusters must not have an opening greater then 4 inches apart. This is considered deficient and does not meet the minimum standard of practice.

Recommend having this looked at further by a licensed general contractor to be repaired.

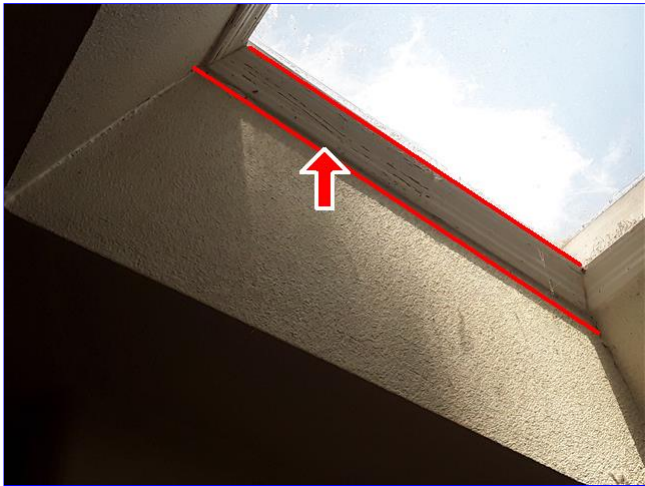
L. Item 1(Picture)

The sky light over the master bathroom shower has moisture intrusion. This needs to be looked at further by a licensed general contractor to make sure the flashing around the light light is properly installed.

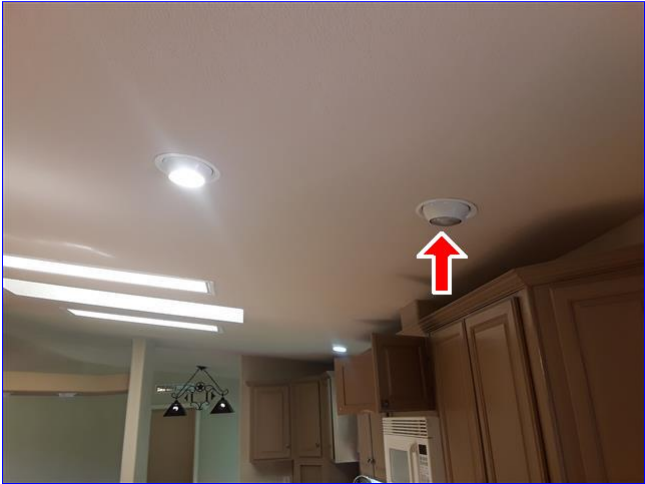
B. Item 1(Picture)

- ☒ ☐ ☐ ☒ B. Branch Circuits, Connected Devices and Fixtures
- Type of wiring:** Copper
- Wiring Methods:** Romex
- Comments:**
- One of the light fixtures over the counter did not turn on at the time of inspection. This is considered deficient and does not meet the minimum standard of practice. Recommend having this looked at further by a licensed electrician to be repaired. The smoke detector should be tested at common hallway to bedrooms upon moving in to home.

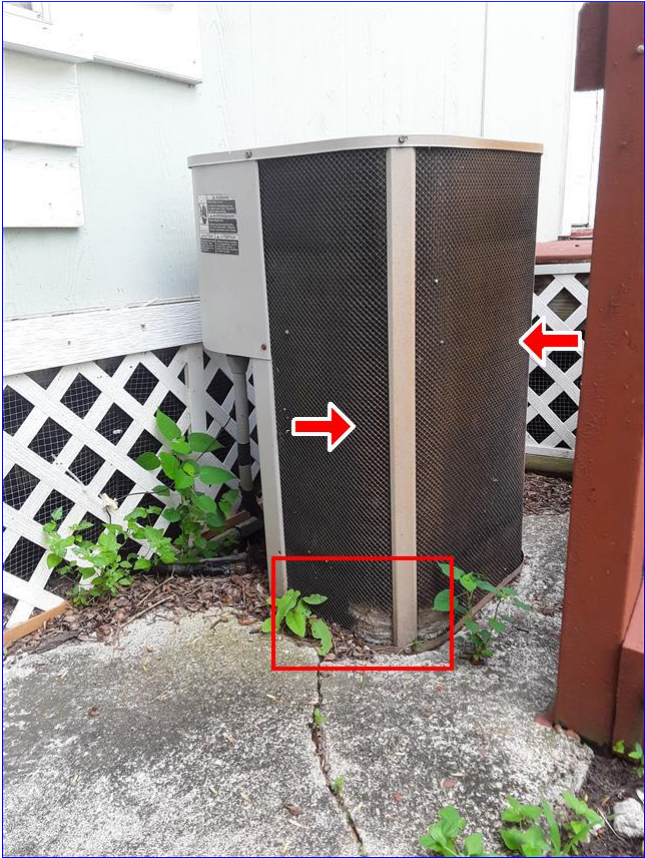
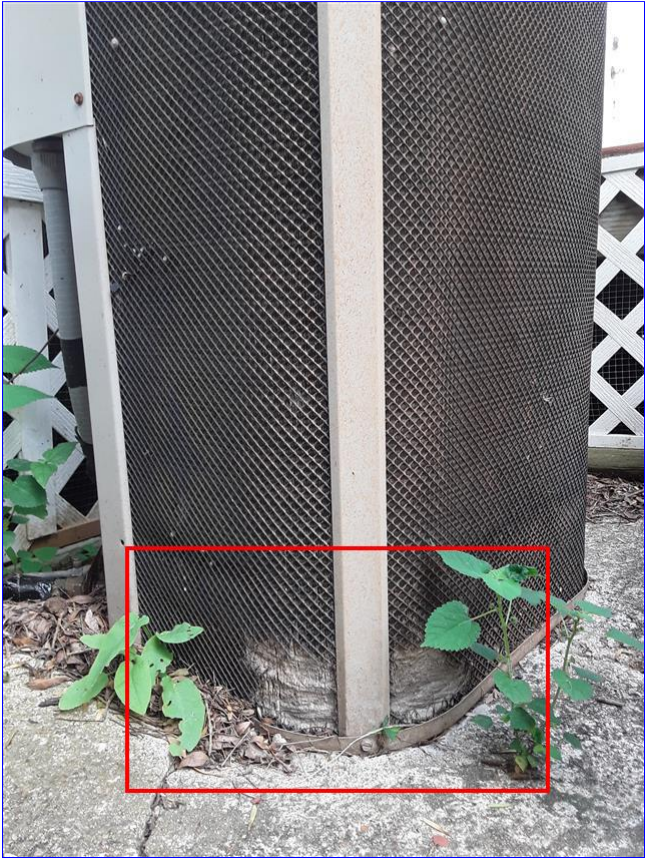
The exterior air handler unit is deficient and is not performing as intended. The ducts at the base of the unit is degraded, this is due to the unit not sitting on a 3 inch base, the base is used to help prevent the unit from being damaged, and help prevent the ducts on the unit from being filled with dirt/debris. This will prevent air from circulating around the unit as intended. Recommend having this looked at further by a licensed HVAC Tech.

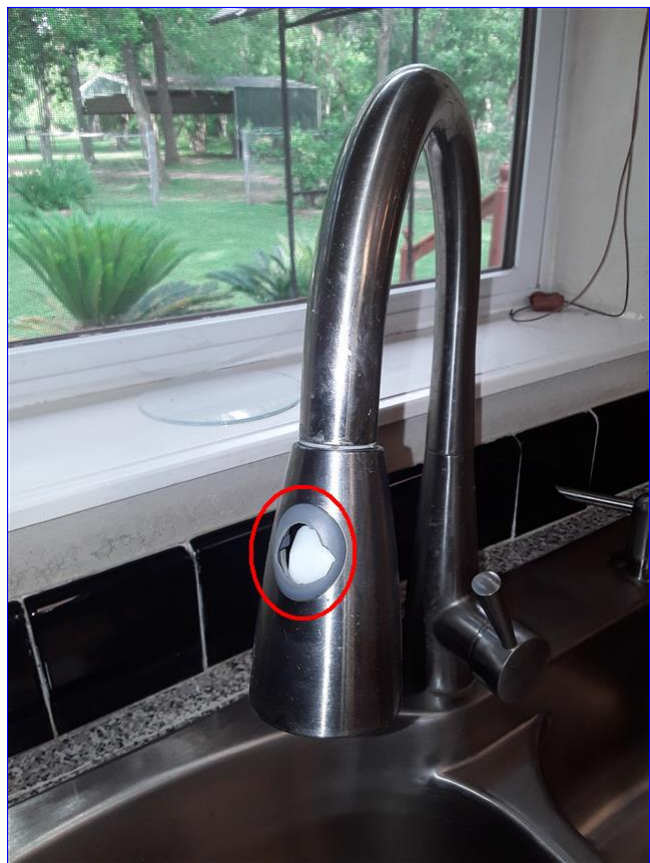
A. Item 1(Picture)

The button on the kitchen faucet is damaged and is no longer performing as intended, this is preventing

the flow of water from being changed. This is considered deficient and does not meet the minimum standard of practice. Recommend having this looked at further by a licensed plumber.

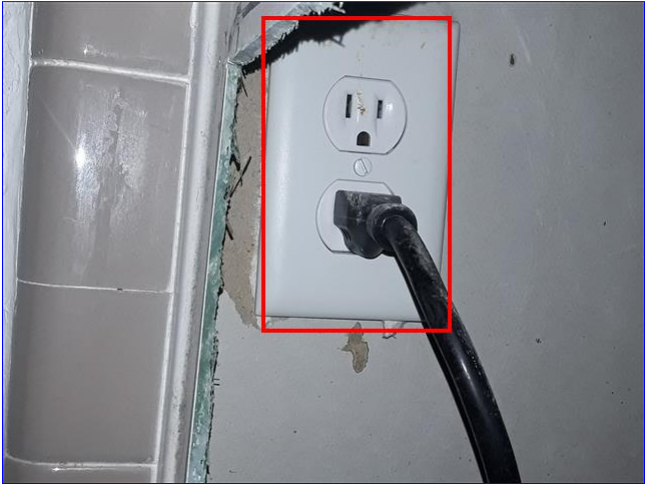
D. Item 1(Picture)

- ☒ ☐ ☐ ☒ **D. Hydro-Massage Therapy Equipment**
Comments:
The jetted tub in the master bathroom is not connected to a Ground Fault Circuit Interrupter (GFCI), this is considered a shock and safety hazard and does not meet the current minimum standards of practice, which requires this tub to be connected to a GFCI.

Recommend having this looked at further by a licensed electrician to be repaired/corrected.

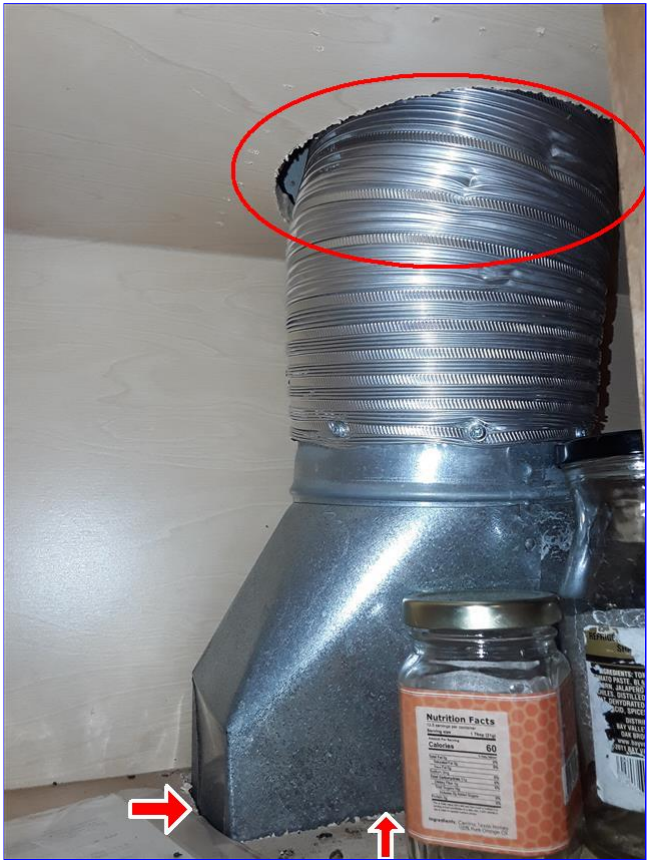
C. Item 1(Picture)

The exhaust vent in the cabinet over the microwave is not sealed at the base of at the top, this can prevent the vent from performing as intended, and allow air to leak from the home. This is considered deficient and does not meet the minimum standard of practice. Recommend having this looked at further by a licensed general contractor to be repaired.

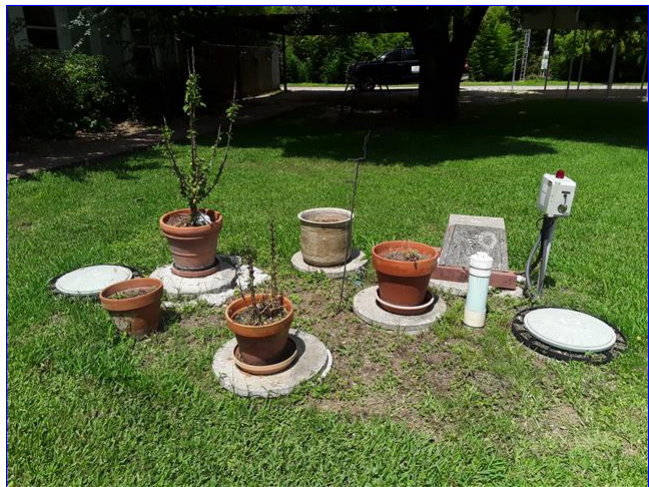
A. Item 1(Picture)

During the inspection, the owner of the property explained to me that the tanks were recently pumped and the was serviced and repaired over the last few month. The system appears to be performing as intended.

The owner should be asked for the information of the servicing company, and they should be used to service the system annually.
