Baker Real Estate Inspections

Property Inspection Report
Exclusively Prepared For
Erin Garcia

1075 W. 17th Street
Houston, TX 77008

PROPERTY INSPECTION REPORT

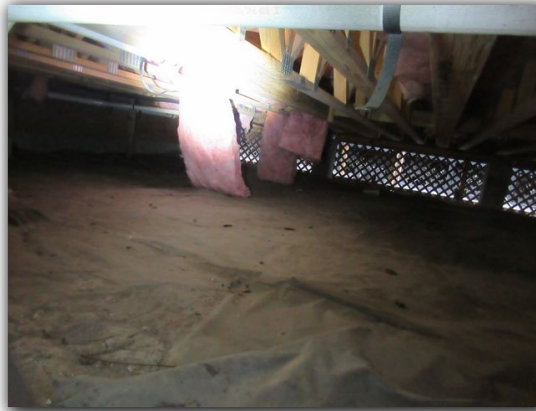
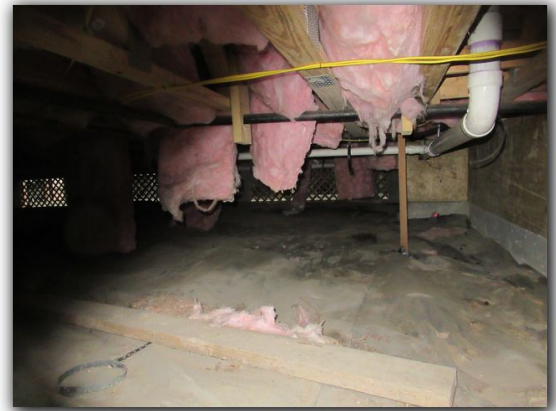
Fallen Insulation

Fallen insulation was noted in the crawl space. Corrections should be undertaken.

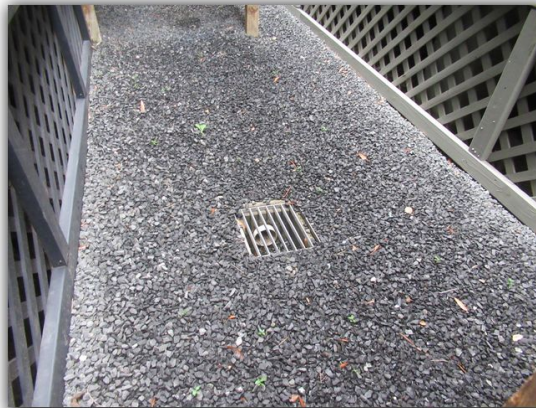
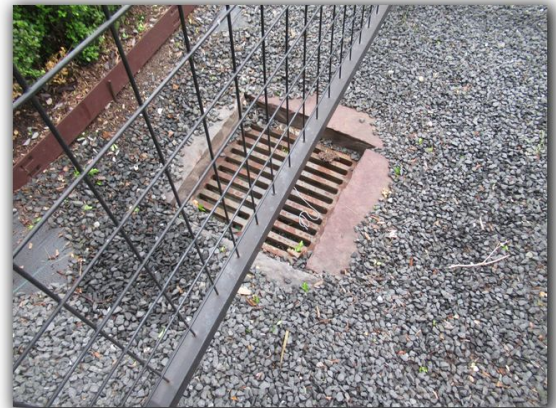
Soil Grade/ Yard Drains

Soil grade and drainage patterns around some areas of the house do not appear to properly direct water away from the foundation to aid in controlling runoff water should yard drains not drain properly.

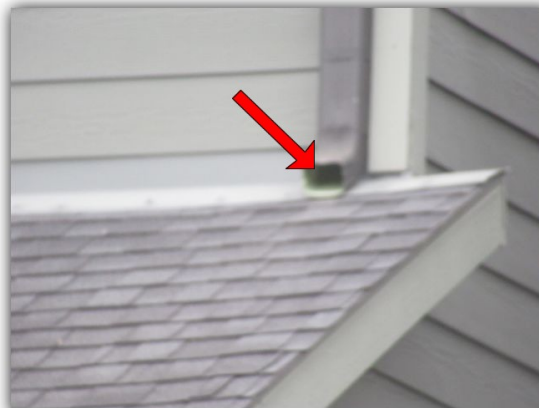
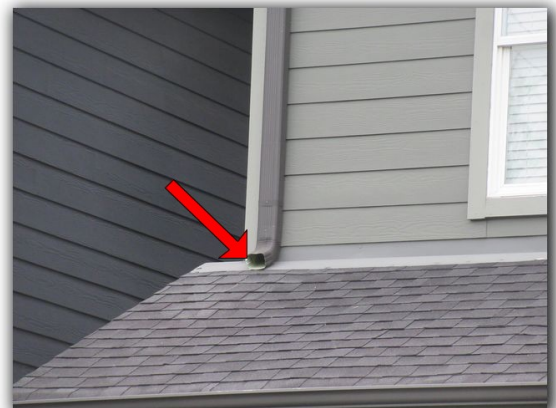
Downspout Discharge on Roof

Downspout(s) that discharge onto the roof should be extended to discharge directly into the gutters below. This condition, if left unattended, can result in premature deterioration of the roofing under the end of the downspouts.

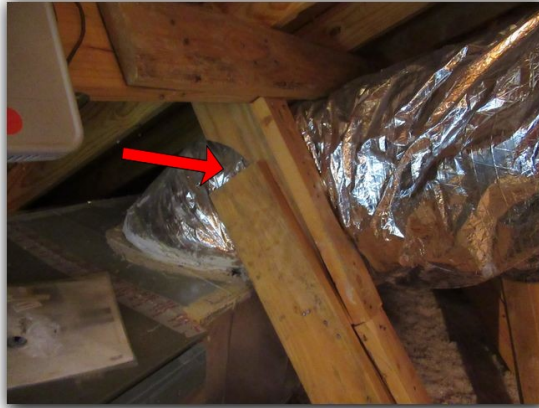
Modified Strut

A strut was noted to have been modified in the attic.

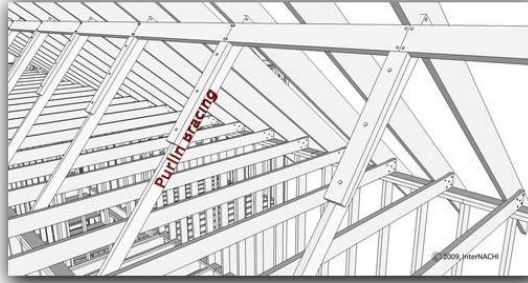
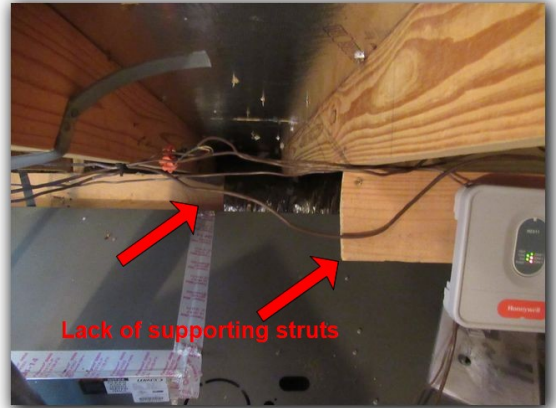
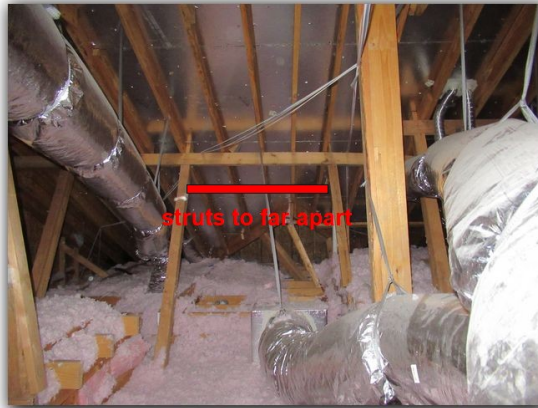
Insufficient Purlin Bracing

Insufficient purlin bracing should be corrected. Purlin braces should be sized no less than the size of the rafter material they support. Purlin braces shall be continuous and supported by a 2 inch X 4 inch braces installed to bearing walls at a slope not less than 45-degrees horizontal. The braces shall not be more than 4 feet on center and the un-braced length of the braces shall not exceed 8 feet.

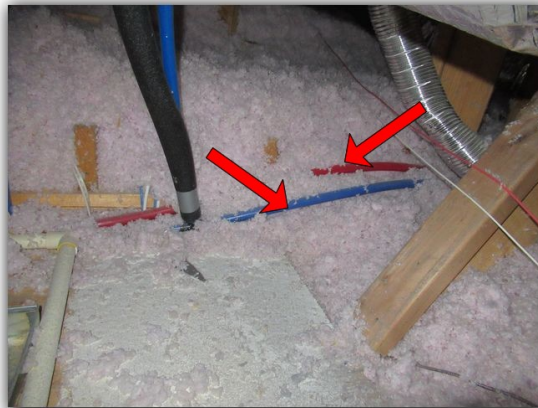
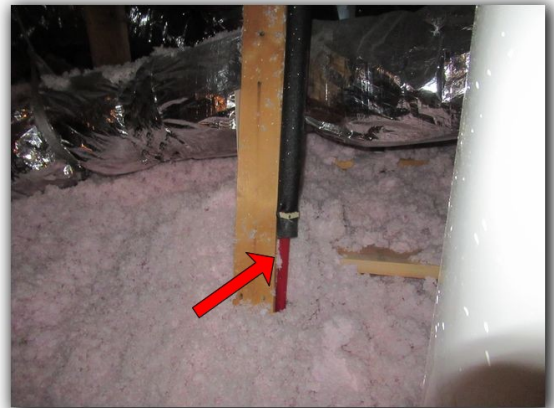
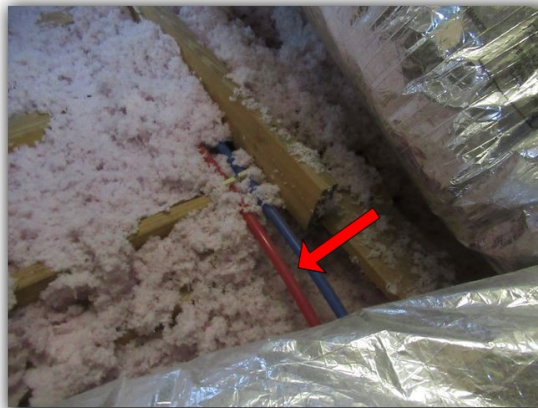
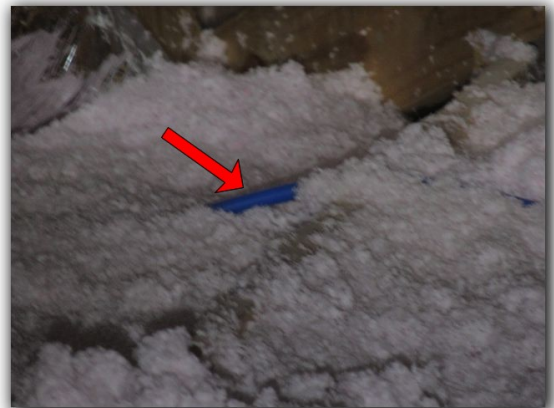
Lack of Insulation on Water Supply Lines

There is a lack of insulation on the water supply lines within the attic space.

Improvements should be undertaken to avoid damage to the pipes in freezing weather, which can also result in interior water damage to the home as well.

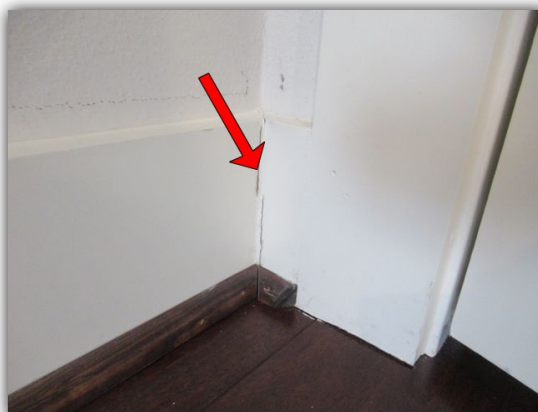
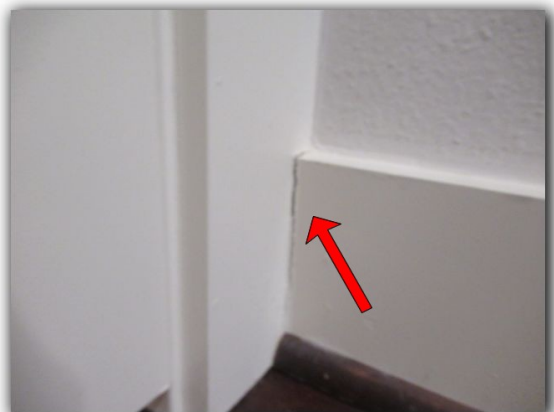
Deteriorated Sealant

Deteriorated sealant was noted at joint in the baseboards.

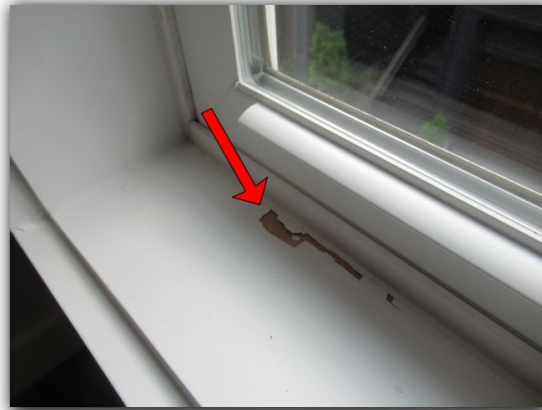
Paint Failure

The paint on the window sill of the southeast bedroom has begun to peel.

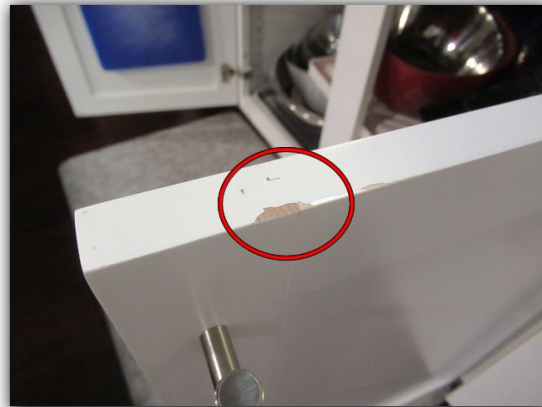
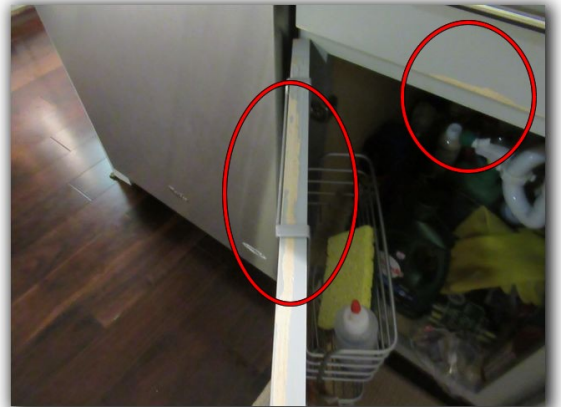
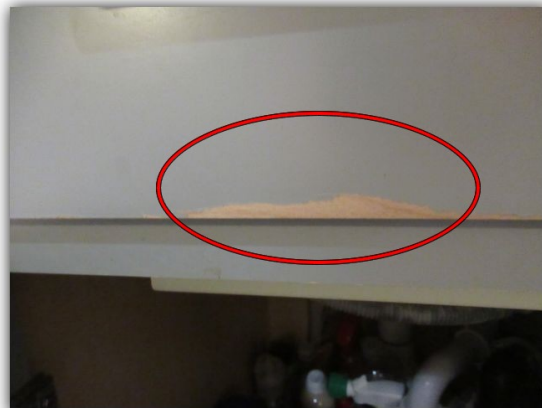
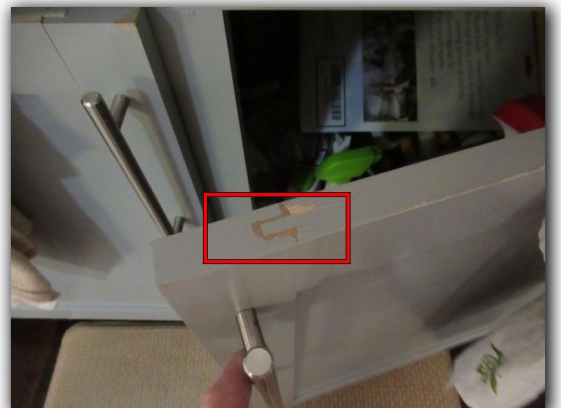
Paint Failure

The paint on the kitchen cabinets has begun to chip/rub off.

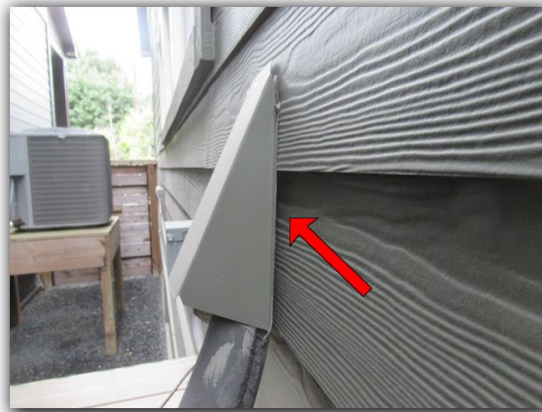
Sealant/Caulk Needed at Wall Penetrations

Seal/caulk around all exterior siding penetrations to prevent water entry and/or air infiltration. Included but not limited to dryer, bath, and range vents, light fixtures, ect.

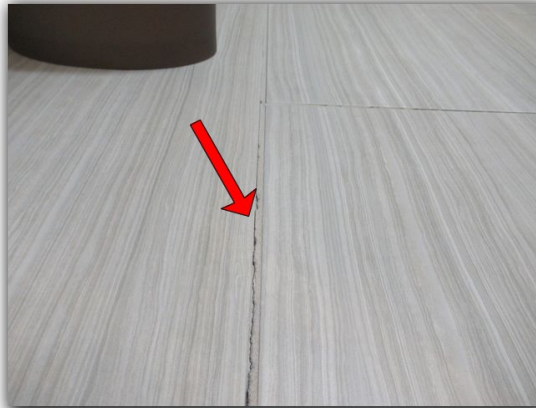
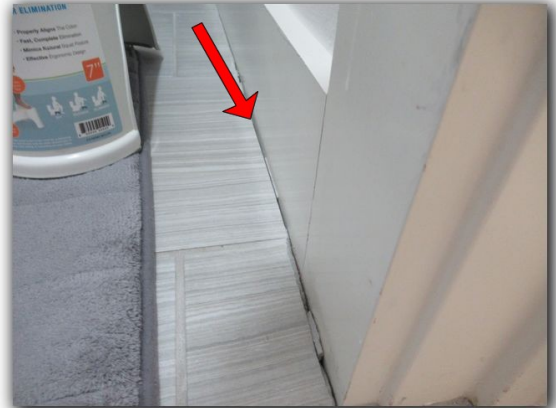
Mortar Cracks

Mortar cracks were noted in the tile of the master bath.

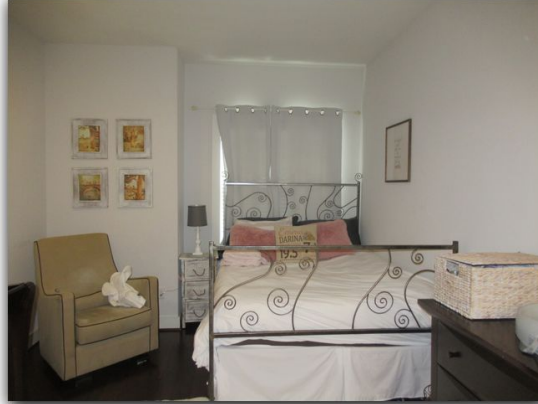
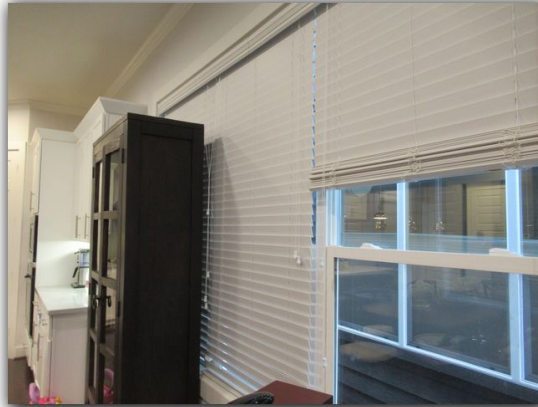
Window Screens Missing

The following listed window screens were found to be missing.

through out the house

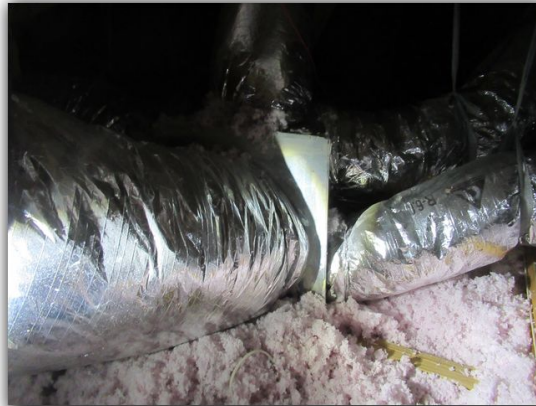
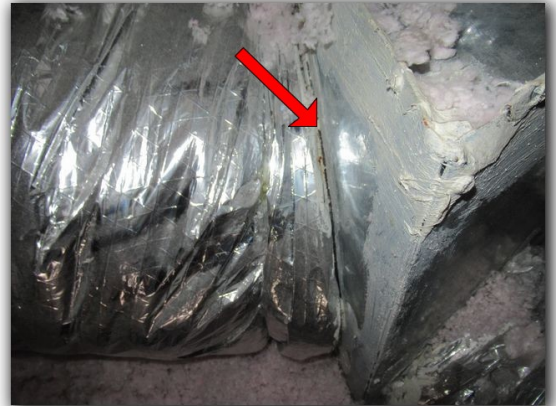
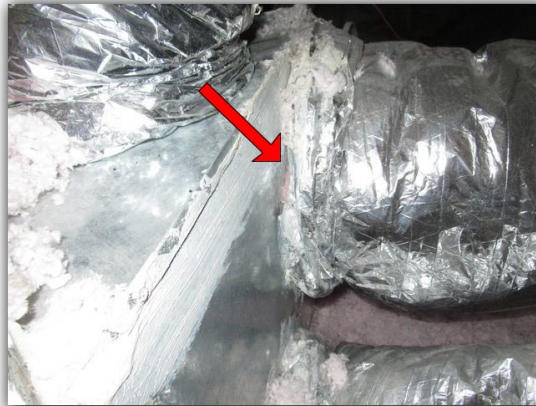
Air Loss at Ducts/Plenum

Conditioned air loss was detected at the duck work connections at the distribution plenums.

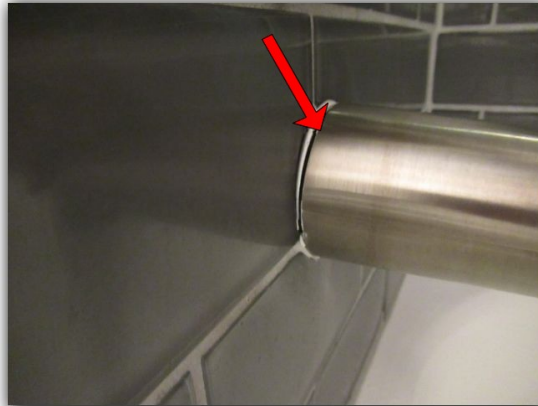
Bathtub: Seal Fixtures

The bathtub fixtures needs to be re-sealed in the hall bath. It is recommended these fixtures be sealed to the bathtub surround/tile to avoid water intrusion into the wall cavity.

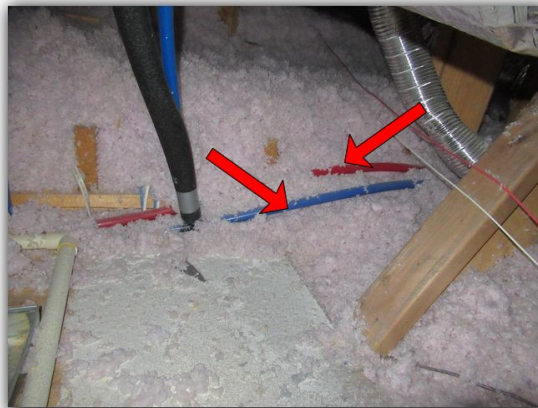
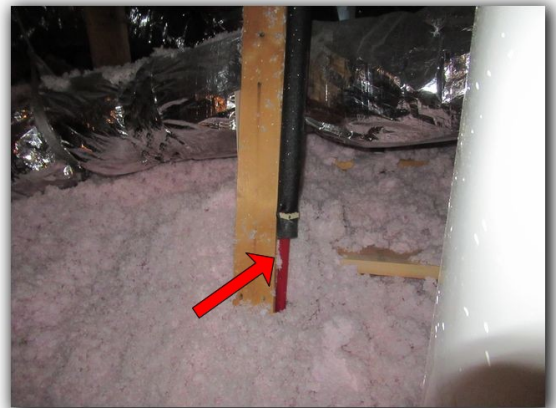
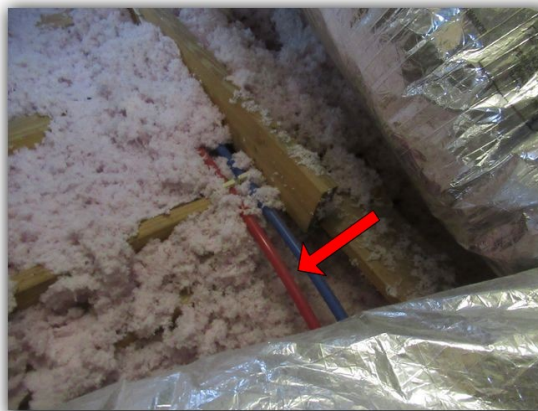
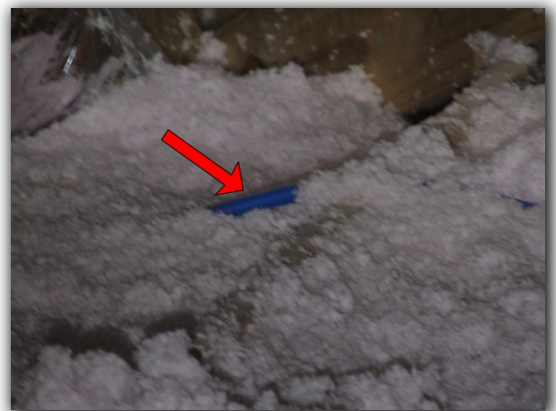
Lack of Insulation on Water Supply Lines

There is a lack of insulation on the water supply lines within the attic space. Improvements should be undertaken to avoid damage to the pipes in freezing weather, which can also result in interior water damage to the home as well.

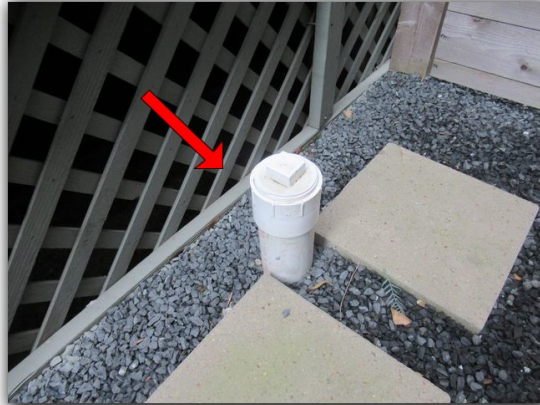
Drains/Clean Outs: Lack of Protection

The exposed plumbing drains and/or clean outs should be painted to avoid deterioration of the PVC material from exposure to UV rays.

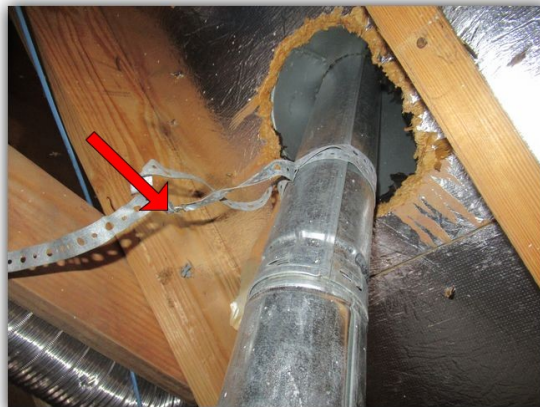
Plumbing Strap Disconnected

The plumbing strap needs to secure be properly to the structure as required.

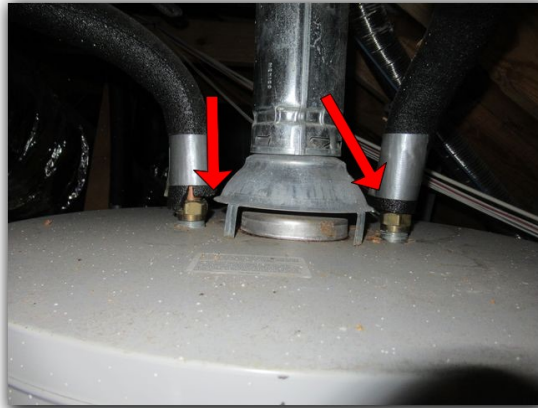
Vent Lacks Proper Clearance from Combustibles

The vent pipe serving the water heater does not have safe clearance from combustible materials. Double walled B Gas vents require a minimum of 1-inch clearance from combustible materials. *This condition should be improved for safety reasons.*

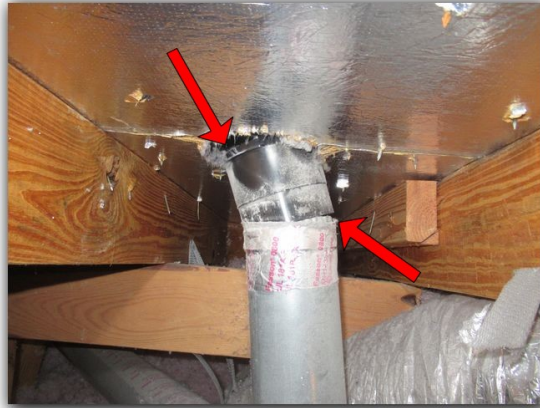
Vent Not Sealed to Roof Bonnet

The dryer vent is not properly sealed to the roof bonnet as it has separated. Therefore lint has fallen back into the attic space. The lint is considered to be highly flammable material thus creating a fire hazard. Improvements should be undertaken by sealing the vent properly to the roof bonnet.
