Inspection Report

Property Address:
8009 Safeway St.
Houston TX 77028

PROPERTY INSPECTION REPORT

By: Kevin Sandel 22389 / American Dream Inspections TX, llc 5/20/2019

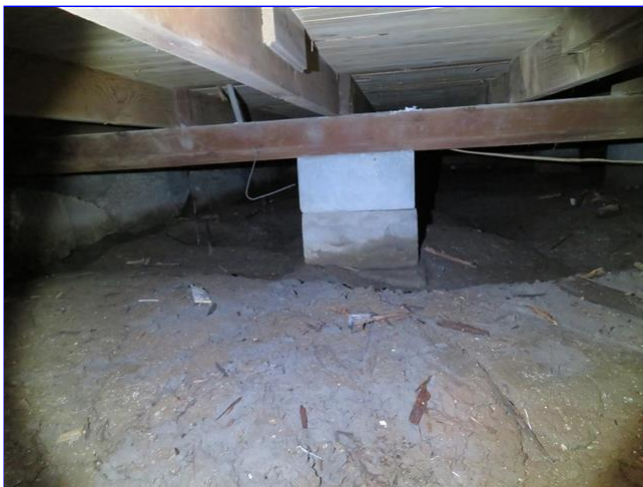
A. Item 1(Picture)

Foundation issues could be hidden and not visible at time of inspection. It's always recommended to have a professional inspect and further evaluate foundation for any defects or deficiencies.

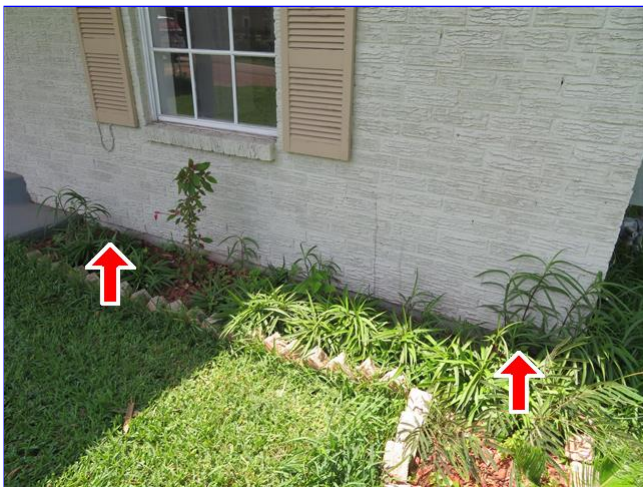
B. Item 1(Picture)

(1) Soil is too high to foundation in several areas at time of inspection. Soil should be graded 6" in 10' away from the foundation.

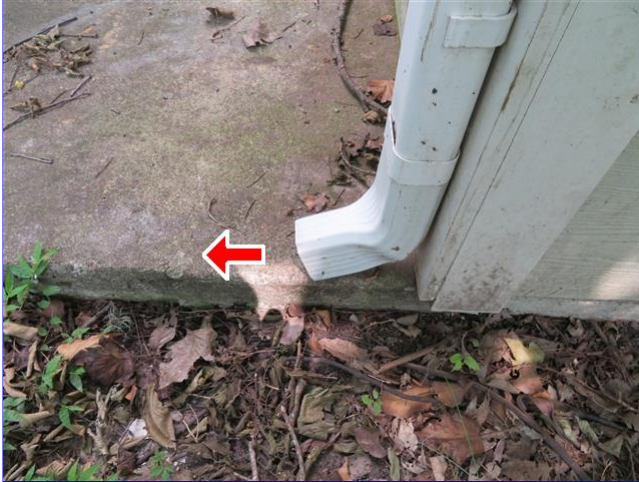
B. Item 2(Picture)

(3) Gutters are full of debris at time of inspection. Should have a professional clean debris from gutters for proper water dispersement.

- 1) Gutters are full of debris at time of inspection. Should have a professional clean debris from gutters for proper water dispersement.
- 2) Gap between drip edge flashing should be corrected and sealed properly by a professional roofer. Conducive to moisture intrusion and causing possible damage.

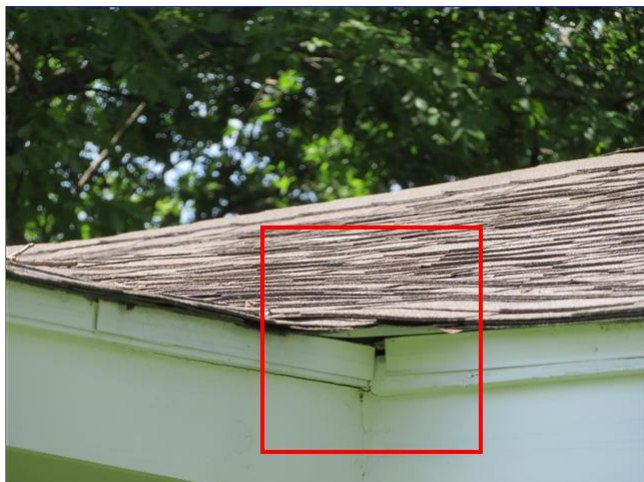
C. Item 1(Picture)

(1) Gap between drip edge flashing should be corrected and sealed properly by a professional roofer. Conducive to moisture intrusion and causing possible damage.

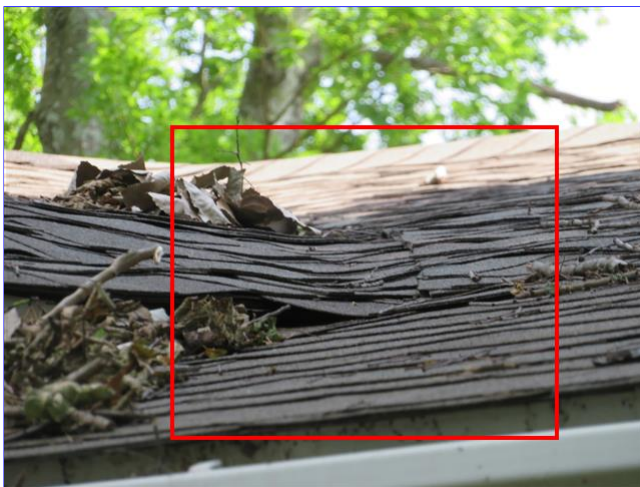
(2) All lifted roof shingles should be corrected and sealed properly by a professional roofer. Conducive to moisture intrusion and causing possible damage. Should have a professional roofer inspect and evaluate roofing.

- 3) All lifted roof shingles should be corrected and sealed properly by a professional roofer. Conducive to moisture intrusion and causing possible damage. Should have a professional roofer inspect and evaluate roofing.

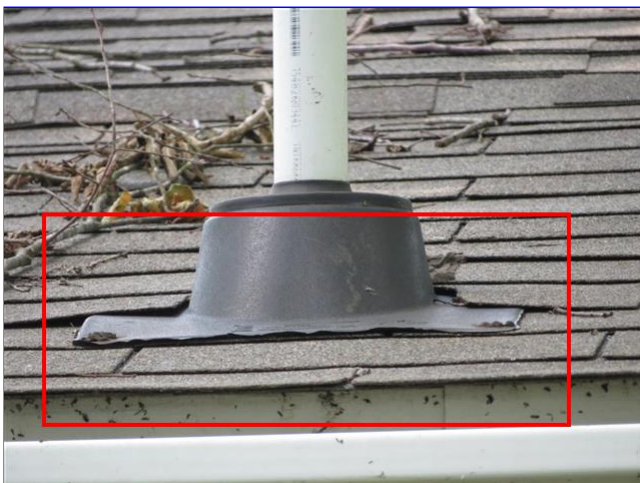
C. Item 4(Picture)

(3) All roof lifted plumbing jacks should be corrected and sealed properly by a professional roofer. Conducive to moisture intrusion and causing possible damage.

- 4) All roof lifted plumbing jacks should be corrected and sealed properly by a professional roofer. Conducive to moisture intrusion and causing possible damage.

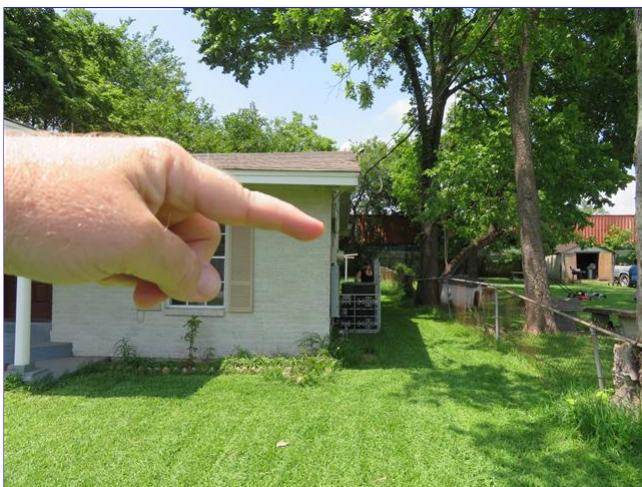
D. Item 1(Picture)

(1) Front roof structure is sloped at time of inspection. Should have a professional inspect and correct if necessary.

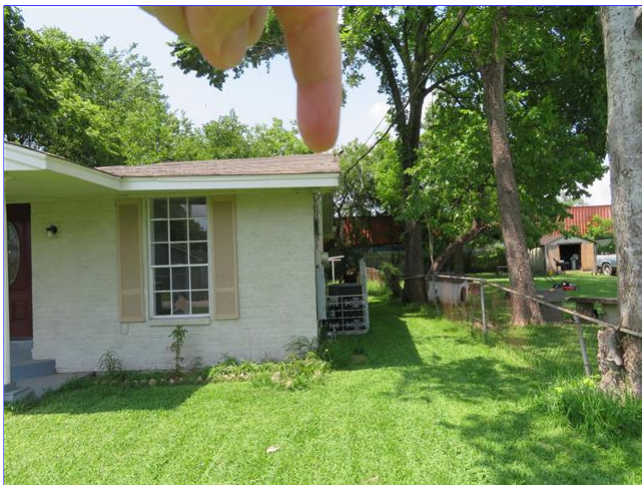
D. Item 2(Picture)

(2) Exterior soffits have signs of possible WDO (Wood Destroying Organisms) growth at time of inspection. Should have a professional correct properly.

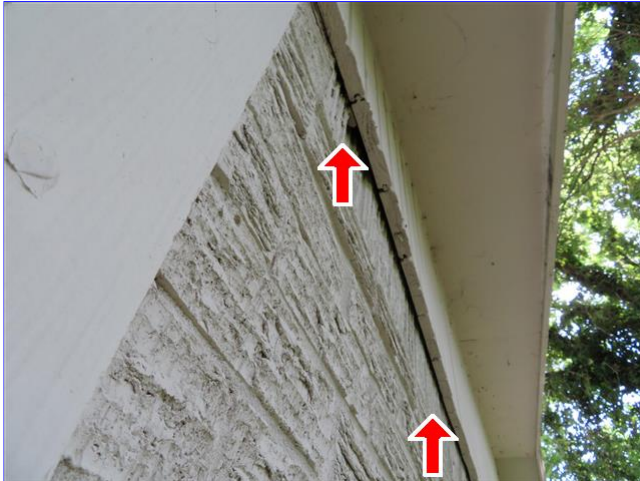
E. Item 1(Picture)

(1) All exterior brick Frieze board gaps should be sealed properly. Conducive to moisture intrusion and causing possible damage.

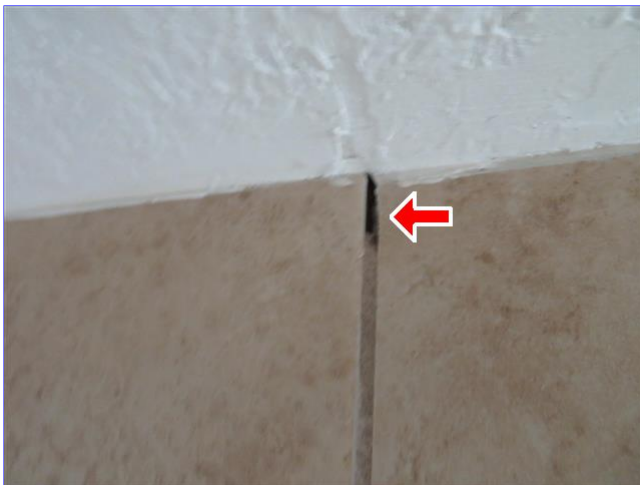
E. Item 2(Picture)

(2) All bathroom tile wall penetrations, gaps or cracks should be sealed properly. Conducive to moisture intrusion.

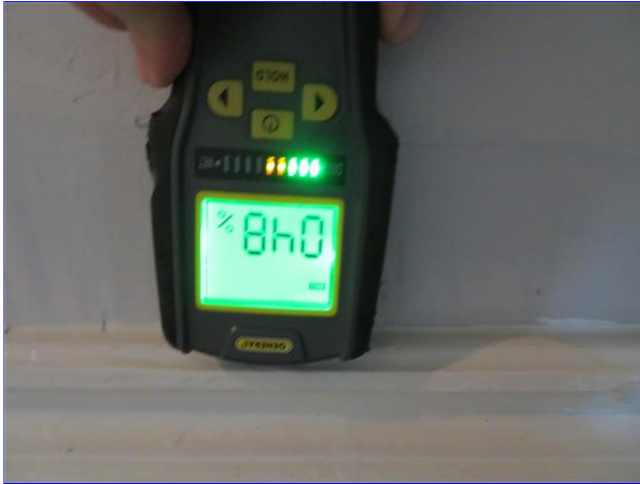
E. Item 3(Picture)

(3) Walls in garage conversion has high moisture in several areas at time of inspection. Should have a professional inspect and correct properly.

- 7) Walls in garage conversion has high moisture in several areas at time of inspection. Should have a professional inspect and correct properly.
- 8) Several interior doors were not operating and latching properly due to not being installed properly. Should have a professional install doors properly.

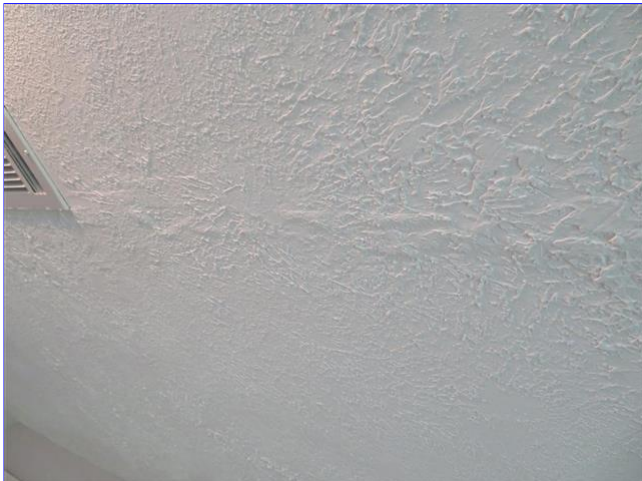
F. Item 1(Picture)

Interior ceilings are sagging, cracked and have been patched in several areas at time of inspection.

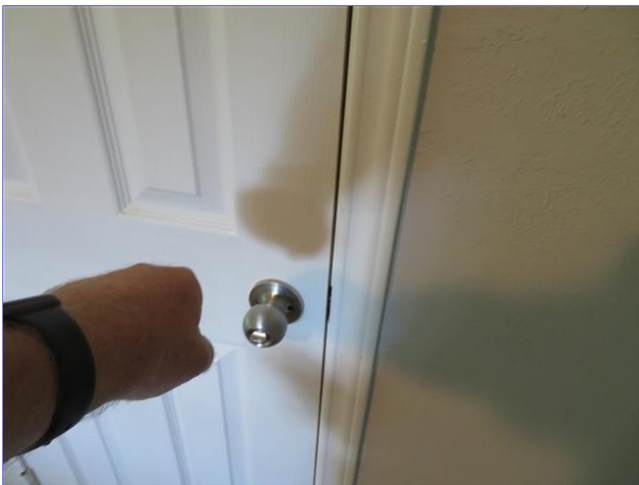
G. Item 2(Picture)

(2) Several interior doors were not operating and latching properly due to not being installed properly. Should have a professional install doors properly.

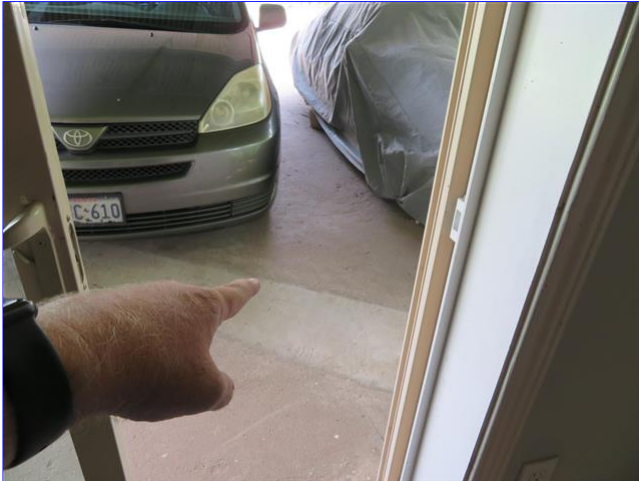
G. Item 3(Picture)

(3) Front glass slider door was missing screen at time of inspection. Should replace screen properly.

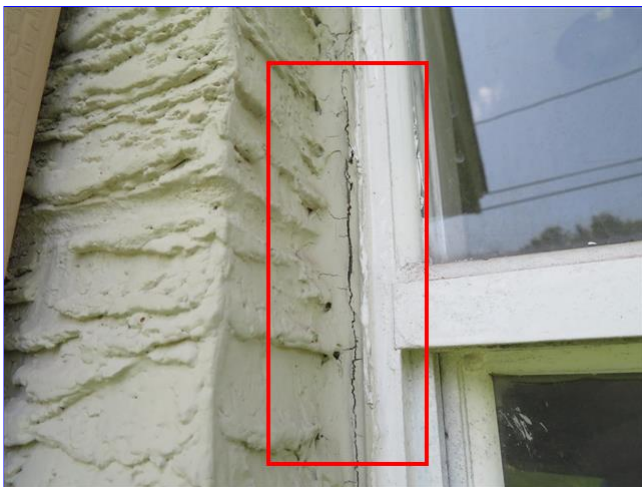
H. Item 1(Picture)

(1) All exterior and interior window penetrations should be sealed properly. Conducive to moisture and WDI (Wood Destroying Insects) intrusion.

- 9) Front exterior door was not seating properly at time of inspection. Should have a professional adjust door properly.
- 10) All exterior and interior window penetrations should be sealed properly. Conducive to moisture and WDI (Wood Destroying Insects) intrusion.

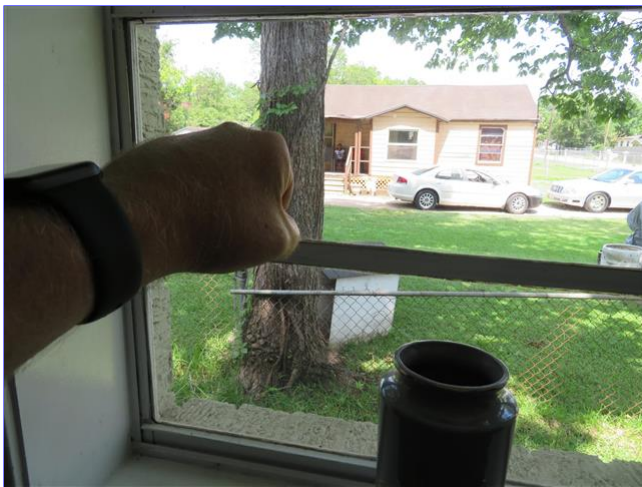
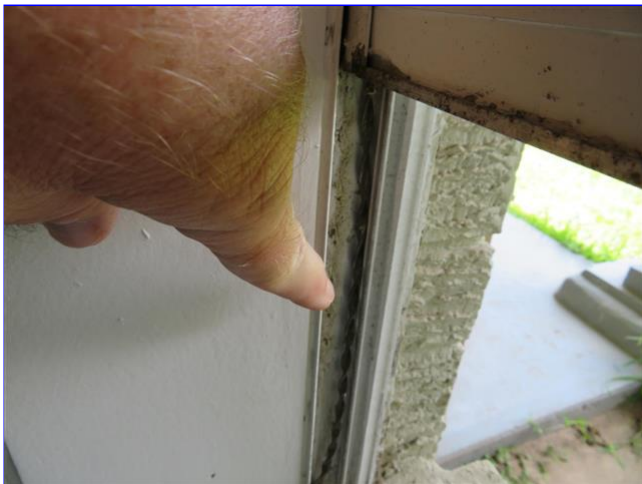
(3) Several windows were not operating properly and has leveler rods un installed at time of inspection. Should have a professional correct for proper egress. Possible safety hazard.

- 11) Side window is cracked in several areas and is plastic at time of inspection. Should have a professional replace with a glass window.
- 12) Several windows were not operating properly and has leveler rods un installed at time of inspection. Should have a professional correct for proper egress. Possible safety hazard.

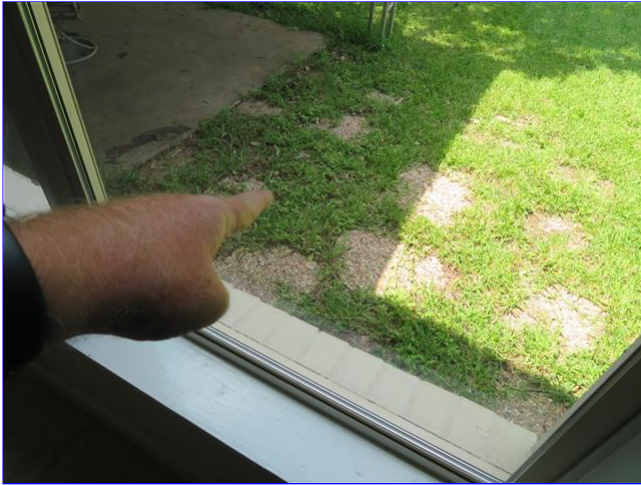
H. Item 5(Picture)

(4) Windows are missing screens at time of inspection. Should have a professional replace screens properly.

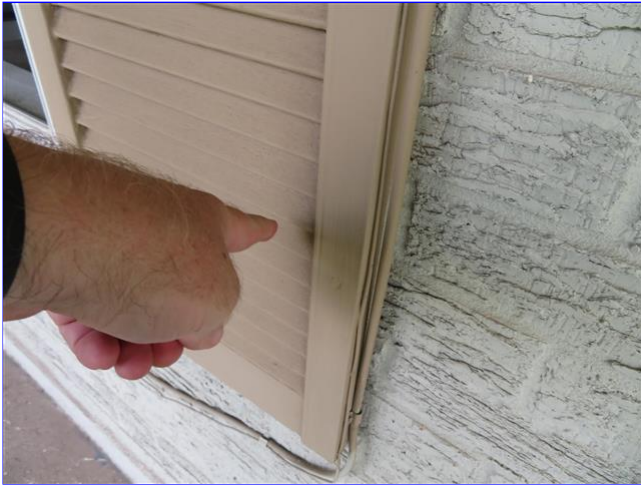
H. Item 6(Picture)

(5) Front window shutter was loose from structure at time of inspection. Should secure properly to the structure.

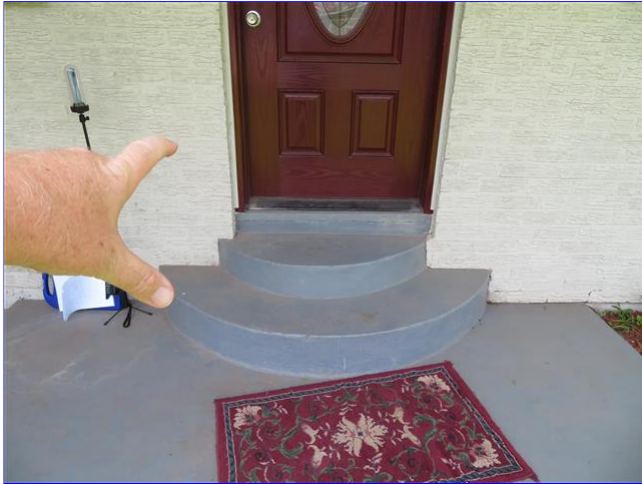
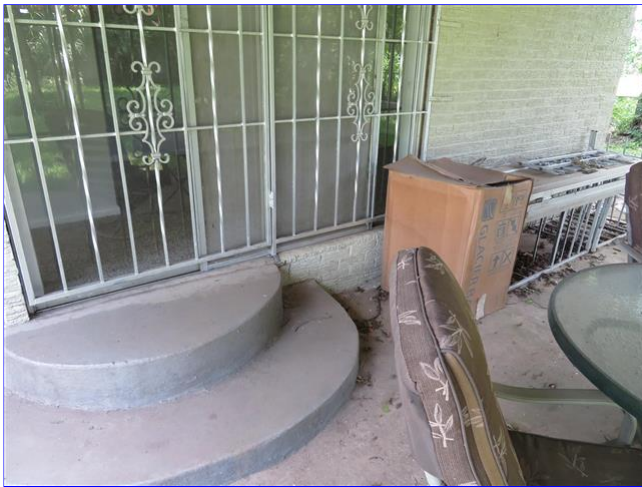
(1) Front and rear exterior steps are missing hand railings at time of inspection. This is a possible safety hazard. Should have a professional correct properly.

- 13) Front and rear exterior steps are missing hand railings at time of inspection. This is a possible safety hazard. Should have a professional correct properly.

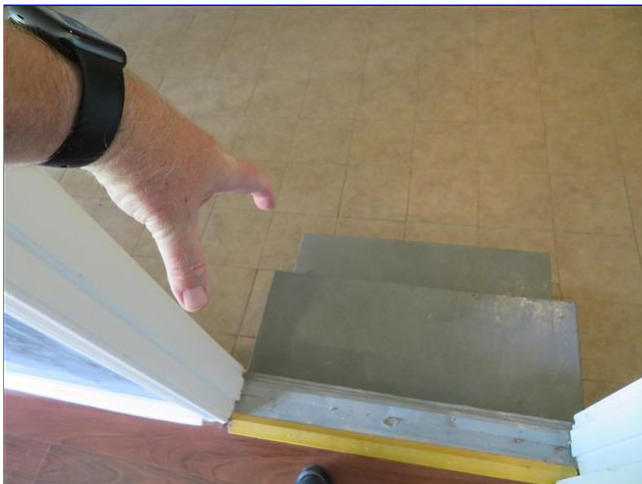
I. Item 3(Picture)

(2) Stairs to garage conversion was missing railings at time of inspection. Should correct properly. Possible safety hazard.

- 14) Stairs to garage conversion was missing railings at time of inspection. Should correct properly. Possible safety hazard.
- 15) Exterior metal carport is damaged and has signs of leaking in several areas at time of inspection. Should have a professional inspect and correct properly.

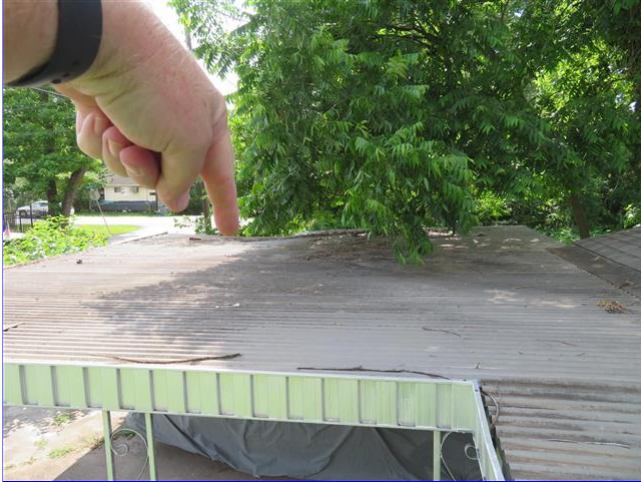
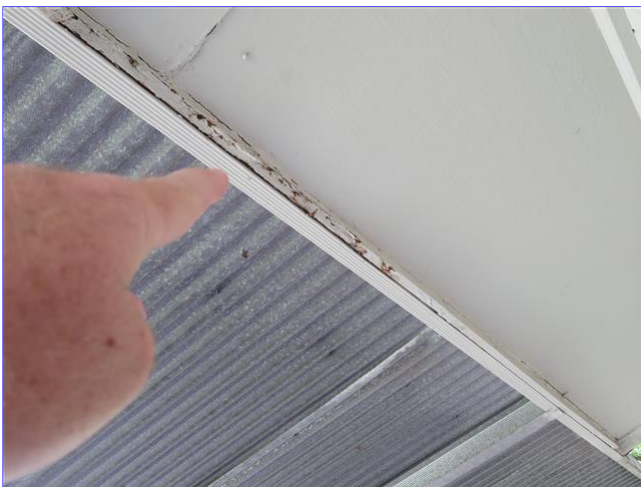
(1) Exterior metal carport is damaged and has signs of leaking in several areas at time of inspection. Should have a professional inspect and correct properly.

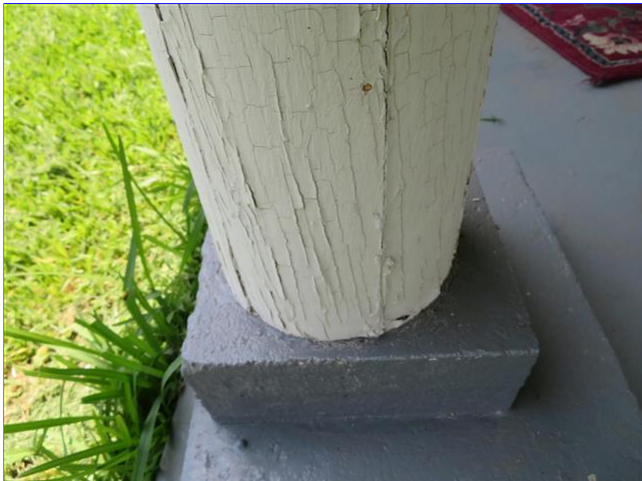
(2) Front exterior wood porch columns have moisture damage and are splitting in several areas at time of inspection. Should have a professional inspect and correct properly.

- 16) Front exterior wood porch columns have moisture damage and are splitting in several areas at time of inspection. Should have a professional inspect and correct properly.

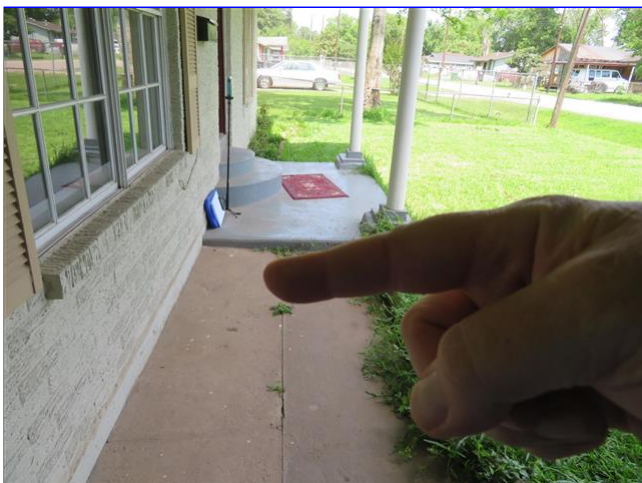
K. Item 10(Picture)

(3) Front porch is sloped toward the structure at time of inspection. This is conducive to moisture distributing toward the structure. Should slope away from the structure.

- 17) Front porch is sloped toward the structure at time of inspection. This is conducive to moisture distributing toward the structure. Should slope away from the structure.

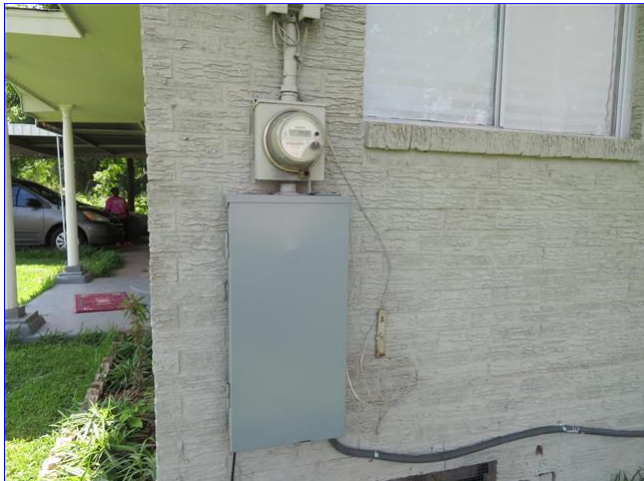
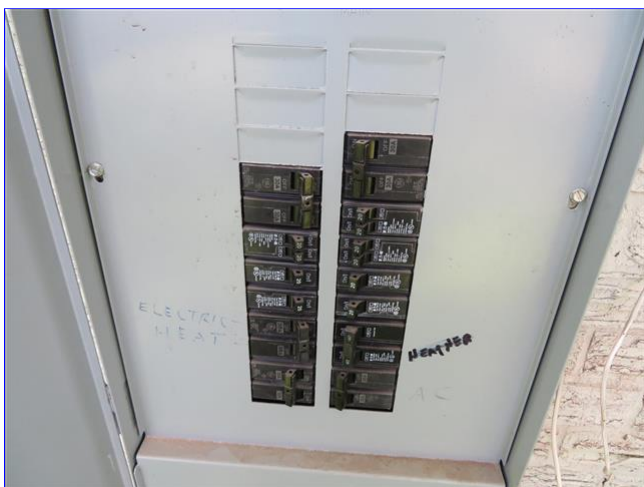
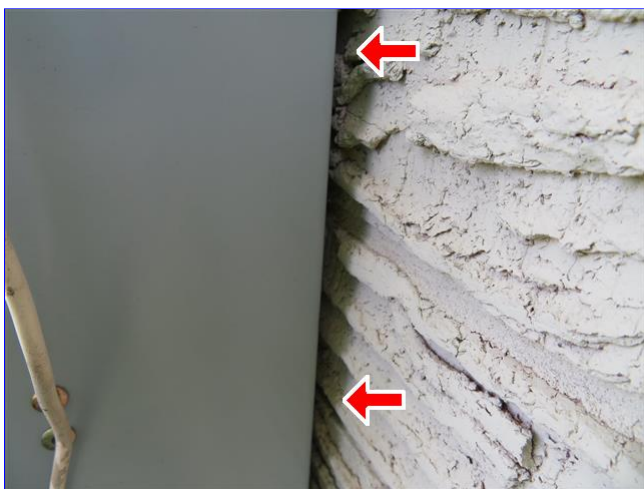
Electric meter and GE breaker box. Breakers were not labeled at time of inspection. Gap between boxes and structure should be sealed properly. Conducive to moisture intrusion and causing possible damage.

- 1) Electric meter and GE breaker box. Breakers were not labeled at time of inspection. Gap between boxes and structure should be sealed properly. Conducive to moisture intrusion and causing possible damage.

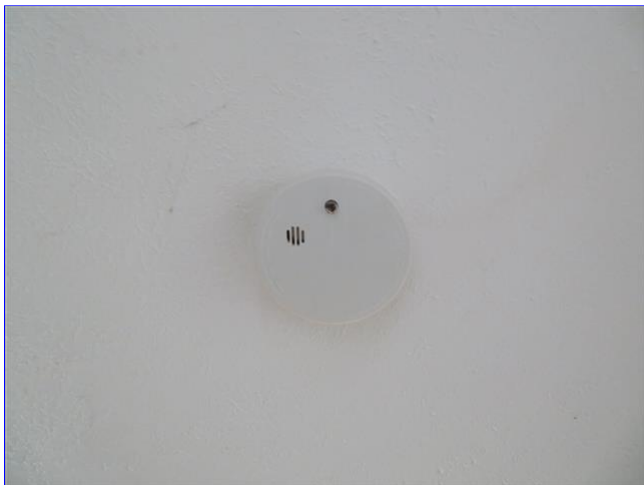
B. Item 1(Picture)

(1) The smoke detector should be tested at common hallway to bedrooms upon moving in to home.

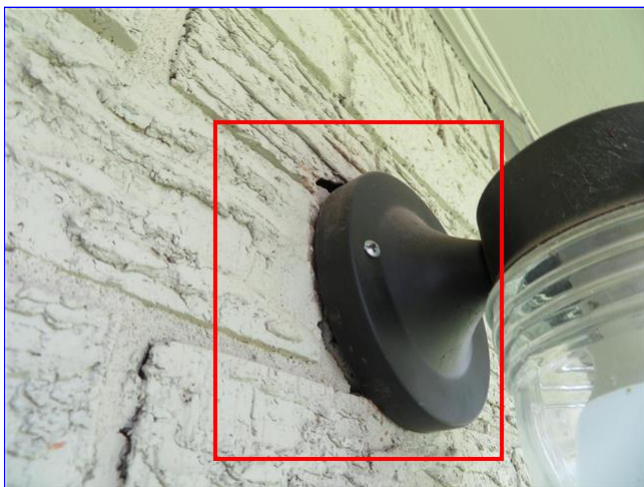
B. Item 2(Picture)

(2) Exterior lighting was loose to structure in several areas at time of inspection. Should be secured and sealed properly to the structure by a professional electrician.

- 2) Exterior lighting was loose to structure in several areas at time of inspection. Should be secured and sealed properly to the structure by a professional electrician.

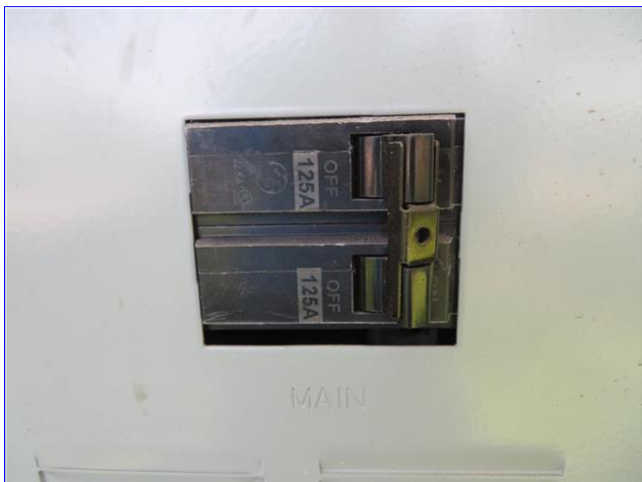
B. Item 3(Picture)

(3) 125 amp main disconnect.

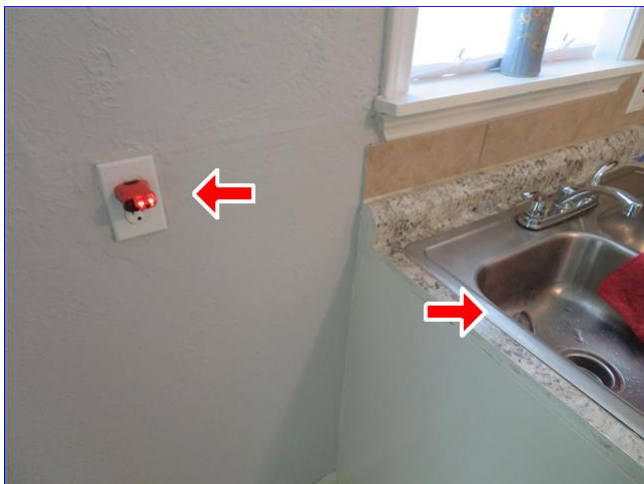
B. Item 5(Picture)

(5) All kitchen electrical outlets should be at least 3' from sink and GFCI protected. Should have a professional electrician inspect and correct. Covers should be labeled GFCI protected.

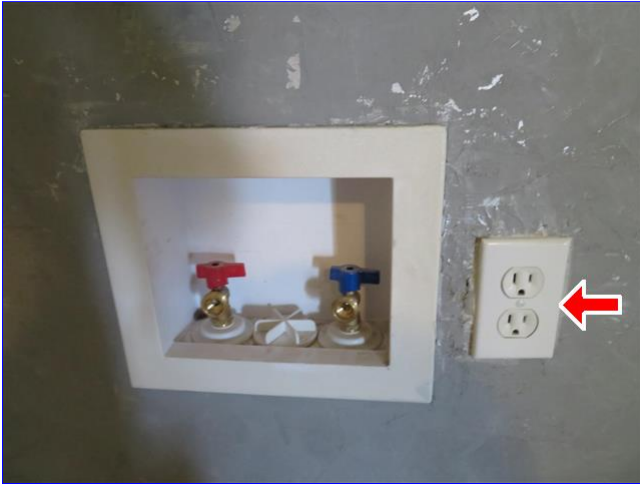
B. Item 7(Picture)

(7) All utility room electrical outlets should be GFCI protected. Electrical covers were missing GFCI protected label at time of inspection. Should have a professional inspect and correct.

- 5) Closet light has broken bulb at time of inspection. Should have a professional electrician inspect and correct properly.
- 6) All utility room electrical outlets should be GFCI protected. Electrical covers were missing GFCI protected label at time of inspection. Should have a professional inspect and correct.

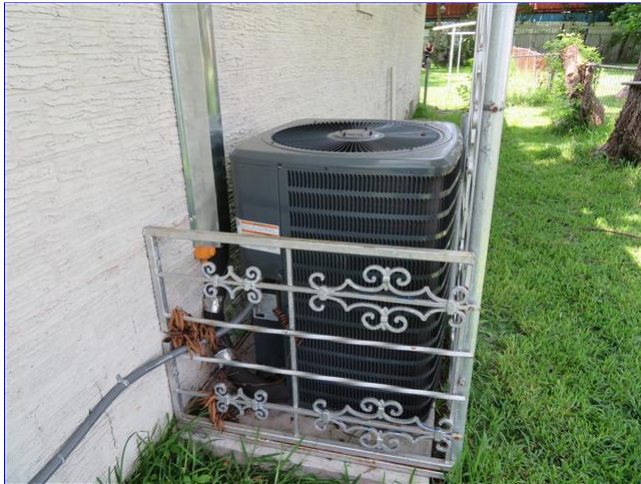
A. Item 1(Picture)

- (1) 2018 Goodman 3 ton AC unit was working properly at time of inspection.

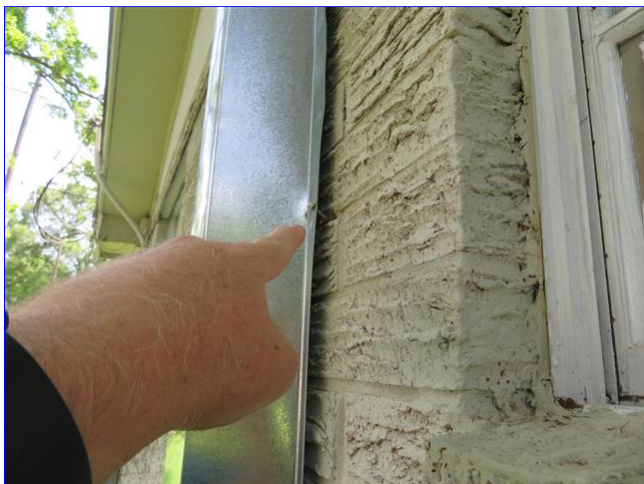
A. Item 3(Picture)

- (2) Exterior metal cover for AC lines was loose from the structure at time of inspection. Should have a professional AC tech secure and seal properly to the structure.

- 1) Exterior metal cover for AC lines was loose from the structure at time of inspection. Should have a professional AC tech secure and seal properly to the structure.
- 2) All HVAC registers should be sealed to the ceilings properly. Leaking air across the ceilings at time of inspection.

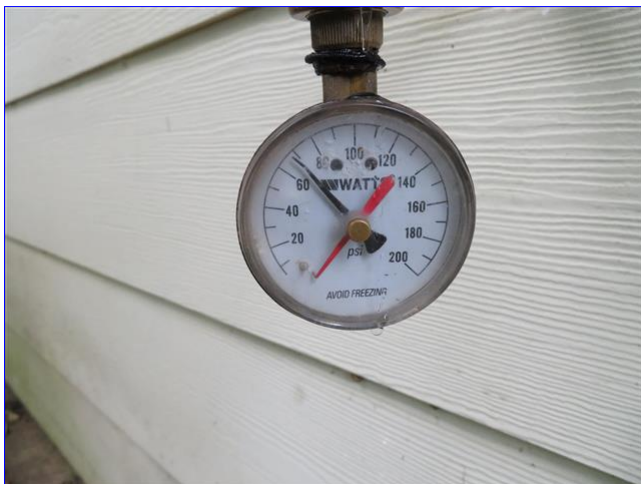
A. Item 1(Picture)

- (1) Static water pressure was 68 psi at time of inspection. Normal pressure is 40-60 psi. Should have a professional plumber inspect and correct.

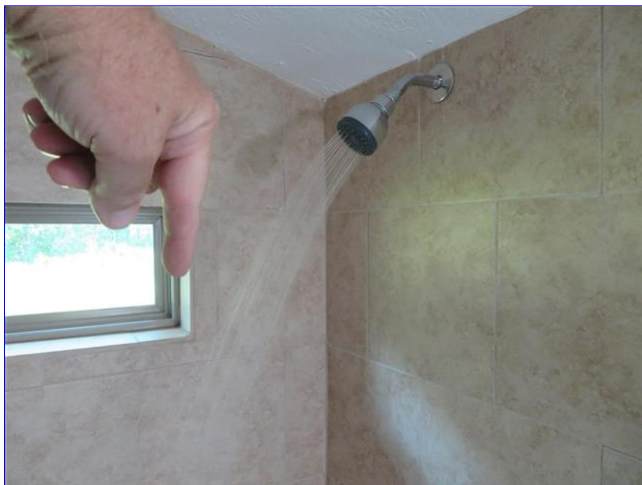
A. Item 2(Picture)

(2) Master bathroom shower and tub has low water pressure at time of inspection. Should have a professional plumber inspect and correct properly.

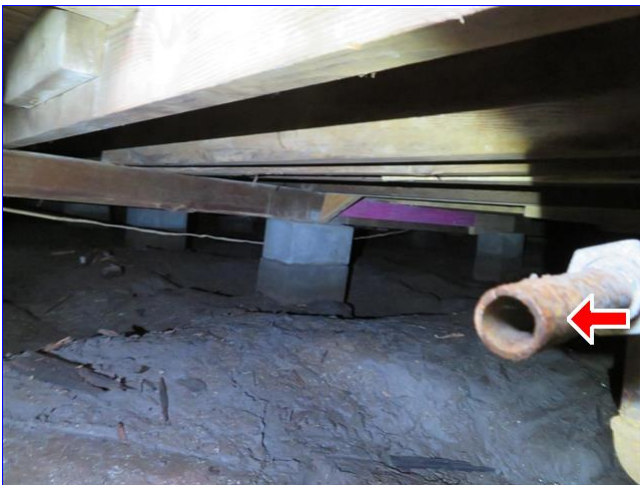
A. Item 5(Picture)

(5) Signs of cut original plumbing under structure at time of inspection.

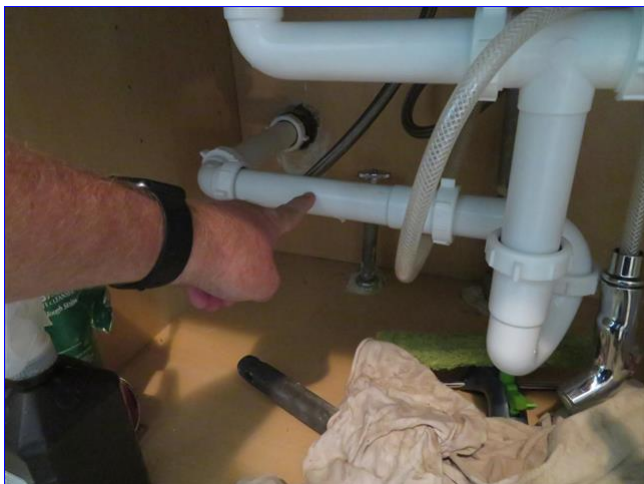
B. Item 1(Picture)

(The house has been vacant); a larger family moving in could result in clogged sewer piping, thus **THE FOLLOWING SHOULD BE DONE:** Have a licensed and qualified plumbing contractor check the main sewer line from the house to the street or on-site sewage system with a video camera to check for blockages **BEFORE YOU CLOSE."**

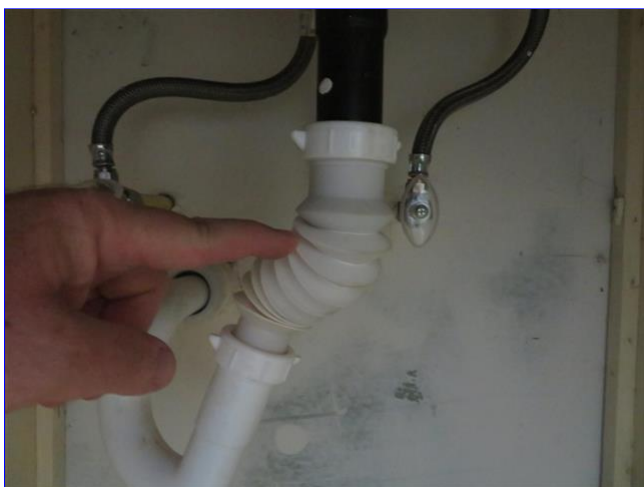
B. Item 2(Picture)

(2) Bathroom sink has loose and incorrect flex plumbing at time of inspection. Should have a professional plumber replace with proper solid plumbing.

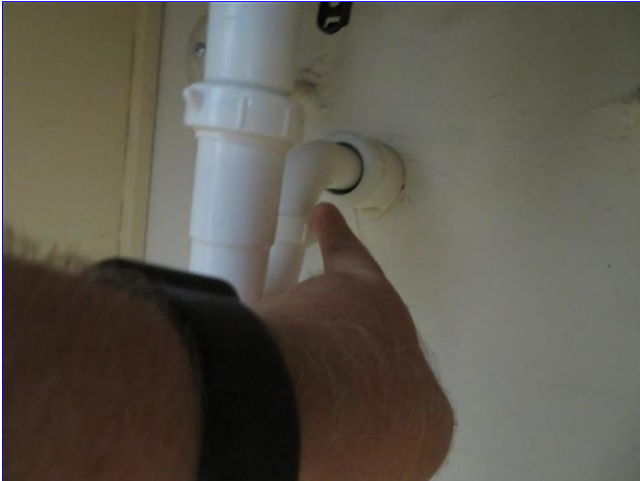
B. Item 3(Picture)

(3) Several bathrooms sink drain plumbing were loose at time of inspection. Conducive to leaking and causing possible damage. Should have a professional plumber correct.

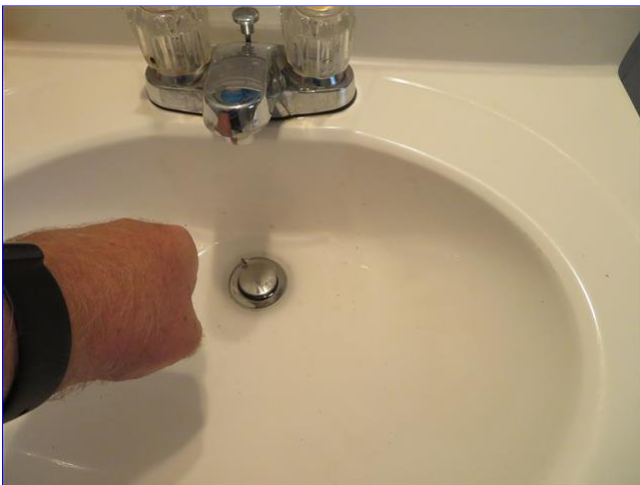
B. Item 4(Picture)

(4) Several bathroom drain stoppers did not operate at time of inspection. Should have a professional plumber correct properly.

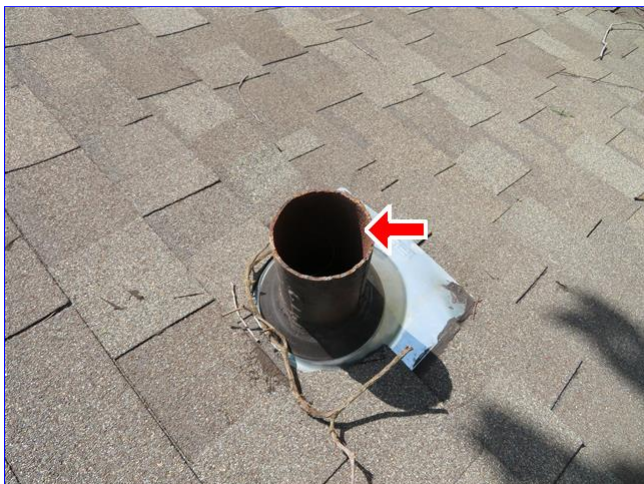
B. Item 5(Picture)

(5) Roof plumbing stack is not correct at time of inspection. Should have a professional plumber inspect and correct properly.

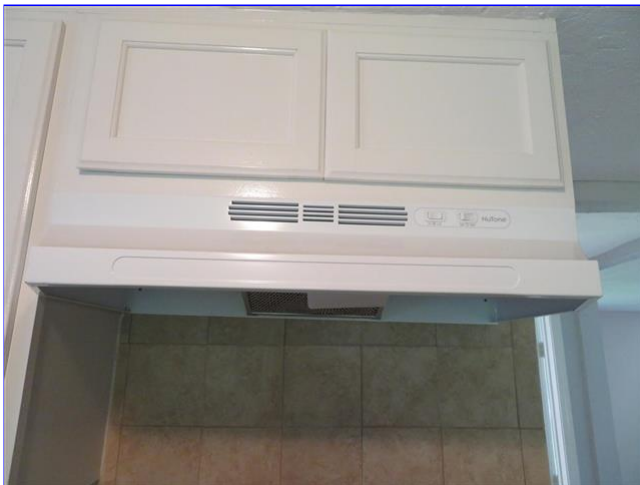
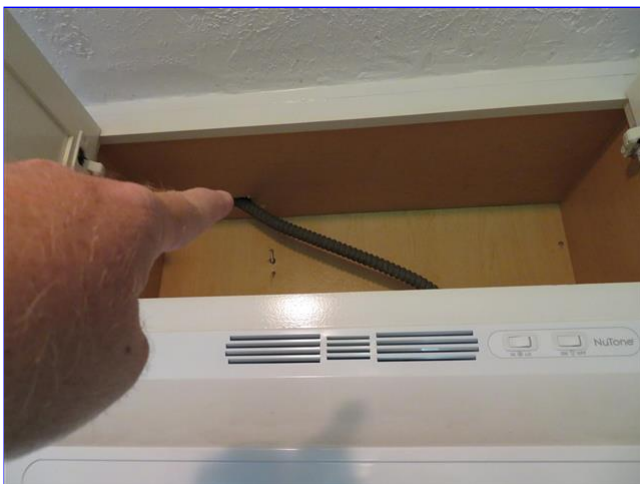
NuTone exhaust fan and light was working properly at time of inspection. Unit was missing cord plug and electrical outlet. Should have a professional electrician inspect and correct properly.

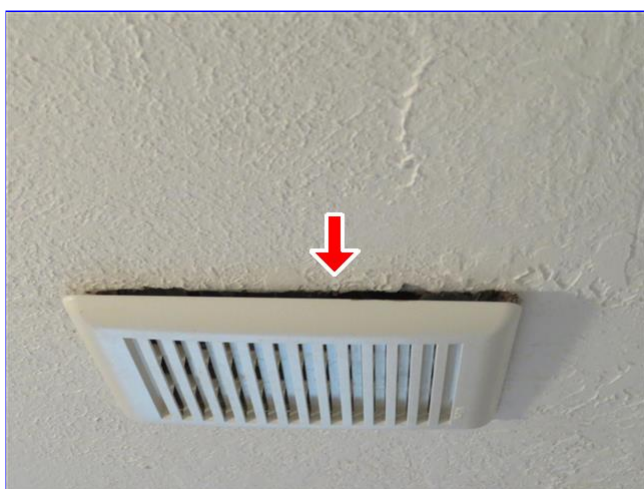
F. Item 1(Picture)

Bathroom exhaust fan was loose from the ceiling at time of inspection. Should have a professional secure and seal properly to the ceiling.
