PROPERTY INSPECTION REPORT

18107 Dalyell Dr Richmond, TX 77407

By: Daniel Byrd #10340
(Name, License Number of Inspector)

04-05-2019
(Date)

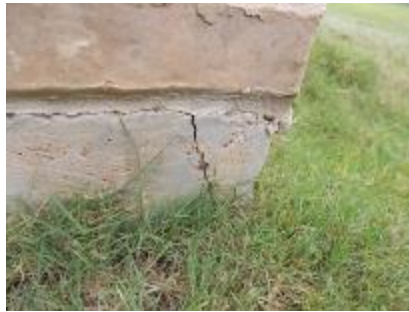
Comments: There is a popped corner at the back right corner. Grout the popped corner.

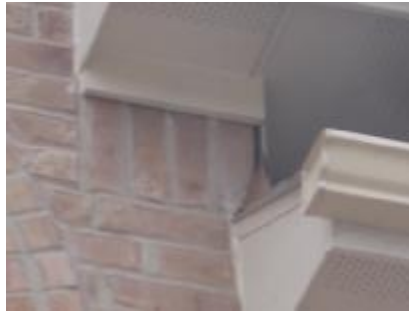
Comments: There is a penetration at the upper front right brick veneer. Seal the open penetration at the front exterior upper right brick veneer.

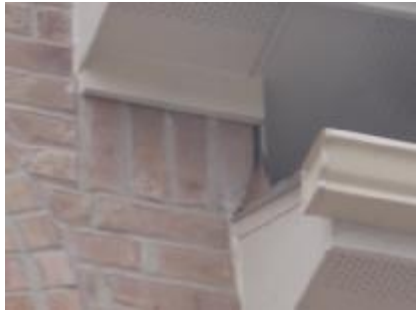
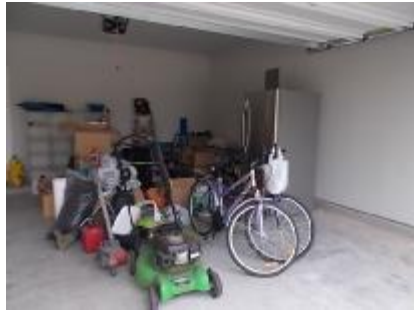
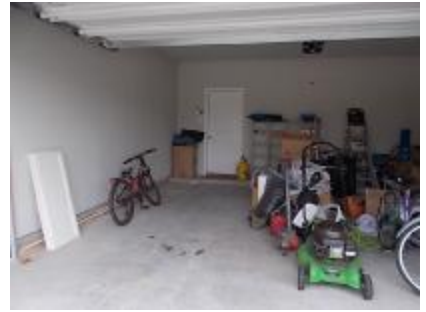
Penetration at front exterior brick veneer/garage

There is a penetration at the upper front right brick veneer. Seal the open penetration at the front exterior upper right brick veneer.
