# Cornerstone Inspection Service

# PROPERTY INSPECTION REPORT

**Concerning:** 5826 Dunsley Drive, Katy, TX 77449  
(Address or Other Identification of Inspected Property)

**By:** Kenneth K Kerby, Lic #21565 06/22/2019  
(Name and License Number of Inspector) (Date)

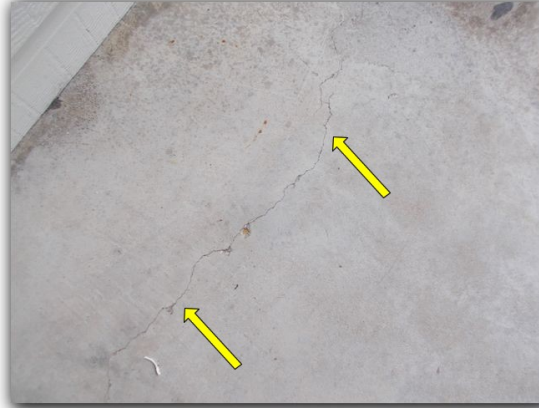
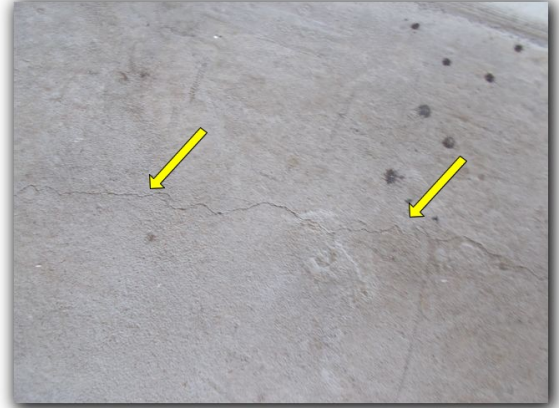
\* There are various cracks in the concrete of the rear patio, the garage floor, etc. for the home - this cracking is fairly common but need to monitor as this is a sign of ground movement.

\*\* The foundation is showing evidence of movement such as the various stress cracks, etc. This movement appears to be normal for the age of the foundation. In my opinion the foundation was working according to design at the time of inspection.

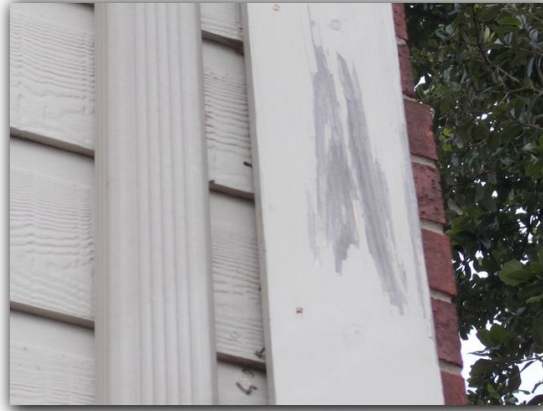
\* There is deteriorated and worn exterior caulking and paint on the home - need to repair the

deteriorated and worn painting of the home to protect the exterior wood of the home.

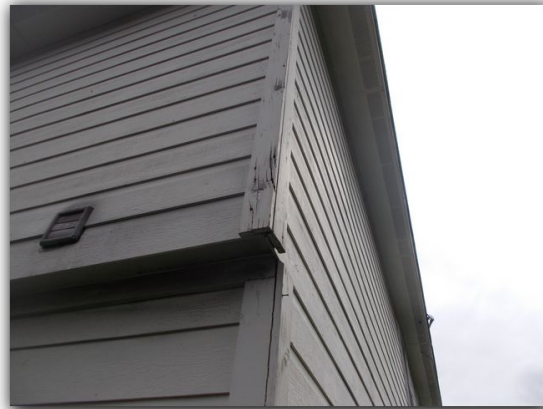
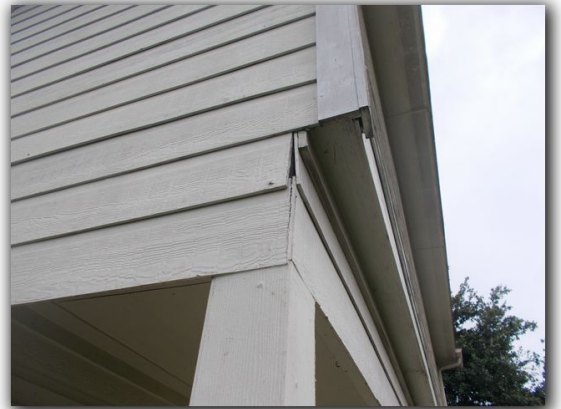
\* There is various damage and deteriorated areas in the exterior siding and trim of the home such as on the rear of the home – need to repair the damage to the siding and trim of the home and seal with caulking and paint.

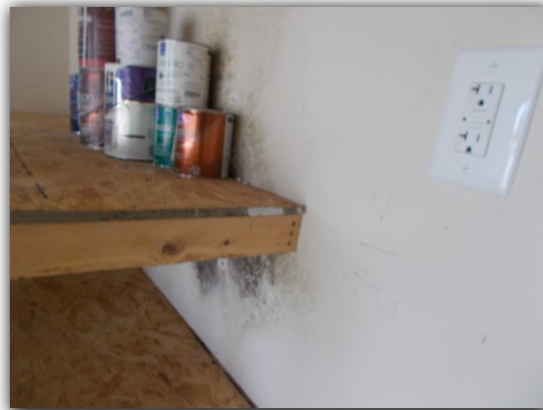
\* There is some organic growth on the sheetrock wall of the garage for the home - need to remove this organic growth from the wall to assure no further damage will occur.

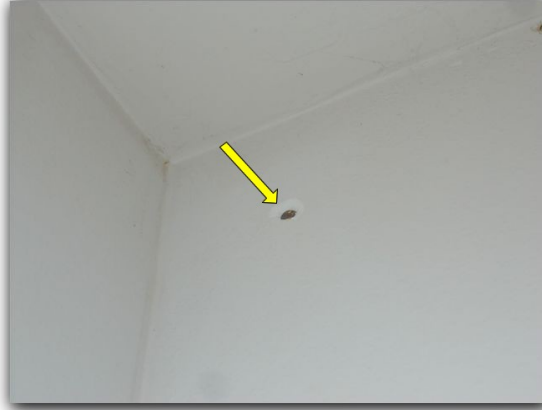
\* There are some nail pops in the sheetrock of the walls and ceilings in the home such as in the kitchen area – need to repair these nail pops.

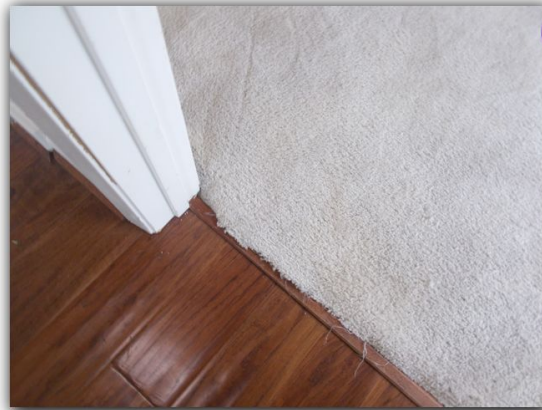
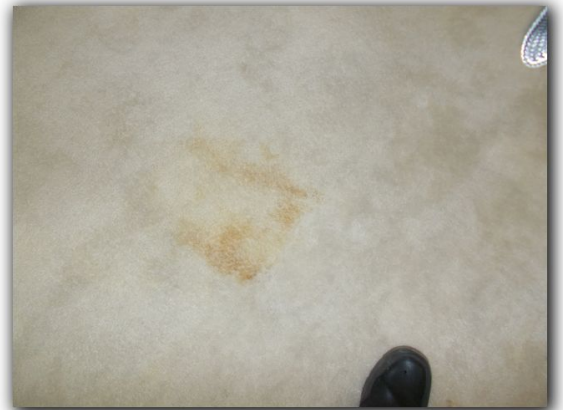
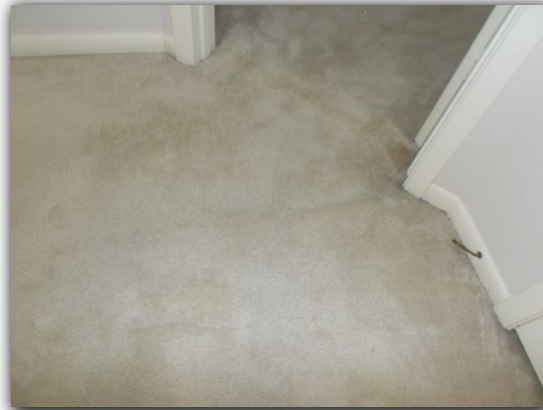
\* The carpeting in the home is damaged, loose and stained in places - need to repair/replace the carpeting in the home.

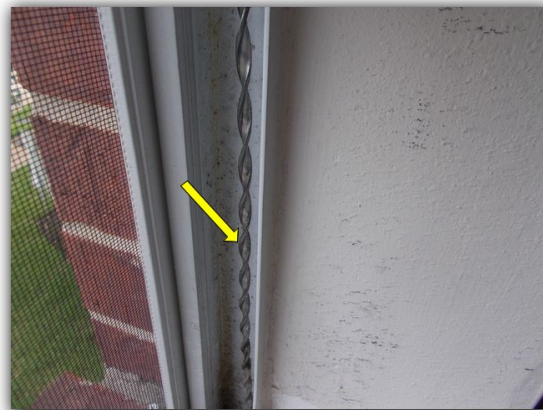
\* There are windows in the home such as in the master bedroom of the home that have broken rods in the tracks, and one of the windows in the master bedroom will not stay up correctly – need to repair the rods in the window tracks to assure the windows will open and close correctly.

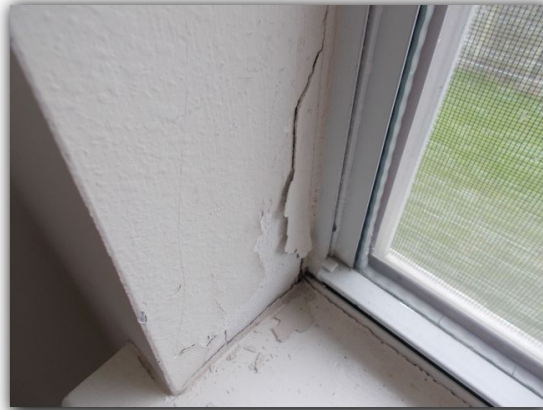
\* There are various windows in the home that have previous water damage at the window sills – these sills were dry at the time of the inspection but need to repair any damage and monitor.

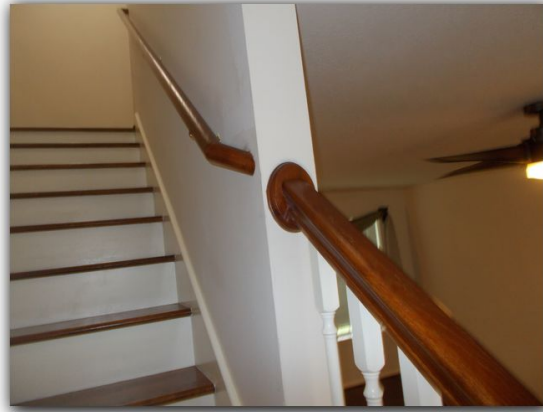
\* The stairway of the home did not have a continuous handrail - need to place a continuous handrail at the stairway of the home for safety.

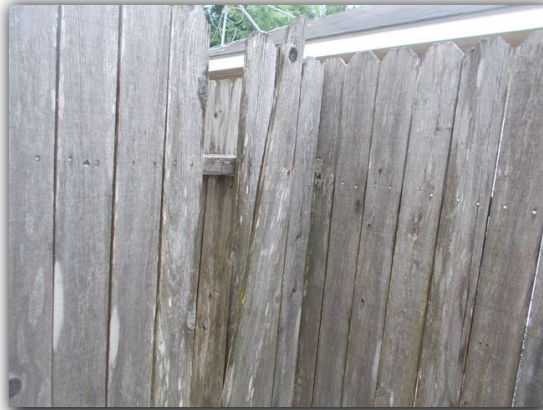
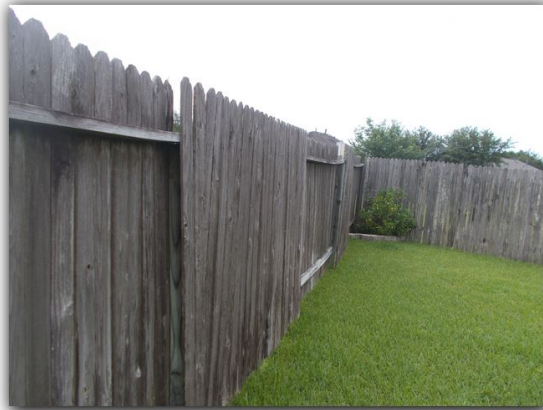
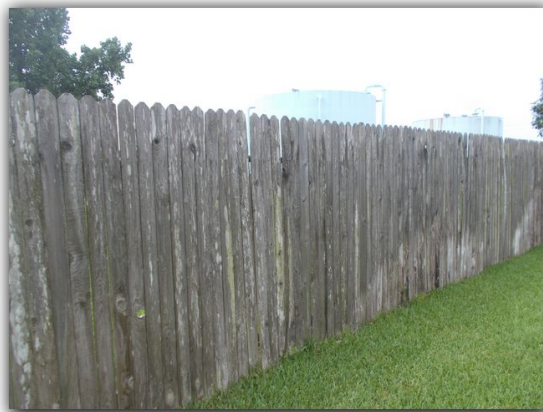
\* The wood fencing for the back yard of the home has deteriorated and missing boards, and is leaning in areas - need to repair/replace all deteriorated and missing boards of the fence and secure the fencing.

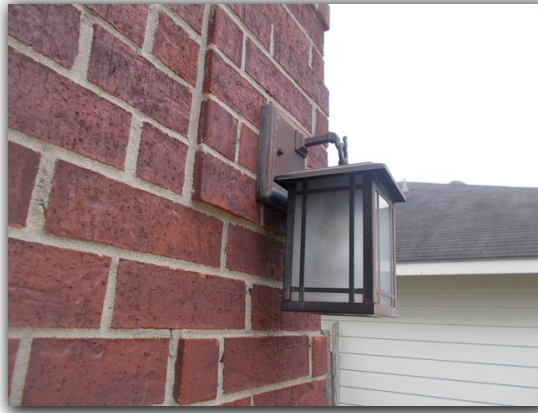
\* The exterior carriage lights on the front of the home are loose and not sealed on the wall - need to secure and seal these lights to the exterior wall of the home to protect the lights and for safety.

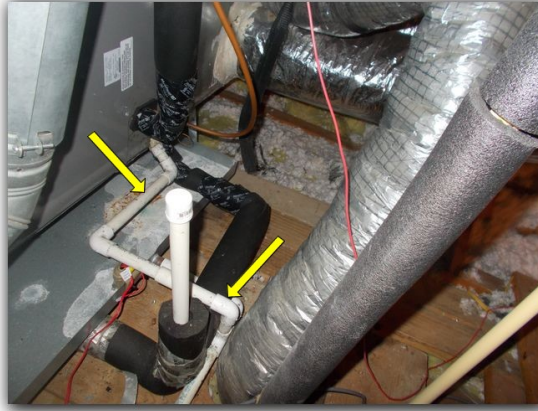
\* The primary drain piping for the evaporator coil of the cooling system that should terminate at the drain for the lavatory in the master bathroom of the home is bypassed and directed to drain into the secondary pan drain terminating in the soffit of the rear of the home - recommend further evaluation of the coil drain by a qualified technician to assure no further damage will occur.

\* The primary drain piping for the evaporator coil of the cooling system that should terminate at the drain for the lavatory in the master bathroom of the home is bypassed and directed to drain into the secondary pan drain terminating in the soffit of the rear of the home - recommend further evaluation of the coil drain by a qualified technician to assure no further damage will occur.

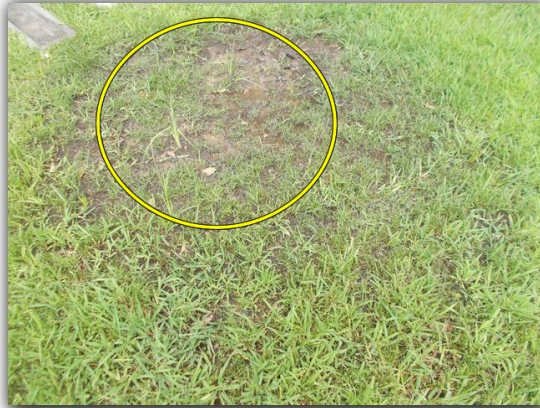
\* There is a wet spot in the left side front yard of the home, this appears to be a spot where a leaking pipe is under the ground in this area - recommend further valuation of the piping in the yard on the left front side of the home by a qualified technician to fix the problem.

\* There is a wet spot in the left side front yard of the home, this appears to be a spot where a leaking pipe is under the ground in this area - recommend further valuation of the piping in the yard on the left front side of the home by a qualified technician to fix the problem.

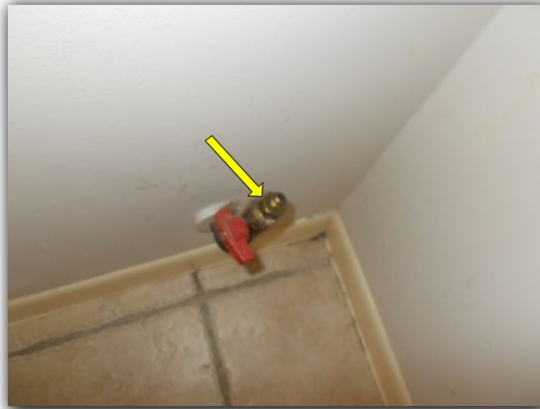
\* The gas supply for the dryer of the home is not capped - need to cap the gas supply if an electric dryer is used for safety.
