Bulkhead/Terracing History

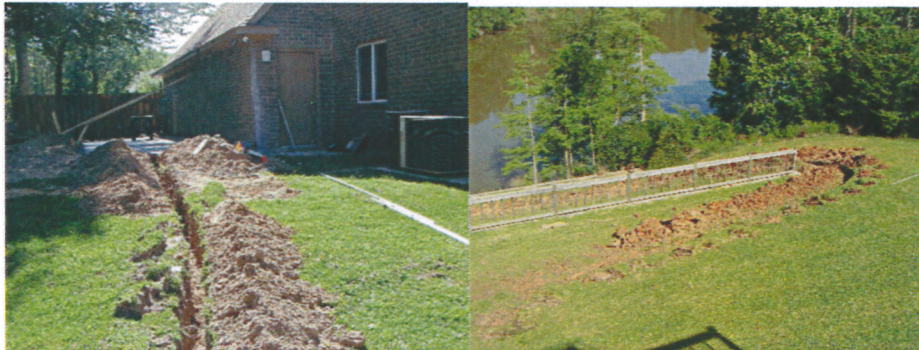
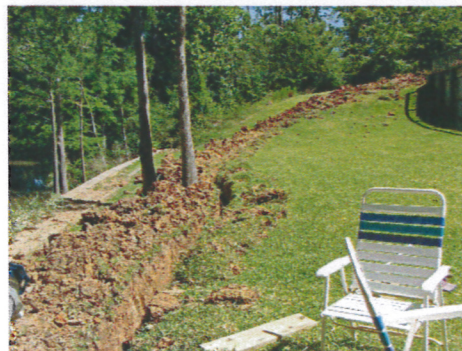
- We had our lakefront area terraced with standard wood bulkhead material in 2001.
- In 2006, we added a dock and contracted an electrician to provide power to the waterfront
- Instead of a small 6 inch trench directly to the waterfront that we had expected to run the electric wiring, we came home to find a 3-4 ft. deep serpentine trench passing close to the edge of the bulkhead and terrace walls:

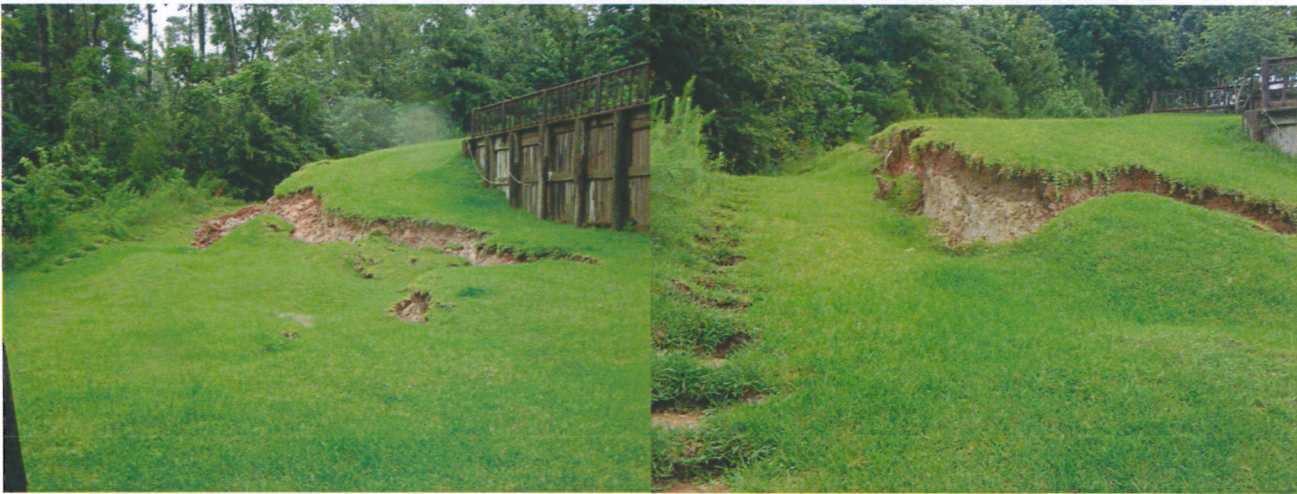
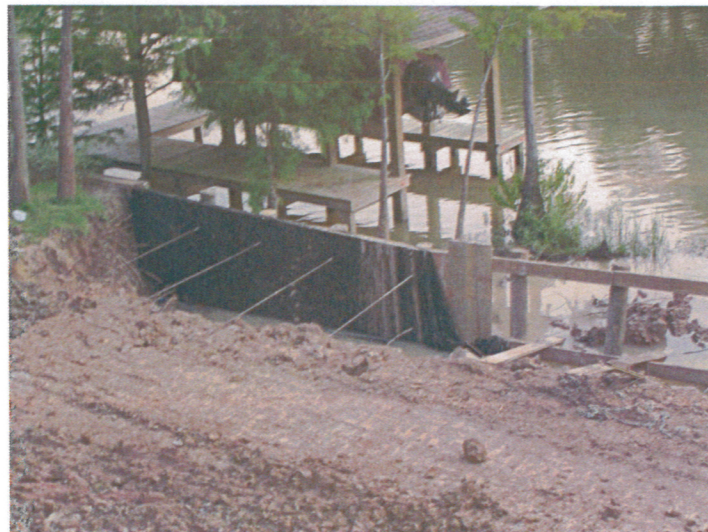
- A few months after this work, we notice some ground shift in the track of the trench and areas below:
- Investigation reveals that the trench damaged tie backs to the lower walls permitting the movement:

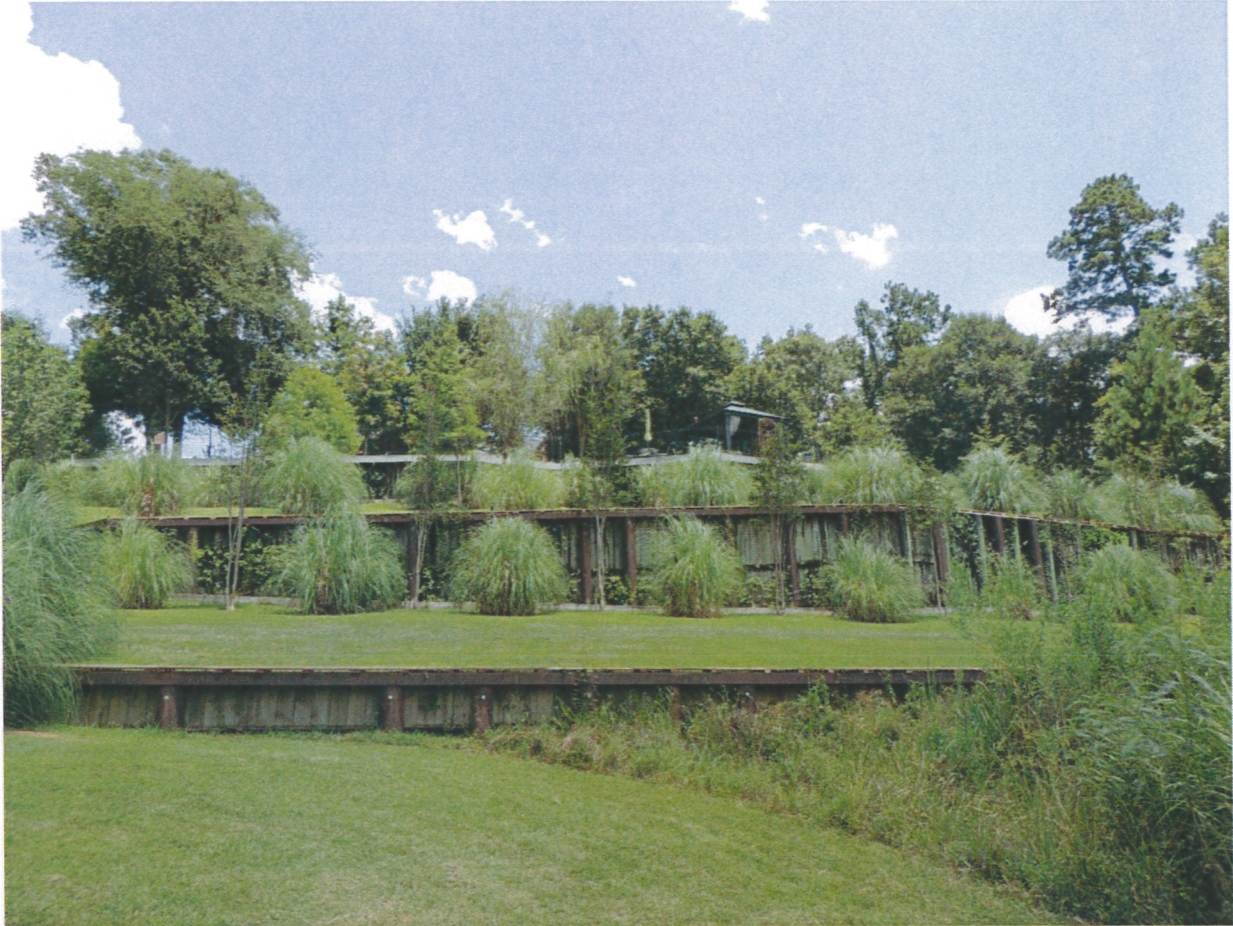
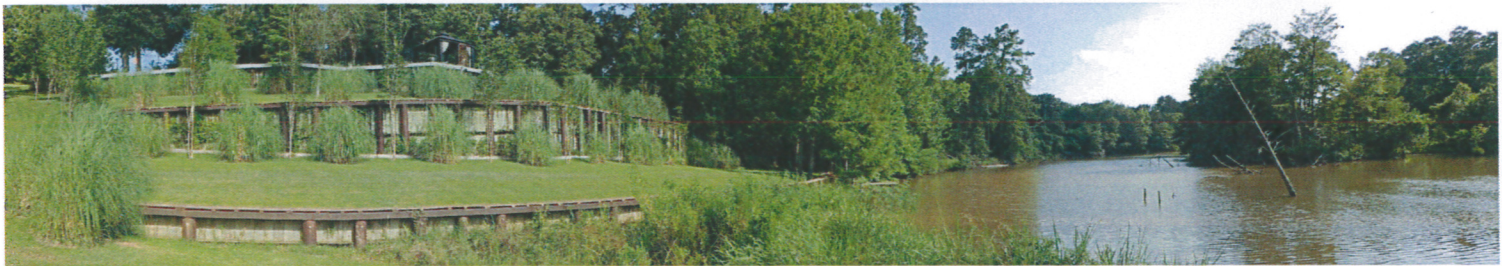
(10 years later)

The Result
