**Information for Submitting an Offer
1306 Ravenel Lane**

This Property Inspection Report of 1306 Ravenel Ln, Sugar Land, TX 77479 is prepared for [REDACTED]

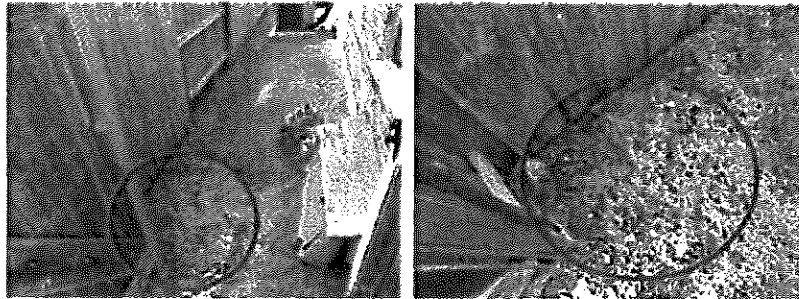
- Drainage improvements are needed at the left side of the home. Standing water was observed. All excess surface moisture should drain to the street as designed.

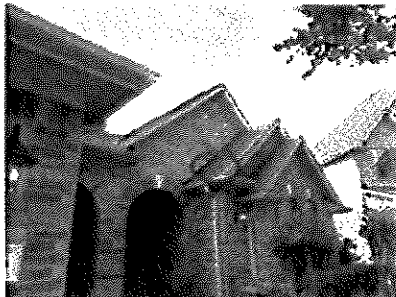
- The roof appears to be original to the home (approximately 11 years old). The average life span of an asphalt roof in this climate is 15-20 years. Normal wear and deterioration consistent with the age of the roof was observed. All roof penetrations should be examined and sealed as necessary. Further investigation by a reputable roofer should be consulted to determine the full condition of the roof and costs associated with repairs. See additional comments below.
- A roof leak likely exists on the lower front roof above the right front guest bedroom closet area. Moisture was observed on the closet ceiling. Repairs should be undertaken as necessary. See addition comments and pictures in the ceiling section below.

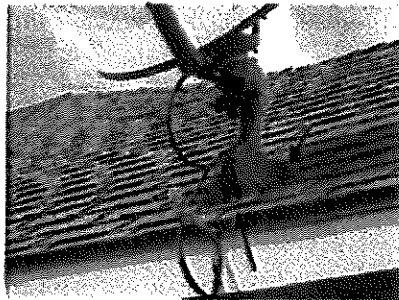
- A satellite dish is mounted to the roof covering. Higher than normal maintenance should be expected in this location.

Think these were fixed prior to sale

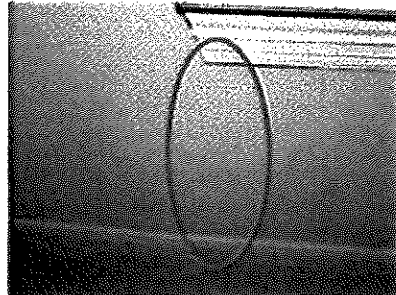
- Water staining was observed under the windows in the right front guest bedroom. This area was dry at time of inspection.

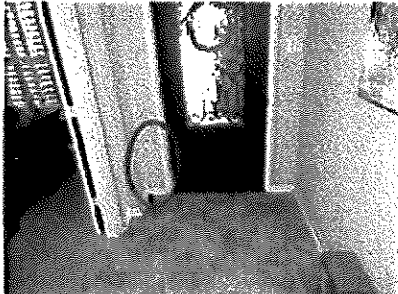
- Water staining was observed on the wall near the front door. This area was dry at time of inspection.

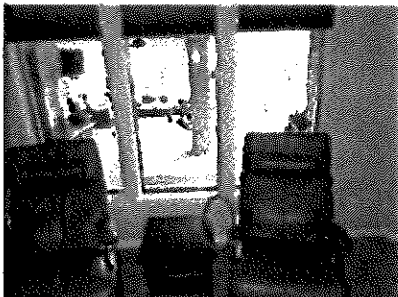
- Water staining was observed underneath the living room rear window. This area was dry at time of inspection.

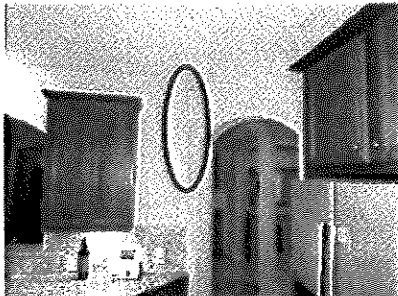
- Minor cracking and separations of the drywall tape joints were observed at the kitchen near the front entrance.

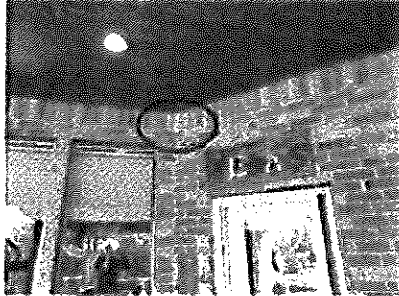
- Brick and fiber cement exterior veneer was observed.
- The bricks at the rear patio wall above the back door are loose.

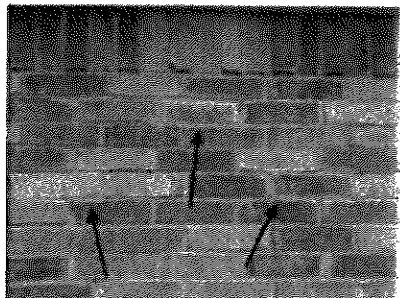
- Mortar repairs were observed in the brick veneer at the rear patio and right side exterior walls.

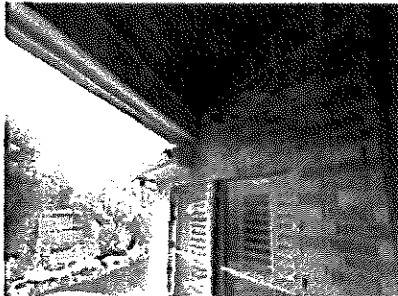
- A missing brick was observed at the rear patio wall corner.

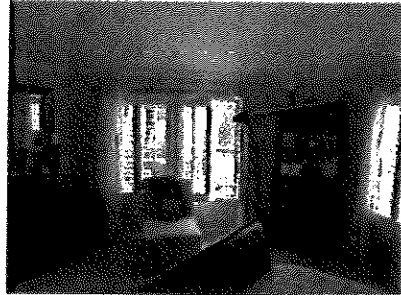
- Double pane, single hung and fixed windows
- The master bedroom window has lost its seal between the window panes. This condition has created discoloration between the window panes.

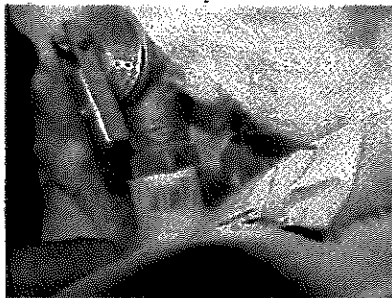
- 2006 State Brand 50 gallon water heater was observed in the attic.
- The water heater was wrapped with insulation. All areas were not visible.
- Water staining was observed running from the bottom of the temperature and pressure relief valve, down the exterior of the water heater, across the right side of the manufacturer's nameplate. The area was dry at time of inspection.

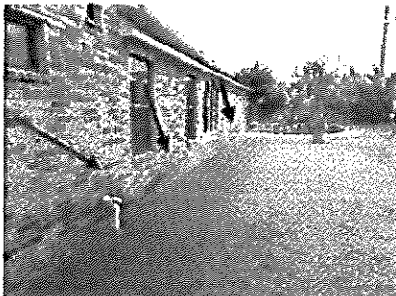
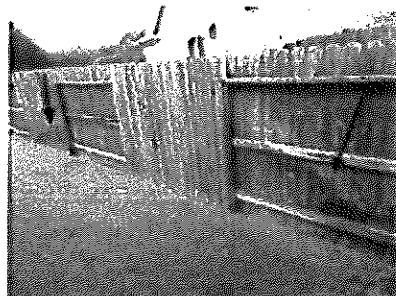
- Rain Bird Brand 6 zone lawn sprinkler system was operated in manual mode only.
- The water spray from the sprinkler system should be re-directed away from the structure and/or any fencing, decks, etc., to decrease the possibility of damage.

Adjusted
