HOME INSPECTION & PEST CONTROL

**Pedro Arguello  
191 Paradise Trail  
Coldspring, TX 77331  
May 30, 2020**

# PROPERTY INSPECTION REPORT

**Concerning:** 191 Paradise Trail, Coldspring, TX 77331

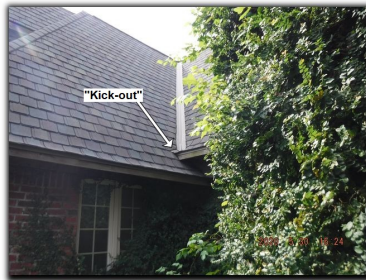
- The valley flashing "kick-out" directly onto the roofing shingles causes premature wear on the roofing material. There should be a downspout to the gutter below.

**A complete gutter system with extensions is recommended on this structure.** The gutter system is designed to expedite the drainage of water away from the property. Splash plates located under the down spouts can help direct water away from the foundation and reduce soil erosion, which can reduce the effectiveness of the termite chemicals placed in the soil. A properly installed gutter system is an important tool in maintaining even moisture content in the surrounding soil.

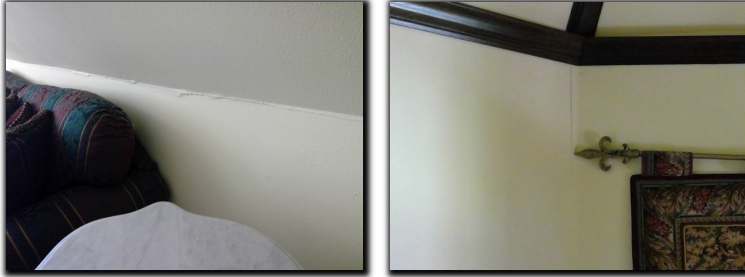
- Some minor tape wrinkling and joint cracking was observed.

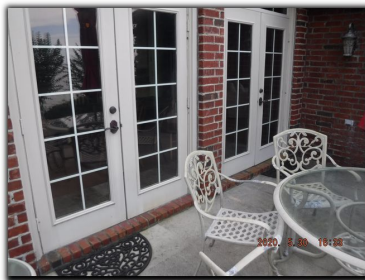
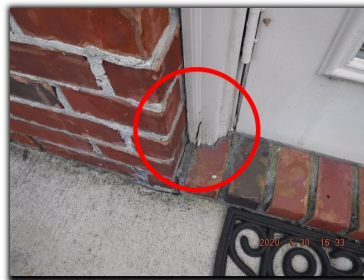
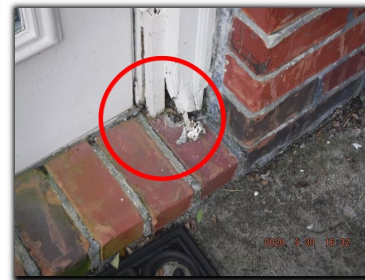
- Door trim or entry ways with wood rot should be repaired. Wet and rotten wood trim increases the possibility of insect infestation.

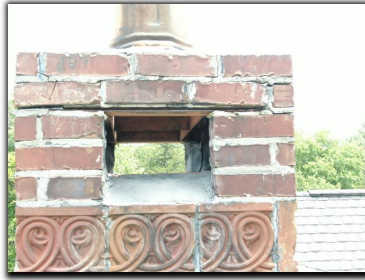
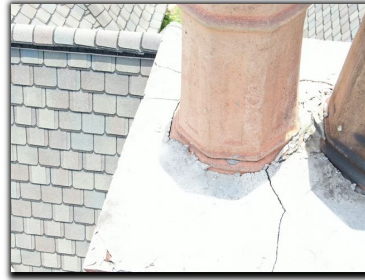
- **The masonry chimney shows evidence of substantial deterioration.** Recommend contacting a qualified contractor.
- **Concrete on top of the chimney stack has minor cracks.** Recommend these cracks be caulked or refinished to avoid water penetration into the fireplace framework area.

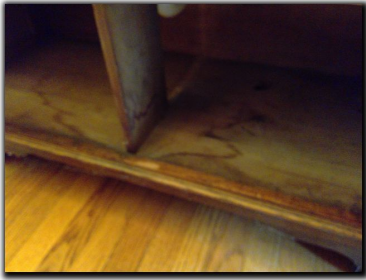
- Water stains in upstairs master bath

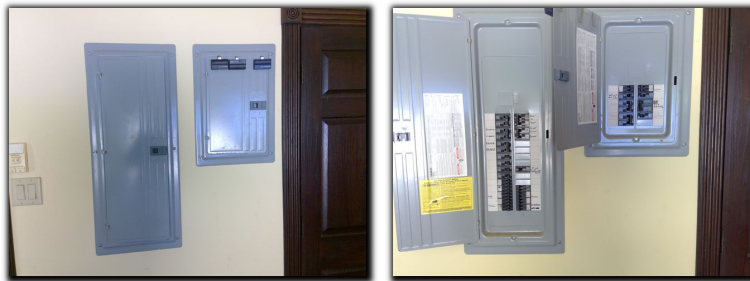
- There was no main disconnect observed in the panel box. This may be an "as-built" condition but Per TREC standards of practice we are required to report this condition as a deficiency.

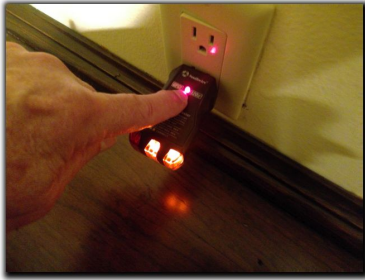
- No ground fault circuit interrupter (GFCI) protection was observed for the receptacles in the upstairs master bathroom. Under current electrical standards, all of the exterior receptacles, all kitchen counter top receptacles, all bathroom receptacles, wet bar countertop receptacles, laundry room sink countertop receptacles, garage non-appliance dedicated receptacles and pool lighting should have GFCI protection.

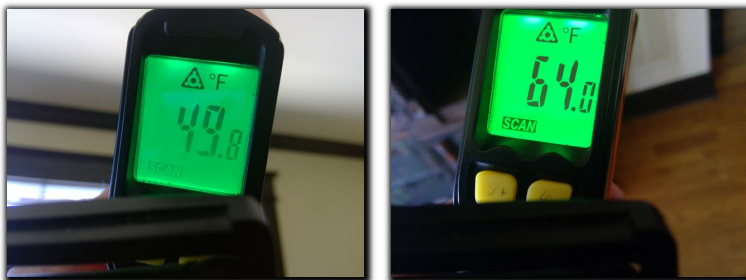
Unit 1 the output temperature = 49 ° and the input temperature = 64 ° for a differential of 15 ° (normal □ range 14° - 23°). These temperatures are **within** the recommended tolerances.

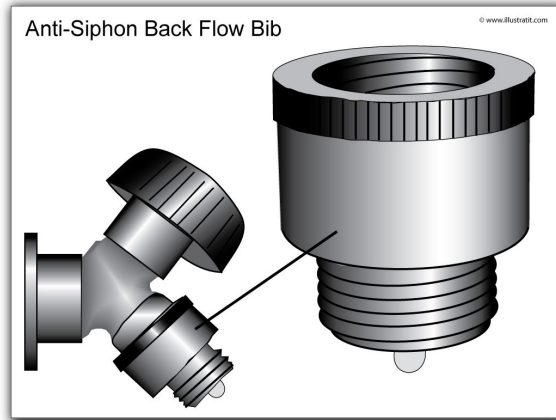
- One or more of the exterior water hose bibbs (faucet) do not have a back-flow or anti-siphon device (Vacuum Breakers) in place. **Note:** *This is not uncommon to observe with a home of this age.*

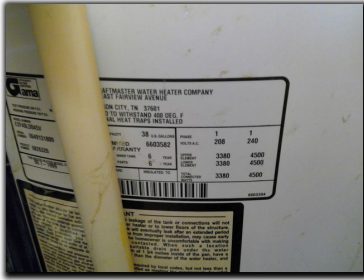
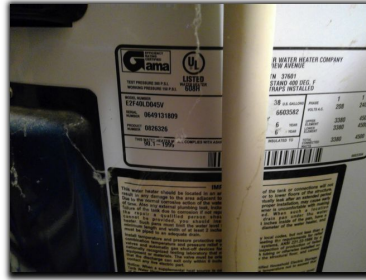
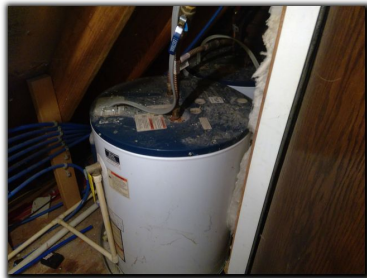
- **Two units connected in series.**

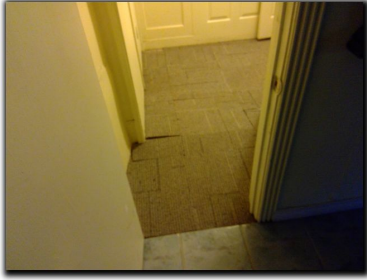
- There is a high area in the floor between the bedroom and the laundry room. The inspector cannot explain this.

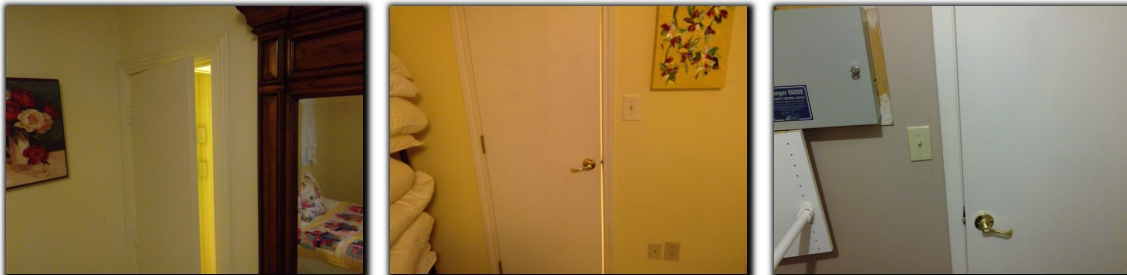
- More than one door is out of alignment and does not latch or close properly.

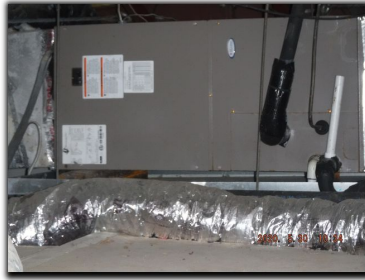
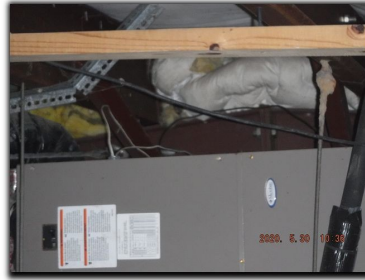
**Air Handler/furnace is above the ceiling and is not accessible for inspection.**

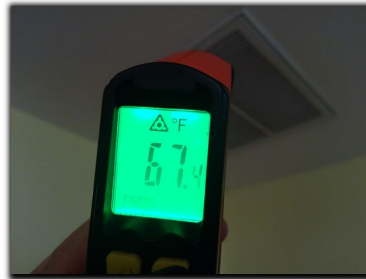
**Unit 1** the output temperature = **52 °** and the input temperature = **67 °** for a differential of **15 °** (normal  range 14° - 23°). These temperatures are **within** the recommended tolerances.

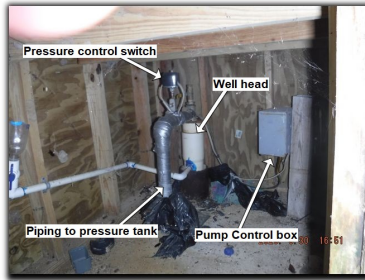
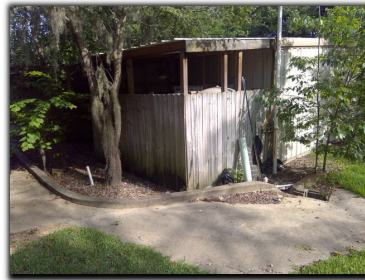
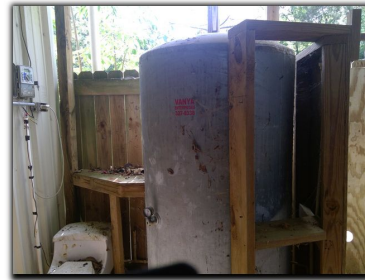
- Water supply well head and pressure tank for the buildings at this address.

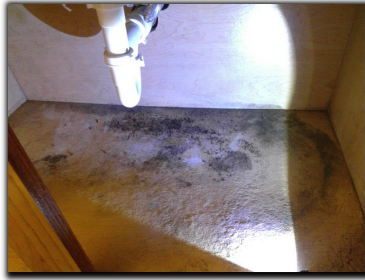
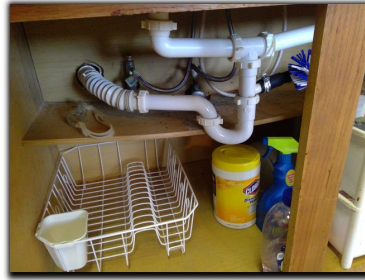
- **There was an unknown dark mold like substance observed in the kitchen cabinet.** Evaluation of this substance is beyond the scope of this inspection. If any concerns exist on the type and/or nature of this substance, we recommend further evaluation by a professional in the Air Quality sampling field.

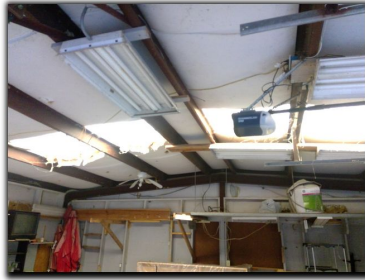
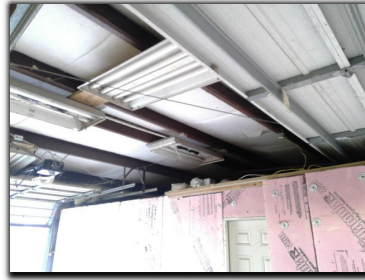
- There are two garage door openers in the structure. One is inoperative due to a broken or damaged chain drive mechanism. The other door is propped open with a length of PVC pipe and was not tested.
