Inspection Report

Property Address:
1415 Ruthven
Houston TX 77019

PROPERTY INSPECTION REPORT

Concerning: 1415 Ruthven, Houston, TX 77019

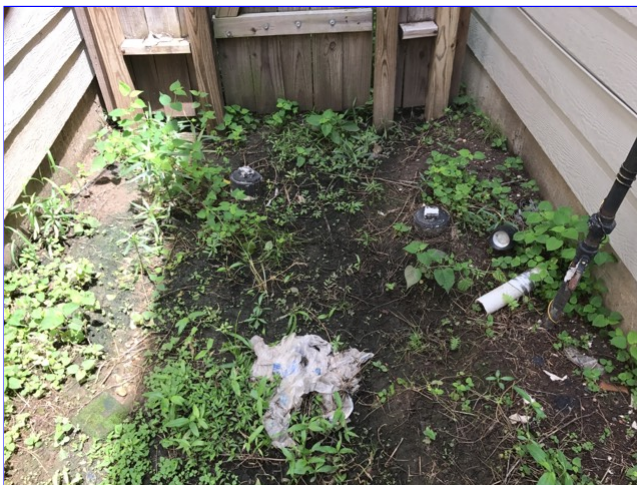
(1) On the west side of the house there is an area where water accumulates. This area should be monitored. Any water standing more than 48 hours indicates the need for subterranean drainage in this area.

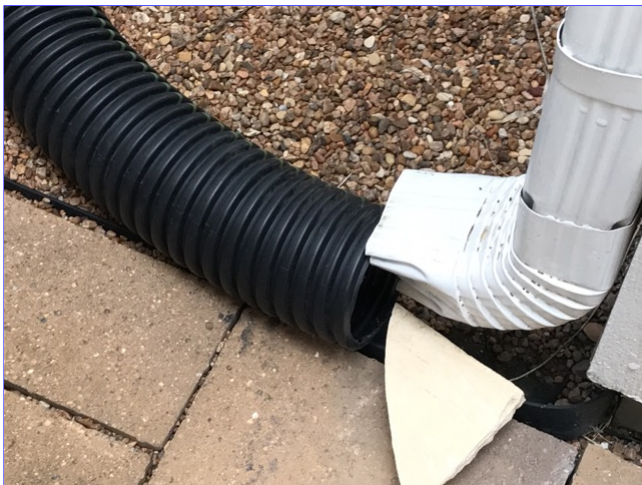
(2) Gutter discharge pipe is disconnected.

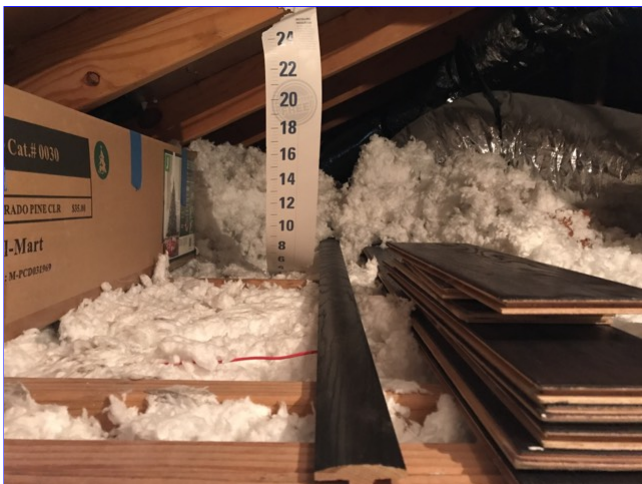
Insulation depth gauge. For information only.

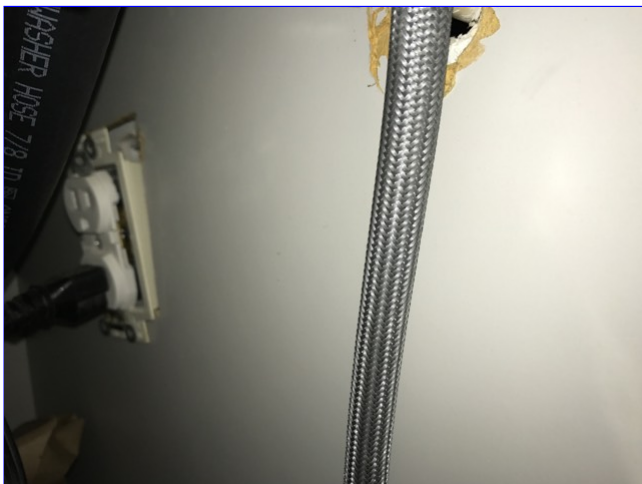
(1) The plug receptacle outlet has no wall cover plate in the ground floor kitchen. A qualified contractor should be consulted for correction.

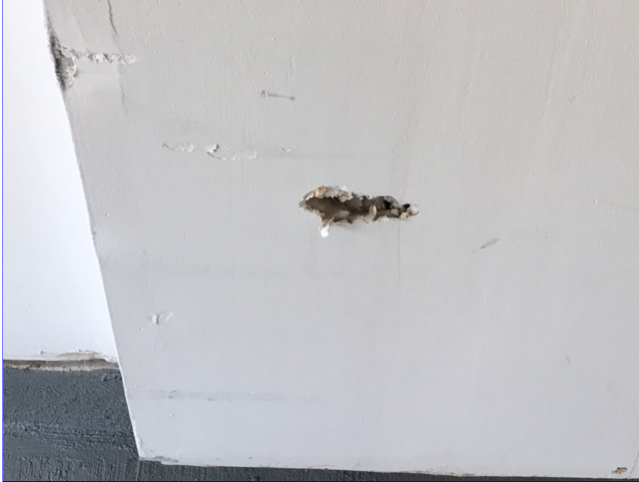
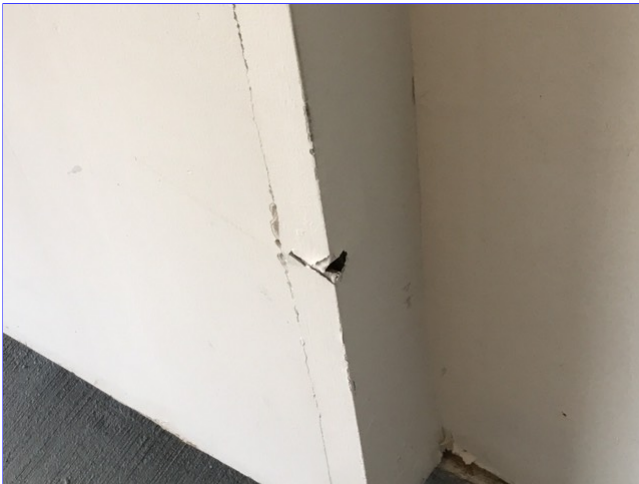
(2) Unsealed penetration in the wall cladding in the garage. A qualified contractor should be consulted for correction.

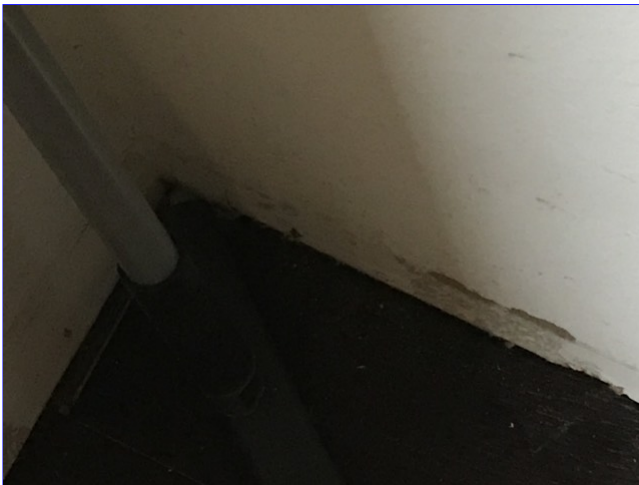
(3) Upstairs hallway closet missing baseboard trim. A qualified contractor should be consulted for correction.

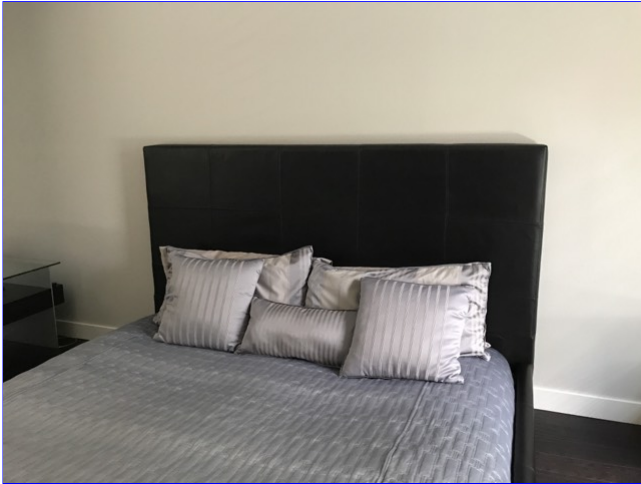
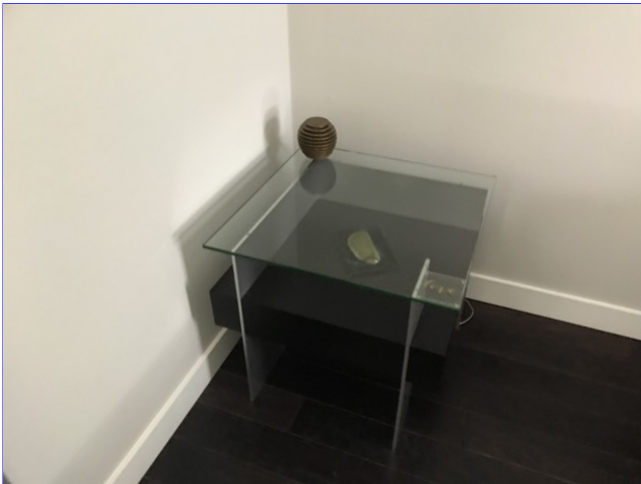
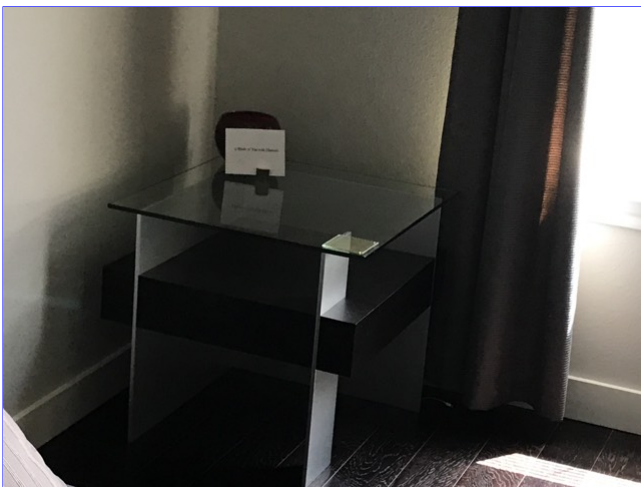
(4) Wall of master bedroom obstructed by personal belongings.

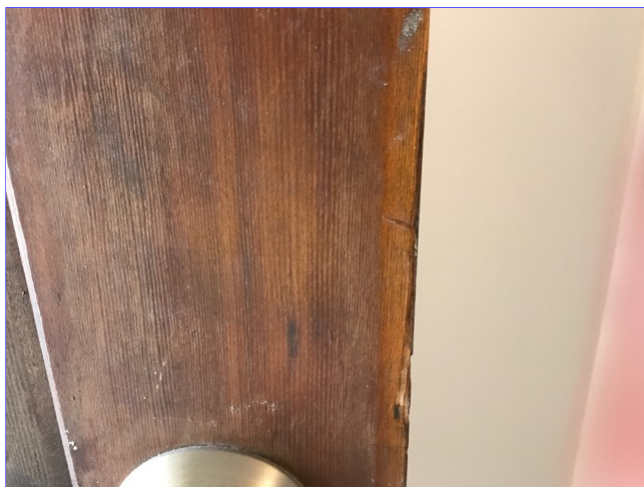
(1) Exterior door finish is deteriorated. This may lead to moisture intrusion and damage to the door. A qualified contractor should be consulted for correction.

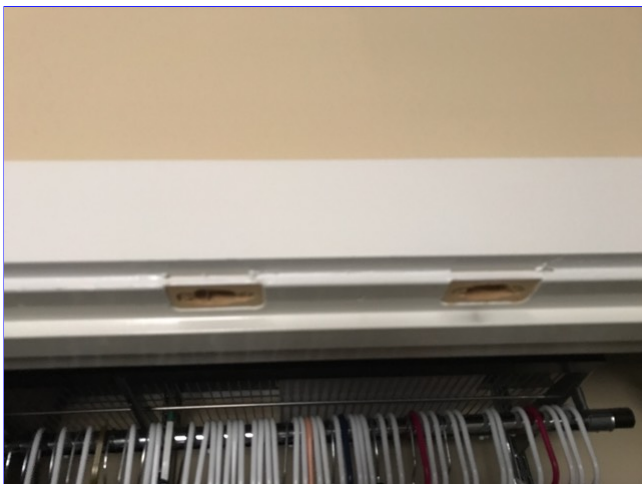
(3) Upstairs southwest bedroom closet doors are missing strike plate at the top. A qualified contractor should be consulted for correction.

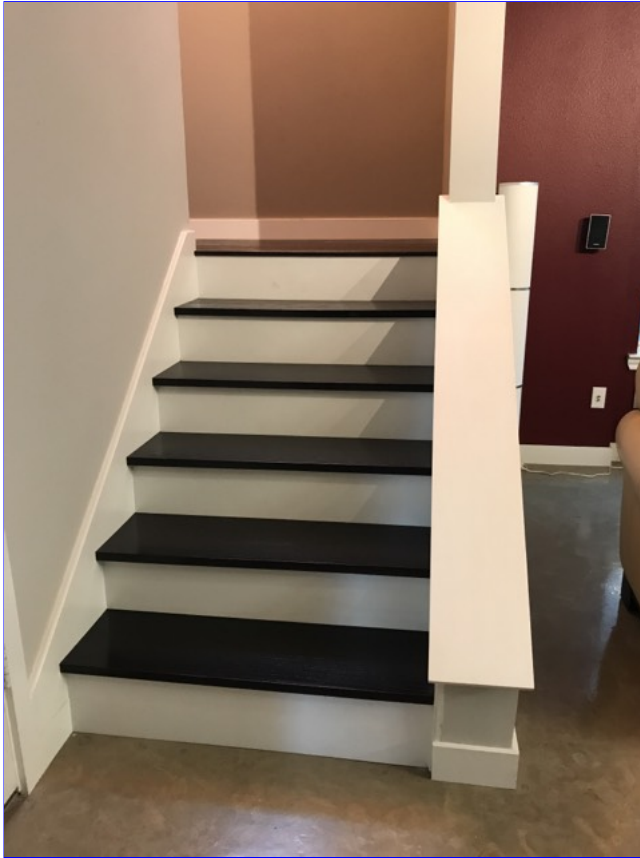
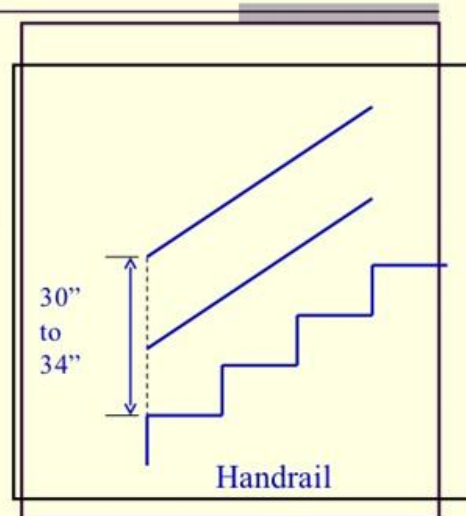
- All stairs with 4 or more risers must have standard stair rails or handrails
- The vertical height must be between 30 and 34 inches from the surface of the tread at the front of the tread

Six riser stairway in living room does not have a standard handrail. This is a safety concern. A qualified contractor should be consulted for correction.

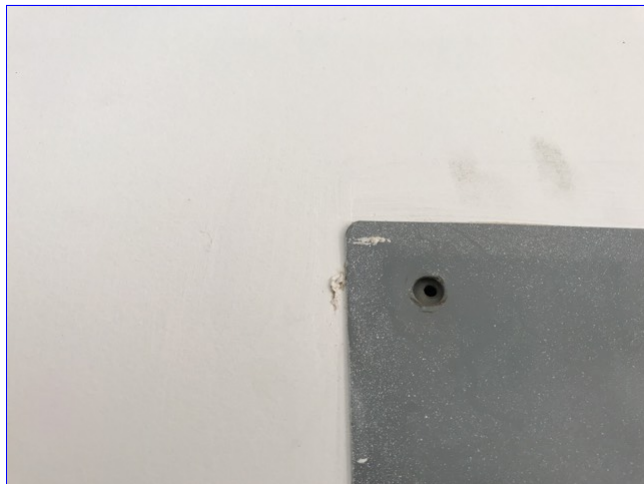
(1) The electrical service/distribution panel dead front is missing screw(s) and is unsecured. This is a safety issue. A qualified electrician should be consulted for correction.

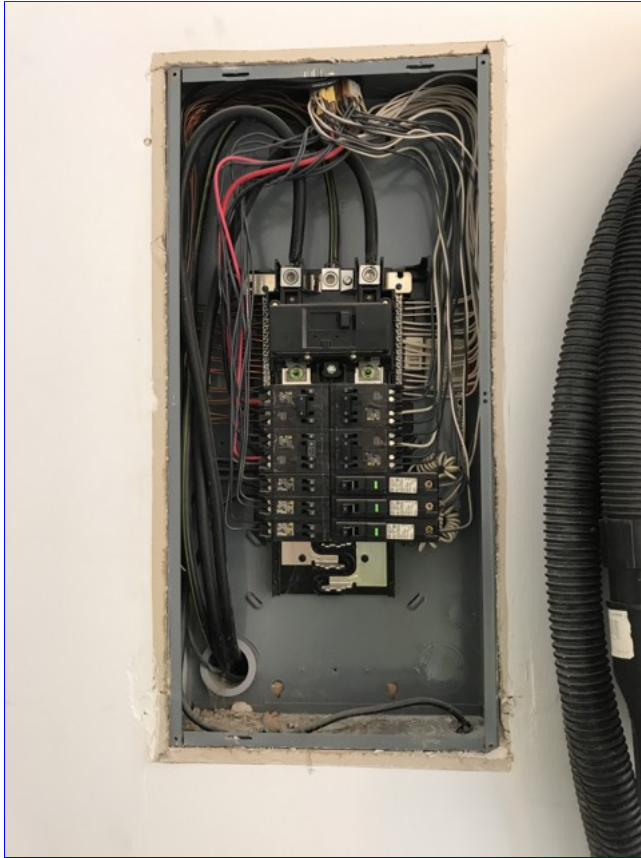
(2) The main electrical service and distribution panel is located inside the structure in the garage. This is for information only.

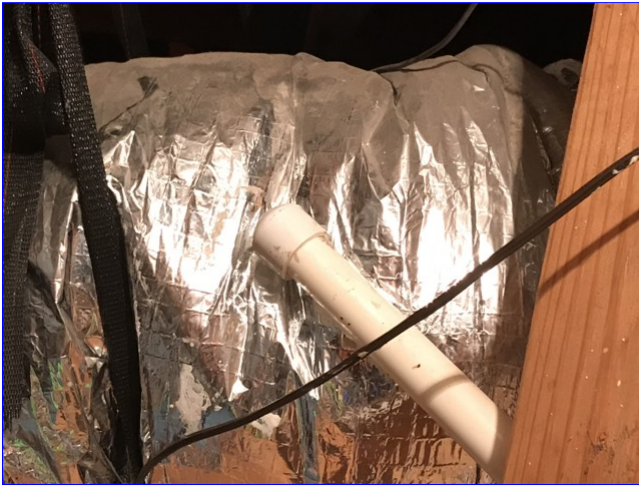
(1) The capped PVC pipe is the primary condensate drain cleanout. The primary condensate drain line is prone to organic growth which will clog the drain. It is recommended that it be cleaned every three months by introducing a cleaning agent such as white distilled vinegar or chlorine bleach. If bleach is used be sure the air conditioner operates continuously for several hours after introduction of the bleach.

The cap on this cleanout prevents loss of efficiency and aids in drainage. It is loose fit so that it may be removed for quarterly cleanings. Be sure it is replaced after each cleaning.

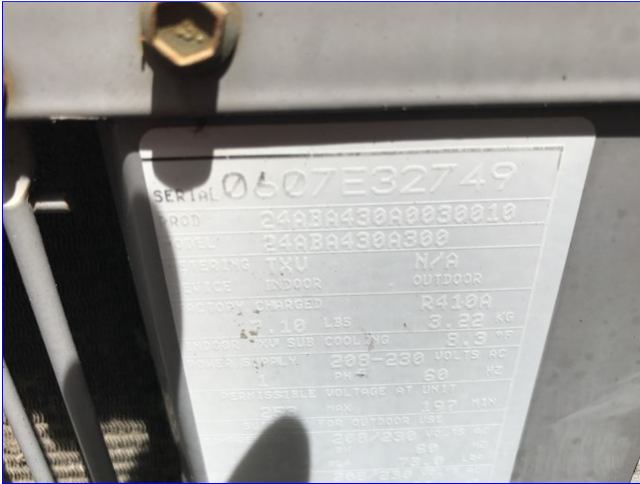
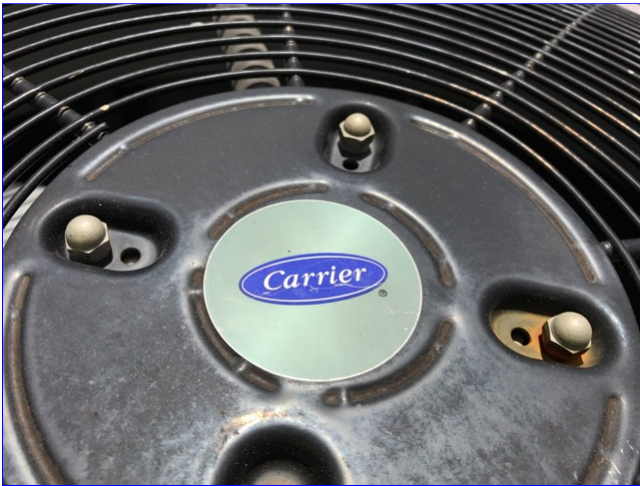
(2) Air conditioning condenser unit Manufacturer and Dataplate for information only. This unit was manufactured in 2007

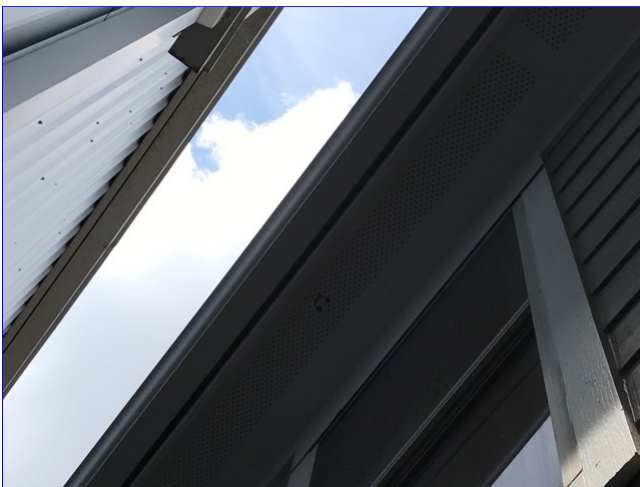
(3) The pipe in the soffit is the secondary condensate drain for the air conditioning system. Water emitting from these drains indicates a problem with the primary drain system. If water is seen, a qualified contractor should be consulted for correction. This is for information only.

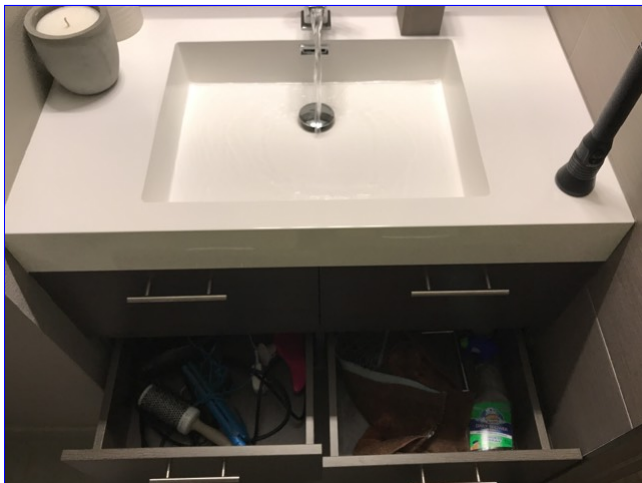
(1) Master bathroom a lavatory fixtures obstructed and not inspected.

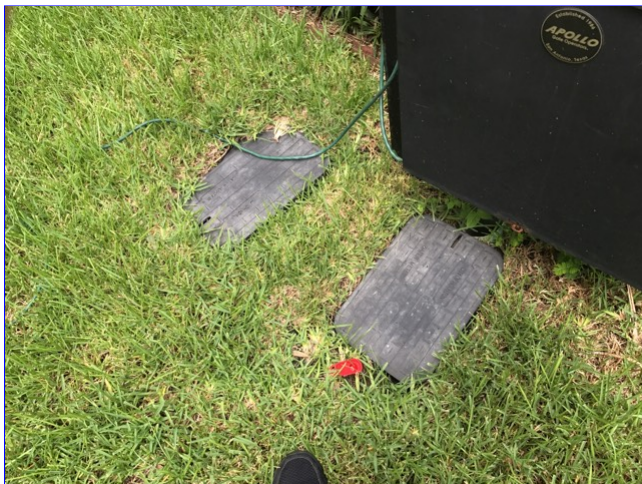
(2) The water meter is located at the utility easement at the street. The meter is closest to the north property line. The water meters were buried. I was not able to check for flow.

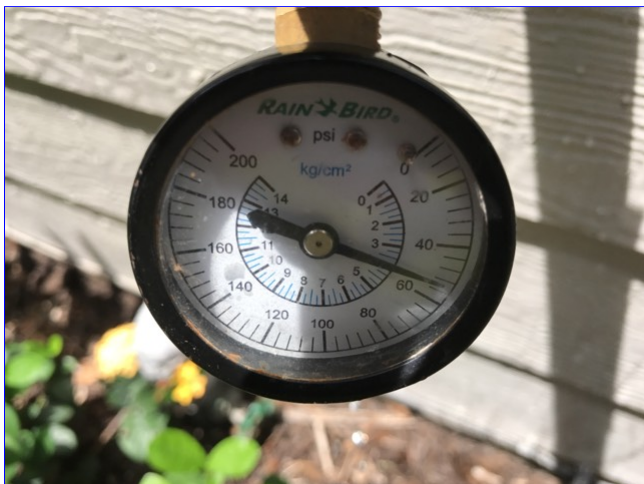
(4) Static water pressure checked at hose bibb closest to water supply entry into the structure.

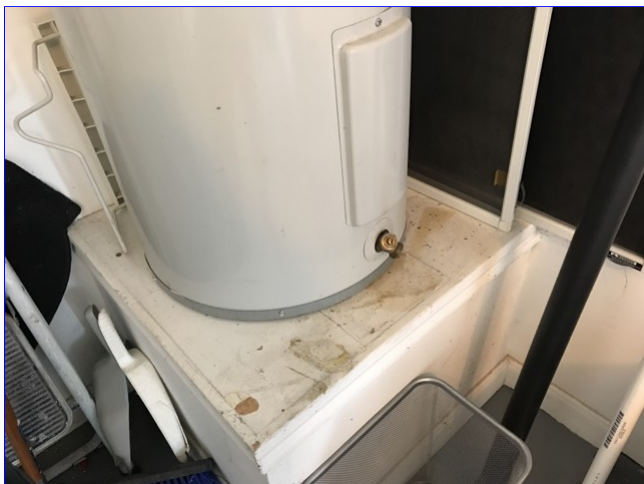
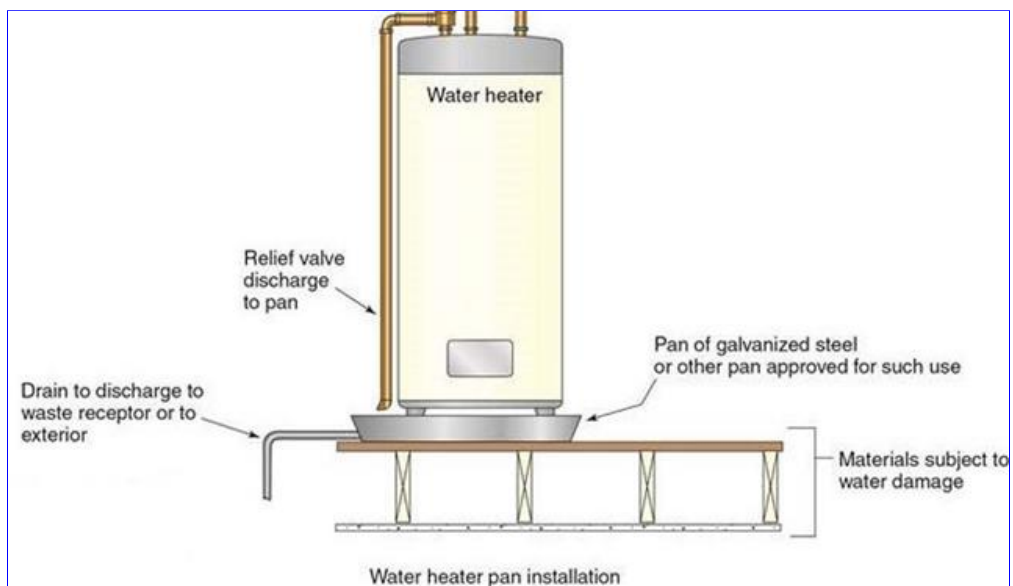
(1) Water heater has no drain pan. Any water heater located where damage to the structure may occur in the event of a leak should have a drain pan present installed in a manner that conveys the leaking water outside of the structure or to an area where damage to the structure will not occur. A qualified plumber should be consulted for correction.

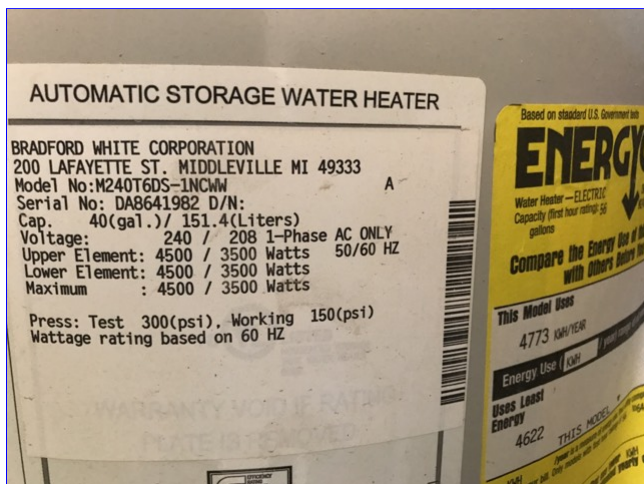
(2) Water heater dataplate(s). Unit(s) manufactured in 2007.

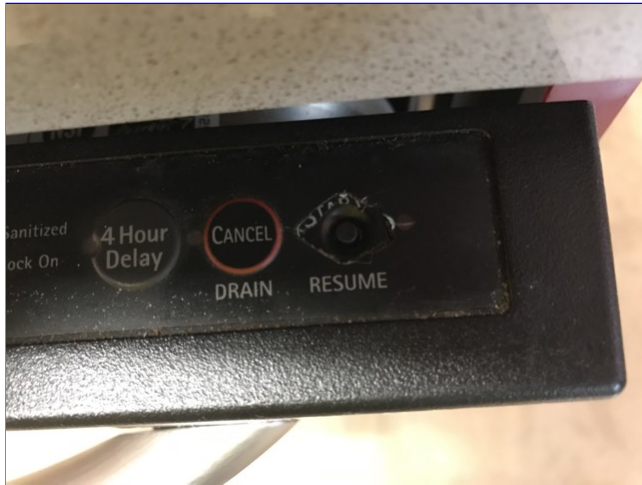
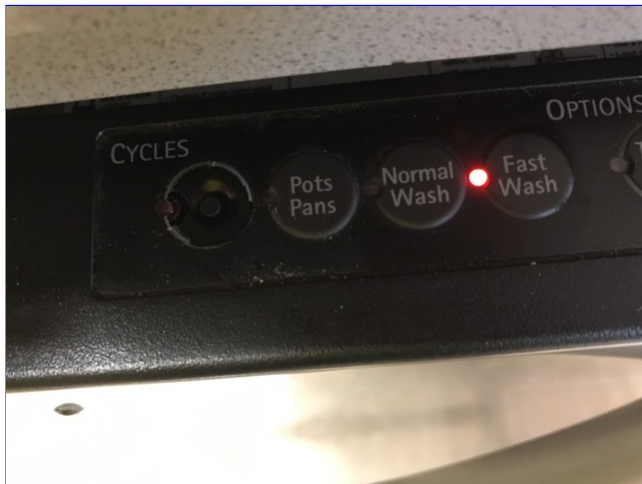
(1) Dishwasher control buttons are damaged. A qualified contractor should be consulted for correction.

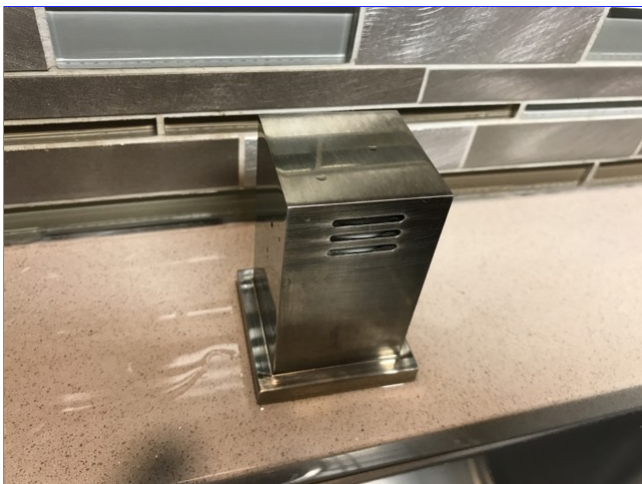
(2) The small device to the right of the sink faucet is the dishwasher air gap. It provides protection against the backflow of contaminants into the dishwasher. The cutout should face the sink so that any water emanating from the device drains into the sink. This is for information only.

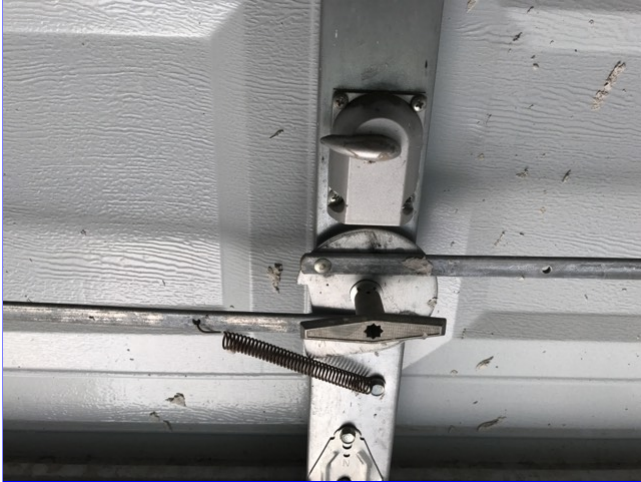
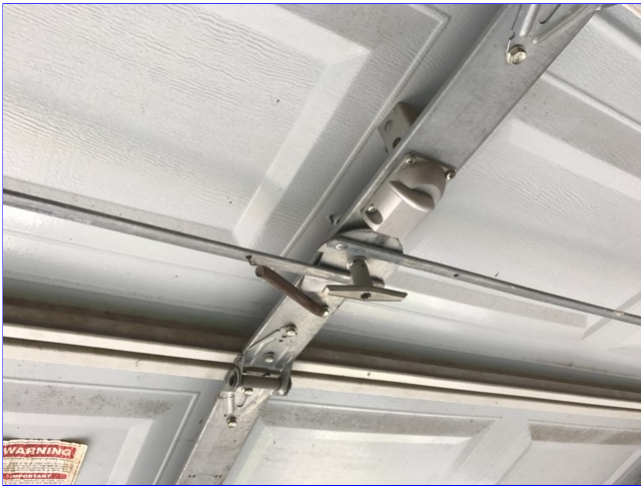
(1) Manual locks for garage doors are not disabled or removed with garage door operator installed. Engaged manual locks may cause damage to the garage door and/or personal property if the operator is engaged.

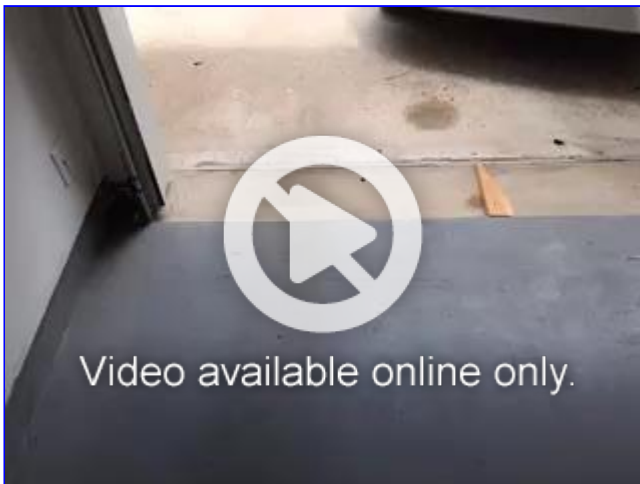
(2) The garage door(s) will not reverse when met with resistance. See attached PDF for additional information. A qualified contractor should be consulted for correction.
