Texas Inspection Professionals

|| || X B. Grading and Drainage

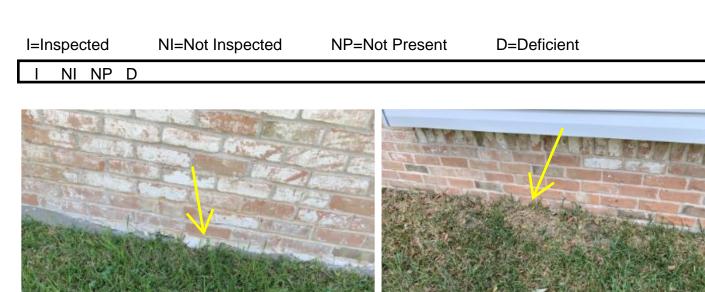
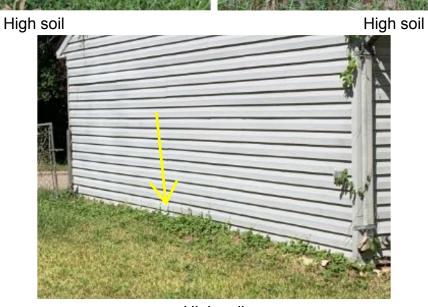
• High soil levels were observed at the foundation walls. A minimum of four inches of foundation wall should be exposed under brick veneer and a minimum of six inches of foundation wall should be exposed under wood surfaces. High soil levels are conducive to wood destroying insect infestation, and possible water penetration into the home. When repaired, the grade should slope downward away from the home directing runoff away from the foundation and provide proper foundation exposure. Improvements should be undertaken by professional landscaper.

High soil

• Recommend re grading away from foundation.

• Recommend re grading away from foundation - Water may run towards or under the property which may effect the efficiency of foundation slab . Water standing under the property may risk of excessive moisture in the house. **Texas Inspection Professionals**
