Insight Property Inspection

INSPECTED PROPERTY ADDRESS:
6200 W. Tidwell Rd. #205
Houston Texas 77092

PROPERTY INSPECTION REPORT

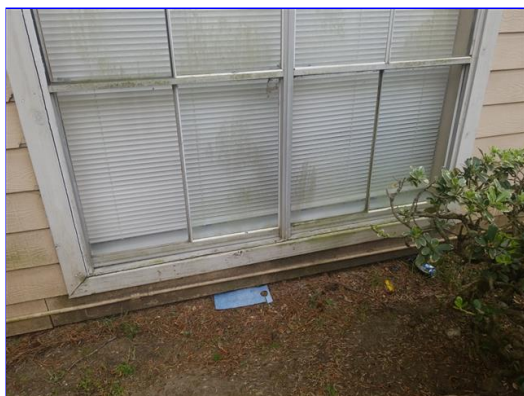
H. Item 1(Picture)

Window screens are missing.

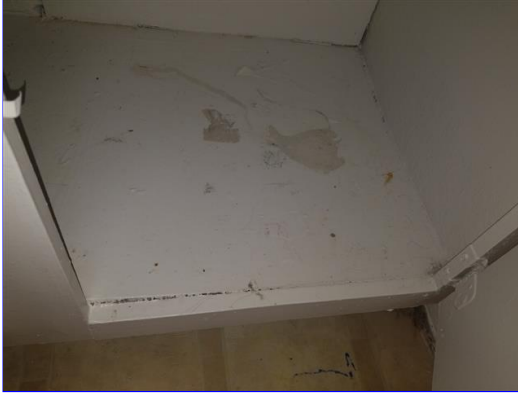
L. Item 1(Picture)

(1) Cabinets have damaged shelves and cabinet doors do not shut completely in both bathrooms.

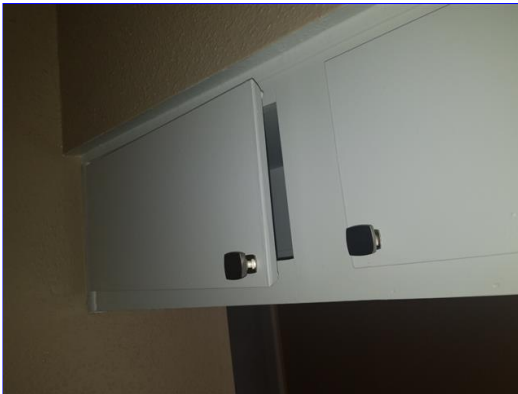
L. Item 3(Picture)

(2) Some kitchen cabinet doors do not close properly.

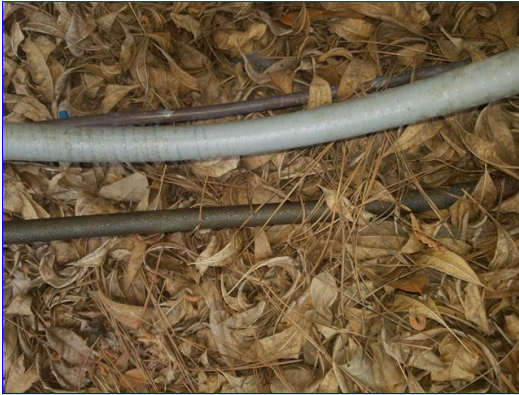
B. Item 1(Picture)

(2) The AC condenser (outside unit) is not level. This can cause damage to the unit or shorten its life span. .

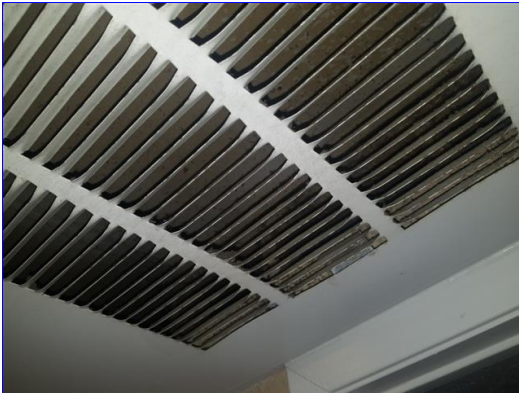
C. Item 1(Picture)

No furnace air filter was installed at the time of the inspection. A filter should be installed to improve indoor air quality.

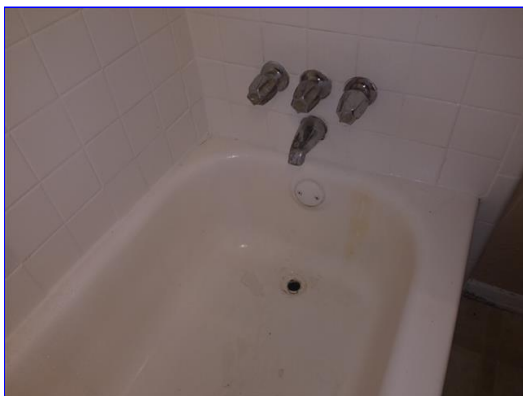
A. Item 1(Picture)

Rust and peeling paint was observed at both bath tubs.
