PROPERTY INSPECTION REPORT

Concerning: 20618 Rainstone Ct, Katy, TX 77449
(Address or Other Identification of Inspected Property)

By: Armando Ramirez, Lic #9896 11/04/2019
(Name and License Number of Inspector) (Date)

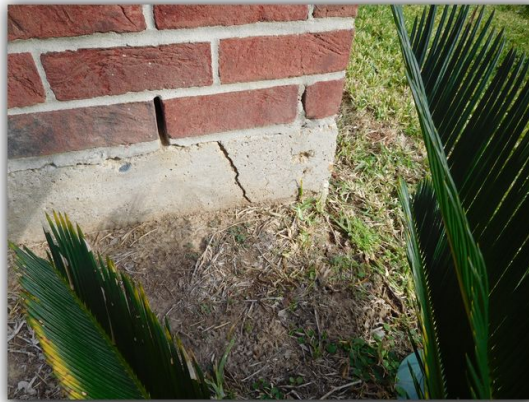
Fractures in the foundation were noted at corners of foundation at the time of inspection. These fractures can offer a pathway for wood destroying insects that are not visibly detectable. These areas should be sealed and monitored.

If the corners detach from the house, they should be repaired as they support the above bricks.

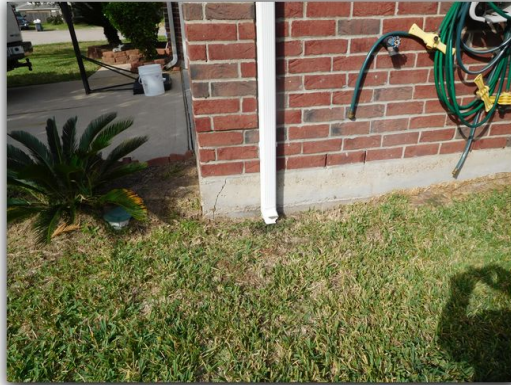
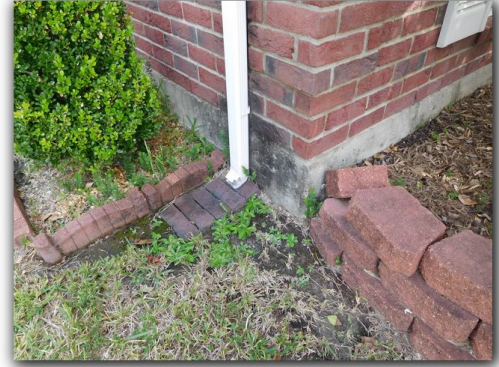
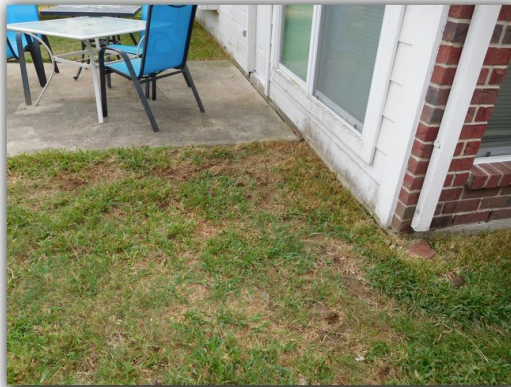
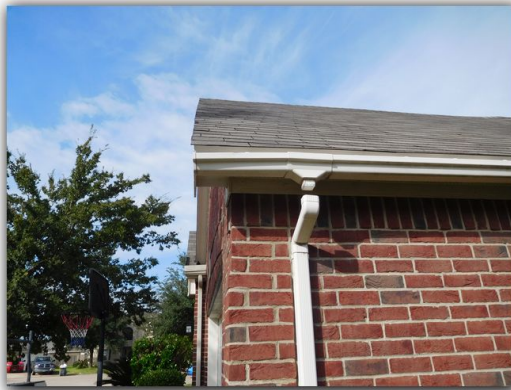
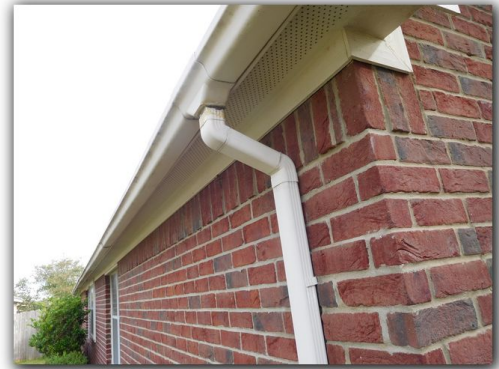
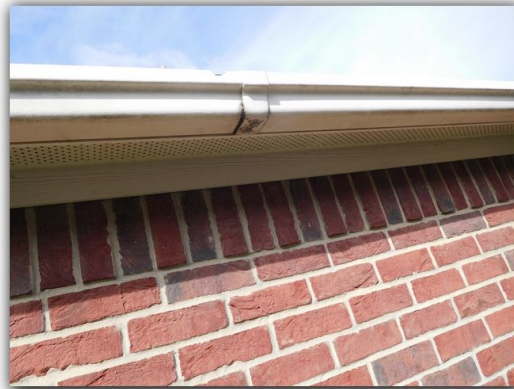
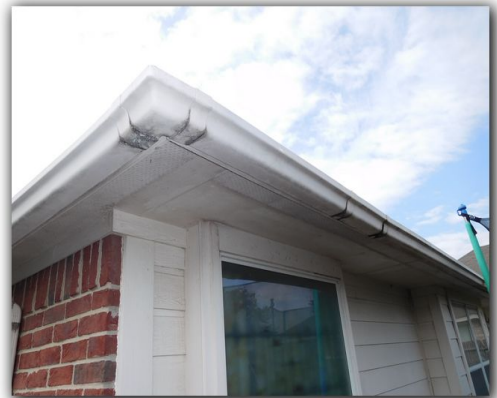
The gutters are damage loose and/or not properly installed and/or leaking at one or more locations and don't appear to have been regularly maintained. It is recommended that the gutters be thoroughly cleaned and re-caulked. Thereafter, as part of routine maintenance, all gutters should be cleaned at least twice a year and the caulked seams and joints inspected and touched up every two years as necessary.

At ground level, the water from the downspout should be directed at least 5 feet away from your house. It is best to have the water flowing onto a hard surface (like a driveway, a fiberglass or concrete splash guard) designed to spread the water and prohibit it puddling on the ground near your home.

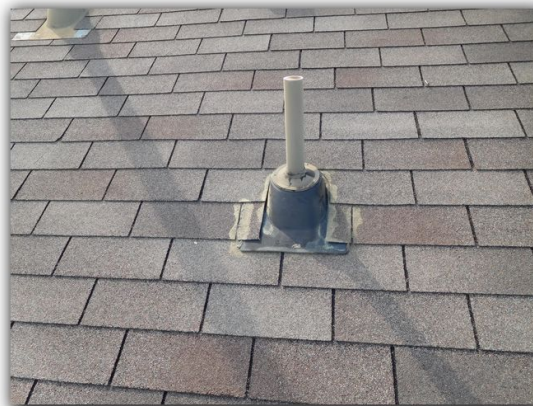
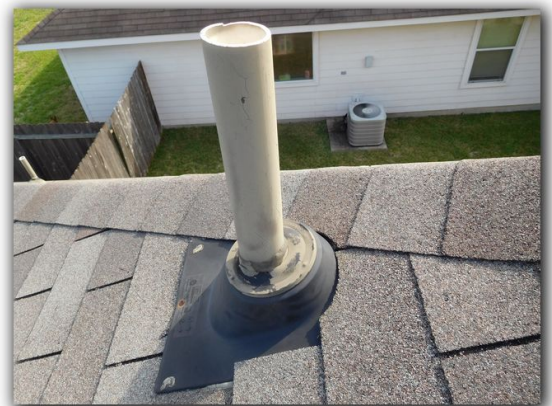
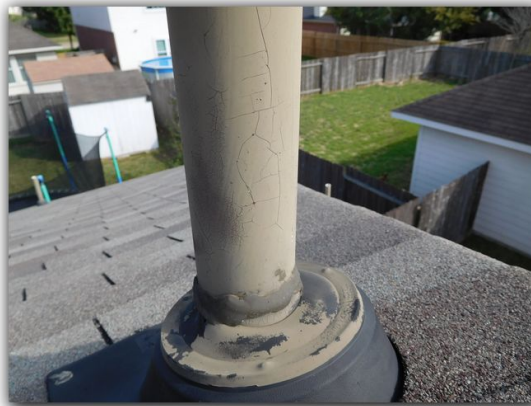
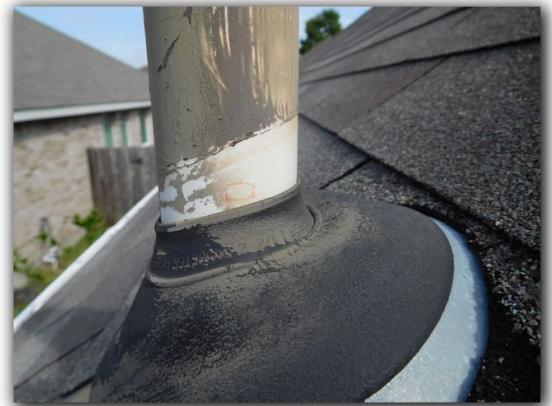
Plumbing vents that extend through the surface of the roof are fitted with weatherproof flashing or boots that prevent rainwater infiltration into the structure. Loose collars were noted during the inspection I recommend repair by a roofer or experienced handy person.

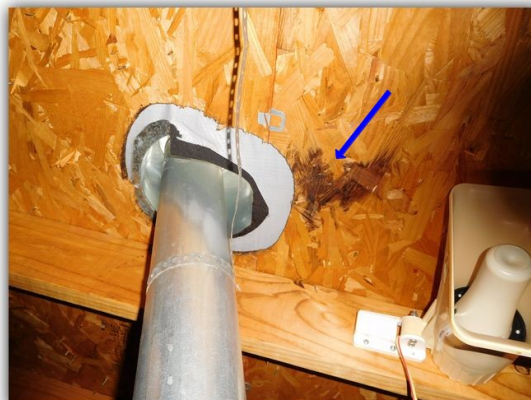
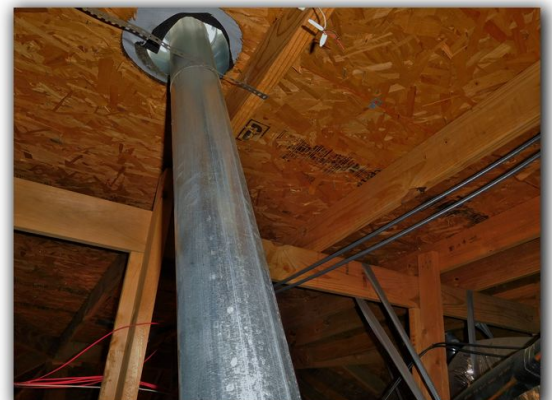
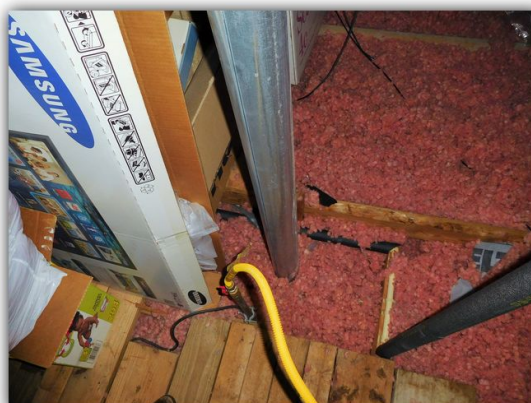
Moisture stains in attic. Condition typically is caused by roof leaks; other causes or multiple causes are possible. Roof drainage problems cannot be adequately determined during dry weather. Recommend determining and eliminating source of moisture stains, and repair or replacement, as necessary.

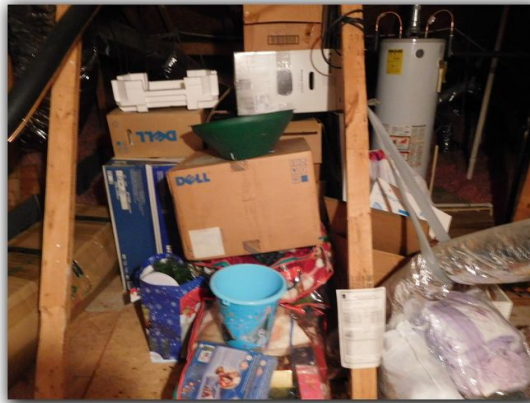
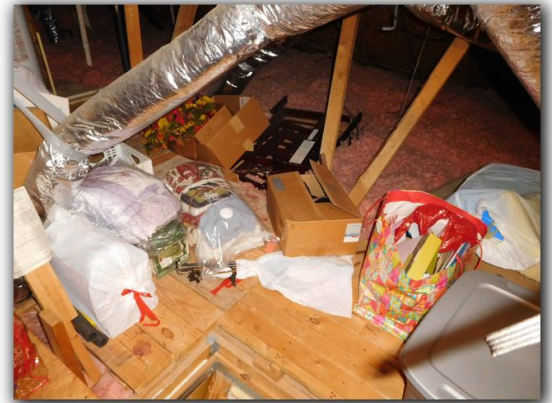
The construction debris and other material should be removed from the attic or appropriately placed out-of-the-way

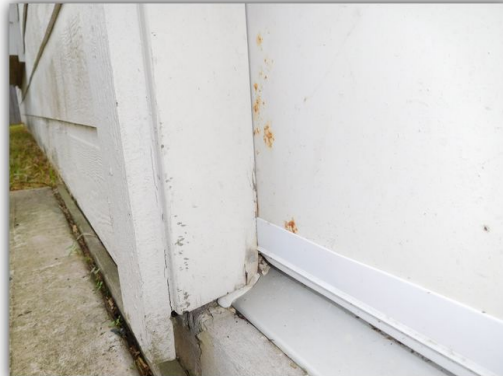
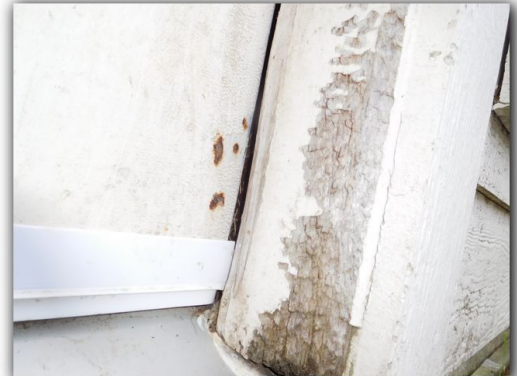
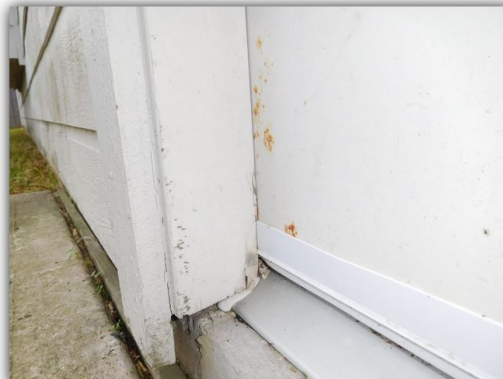
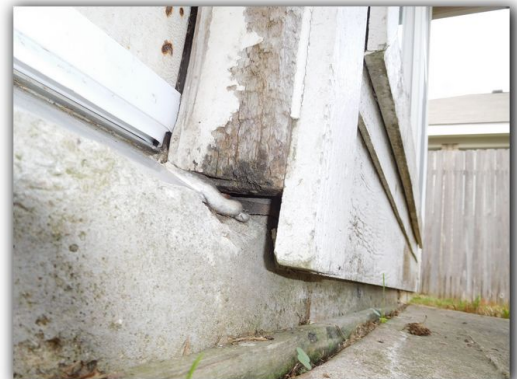
The weather stripping and/or caulking around the exterior door(s) should be improved, as well as, under the threshold should be sealed.

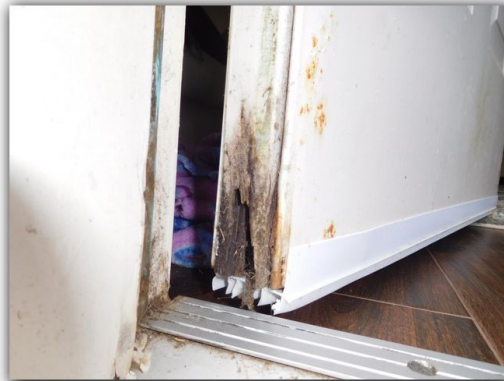
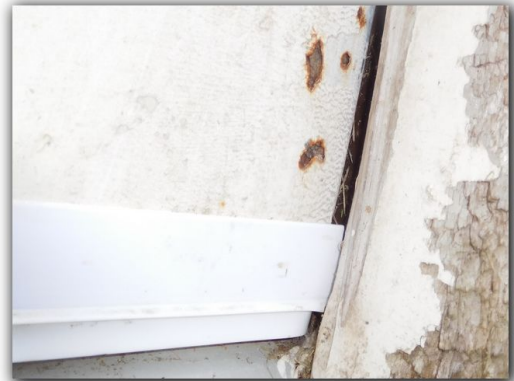
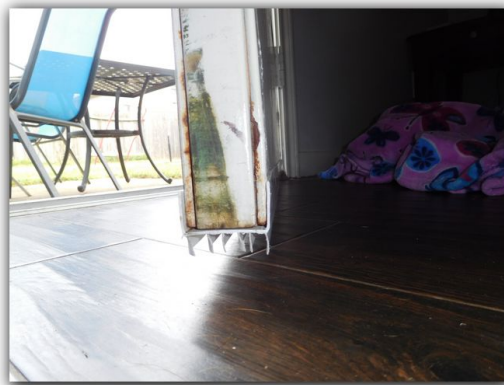
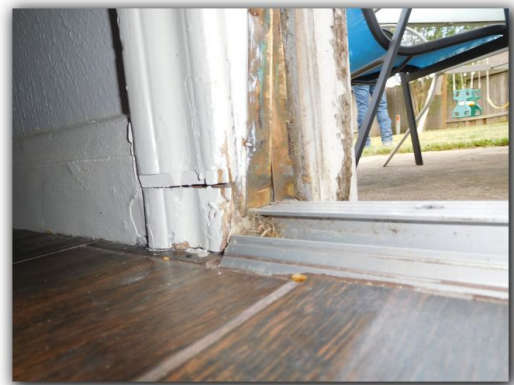
Water damage and/or rust was observed at the time of inspection at: Back door

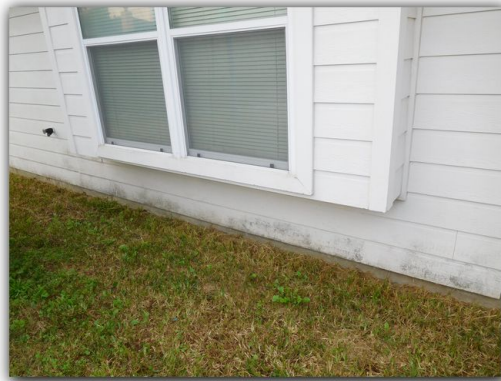
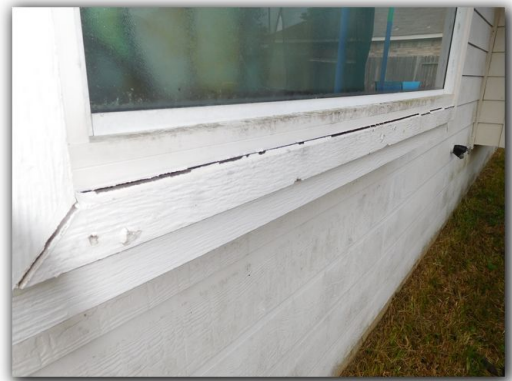
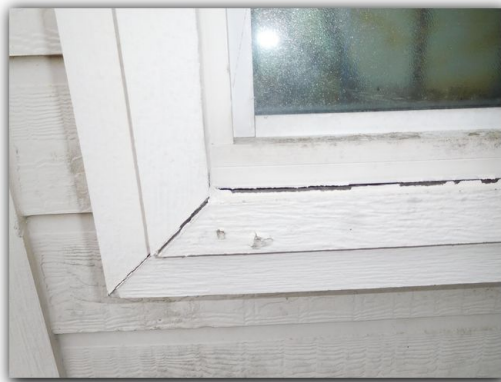
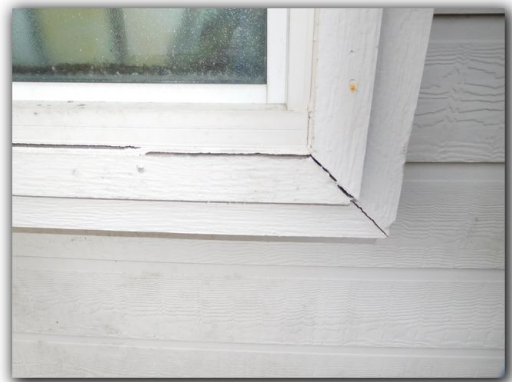
Each window should be individually inspected and sealed as necessary. There are areas where moisture can penetrate into the structure.

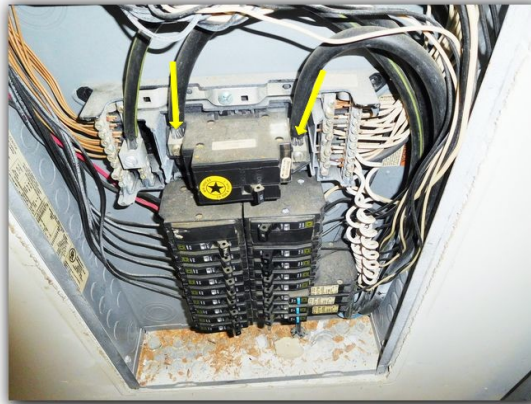
The aluminum service entrance conductors were not coated with a anti-oxidant solution. This can allow the conductors to oxidized, which can be a fire hazard.

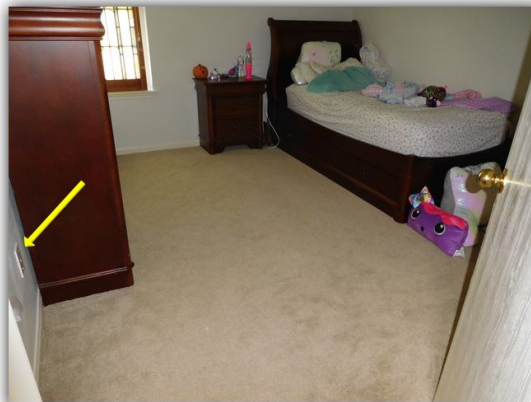
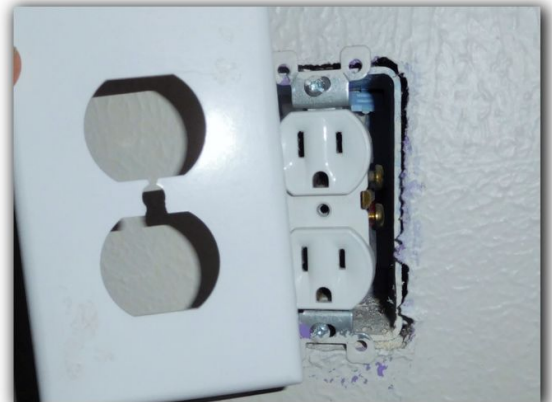
Loose and/or damage outlet plate was observed at the right front bedroom facing front of house. This is a safety hazard that must be corrected.

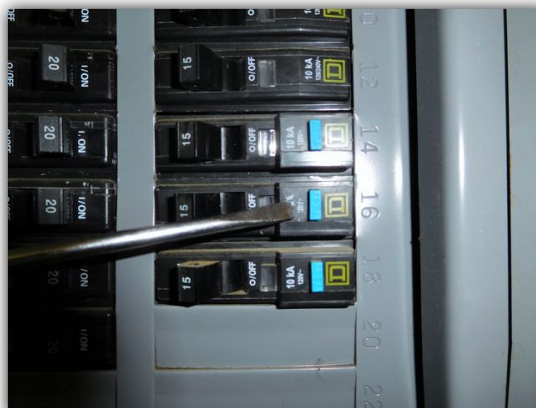
Arc fault breaker for bedrooms 2 & 3 did not respond to the arc fault test at the time of inspection suggesting that this breaker is damage and in need of repair/replace (This breaker was tested manually)

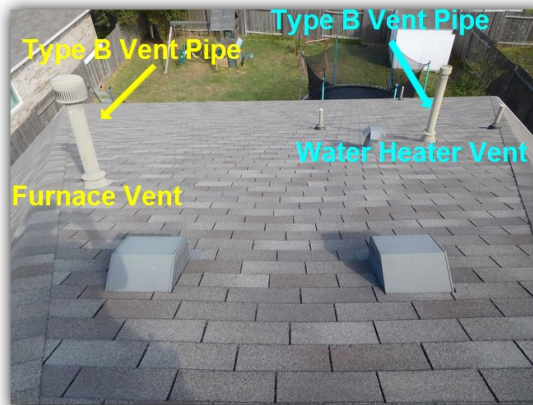
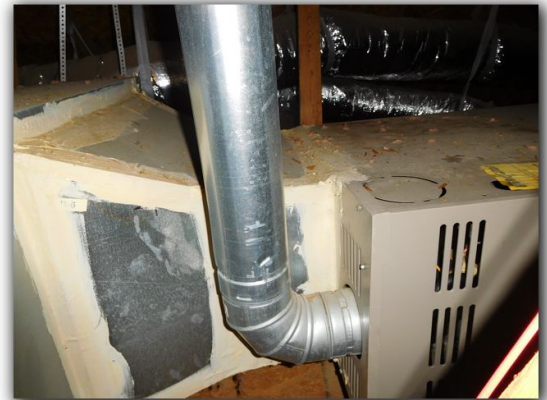
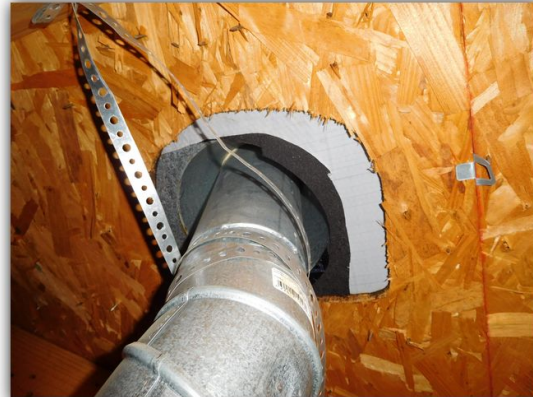
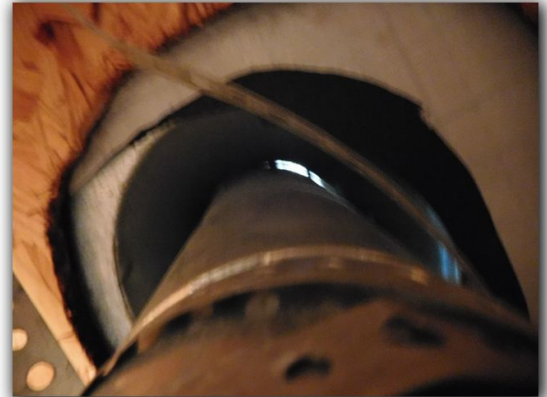
- Roof Leak: Type B Vent Pipe Through the Roof Deck. The furnace exhaust vent pipe was loose and/or was not properly installed, Water Leak Residue Trail was observed on the pipe at the time of inspection

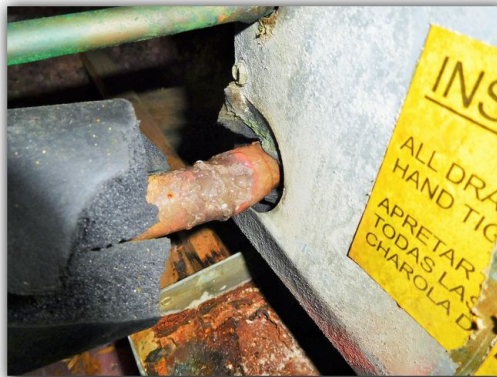
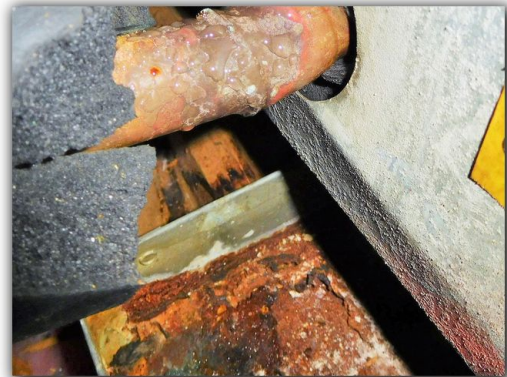
Freon lines not properly insulated at: Air Handler(s) In Attic
 Moisture present

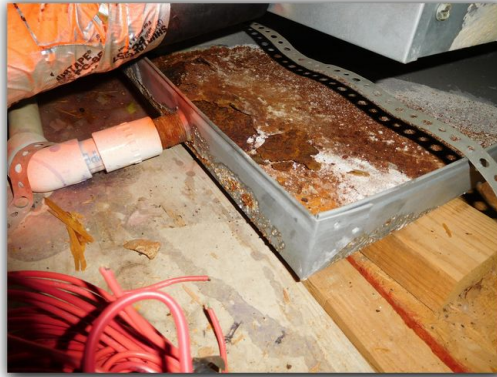
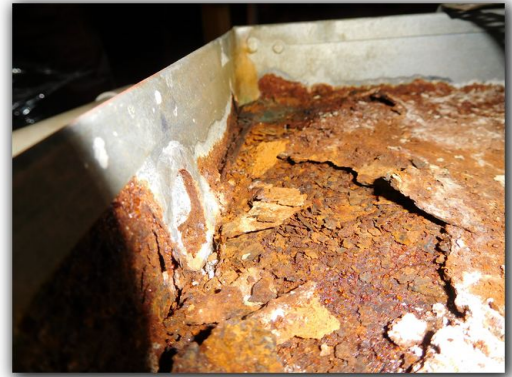
Rust and/or severe damage was observed to the AC emergency drain pan. This should be repaired/replaced to avoid water intrusion and/or damage in to your home

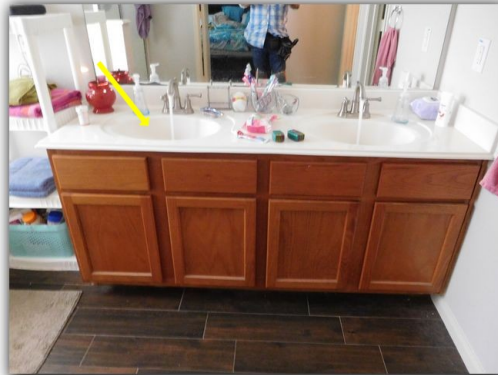
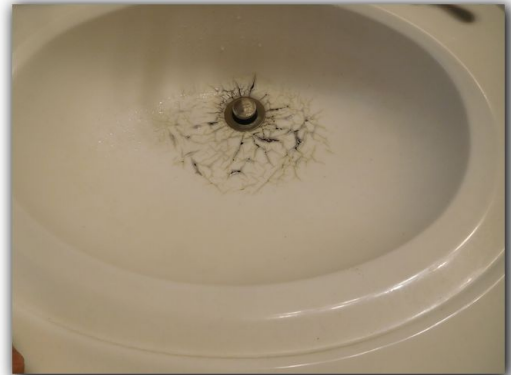
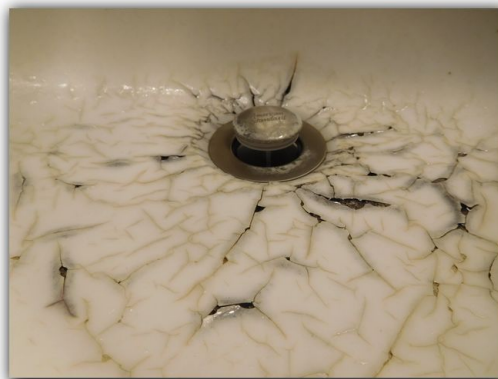
Finish on sink is damaged - Master Bathroom . Repair and/or replace as necessary

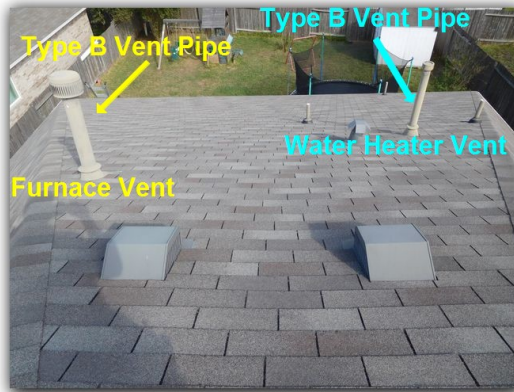
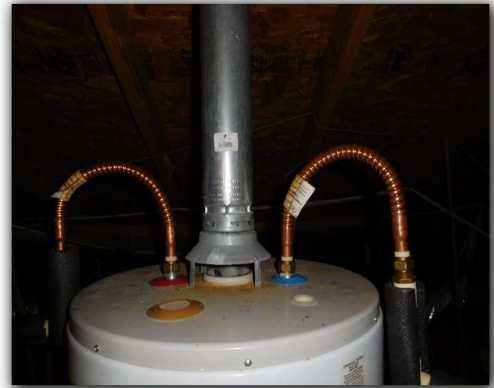
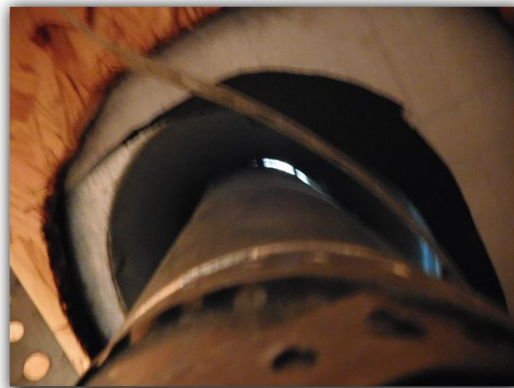
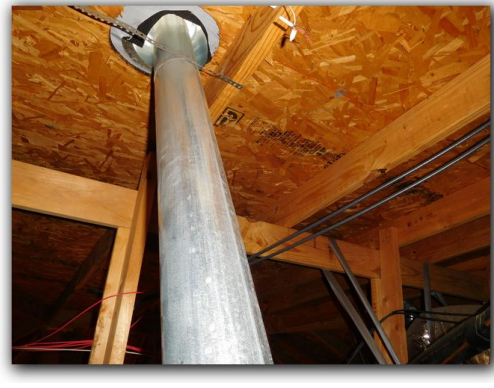
- Roof Leak: Type B Vent Pipe Through the Roof Deck. The water heater exhaust vent pipe was loose and/or was not properly installed, Water Leak Residue Trail was observed on the pipe at the time of inspection

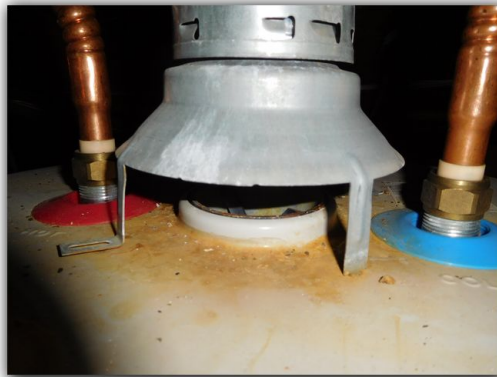
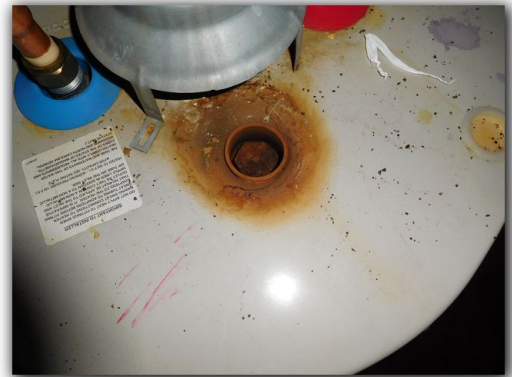
It appears that there are burn marks on top of the water heater these are a BIG warning sign. If there are burn marks on top and/or bottom of your water heater, you could usually have one, if not more, possible problems. (Burn marks are usually only on gas or propane water heaters).

Burn marks can also mean the flue pipes are blocked or damaged. This is also a potentially unsafe situation, so that water heater will need to be replaced – and soon.

You're going to need a water heater replacement. Get a plumber onsite as soon as possible.

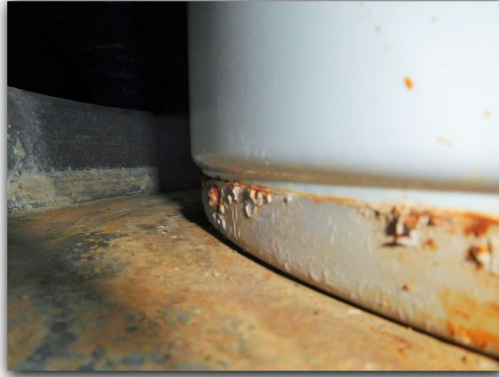
Water heaters contain what is called a sacrificial anode. This anode seats inside the water heater's tank and essentially rusts so that the tank does not rust. Without a sacrificial anode, the minerals and chemicals in your water would quickly rust away the water tank. When a sacrificial anode goes bad and is not replaced, the rust does begin to hold of the tank and a rusty bottom can result. I recommend replacing the water heater ASAP to prevent leakage and damage resulting from the leakage

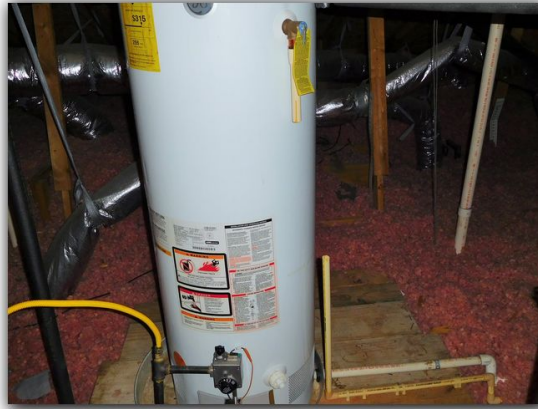
T/P valve has no drain line and/or damage line was observed at the time of inspection

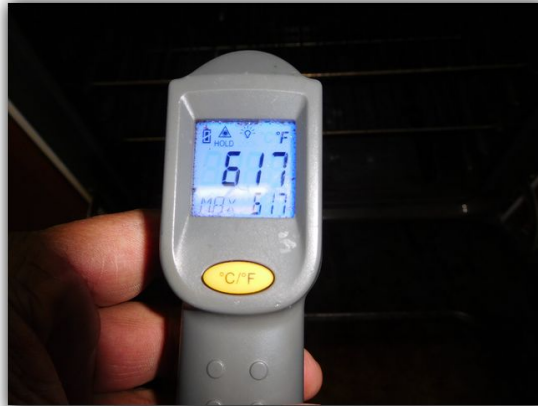
Unit #1: Electric Gas
Tested at 350°F, Variance noted: 617.0°F (max 25°F)
