**10563 Longleaf Drive
Conroe Tx 77385**

PROPERTY INSPECTION REPORT

Concerning: 10563 Longleaf Drive, Conroe, Tx 77385

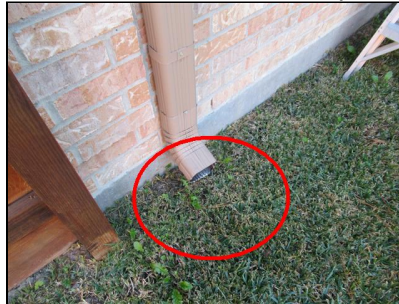
Extend downspouts farther away from the house to improve surface drainage and reduce water ponding and percolating near the foundation.

Recommend gutter extensions or splash blocks for all gutter turn-outs to facilitate proper drainage away from the structure. Discharging roof water next to the structure has the potential of causing foundation movement

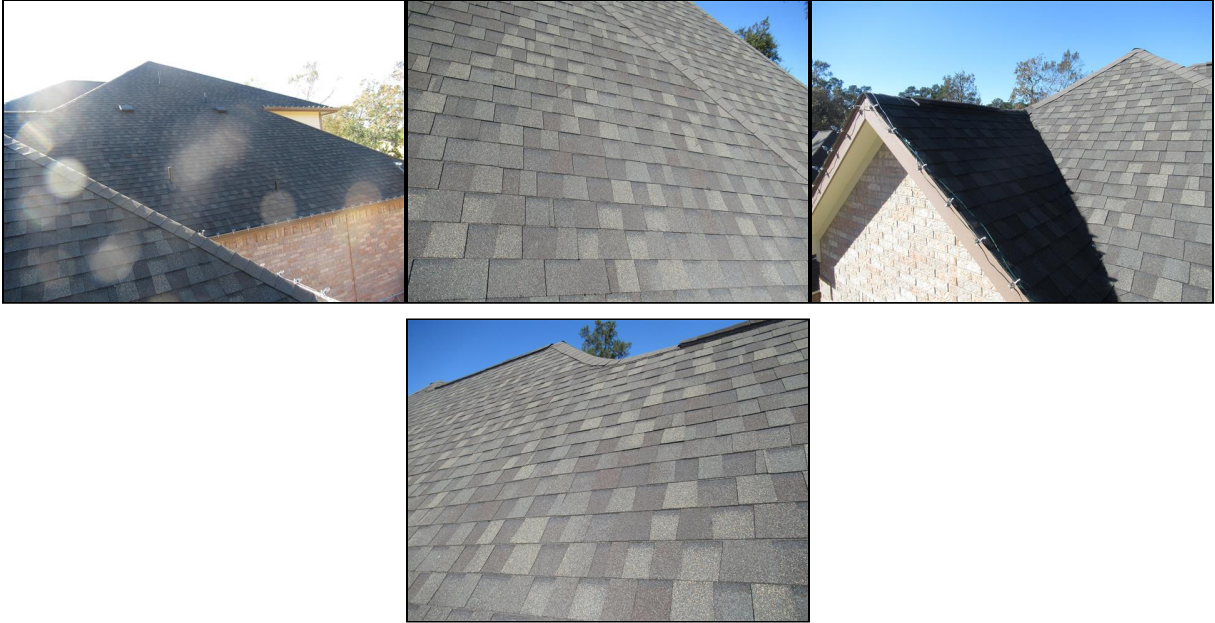
Covering appeared in good condition. No leaks were active at time of inspection. Shingles appeared to be properly fastened.

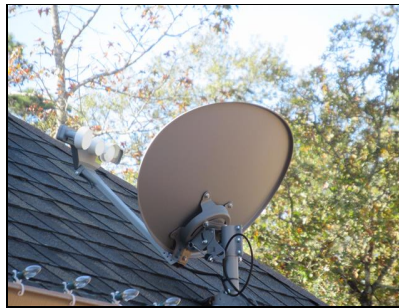
Satellite dish mounted directly through roof not recommended. Better installation is on side wall or eaves. Extra sealant needed on fastening bolts.

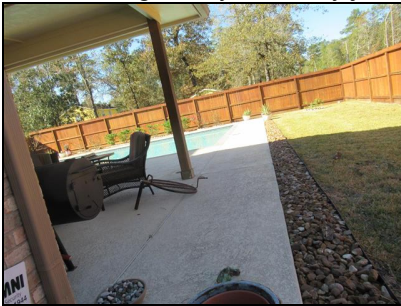
The walks and rear patio have no significant cracks or uplifts but monitor for future tripping hazards.

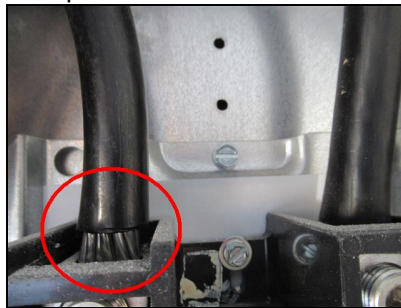
The incoming aluminium main service wires should be coated with anti-oxidation grease where they are stripped back to be connected to the main panel. Have an electrician correct as needed.

needs anti-oxidation grease

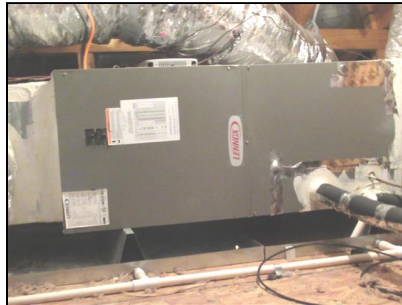
The electric furnace responded to thermostat demand and provided an appropriate temperature increase of over thirty degrees.

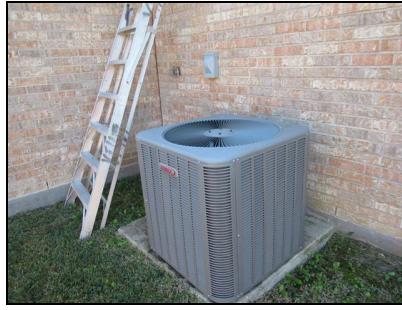
5 ton unit

The air conditioning equipment responded to thermostat demand, sounded normal during operation and produced an appropriate temperature drop between 15 and 22 degrees measured between supply and return air ducts. Typical service life is 13 - 17 years. The electrical disconnect box at the exterior compressor was not opened. Determining if the A-coil is properly matched to the compressor is outside the scope of this inspection. The "tonnage" adequacy of the system was not evaluated.

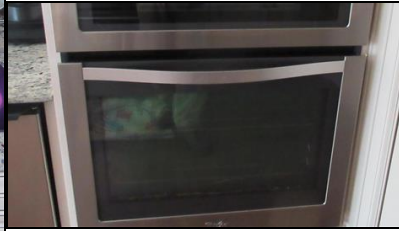
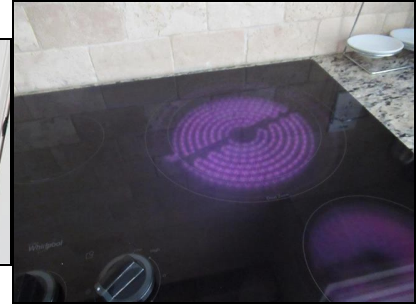
rear worked intermittingly

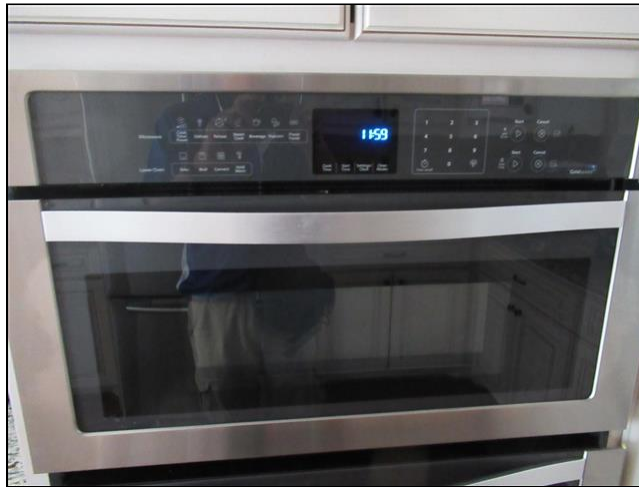
Unit functioned normally.

The unit is self venting.

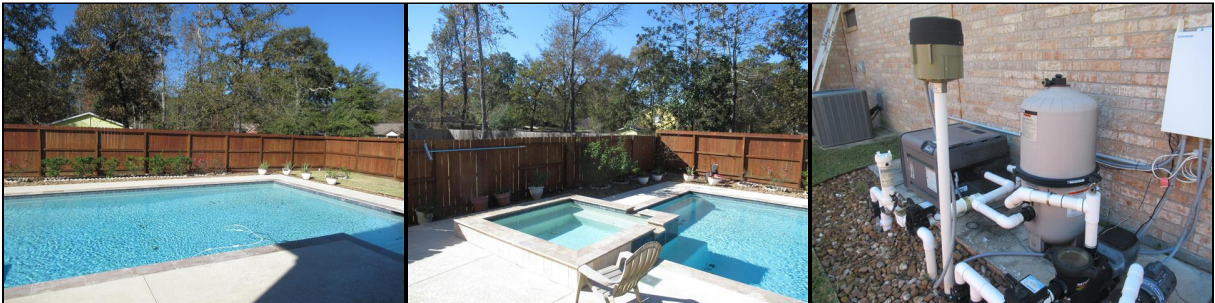
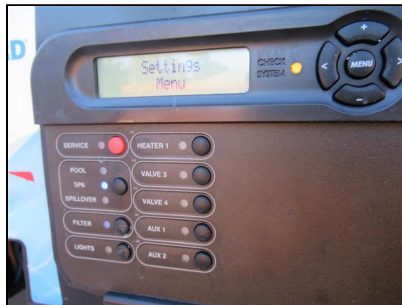
Pool equipment functional and properly bonded/grounded.

Filtration system functioning. Filters where they need to be.
