TEXAS OFFICIAL WOOD DESTROYING INSECT REPORT

7518 Carew Street
Inspected Address

1 story, wood framed single family residence
 brick / lapboard/wood exterior
 Composition roof; attached garage

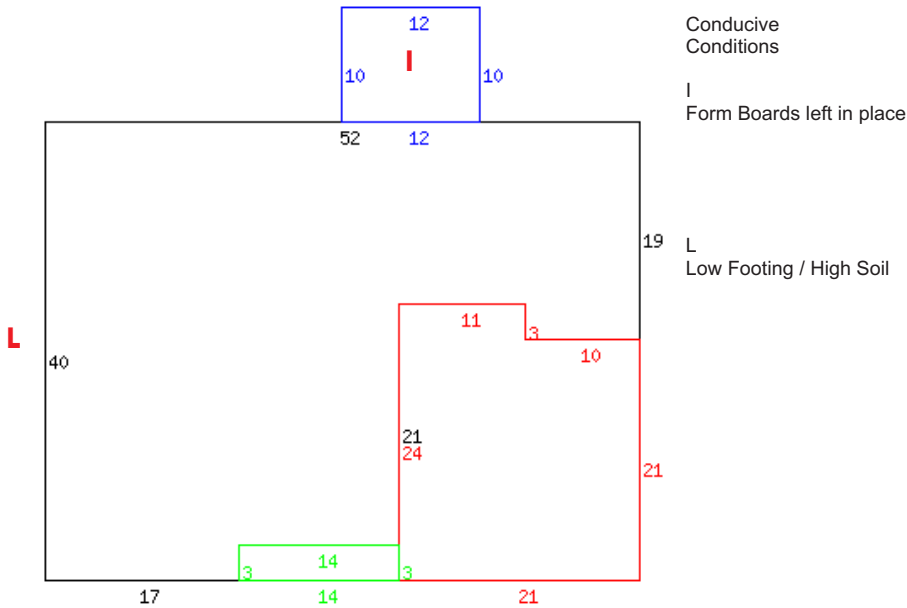
9A. Corrective treatment recommended for active infestation or evidence of previous infestation with no prior treatment as identified in Section 8. (Refer to Part G, H, and I, Scope of Inspection) Yes No
 9B. A preventive treatment and/or correction of conducive conditions as identified in 7A & 7B is recommended as follows: Yes No
 Specify reason: Form boards left in place (I), Footing too low or soil line too high (L)

Approx. 1625 Sq Ft Approx. 168 Ln Ft

Structure Type: Residence
 Roof Type: Composition
 Foundation Type: Monolithic style slab on grade
 Occupancy Status: Occupied

Additional Comments: Your Report Recommends a Preventive Treatment. Your WDI Inspection makes a recommendation for Treatment based solely on Conducive Conditions which makes it eligible for WDI Suppression treatment. Please see the attached addendum for important information.
