Report #TC2605

PROPERTY INSPECTION REPORT

Concerning: 2721 La Branch St; Houston, TX 77004
(Address or Other Identification of Inspected Property)

By: Anthony Chavez, TREC #5611 August 9, 2016
(Name and License Number of Inspector) (Date)

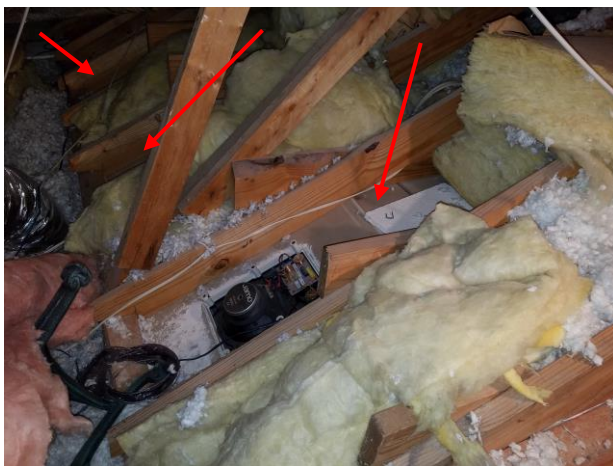
D-The insulation has been pulled away from some areas of the ceiling above the master bedroom and should be replaced. See picture.

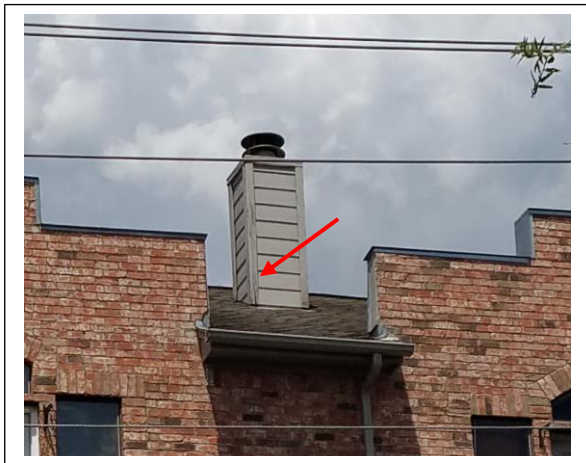
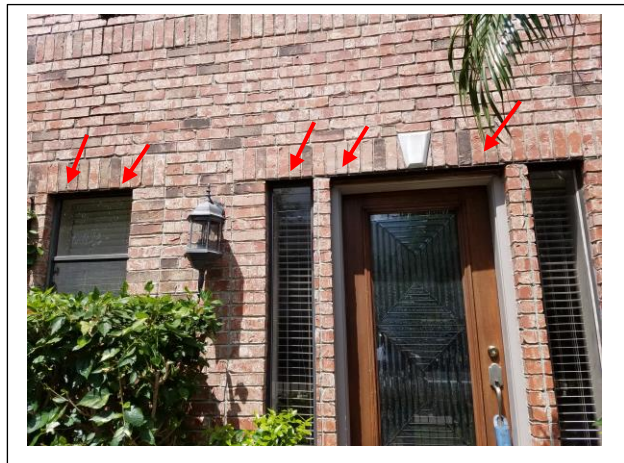
D-Caulking is required at the hose bibs, fixtures and any other wall penetrations to prevent moisture entry.
D-There is a hairline crack in the brick mortar at the left side of the balcony that needs to be caulked.
D-There is trim deterioration at the chimney that needs to be repaired. See first picture.
D-The second picture shows the windows and door openings with the brick above the openings that need weepholes created to allow moisture to escape/evaporate from the wall cavity.
 C- Condition of walling material, wood framing, insulation, "moisture barriers", electrical wiring, plumbing piping, gas lines and etc. between interior and exterior wall surfaces is unknown and not accessible for inspection.

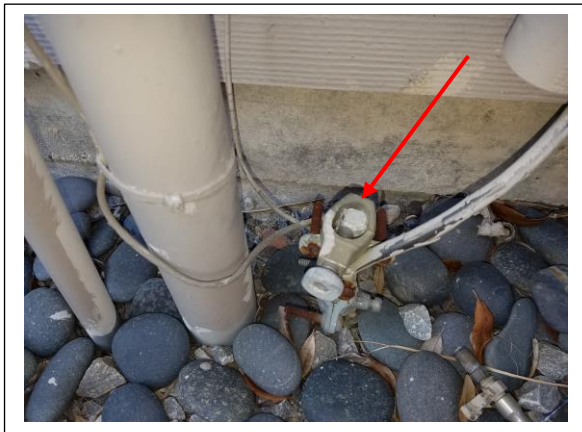
D-The ground clamp used at the ground rod for the ground wire is a pipe clamp and should be changed out to an acorn clamp to provide a more complete connection. See picture.

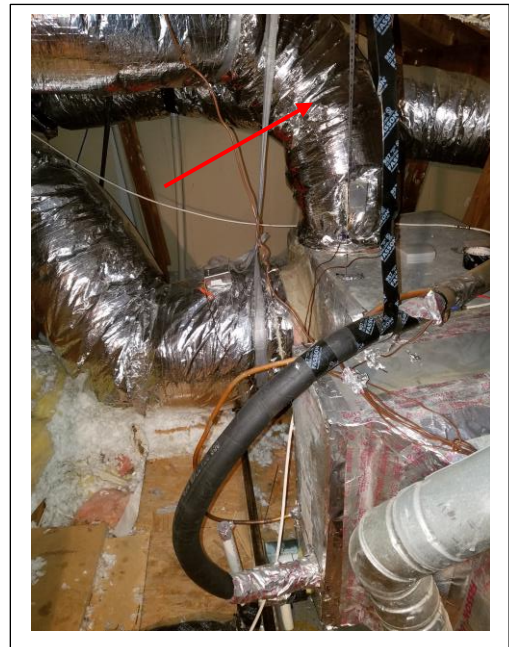
D-The picture shows a duct at the supply plenum that is cut open and leaking air and needs to be repaired.
