Inspection Report

Property Address:
22839 Twisting Pine Dr
Spring TX 77373

PROPERTY INSPECTION REPORT

By: Kristi Hart TREC# 21276 / HG Home Inspection 10/12/2019

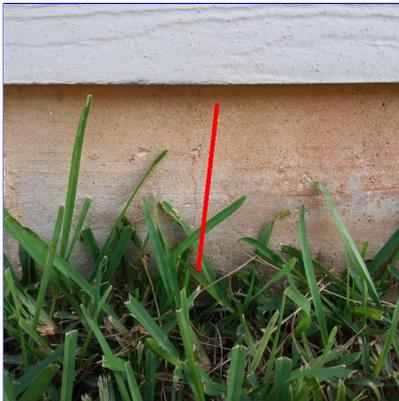
A. Item 3(Picture) Right side of home

(3) Typical settlement cracks in the concrete slab. Many homes have hairline or settlement cracks which have no effect on the function of the slab. A qualified licensed general contractor should inspect further and repair as needed.

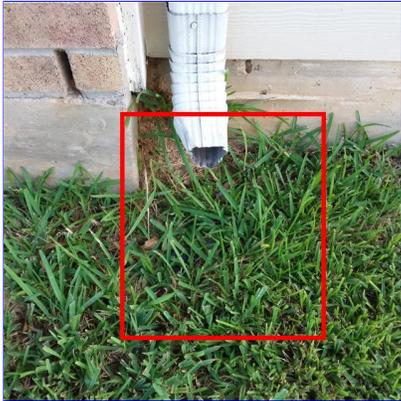
B. Item 1(Picture) Front right side of home

(1) The gutter downspout(s) missing deflector(s) at the exterior. Erosion can continue or become worse if not corrected. A qualified contractor should inspect and replace as needed.

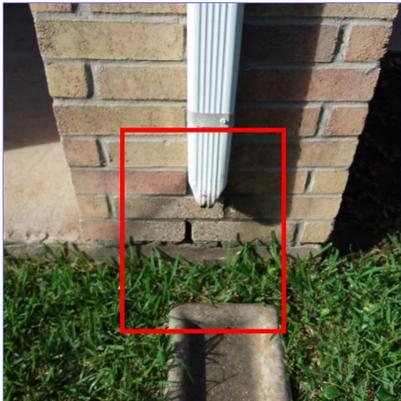
B. Item 2(Picture) Front left side of home

(2) The downspout missing part (S) at the front left corner of home. Erosion can continue or become worse if not corrected. A qualified person should repair or replace as needed.

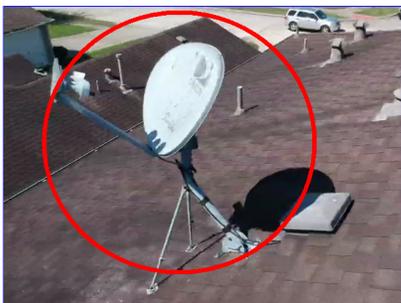
C. Item 1(Picture)

(2) There is a satellite dish bracket mounted on roof that is screwed directly through roofing surface. This is not considered to be today's standard. I recommend having a qualified person remove and patch roofing as needed. (The area will need periodic maintenance)

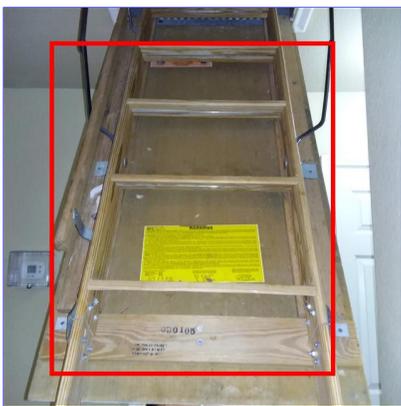
D. Item 1(Picture)

(1) The pull down stairs are not properly insulated. This can cause some heat loss in winter and loss of cool air in summer if not corrected. I recommend repair as desired.

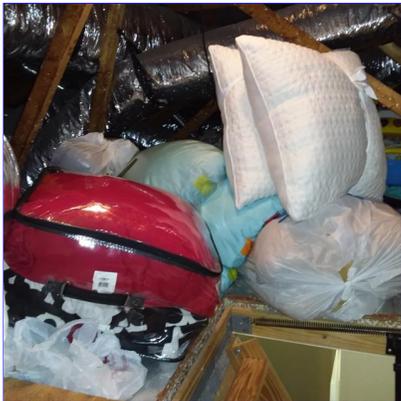
D. Item 2(Picture)

(2) Attic space inspected with limited access. This is for your information.

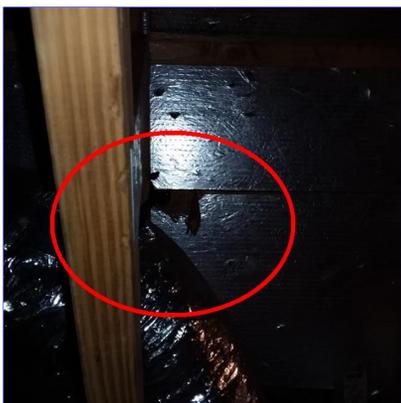
D. Item 3(Picture) Above attic access

(3) The roof sheathing is damaged . Area still remains strong. It is not cost effective to replace until next roof. A qualified contractor should repair as needed.

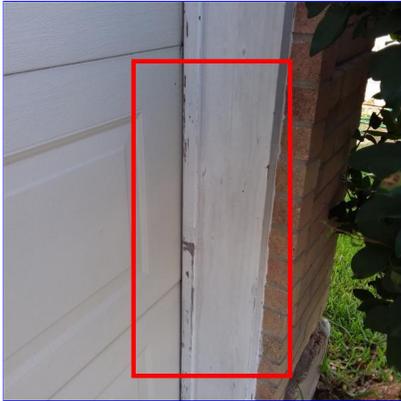
E. Item 1(Picture) Front right of home

(1) The Wood trim exterior in areas peeling paint or failing. Further deterioration can occur if not corrected. A qualified person should repair or replace as needed.

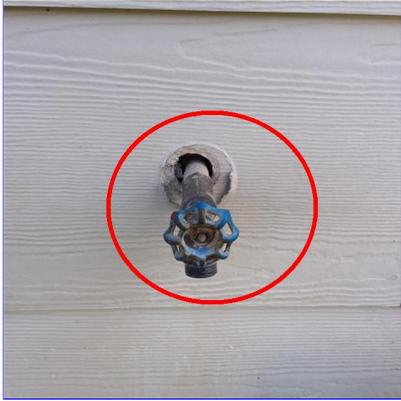
E. Item 5(Picture) Front right side of home

(2) Areas where wiring or piping passes through walls should be sealed. I recommend having a qualified person seal as needed.

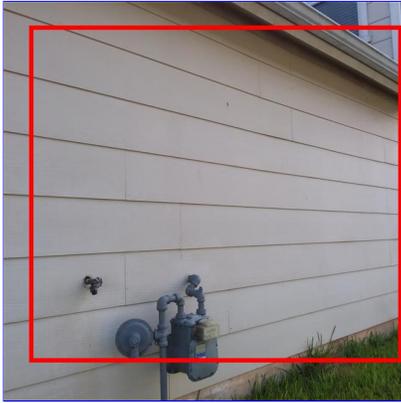
E. Item 8(Picture) Front right side of home

(3) The siding exterior has caulking that is weathered or missing and some lifted nails. Deterioration can eventually occur if not corrected. A qualified person should repair as needed.

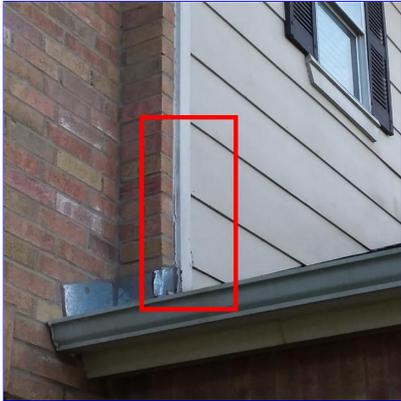
E. Item 16(Picture) Front left of home

(5) The Wood trim exterior area's of home beginning to deteriorate. Further deterioration can occur if not corrected. A qualified person should repair or replace as needed.

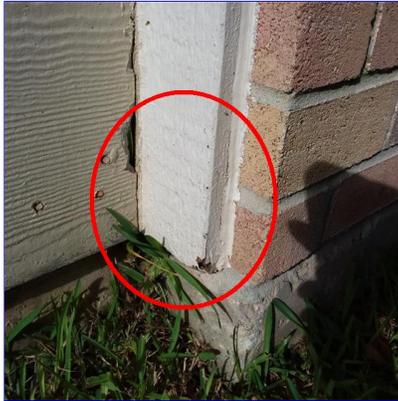
E. Item 17(Picture) Front left side of home

(4) The Brick siding front of home loose, and missing mortar. Further deterioration can occur if not corrected. A qualified person should repair or replace as needed.

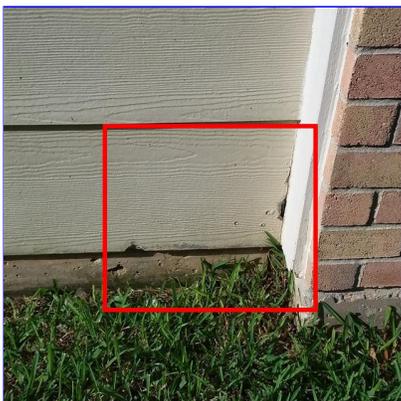
E. Item 20(Picture) Front left side of home

(6) The Cement board exterior in areas is damaged. Further deterioration can occur if not corrected. A qualified person should repair or replace as needed.

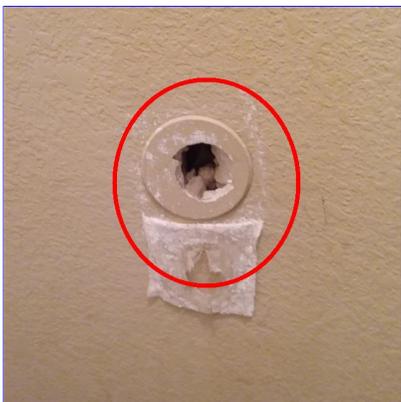
E. Item 22(Picture) Garage hallway

(7) The drywall on the wall is damaged. While this damage is cosmetic, it needs to be repaired. A qualified person should repair or replace as needed.

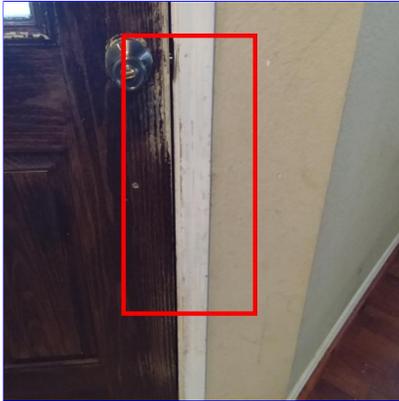
E. Item 32(Picture) Main entry

(8) Interior trim is damaged or peeling paint in areas. This is a cosmetic issue. I recommend repair as desired.

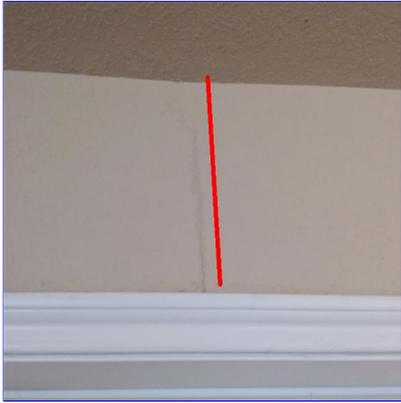
E. Item 37(Picture) Downstairs bedroom entry

(10) The drywall on the wall has several hairline cracks in areas. This damage is considered cosmetic. A qualified person should repair or replace as needed.

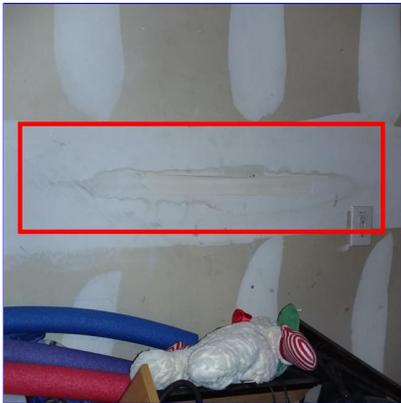
E. Item 39(Picture) Rear of garage

(11) The drywall on the wall shows wet stains indicating moisture or intrusion did or still may occur in areas. The moisture meter was used and it did not indicate an active leak. A qualified person should repair or replace as needed.

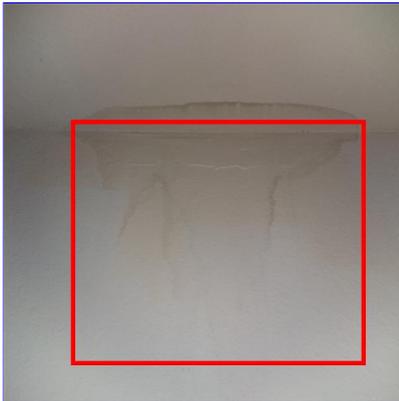
E. Item 42(Picture) Right side of upstairs entry

(12) The drywall on the wall shows wet stains indicating moisture or intrusion did or still may occur in

areas. Due to recent dry weather, I am unable to determine if the leak still exists. A qualified person should repair or replace as needed.

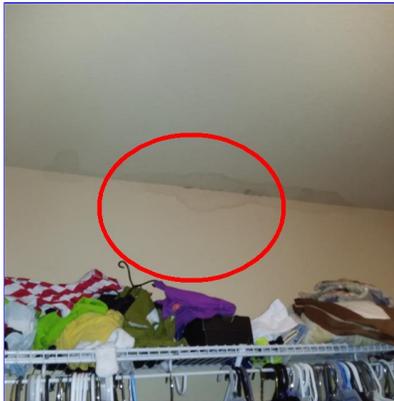
E. Item 43(Picture) Right side of master bedroom closet

(13) Signs of fungi growth are present. We did not inspect, test or determine if this growth is or is not a health hazard. The underlying cause is moisture. I recommend you contact a mold inspector or expert for investigation or correction if needed.

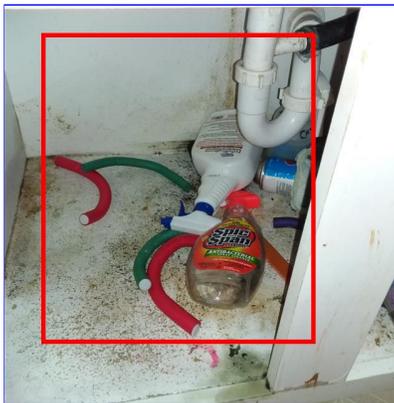
E. Item 45(Picture) Under hall bath sink

(14) The drywall on the wall shows wet stains indicating moisture or intrusion did or still may occur Bedroom closet. The moisture meter was used and it did not indicate an active leak. A qualified person should repair or replace as needed.

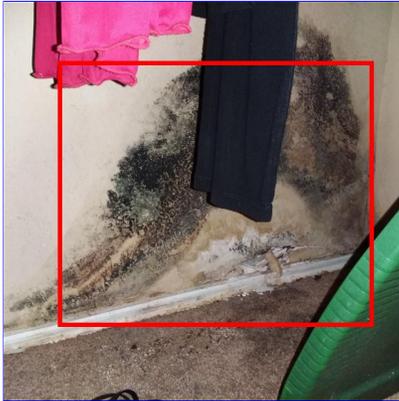
E. Item 46(Picture) Front left bedroom closet

(15) The drywall on the wall shows wet stains indicating moisture or intrusion did or still may occur Hall Bath. The moisture meter was used and it recorded 19% or higher, which indicates the leak has not been corrected. A qualified person should repair or replace as needed.

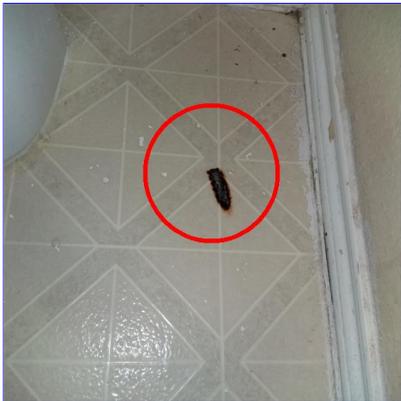
F. Item 1(Picture) Front left of 1/2 bath

(1) The Linoleum is damaged at the in areas. This damage is considered cosmetic. A qualified person should repair or replace as needed.

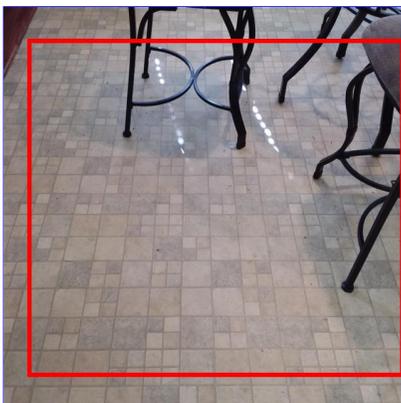
F. Item 3(Picture) Dining room

(2) The tile flooring is cracked/damaged. This damage is considered cosmetic. I recommend repair as desired.

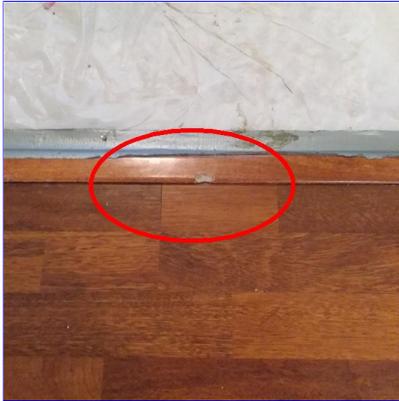
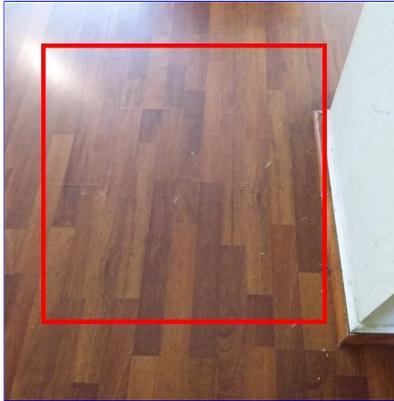
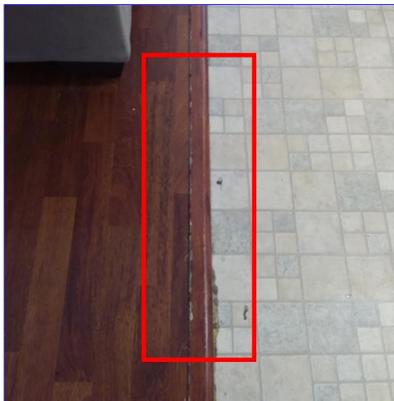
(3) The wood style flooring is damaged in areas. Repairs are needed. A qualified contractor should inspect and repair as needed.

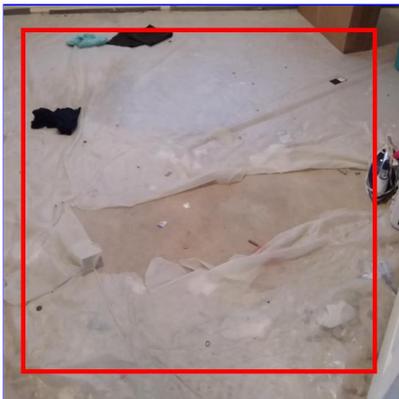
F. Item 9(Picture) Lower level bedroom

(4) The floor covering is missing in area's. This damage is considered cosmetic. A qualified person should repair or replace as needed.

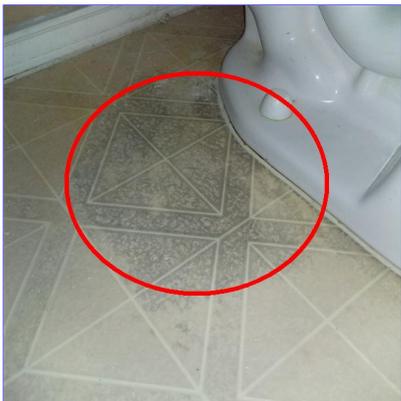
F. Item 12(Picture)

(6) Linoleum is stained around toilet indicating a leak did or still exists at the half bath. The moisture meter was used and it did not indicate an active leak. A qualified person should repair or replace as needed.

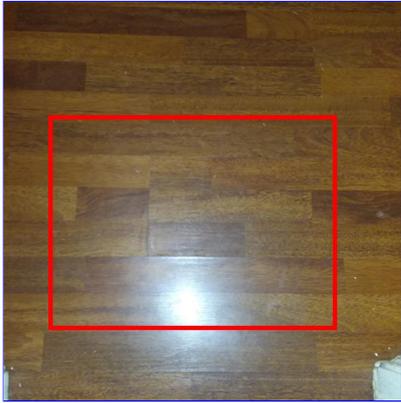
F. Item 13(Picture) Garage entry

(7) The Wood covering is curling around edges and is not impervious to water at the in areas. This damage is considered cosmetic. A qualified person should repair or replace as needed.

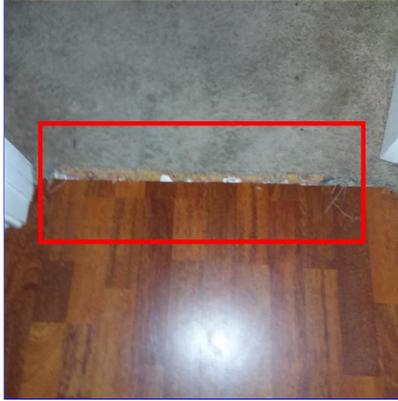
F. Item 17(Picture) Left rear bedroom entry

(8) The wood style flooring was not installed according to standard workmanlike practices in areas. Repairs are needed. A qualified contractor should inspect and repair as needed.

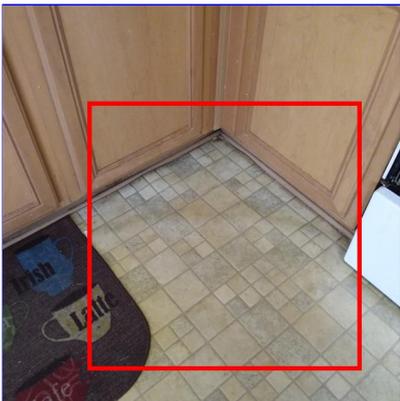
F. Item 19(Picture) Front right of kitchen

(9) The Linoleum is loose in area's. While this damage is cosmetic, it needs to be repaired. A qualified person should repair or replace as needed.

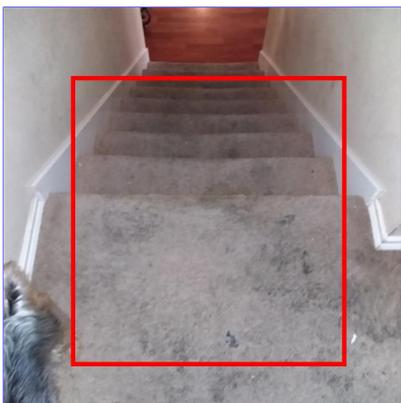
F. Item 22(Picture) Stairway

(11) The Carpet is stained in areas. This damage is considered cosmetic. A qualified contractor should inspect and clean or replace as needed.

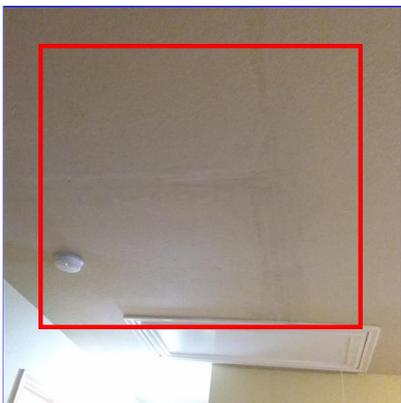
F. Item 23(Picture) Front of upstairs living room

(12) The Drywall on the ceiling shows repair signs in areas. This damage is considered cosmetic. A qualified person should repair or replace as needed.

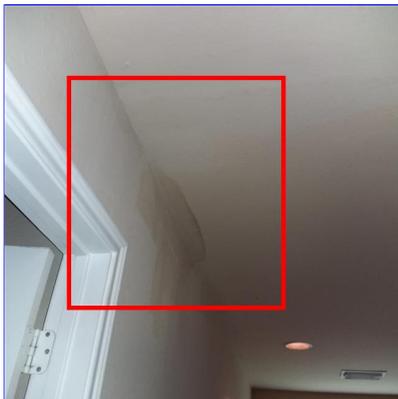
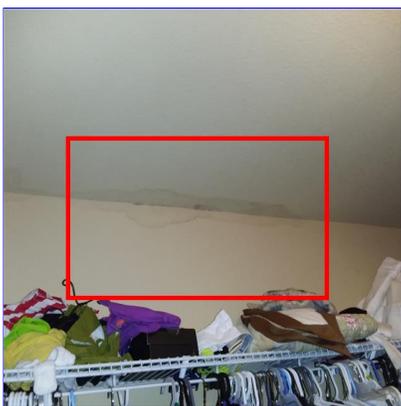
(13) The Drywall on the ceiling reveals a water stain indicating a leak did or still exists in areas. Due to

recent dry weather, I am unable to determine if the leak still exists. A qualified person should repair or replace as needed.

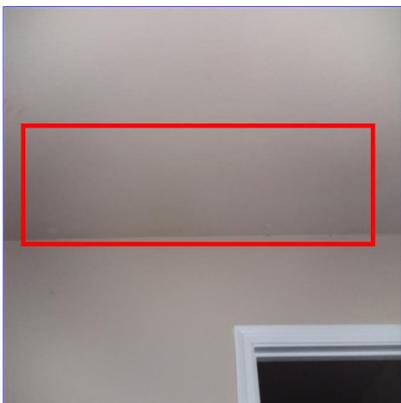
F. Item 27(Picture) Front right side of upstairs living room

(14) The Drywall on the ceiling has some "nail pops," (cosmetic). While this damage is cosmetic, it needs to be repaired. A qualified contractor should inspect and repair as needed.

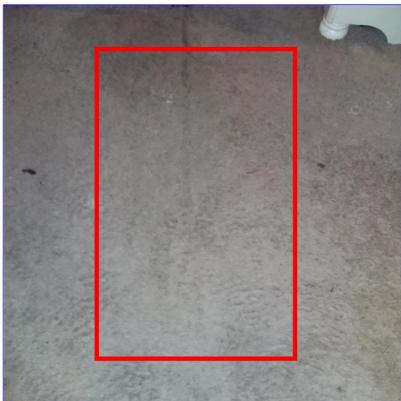
F. Item 28(Picture) Left rear bedroom

(15) The Carpet is loose or baggy and not stretched for a tight installation at the Bedroom. While this damage is cosmetic, it needs to be repaired. A qualified person should repair or replace as needed.

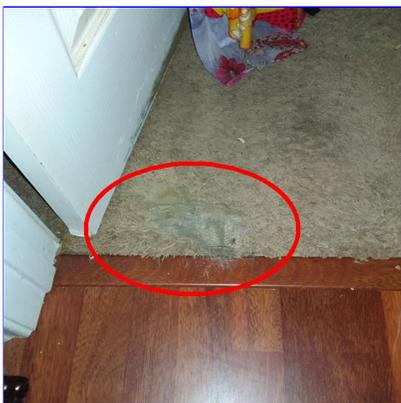
F. Item 29(Picture)

(16) The Carpet is damaged at the Master Bedroom closet. While this damage is cosmetic, it needs to be repaired. A qualified person should repair or replace as needed.

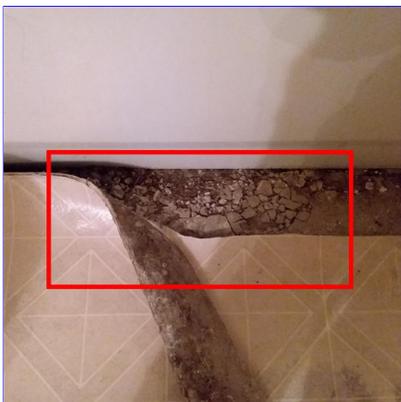
F. Item 30(Picture)

(17) Sub floor is deteriorated at the hall bath. Repairs are needed. A qualified person should repair or replace as needed.

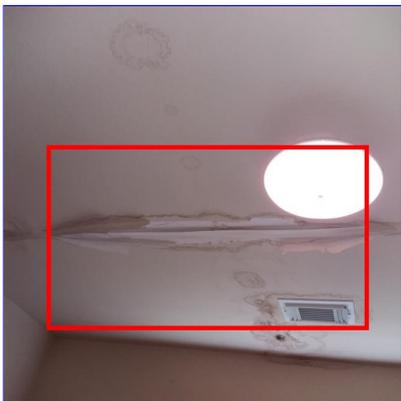
F. Item 31(Picture)

(18) The Drywall on the ceiling is peeling as a result from water leak above downstairs Bedroom. The moisture meter was used and it did not indicate an active leak. A qualified person should repair or replace as needed.

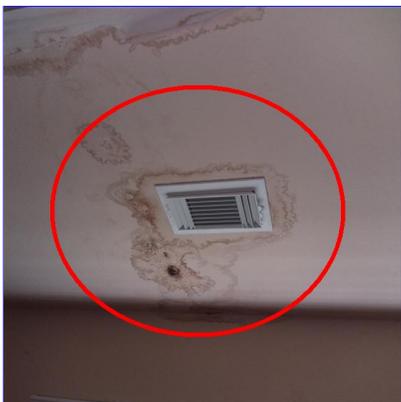
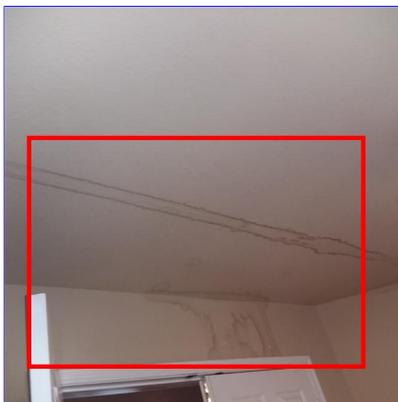
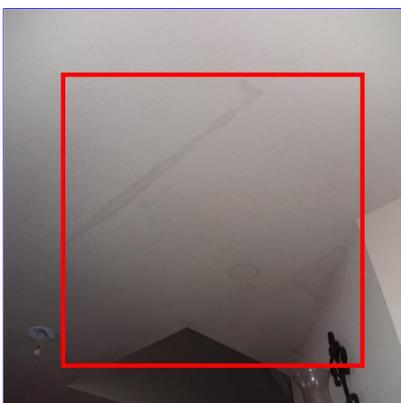
(19) The Drywall on the ceiling reveals a water stain indicating a leak did or still exists in areas. The moisture meter was used and it did not indicate an active leak. A qualified person should repair or replace as needed.

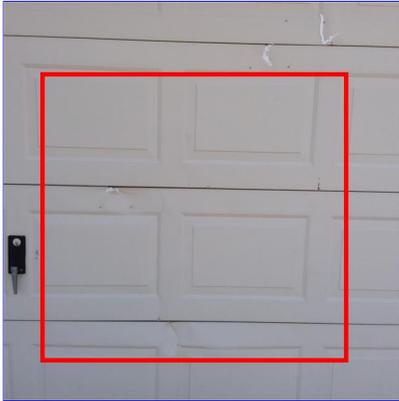
G. Item 1(Picture)

(1) The garage door at the front of home is damaged at panel. This is cosmetic and for your information. A qualified person should repair or replace as needed.

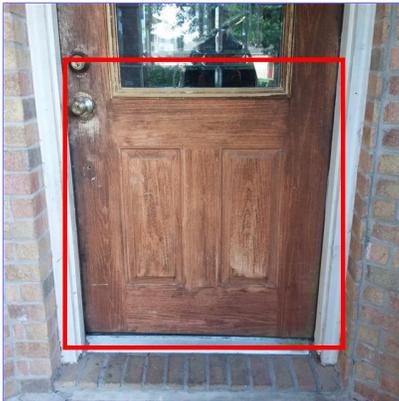
G. Item 2(Picture)

(2) The main entry door weathered and needs prep and paint (exterior). Further deterioration may occur if not repaired. A qualified person should repair or replace as needed.

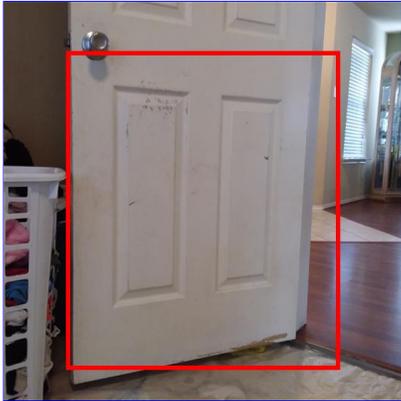
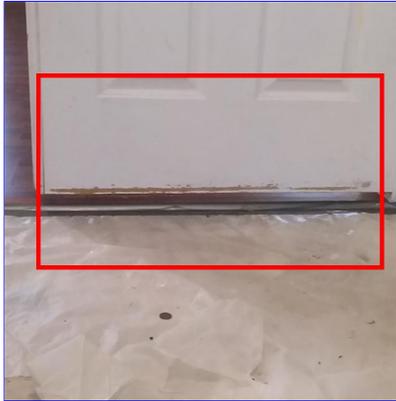
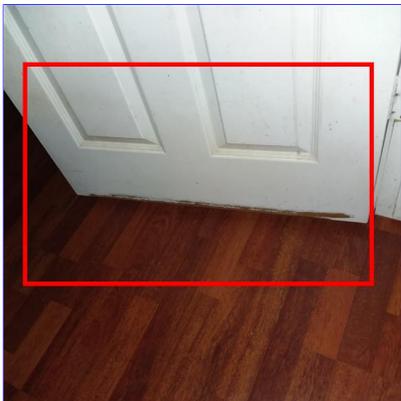
(3) The Entry door is damaged in areas. This is cosmetic and for your information. A qualified person should repair or replace as needed.

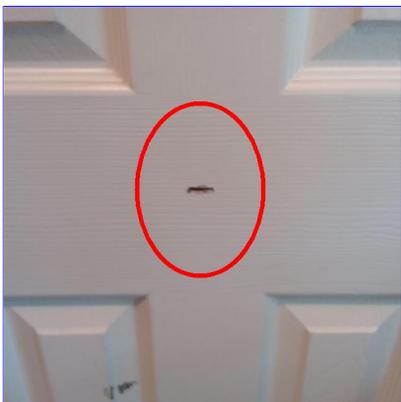
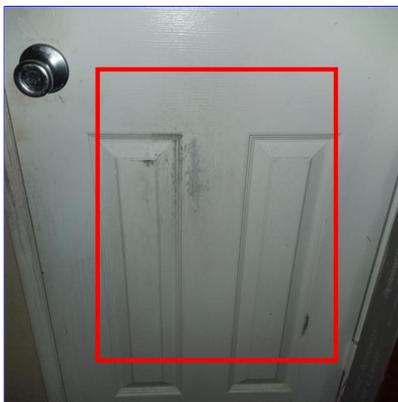
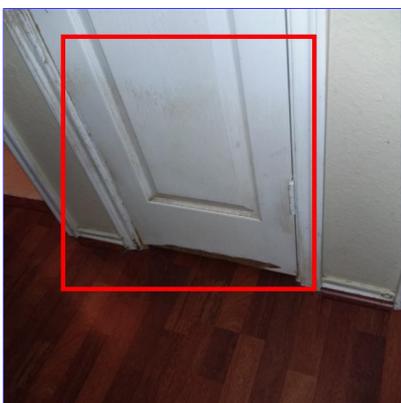
(4) The Closet door is damaged in areas. This is cosmetic and for your information. A qualified person should repair or replace as needed.

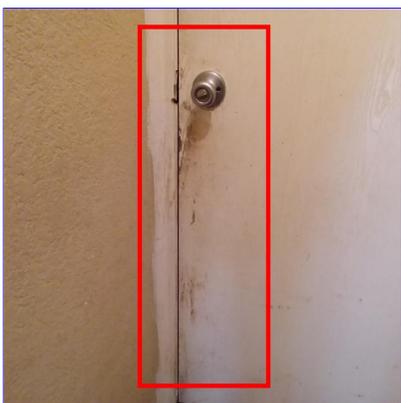
G. Item 9(Picture)

(7) The garage was damaged by pet. This is cosmetic and for your information. A qualified person should repair or replace as needed.

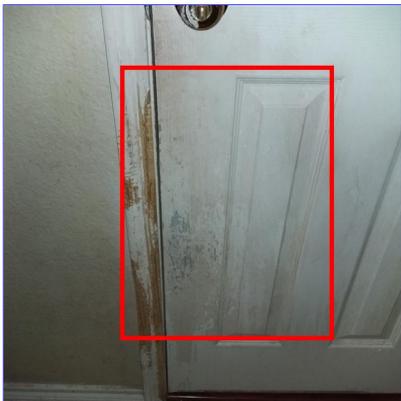
G. Item 10(Picture)

(8) The Entry door shows areas of peeling paint in areas. This is cosmetic and for your information. A qualified person should repair or replace as needed.

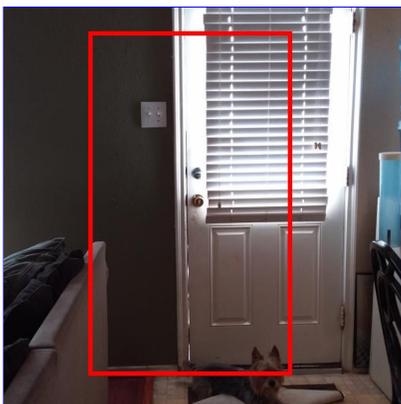
G. Item 11(Picture)

(9) The rear of home reveals daylight when latched at areas missing weather-stripping. This can cause some heat loss in winter and loss of cool air in summer if not corrected. A qualified person should repair or replace as needed.

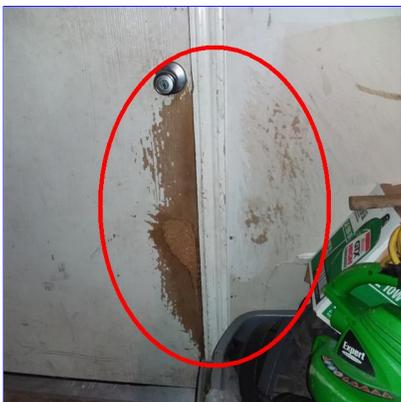
G. Item 12(Picture)

(10) The garage was damaged by pet. A repair or replacement is needed. A qualified person should repair or replace as needed.

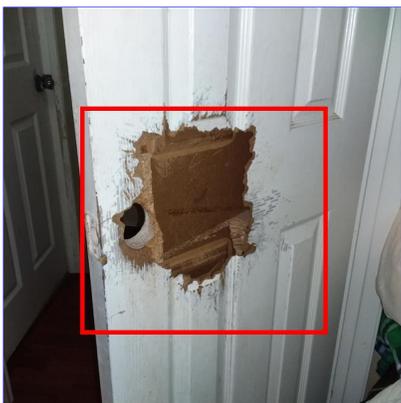
G. Item 13(Picture) Upstairs rear hall closet

(11) The Closet door is damaged upstairs hallway. A repair or replacement is needed. A qualified person should repair or replace as needed.

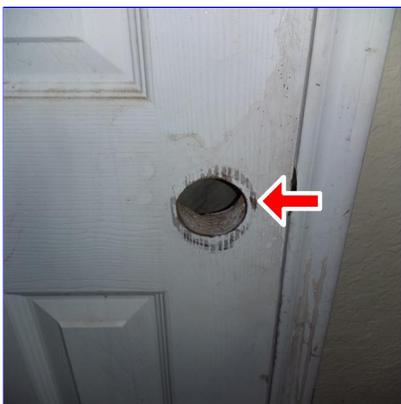
G. Item 14(Picture)

(12) The Closet door missing knob hardware upstairs hallway. This is a small repair. A qualified person should repair or replace as needed.

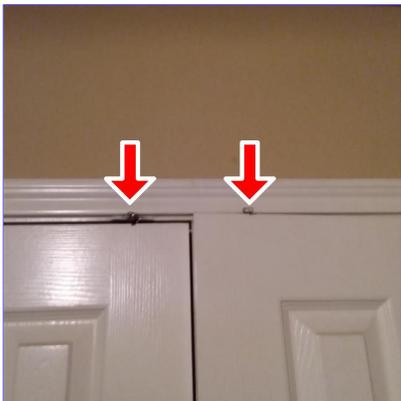
G. Item 15(Picture) Front left bedroom

(13) The Closet door missing strike hardware Bedroom. This is a small repair. A qualified person should repair or replace as needed.

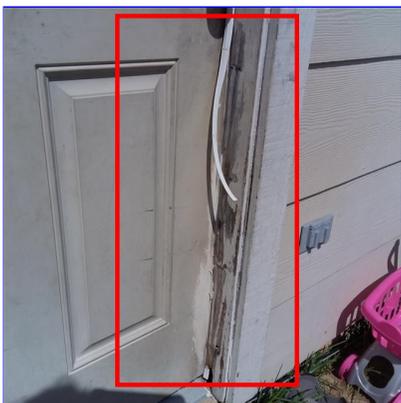
G. Item 16(Picture)

(14) The rear of home was damaged by pet. Further deterioration may occur if not repaired. A qualified person should repair or replace as needed.

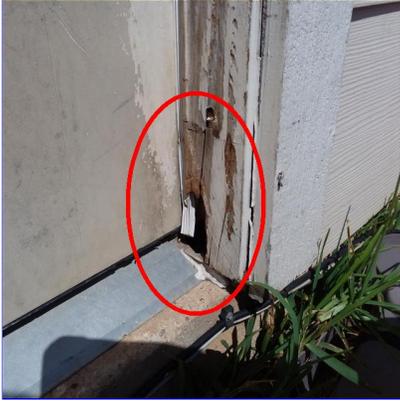
G. Item 17(Picture)

(15) The rear of home deteriorated at bottom of jamb (s). Further deterioration may occur if not repaired. A qualified person should repair or replace as needed.

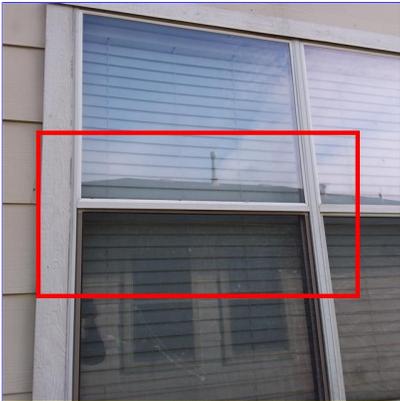
H. Item 1(Picture) Right side of home

(1) There are window frames that are not properly sealed. This can cause energy loss. I recommend having a qualified person seal and repair as needed,

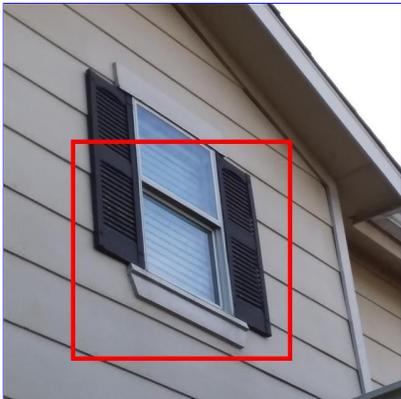
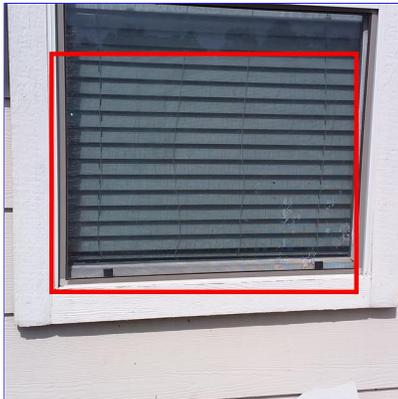
(2) Windows have damaged or missing screens. This is not considered to be today's standards. I recommend having a qualified person make repairs as needed.

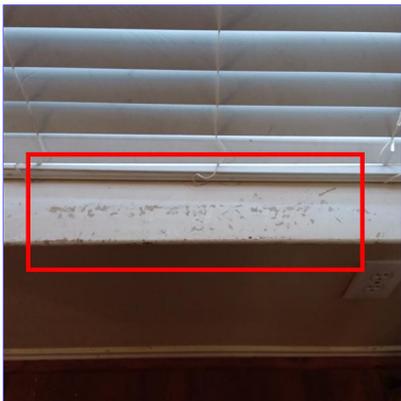
H. Item 5(Picture) Front of formal dining room

(3) Some windows have damaged sills in areas. This is a cosmetic issue for your information. A qualified person should repair or replace as needed.

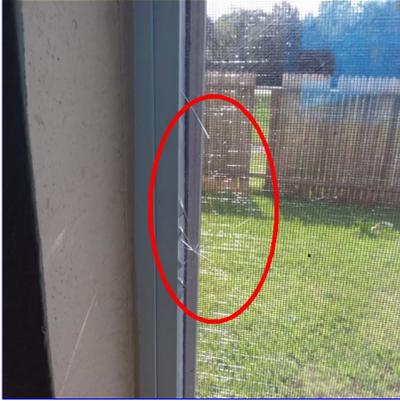
H. Item 8(Picture) Right rear of living room

(4) There is a cracked glass pane in window. I recommend having a qualified person make repairs as needed.

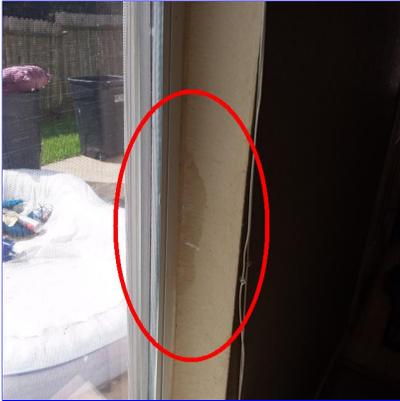
H. Item 9(Picture) Right rear of living room

(5) Several windows show minor water spotting caused from condensation and caulking that is showing signs of deterioration. I recommend having a qualified person make repairs as needed.

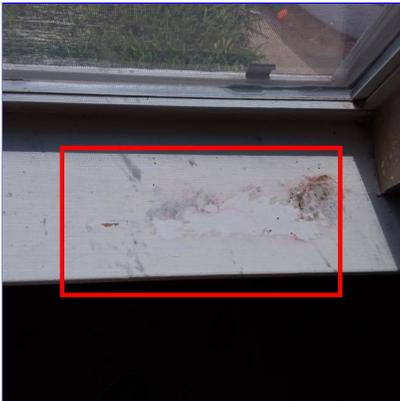
H. Item 11(Picture) Right rear of living room

(6) The wood trim is peeling paint at most windows. Further deterioration may occur if not repaired. I recommend a qualified contractor inspect and repair as needed.

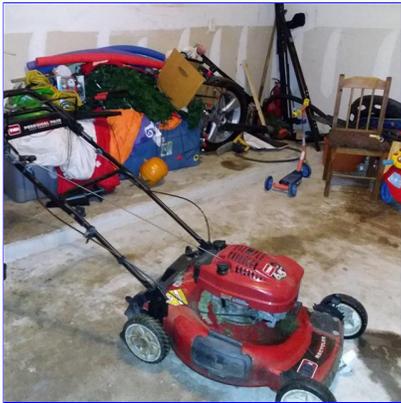
L. Item 1(Picture)

Areas of the home have limited access due to furniture or occupants belongings. This is for your information.

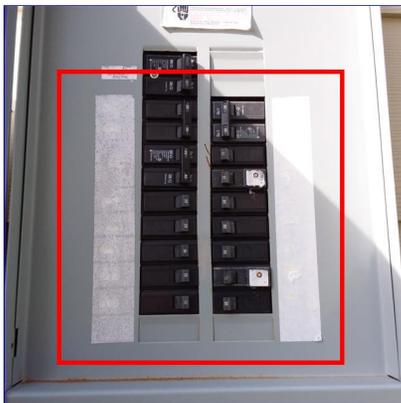
A. Item 1(Picture)

(1) The panel is missing circuit identification. **This is a safety hazard.** I recommend having a qualified person mark circuits as needed.

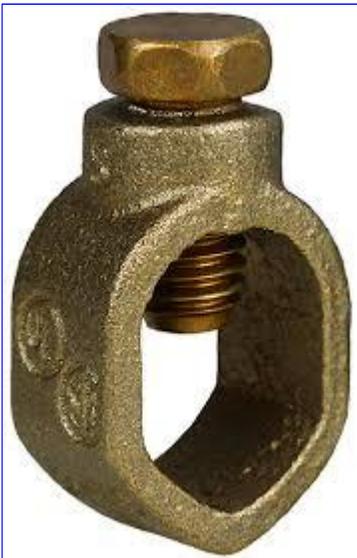
A. Item 3(Picture)

(3) The grounding rod near meter is using improper clamp for grounding of main panel (solid brass clamp is recommended). This is not considered to be today's standard. I recommend having a qualified person replace with proper clamp to assure proper grounding.

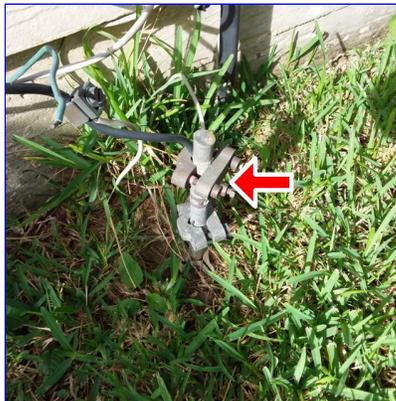
A. Item 4(Picture)

(4) The panel is missing cover screw(s). **This is a safety issue.** I recommend having a qualified person repair as needed.

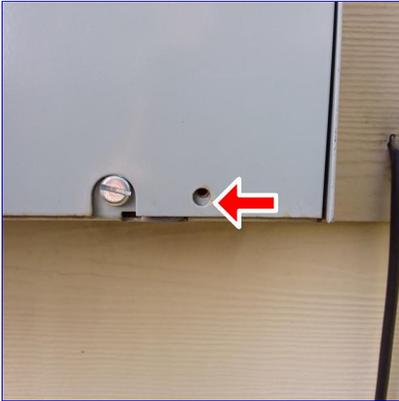
A. Item 5(Picture)

(5) There is no antioxidant on aluminum conductors feeding panel. This is not considered to be today's standard. I recommend having a qualified electrician evaluate make repairs as needed.

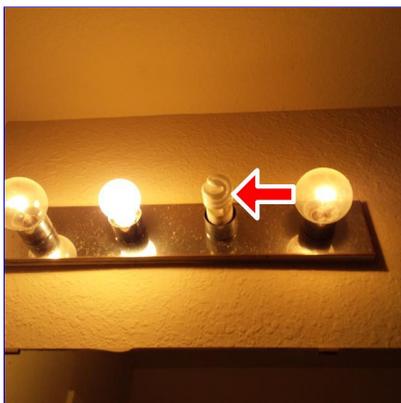
B. Item 5(Picture) Hall bath

(5) The light fixture is missing globe at the hallway. Electrical issues are considered a hazard until repaired. I recommend repair as needed.

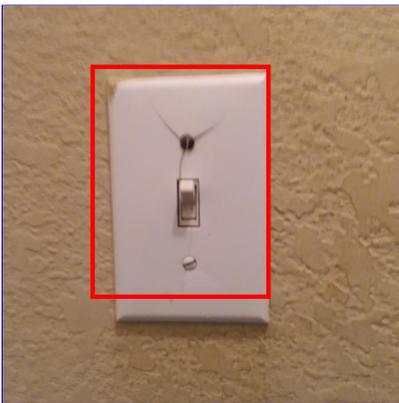
B. Item 7(Picture) Garage entry

(6) The wall switches have damaged "cover-plates" in area's. Electrical issues are considered a hazard until repaired. I recommend repair as needed.

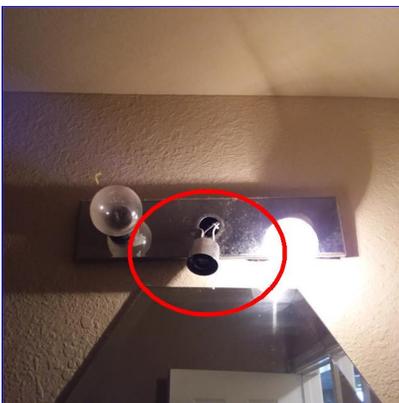
B. Item 9(Picture)

(8) "three-prong" outlets are loose in wall in most if not all rooms. Electrical issues are considered a hazard

until repaired. I recommend repair as needed.

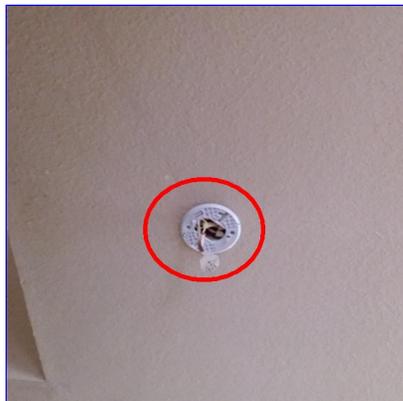
B. Item 10(Picture) Lower level stairway entry

(9) The smoke detector has been disconnected intentionally at the lower level. Without a working smoke detector in your home you have no first alert to a possible fire. A qualified person should repair or replace as needed.

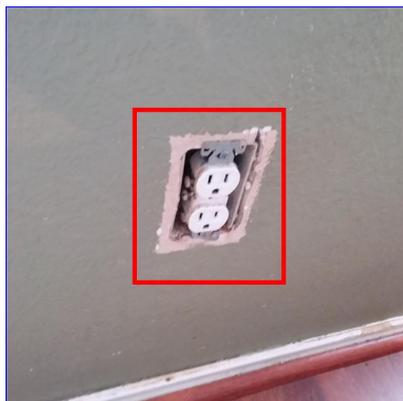
B. Item 11(Picture) Right rear of living room

(10) "three-prong" outlet is missing cover-plate in the living room. Electrical issues are considered a hazard until repaired. I recommend repair as needed.

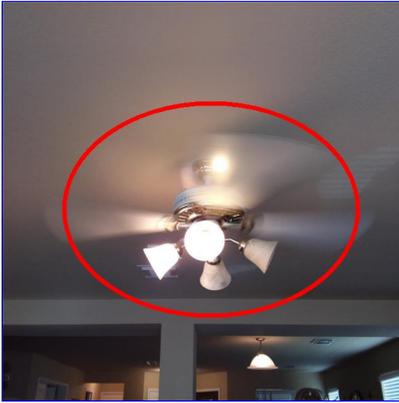
B. Item 12(Picture) Living room

(12) The light fixture is missing cover at the in areas. Electrical issues are considered a hazard until repaired. I recommend repair as needed.

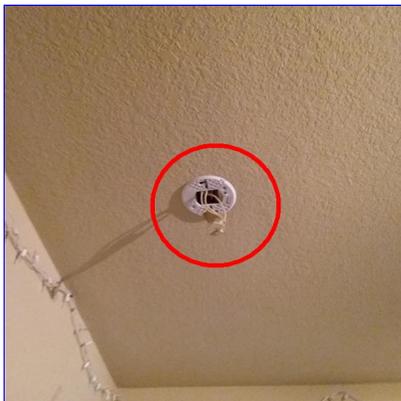
B. Item 17(Picture) Left rear bedroom

(14) The smoke detector has been disconnected intentionally at the bedroom. Without a working smoke detector in your home you have no first alert to a possible fire. A qualified person should repair or replace as needed.

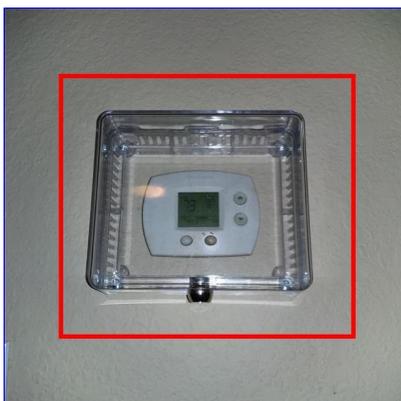
B. Item 1(Picture)

- (1) It is recommended to have HVAC systems serviced annually.
- (2) Unable to test. No key for thermostat cover.

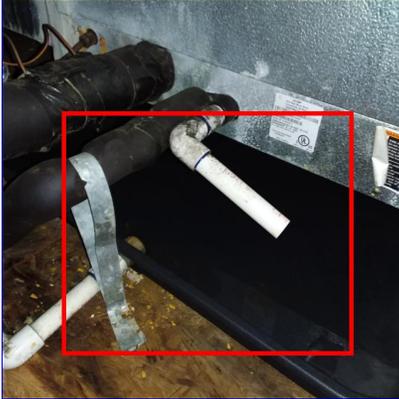
B. Item 2(Picture)

- (3) The Filter is dirty and needs replacing.
- (4) The water or overflow tray is full of water and is not working properly. Leaks can cause damage to unit or home. A licensed HVAC contractor should service or repair unit.

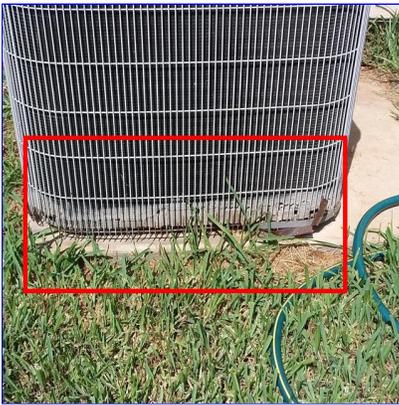
B. Item 3(Picture)

(6) The cooling fins on compressor appear damaged and may no longer work properly. This can cause damage to the unit or shorten its life span. A licensed HVAC contractor should service or repair unit.

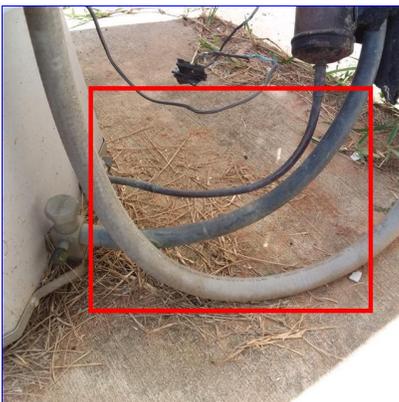
B. Item 4(Picture)

(7) The foam sleeve on suction line is missing foam sleeve in area(s). Missing foam on suction line can cause energy loss and condensation. I recommend service or repair as needed.

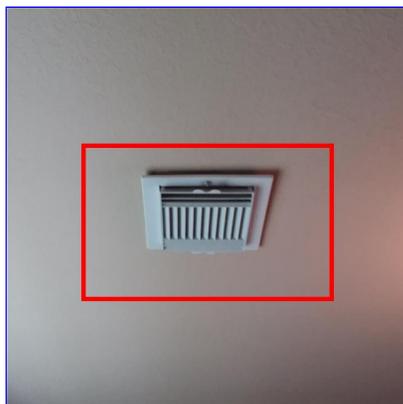
C. Item 1(Picture) Left side of formal dining room

(2) The supply register is loose in the dining room. This is for your information. I recommend service or repair as needed.

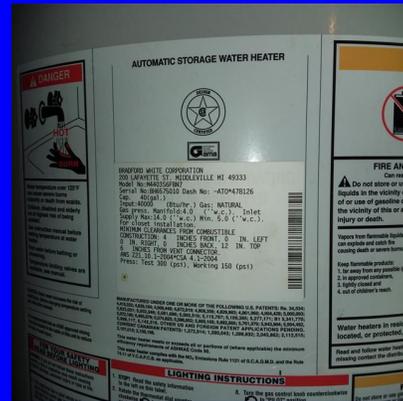
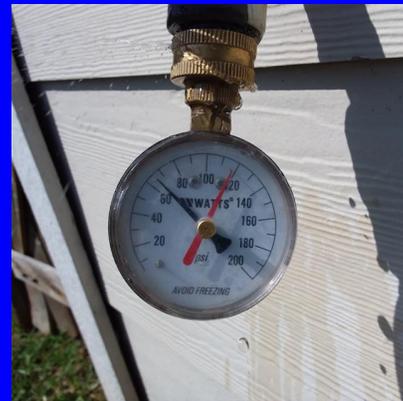
65 psi water pressure

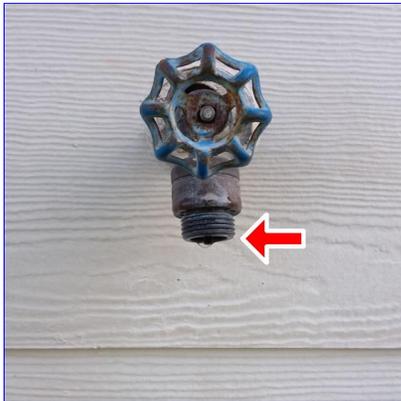
A. Item 1(Picture)

(1) The outside water faucet drips when off at the right side of home. Repairs are needed. A qualified person should repair as necessary.

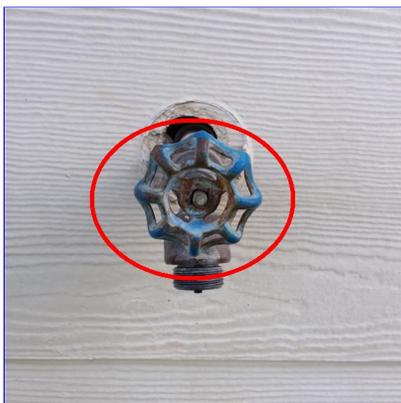
A. Item 2(Picture)

(2) The outside water faucet has loose knob(s) at the right side of home. Repairs are needed. A qualified person should repair as necessary.

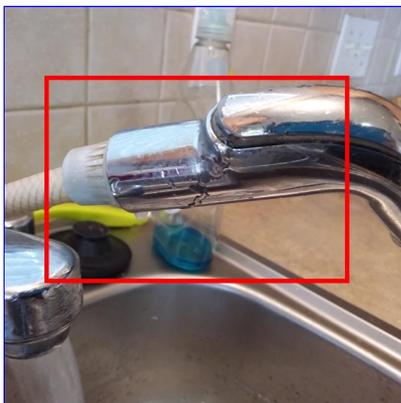
A. Item 3(Picture)

(3) The spray nozzle leaks at the kitchen sink. Repairs are needed. A qualified person should repair as necessary.

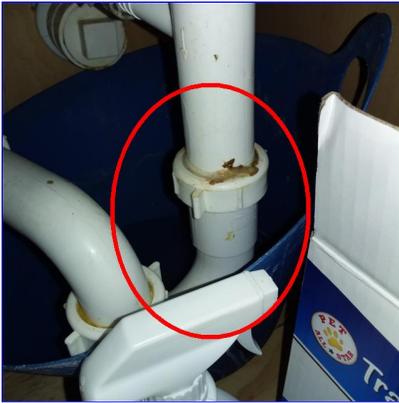
B. Item 1(Picture)

(1) The waste line is leaking at the Kitchen sink. Repairs are needed to stop leaking water from damaging the cabinet bottom or to eliminate moisture that may contribute to fungi growth. A qualified licensed plumber should repair or correct as needed.

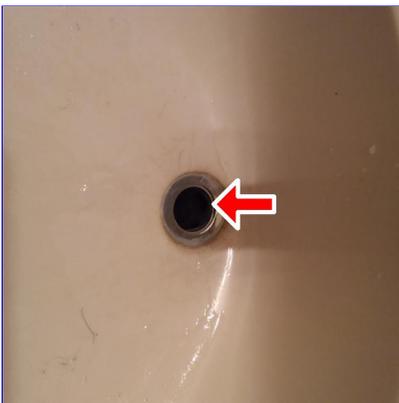
B. Item 2(Picture)

(3) Plumbing waste line plug is damaged or missing and no longer operates. A drain plug is being used instead at Hall Bath sink.

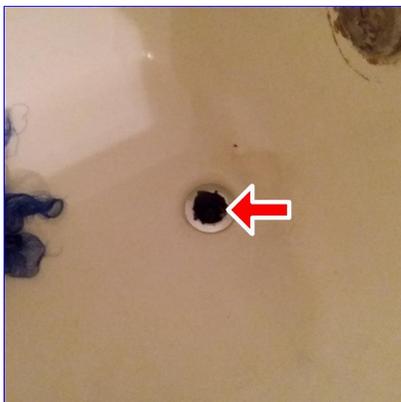
B. Item 3(Picture)

(4) Tub drain plug is damaged or missing and no longer operates. A drain plug is being used instead at hall bath.

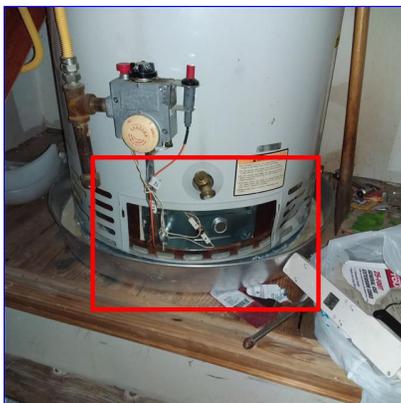
C. Item 1(Picture)

The water heater missing panel cover. This is a safety issue and should be repaired. A qualified person should repair as necessary.

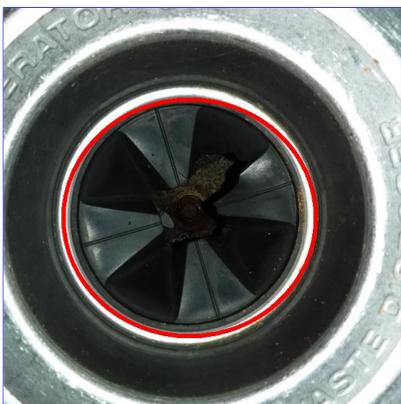
B. Item 1(Picture)

(1) The food disposer is rusted inside at the blades. I recommend repair as needed.

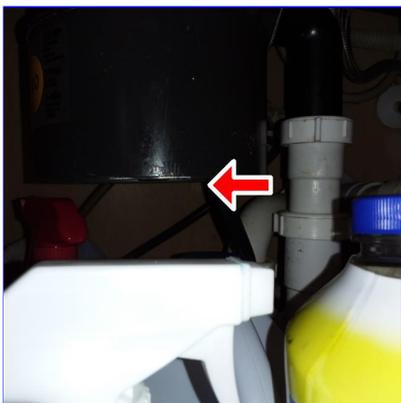
B. Item 2(Picture)

(2) The food disposer wiring is missing a wire connector (anti-strain device). I recommend repair as needed.

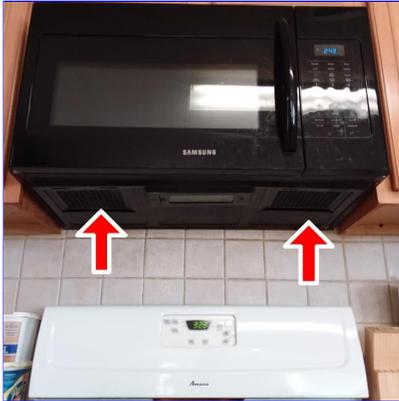
C. Item 1(Picture)

(1) The grease filters are missing. I recommend repair or replace as needed.

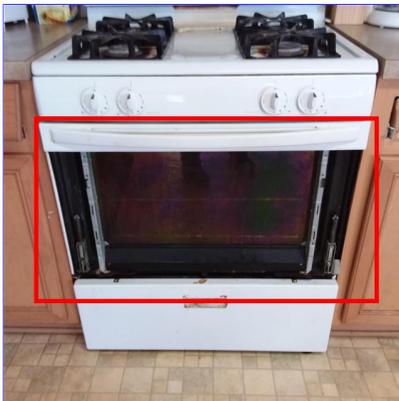
D. Item 1(Picture)

(1) The oven door for oven is damaged. I recommend repair as needed.

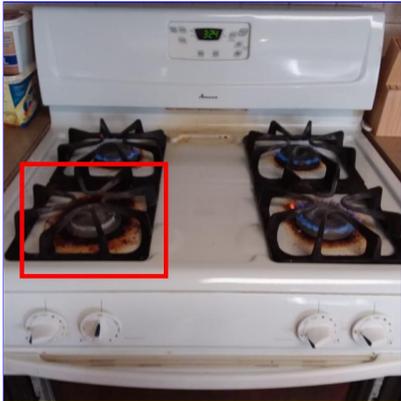
D. Item 3(Picture)

(3) The front left burner for range would not ignite properly. I recommend repair as needed.

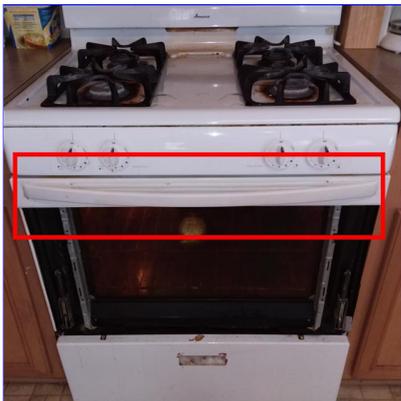
D. Item 4(Picture)

(4) The oven door handle for oven is loose. I recommend repair as needed.

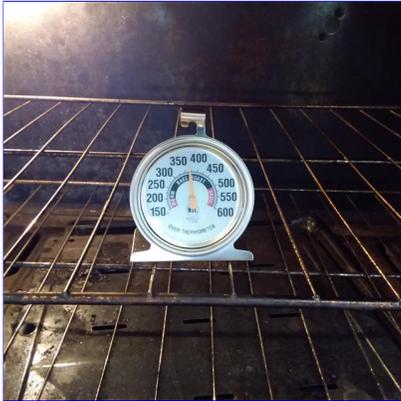
D. Item 5(Picture) Oven tested at 350° (within the 25° differential)

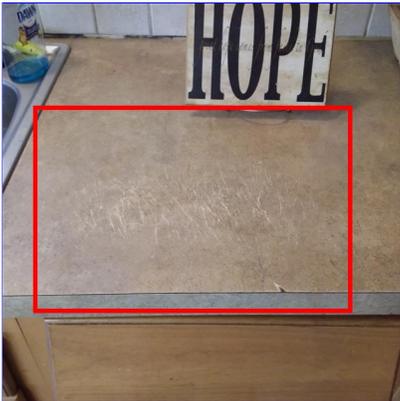
I. Item 1(Picture) Right of sink

(1) Laminated countertop is damaged . This is a cosmetic issue for your information. Recommend repair or replace as necessary.

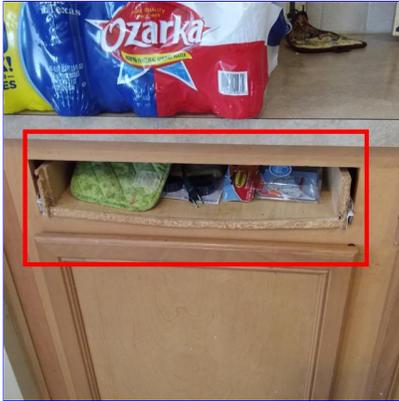
I. Item 3(Picture) Right rear side of kitchen

(2) Drawer face is missing at some drawers. This is a cosmetic issue for your information. Recommend repair or replace as necessary.

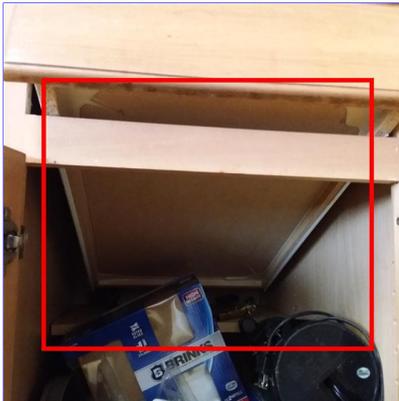
I. Item 5(Picture) Front right side of kitchen

(3) Drawer track is missing at some drawers. This is a cosmetic issue for your information. Recommend repair or replace as necessary.

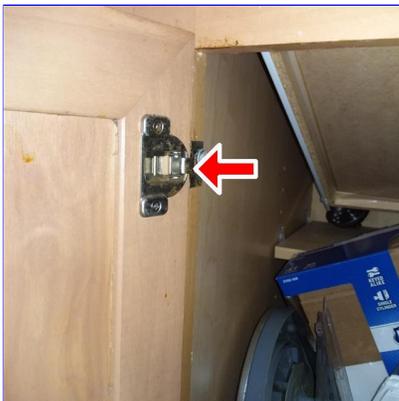
I. Item 7(Picture) Front right of kitchen

(4) Cabinet door (s) is loose at some cabinet doors. This is a cosmetic issue for your information. Recommend repair or replace as necessary.

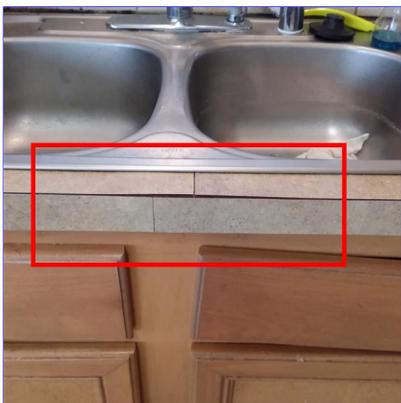
I. Item 8(Picture)

(5) Laminated countertop is swollen and beginning to blister under sink. This is a cosmetic issue for your information. Recommend repair or replace as necessary.

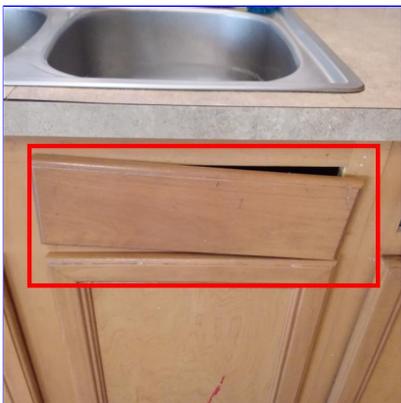
I. Item 9(Picture)

(6) Drawer face is loose under sink. This is a cosmetic issue for your information. Recommend repair or replace as necessary.

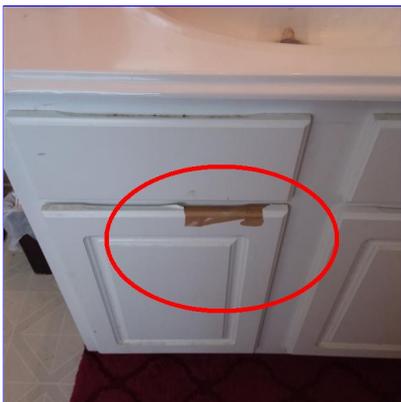
I. Item 10(Picture)

(7) Cabinet door (s) in master bath is peeling in areas. This is a cosmetic issue for your information. I recommend repair or replace as necessary.

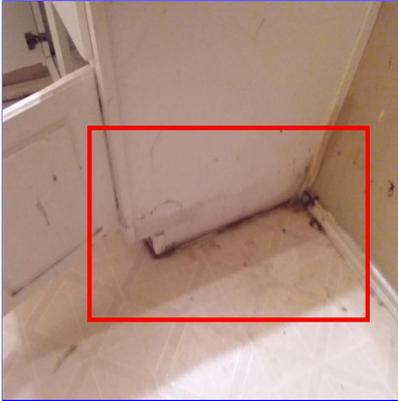
I. Item 11(Picture)

(8) Base cabinetry in hall bath is damaged. This is a cosmetic issue for your information. I recommend repair or replace as necessary.
