# Above Par Home Inspections

## PROPERTY INSPECTION REPORT

Concerning: 2003 Golden Topaz Drive Rosharon, Texas 77583  
(Address or Other Identification of Inspected Property)

By: Joseph Parnell TREC #8013 12-07-2018 8:00 am  
(Name and License Number of Inspector) (Date) (Time)

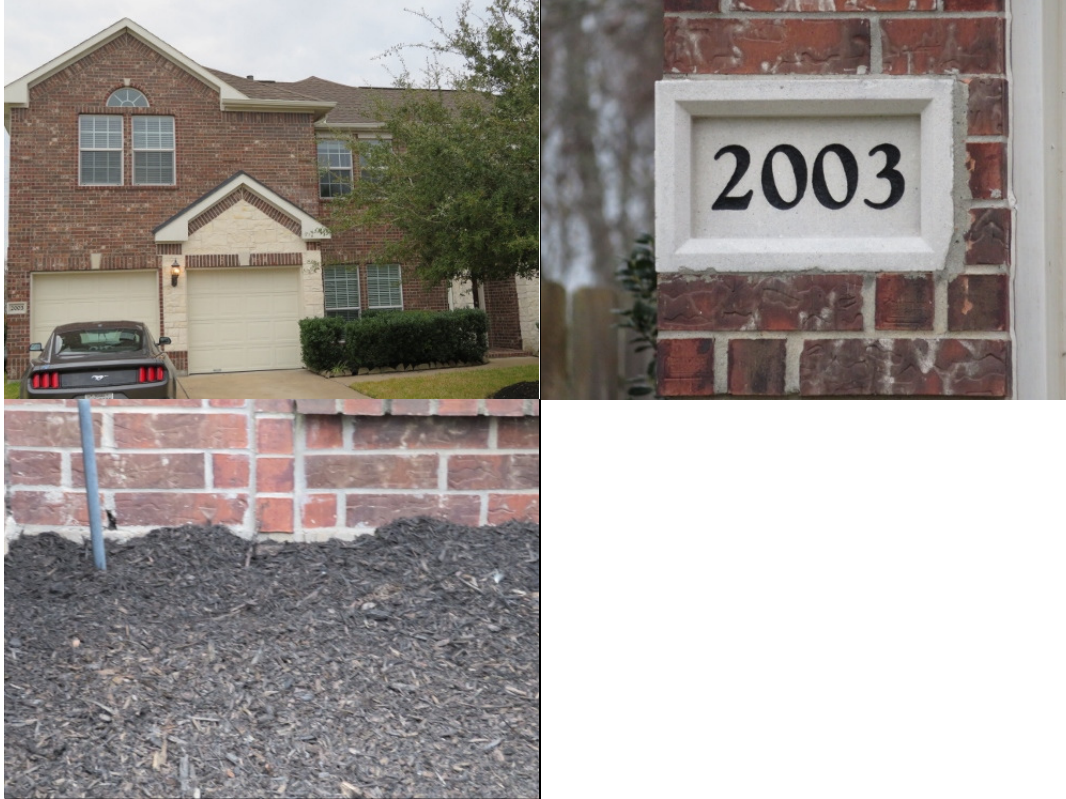
Type of Foundation– Concrete / Post Tension / Steel Reinforced / Slab on Grade: Unable to inspect portions of slab perimeter due to elevated soil, concrete flatwork and foliage. Cracking across the corners of the foundation known as “Spalling” was observed on one or more corners at the time of inspection. “Spalling is not considered structurally significant. Slab has experienced signs of settlement as evidenced by cracks in the grade beam and sheetrock. At the time of inspection the foundation was performing its intended function.

**Recommendation / Comment Only:** Trees & tree stumps located within 5 Ft. of the foundation may constitute a potential threat to the future integrity of the foundation and its underlying soil. Exposed tendon ends and /or rebar should be cleaned & covered with approved materials. Due to the expansive nature of the soil in the Houston and surrounding areas, a frequent foundation watering program is recommended. Consistent watering at the entire perimeter of the slab can help prevent further and/or future settlement and damage.

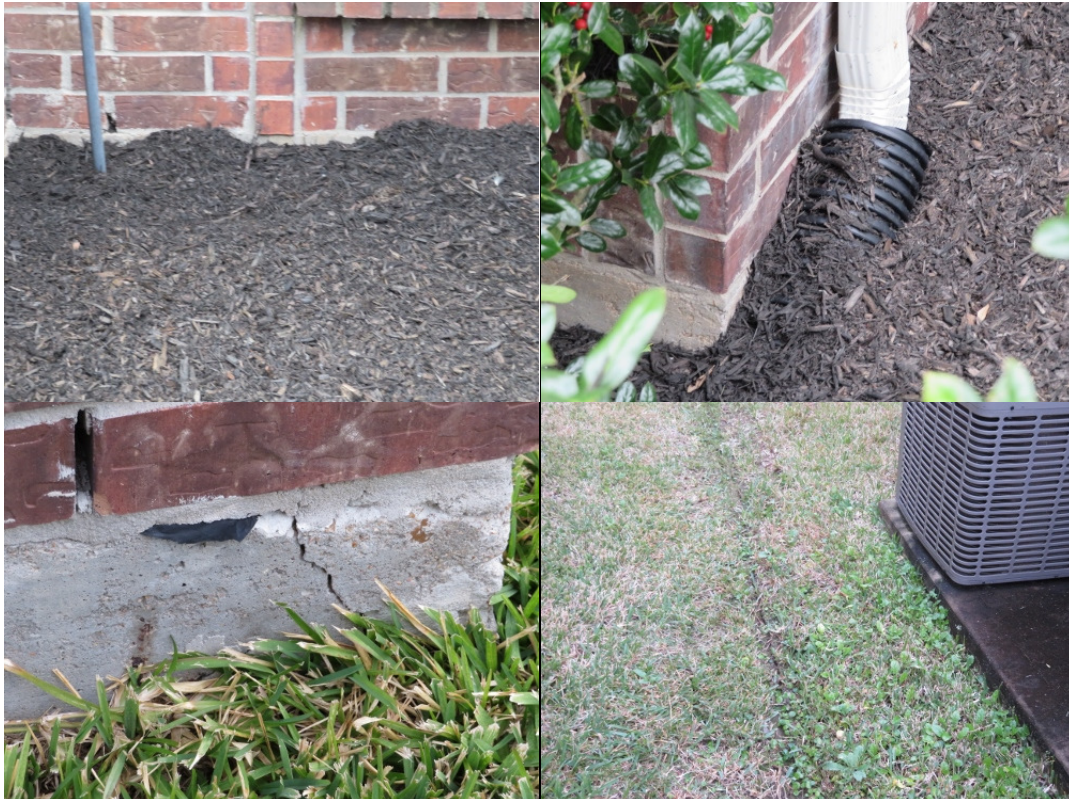
*Comments:* Observed soil / mulch too high in flower beds and/or at various

places of slab perimeter at house and garage. Observed areas of possible ponding in rear and side yards as evidenced by low areas. Reverse slopping was observed. Recommend repairs, establish proper grading and drainage, and top soil / mulch should be at least 2" below the siding or brick line and sloped away from the foundation. Observed drainage systems and was unable to determine serviceability of the drainage systems. Soil erosion was observed in several locations.

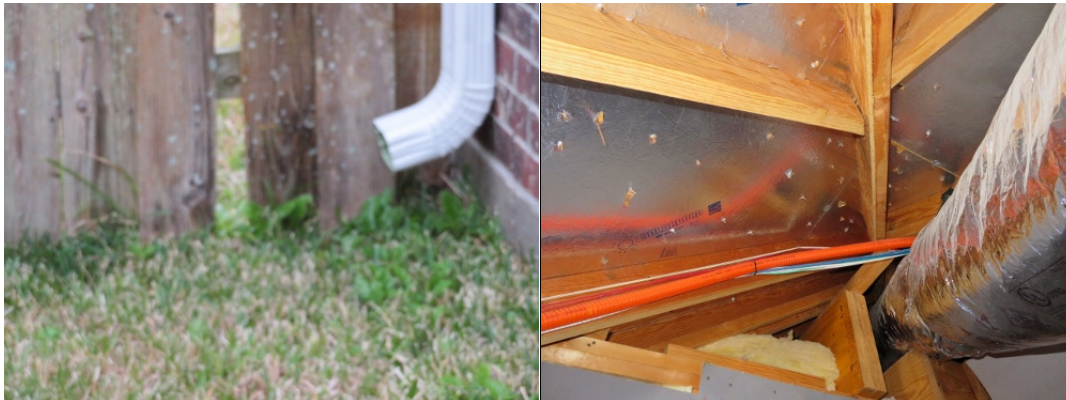
**Type of Roof Covering** – Composition (Observed rooftop from ground level and accessible attic areas only): Raised flashing was observed on the left side of the house. All exposed fasteners on the roof (nails, staples, screws, or bolts) should be covered with a proper material to prevent rusting through and possible water entry. Splash blocks are missing. The cricket for the chimney was not visible to this inspector. Observed no active water penetration. At the time of the inspection the roof was performing its intended function.

**NOTE:** Tree limbs in contact and/or too close to roof should be trimmed / removed approx. 3 Ft. from the dwelling. The entire roof was not visible from the street elevation. The roof was attached with nails.

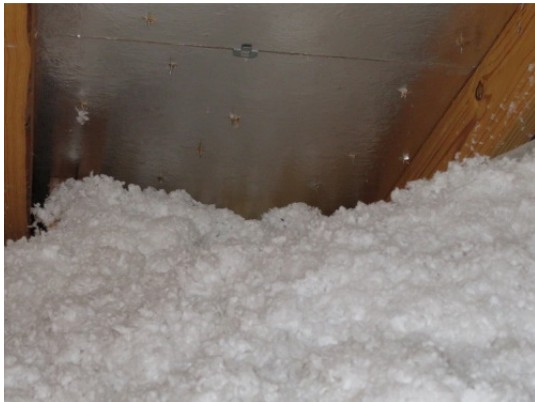
Inadequate attic ventilation. Observed an inadequate amount of attic ventilation due to an insufficient amount of soffit and or roof venting. Increased attic temperatures shorten the life span of mechanical equipment and roofing materials.

Note: Portions of attic (house & garage) were inaccessible and not visible.

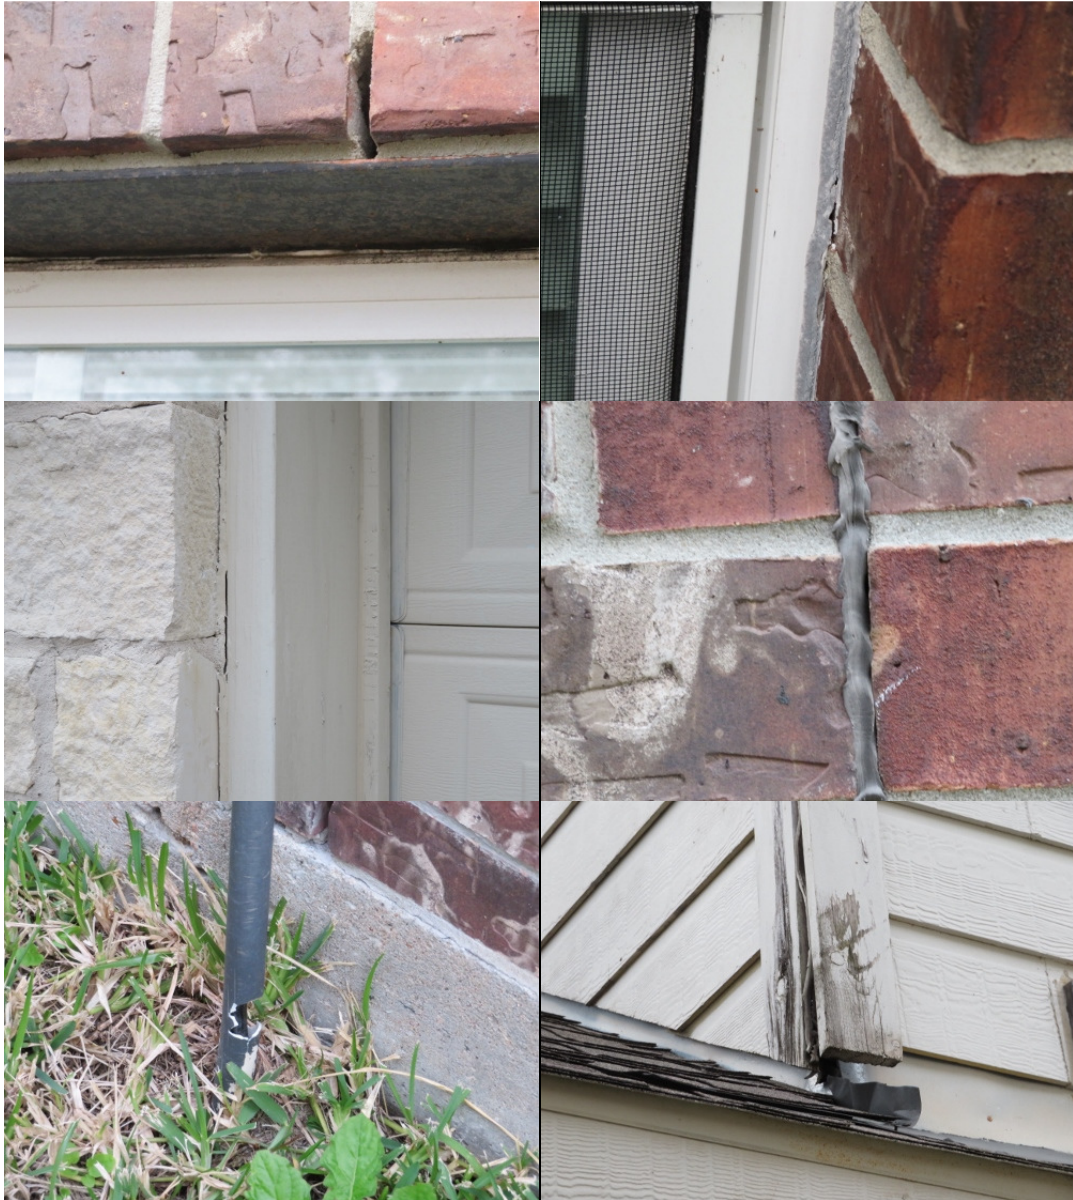
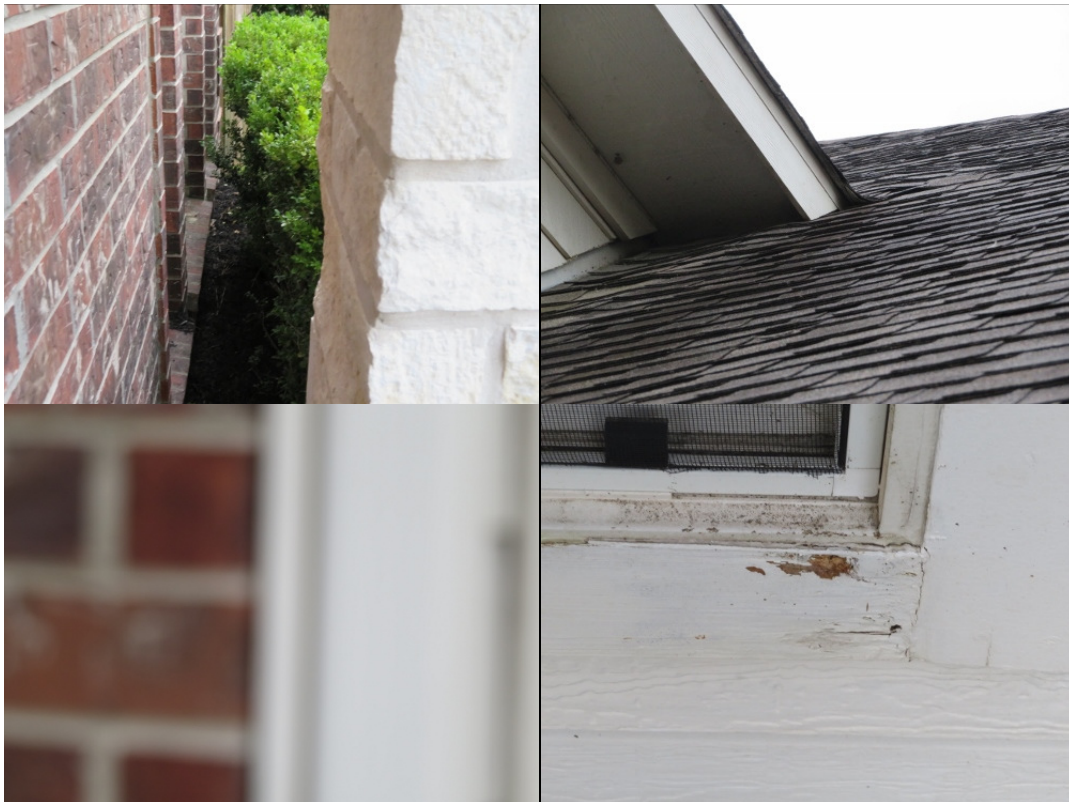
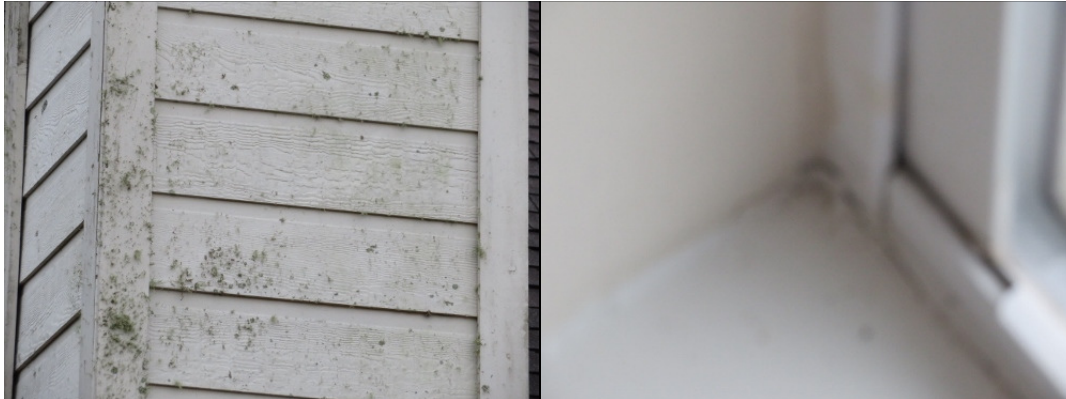
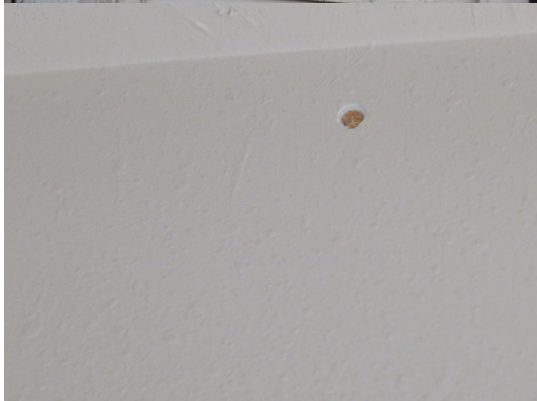
**Interior:** Observed cracks, nail pops and holes in sheetrock. Moisture damage around the windows was observed.

**Note:** Observed previous / recent repairs to sheetrock

**Exterior:** Observed damaged siding and wood trim at various places of exterior walls including doors and windows at house and garage. Expansion joints are missing caulk/sealant. Observed rusted lintels at several locations. Through-wall flashing is missing above all lintels. Window and doors need to be sealed. The brick, siding and trim boards need to be sealed. Observed materials along the wall in one or more areas around the house, these materials are conducive to insect infestation and obscure the view of the slab and exterior wall in these areas. Most wood siding installation requirements specifically state "Leave 1 to 2 inches of clearance between roofing and the bottom of the siding to prevent wood rot. The normal 1 to 2 inches of clearance from the roof surface was not observed. PVC pipe on the left side of the house is damaged and needs to be repaired and sealed. Organic growth was observed on the exterior of the house. Underlying damage may be present.

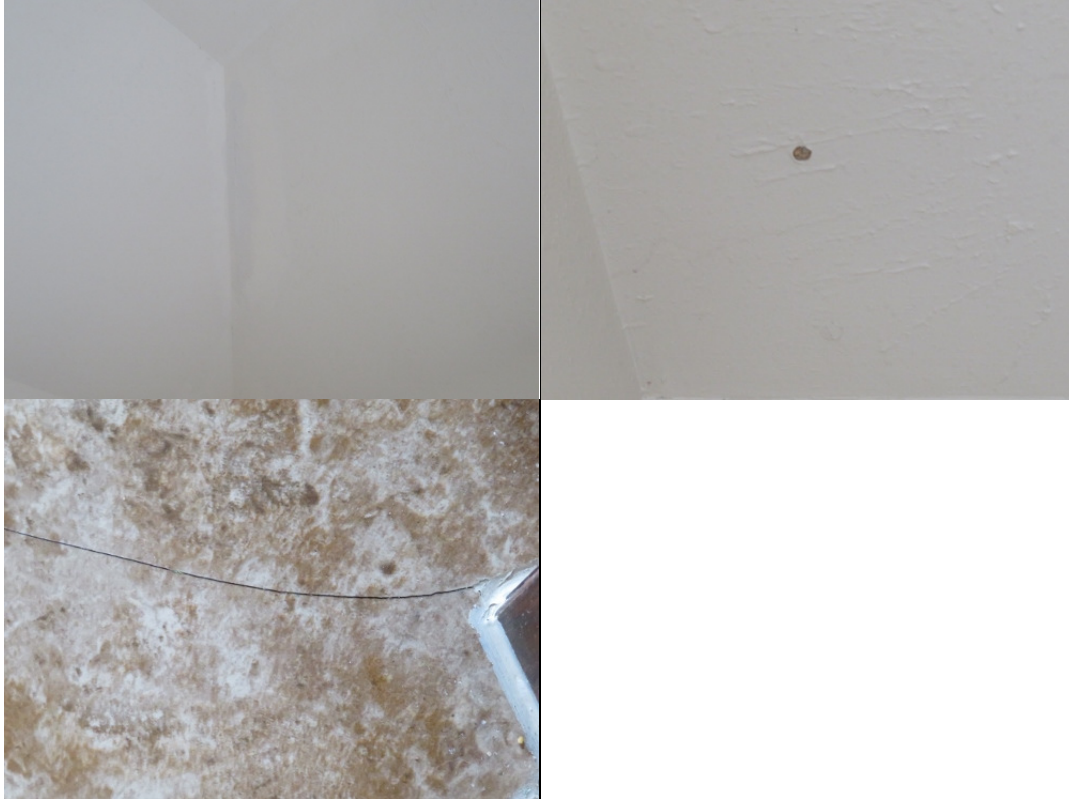
Ceilings: Observed cracks, loose seams and nail pops in the sheetrock in various locations.

Note: Observed previous / recent repairs to sheetrock.

Floors: Tile flooring was cracked.

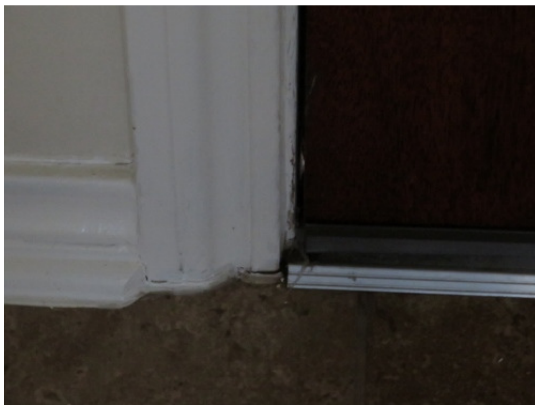
**Interior:** Missing door stops at various places.

**Exterior:** Voids in the weather-stripping at front entry door.

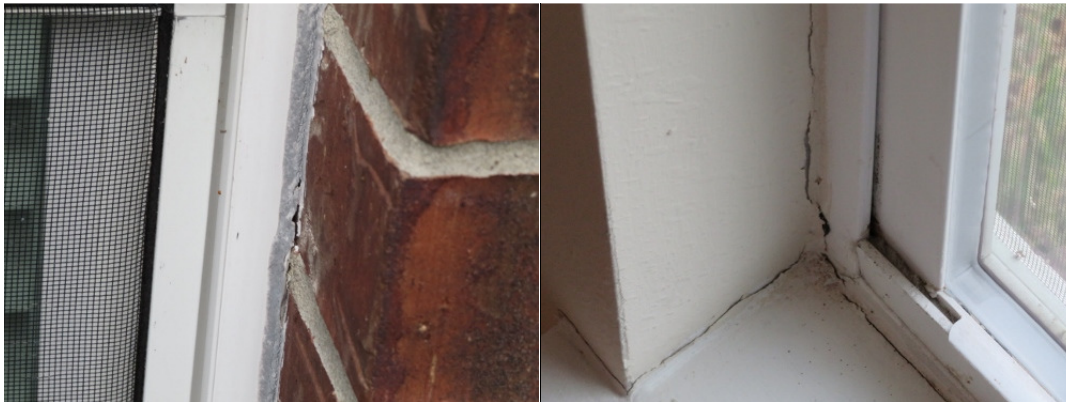
Void in caulk/sealant at exterior and interior of windows at various places.

Note: Glass in windows next to exterior entry doors (within 24" either side of entry doors) should be tempered glass. No safety label was observed. Recommend further investigation to ensure glass is safety type.

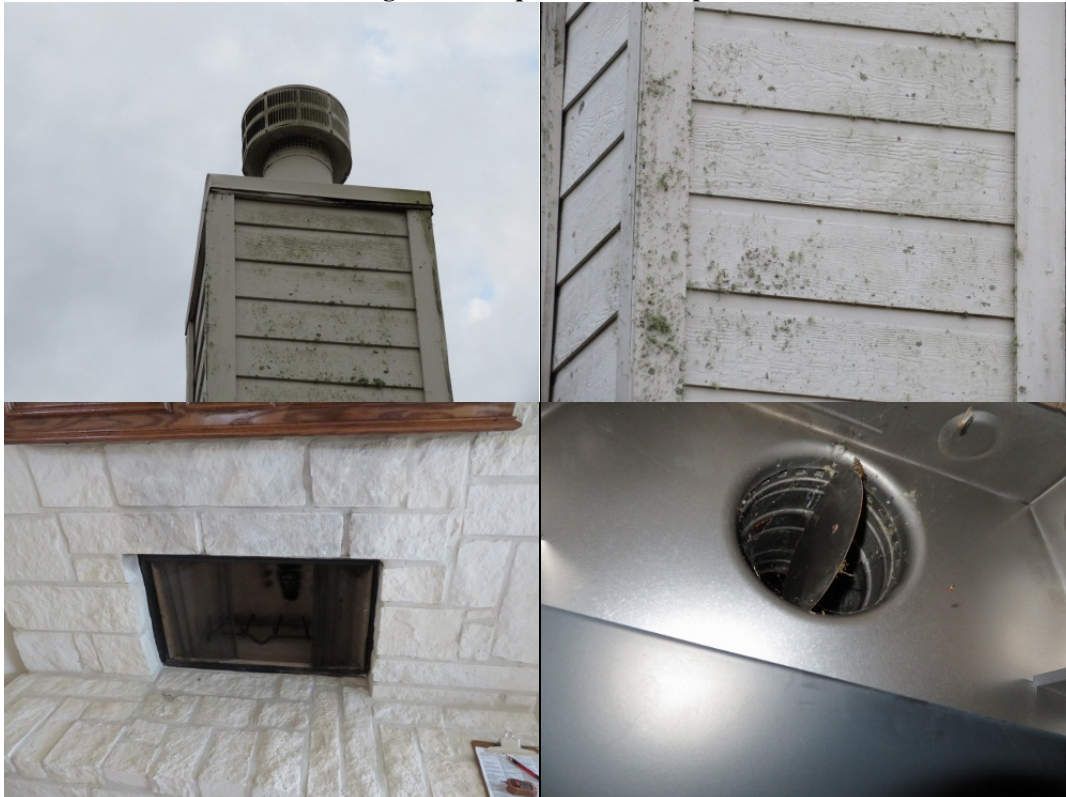
(Pre-Fab Unit) The unit needs to be cleaned. Chimney should be cleaned prior to use.

Note: Chimney should be repaired and cleaned prior to use. The unit was not ignited. Not parts of the fireplace were visible and accessible.

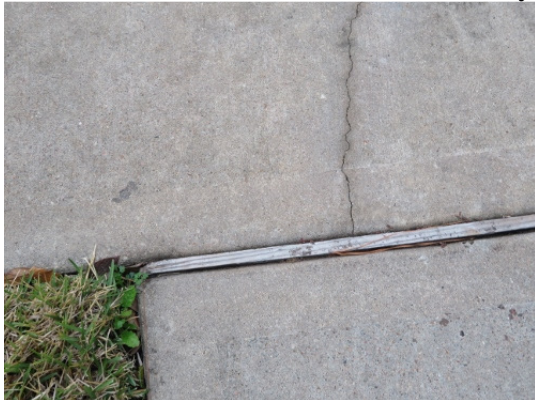
The driveway is cracked.

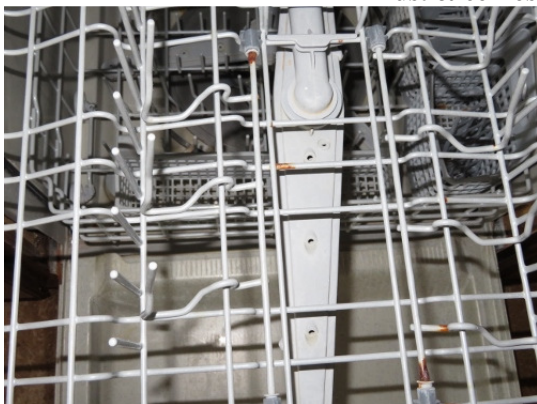
Rust & corrosion spots on both dish trays / racks;

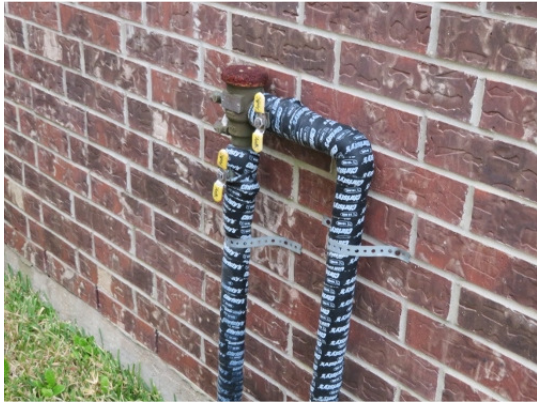
Controls located in garage & backflow preventer is located on the left side of the house. The valves were turned to the off position and the unit was inoperable at the time of this inspections.
