PROPERTY INSPECTION REPORT

ADDRESS: #63 Quiet Oak Circle
Inspection prepared for: Ingrid Lee
Inspection Date: 4/08/20 Time: 2:00pm.-5:00pm.
Age: 1984 Size: 2600 sq. ft.
Weather: 85°F clear
Inspector: Joe Hultman
TREC License # 1531
Phone: 281-363-0407
Email: jhultman50@gmail.com
WEB SITE: www.GHInspect.com
Vacant

Confidential Home Inspection Report

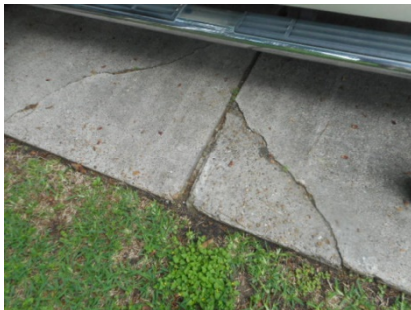
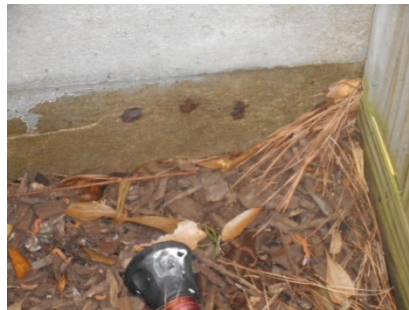
1. The Concrete driveway has cracked and heaved at several areas. This is a safety hazard.
2. Exposed post tension cable ends are present at the grade beams. Clean and seal all exposed cable ends.

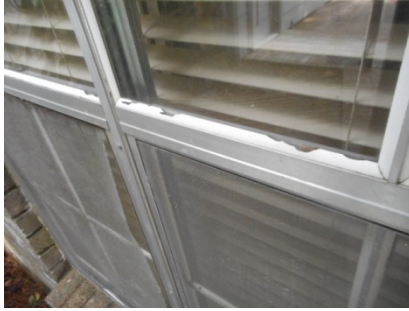
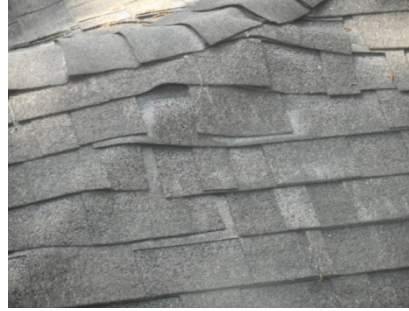
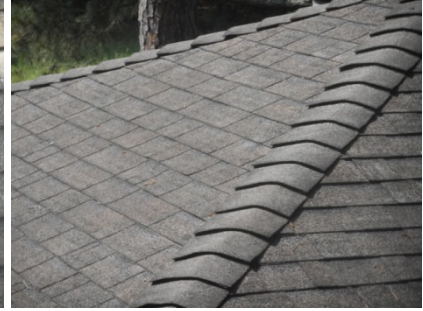
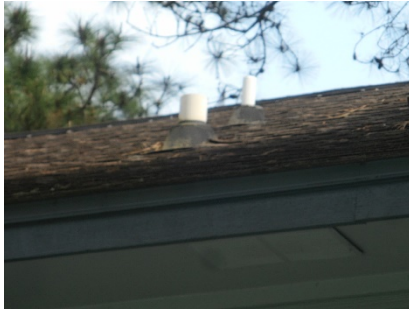
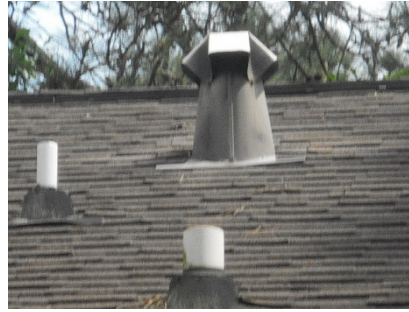
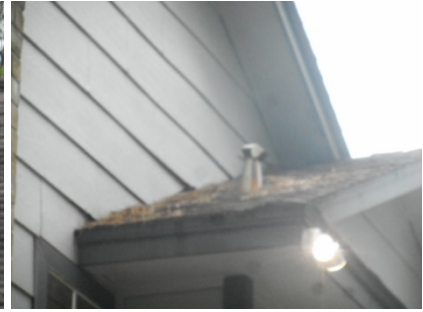
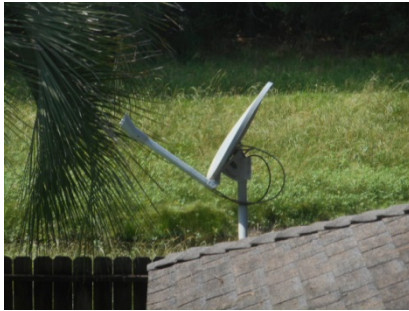
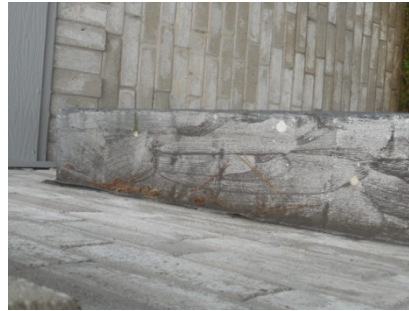
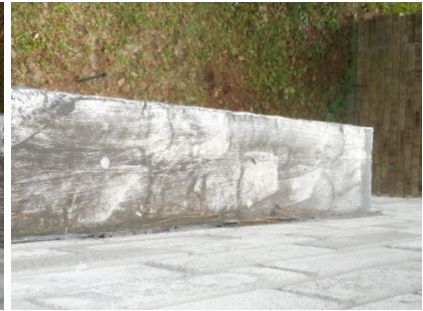
1. A satellite dish is installed through the roof shingles. A roof repair will need to be performed when the dish is removed.
2. Excessive granule loss is present at the shingles due to age. Impact damage is present at the window glazing strips Common with impact damage.
3. All plumbing vents are not caulk sealed and panted and need repaired or replacement.
4. The gas appliance vents at the water heater are corroded and are not a class-B type vent. These vents should be replaced.
5. The front left elevation roof system and flashing over the boxed out window is deteriorated and should be replaced.
6. A further evaluation is needed by a qualified roofing contractor and insurance adjuster is needed to determine if permanent replacement is required.

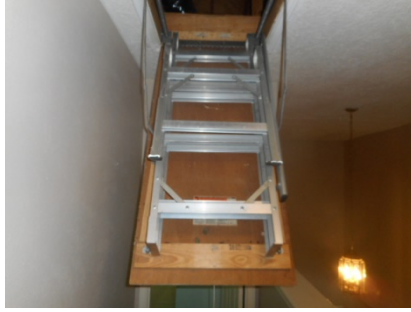
1. The attic access stairs should be insulated.

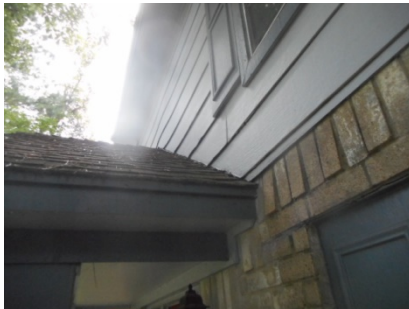
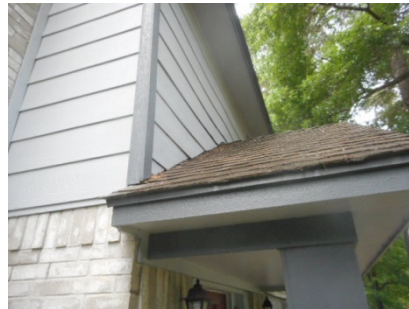
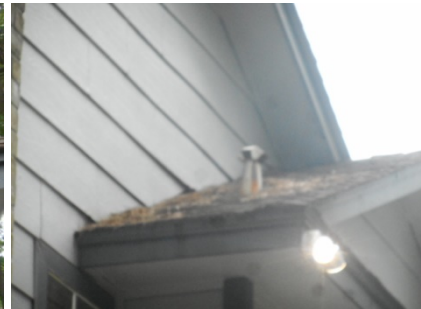
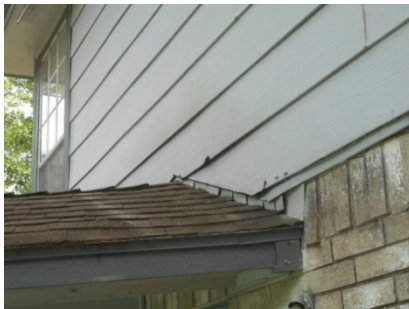
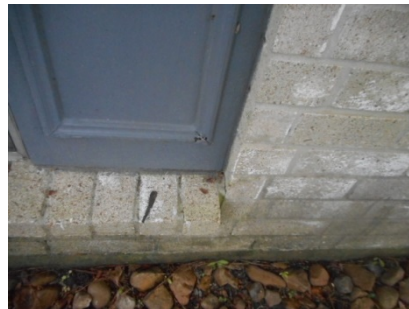
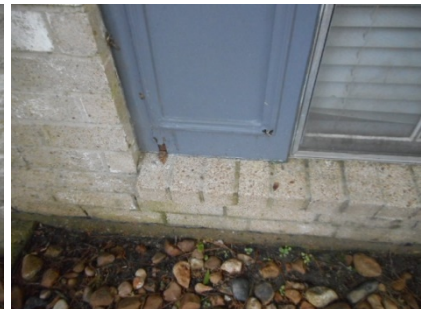
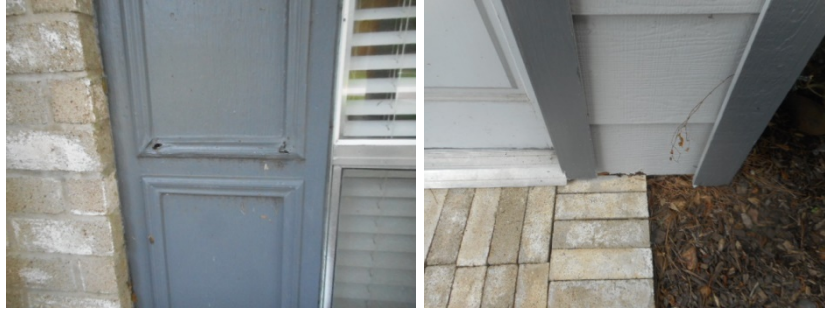
The exterior siding veneer is not functioning at the time of inspection.

1. Wood rot is present at the all exterior siding at the roof lines and grades row at the garage. Replace as needed.
2. The wood shutters at the front right window shutters are deteriorated and needs replaced.

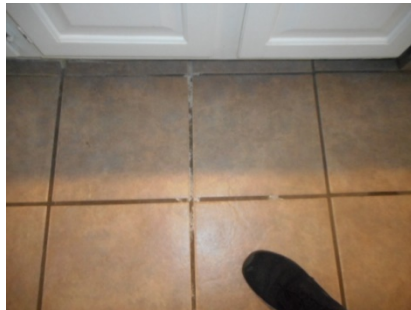
1. Hard water stains are present at the kitchen in front of the base cabinet.

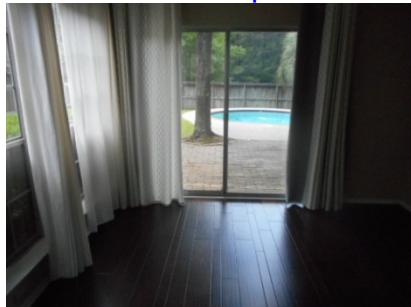
1. The rear exterior patio door is very hard to open and close and needs repaired.

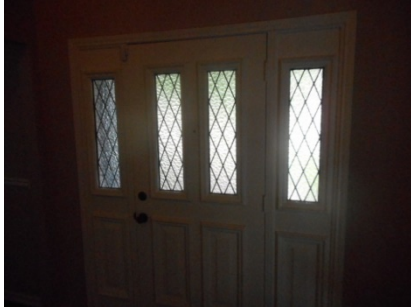
1. Replace all missing and damaged window screens.
2. The front entry door and side light windows are not tempered safety glass. This is a safety hazard.

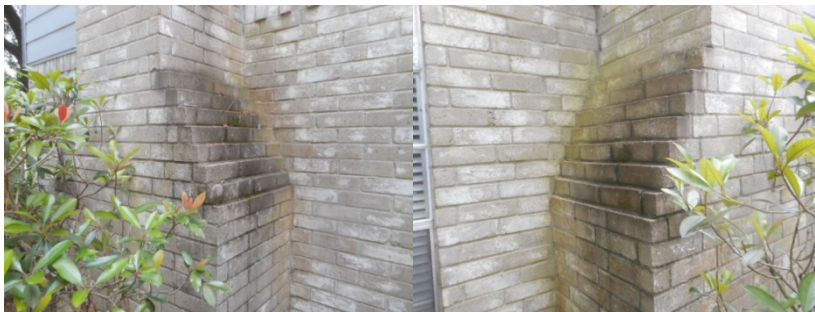
1. The brick veneer chimney shoulders exposed to weather should have flashing installed to prevent moisture from entering the chimney cavity.

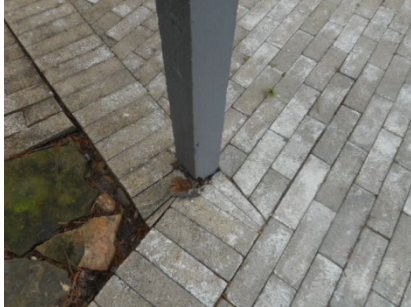
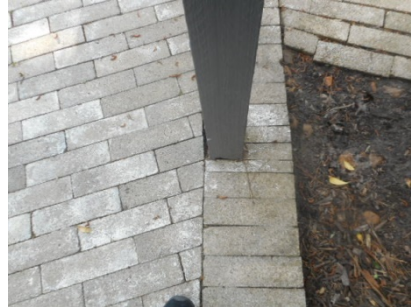
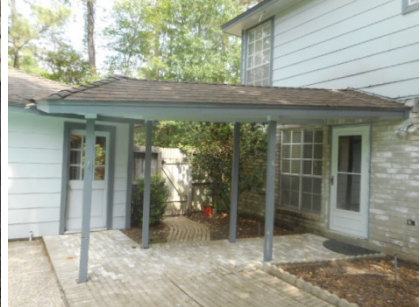
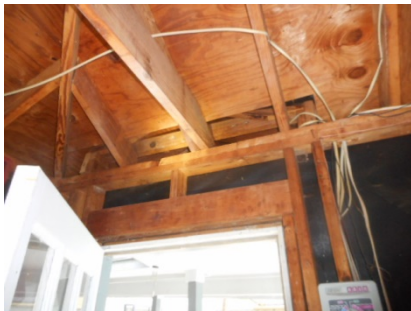
1. The rear house breezeway that that is attached to the garage has deteriorated wood support columns at the bases. The structure has shifted and is not level. The wood columns should be replaced and the structure leveled.
2. A fire-stop should be installed at the garage side of the breezeway. A further evaluation is needed by a qualified contractor for the necessary repair.

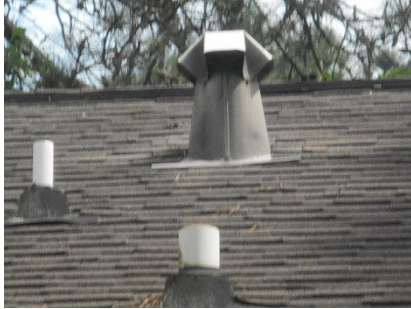
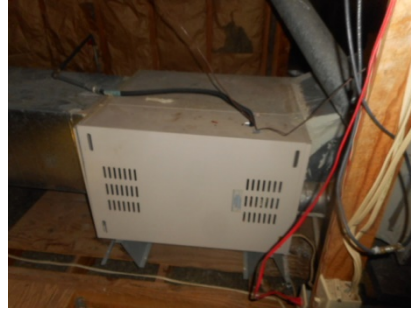
1. A sediment trap should be installed at the gas supply pipe.
2. The furnace flex pipe enters the furnace casing. This is a fire safety hazard.
3. The furnace vent does not vent to the exterior through a dedicated vent pipe. A Class-B vent system should be installed at the roof vent. This is a safety hazard.

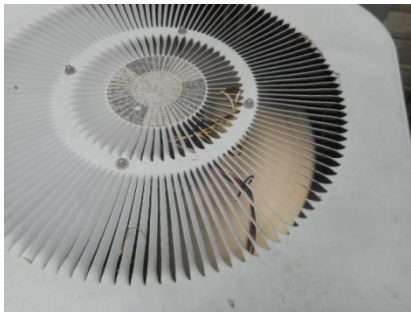
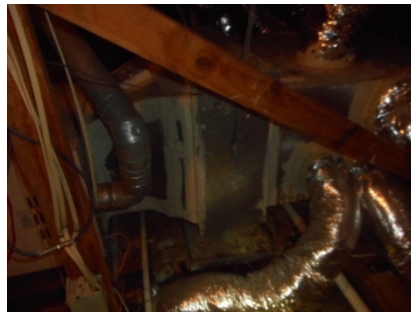
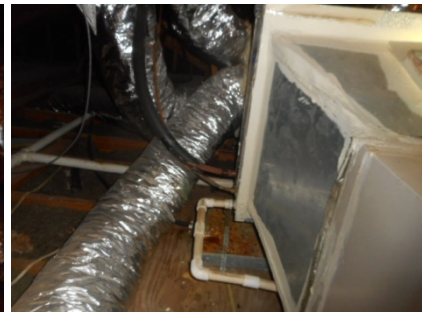
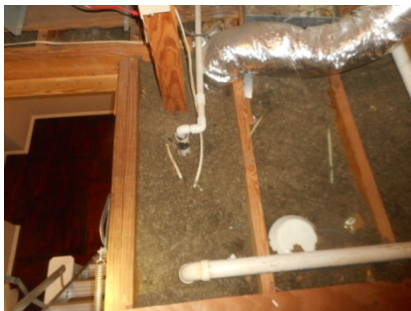
1. Exposed wiring is present at the condensing unit fan motor.
2. A float switch should be installed at the secondary drain pan.
3. The primary drain is a loose drain connection in the attic. This drain should be hard piped with vent riser.

The system should be checked for leaks and serviced by licensed HVAC contractor prior to closing.

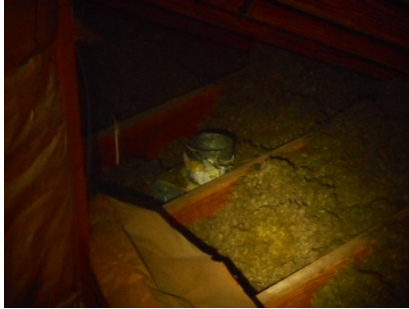
1. A disconnected HVAC supply duct and register are present at the master bathroom. The bathroom was very warm due to this defect. Replace the duct and attach to the HVAC system.

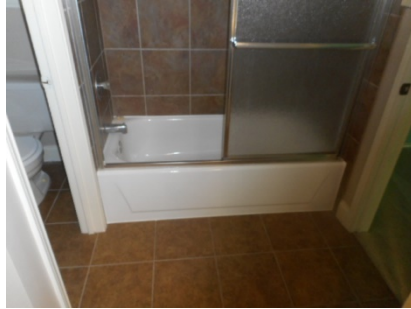
1. There is limited plumbing access at the bathroom bathtubs and showers behind the plumbing walls. Plumbing access should be installed at the bathtub plumbing walls.

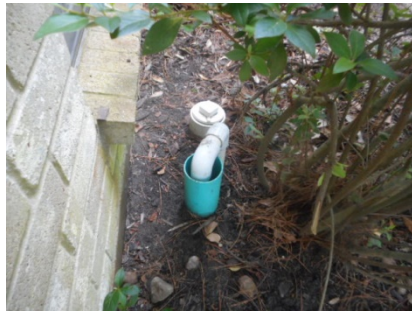
1. The sewer main clean out access was located at the front right wall.

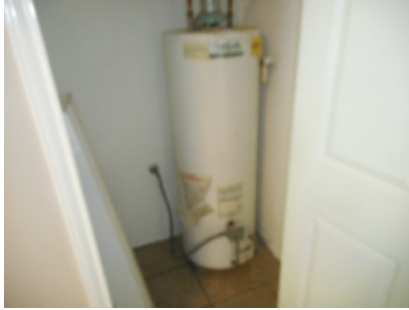
1. The water heater vent does not vent to the exterior through a dedicated vent pipe. A Class-B vent system should be installed at the roof vent. This is a safety hazard.
2. A sediment trap should be installed at the gas supply pipes.
3. The T&P Valve is leaking and needs replaced.

4. This water heater rumbles during the heating cycle and prematurely runs out of hot water due to age and interior sediment. The water heater should be replaced.

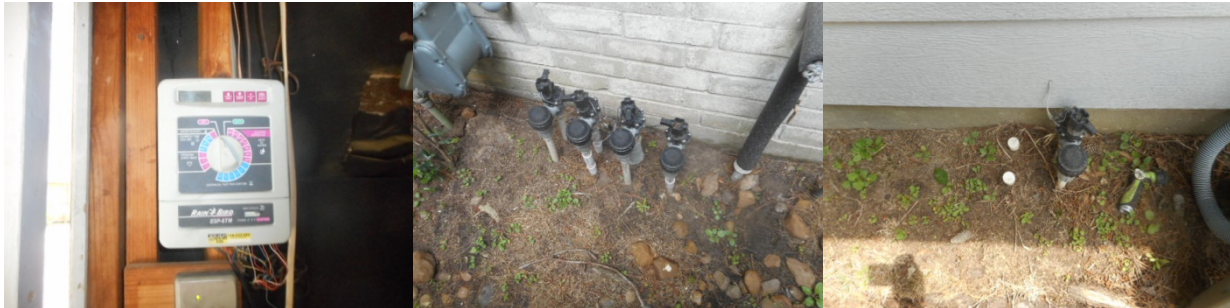
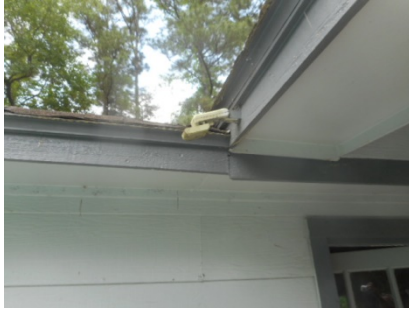
Comments: The six zone irrigation system is not functioning at the time of inspection.

1. The rain sensor is present on the system at the garage eave.
 2. Zones 4, 5, 6 are not functioning and need repaired.
 3. Zone 3 at the front left yard has broken supply pipe and need repaired.
 4. Exposed wiring is present at the left rear yard above the grade.
 5. A backflow prevention valve should be installed at the water supply. This is a health hazard due to cross contamination in the potable and non-potable water supply. .
- All repairs should be performed by a licensed irrigation contractor.

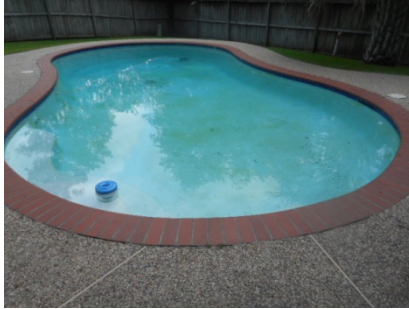
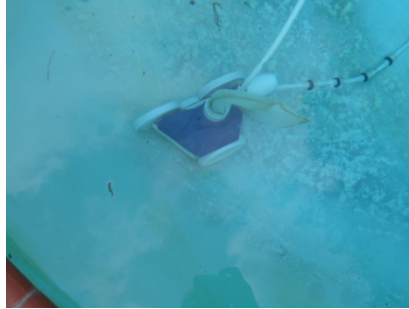
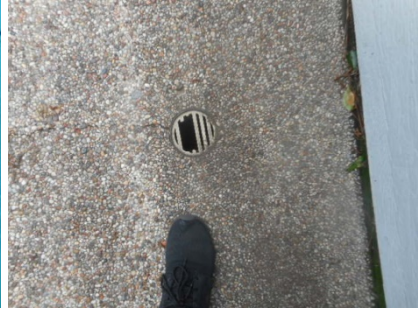
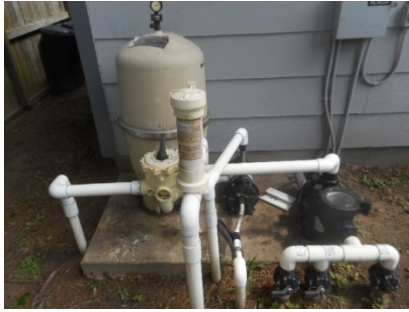
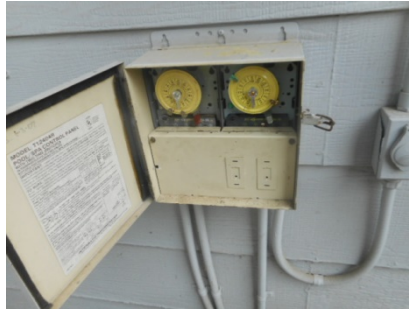
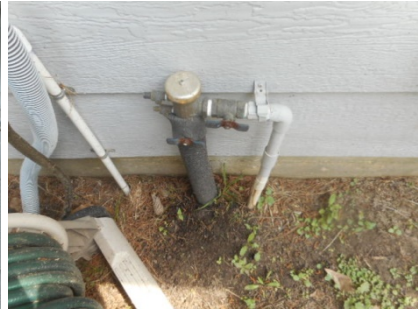
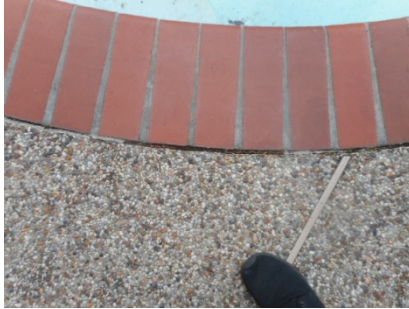
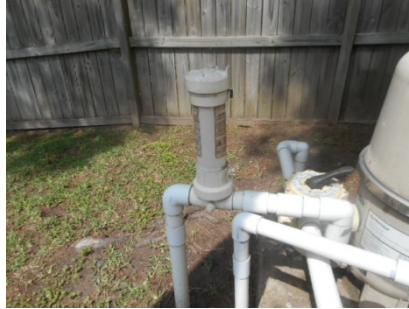
Comments: The pool foundation and concrete decking appear to be functioning at the time of inspection. The Polaris pool Cleaner installed in the pool is not functioning and needs repaired.

1. The pool plaster is in poor condition due to age.
2. The pool pump motor is not GFCI protected. This is a safety hazard.
3. The pool lighting is inoperable and needs repaired. There are two pool lights.
4. The coping deck sealant is deteriorated and needs replaced. This keeps water from entering the soil below the concrete deck and foundation.
5. The automatic pool chlorinator is disconnected and needs replaced.
6. A pool perimeter fence was not installed at the time of inspection. Door alarms to the pool area were not present. This is a safety hazard.
7. Deteriorated drain inlet grates should be replaced to keep debris from entering the drain pipe. All repairs should be performed by a licensed pool service contractor.
