Inspection Report

Property Address:
10311 Olivia View Lane
Cypress TX 77433

PROPERTY INSPECTION REPORT

By: Patrick Miceli TREC #22417 / Spot On Inspection, PLLC 18-May-18

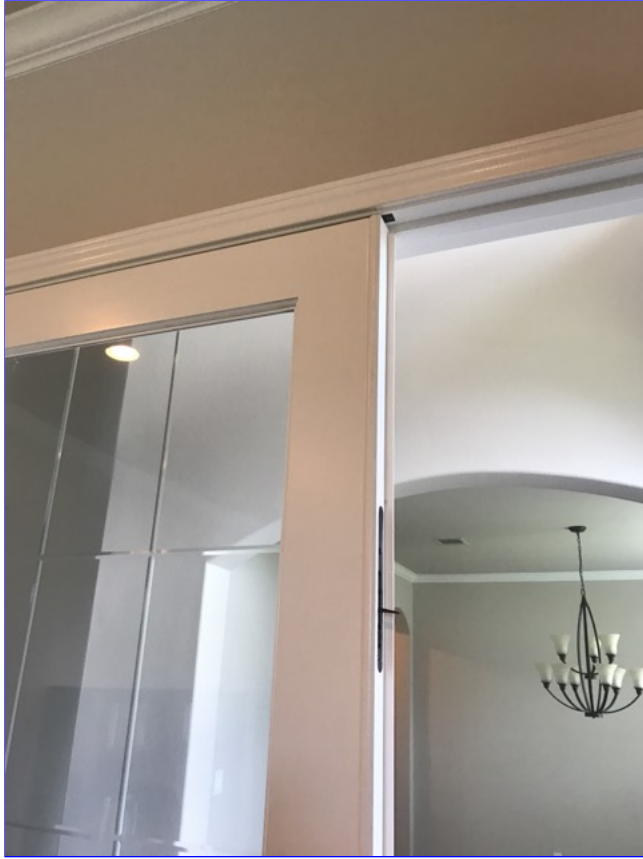
(1) The front parlor entry door top latch does not engage the strike plate. A qualified contractor should be consulted for correction.

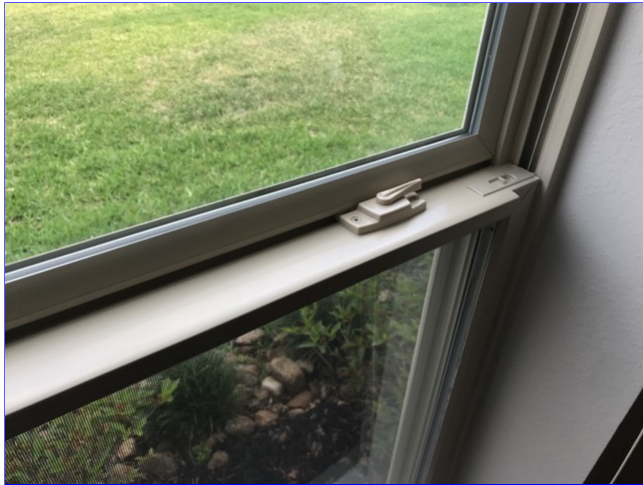
(1) Master bedroom window will not shut completely. The right latch will not engage. A qualified contractor should be consulted for correction.

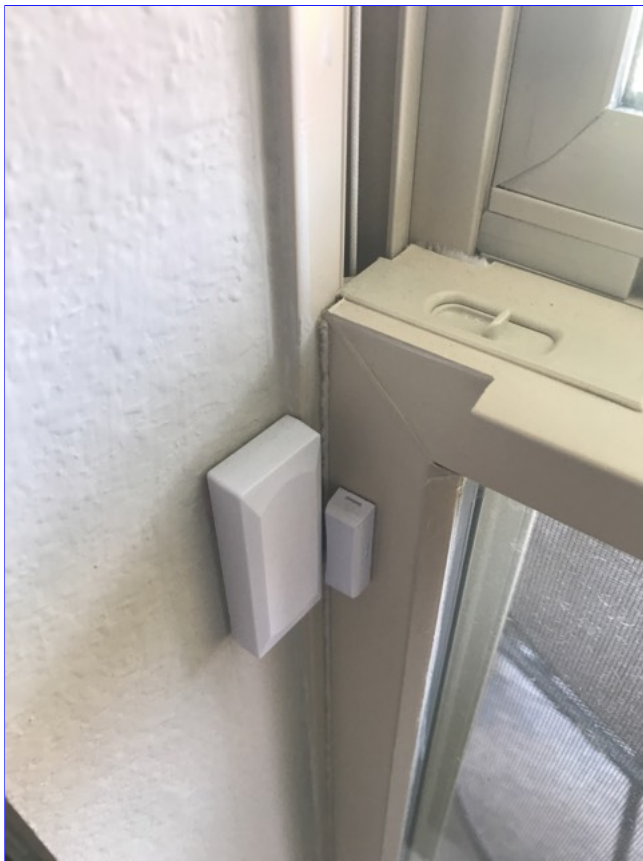
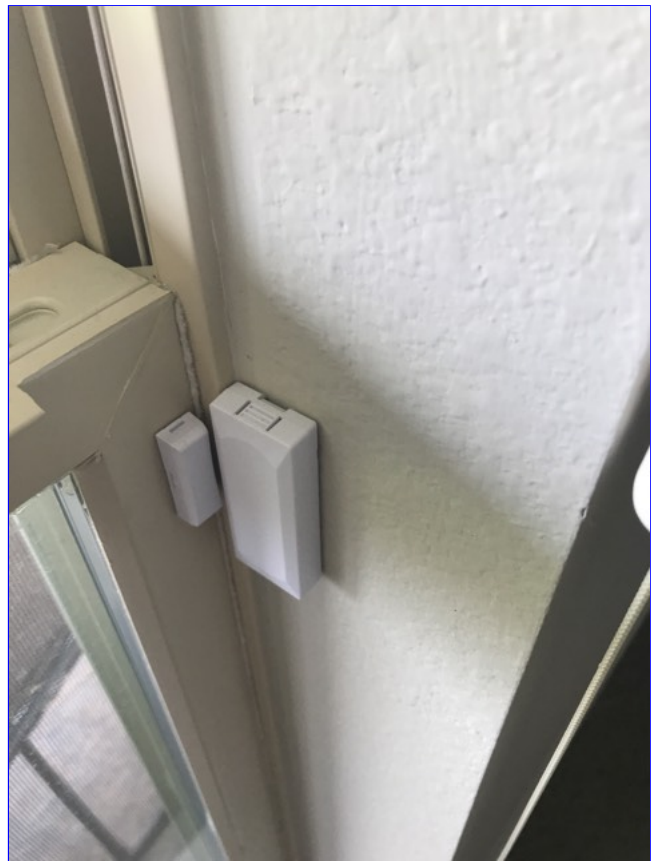
(2) Security sensors interfere with window opening.

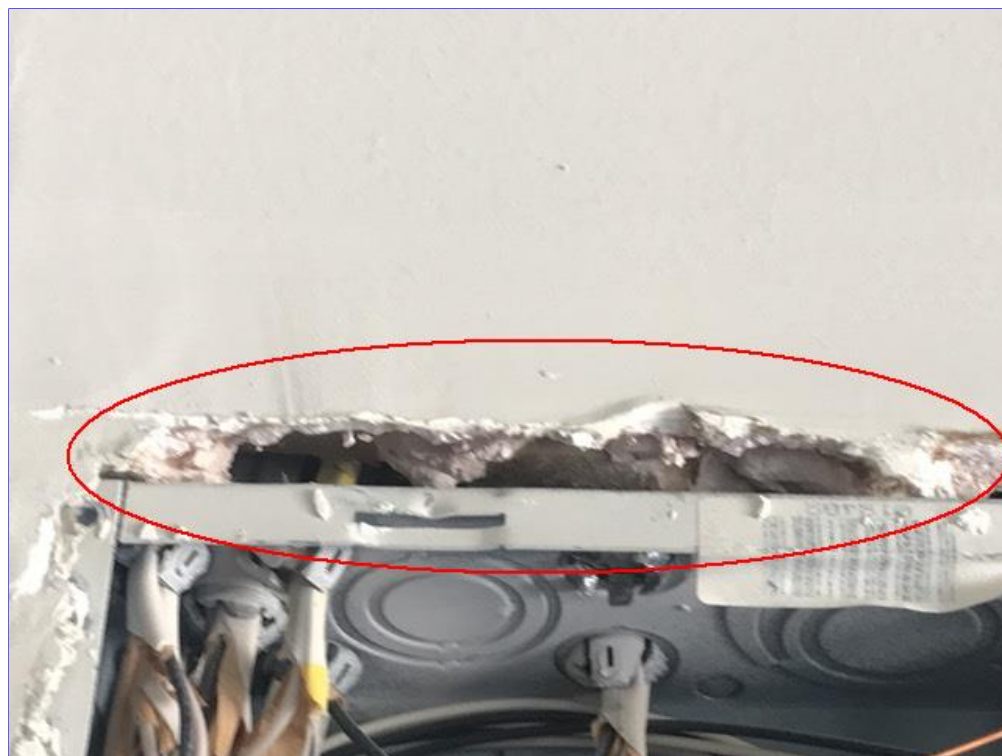
(1) Excessive gap between distribution panel and wall cladding. This is a fire hazard. A qualified contractor should be consulted for correction.

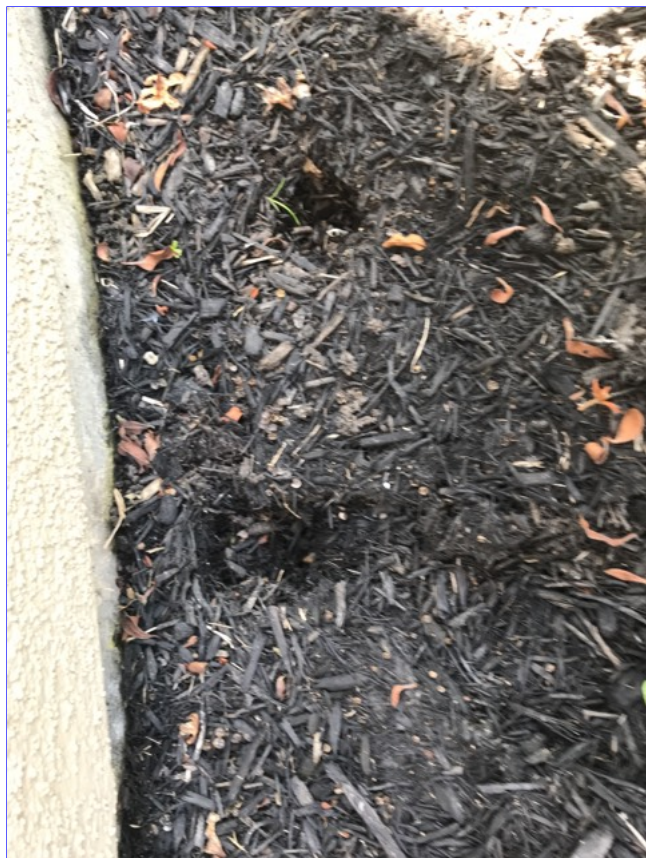
(2) There are depressions underneath both secondary condensate drain line discharges. This indicates recent condensate discharge from both air-conditioner evaporator units. A qualified HVAC technician should be consulted for an evaluation of both units.

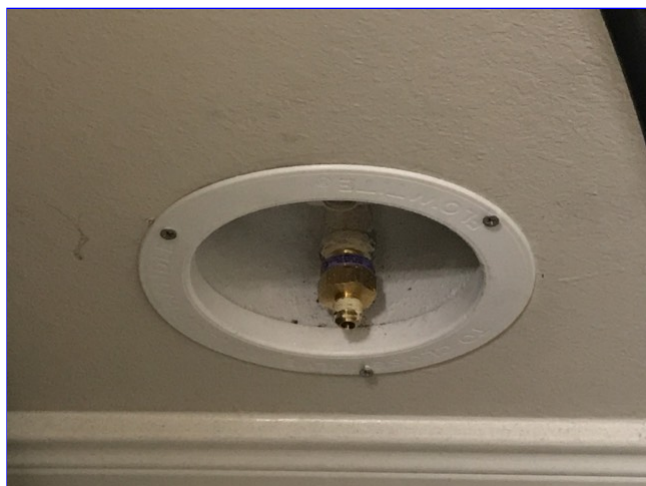
(1) Laundry natural gas outlet should be capped when not connected to an appliance. A qualified plumber should be consulted for correction.

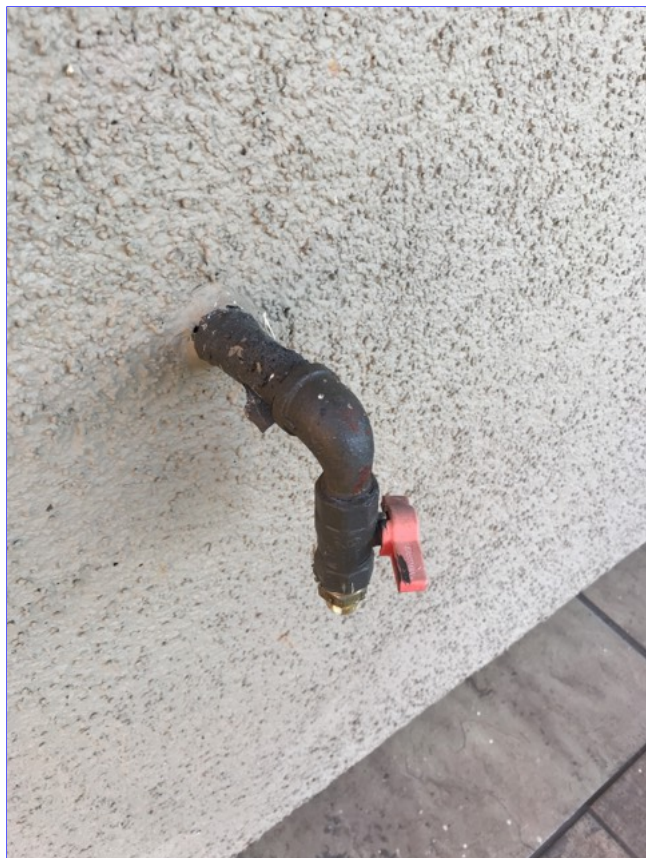
(2) Exterior gas outlet should be capped when there is not an appliance attached. The qualified plumber should be consulted for correction.

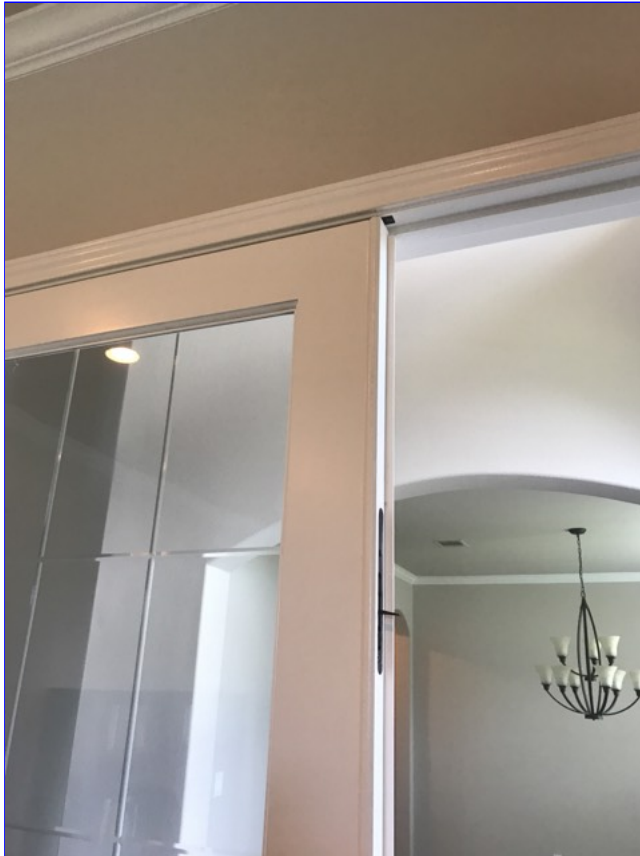
(1) The front parlor entry door top latch does not engage the strike plate. A qualified contractor should be consulted for correction.

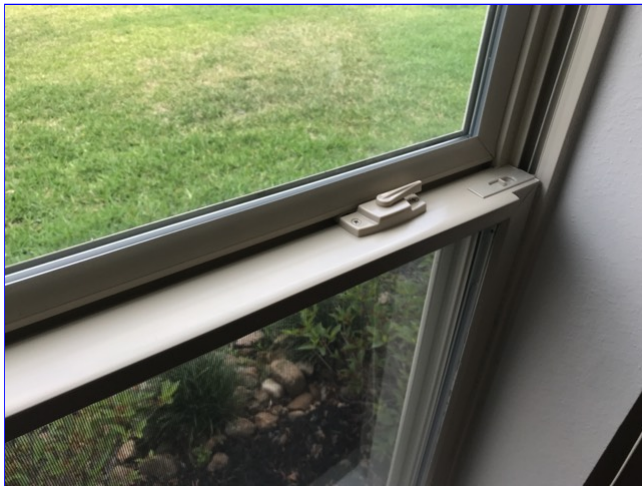
(1) Master bedroom window will not shut completely. The right latch will not engage. A qualified contractor should be consulted for correction.

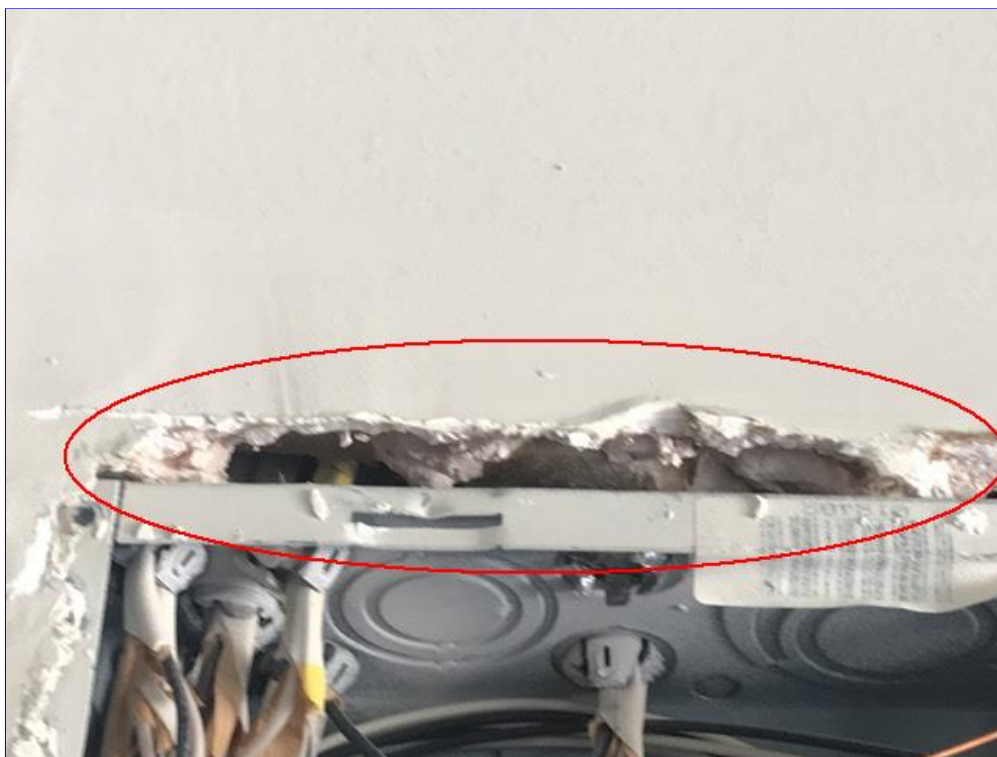
(1) Excessive gap between distribution panel and wall cladding. This is a fire hazard. A qualified contractor should be consulted for correction.

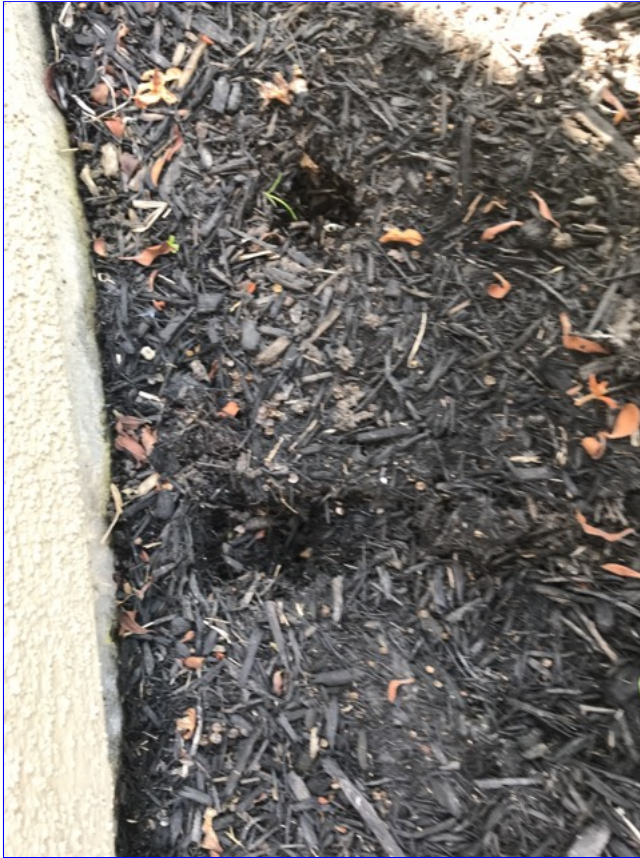
(2) There are depressions underneath both secondary condensate drain line discharges. This indicates recent condensate discharge from both air-conditioner evaporator units. A qualified HVAC technician should be consulted for an evaluation of both units.

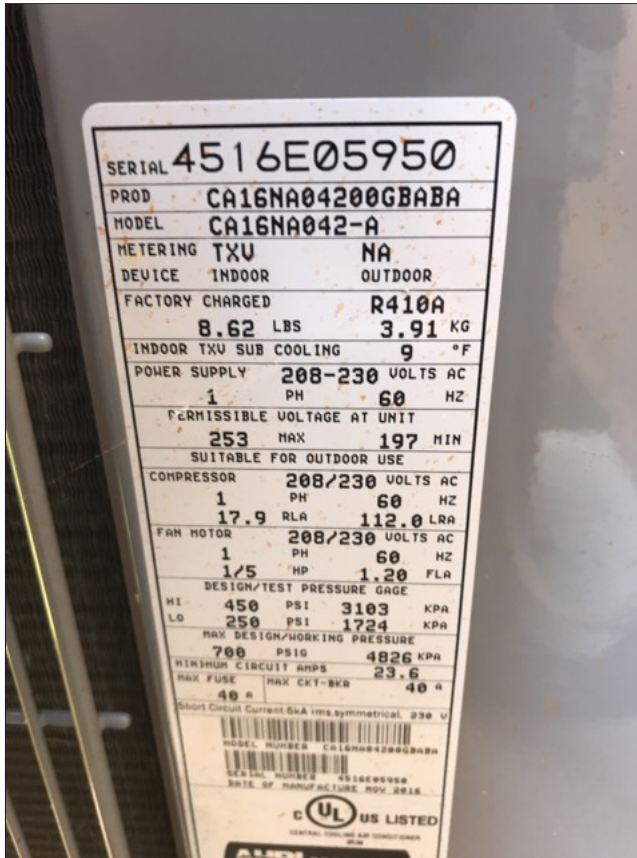
(5) Air conditioning condenser unit dataplate for information only. This unit was manufactured in 2016

Expected service life of condenser units is 10-15 years although some units remain in service for much longer. Regular maintenance may increase service life.

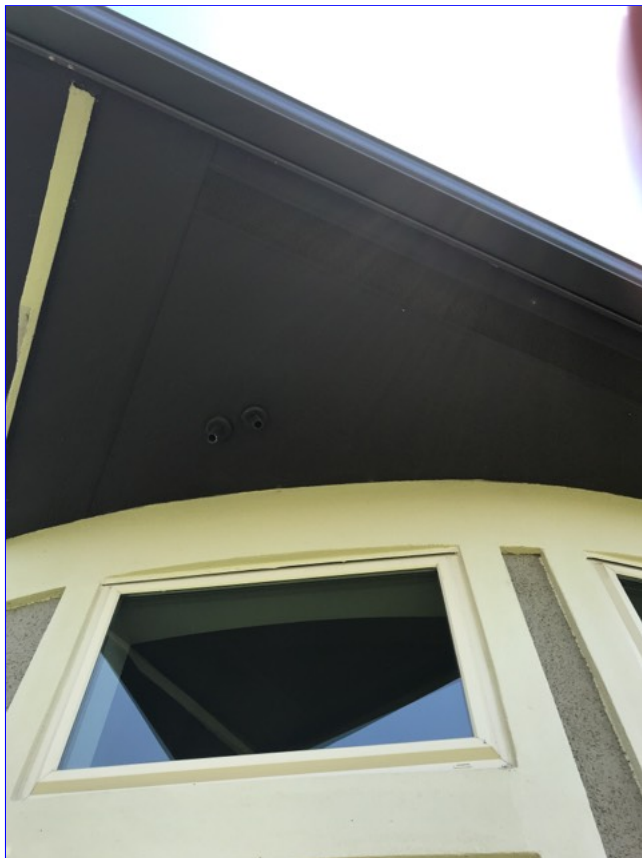
(11) The pipes in the soffit are the secondary condensate drain for the air conditioning system. Water emitting from these drains indicates a problem with the primary drain system. If water is seen, a qualified contractor should be consulted for correction. This is for information only.

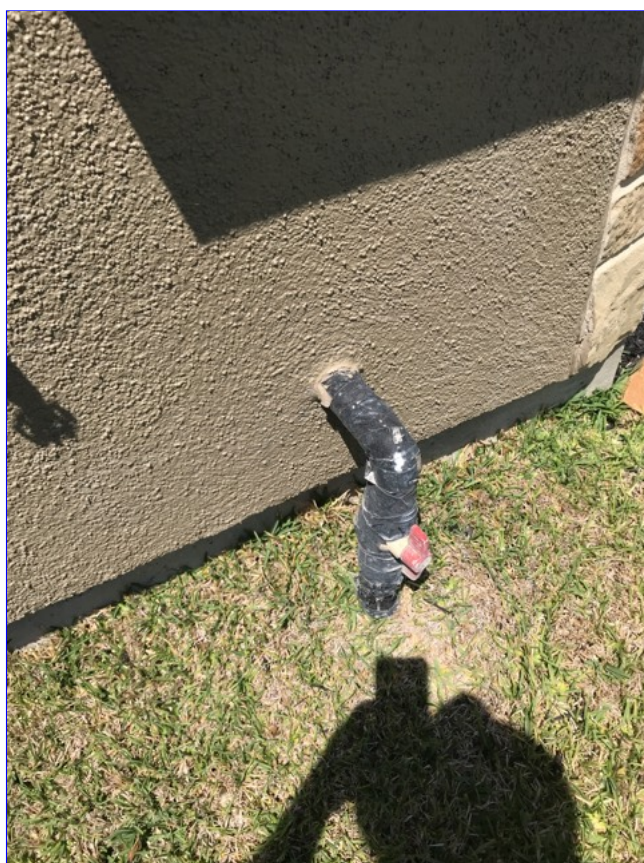
(3) The homeowner's water supply shutoff valve is located outside outside on the west side of the structure.

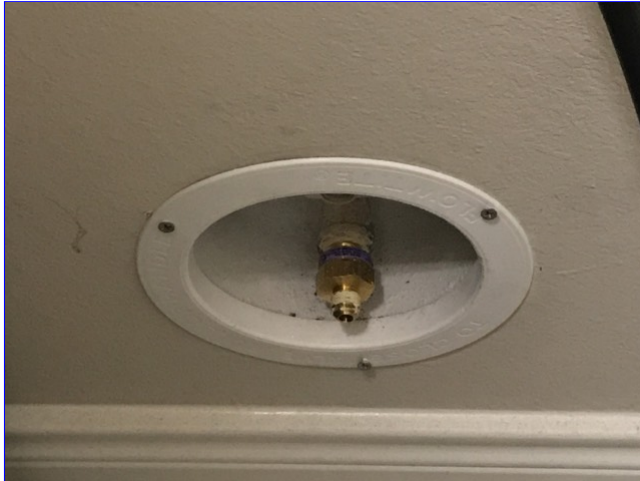
(2) Exterior gas outlet should be When there is not an appliance attached. The qualified plumber should be consulted for correction.

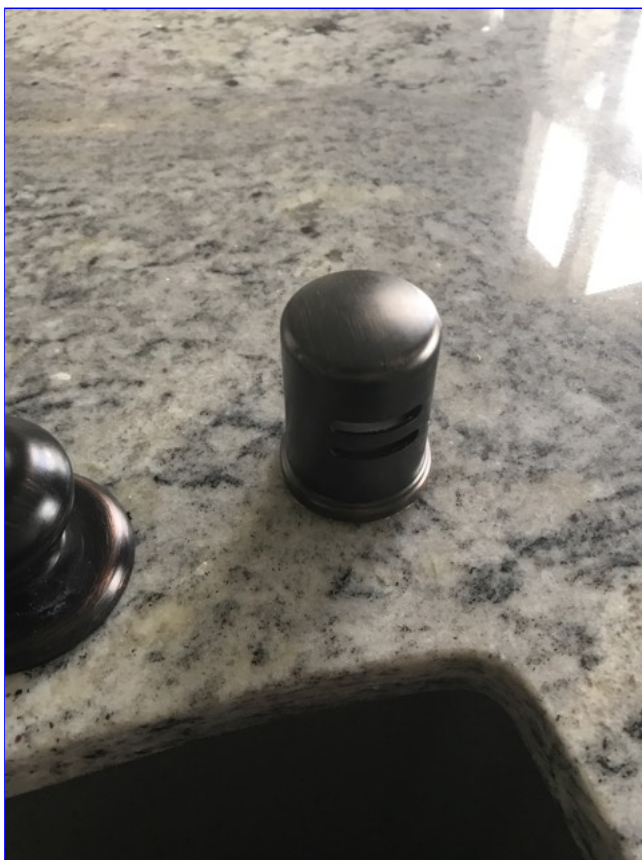
- (1) The dishwasher was operated through a full cycle and no deficiencies were noted.
- (2) The dishwasher is switched as the means of disconnect. This is for information only.
- (3) The small device to the right of the sink faucet is the dishwasher air gap. It provides protection against the backflow of contaminants into the dishwasher. The cutout should face the sink so that any water emanating from the device drains into the sink. This is for information only.

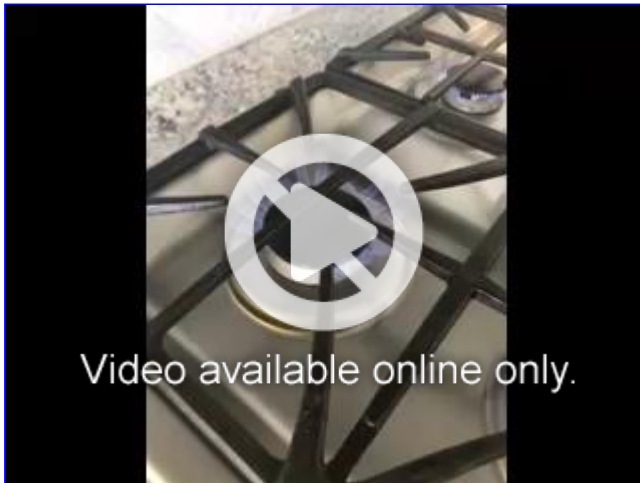
The rear left cooktop burner does not have complete flame. A qualified technician should be consulted for correction.
