PROFESSIONAL HOME INSPECTION REPORT- D

2214 Blindlake Dr
Houston TX 77084

Concerning: 2214 Blindlake Dr, Houston TX 77084

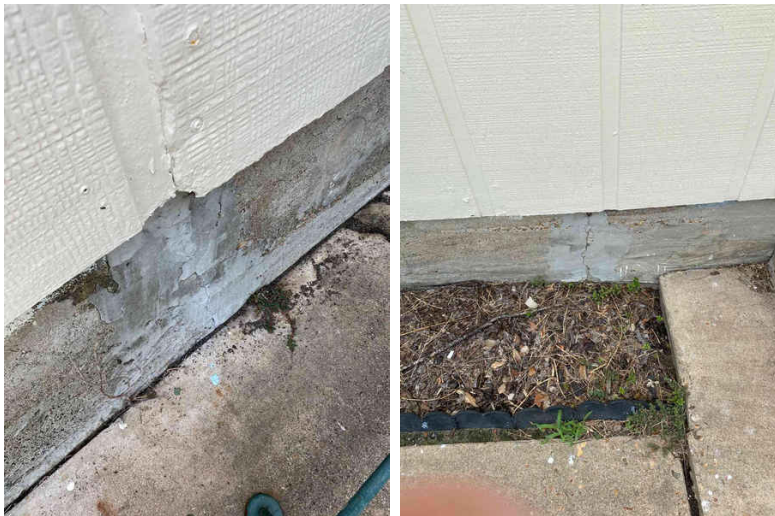
Structural Movement Noted:

Structural movement and/or settling is noted. **In my opinion** the foundation appears to be supporting the structure and settlement does not appear to be excessive at this time.

Signs of structural movement/settling: Cracking/deflecting masonry cladding, Exterior wall cracking/movement

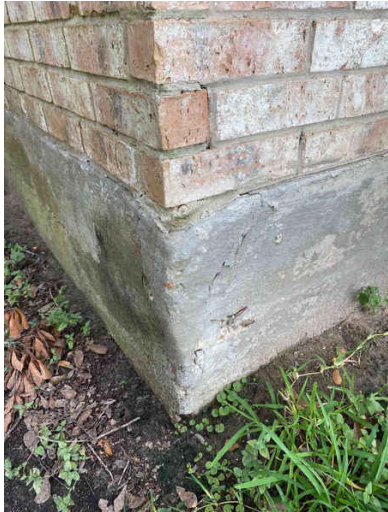
1: Cracking in the garage/service walks/driveway

Cracking was observed in various locations. This implies structural movement has occurred as well as soils are moving. Have further investigated.

Recommendation: Contact a qualified professional.

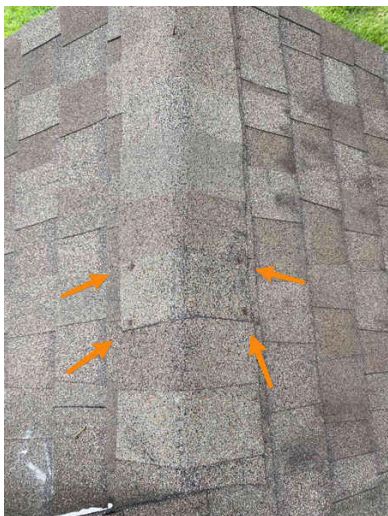
2: Trees in contact

Tree branches are in contact with the roof. Recommend trimming tree branches back 3 to 5 feet to prevent roof damage.

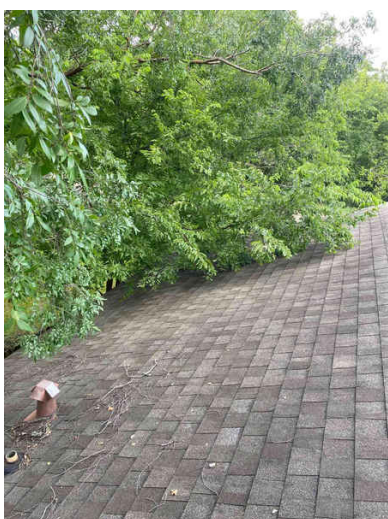
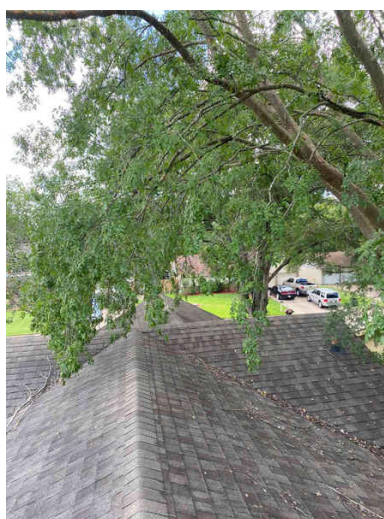
3: Granular deterioration

Granular deterioration (erosion of the shingle grains) is visible in one or more areas.

Recommendation: Contact a qualified roofing professional.

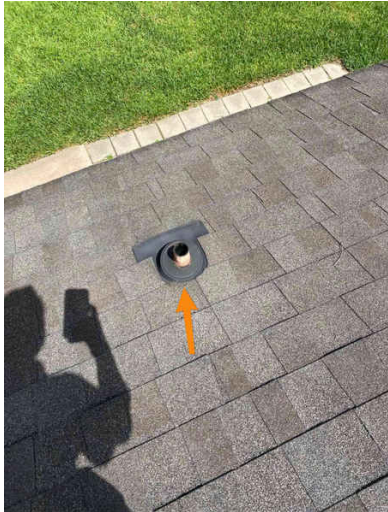
5: Clearance- Plumbing vents

plumbing vents should be at least 6 inches above roof decking materials. Have further investigated and repaired as needed.

Recommendation: Contact a qualified professional.

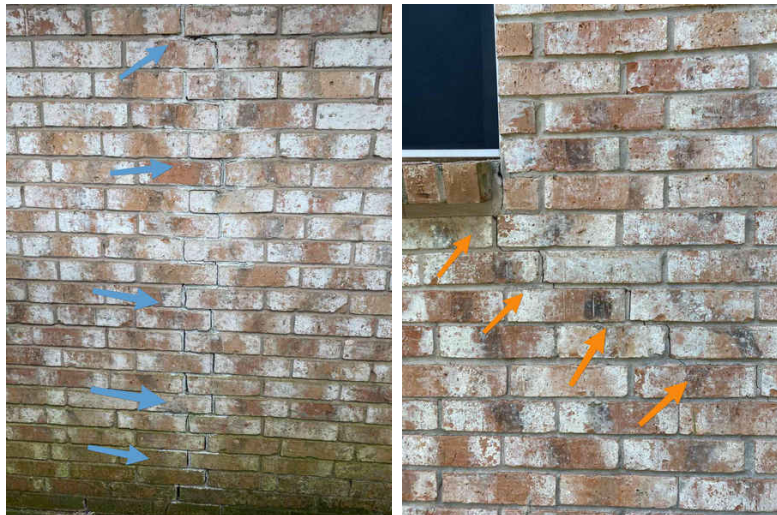
1: Exterior- Mortar cracks

Brick/stone veneer mortar is cracked in some areas. May be excessive and may be caused by normal settlement.

Recommendation: Contact a qualified professional.

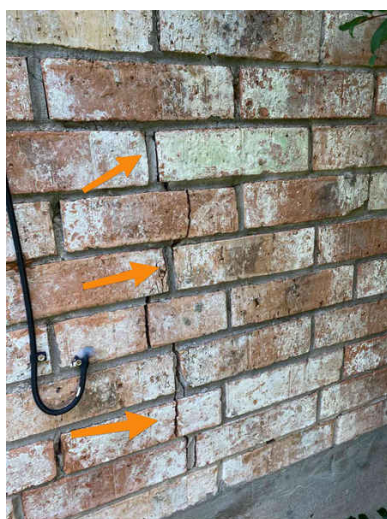
2: Exterior wall movement

Exterior wall movement was evident. This implies structural movement has occurred. Recommend further evaluation.

Recommendation: Contact a qualified professional.

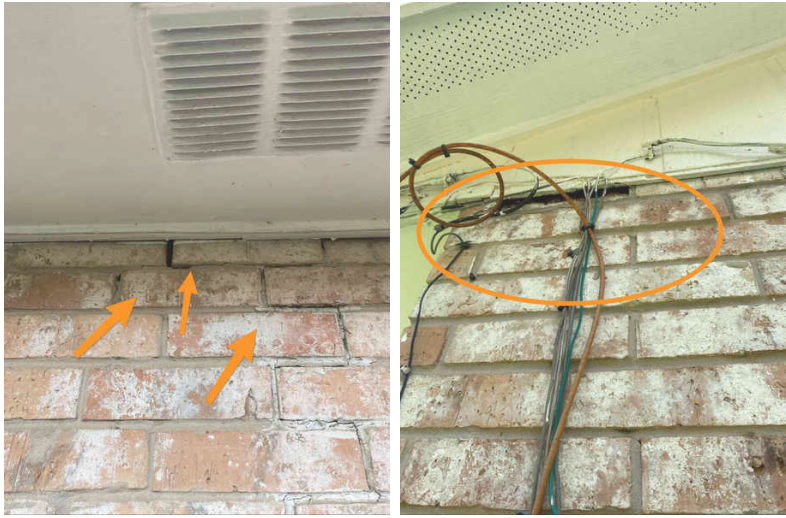
3: Exterior vulnerable areas

Vulnerable areas were noted in various areas around the house. Sealant or mortar is recommended to avoid water intrusion.

Recommendation: Contact a qualified professional.

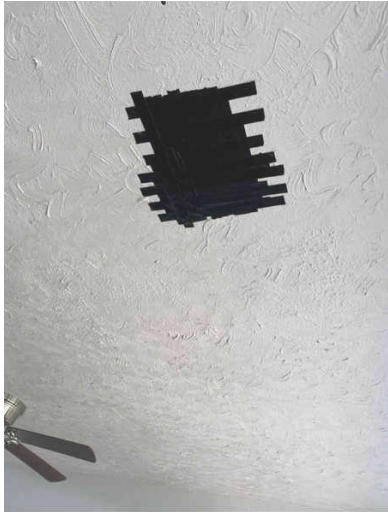
2: Improper repair materials

Tape is not a proper means of repair to the ceiling. Have repaired by a professional.

Recommendation: Contact a qualified professional.

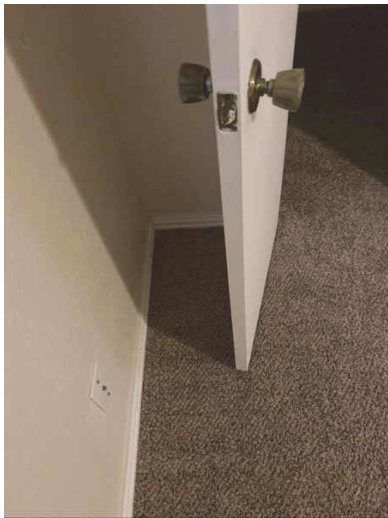
1: Missing door stoppers

One or more door stopper(s) are not installed. Have installed to prevent damage to the interior walls.

Recommendation: Contact a qualified professional.

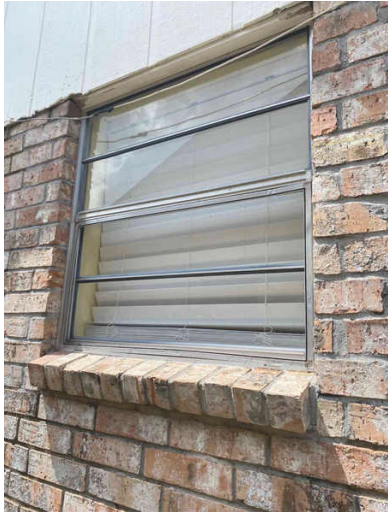
1: Missing Screen(s)

It may be desirable to replace window screens where missing. The owner should be consulted regarding any screens that may be in storage.

Recommendation: Contact a qualified window repair/installation contractor.

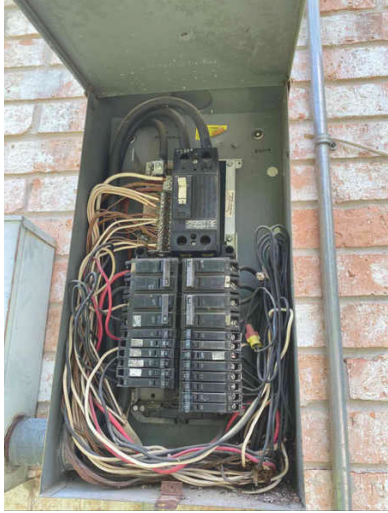
2: Neutrals are Double Lugged

Some neutral (white) wires are double-lugged (two or more neutral wires placed under one lug on the neutral bus bar). Only one wire should be placed under each screw lug on the neutral bus bar. Not to current standards.

Recommendation: Contact a qualified electrical contractor.

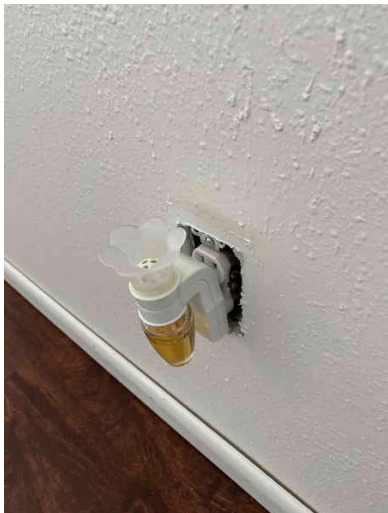
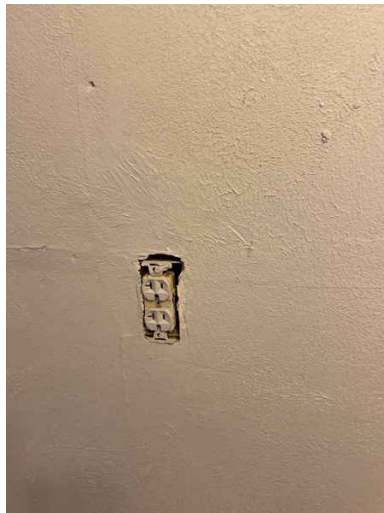
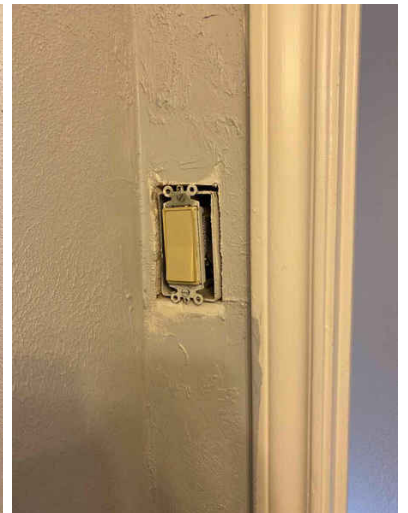
1: Cover Plates Missing

One or more receptacles are missing a cover plate. This is a safety hazard. Recommend installation of plates.

Recommendation: Contact a qualified electrical contractor.

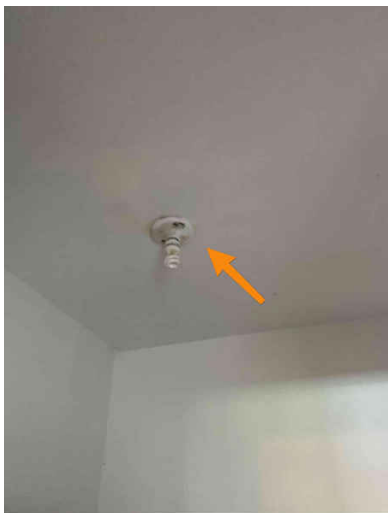
2: Light Inoperable

One or more lights are not operating. New light bulb possibly needed.

Recommendation: Contact a qualified electrical contractor.

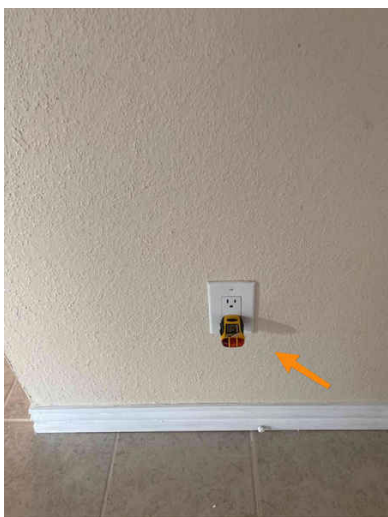
3: No Power at outlet

There is no power indication at the receptacle(s).

Recommendation: Contact a qualified electrical contractor.

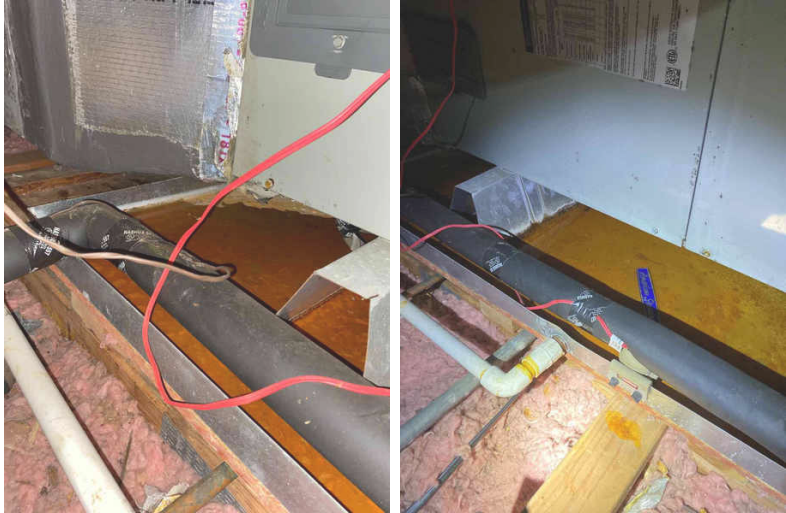
1: Pan rusted

The pan under the unit is rusted. Recommend replacing.

Recommendation: Contact a qualified professional.

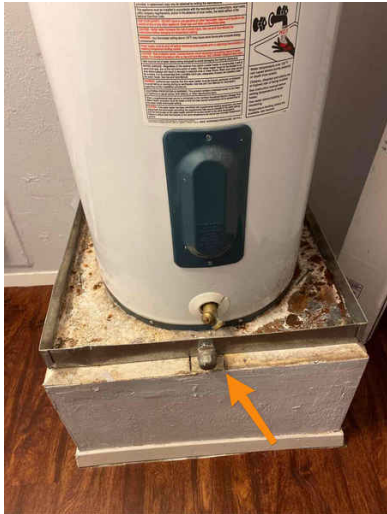
1: No Drain line connected to pan

A water heater drain pan drain line is not connected to the pan. If the water heater begins to leak, water in the drain pan will flow out of the pan and into the surrounding area causing damage.

Recommendation: Contact a qualified plumbing contractor.

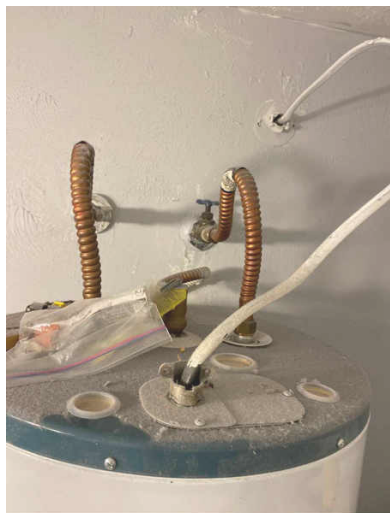
2: No Wire clamp on wires

A wire clamp (strain clamp) is not installed where the water heater electrical wire enters the water heater.

Recommendation: Contact a qualified plumbing contractor.
