Inspection Report

Property Address:
1101 GROSS ST
HOUSTON TX 77019

PROPERTY INSPECTION REPORT

By: Jon Rabun TREC License #23539 / Hilsher Group LLC 1/28/2020

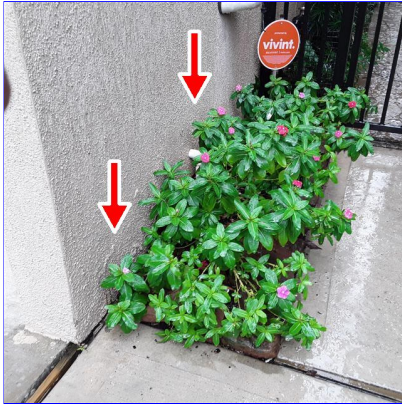
A. Item 1(Picture) Right side front of home at entry

(2) There is vegetation obstructing clear visibility of foundation. This limits full inspection of foundation condition and can create conducive condition for certain types of wood destroying insects. I recommend removing vegetation and having a qualified person inspect foundation wall and pest control company inspect and treat as needed.

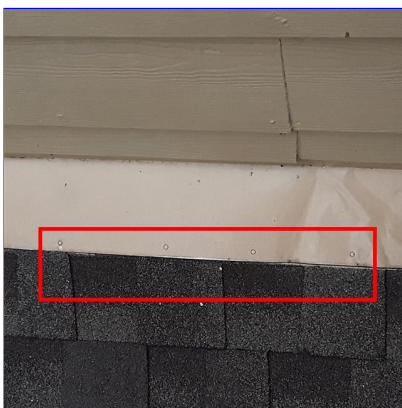
C. Item 1(Picture) First level roof system at rear

(2) The roofing surface has exposed nail heads that are showing signs of deterioration. Further deterioration will occur if not corrected. I recommend having a qualified person repair or replace as needed,

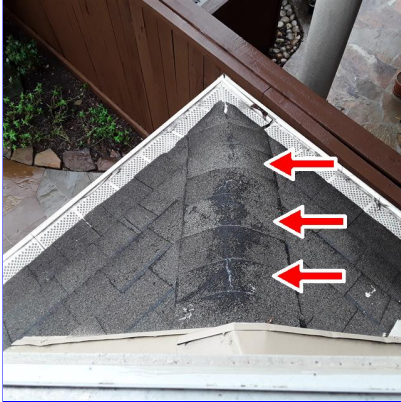
C. Item 2(Picture) Heavily damaged hip ridge shingles at rear lower level.

(3) The roof covering is damaged in areas. These areas may need replacement and or periodic maintenance. A qualified roofing contractor should inspect and repair as needed.

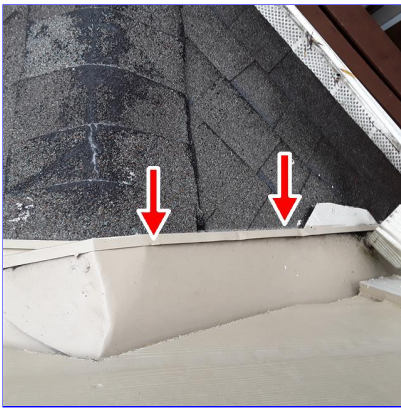
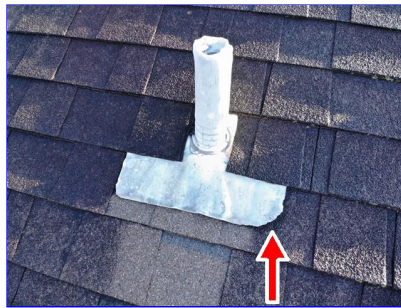
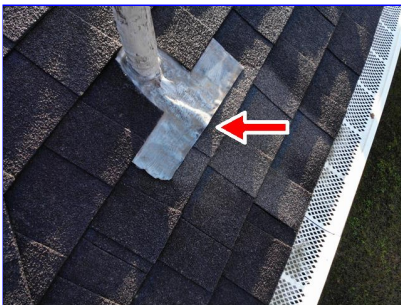
(4) The flashing is loose and needs repair. I recommend having a qualified person make repairs as needed.

C. Item 3(Picture) Rear lower roofing system

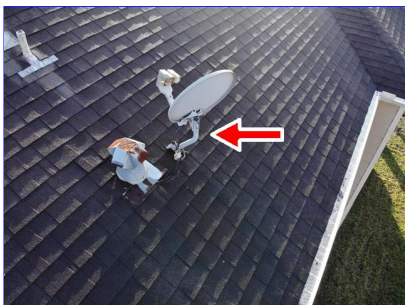
C. Item 6(Picture)

(5) There is a satellite dish bracket mounted on roof that is screwed directly through roofing surface. This is not considered to be today's standard. I recommend having a qualified person remove and patch roofing as needed. (The area will need periodic maintenance)

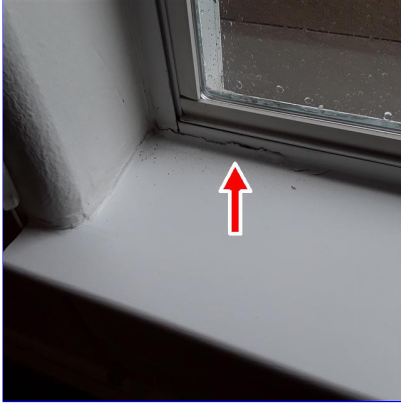
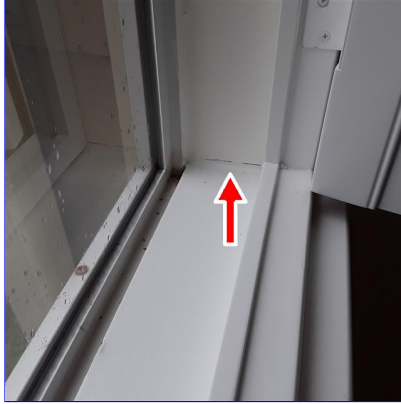
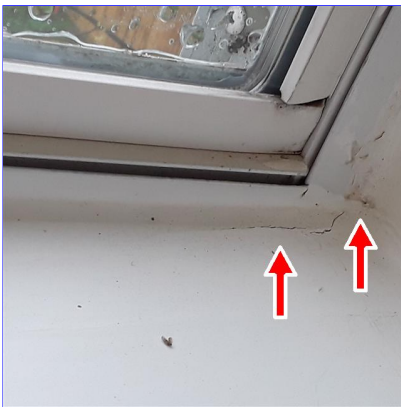
(1) Interior trim is damaged or peeling paint in areas. This is a cosmetic issue. I recommend repair as desired.

E. Item 1(Picture) Areas at some window sill trim, need fresh caulk

E. Item 2(Picture) First landing past kitchen

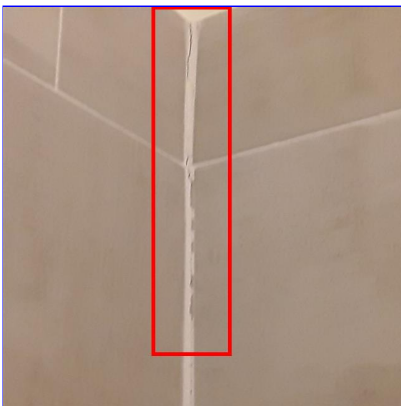
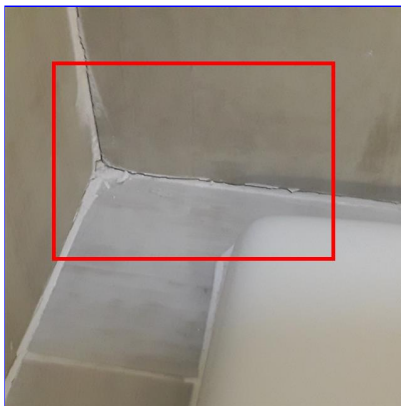
(2) The tile surround at the bath wall is deteriorated and needs repair or replacement. The wall board and framing may need repair (not visible). I recommend repair or replace using a qualified contractor.

E. Item 4(Picture) Master shower

E. Item 5(Picture) At master tub corners

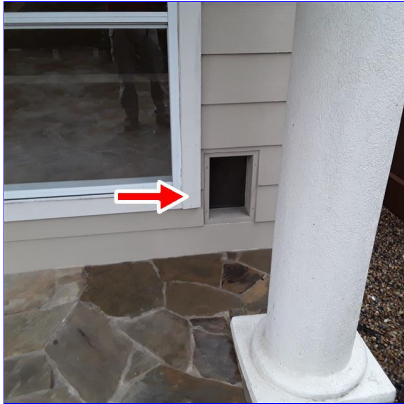
E. Item 6(Picture)

(3) The Cement board rear of home at lower patio, has a doggie installed. This is for your information.

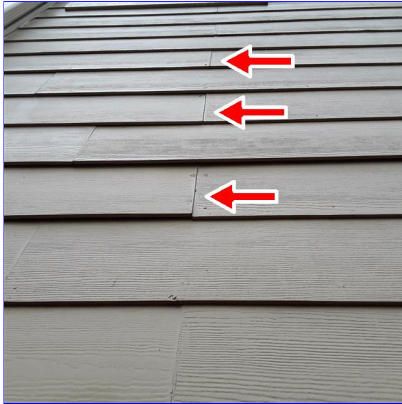
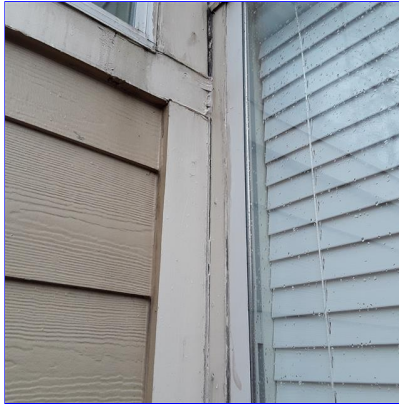
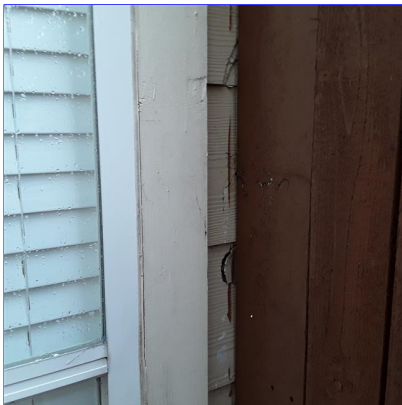
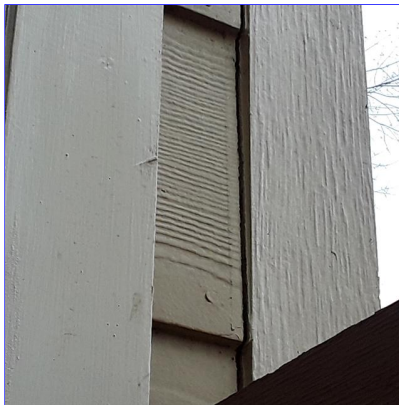
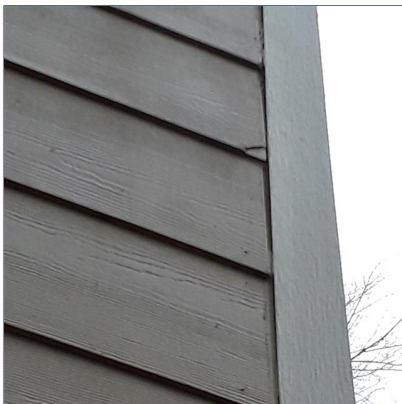
(4) The exterior siding and trim is deteriorated in areas. Further deterioration will occur if not corrected. A qualified contractor should inspect and repair as needed.

E. Item 7(Picture) Left side siding and areas around home need the caulk at joints. to prevent moisture from penetrating wall system.

E. Item 8(Picture) Left side of home

E. Item 9(Picture) Damaged siding at left side, lower level

E. Item 10(Picture) Left side towards rear, needs fresh caulk at corner board trim.

E. Item 11(Picture) Damaged siding at left side

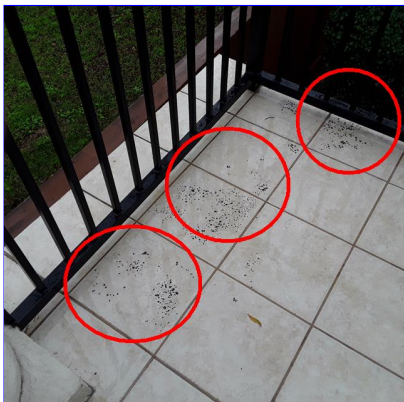
The tile flooring is cracked/damaged. This damage is considered cosmetic. I recommend repair as desired.

F. Item 1(Picture) Chipped tile at upper first level balcony

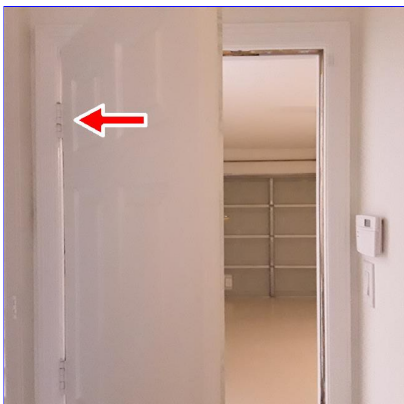
(1) The interior garage door does not have the required self closing hinge. This is not considered to be today's standard. I recommend having a qualified person make repairs as needed.

G. Item 1(Picture) Should be self closing hinge

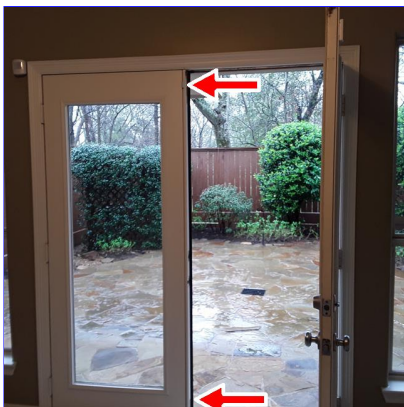
(2) The door does not operate properly and needs adjustment . A repair or replacement is needed. A qualified person should repair or replace as needed.

G. Item 2(Picture) Is hard to open

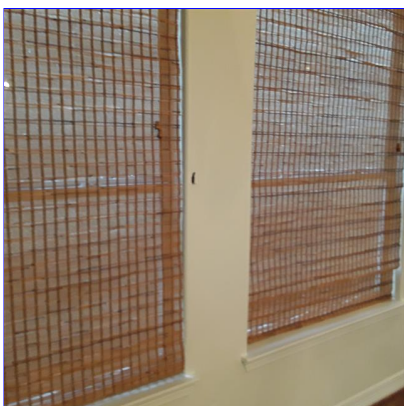
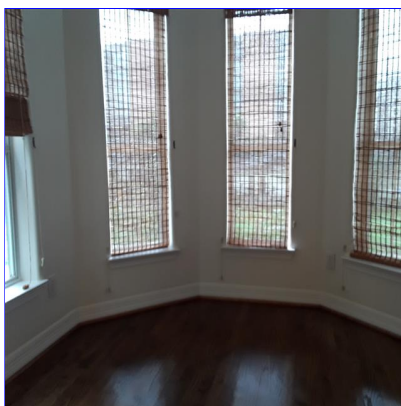
- (1) Windows have damaged or missing screens at most window locations This is not considered to be today's standards. I recommend having a qualified person make repairs as needed.
- (2) Several windows difficult to operate in areas. This is a maintenance issue and is for your information. A qualified contractor should inspect and repair as needed. (Note: Multiple areas on multiple floors)

H. Item 1(Picture) Second floor windows

H. Item 2(Picture) At second level living area

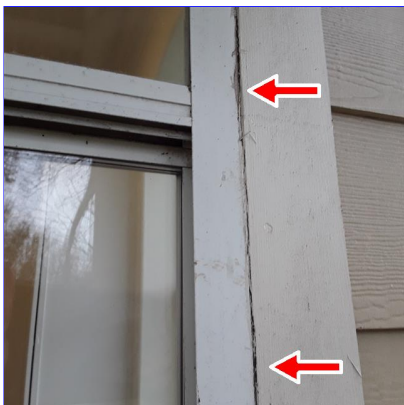
- (3) There are window frames that are not properly sealed. This can cause energy loss. I recommend having a qualified person seal and repair as needed,

H. Item 3(Picture) Window at back upper balcony by kitchen

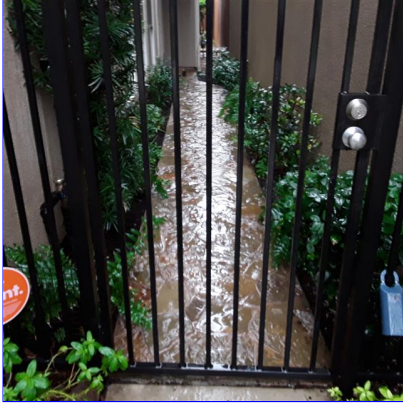
K. Item 1(Picture) Front walk/
porch

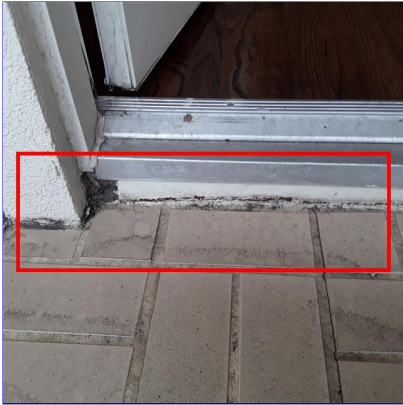
(2) Decking is showing signs of deterioration in several areas. I recommend having a qualified contractor repair or replace as needed.

K. Item 2(Picture) First level deck,
front living area needs fresh caulk
at the exterior to wall, to keep
moisture out of the wall system

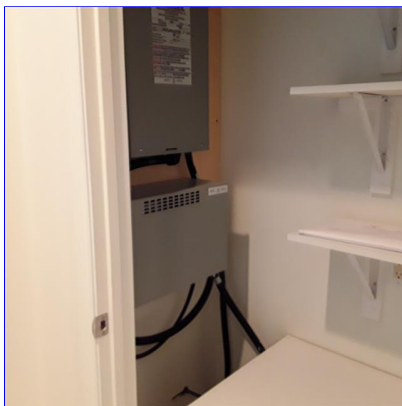
A. Item 1(Picture)

(1) There is an electrical system for the elevator service, located in the closet right of elevator on third level. This is not in our scope. Not inspected.

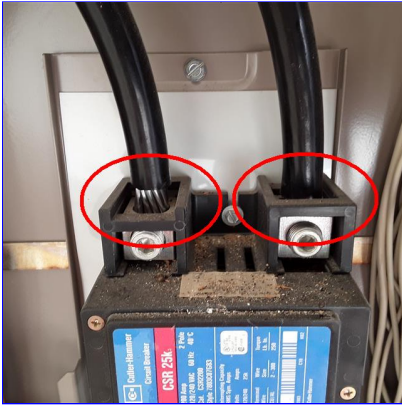
A. Item 2(Picture)

(2) There is no antioxidant on aluminum conductors feeding panel. This is not considered to be today's standard. I recommend having a qualified electrician evaluate make repairs as needed.

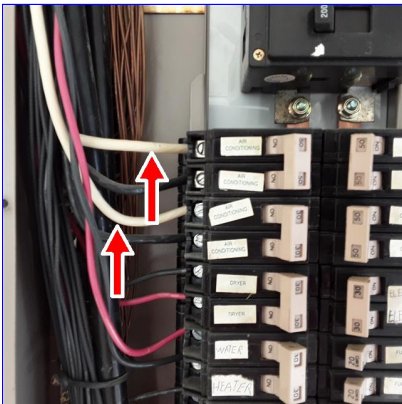
(2) Problem(s) discovered with Branch Circuits such as amateur wiring installation, and any other problems that an electrical contractor may discover while performing repairs need correcting. I recommend a licensed electrical contractor inspect further and correct as needed.

B. Item 1(Picture) White neutrals been used as hot lead. Needs to be marked as such.

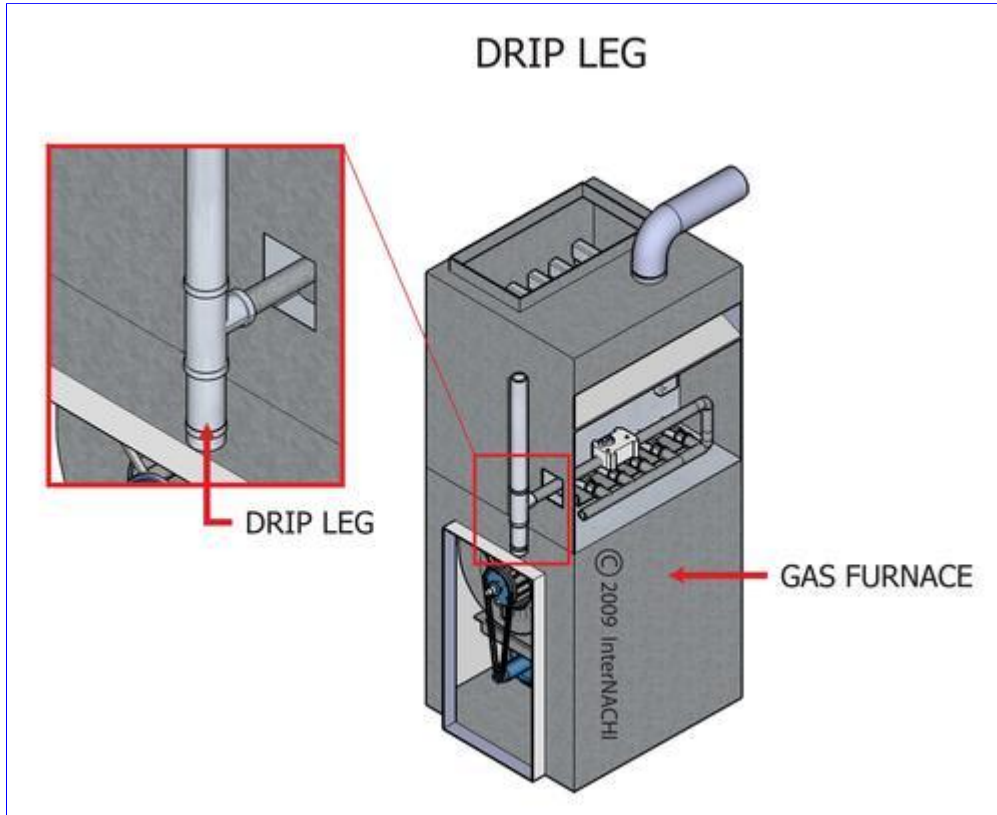
(2) The gas furnace is installed without the recommended sediment trap or "drip leg" that is designed to extend the life of the unit. This is not considered to be today's standard. I recommend having a qualified person make repairs as needed.

A. Item 1(Picture) dripleg

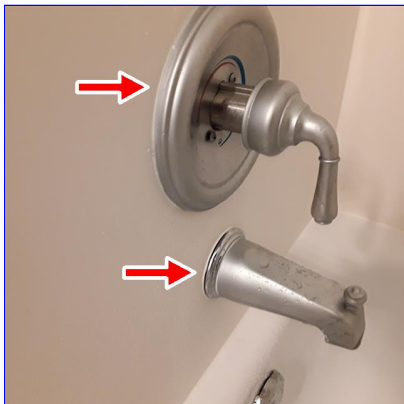
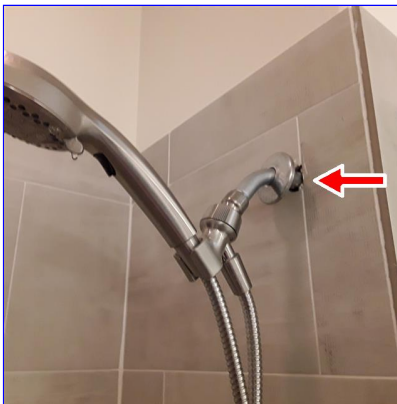
Tub/shower fixtures at multiple baths, are a little loose and need caulk/seal at base to wall mount, to prevent moisture from seeping into the wall. This needs repair. Recommend a qualified contractor to make repairs is necessary.

A. Item 1(Picture) Upper level rear bath

A. Item 2(Picture) Master shower head

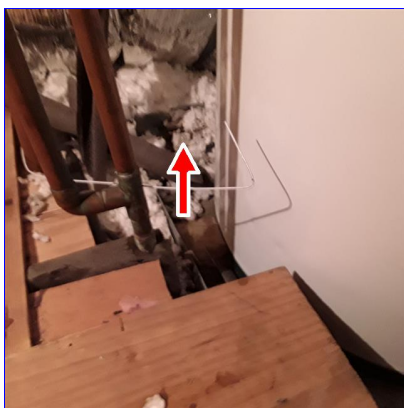
The emergency over flow drain pan for the unit is cluttered with debris.. I recommend cleaning.

C. Item 1(Picture) Water heater pan needs to be cleaned out.

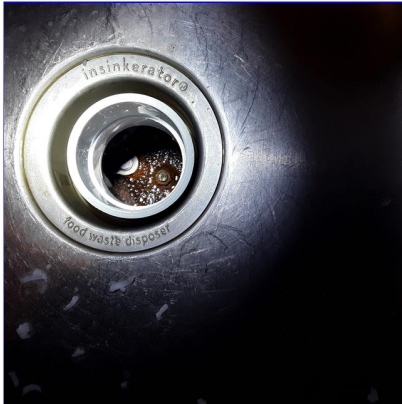
B. Item 1(Picture)

The food disposer is rusted inside at the blades. I recommend repair as needed.
